**NIST NCSTAR 1-5A**

**Federal Building and Fire Safety Investigation of the  
World Trade Center Disaster**

# **Visual Evidence, Damage Estimates, and Timeline Analysis**

September 2005

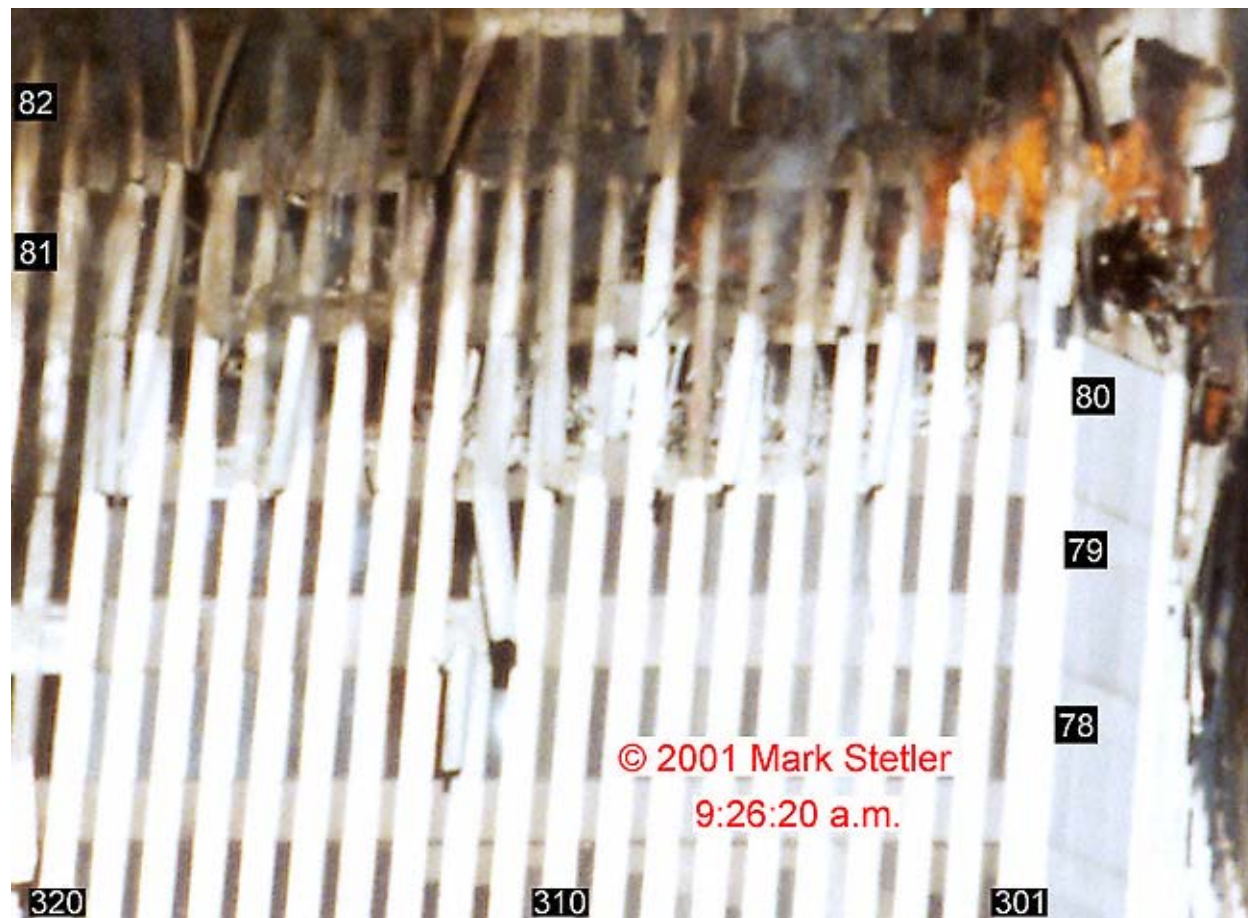
Figure 7–30 shows an enlarged region of the northeast corner of the tower taken from Figure 7–28. Large piles of debris can be seen through the windows near the corner on the 80th and 81st floors. It is likely that a large fraction of this debris was derived from the aircraft, since its body impacted on these two floors (see Figure 7–26). This suggests that either the debris was deflected from the core or that the aircraft was moving toward the east when it struck the tower, since the nose struck near column 422 on the south face.

Figure 7–30 also shows that the aluminum panels on the 80th and 81st floors of the northeast corner have been pushed out and partially removed. This damage was present immediately following the aircraft impact. Observations included in Table 7–1 indicate that the initial damage in this area appeared 0.4 s after the aircraft impact. As discussed below, it is likely that one of the engines of the aircraft passed through this corner. A pile of debris can also be seen jutting from this corner on the 81st floor. The debris in the corner can be seen more clearly in Figure 7–31, which was shot from the northeast. Additional debris extends from windows on either side of the corner.

**Figure 7-30.** This photograph showing a portion of the east face of WTC 2 was cropped from the image shown in Figure 7–28. The image has been rotated, and column and floor numbers have been added. Note the large piles of debris on the 80th and 81st floors.

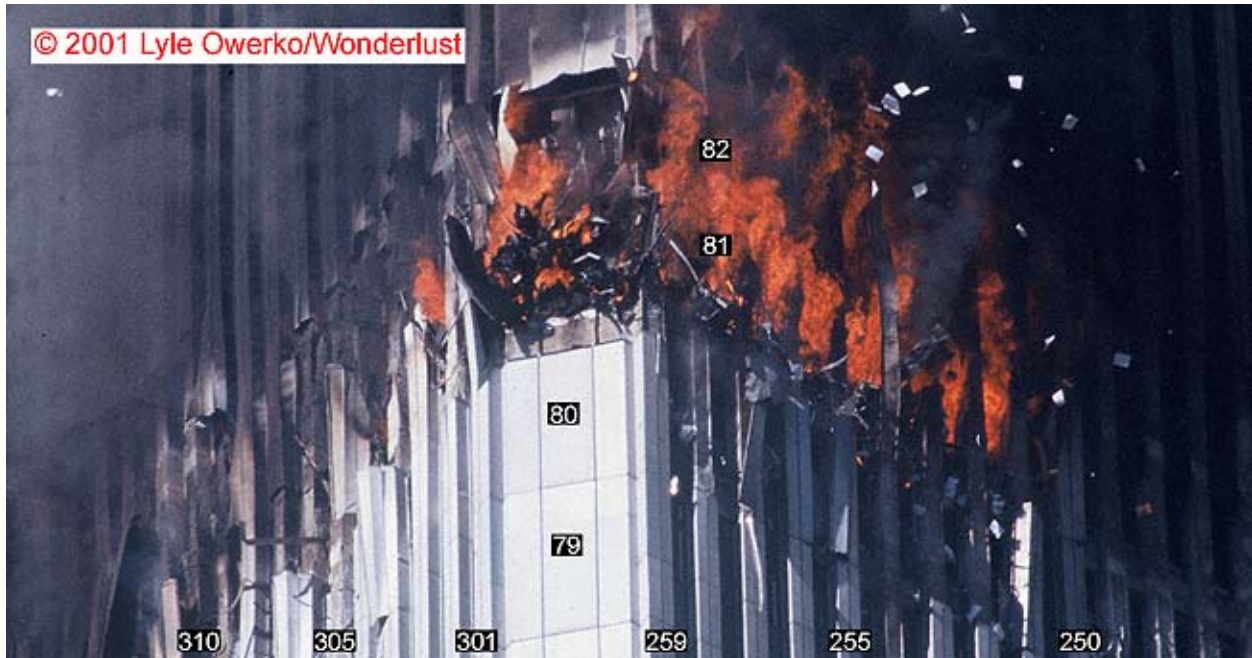
Figure 7-31. This cropped photograph shows the northeast corner of WTC 2. This image was recorded between 9:05 a.m. and 9:19 a.m. Column and floor numbers have been added. The corner aluminum panels on the 81st and 82nd floors have been pushed outward. A large pile of debris is evident in the opening on the 81st floor, and a vertical steel column, numbered 82-300, can be seen on the 82nd floor.

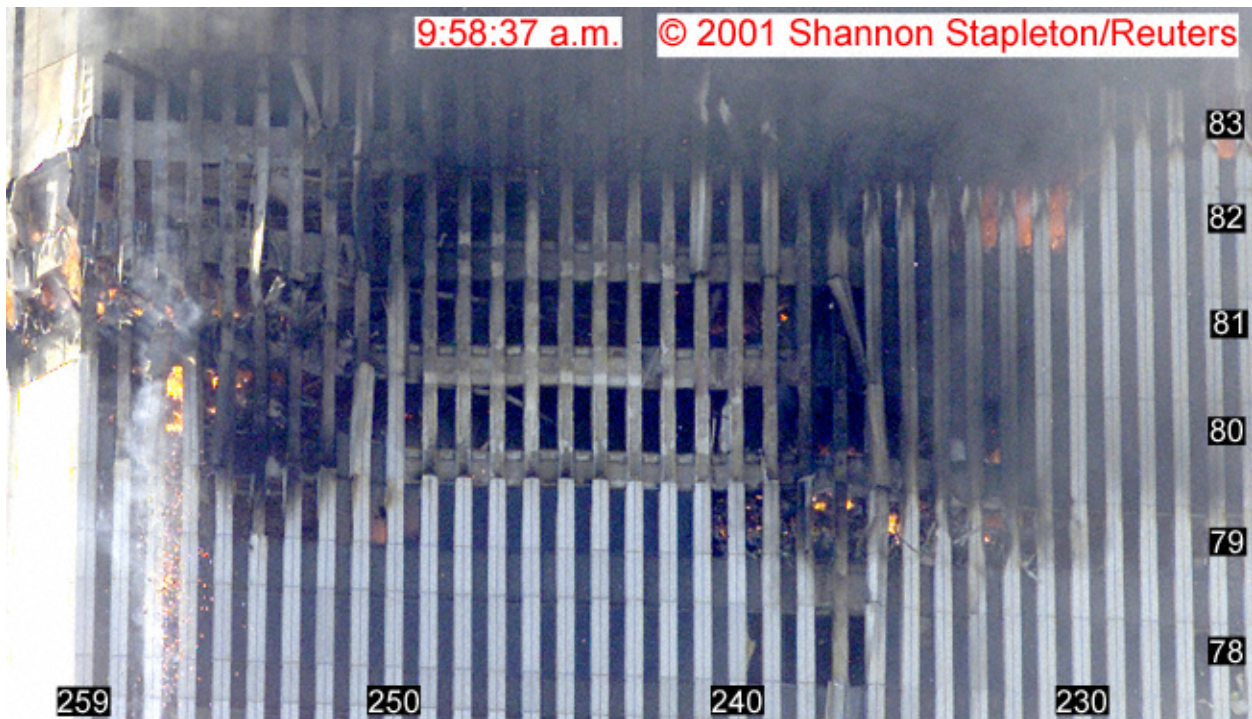
A casual inspection of Figure 7–32 reveals that significant areas of the aluminum curtain wall are missing. Reviews of early photographs and videos indicate the vast majority of this damage was present immediately after the fireball created by the aircraft impact dissipated. The most prominent region of missing curtain wall is a roughly rectangular area extending from column 238 to column 249 and covering the 80th, 81st, and 82nd floors. This area coincides with the locations (see Table 7–1) where the nascent fireball was first observed on this face 0.63 s following the aircraft impact. As will be discussed in more detail in Chapter 9, the observed fire behavior in this area following the fireball and before the

collapse of the tower was unusual in that very little fire was observed, and the area was close to the ambient temperature well after the aircraft impact. As a result, this area is referred to as the “cold spot”.

Three large piles of debris are evident through the windows on the north face. Two of these piles start at the northeast corner and extend out about eight windows toward the west on the 80th and 81st floors. These are the same floors where similar piles were observed on the east face at the north edge, suggesting that the debris essentially filled up the corners of the tower on these two floors. The third pile of debris can be seen on the 79th floor extending from roughly column 79-231 to column 79-240. As indicated in Table 7–1, these windows overlap an area where a distinct line of fire appeared 0.92 s after the aircraft impact.

Closer inspection of Figure 7–32 shows that column 253 has been severed just below the spandrel between the 81st and 82nd floors. The adjacent column, 81-254, is bent and split. This damage must be the result of a large part of the aircraft passing through the tower. As indicated in Table 7–1, such an object was observed breaking through the north face at this location 0.5 s after the aircraft impact on the tower.

Figure 7-32. A cropped and enhanced photograph of WTC 2 taken at 9:58:37 a.m. shows the east side of the north face. Piles of debris are evident on the 80th and 81st floors at the northeast corner and on the 79th floor to the right of column 241. The “cold” spot extends over the 80th to 82nd floors from column 238 to 249.

In the photograph the glass for four windows, 78-236 to 78-239, is missing. Again, this observation is consistent with the events listed in Table 7-1, which indicates that this damage first appeared on the north face 0.86 s after the aircraft impact. While not shown in Figure 7-32, the uncropped version of this photograph and numerous earlier photographs and videos indicate that the glass in windows 78-224 to 78-226 was broken out during the aircraft impact. The time line in Table 7-1 indicates that façade damage and dust appeared at this location 0.56 s after the aircraft impact. It is interesting that even though aircraft and/or parts of the building exited the north face on the 78th floor at two locations, no fire was observed emanating from windows on this floor.

The agreement between damage observed on the north face of WTC 2 and the events included in the time line provided in Table 7-1 is excellent. This agreement provides added confidence that locations identified on the faces of the tower from aircraft impact videos are accurate and that the various observations from Figure 7-32 are due to events that occurred during the aircraft impact.

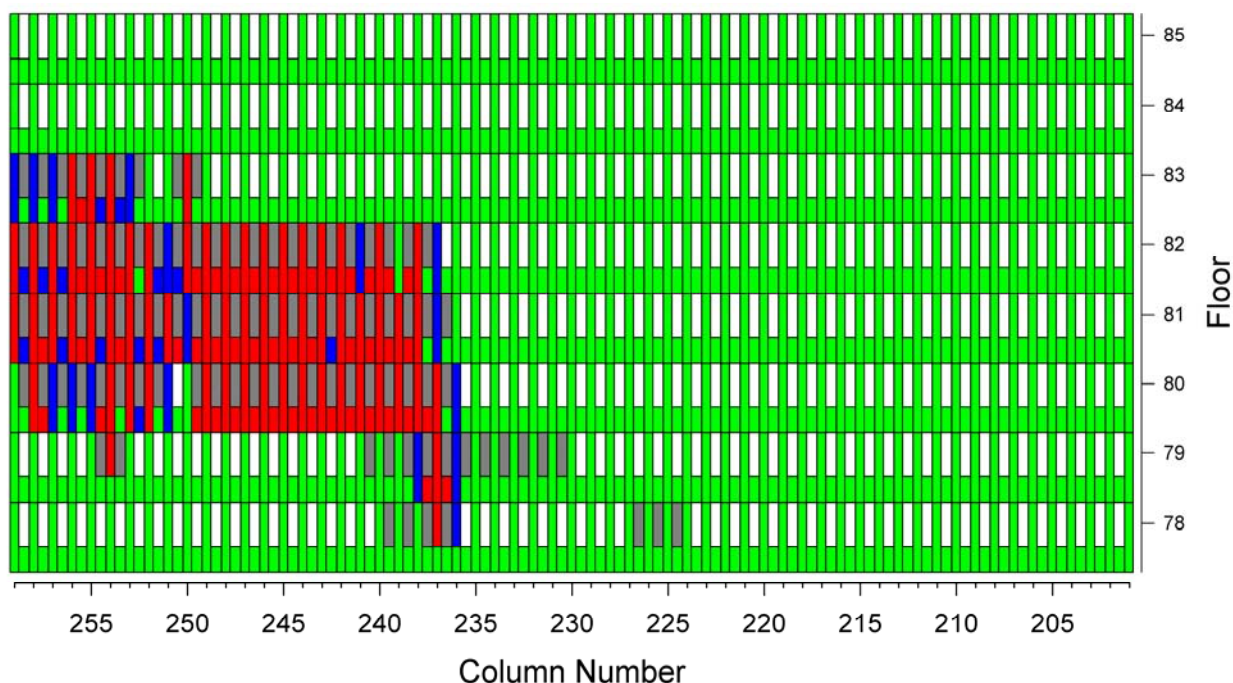
Figure 7-32, along with other photographs and videos, was used to develop the map for exterior damage shown in Figure 7-33 for the north face of WTC 2 that combines damage to the aluminum facing and window glass that make up the curtain wall. Damage on this face is inclined at an angle which roughly matches that at which the aircraft struck the tower on the south face on the opposite side of the tower. This suggests that debris from the aircraft tended to pass straight through the tower, perhaps passing between and being guided by the floor slabs.

**Figure 7-33. A color-coded visualization of initial damage to the north face of WTC 2 is shown. Information concerning damage to the aluminum on the curtain wall (■ - undisturbed, ■ - disturbed but still in place, and ■ - aluminum facing missing) and windows (■ - glass missing and □ - glass in place) are combined.**

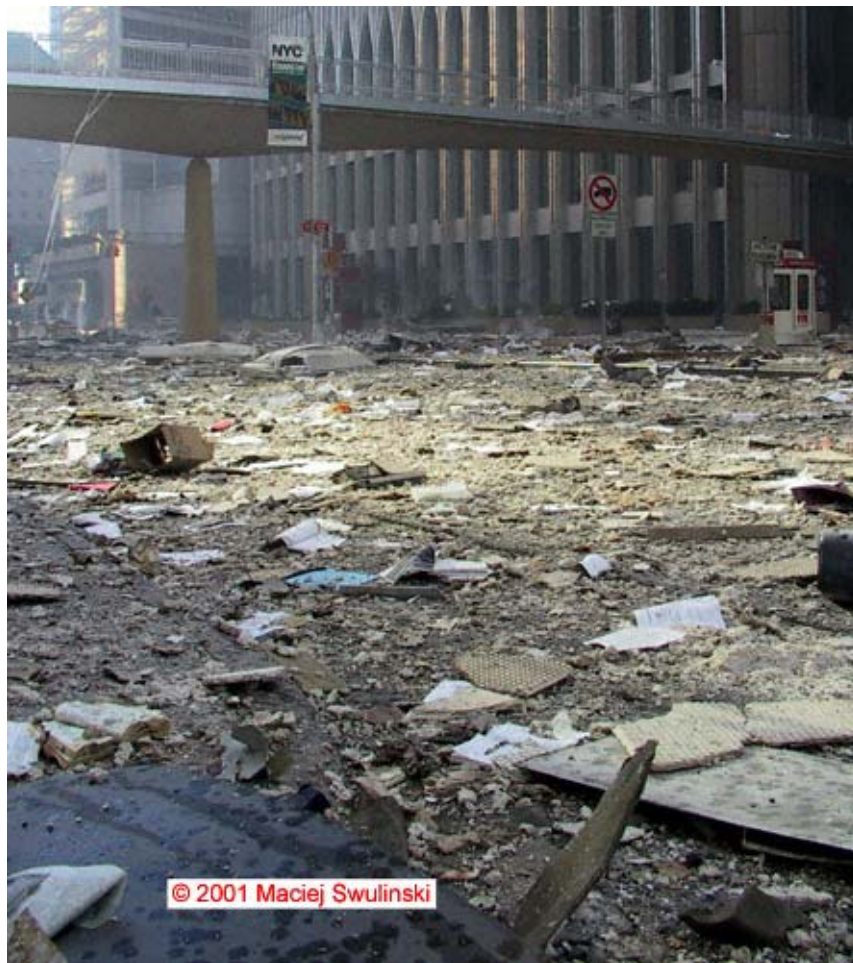
Photographs and videos taken on Liberty Street and in the immediate vicinity show that a great deal of debris was also present on the south side of WTC 2. Some of this debris came from the first aircraft impact on WTC 1, as described in Section 6.4.3, but there was a much larger amount following the second aircraft impact. Figure 7-35 shows a photograph that was taken looking across Liberty Street toward WTC 2 following the second aircraft impact. The street is completely covered with debris.

**Figure 7-35. This cropped photograph taken from near the corner of Greenwich Street and Liberty Street shows debris on Liberty Street following the second aircraft impact on WTC 2. WTC 2 and WTC 3 are located in the background.**

The debris in Figure 7-35 and Figure 7-36 most likely made up a portion of the dust cloud evident on the south face of WTC 2 in Figure 7-3 and Figure 7-9. This material was blown backward out of the tower by the overpressure generated by the initial fire inside the building that appeared shortly after the aircraft impact. The relatively large amount of what appears to be concrete, as well as its small size, suggests that the aircraft impact pulverized a significant amount of concrete floor slabs as it entered the tower. This is consistent with the large scooped-out cavity seen in the aircraft impact location (see Figure 7-22 to Figure 7-24). As noted previously, it has not been possible to visually observe the depth of such damage.

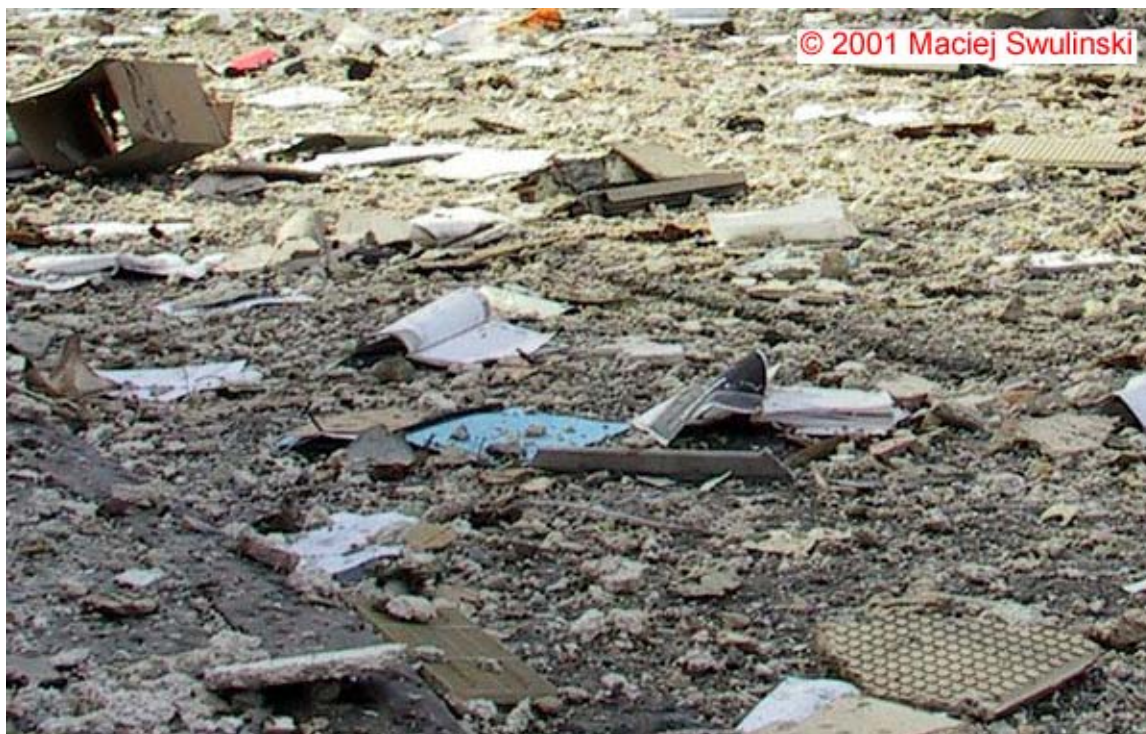
Figure 7-36 shows an enlarged portion of Figure 7-35. This photograph is typical of other photographs of the debris taken in the vicinity. Various types of debris, including papers and cardboard boxes, are identifiable. There is also a great deal of what appears to be crushed concrete. A dimpled material is evident in the foreground. Similar material is seen elsewhere in the street debris. This material is likely a portion of a ceiling tile.

**Figure 7-36. A close-up of the debris on Liberty Street created by the second aircraft impact is shown in an enlarged section from Figure 7-35.**

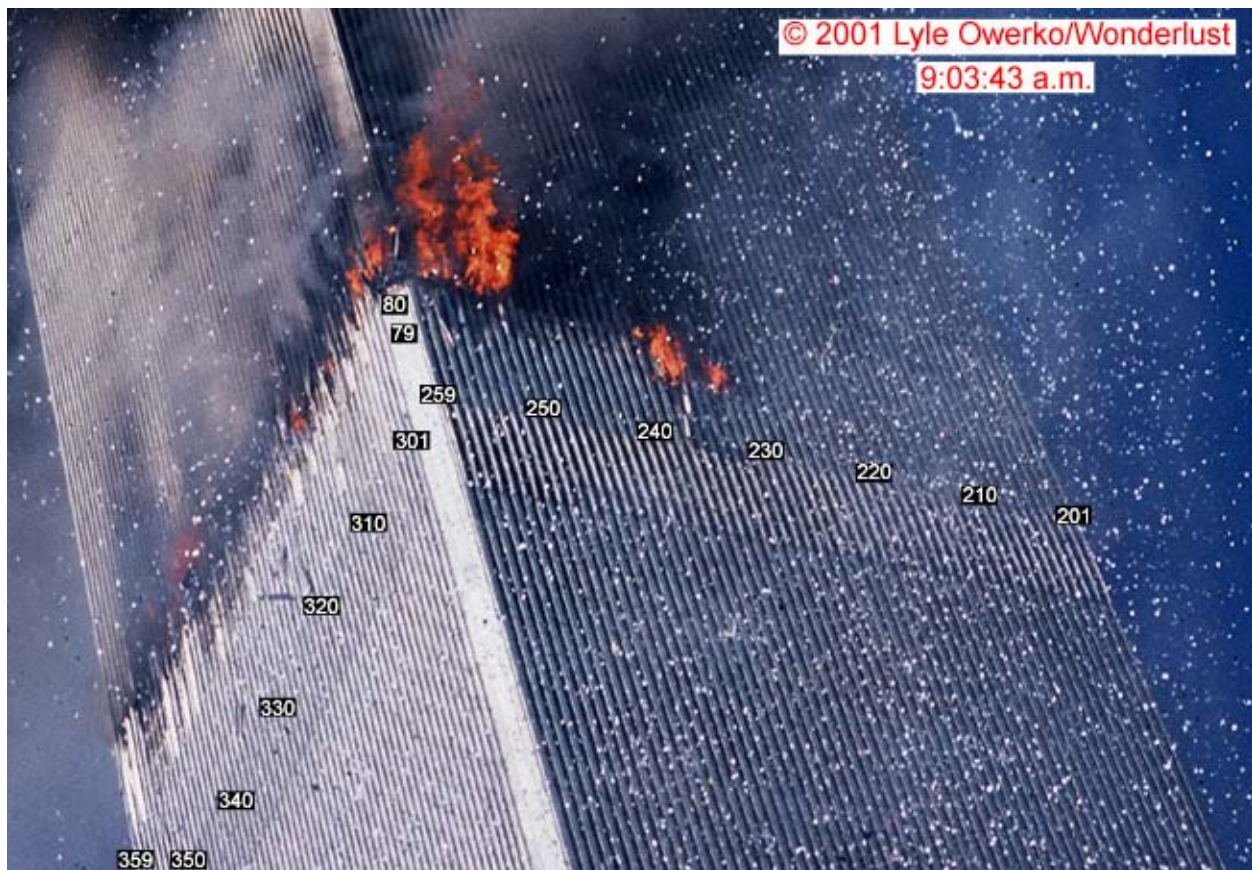
After the initial ten-second period following the aircraft impact, most of the large fires burning around WTC 2 began to decrease in size and to recede back into the building. In many locations fires were no longer visible after about 30 s. Figure 7-37 shows a photograph that was taken 44 s after the aircraft impact. Comparison with Figure 7-6 to Figure 7-8 indicates to what a large extent the flames coming from open windows have died down. Only relatively small fires are now observed on the east face. Substantial flame extension is still present on the north face, with large flames evident on the 81st floor near the northeast corner, and somewhat smaller flames located near the center of the north face on the 79th floor. Both of these flaming regions are in areas where large piles of debris can be seen through the windows. The cold spot discussed earlier stands out between the two fire zones due to the absence of flame. Similar close-up photographs and videos from the south are not available in the database for this early time, but more distant images indicate only a few isolated small fires were present on this face at this time.

**Figure 7-37.** This cropped photograph showing WTC 2 from the northeast was taken from the corner of Vesey Street and Church Street at 9:03:43 a.m., i.e., 44 s after the aircraft impact. The intensity levels have been adjusted, and column and floor numbers have been added.

The lack of significant burning in interior regions in the immediate aftermath of the fireballs is also reflected in the absence of heavy smoke coming from the tower. Some smoke is evident in Figure 7–37, but it does not obscure the faces of the tower. Most of it seems to be emanating from the flaming areas visible near the outer edge of the tower. Figure 7–38 shows the east side of WTC 2 at roughly the same time. Only very light smoke is present, and most of the façade area above the floors with fires is visible.

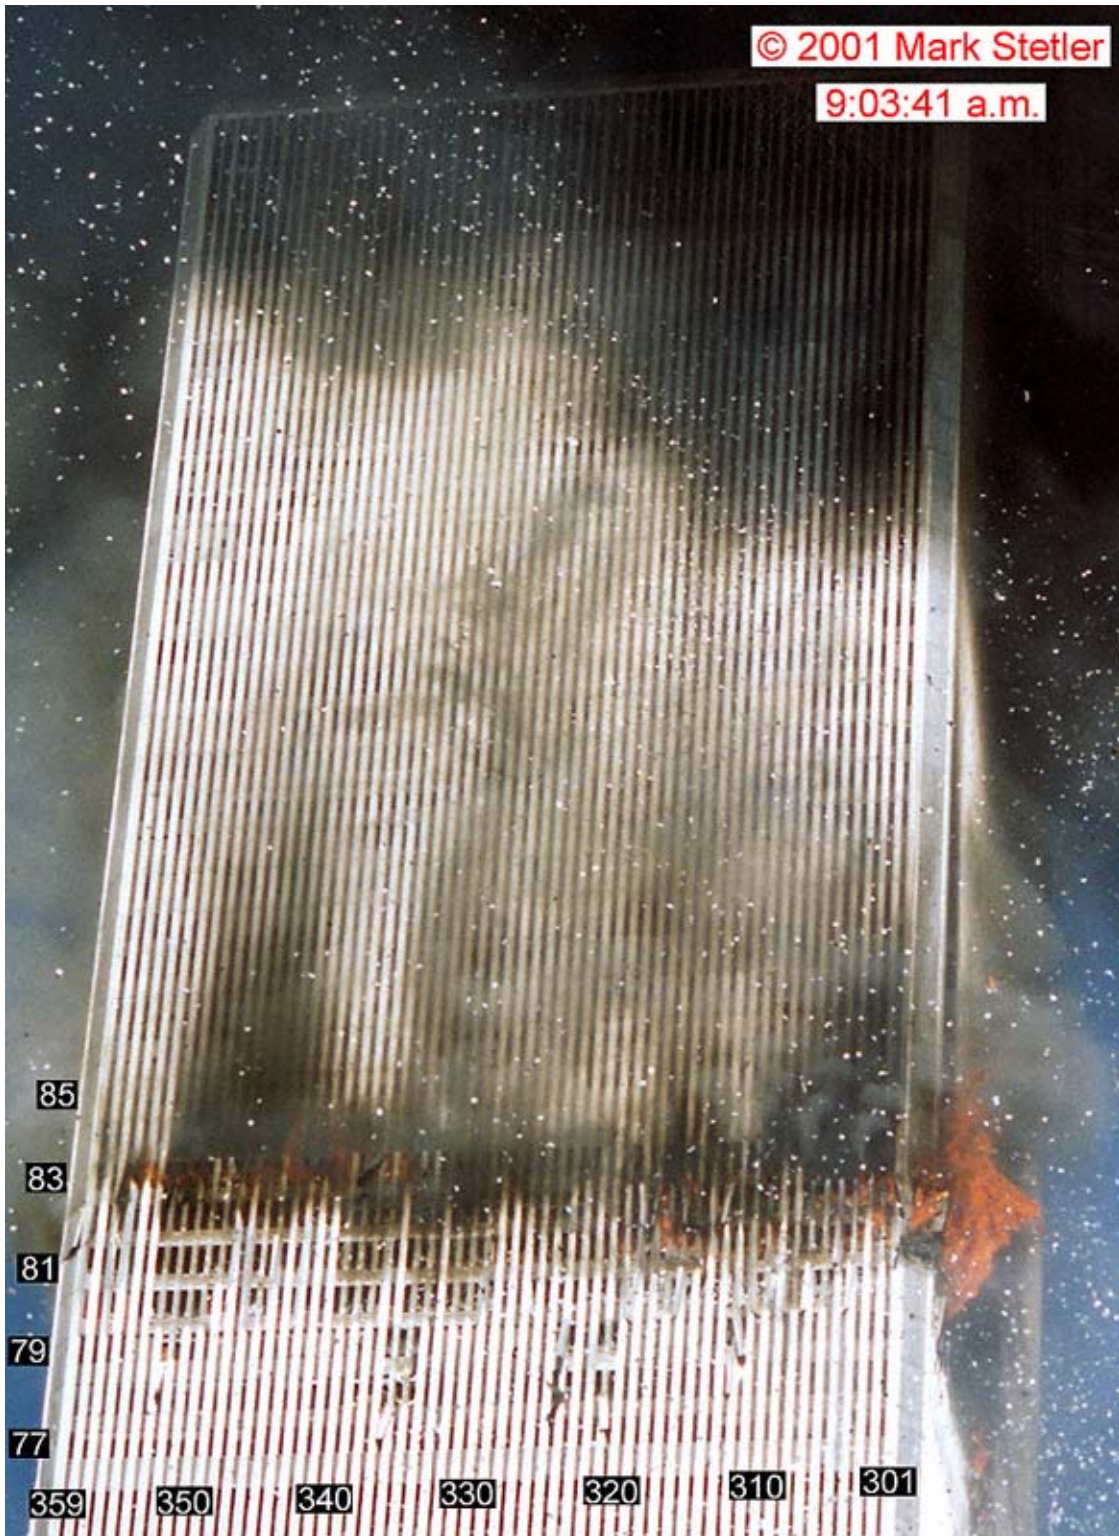
Figure 7-38. This cropped photograph shows the east face of WTC 2 at 9:03:41 a.m. Column and floor numbers have been added.

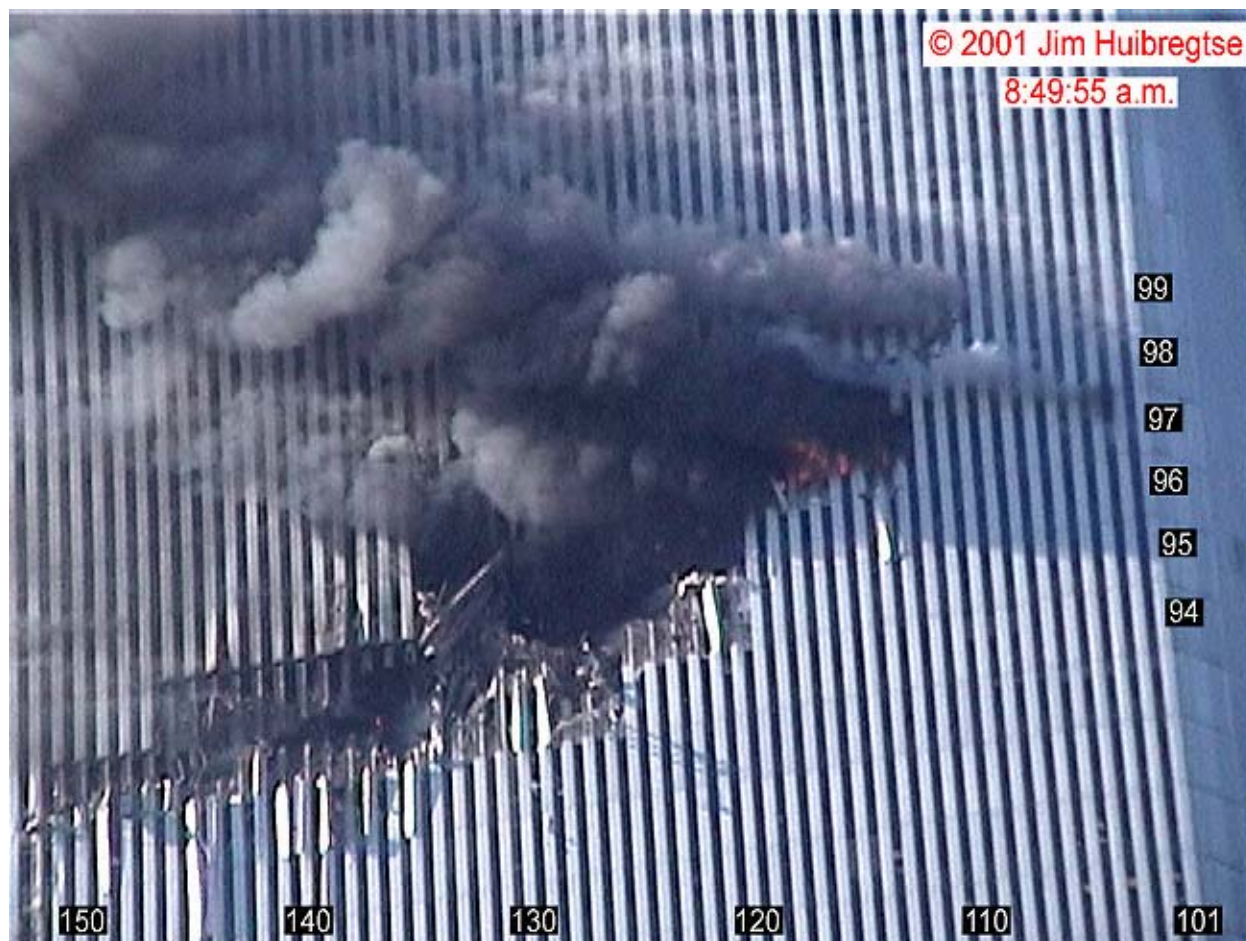
**Figure 8-1. This image is extracted from a video recording that shows the north face of WTC 1 at 8:49:55 a.m. Column and floor numbers have been added.**

At 8:50:55 a.m., light smoke began to come from window 97-144 on the 97th floor, which is located on the north face to the east of the cavity created by the aircraft impact. Fourteen seconds later the smoke suddenly became very dark and heavy. Shortly afterward flames appeared. As evident in Figure 8-1, prior to this time little or no smoke was seen in this region, and the windows in the area appeared to be intact. This developing fire grew rapidly and by 8:52 a.m. fire was visible in windows 97-142 to 97-146, with flames extending from windows 97-144 and 97-145.

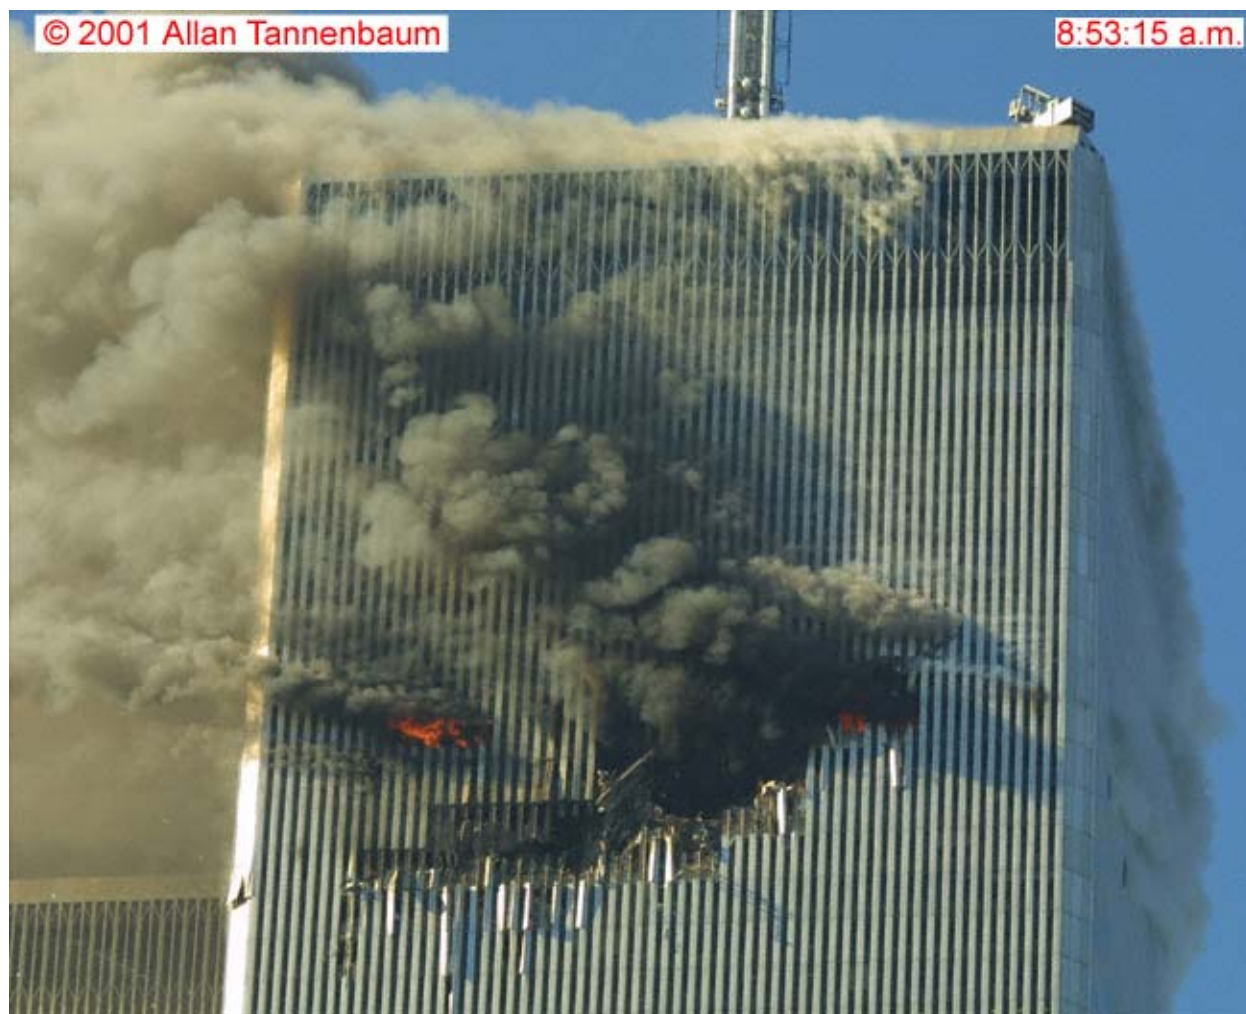
Figure 8-2, showing the north face, was shot at 8:53:15 a.m. An enlarged portion of the image is reproduced as Figure 8-3. The fire to the east of the aircraft impact area has continued to spread, now extending from windows 97-142 to 97-148. In three of the windows (97-142, 97-143, and 97-144) isolated fires are burning at the tops of the open window frames. Videos show that pieces of solid burning fuel from these areas eventually fell and formed the white streamers described in Section 5.2 as the material floated downward. Appendix L summarizes observations of streamers on the four faces of WTC 1. The first streamer from the left of the impact cavity was observed at 8:54:52 a.m., falling from the top of window 97-145, and many additional streamers were observed during the next few minutes.

In Figure 8-2 and Figure 8-3 light smoke is coming from near window 96-150. This smoke is an early indication of a developing fire that will appear shortly and grow rapidly in this area.

Smoke is also flowing from the mechanical equipment rooms at the 108th and 109th floors in Figure 8-2. Smoke and/or dust were observed coming from these floors immediately following the aircraft impact, suggesting that ductwork within the core area had been compromised. Smoke was observed continuously coming from these floors after the impact. As described in Section 4.2.5, the smoke was actually flowing from louvers mounted in an interior wall located nearly 5 feet behind the exterior facade that is visible. The smoke appears to be coming from three distinct locations centered near windows 113, 122, and 132. Figure A-1 in Appendix A shows the locations of the various louvers on these floors and identifies which parts of the ventilation system were serviced by these louvers. On the north face of WTC 1 the louvers were part of the fresh air intake system that serviced the upper portion of the building extending from the 92nd floor to the top. The three locations are close to the three intakes that provided air to the core, interior, and peripheral areas of the lower floors in the northwest quadrant of the building. The ductwork for these ventilation systems extended downward through a shaft located on the northwest corner of the core. Smoke was clearly entering these three sets of ducts at some point. It should be noted that in order for the smoke to backflow through the intakes as observed, it had to pass through an extensive series of fans, preheating and cooling coils, and air filters.

**Figure 8-2. A photograph of the north face of WTC 1 recorded at 8:53:15 a.m. is shown. The original has been cropped.**

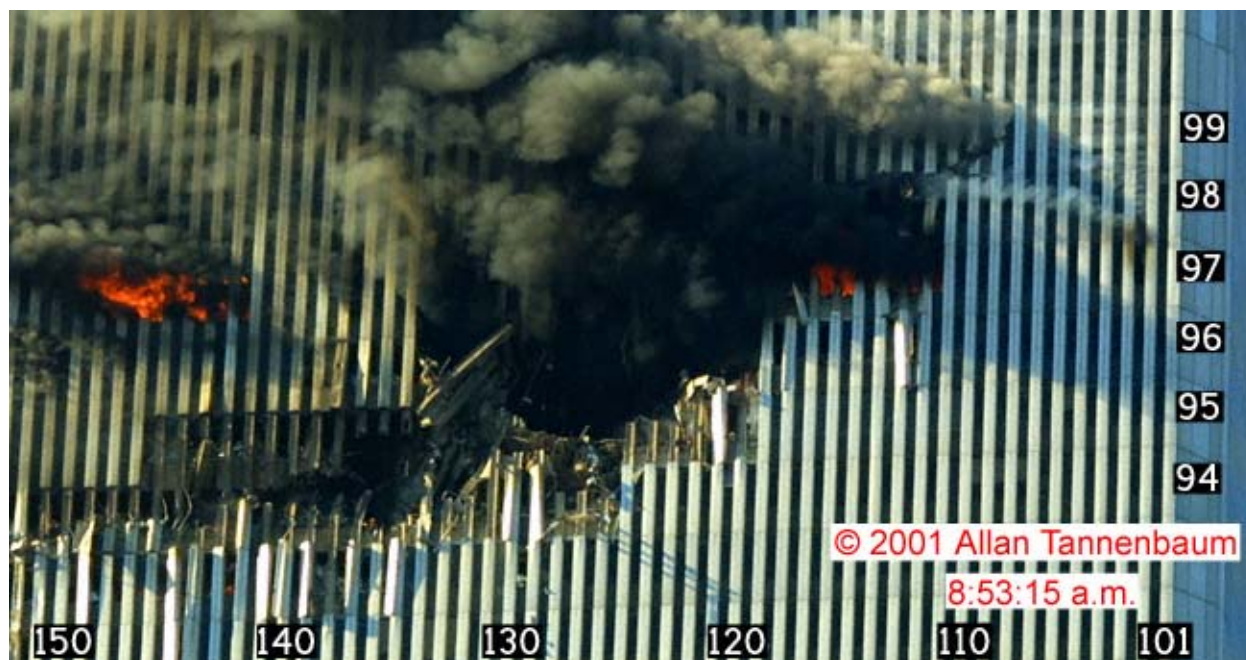
**Figure 8-3. An enlargement of a portion of the photograph reproduced in Figure 8-2 showing the north face of WTC 1 at 8:53:15 a.m. is shown. Labels showing floor and column numbers have been added.**

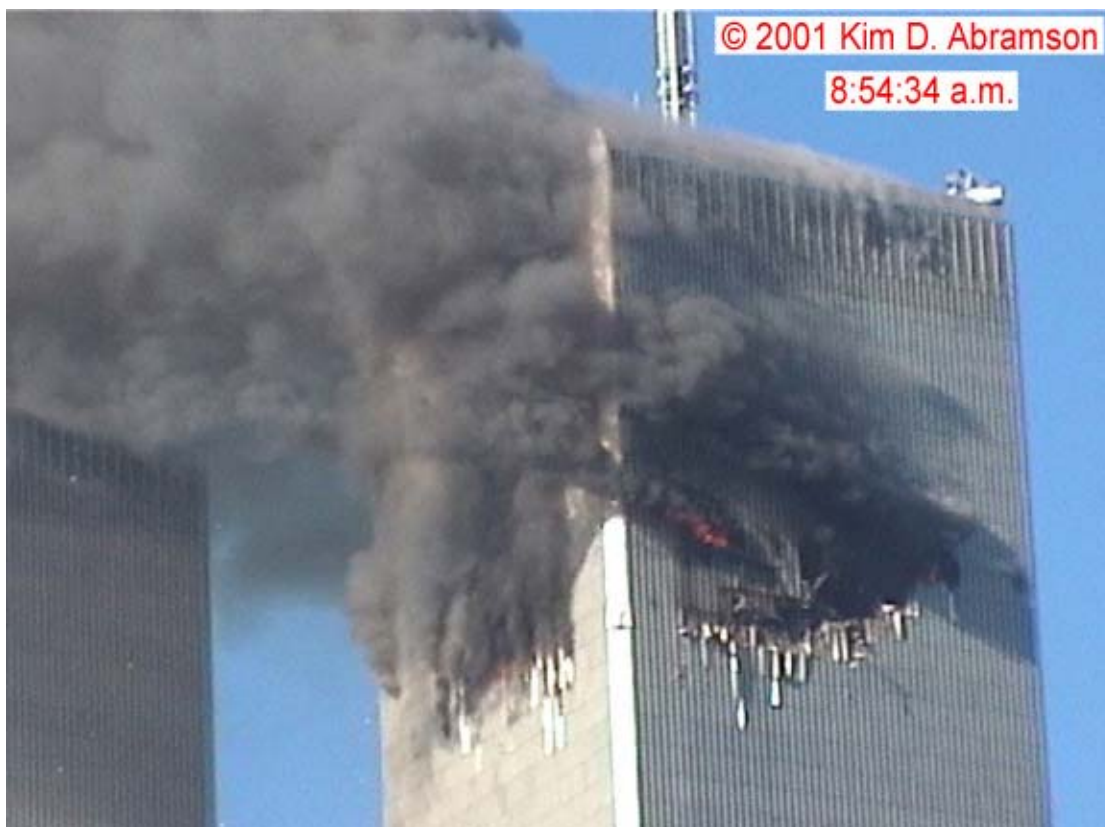
Near the top of the tower in Figure 8-4 there appears to be a heavy flow of smoke from the area of the mechanical equipment room floors near the north edge of the east face. Smoke was present in this region continuously until the tower collapsed over an hour later. This area is close to the exhaust spill louver that served the northeast quadrant of the tower (see Figure A-2), and it is possible that the observed smoke was flowing from this system. However, there is another plausible explanation for these observations based on predictions of smoke movement obtained using the Fire Dynamics Simulator (FDS) (McGrattan 2004). For the simulations, smoke was assumed to come from the 94th floor across

Even though a large amount of smoke hides much of the east face in Figure 8-4, it is still possible to see portions of the façade for floors above the 94th floor where fire is present. This is true for a small region on the lower northern edge and a larger area on the southern side of the face. In these areas smoke was observed coming from windows higher on the face, which indicates that people were also breaking windows on this face at roughly the same time as on the west and north faces. At 8:53:24 a.m. dense smoke plumes appeared at windows 105-245 and 105-246 on the 105th floor. Several additional windows on this floor were broken around this time. The nearly simultaneous decisions by people to break windows on three sides of the tower suggest that smoke had already spread over extensive volumes of the upper floors. Two windows, 99-201 and 99-202, were also broken out on the 99th floor around 8:53 a.m. Light smoke was observed flowing from these windows. Earlier, the windows appeared to be intact.

**Figure 8-4. A frame captured from a video shot from the northeast shows the north and east faces of WTC 1 at 8:54:34 a.m. The undamaged WTC 2 is to the left.**

In Figure 8–4, heavy smoke can be seen on the east face, coming from a few windows on the 93rd floor, located immediately below the 94th floor where significant fires and smoke flow are evident. An area of light smoke is also coming from a section of the open windows on the 92nd floor. Review of visual material around this time indicates that both the number of windows where smoke was observed and the smoke density appeared to be increasing on these floors. These observations suggest that fires, which were not yet visible from the outside, were growing on these two floors.

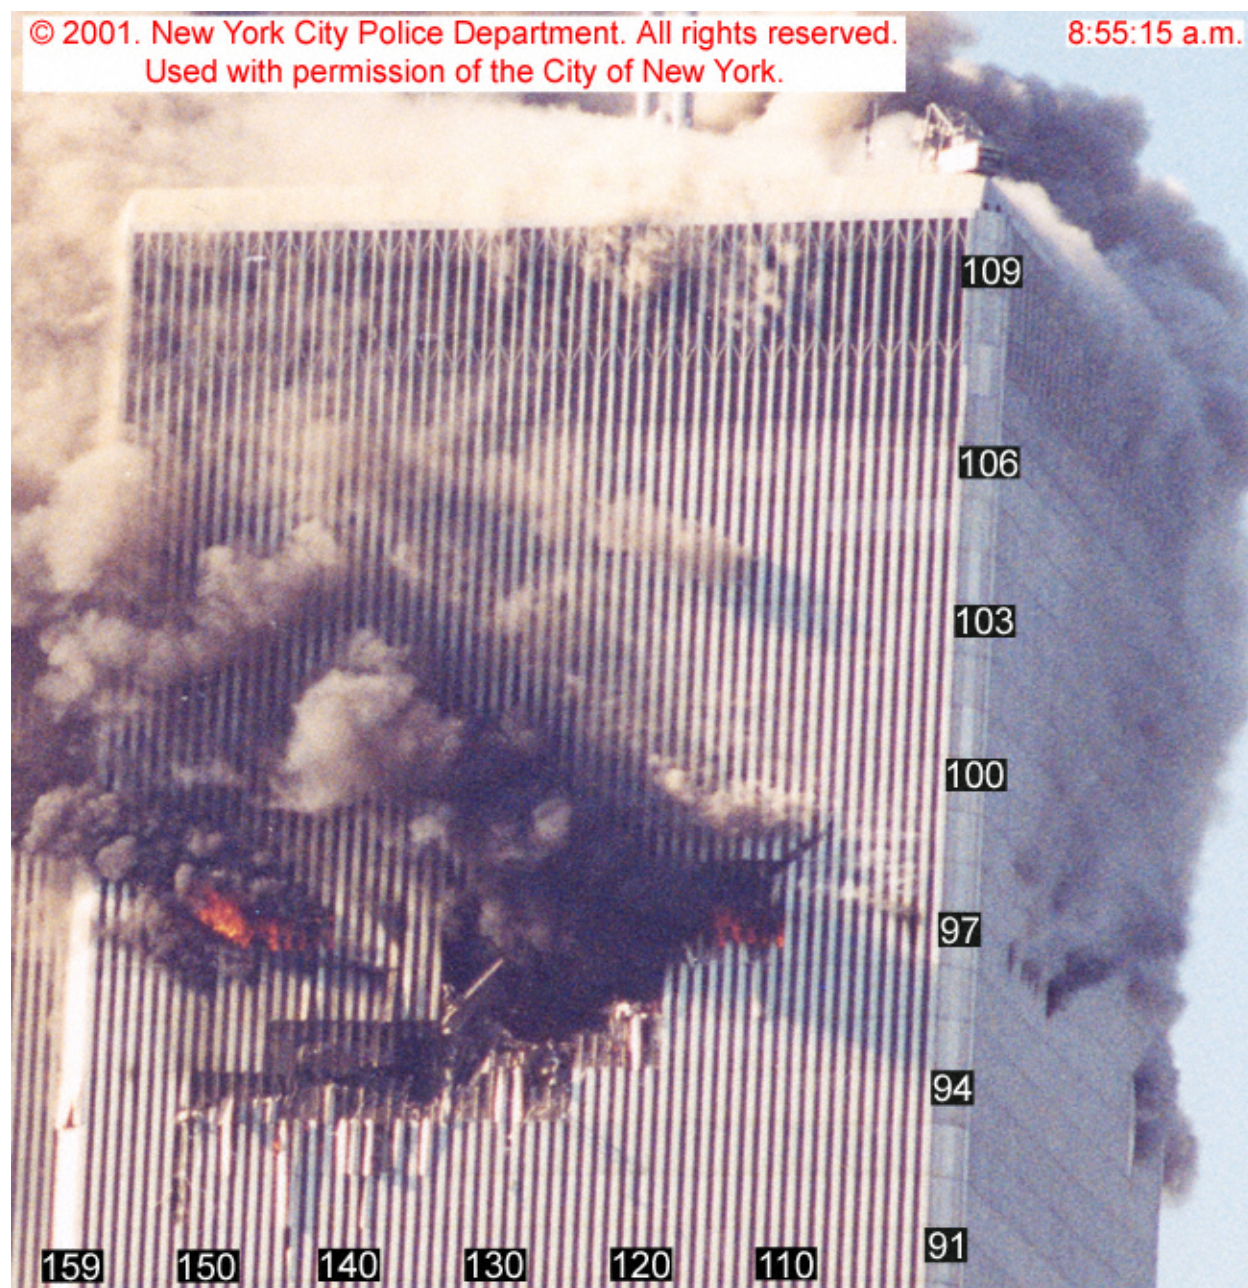
Figure 8–5 was taken just after the beginning of a dramatic change in the fire behavior on the west face of the tower. Videos show that at 8:55:09 a.m. there was a sudden increase in the volume of smoke coming from near window 97-435 on the 97th floor. Almost immediately, smoke began to appear at additional windows, and flames were observed shortly afterwards. The initial stages of this rapid change are indicated by the appearance of smoke at multiple windows on the 97th floor in Figure 8–5. Within a minute following the initial increase in smoke, external flaming was observed from roughly

window 97-430 to window 97-444. The number of windows where heavy smoke was observed was greater, reaching from window 97-425 to window 97-445. In the span of roughly one minute, this fire on the west side of the 97th floor opened windows over a distance of nearly 97 feet.

**Figure 8-5. A photograph of WTC 1 recorded at 8:55:15 a.m. shows the north and west faces. The original image has been rotated and cropped. Numbers indicating column numbers for the north face and floors have been added.**

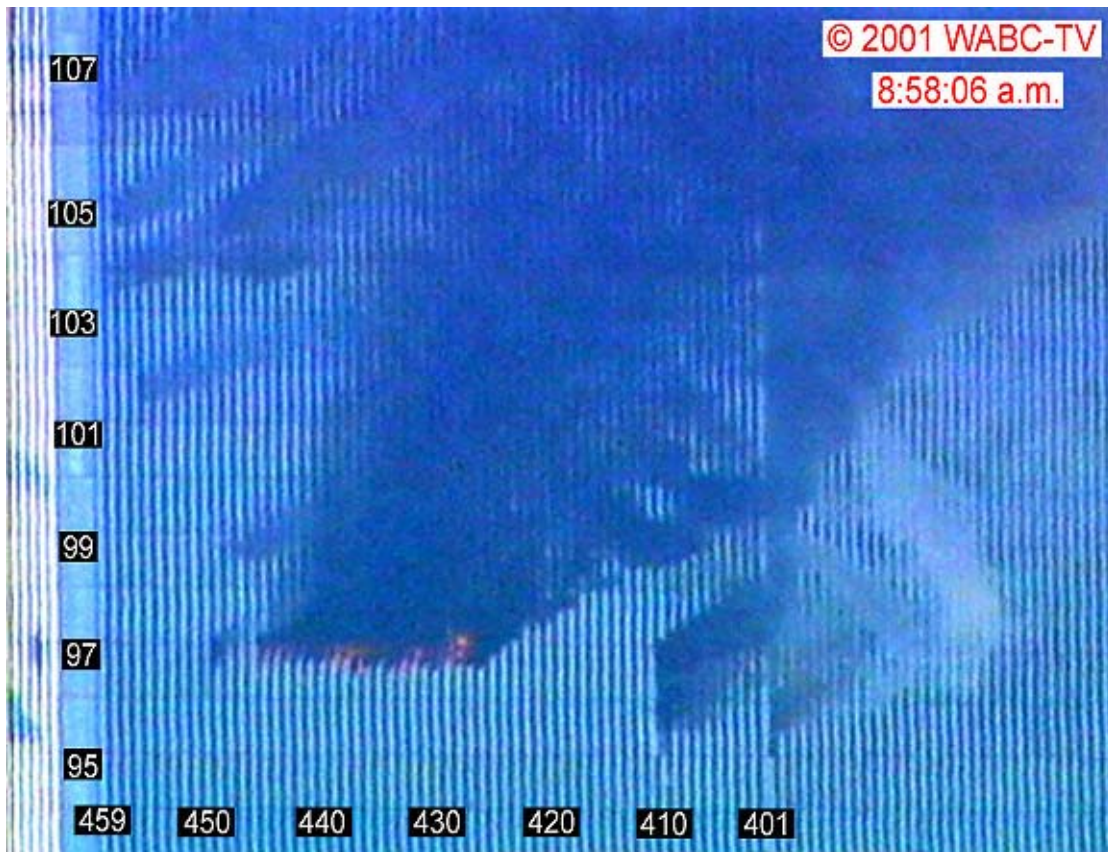
The west face of WTC 1 was filmed from a helicopter around this time. Figure 8–6 shows a frame taken from this video that was recorded at 8:58:06 a.m. Intense fire and heavy smoke are present over the same range of windows observed roughly two minutes earlier. Following the extremely rapid fire spread during the minute that started around 8:55 a.m., the fire appears to have stabilized for a period of time. It

Another feature of the west face around 8:58 a.m. can be seen in Figure 8–6. Numerous plumes of heavy dark smoke are flowing from windows high above the 97th floor on the north side of the face. These plumes are present on the 102nd, 104th, 105th, and 107th floors. People in these areas have broken out the window glass. It is difficult to determine exactly when these windows were opened due to the quality of the imagery during this period, but smoke first appears from the upper regions of the northern side around 8:55:30 a.m. Multiple windows over several floors had been broken by 8:56 a.m., and the number continued to increase during the next two minutes.

**Figure 8-6.** This image shows the west face of WTC 1 at 8:58:06 a.m. It is a frame taken from a video shot from a helicopter. Floor and column numbers have been added for WTC1. WTC 2 is in the background on the right side. Smoke is flowing from the damaged area on the corner of the 96th floor.

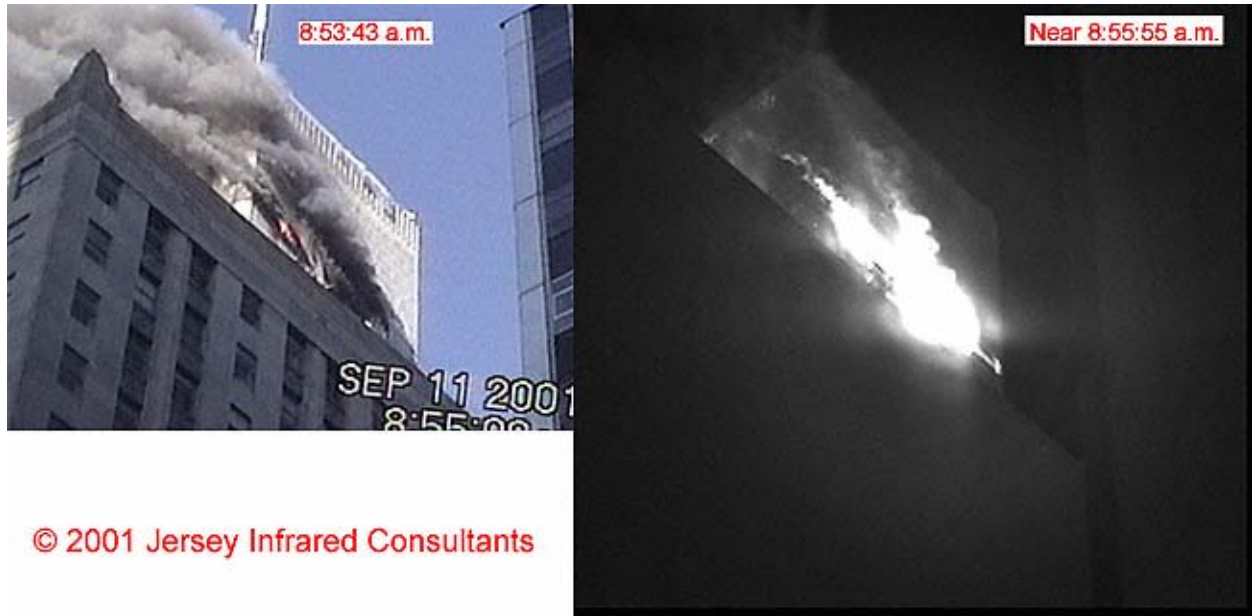
The fire on the 97th floor to the immediate right of the aircraft impact cavity has saturated the camera output. Much of the area inside the aircraft impact cavity is also saturated, showing that the smoke flowing from this area was hot. The heat distribution on the east side of the cavity is consistent with the visible fire distribution. There is an extensive length across the face that is saturated. This corresponds to the large fire on the 97th floor that is visible in the video frame and Figure 8–5. This area does not extend all the way to the east edge of the face, and the northern edge of the east face is still relatively unheated. There is a shorter heated length on the floor below that is separated from the aircraft cavity by a cooler

region. This heating is due to the fire that was growing on the 96th floor and had not yet appeared on the face. There is evidence of an isolated fire burning in the eastern half of the 94th floor on the north side.

**Figure 8-7. Images of the north face of WTC 1 recorded using a standard video camera (left) and an infrared camera (right) are shown. The frame from the video camera was recorded at 8:53:43 a.m., and the infrared image was shot around 8:55:55 a.m. (the uncertainty is estimated as 15 s) from roughly the same location. The infrared image intensity levels were adjusted. The video frame has been cropped, rotated and sized to match the infrared image. The building in the foreground is the post office on the corner of Church and Vesey Streets.**

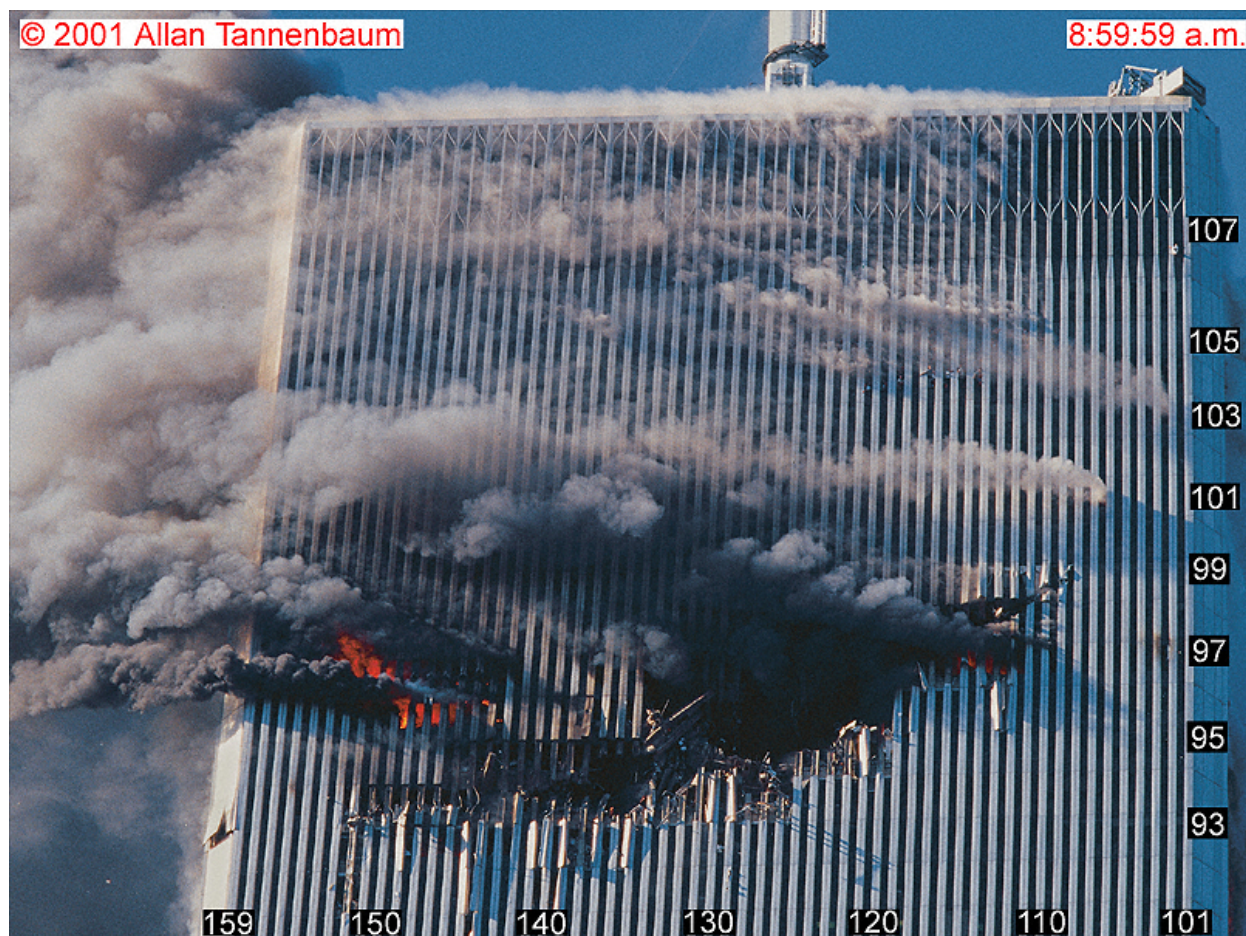
In Figure 8-8, numerous plumes of smoke are seen exiting from windows well above the fire floors on the north façade. There are also many additional windows that have been broken by people at these locations, but they do not have dense smoke flowing from them. The smoke coming from the mechanical equipment room on the 108th and 109th floors can also be seen in this photograph.

**Figure 8-8.** This photograph of the north face of WTC 1 was recorded at 8:59:59 a.m. The image has been cropped and floor and column numbers have been added.
