**NIST NCSTAR 1-5A**

**Federal Building and Fire Safety Investigation of the  
World Trade Center Disaster**

# **Visual Evidence, Damage Estimates, and Timeline Analysis**

September 2005

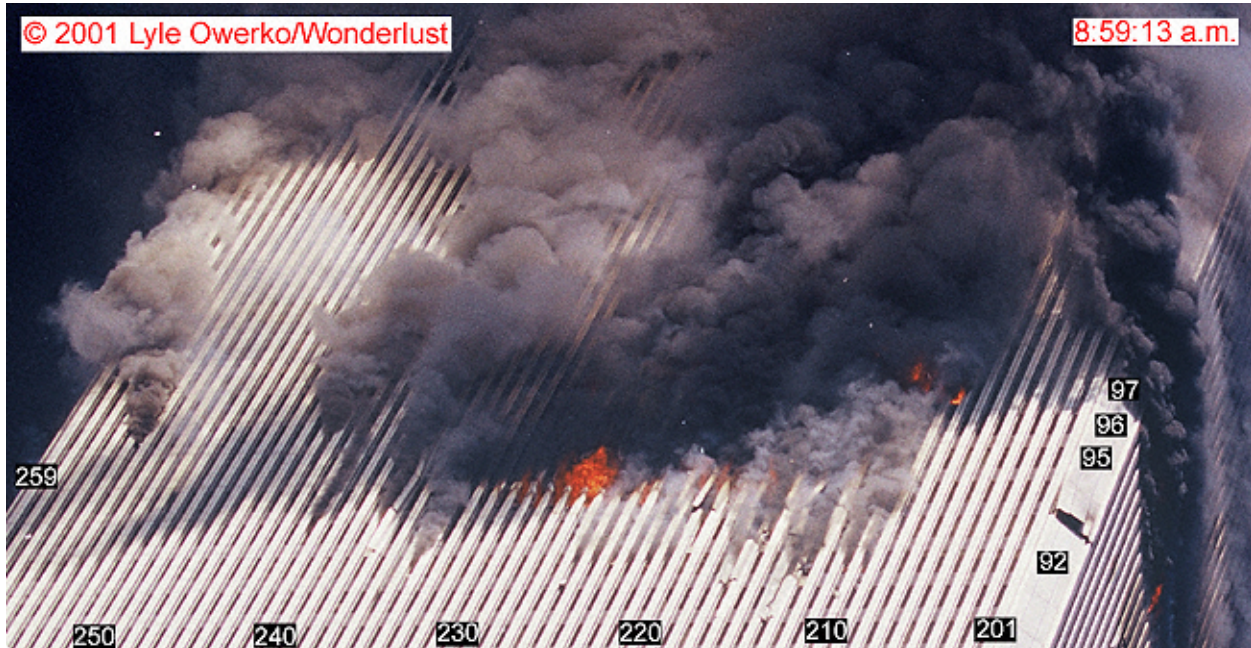
Figure 8-9 shows the east face of WTC 1 at 8:59:13 a.m. As observed earlier, a significant fire continues to burn over a large extent of the 94th floor. Intense burning was particularly evident at windows 94-226 and 94-227. Closer inspection of the photograph shows that distinct “caretts” are present on the column covers next to these windows as well as on the covers for columns 94-229 to 94-232. As discussed in Section 5.2, these caretts indicate that sometime earlier flames were extended out of windows 94-229 to 94-231 and subsequently withdrew back into the windows. These caretts are an additional indicator of the intensity of the fires burning on this floor.

A major change in the east façade fire behavior is also apparent in Figure 8–9. Flames can now be seen at windows 97-208 to 97-210 on the 97th floor. It is difficult to determine exactly when fire growth started at this location due to obscuration by smoke coming from below. However, at least two videos showed flames erupting from these windows at 8:56:45 a.m., while another video showed an intense flame near window 97-211 at 8:58:19 a.m. A close-up photograph showed fire in window 97-114 at 8:57:38 a.m. It seems likely that fire first broke out on the 97th floor on this face around 8:56:45 a.m. and rapidly spread over at least seven windows.

**Figure 8-9.** This view of the east face of WTC 1 was recorded at 8:59:13 a.m. The original image has been rotated and cropped. Column and floor numbers have been added.

The amount of smoke coming from windows on the 92nd and 93rd floors in Figure 8–9 has increased further from earlier times, suggesting that internal fires are continuing to grow on these floors in the vicinity of the windows where smoke is observed (see Figure 8–9). Observations of people falling from the tower support this conclusion. Appendix M summarizes times when and locations where people were observed falling from WTC 1. Very shortly following the aircraft impact (8:51:01 a.m.), a single person was observed falling from window 93-149 on the 93rd floor. Images of the north face indicate that a fire

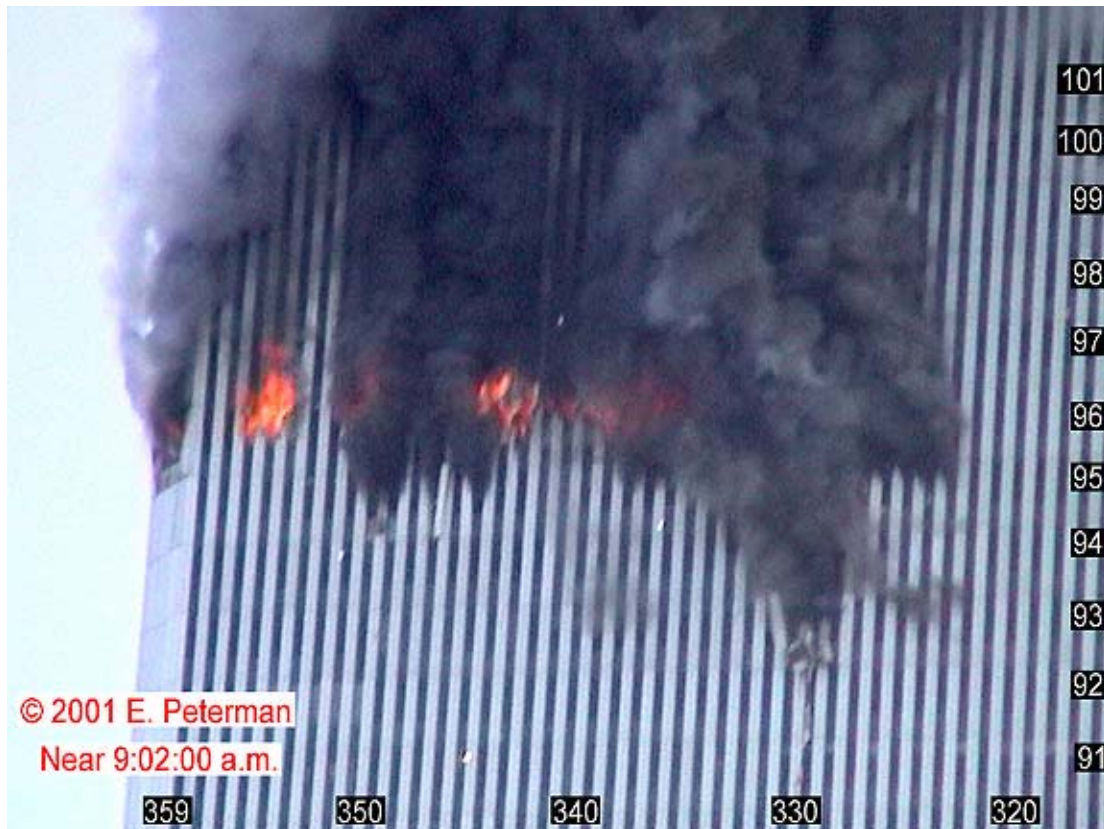
As seen in Figure 8–10, there is a large amount of smoke coming from broken windows on the 95th floor, even though no flames are apparent. This may be an indication that a substantial fire was present somewhere on this floor. The heavy smoke coming from the center of the face at the 93rd floor continues to hide the location where the steel panel section is believed to have been dislodged during the aircraft impact. Lighter smoke is flowing from several other windows on the 93rd floor.

**Figure 8-10. This image showing the south face was captured from a video. It was not possible to time this image exactly, but it was recorded within a minute of 9:02 a.m. Column and floor numbers have been added.**

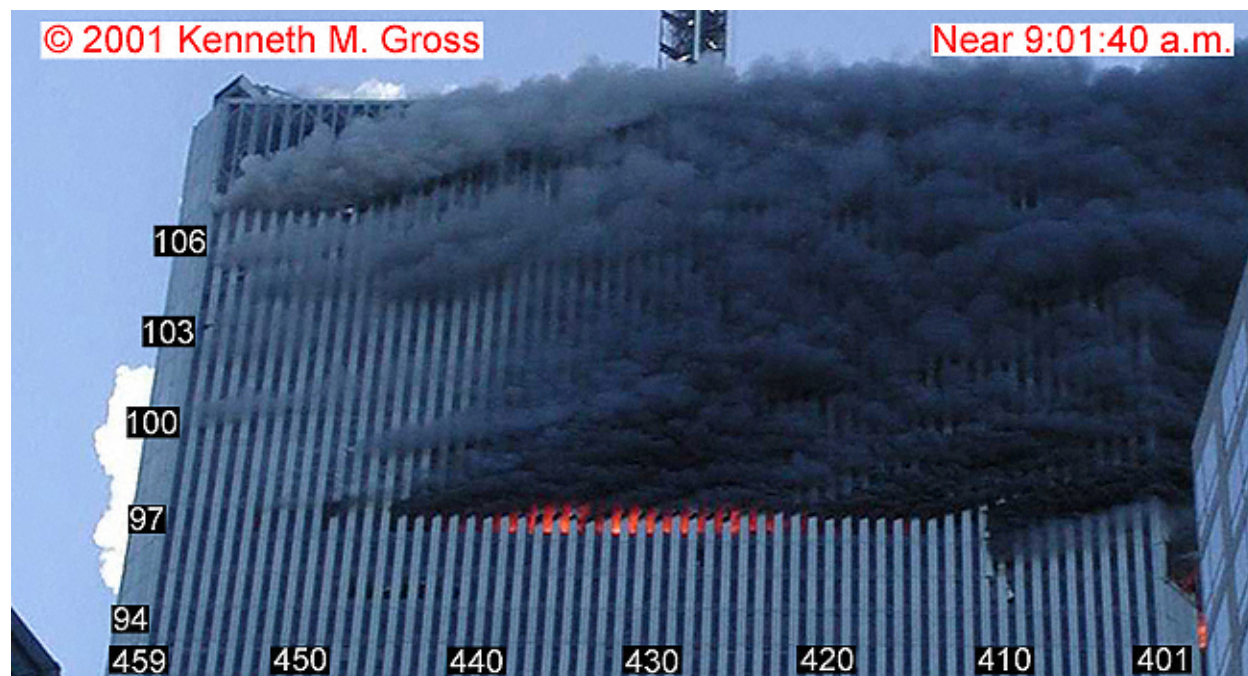
Figure 8–11 is a photograph of the west face of WTC 1 taken shortly after the second rapid fire spread episode. It has not been possible to time this image exactly, but based on observed fire behaviors on this face, it was taken between 9:01:09 a.m. and 9:02:17 a.m., or roughly around 9:01:40 a.m. Intense fires are present in the windows where the initial rapid fire spread took place, and heavy smoke is coming from

windows where the second took place. In the area with flames, carets are present at the tops of the columns, indicating the past presence of flames coming out of these windows.

The figure shows large amounts of smoke continuing to pour from windows well above the 97th floor on the north side of the face. The smoke is particularly heavy from window 107-458. A row of open windows is also present on the 95th floor extending from window 95-441 to window 95-447, with window 95-442 still in place. It is not known exactly when these windows were broken since they were not observed until around 9:00 a.m. They may have been broken during the aircraft impact or by people, who were observed in the open windows. The absence of any smoke or dust coming from the area may indicate that the latter explanation is more likely. The same is true for two windows (windows 92-424 and 92-434) on the 92nd floor that appear to be open in the uncropped version of Figure 8-11.

**Figure 8-11. Image of the west face of WTC 1 recorded between 9:01:09 a.m. and 9:02:17 a.m. The image has been cropped and rotated, and column and floor numbers have been added.**

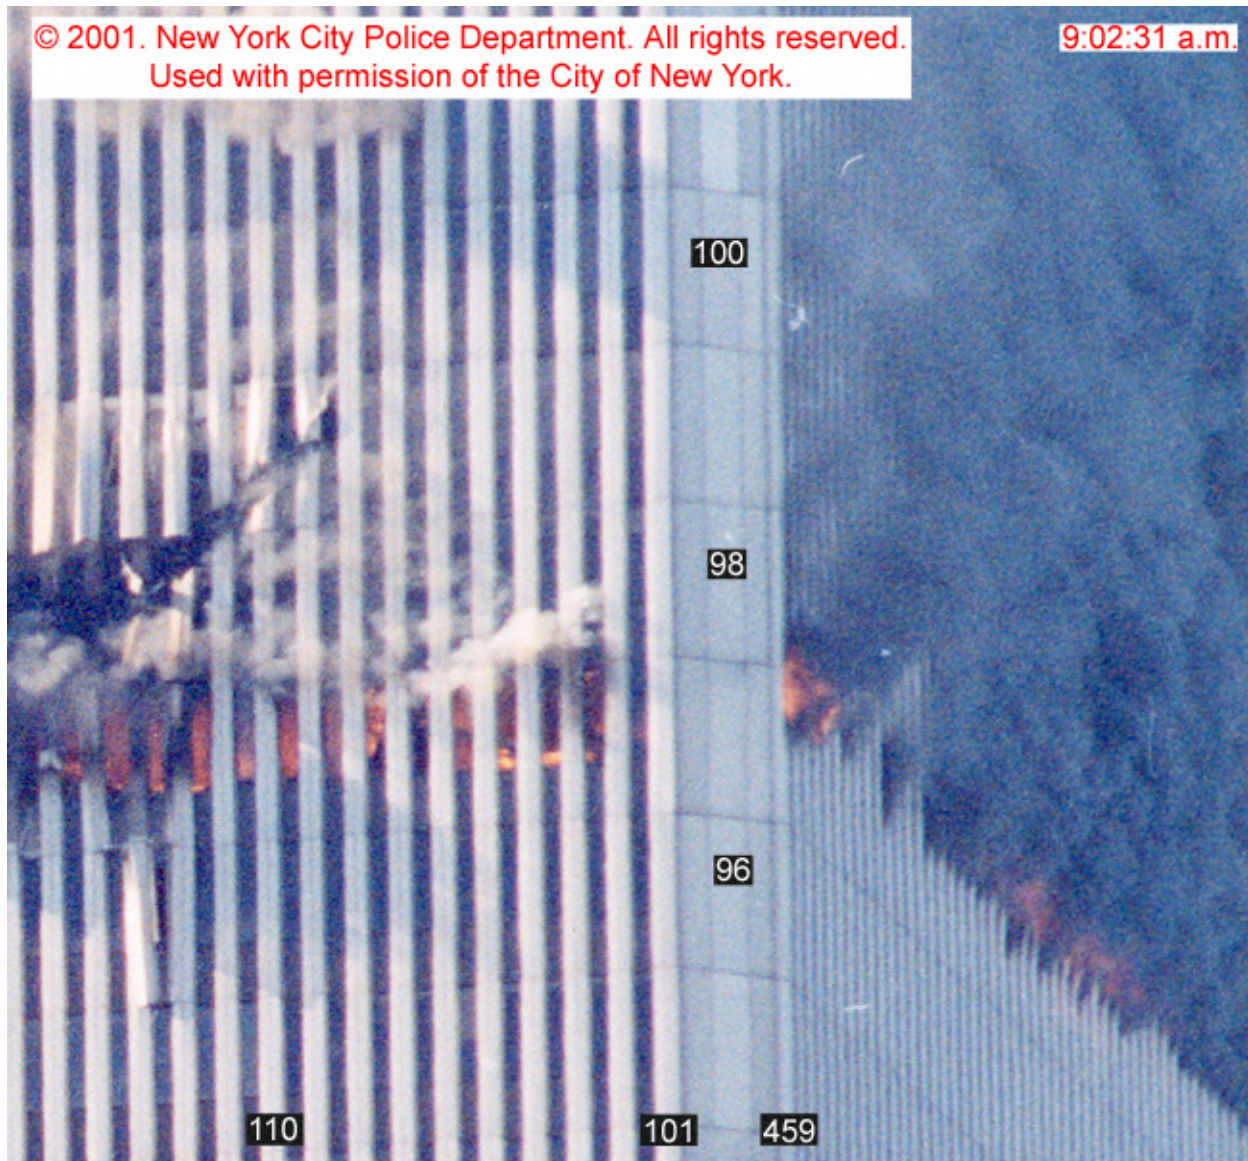
The fire behavior described above suggests that the fire that erupted from window 97-458 at 9:02:17 a.m. was a continuation of the fire spread observed on the north face. It is interesting to consider why the intense fire that grew rapidly over windows 97-110 to 97-116 around 8:50 a.m. did not spread westward for the next ten minutes. A review of the floor plan layouts for the 97th floor (see Figure B-6) shows that

there was a group of three rooms located at the northwest corner of the floor. One of these rooms had a rectangular shape, with one interior wall that abutted column 97-108 and a second that terminated at column 97-456, with the remaining two walls formed by the exterior walls. Based on visual observations, it can be concluded that these walls were able to appreciably slow the fire spread into these rooms. This conclusion requires that these walls remained essentially intact despite the aircraft impact only a short distance away. The sudden appearance of flame and smoke on the west face suggests that flashover occurred in the enclosed space at this time, even though fire seems to have entered the space somewhat earlier.

**Figure 8-12. This photograph was shot from the northwest and shows the north and west faces of WTC 1 at 9:02 31 a.m. The image has been cropped and the intensity levels have been adjusted. Column and floor numbers have been added.**

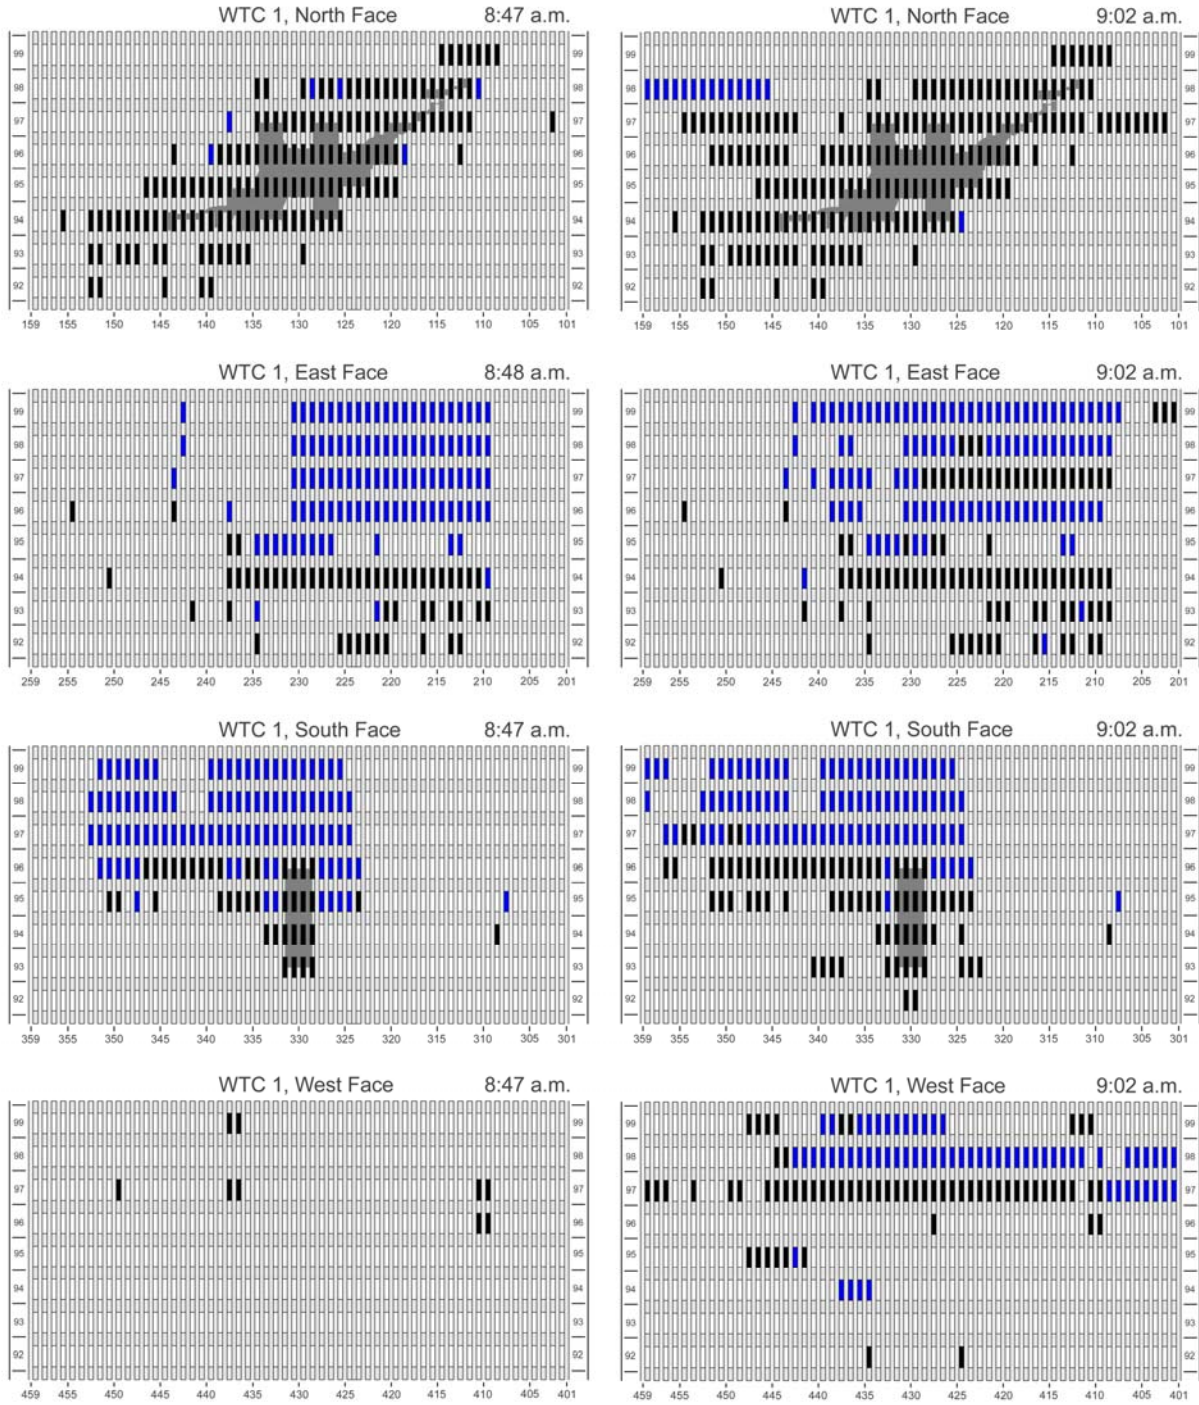
A quick glance at the maps shows that the most extensive fire growth took place on the 97th floor. This growth can be quantified by counting the various window conditions on the four faces of WTC 1 shortly after it was impacted by the aircraft and around 9:03 a.m., when WTC 2 was struck. Table 8–1 is a summary of the results of such an analysis for the 92nd through 99th floors, which include the floors where most of the early fire growth was seen. One simple approach, which is approximate due to the presence of hidden windows, but revealing, is to determine the increase in the number of open windows on each face and to sum the results for each floor. The results are 4, 19, 22, and 85 for the 94th, 95th, 96th, and 97th floors, respectively. Based on the visual observations discussed above, the increases in observed open windows on the 94th and 95th floors were not likely due to spreading fires, but were mostly due to either people breaking windows or to windows that were hidden at the earlier time becoming visible later. On the other hand, the changes for the 96th and 97th floors were primarily due to fire spread. By far, the largest fire growth during the period occurred on the 97th floor, with the number of observed open windows increasing from 30 to 115. On the 96th floor, the initial number was 41, which increased to 63.

The approximate total number of windows that were opened during the first fifteen minutes of the fires in WTC 1 is 130, which can be compared with an approximate total number open immediately following the aircraft impact of 179. This roughly 73 % increase in open window area, as well as the spatial distribution of the open windows, has significant implications for subsequent fire growth and spread. This is particularly true because, in some areas of the building, burning may have been ventilation limited. For these areas, the total area of vents for outside air and their spatial distribution would be expected to be a major factor in determining the maximum possible heat release rate within the tower at a given time, as well as influencing where burning could take place and where additional fire spread would occur.

**Figure 8-13. Maps for the 92nd through the 99th floors compare missing window glass for the four faces of WTC 1 at two times, shortly after the aircraft impact and roughly 15 minutes later. The color coding used for the maps is indicated in Figure 5-1.**

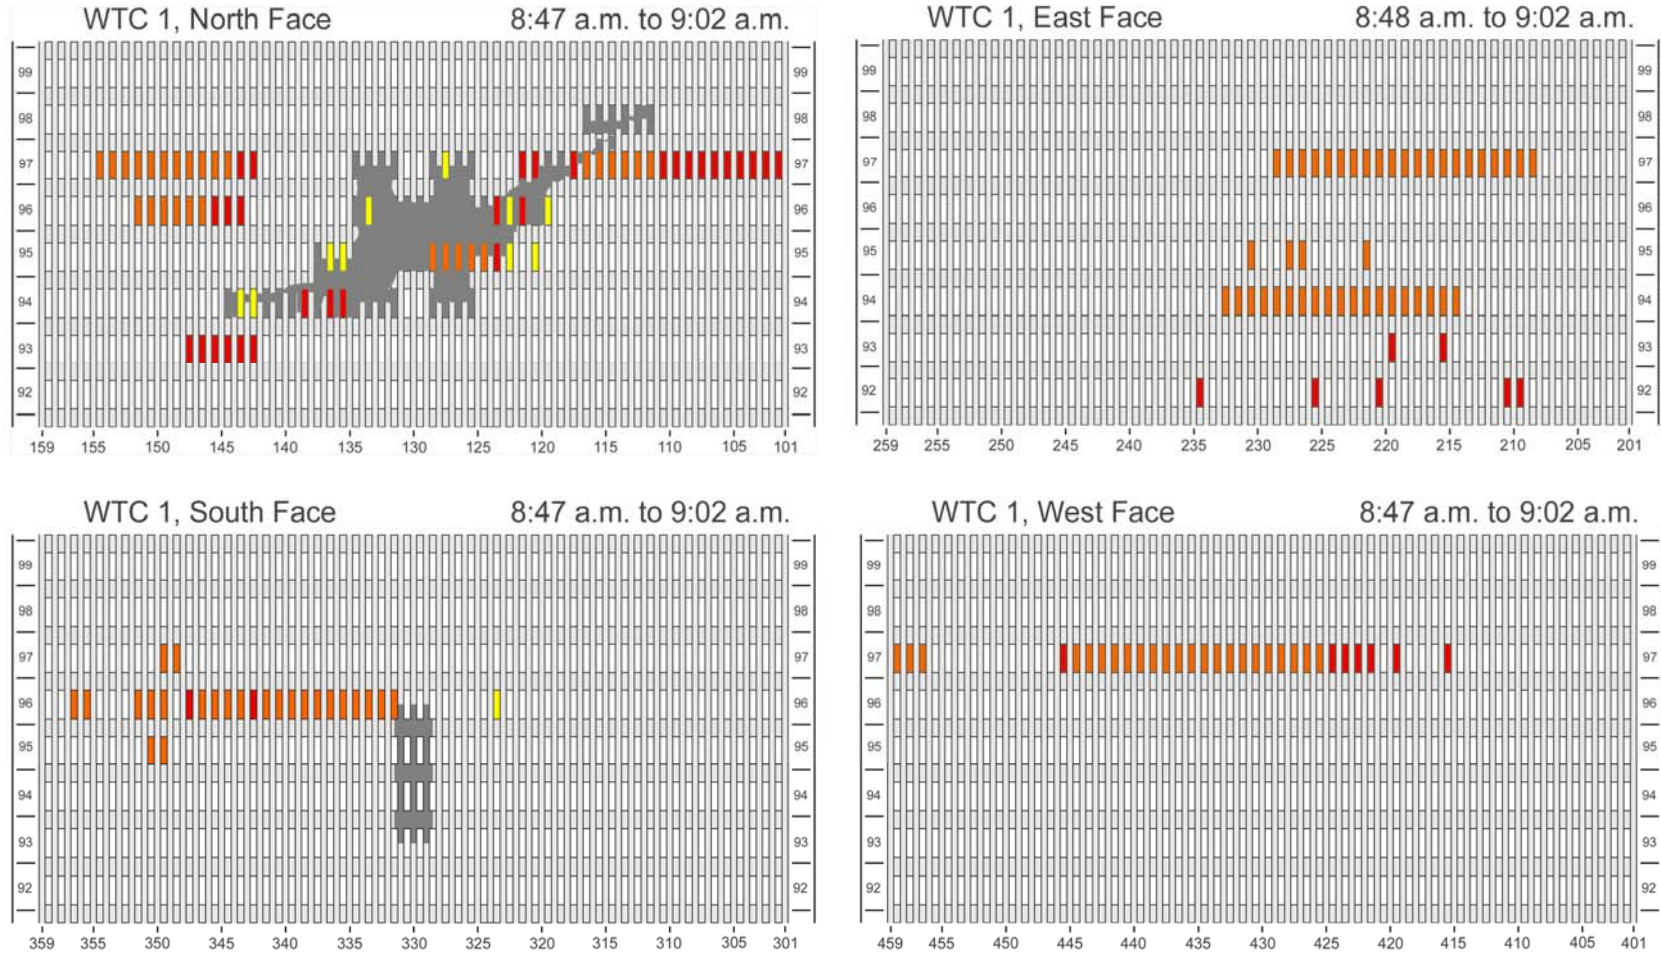
In Figure 8–14, a different type of mapping is used to provide additional insights into the fire behavior during the period. For this mapping, the fire data sheets have been used to generate a description of the integrated fire behavior for each face. The maps are based on new data sheets generated for the four faces in which each window is assigned the highest fire value reported in the fire data sheets for that window during the period. The result shows windows where fire was observed during the period along with an indication for the maximum intensity of a fire in a given window.

Figure 8-14. Maps of integrated fire observations between 8:47 a.m. and 9:03 a.m. are shown for the four faces of WTC 1. Colors represent the highest intensity fire observed in a window using the color scale defined in Figure 5-1.

The extraordinarily rapid fire spread and intense flames observed on the 97th floor are likely associated with the presence of unburned aviation fuel distributed in these areas. As discussed in Section 6.5, a significant amount of fuel was likely dumped on this floor from the starboard fuel tank of the aircraft. The absence of extensive window breakage immediately after impact in locations away from the impact zone implies the absence of significant overpressures, which suggests, in turn, that a large area of the distributed aviation fuel on the 97th floor did not ignite immediately following aircraft impact. This unburned fuel was presumably distributed over areas extending along the intact north exterior wall and the central sections of the east and west walls, since subsequent rapid fire growth occurred in these areas.

As described in Section 6.5, it is likely that significant aviation fuel was also distributed on the 94th and 96th floors during the aircraft impact. On the 96th floor, the observed rapid fire growth to the east of the aircraft impact cavity on the north face could be the result of this distributed fuel. Subsequent rapid fire spread along the east face (see the following section) is also consistent with the presence of aviation fuel. However, up to the current time, no substantial fire growth has been observed on the west side of this floor. Later fire growth on this side will prove to be much less vigorous than on the 97th floor and will move from south to north. On the other hand, fires were observed on the west side of the south facade of the 96th floor shortly after the aircraft impact, and these fires did spread and become more intense during this early period. Recall also that a fireball was observed on the south face, most likely, indicating that ignition occurred somewhere on the west side of the tower, based on the south face damage pattern. These observations are consistent with the hypothesis that a significant volume of atomized aviation fuel on the west side of the 96th floor was ignited during the aircraft impact and that the subsequent fire and overpressure removed a significant portion of the fuel initially distributed in the area.

Little fire growth has been observed on the 95th floor up to this time. This suggests that significant amounts of aviation fuel were not distributed on this floor. This conclusion is consistent with the expected initial distribution of the fuel on the aircraft (see the discussion in Section 6.5).

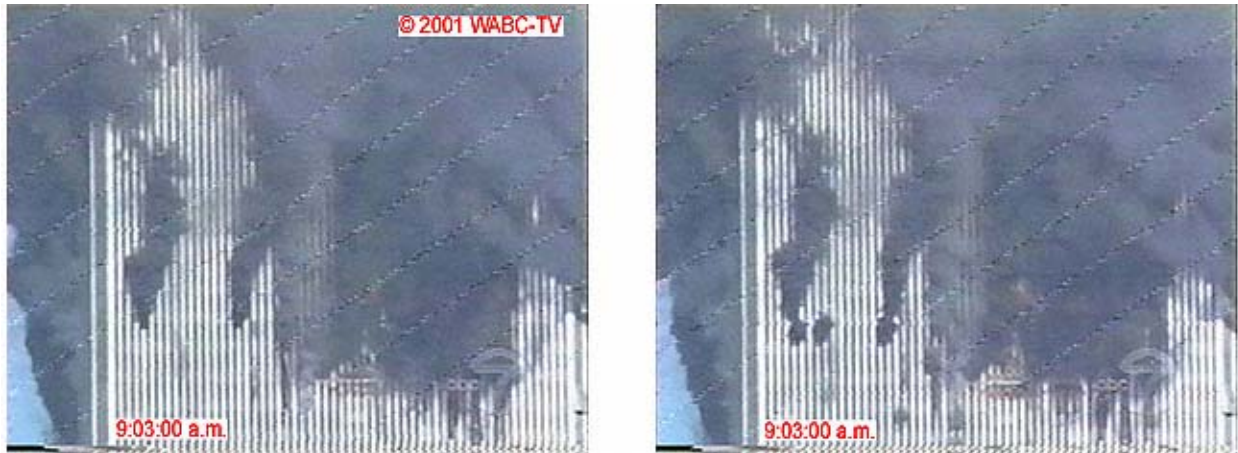
The impact of United Airlines Flight 175 on WTC 2 resulted in some interesting short-term effects in WTC 1. Almost exactly one second after the nose of the aircraft entered WTC 2, a pressure pulse passed through WTC 1 that pushed smoke, and in a few cases fire, from windows located throughout the upper portion of the tower. Figure 8–15 shows the results of this pressure pulse on the east face of WTC 1. The two images are separated by 0.4 s and were recorded roughly one second after the aircraft struck. In the image on the right, puffs of smoke have been pushed out of several windows on the south side of the 96th floor (the floor with smoke coming from a window near the south edge) as well as windows on the 92nd

through 95th floors. Other videos show that almost simultaneously similar puffs of smoke appeared from broken windows on the 92nd, 93rd, 94th, 96th, 97th, 101st, 103rd, 104th, 105th, and 107th floors, as well as from the mechanical equipment room on the 108th and 109th floors. A large burst of flame was ejected by the fire burning on the 97th floor at the north edge of the west face. These observations suggest that a pressure pulse created either by the entry of the aircraft into WTC 2 or the resulting ignition of aviation fuel within the tower was transmitted to WTC 1. The widespread observation of ejected gases suggests that low resistance pathways existed that allowed pressure pulses to be transmitted throughout the upper regions of WTC 1.

**Figure 8-15.** This figure shows two frames taken from a video that were recorded 12 frames apart, i.e., 0.4 s. The images show the east face of WTC 1 at 9:03:00 a.m.

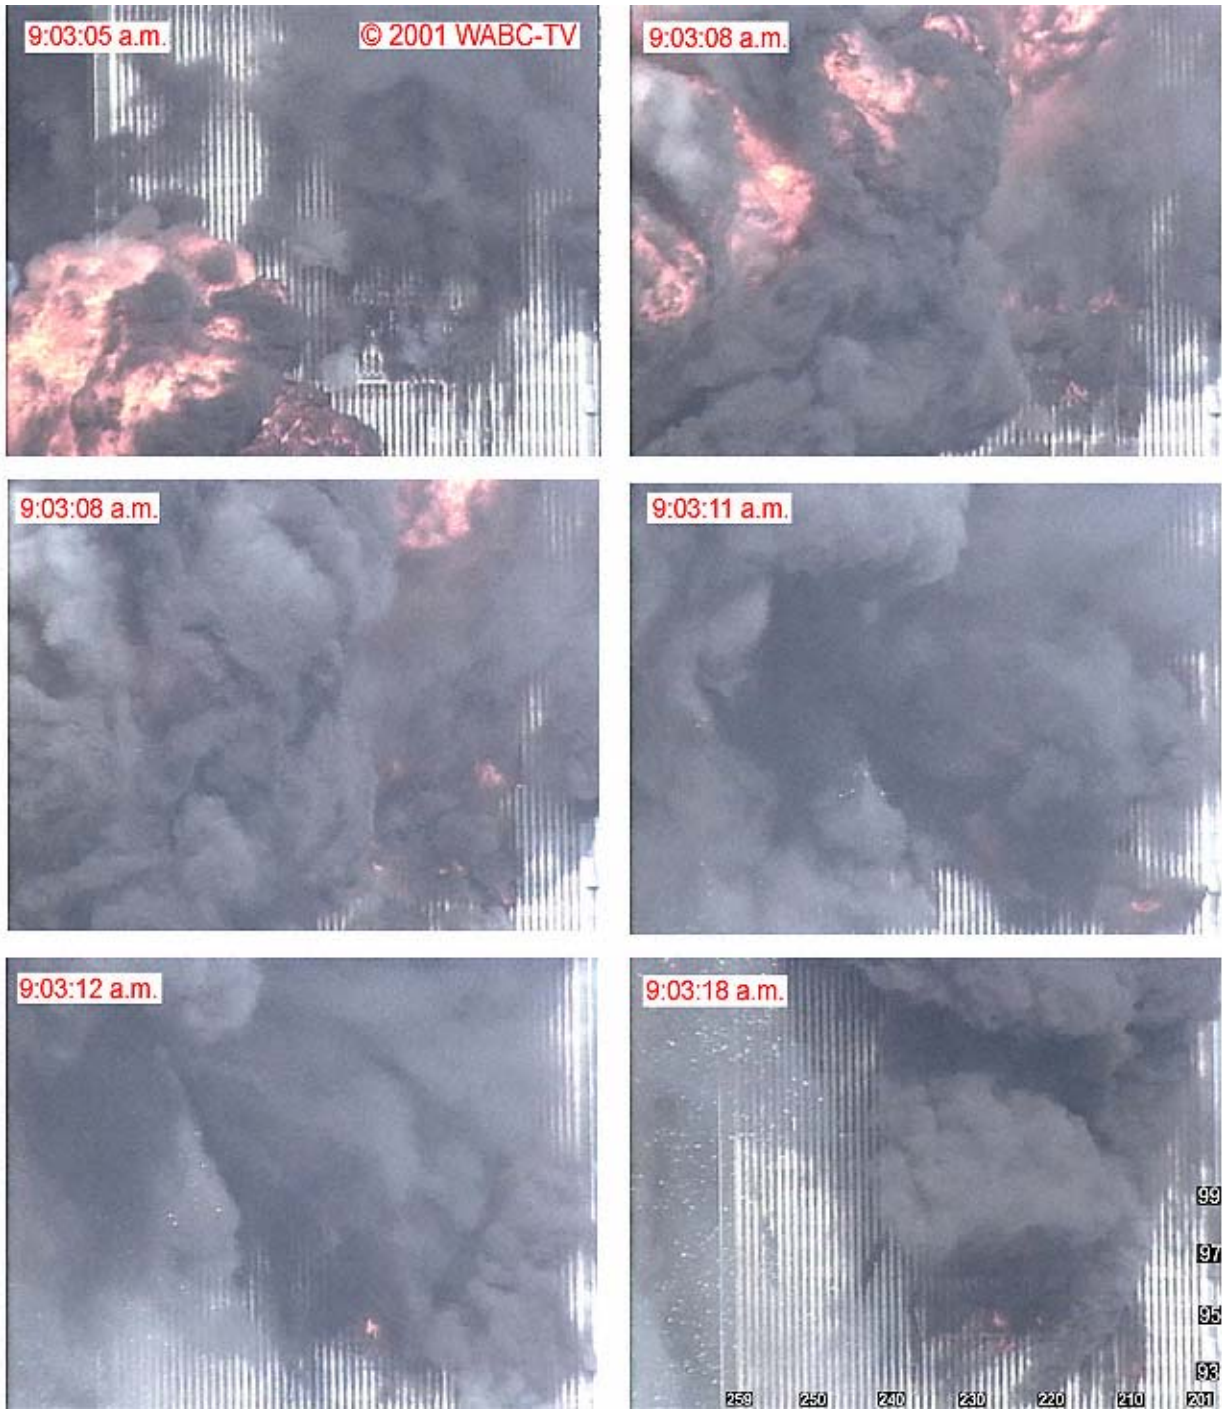
Figure 8–16 shows six frames taken from a video of the east face of WTC 1 during the period when the fireball was forming and rising away from the north face of WTC 2. The fireball itself is visible at the sides of the two earliest images and at the top of the third. In the image at 9:03:05 a.m., much of the smoke has been drawn away from the face of the tower, and it is possible to see the area near the right center of the face where fires have been burning. It is interesting that there are no external flames present at this time. While it still difficult to determine with certainty, it appears as if windows are open on the 94th floor from windows 94-212 to 94-233, on the 95th floor from windows 95-222 to 95-227, on the 96th floor at window 96-224, and on the 97th floor from windows 97-212 to 97-227.

**Figure 8-16. Six frames taken from a video of the east face of WTC 1 are shown. These images were recorded during and just after a fireball formed on the north face of WTC 2 following the aircraft impact. Column and floor numbers have been added to the lower right-hand image.**

The appearance of the face changed dramatically during the next three seconds. At 9:03:08 a.m. more of the face is hidden by the fireball, but most significantly, flames now appear to have been drawn out of windows 94-216 to 94-218 on the 94th floor, window 95-221 on the 95th floor, and a range of windows on the 97th floor extending from window 97-208 to window 97-227. This is the first image that shows a fire burning on the 95th floor. The next image was recorded 0.6 s later. Flames can now be seen coming from window 93-210 as well as from windows 94-225 and 95-226. At 9:03:11 a.m. the flame extending from around window 93-210 was particularly evident, and at 9:03:12 a.m. the same was true for the flames near windows 95-226 and 95-227. At 9:03:18 a.m. a small flame was observed burning at the top of window 92-212. In this image the flames extending from window 93-209 on the 93rd floor are distinct. Flames are also present on the 94th floor at windows 94-225 and 94-226 and on the 95th floor at two locations around windows 95-220 and 95-226. Even though not easily seen in the captured images, there appeared to be a small fire on the 96th floor near window 96-216 during the sequence.

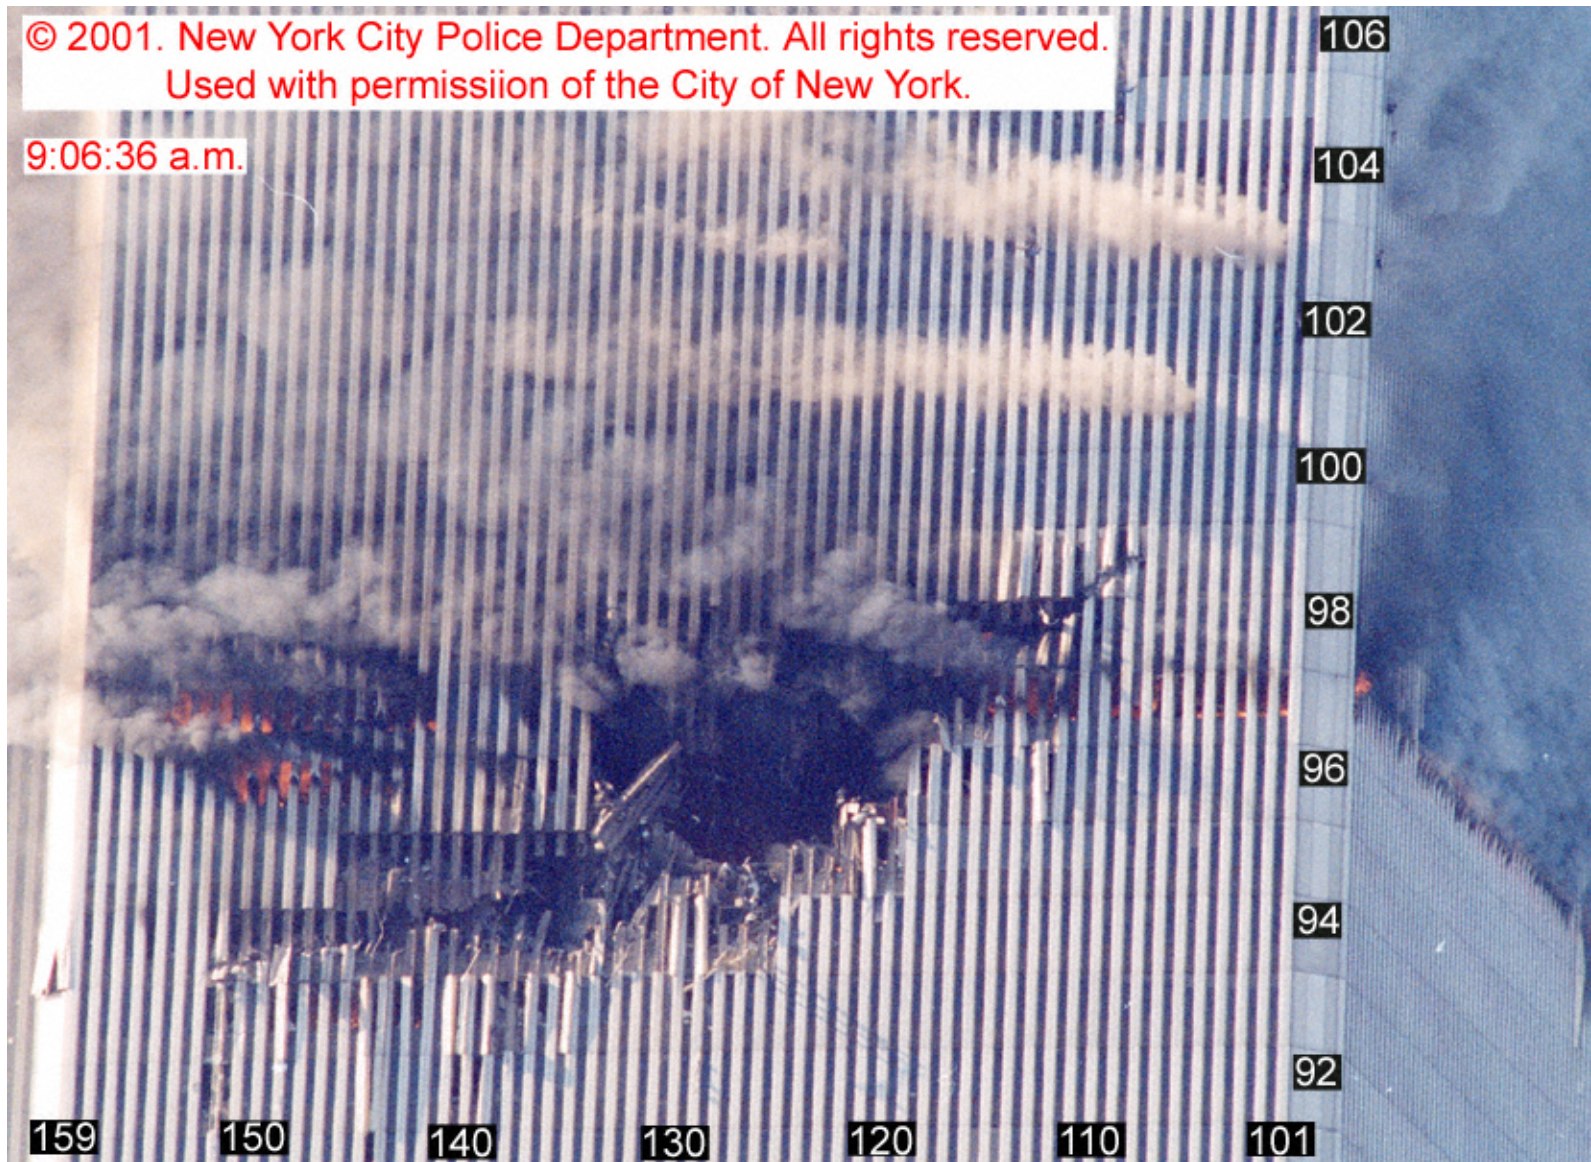
Compared to the rapid fire growth on the north face of WTC 1 during the first fifteen minutes of the event, fire spread during the following fifteen minutes was much reduced. The intense fires that grew on the 96th and 97th floors retreated into the building and began to die down. Figure 8–17 shows a photograph of the north face that was shot at 9:06:36 a.m. Even though the fire on the west side of the 97th floor had spread all the way to the west wall somewhat earlier, the two fires burning eastward on the 96th and 97th floors appear to have stopped spreading. The last window with fire present on the 97th floor is window 97-154. Flames are also evident at the other end of the area, starting at window 97-141. On the 96th floor fire is present at window 96-151, and from window 96-152 on to the east end of the floor, windows appear to be intact. This is clearer in Figure 8–18, which shows a blowup of the area taken from Figure 8–17.

Figure 8-17. A photograph of the north face of WTC 1 recorded at 9:06:36 a.m. is shown. The image has been cropped, rotated, and enhanced. Column and floor numbers have been added.

A small fire continues to burn on the 93rd floor around window 93-145. There is also a small spot fire present in window 98-115 on the 98th floor. This window is immediately above the location where an intense fire initially grew on the 97th floor. Since the windows immediately above on the 98th floor were broken out by the aircraft impact, it is reasonable to assume that flames from below ignited this fire.

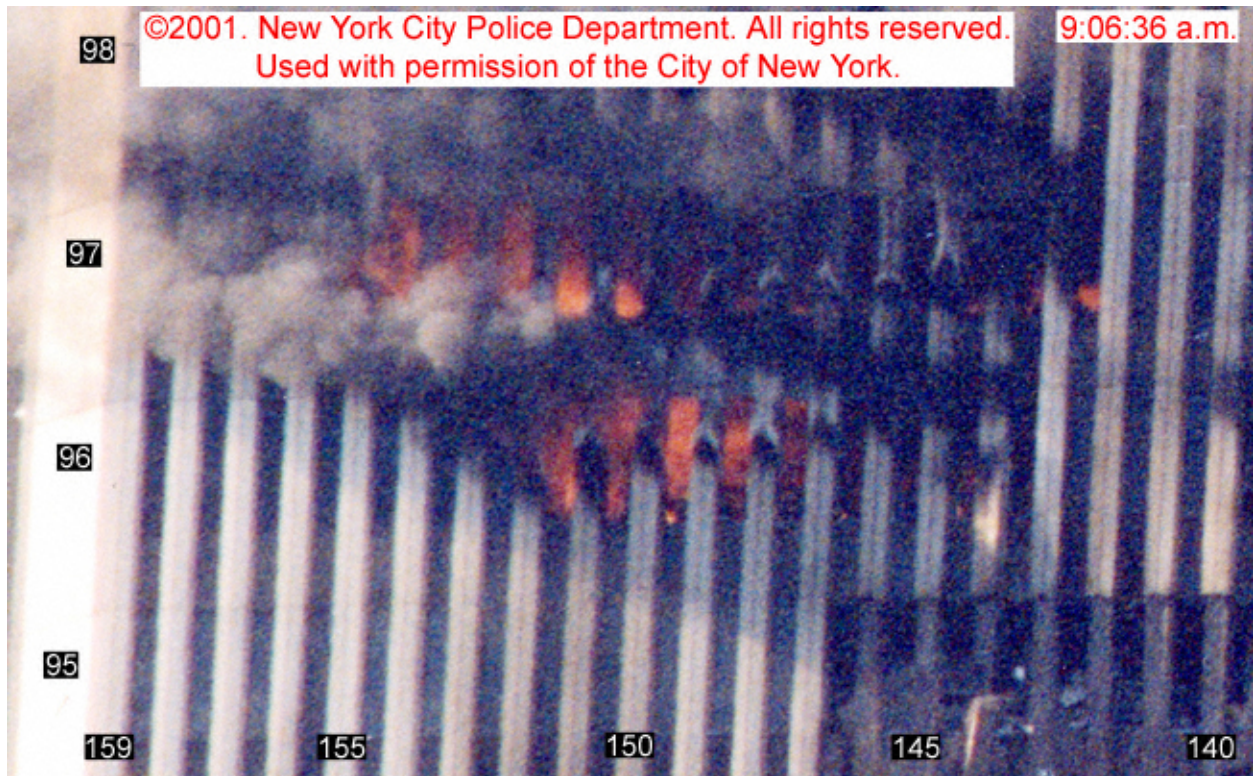
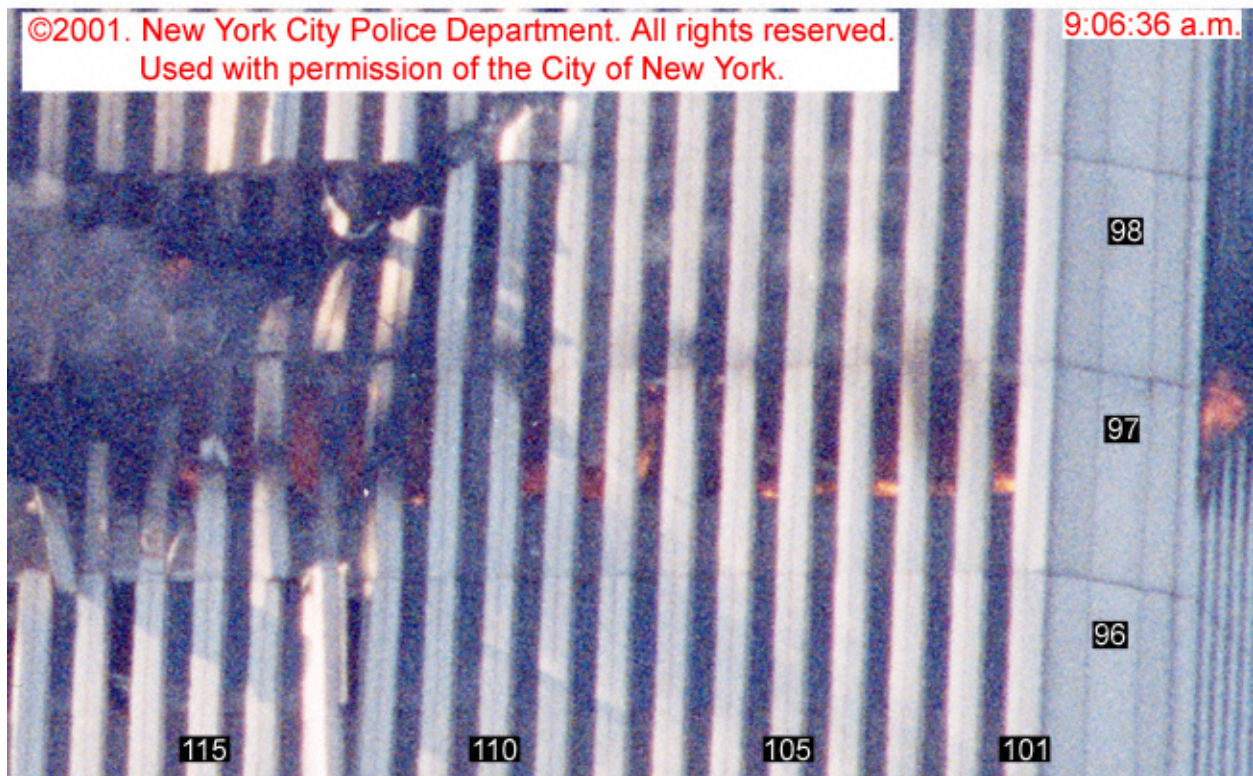
Another prominent feature in Figure 8–18 is the row of carets running across the tops of the column covers. These provide a clear visual indication of how intense the earlier fires in these windows were. It is interesting to compare the appearance of the column covers in this area with those on the 97th floor to the west of the aircraft impact cavity. A blowup of this area is also included in Figure 8–18. The columns are barely marked despite the presence of an active fire in the area for many minutes. This suggests that this fire must be venting somewhere other than through the open windows on the north face. As already discussed, and can be seen in the figure, flames and smoke were coming from this area on the west face of the tower. The smoke issuing from the right side of the aircraft impact cavity may also be due to effluent from this fire. Comparison of Figure 8–17 with earlier images of the north face shows that the flow of smoke from the cavity had also decreased with time. The pathways of venting are expected to influence the local heating of the exterior columns since the imposed heat flux will vary with changes in the flow direction through the opening. Exhausting fire gases will tend to heat the columns, while in-flowing outside air will cool the columns.

Figure 8-18. Two close-ups of the north face of WTC 1 taken from the photograph in Figure 8-17 show the east and west sides of the face around the 97th floor. The photos have been rotated, enhanced, and column and floor number have been added.

In-place windows can be seen in Figure 8–18. On the east side of the building window panes are in their frames on the 95th floor as well as on either side of the fire areas on the 96th and 97th floors. On the west side most windows are still in place on the 96th floor and on the 98th and 99th floors at locations removed from the immediate vicinity of the aircraft impact. These observations suggest that windows are only removed when active burning is present in the immediate area of the window.

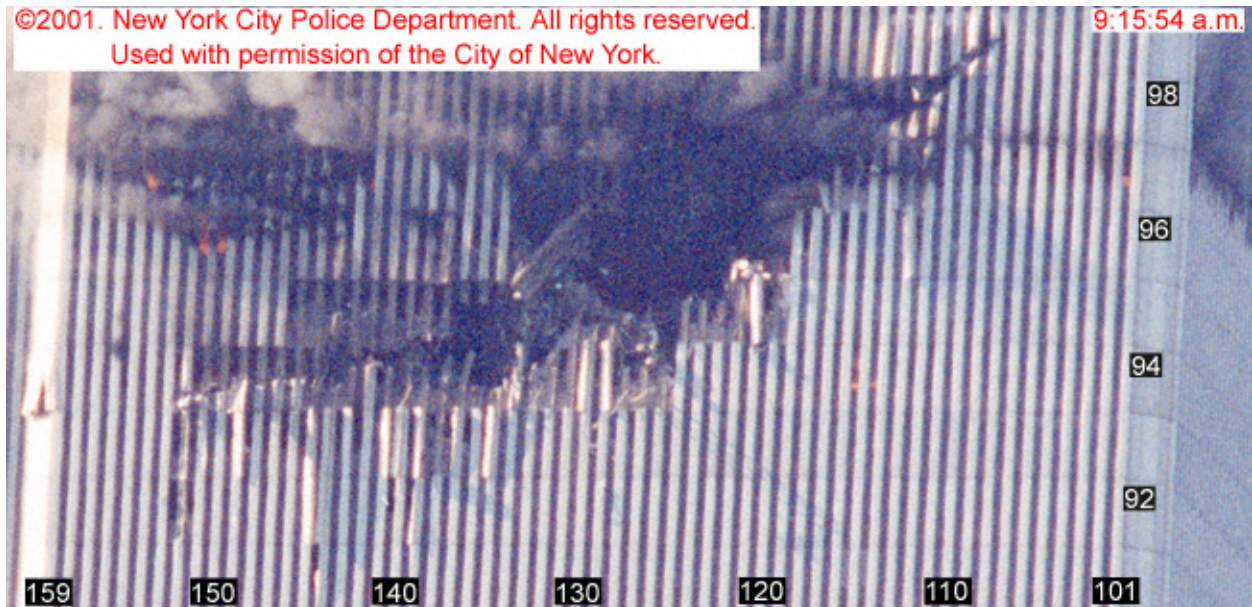
**Figure 8-19.** An image recorded at 9:15:54 a.m. shows the north face of WTC 1. The original has been cropped, rotated, and enhanced. Column and floor numbers have been added.

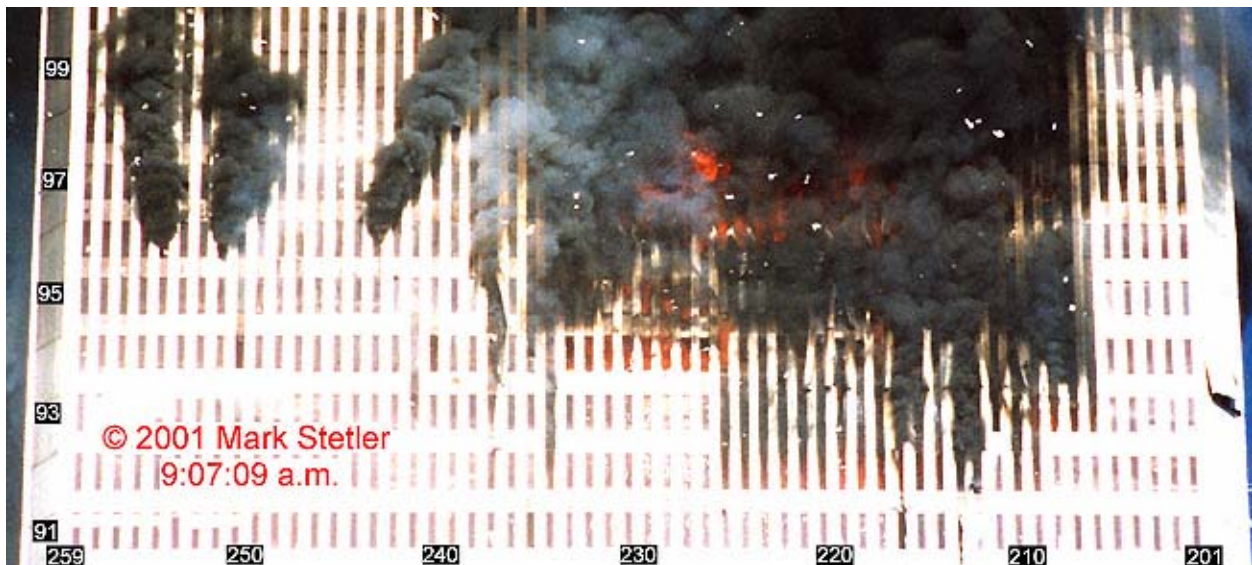
In contrast to the north face of WTC 1, the fires burning on the periphery of the east side of the tower continued to spread during this time period, initiating new areas of intense burning, while areas ignited somewhat earlier were dying down. Figure 8–20 shows the east face at 9:07:09 a.m. The appearance has changed considerably in the four minutes since 9:03 a.m. (see Figure 8–15 and Figure 8–16) and even more so from earlier times. Two important changes are the appearance of extensive areas of flame on the 92nd floor (extending roughly from window 92-216 to window 92-225) and on the 96th floor (visible over at least windows 96-217 to 96-227). Several distinct carets can already be seen on column covers on the 96th floor, indicating that strong external flaming had already taken place from windows adjacent to these columns. At the earlier time there had only been indications of small fires on both of these floors.

**Figure 8-20.** This cropped photograph shows the east face of WTC 1 at 9:07:09 a.m. It has been rotated slightly and enhanced to emphasize the presence of fire. Column and floor numbers have been added.

The intense fires on the 94th and 97th floors, which developed earliest on this face, have died down considerably in the windows where they were first observed. For an example of the earlier fire distribution, see Figure 8–9, which shows fire locations around 8:59 a.m. At this earlier time, intense burning with flame extension was seen over windows 94-214 to 94-228 on the 94th floor and windows 97-208 to 97-228 on the 97th floor. In Figure 8–20, a region of intense flaming is evident on the 94th floor, extending from window 94-225 to at least window 94-233, with some flame extension in the area, while windows further to the north appear to have little fire present. This shows that the fires on this

floor were spreading to the south at the same time they were dying down in areas that were ignited earlier. The same was true for the 97th floor. At 9:07 a.m., the most intense burning was located near windows 97-218 to 97-229. The largest flame extension was from window 97-226 at this time. At the time the photograph in Figure 8-9 was taken, flames were coming from window 97-208.

Around 9:03 a.m. there was a fire near column 95-225 on the 95th floor. In Figure 8-20, the fire on this floor now extends to window 95-231. The extended flames observed on the 93rd floor near column 93-210 around 9:03 a.m. have receded back into the building and are not obvious in the photograph. In their wake they left a dark caret at the top of the aluminum cover for column 93-210.

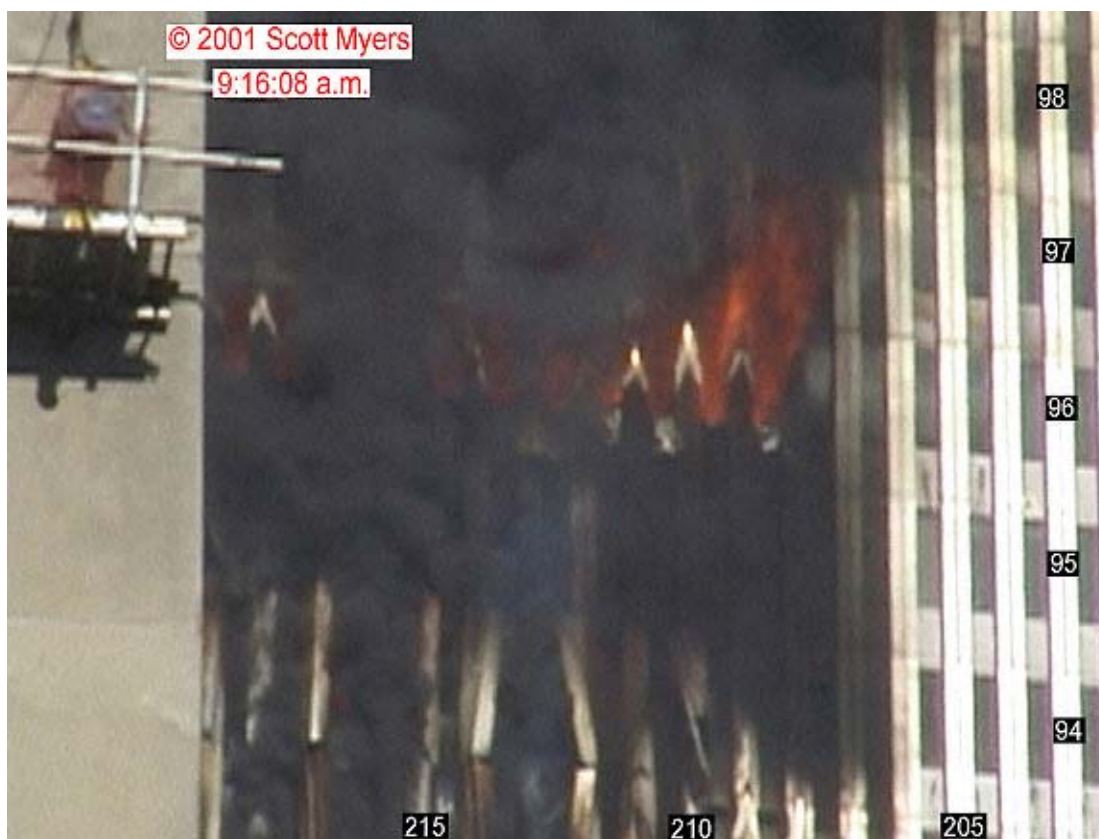
Figure 8-21 shows a close-up frame from a video of a portion of the east face recorded at 9:16:08 a.m. Intense flames are coming from windows 96-208 and 96-209. In the video it is clear that flames are exiting from across the entire burning region that is visible on this floor. A series of carets are seen at the tops of the column covers. The carets appear to be glowing near the center. The physical mechanism responsible for this glow is not known, but it does suggest that significant heating was taking place at this time. Recall that flames were observed on the 97th floor immediately above this location around 8:59 a.m. (see Figure 8-9). These flames are no longer visible, providing additional evidence that flames are growing and then decaying in relatively short period of times.

**Figure 8-21.** A close up of a portion of the east face of WTC 1 is shown. The image is a frame taken from a video recorded at 9:16:08 a.m. Column and floor numbers have been added. The area to the left with the scaffolding is another building in the foreground.

Even though flames have been observed extending from windows 96-208 and 97-208 on the 96th and 97th floors, the adjacent windows to the north, window 96-207 and window 97-207, are still intact. In fact, the entire area to the east of column 208 on floors 94 through 98 appears to be unaffected by the fires, except for soot deposited on the left side of the area. The sharp demarcation line for the fires on the 96th and 97th floors suggests that fire spread is being inhibited in a manner similar to that already described for the north face. The plan layouts for these floors shown in Appendix B (Figure B-5 and Figure B-6) indicate that both floors had rooms in the northeast corners, with walls that terminated at column 208.
