**NIST NCSTAR 1-5A**

**Federal Building and Fire Safety Investigation of the  
World Trade Center Disaster**

# **Visual Evidence, Damage Estimates, and Timeline Analysis**

September 2005

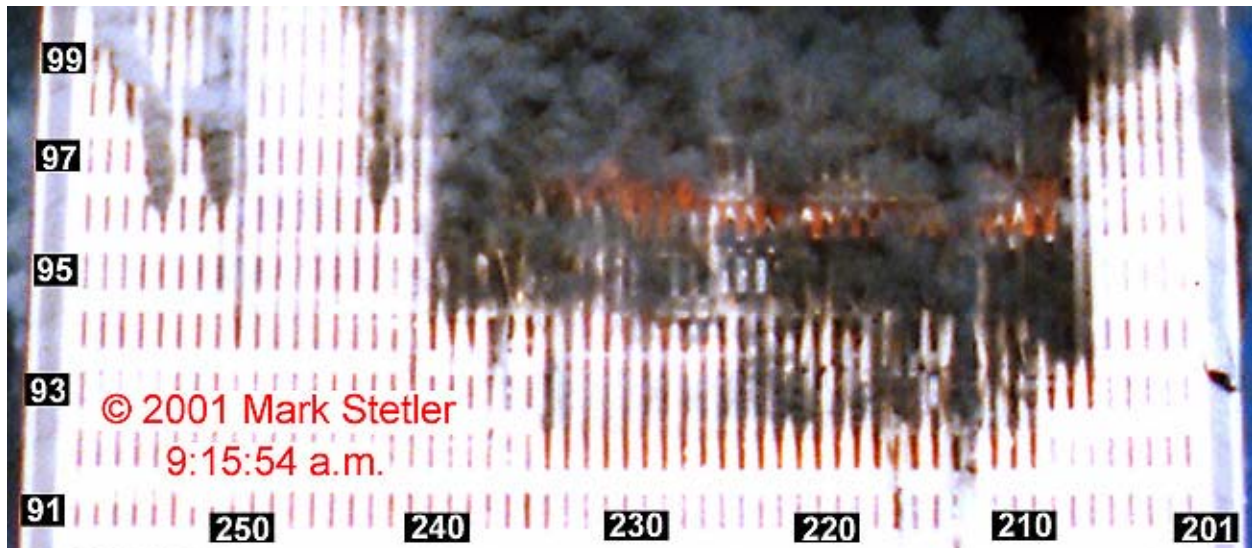
These general trends in the observed fire behavior for the east face continued over the next several minutes. Figure 8–22 shows a photograph that was taken at 9:15:54 a.m. There are regions of extensive fire. Flames can be seen on the 92nd floor from window 92-209 to window 92-235. One curious aspect of these flames is that there is little, if any, flame extension, and there is only heavy smoke coming from windows on the right side of the area. As a result of these characteristics, in many images of the east face recorded around this time, the fire on the 92nd floor is not readily apparent, and the smoke flow from these windows appears to be light. Fire is only observed in images taken nearly perpendicular to the face from relatively long distances. As discussed in Section 4.2.7, such observations are due to the geometry of the building and either suggest the fires are located near the floor or are set back from the windows.

**Figure 8-22.** This cropped photograph shows the east face of WTC 1 at 9:15:54 a.m. The image has been rotated and enhanced to improve the dynamic range. Column and floor numbers have been added.

On the 93rd floor, there appears to a small fire covering several windows starting at window 93-206. There is some smoke coming from the area.

Unlike earlier, at this moment, only limited flame extension is observed from windows on the 94th floor. Flames can be seen inside the windows starting near window 94-224, and they have now spread as far south as window 94-240. Even though smoke is still coming from some windows, there is little flame evident in windows to the north of window 94-223.

The fire observed earlier on the 95th floor in windows 95-225 to 95-231 has died down. Interestingly, intact windows can be seen to the immediate right of this area. Images recorded much later show that many windows to the north remained intact.

The fire on the 96th floor continues to burn fiercely. A continuous region of flames extends from windows 96-208 to 96-234. There is significant flame extension from around windows 96-208 and 96-209 and from windows 96-227 to 96-234. A distinct row of carets at the tops of the column covers is visible over much of the fire length, providing an indication of the maximum depths of the layer of flaming gases that flowed earlier from the adjacent windows. The layer depth is related to the local intensity of burning, with a deeper depth indicating a more intense fire.

Some of the 97th floor is hidden by smoke. This is especially true near the center of the face, where a substantial fire may still be present. Many open windows can be seen to the north of this area in which there does not appear to be fire present. In other places, e.g., near window 97-211, relatively low-level burning is taking place. Similar to part of the 94th floor, the fires on the 97th floor that grew the earliest on this face now appear to have died down.

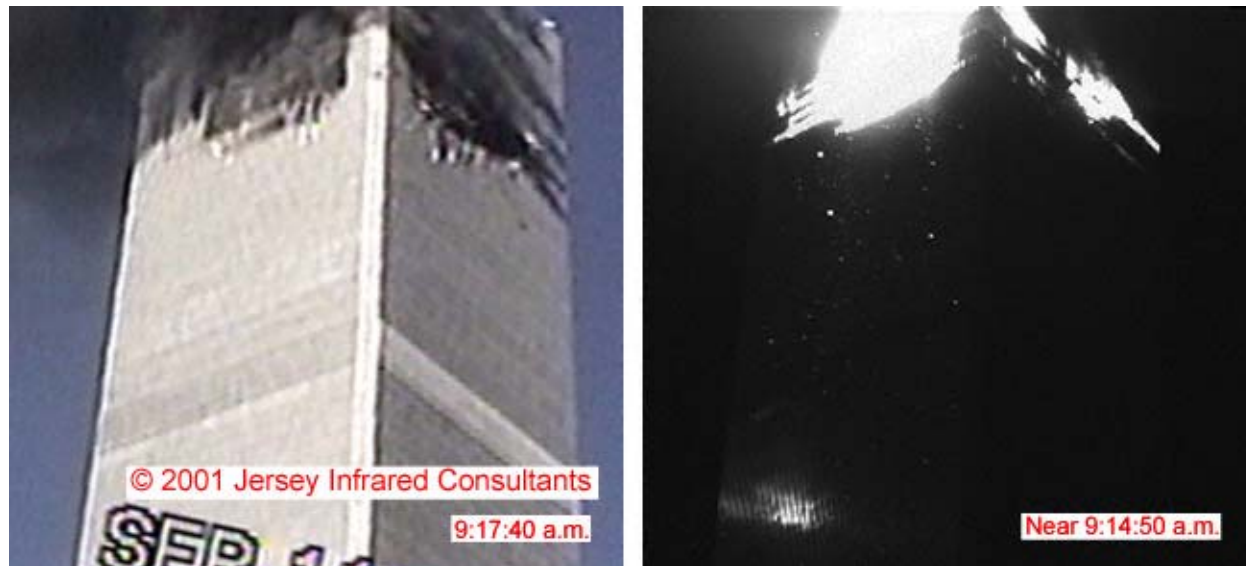
An infrared image showing the north and east faces of WTC 1 that was taken around 9:14:50 a.m. is compared in Figure 8–23 with a standard video frame recorded shortly afterward from the same location. These images were recorded at roughly the same times as Figure 8–19 (9:18:17 a.m.) and Figure 8–22 (9:15:54 a.m.), which show the north and east faces of WTC 1, respectively. Recall from the earlier discussion that the infrared photographs provide only a qualitative indication of where heating of the building façade is taking place.

**Figure 8-23. A frame from a standard video camera (left) and an image from an infrared camera (right) showing the north and east faces of WTC 1 are compared. The video frame was shot at 9:17:40 a.m., and the infrared image was taken around 9:14:50 a.m. (an uncertainty of 15 s has been assigned). The infrared image intensity levels were adjusted. The video frame has been rotated and sized to match the infrared image.**

There is considerable heating in the immediate vicinity of the aircraft impact cavity. This is most likely associated with the heavy smoke (presumably heated) that is still flowing from the area. The two bright lines on the east side of the north face are due to heating by the fires that have been burning on the 96th and 97th floors. It is interesting that there is a region between the aircraft impact cavity and these heated regions that has remained relatively cool. This means that this area had neither burned nor been heated by fire gases from nearby fires.

In Figure 8–23 there appears to be a heated area on the east face many floors below the fire floors. There are no other indications of a fire burning in this area, and it is believed that this apparent heating results from a reflection of the fires burning in WTC 2.

Despite this strong heating, there are parts of the east face in Figure 8–23 where individual floors and windows can be identified. On the south side of the face heat has migrated along the 94th through 97th floors, resulting in the bright lines that are visible in the infrared image. Individual windows are barely resolved. Figure 8–22 shows that smoke was flowing from only a few of the windows in this area and that most of the windows were still closed around this time. Heavy smoke can be seen coming from two windows (96-251 and 96-254) on the southern side of the 96th floor in Figure 8–22. In Figure 8–23 these two windows stand out as two larger bright spots near the southern edge of the tower. Using these windows for reference, it can be seen that the heated sections of the 95th, 96th, and 97th floors do not extend beyond column 250, while the heating on the 94th floor seems to have reached the south end of the

floor. The southern portion of the east side of the 92nd floor appears unheated despite the presence of a substantial fire near the center of this floor.

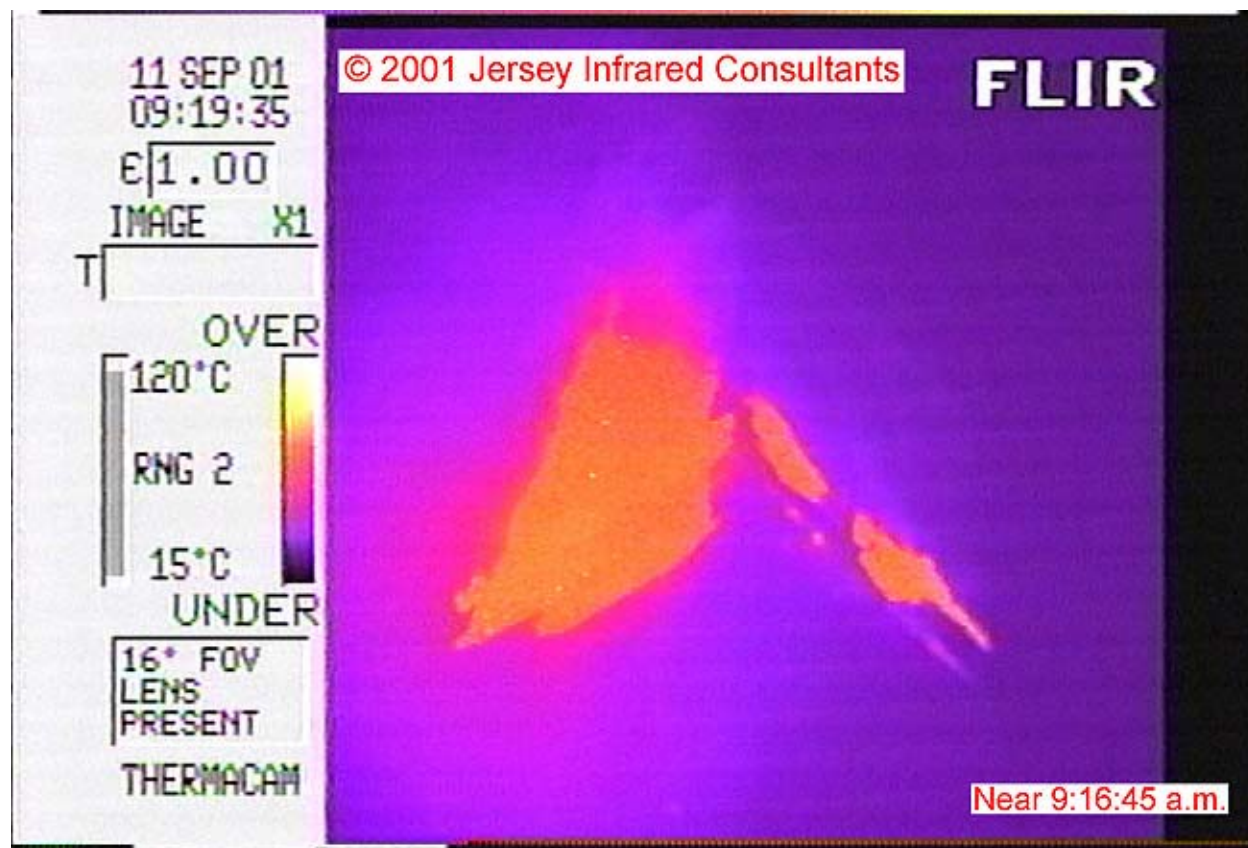
The difference in the amount of heating on the north and east faces in Figure 8–23 and Figure 8–24 is striking. Much of the area above the fires on the 92nd floor at the center of the east face is saturated, i.e., strongly heated. This is likely due to the large amounts of smoke and heat flowing from open windows near the intense fires burning on multiple floors of this face.

**Figure 8-24.** This frame from a standard video recording of the display from an infrared camera shows the north and east faces of WTC 1. It was shot around 9:16:45 a.m. (an uncertainty of 15 s is assigned) using a false-color scale for intensity. The output is strongly saturated.

On the northern side of the east face there are heated areas that reach as far as the northeast corner on the 96th and 97th floors. This is clearer in Figure 8–24, which shows more of the tower. Recall that at the times these images were taken the glass for all of the windows inside the northeast corner rooms was still in place on these floors despite the presence of nearby intense fires. On the lower floors there appears to be mild heating at the northern edges of the 92nd and 94th floors, while the 93rd and 95th floors are close to the ambient temperature.

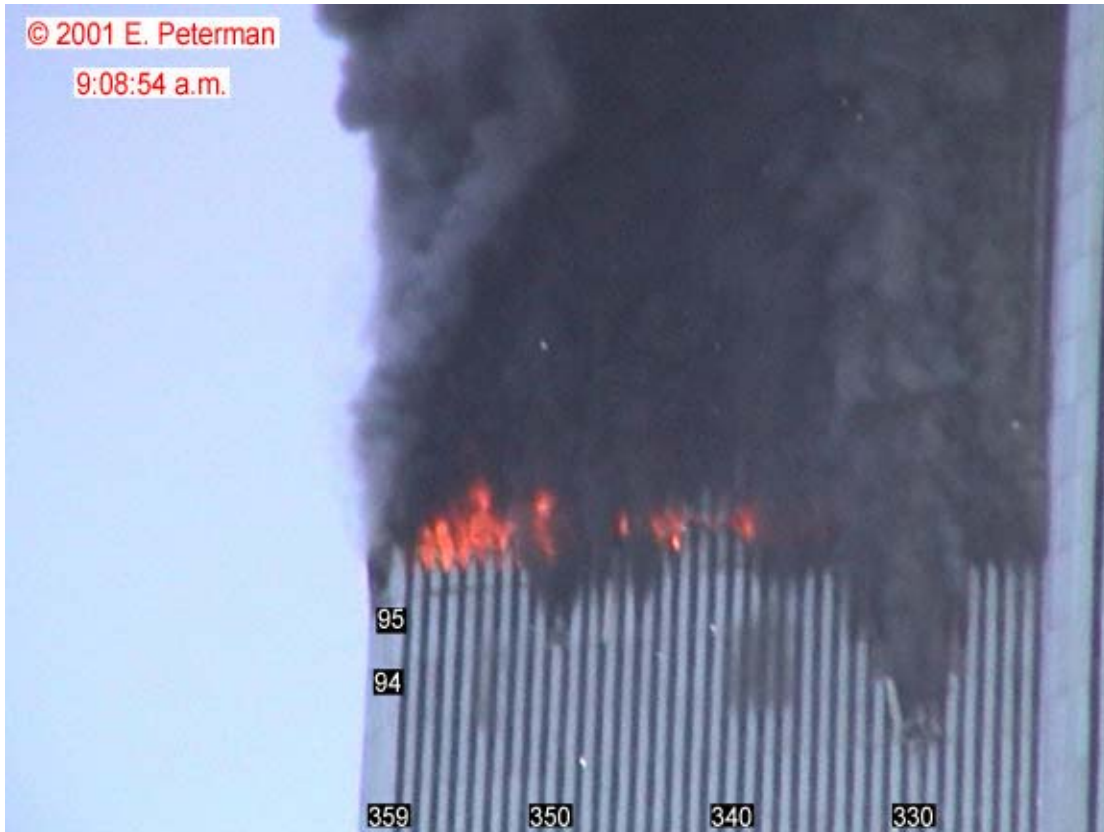
During the initial part of this time period, the fires on the west side of the 96th floor on the south face continued to spread and grow. Distant images indicate that fire fully covered the area near the west wall shortly after 9:03 a.m. Figure 8–25 shows the west side of the south face as it appeared at 9:08:54 a.m. The image was captured from a video recording. On the 96th floor, flames now extended from at least

window 96-335 all the way west to window 96-358. The flames were particularly heavy on the west edge from windows 96-350 to 96-358. At this time, flames are not visible on other floors.

**Figure 8-25.** This image showing the south face of WTC 1 at 9:08:54 a.m. is a frame taken from a video. Column and floor numbers have been added.

During the next five minutes, the appearance of the south face changed dramatically as can be seen by comparing Figure 8–25 with another captured video frame shown in Figure 8–26. While the fires on the 96th floor were beginning to die down and recede back into the tower, extensive areas of flame were now apparent on both the 95th and 97th floors. The fire on the 95th floor can be seen in windows 95-340 to 95-346, while flames are visible extending from windows 97-336 to 97-354 on the 97th floor. The fire on the 97th floor may actually extend to the west face, but this cannot be confirmed since the area was hidden by heavy smoke coming from below.

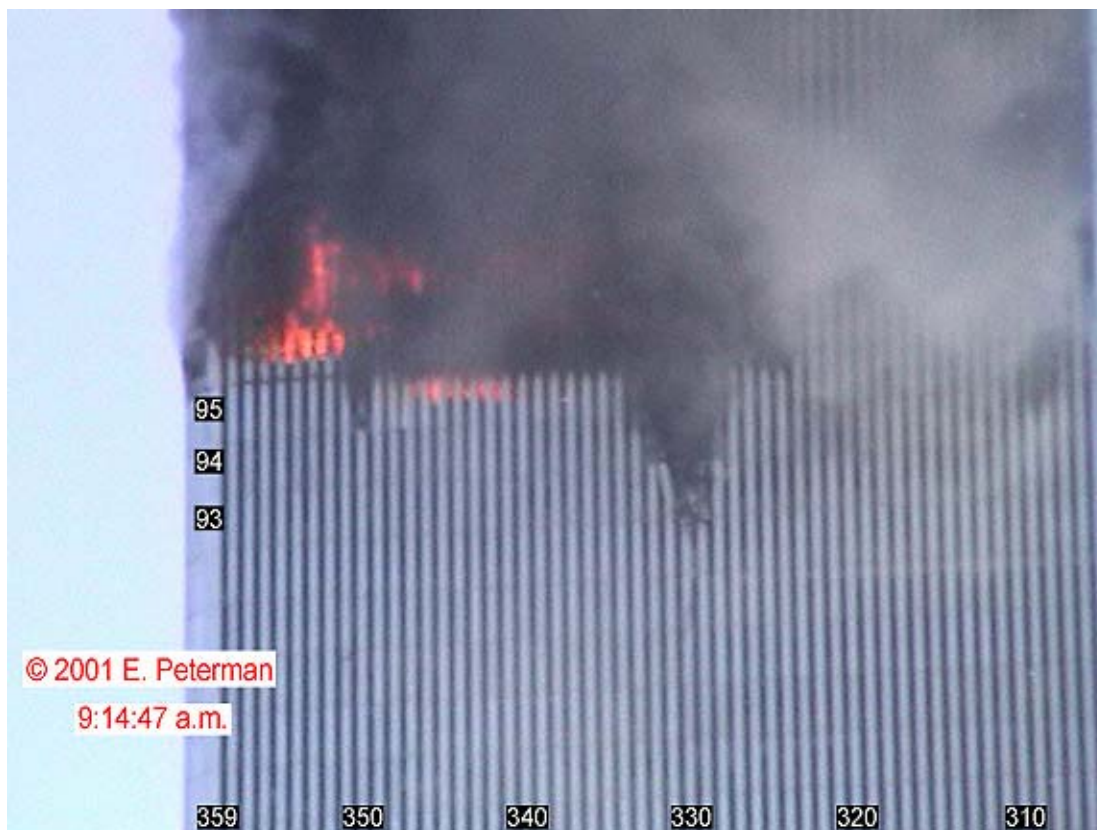
**Figure 8-26. This image showing the south face of WTC 1 at 9:14:47 a.m. is a frame taken from a video. Column and floor numbers have been added.**

A row of carets is already visible at the tops of the covers for columns 96-352 to 96-359. Despite the intense flames, few streamers were observed falling from the south face as shown in Appendix L. This is not unexpected since imagery from this direction is more limited than for the north and east faces, and many of the available shots are from such distances that streamers are difficult to identify. During this time period, the south face was in shadow, and streamers were not illuminated by sunlight until they had traveled a considerable distance from the building.

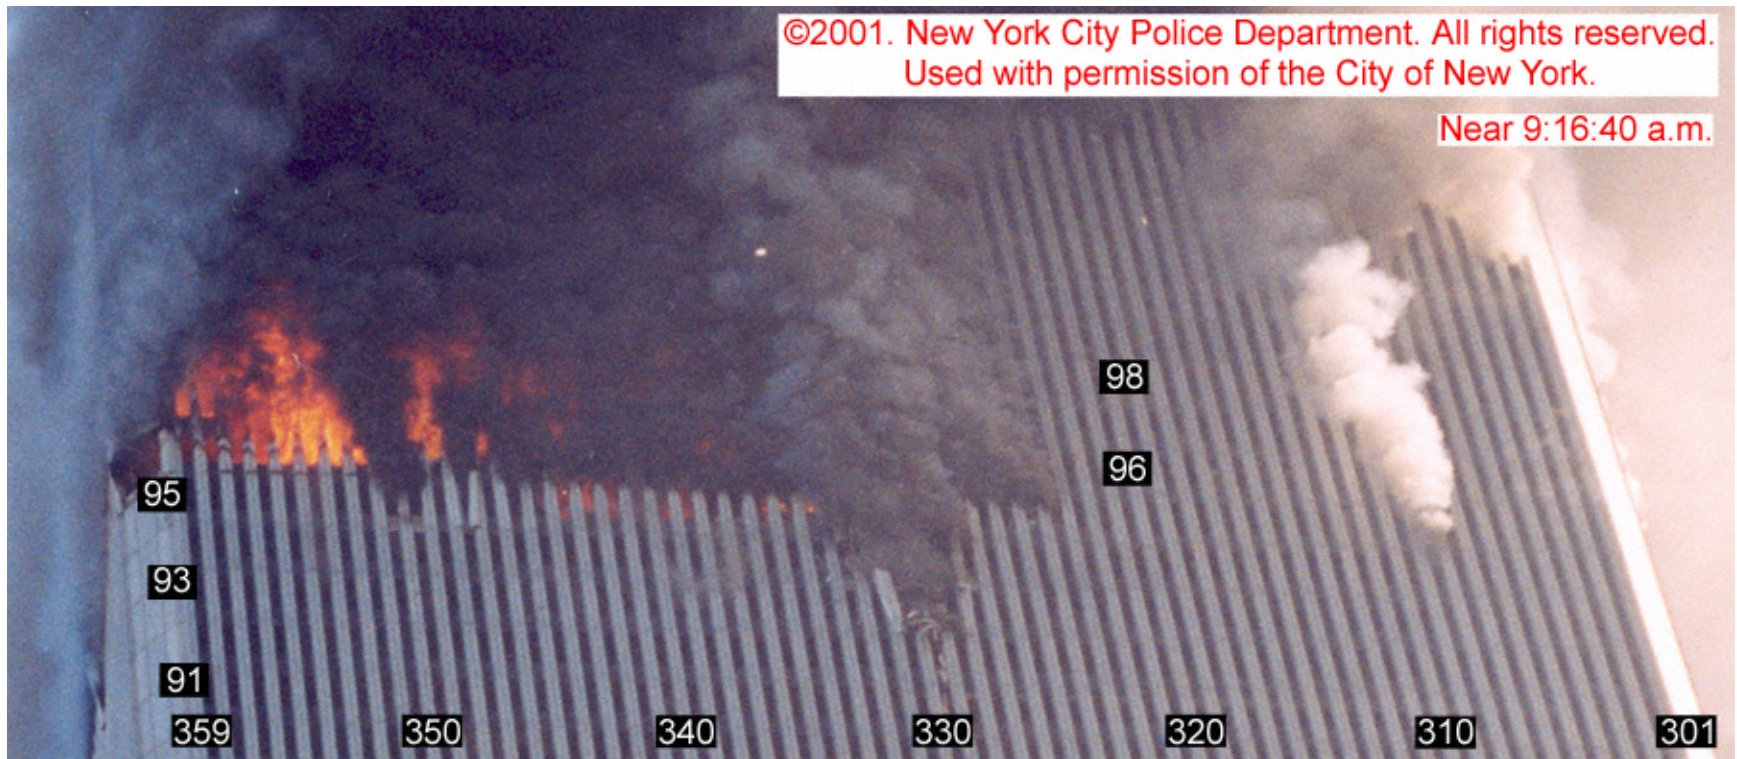
The fire intensity on the south face appears to have gone through several cycles, alternating between periods during which flames extended large distances from multiple windows and those where the flames receded back into the building. Figure 8–27, a photograph shot at around 9:16:40 a.m., i.e., roughly two minutes later than Figure 8–26, shows an example of one of the intense burning periods. The fire on the 95th floor has spread to the east and now extends to at least window 95-333. Flames are coming from several windows to the left of window 95-340. Heavy smoke, which partially obscures the areas above, is pouring from the openings. Bright yellow flames, which appear to reach down to the bases of the

windows, are now jetting from multiple windows on the 96th floor. It appears as if a portion of the exterior wall is covered by a continuous sheet of flame several stories tall. Fire is evident on the 97th floor, but it is not possible to judge whether flames are coming out of the windows on this floor due to the heavy smoke and flames rising from the 95th and 96th floors.

Figure 8-27. This image of the south face has been cropped from a high-resolution photograph. There is a 35 s uncertainty in the assigned time of 9:16:40 a.m. The image has been enhanced and rotated. Column and floor numbers have been added.

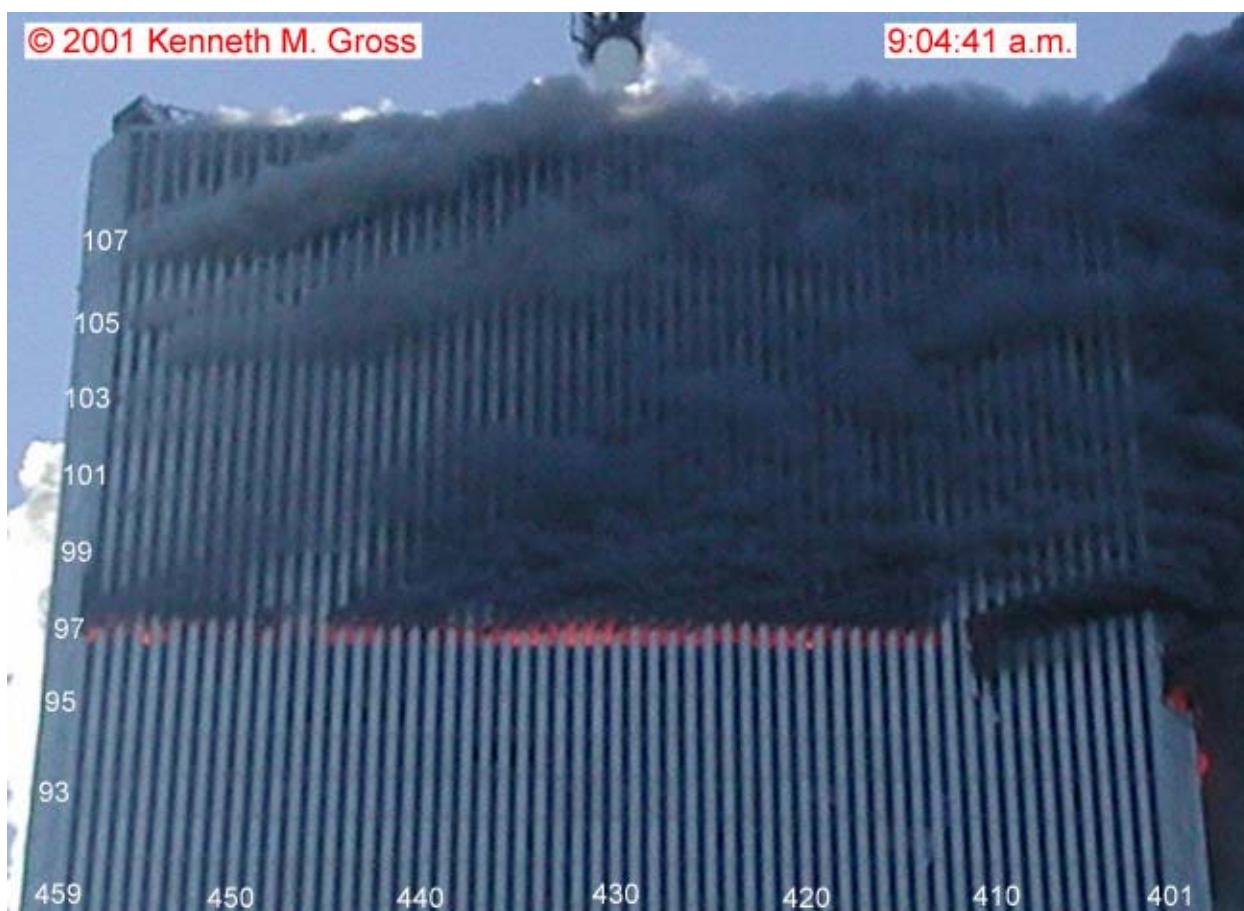
The fires on the west face during this time period continued to undergo unusual and dramatic changes in behavior. But first, following the two periods of rapid fire spread prior to 9:03 a.m., the fires again underwent another pause during which further fire spread was not evident. Figure 8–28 shows the west face as it appeared at 9:04:41 a.m. Flames, with a couple of breaks, can be seen in or extending from window 97-412 to window 97-458. This is roughly the same area that was burning just prior to 9:03 a.m., although the flames in the southern part of the area are more evident than earlier. Heavy smoke is pouring from multiple windows on this floor. Other features present in Figure 8–28 include heavy smoke flow from windows 96-409, 96-410, 97-409, and 97-410 on the 96th and 97th floors, the heavy smoke coming from broken windows in the upper northern portion of the face, and the fire coming from the southwest corner of the 96th floor where the aluminum panel was dislodged during the aircraft impact and subsequent fireball. A streamer can be seen near column 414 at the bottom of the photograph.

The open windows on the 95th floor, visible in Figure 8–11, can also be seen in Figure 8–28. There are also four windows, 94-434 to 94-437, on the 94th floor that are now open, but were in place in the earlier photograph taken at 9:01:40 a.m. These windows are believed to have been broken out by people. At this time there is no smoke coming from either set of open windows despite the presence of fires elsewhere on both floors.

**Figure 8-28. A cropped photograph of the west face of WTC 1 taken at 9:04:41 a.m. is shown. The image has been enhanced and rotated. Window and floor numbers have been added. A streamer can be seen falling near the bottom of the image at column 414.**

During the time period from 9:03 a.m. to 9:18 a.m., only a few streamers were observed on the west face, as shown in Appendix L. One of these streamers is visible in Figure 8–28. It is difficult to see this streamer, even though the photograph is fairly close up. This is due to the fact that the streamer is not illuminated by sunlight. There are relatively few photographs of the west face showing the detail of Figure 8–28 during this time period. Given the intensity of the fires on the west face, it is likely that numerous streamers were formed, but that they simply were not observed.

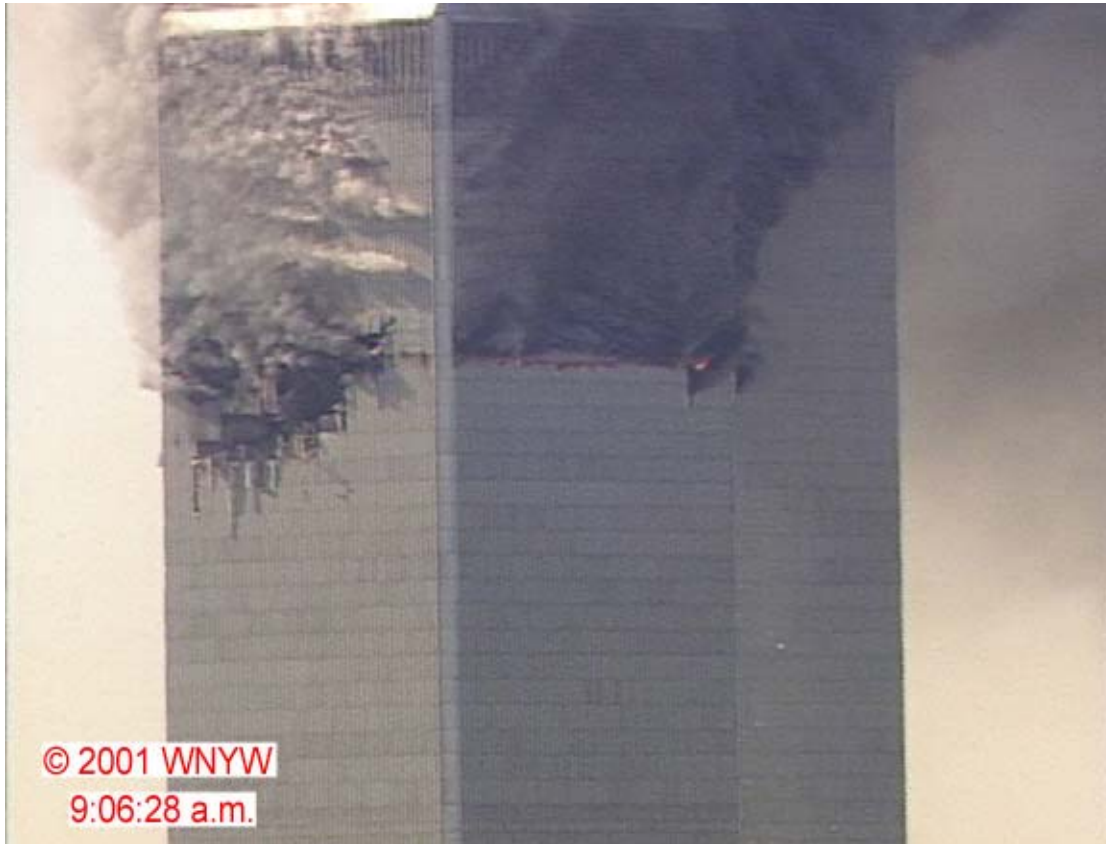
Mostly long-distance photographs and videos show that the conditions present in Figure 8–28 did not change appreciably until 9:06:27 a.m. At this time a short-lived, but intense, burst of flame appeared near the top of window 97-408, as can be seen in Figure 8–29. Very shortly after this flame appeared, the amount of smoke coming from open windows on the 97th floor decreased dramatically, and it was possible to see parts of the west façade that had been hidden just before. The heavy smoke is still evident in Figure 8–29.

**Figure 8-29.** This image of the north and west faces of WTC 1 is a frame from a video recorded by a news helicopter at 9:06:28 a.m. WTC 2 can be seen behind WTC 1. Note the burst of flame from near window 97-408 at the southwest corner of WTC 1.

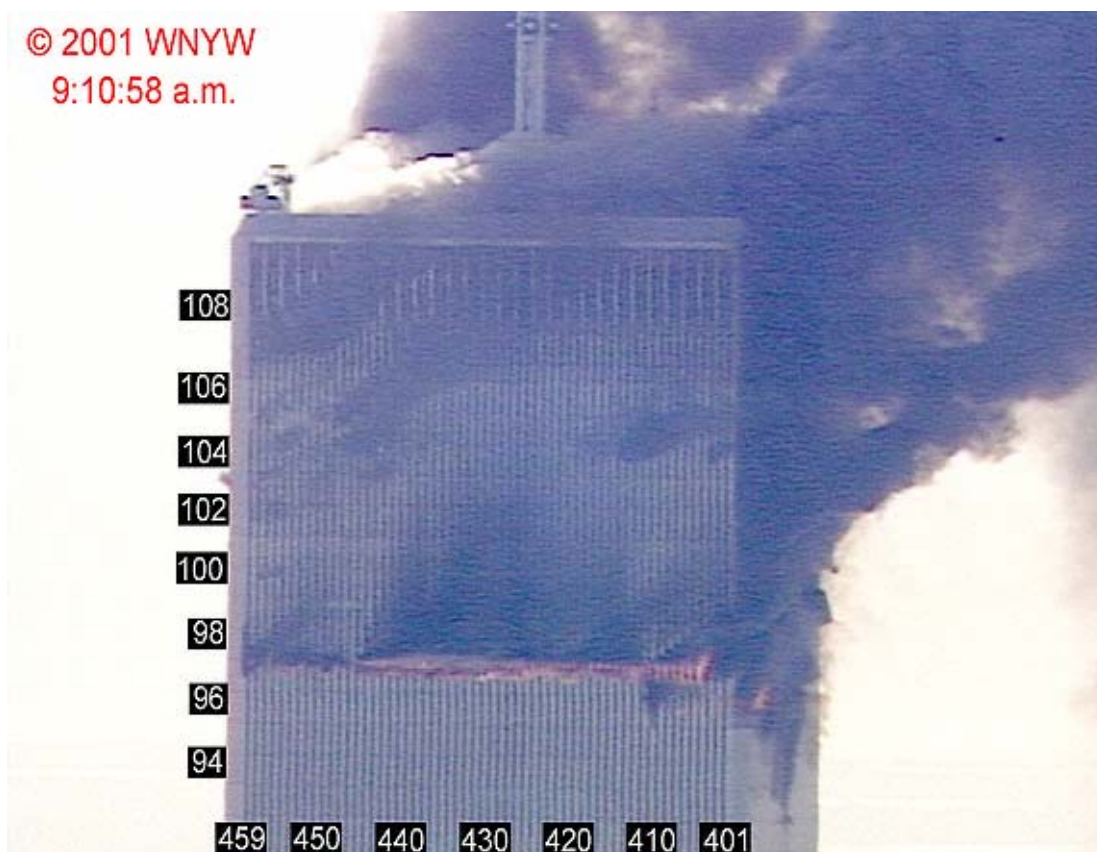
Another frame taken from a video shot by a news helicopter is shown in Figure 8–30. This image was taken four and a half minutes later than Figure 8–29. An extensive area of flame is still present on the 97th floor, but the flames toward the center of the face appear to have receded deep inside the building. There is very little smoke coming from the region. Most of the west face is now visible. In particular, the smoke coming from two areas on the south side of the face at the 104th floor can now be seen clearly. On the north side of the face the heaviest smoke flow from the upper floors is coming from the 107th floor, with strong smoke plumes also issuing from open windows on the 104th and 105th floors.

There appears to be a small fire on the 96th floor at window 96-406. Small fires such as this one were not observed on the west face of the 96<sup>th</sup> floor until around 9:08 a.m. This was the case despite the fact that an intense fire had been burning just around the southwest corner on this floor for over 20 minutes. Several windows did open near the corner during this time period, suggesting that heating was taking place in the area. There is a remarkable difference in the fire growth and spread on the western

peripheries of the 96th and 97th floors. This is especially true when it is recalled that substantial amounts of aviation fuel were likely spread across the western sides of both of these floors (see the discussion in Section 6.5).

**Figure 8-30. This image of the west face of WTC 1 and an oblique view of the south face is a frame from a video recorded by a news helicopter at 9:10:58 a.m. Column and floor numbers have been added.**

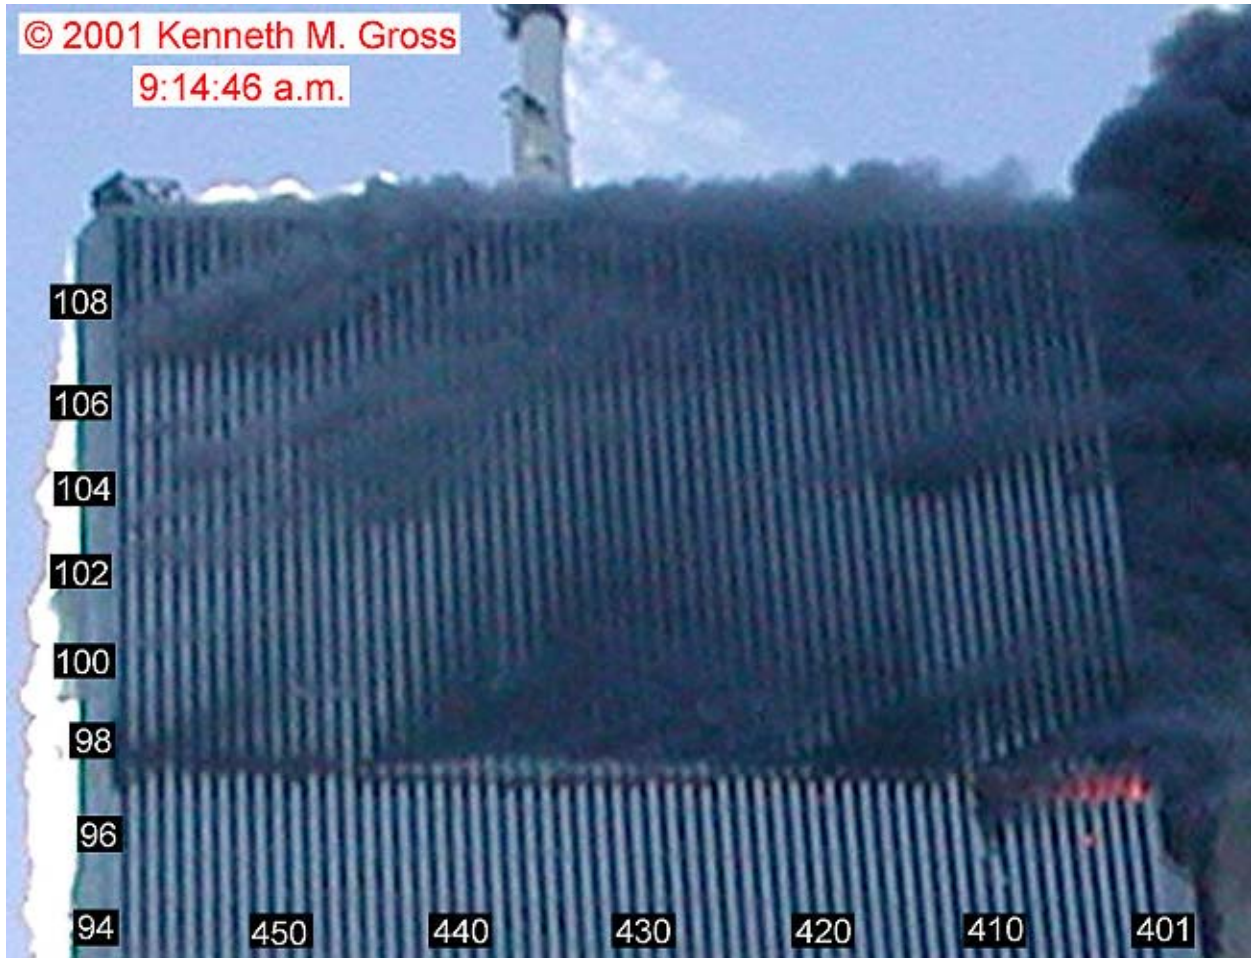
A higher resolution photograph of the west face taken at 9:14:46 a.m. is shown in Figure 8–31. The photographer was located just to the west of the WTC site and was, therefore, shooting up at the building from a steep angle. The only area in which fire is evident in this photograph is on the 97th floor at the south edge in windows 97-401 to 97-406. While the flame lengths are fairly short, there does appear to be some flame extension from these windows. The smoke plumes from higher floors described above are also visible, and a spot fire is present in window 96-404. There are still no indications of smoke or fire on floors below the 96th.

**Figure 8-31.** This cropped photograph shows the west face of WTC 1 at 9:14:46 a.m. It was shot from the ground a short distance from the WTC site. Column and floor numbers have been added.

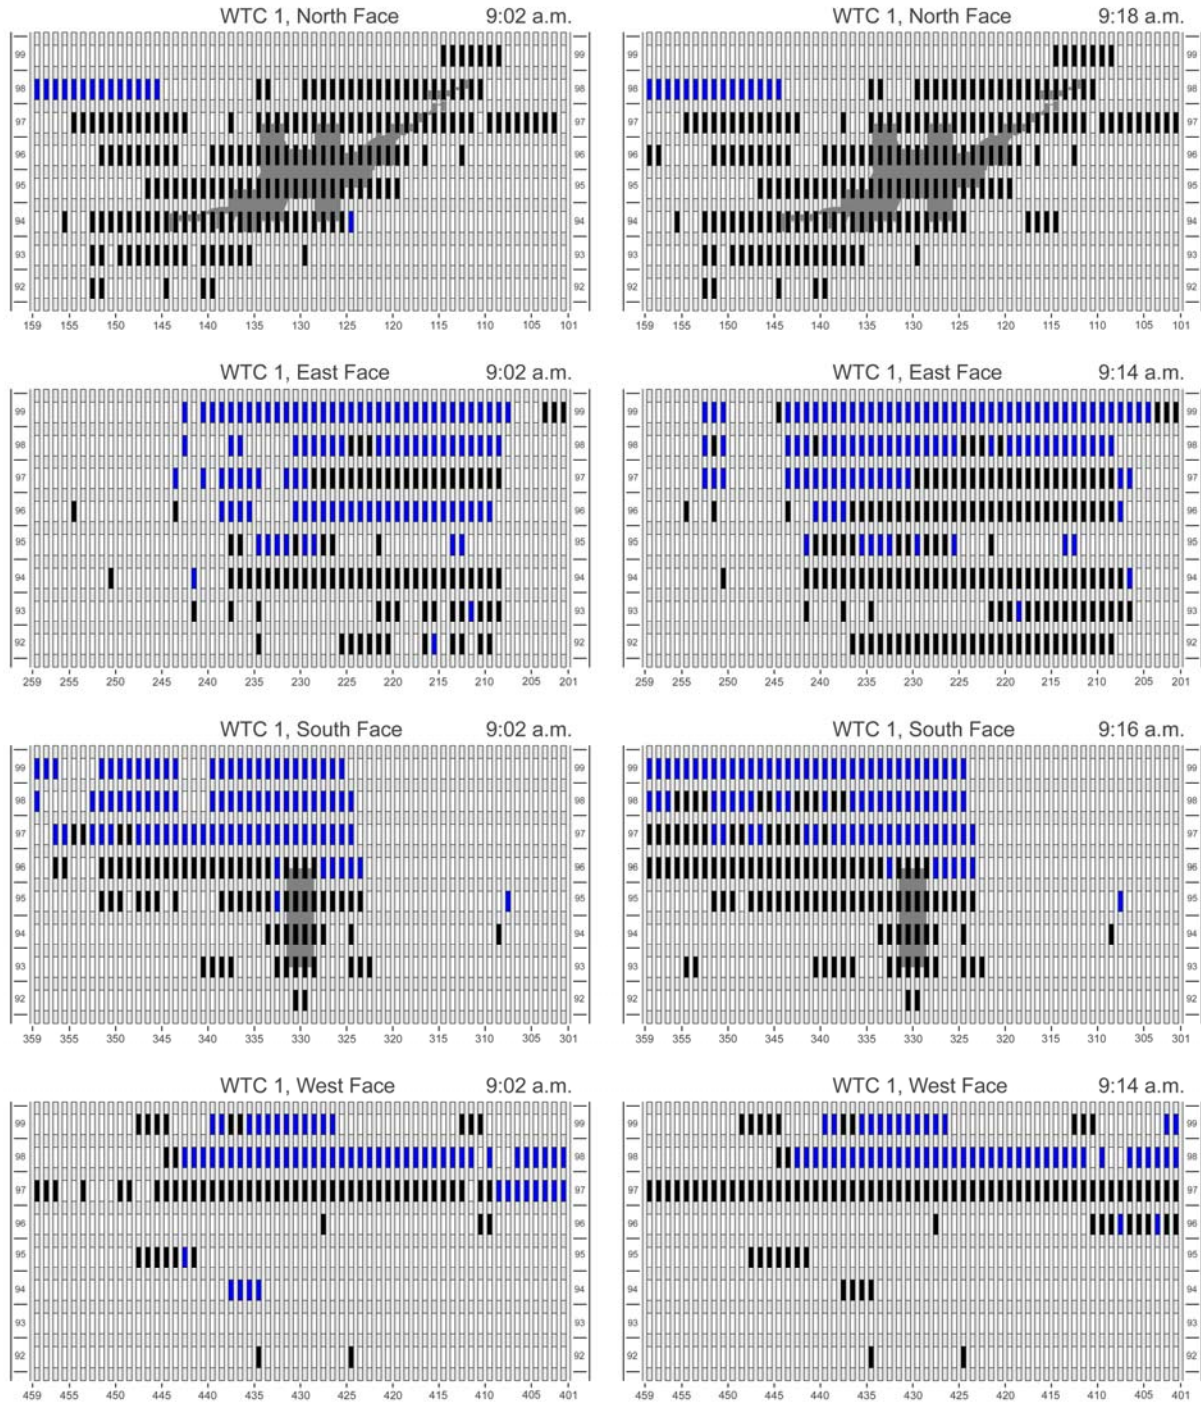
In Figure 8–32, window breakage is used as a surrogate for fire spread to provide a visual indication for fire growth during the period covering roughly 9:03 a.m. to 9:18 a.m. It should be kept in mind that open windows do not provide a perfect history of fire locations since many windows were broken during the aircraft impact and accompanying fireballs. It is also likely that some of the windows that were open at this time were broken by people. This is particularly the case on the 94th and 95th floors on the west face.

**Figure 8-32. Maps for the 92nd through the 99th floors compare missing window glass for the four faces of WTC 1 at two times, around 9:02 a.m. and roughly 15 minutes later. The color coding used for the maps is indicated in Figure 5-1.**

As described in detail above, the primary areas of fire growth during this period were on the east and south faces of the tower. On the east face, the major fire expansion was on the 92nd and 96th floors, with smaller areas of growth on the 94th and 95th floors. On the south face, fire spread continued on the western side of the 96th floor and wide-spread fires appeared on the same side of the face on the 95th and 96th floors.

In Section 6.4.2 it was pointed out that the aircraft and fireball damage to the tower was asymmetrical and that the southeast quadrant appeared to be relatively undamaged. Figure 8–32 and Figure 8–33 show quite distinctly that major fire development has not yet occurred at the periphery of this quadrant. This is further evidence that aircraft debris and/or fuel did not reach the periphery of this quadrant to any great extent.

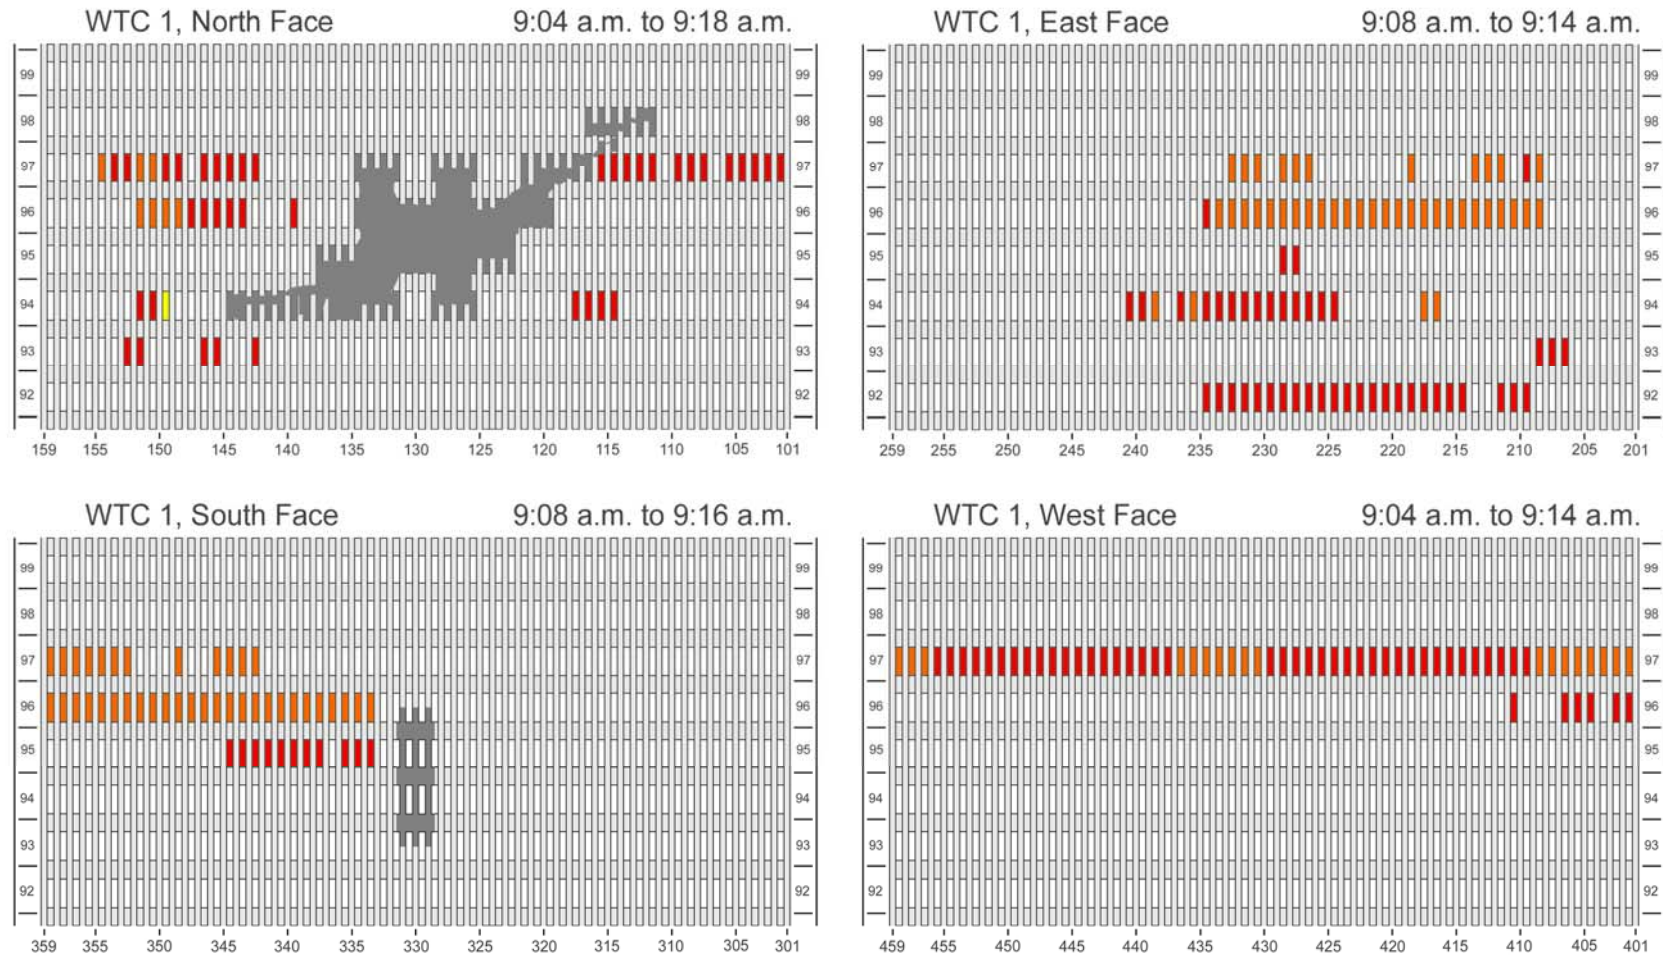
Integrated maps for fire intensity for the period, similar to those shown in Figure 8–14, are included in Figure 8–33. Comparison of these two figures confirms the general trends in fire spread described above. Such a comparison also shows that some of the fires observed during the initial period have died down and are not apparent during the second time period. Examples include fires on the 97th floor on the north face and areas on the 94th and 97th floors on the east face.

From Figure 8–33 it appears as if the most intense and widespread fires during the period from 9:03 a.m. to 9:18 a.m. were on the 96th and 97th floors. The east side of the tower had the most widespread fires, with flames visible from the 92nd floor to the 97th floor. The absence of burning in the southwest quadrant of the tower is evident from the maps.

On the other hand, the extremely rapid fire spread on the 97th floor suggests that aviation fuel was distributed widely over this floor, with the exception of the southeast quadrant. Similarly, the rapid fire spread on the east side of the 92nd floor suggests a significant amount of aviation fuel reached this floor. Presumably this fuel came from the 94th floor, where the aircraft's port fuel tank is likely to have spilled most of its contents.

**Figure 8-33. Maps of integrated fire observations between 9:03 a.m. and 9:18 a.m. are shown for the four faces of WTC 1. Colors represent the highest intensity fire observed in a window using the color scale defined in Figure 5-1.**

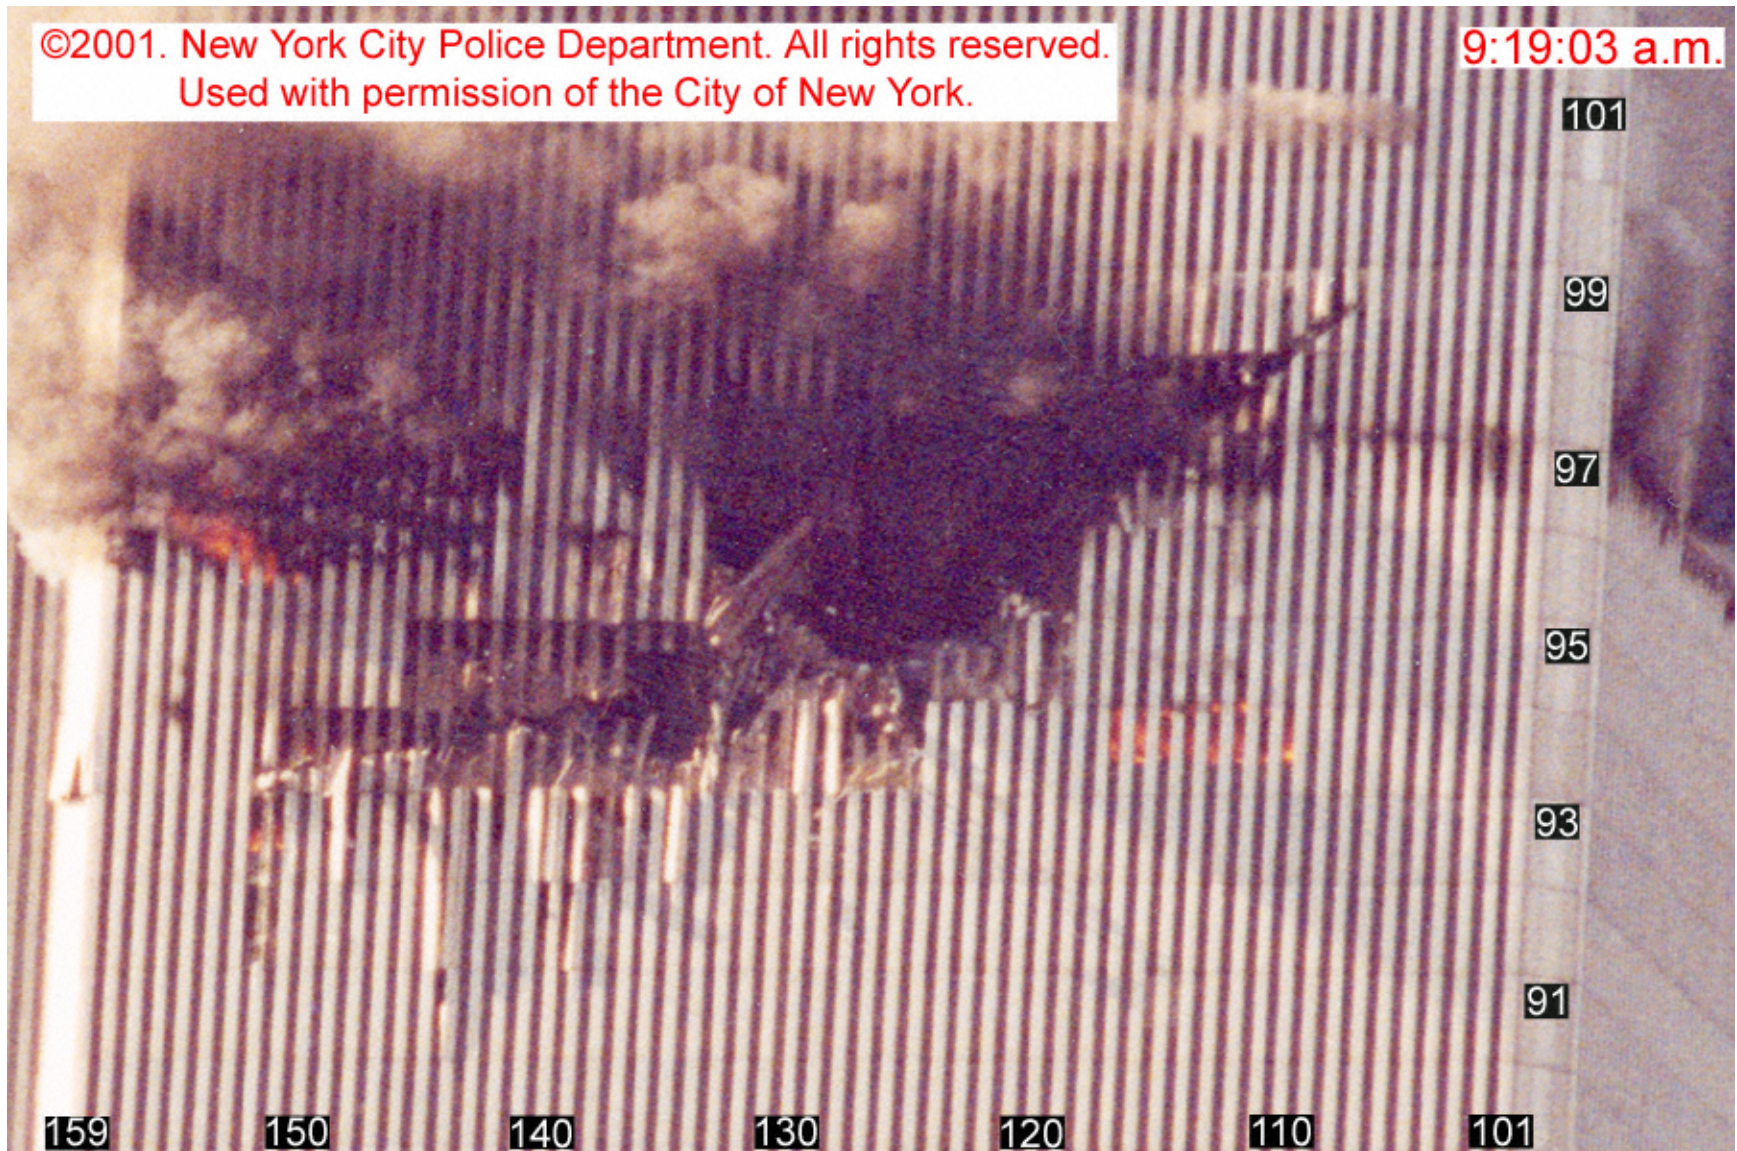
At 9:18:32 a.m. a bright flame appeared in window 94-111, well to the west of the flame present on this floor in Figure 8–19. Fire filled in the length between the two locations during the next 20 s or so. By 9:19:03 a.m. windows from 94-110 to 94-117 were open with flames visible, as seen in Figure 8–34. Note the large number of windows where isolated flames are evident at the tops of the frames in Figure 8–34. Not surprisingly, streamers were observed falling from this region starting at 9:19:42 a.m. Given the amount of fire, there is remarkably little smoke exhausting from the open windows. It is difficult to determine if smoke is flowing elsewhere, but there is no indication of smoke at the 94th floor level from the aircraft impact cavity.

A close-up photograph taken at 9:20:51 a.m. shows that the appearance of the fires on the 96th and 97th floors was somewhat changed from that seen in Figure 8–34. Heavy flames were present in all of the north side windows that were originally within the corner rooms. Flames were extended primarily from the two windows nearest the east face on both floors. The fire on the 94th floor had a similar appearance to that in Figure 8–34, with extensive flames present inside the building, numerous areas burning at the tops of window openings, and only light smoke coming from the windows. This fire had continued to spread to the east and now extended from windows 94-106 to 94-117.

Figure 8-34. An image recorded at 9:19:03 a.m. shows the north face of WTC 1. The original has been cropped, rotated, and enhanced. Column and floor numbers have been added.

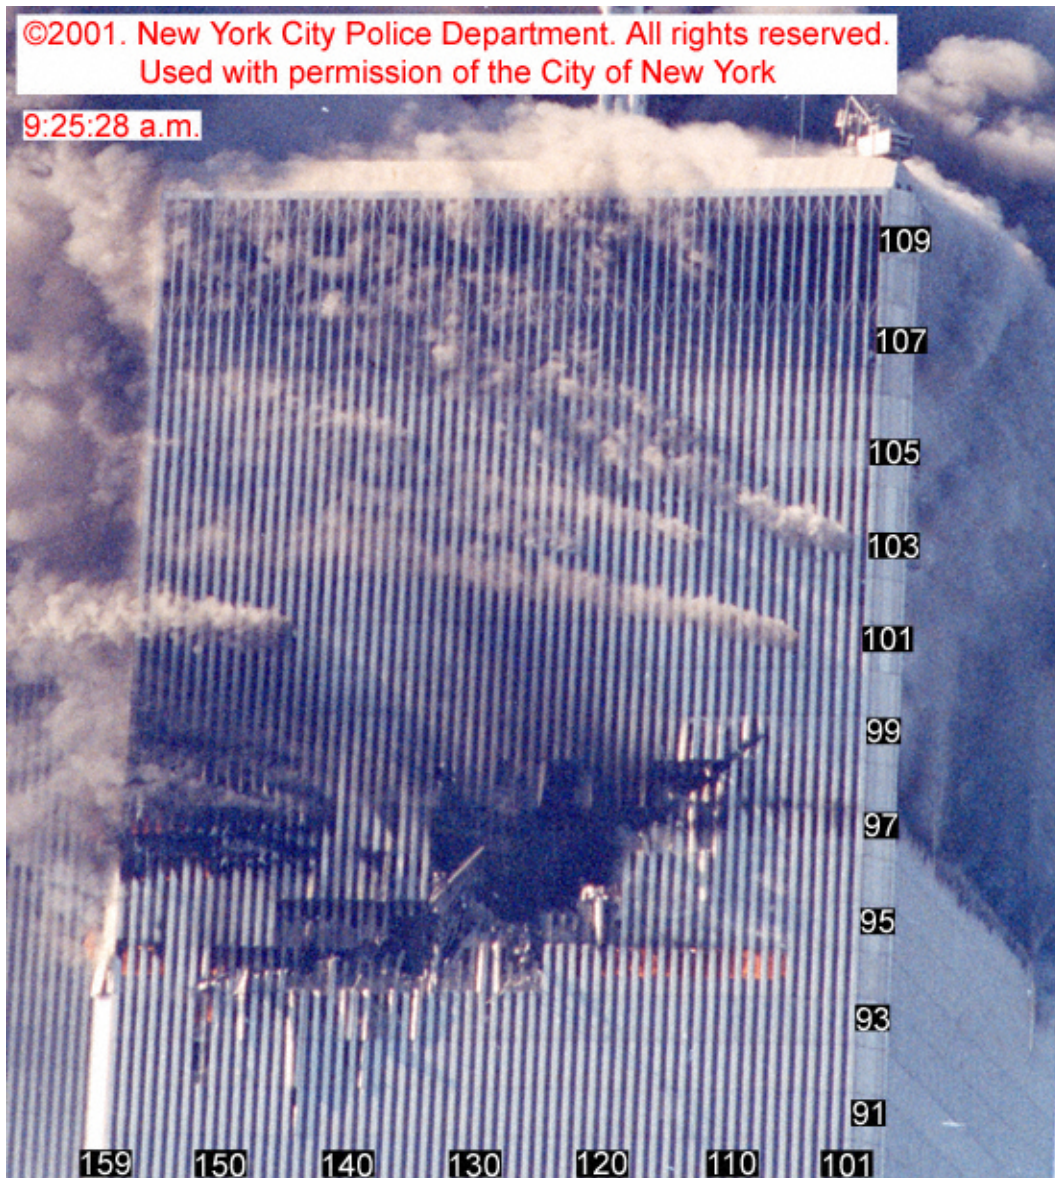
Figure 8–35 shows the north face of WTC 1 as it appeared at 9:25:28 a.m. The amount of smoke coming from the north face, particularly the aircraft impact cavity, has decreased markedly as compared to images taken earlier. There are fires visible on multiple floors, but the amount of smoke coming from these floors is very low. In fact, the densest smoke appears to be coming from open windows that are well above the fire floors. This observation indicates that smoke is still moving upward inside the building and following flow pathways to windows opened by people trapped above the aircraft impact floors. Smoke is still flowing from the air intakes on the 108th and 109th floors.

**Figure 8-35.** An image recorded at 9:25:28 a.m. shows the north face and an oblique view of the west face of WTC 1. The original has been cropped, rotated, and enhanced. Column and floor numbers have been added.
