**NIST NCSTAR 1-5A**

**Federal Building and Fire Safety Investigation of the  
World Trade Center Disaster**

# **Visual Evidence, Damage Estimates, and Timeline Analysis**

September 2005

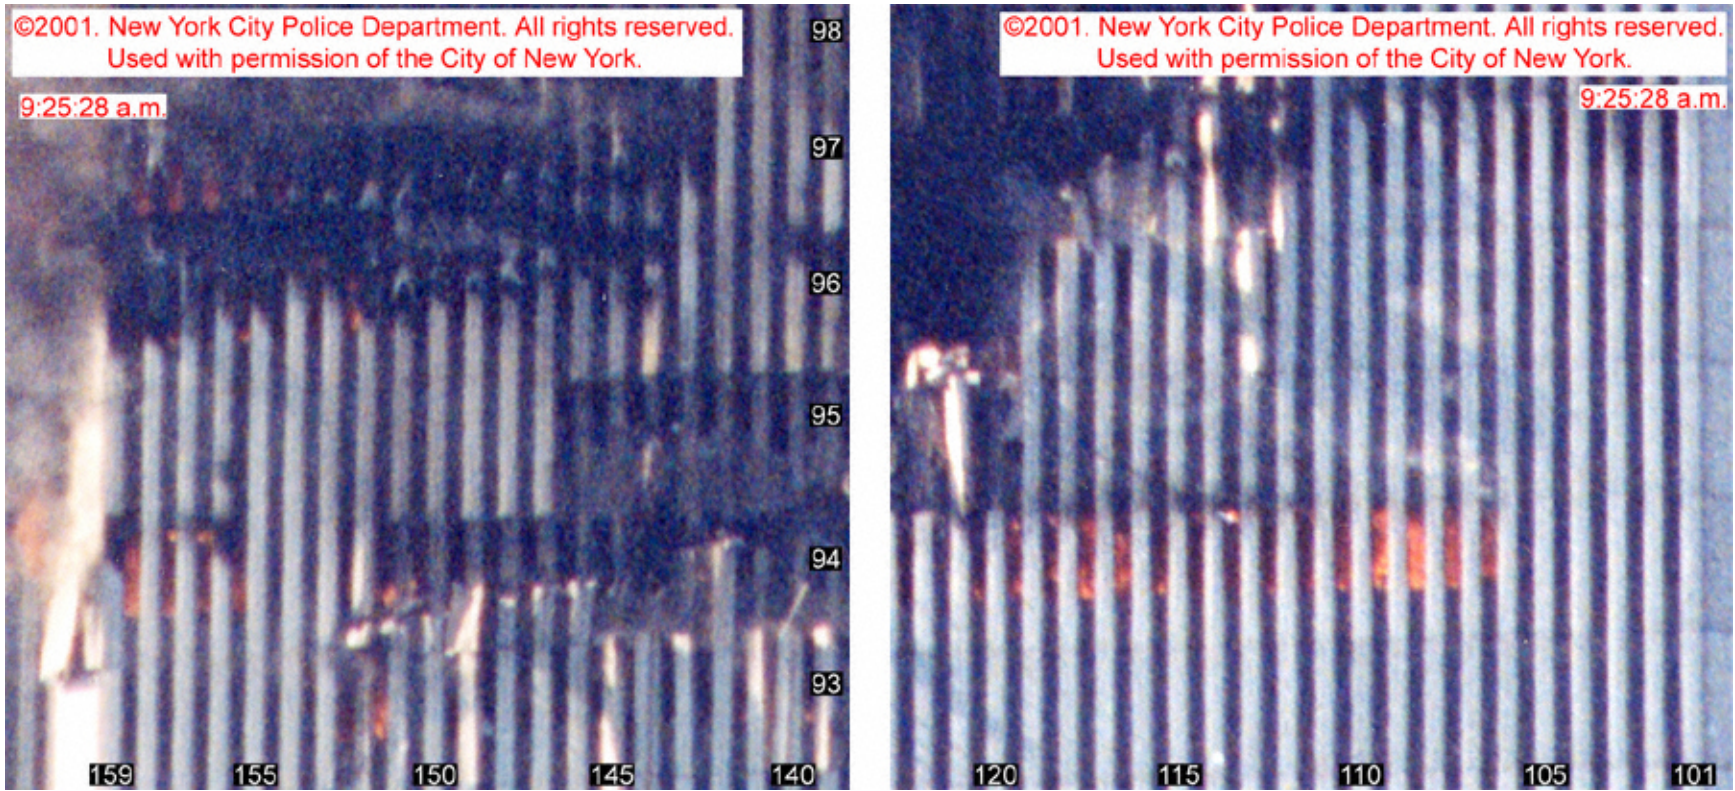
In Figure 8–36 two areas on either side of the aircraft impact cavity in Figure 8–35 have been blown up in order to provide a better view of the active fires. On the east side, fires can be seen on the 93rd, 94th, 96th, and 97th floors. Fires that appear to be relatively small and isolated are present at two locations centered near windows 93-139 and 93-151 on the 93rd floor. On the 94th floor an isolated fire is also present near window 94-151, but the major change from earlier times is that the glass in windows 94-155 to 94-158 is now missing, and an intense fire is evident burning within the building behind the four open windows. Isolated fires are present at the tops of the two windows in the center of the group. Note that the two adjacent windows, 94-153 and 94-154, are still in place. Flames can be seen through multiple open windows on the 96th and 97th floors. There is now no flame extension from the north face windows, and the fires have died down considerably from their levels of a few minutes earlier (e.g., compare with Figure 8–34 recorded at 9:19:03 a.m.).

On the west side of the north face, fire is only visible on the 94th floor. The apparent intensity of this fire has also died down somewhat from a few minutes earlier. The fire has broken into two sections on either side of a central region running from roughly windows 94-109 to 94-113, where only small fires near the bases or tops of the windows are evident. The fire spread to the west has paused at window 94-106, and the five windows to the west have glass in place. This suggests that the fire spread to the west had been slowed down by an internal wall located at column 94-106. The floor plan layout in Figure B-3 indicates that there was indeed an internal wall that terminated on this column.

The areas of the north face of WTC 1 included in Figure 8–36 provide good examples of the correlation of local fire behavior with the column cover marks observed next to windows where fire is present. On the 96th and 97th floors the fires created conditions in which flames extended from the windows. A series of carets are present at the tops of the windows running across these two floors. The heights of the carets vary over the region providing an indication of the local maximum burning intensity. In contrast, fires on the 93rd and 94th floors did not generally extend from windows and did not generate a great deal of smoke flow from the windows. For these windows there were sometimes narrow, dark lines at the tops of the adjacent aluminum column covers, and for others very little marking of the column covers occurred.

An enlarged image of the fires on the west side of the north face is also included in Figure 8–36. The marks on the column covers on the 97th floor show evidence for both types of fires. Those nearest the airplane strike point are marked with carets. Flame extension was observed in this area shortly following the aircraft impact. Further to the west there are black marks above the windows, except for the column covers on either side of window 97-102, which are marked with carets. As discussed earlier, fires on this part of the 97th floor did not extend from these windows for any significant period of time. The same types of narrow black bands are observed at the tops of the columns above the burning region on the 94th floor. Recall that this was a region of heavy burning, but without flame extension.

Figure 8-36. Two blowups from Figure 8-35 of areas on the north face of WTC1 are shown. The photograph was taken at 9:25:28 a.m. The images have been enhanced, and column and floor numbers have been added.

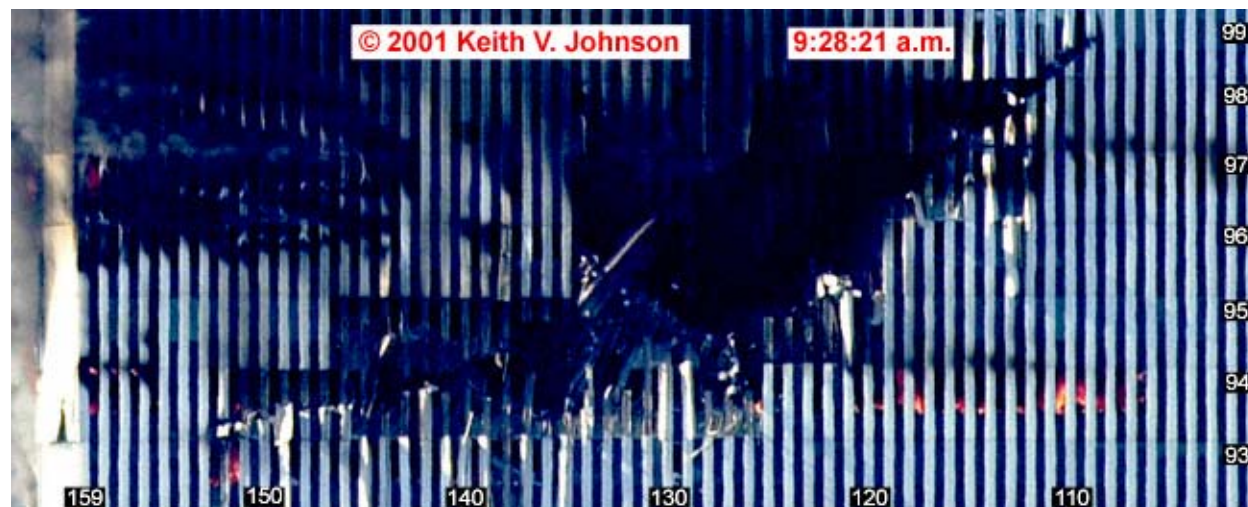
**Figure 8-37. This cropped photograph shows the north face of WTC 1 at 9:28:21 a.m. The image has been rotated and enhanced. Column and floor numbers have been added.**

Figure 8–37 shows a photograph of the fire floors on the north face taken at 9:28:21 a.m. The fires which grew rapidly at the start of the period are continuing to die down. In particular, the large fires that appeared within the rooms on the northeast corners of the 96th and 97th floors are now barely visible. The fires on either side of the aircraft impact cavity on the 94th floor are also decreasing in size. On the east side there are still fires burning at the window head casings of windows 94-156 to 94-158. An isolated fire can still be seen on the 93rd floor through open windows 93-152 and 93-153.

While it is difficult to make out in Figure 8–37, close inspection shows that there is a small spot fire visible in window 98-123 on the 98th floor. Recall that a similar fire was observed on this floor in window 98-115 around 9:06 a.m. Most windows were still in place on this floor around the time Figure 8–37 was taken.

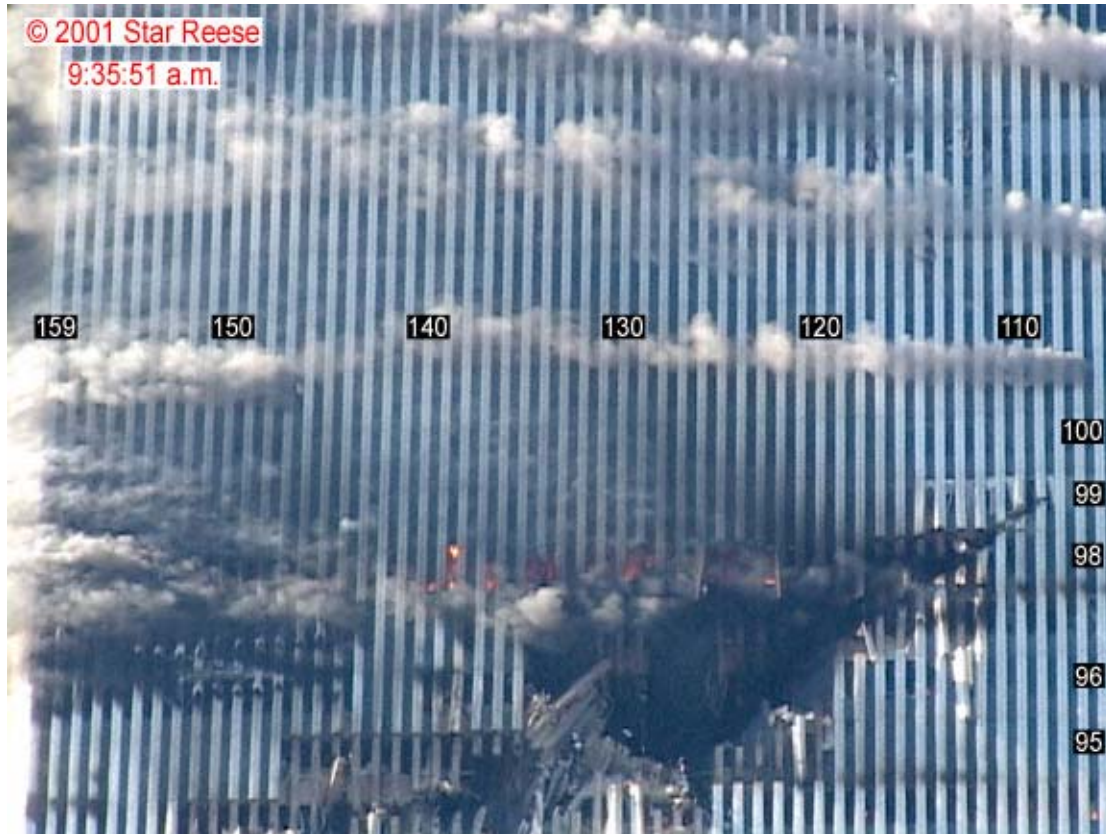
**Figure 8-38. A frame taken from a video shows the north face of WTC 1 at 9:35:51 a.m. The image has been enhanced. Column and floor number have been added.**

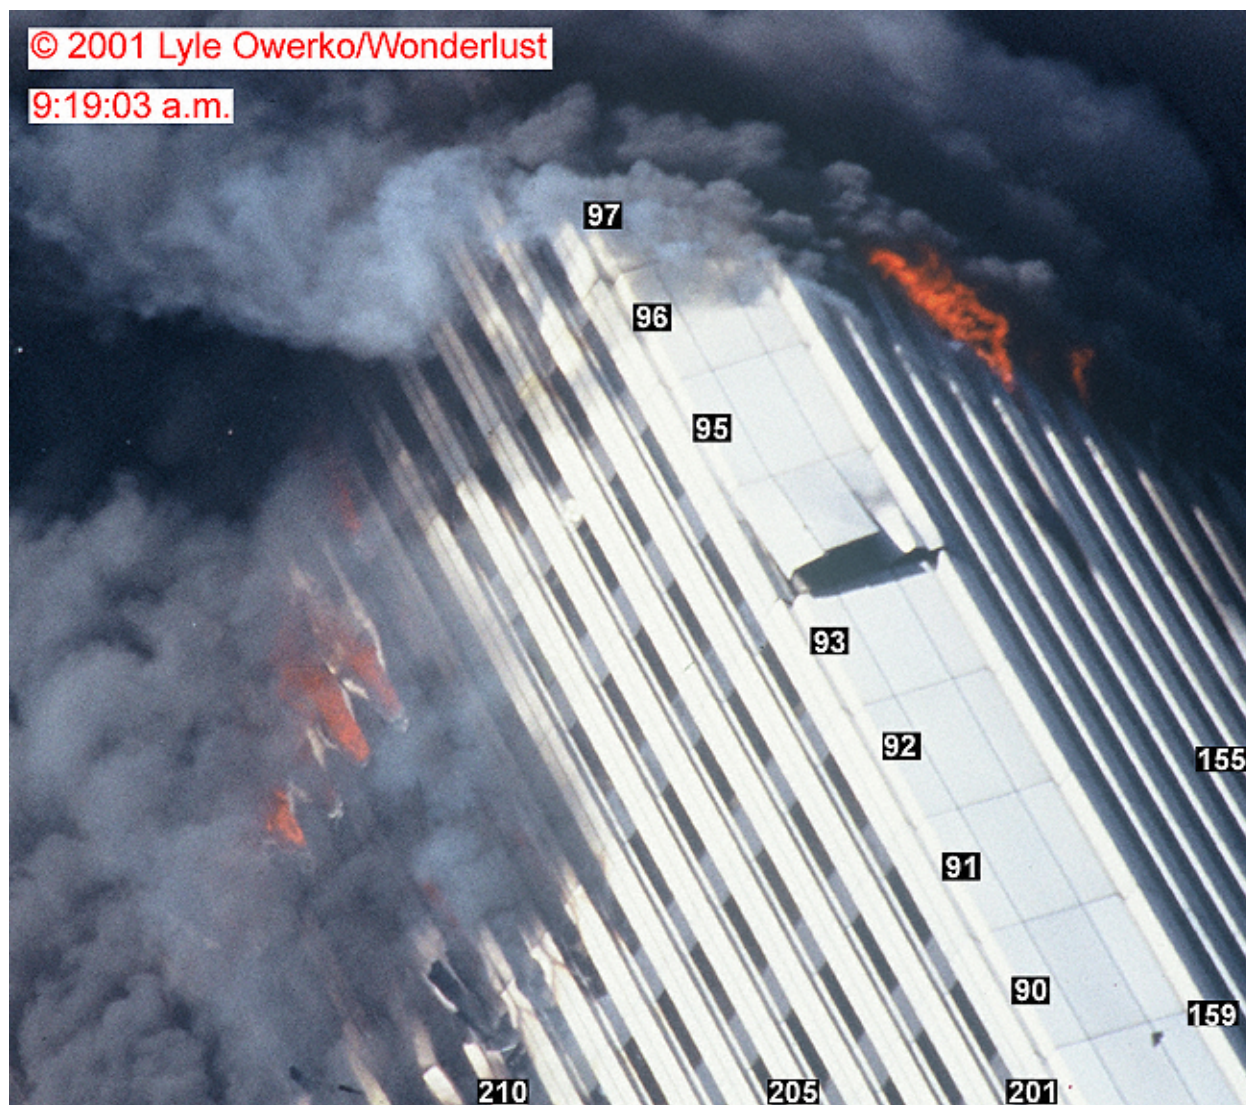
The close-up photograph in Figure 8–39 shows the northeast corner of WTC 1 at 9:19:03 a.m. On the north face, the flames that first emerged from windows on the 96th floor at 9:19:00 a.m. are evident. At the time of Figure 8–39, the largest flame jet was coming from window 96-154. On the east face heavy flames were present in windows 96-208 to 96-211. The distinct carets on the column covers attest to the intensity of the fires that have been burning in the area. The window glass on the inside of the internal wall at column 96-208 is still in place. This is not the case on the 97th floor. Flames are evident through a partially opened window 97-207, indicating that fire had penetrated the wall at column 97-208 by this

On the 95th floor, windows from the north edge out to window 95-207 appear intact. It looks as if there was a small fire in window 94-207, and the window may be partially broken out. This is not clear. Carets on the covers of columns 93-206 to 93-208 are telltale signs of the extended flames that came from windows 93-206 to 93-208 at an earlier time. Glass for windows to the north of column 93-205 is still intact. These observations suggest that a wall at column 93-205 may have slowed the spread of this fire. However, it is not possible to confirm this since the plan layout for this floor shown in Figure B-2 does not cover this section of the floor. For the 92nd floor, glass is intact in windows extending from the north edge to at least window 92-207. The floor plan layout in Figure B-1 indicates that there was a room in the northeast corner of this floor with walls that extended to columns 92-155 and 92-204. The interior wall on the south side of this room was glass.

**Figure 8-39.** This cropped close-up photograph showing the northeast corner of WTC 1 was taken at 9:19:03 a.m. It has been enhanced, and column and floor numbers have been added.

Fire is evident at a couple of locations on the 93rd floor. It appears as if flames are present inside window 93-206, while adjacent windows to the north still have glass in place. Recall that window 93-206 was already open at 9:19:03 a.m. (see Figure 8–39) and that fire spread to the north had seemed to pause at this location prior to this. The observations continue to suggest the presence of a room in the northeast corner of this floor with a wall at column 93-206, even though the incomplete floor plan layout in Figure B-2 does not allow this to be confirmed.

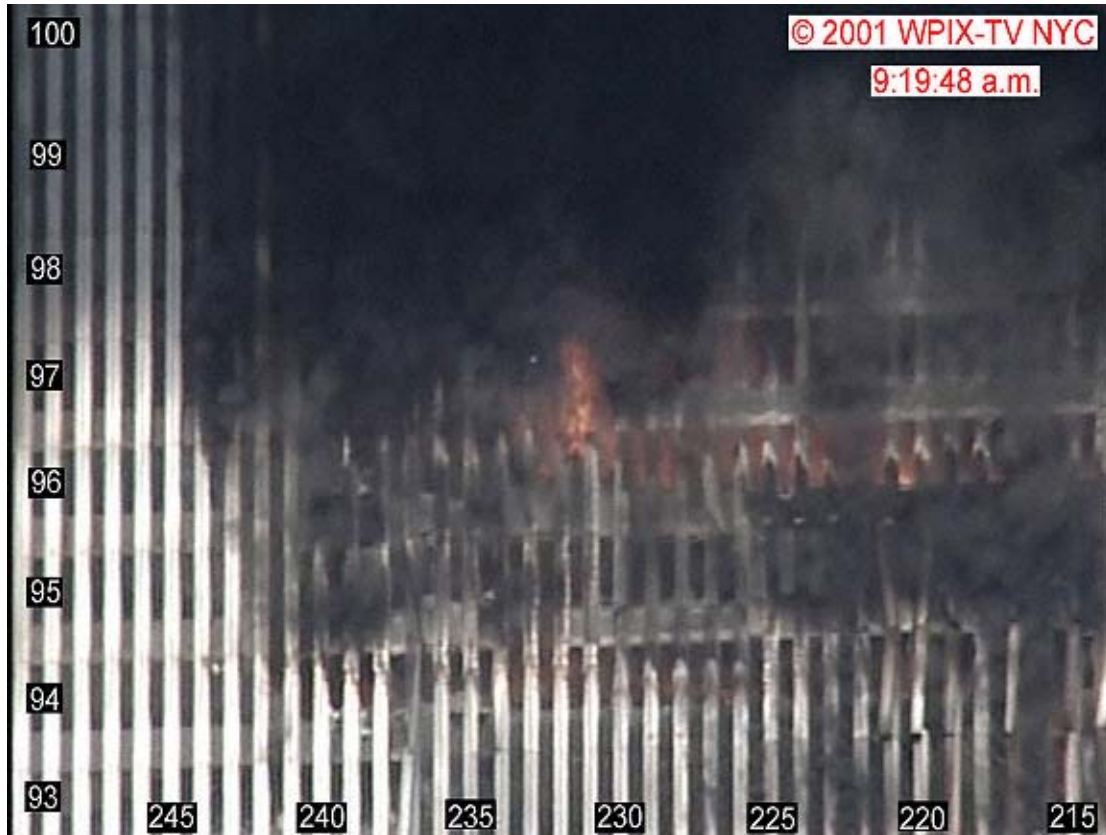
The image in Figure 8-40 was taken from a close-up video showing the central portion of the east face. It was recorded at 9:19:48 a.m. A fire on the 96th floor extends from at least window 96-214 to window 96-233. The fires in the northern part of the photograph on the 96th floor are less intense than those further to the south. When combined with Figure 8-39, this suggests that the fires on the 96th floor are still most intense at either end of the burning area, with an area of dying fire in the center.

Extended flames are coming from window 96-231 in Figure 8–40. The presence of carets indicates that flames had earlier been present at least as far south as window 96-238, but at this time these flames were not visible. The floor plan layout for this floor (see Figure B-5 in Appendix B) does not provide an explanation for this fire distribution, since there are no walls or rooms indicated in this area of the floor.

A region of flame is also evident on the 97th floor, starting near window 97-225 and going west. The full extent of this flaming region is not known, since fire and smoke from the 96th floor hides a portion of these windows. The flames visible on the 97th floor do not extend from windows and appear to be dying down.

There are no extensive flame regions evident on the 93rd or 94th floors. A review of videos recorded around this time indicates that the fires on these floors had indeed died down. Smoke is visible coming from below in Figure 8–40. This smoke is coming from the 92nd floor.

**Figure 8-40.** A frame taken from a video shows a portion of the east face of WTC 1 at 9:19:48 a.m. The image has been enhanced, column and floor numbers added.

There are some interesting variations in the column smoke markings in Figure 8–40. In particular, consider the 94th floor. Many of the column covers have distinct carets that are characteristic of locations next to windows that have experienced extended flames. Clear examples of carets can be seen on the covers for columns 94-226 to 94-230. On other column covers the smoke marks take the form of alternating horizontal bands of light and dark areas. The marks on the covers for columns 94-231 to 94-234 show good examples of this type. By comparing the markings with the local fire behavior, it has been possible to correlate the formation of this type of smoke mark with windows from which there had been a heavy smoke flow, but for which external flaming was not observed. In contrast to the mixed fire behavior seen on the 94th floor, carets are present on nearly all of the columns on the 96th floor visible in Figure 8–40.

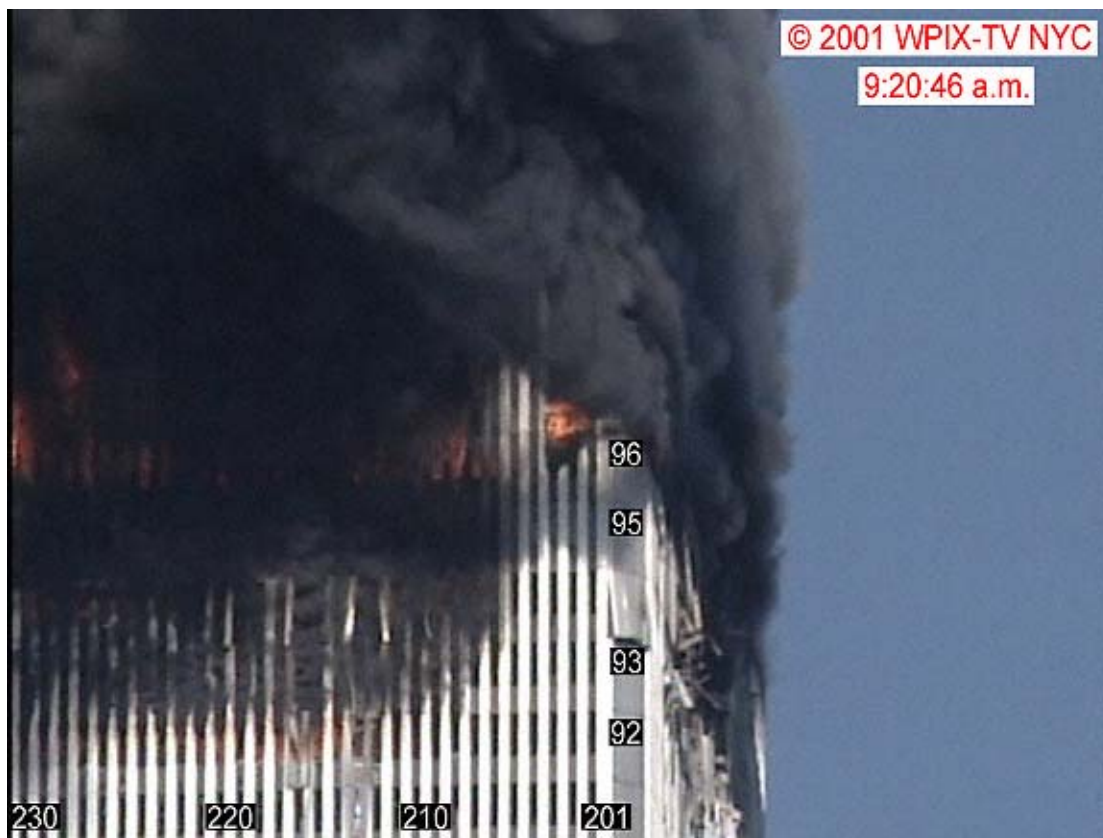
**Figure 8-41. A frame taken from a video shows a portion of the east face of WTC 1 at 9:20:46 a.m. The image has been enhanced. Column and floor numbers have been added.**

In Figure 8-41 heavy smoke is flowing from a number of windows on the 92nd floor, starting at window 92-208 and running to the last visible window, 92-230. A dull orange glow is evident in the vicinity of windows 92-214 to 92-218, but the remaining open windows appear to be dark. Shortly after Figure 8-41 was shot, the video zoomed out, revealing that internal fires were present inside the tower at least as far south as window 92-234, with open windows as far as window 92-237. Figure 8-22, which was taken at 9:15:54 a.m., showed internal fires in this same area. During the intervening period, the fire had moved north one window, having opened window 92-208. There is no obvious reason for the fire spread to slow down at this location, since the floor plan layout in Figure B-2 in Appendix B indicates there was not a wall at column 92-208. At 9:15:54 a.m. the fire had already moved as far south as window 92-234. During the next five minutes, three additional windows were opened. Fire spread in this direction also appears to have been retarded. The floor plan layout for this floor does indicate that there was a wall located at column 92-238, i.e., right next to open window 92-237. Detailed drawings for this floor show

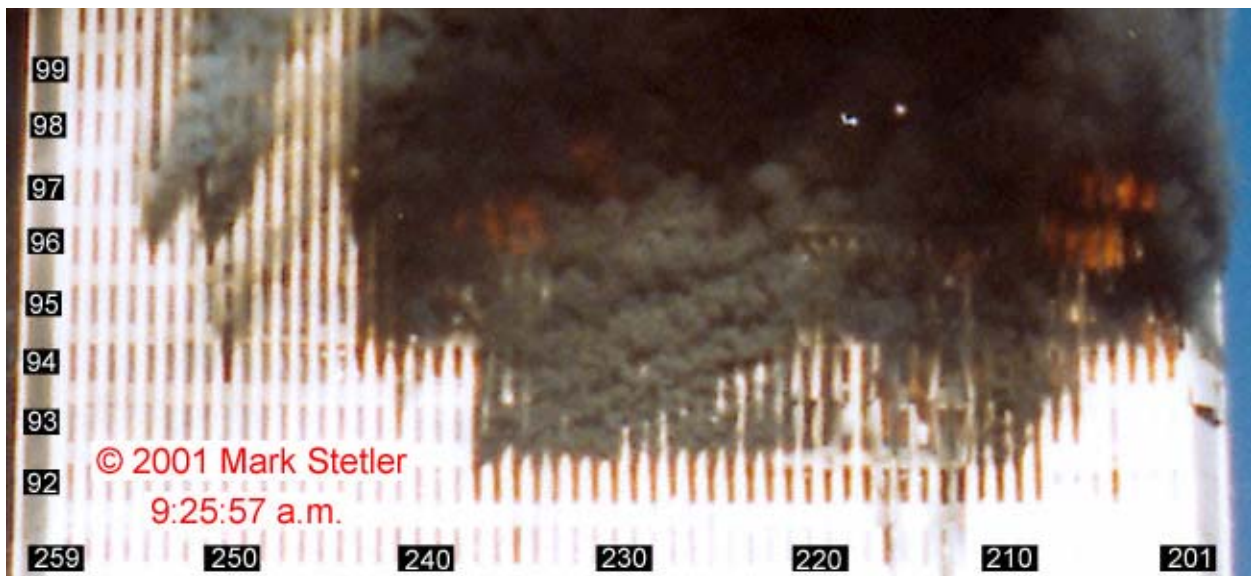
Figure 8–42 is a photograph of the east face taken at 9:25:57 a.m. The flames which had earlier spread into rooms located on the northeast corners of the 94th and 96th floors are still burning intensely. There is also now a large fire burning in the northeast corner room on the 97th floor. It has not been possible to identify exactly when this fire appeared because smoke and fire from the 96th floor hid its development from view. However, a video taken near 9:23:30 a.m. shows that flames were coming from window 97-203 at that time, so it must have appeared between 9:20:45 a.m., when fire was first visible in the area on the 96th floor, and this time.

**Figure 8-42.** This cropped photograph shows the east face of WTC 1 at 9:25:57 a.m. The image has been rotated slightly and column and floor numbers have been added.

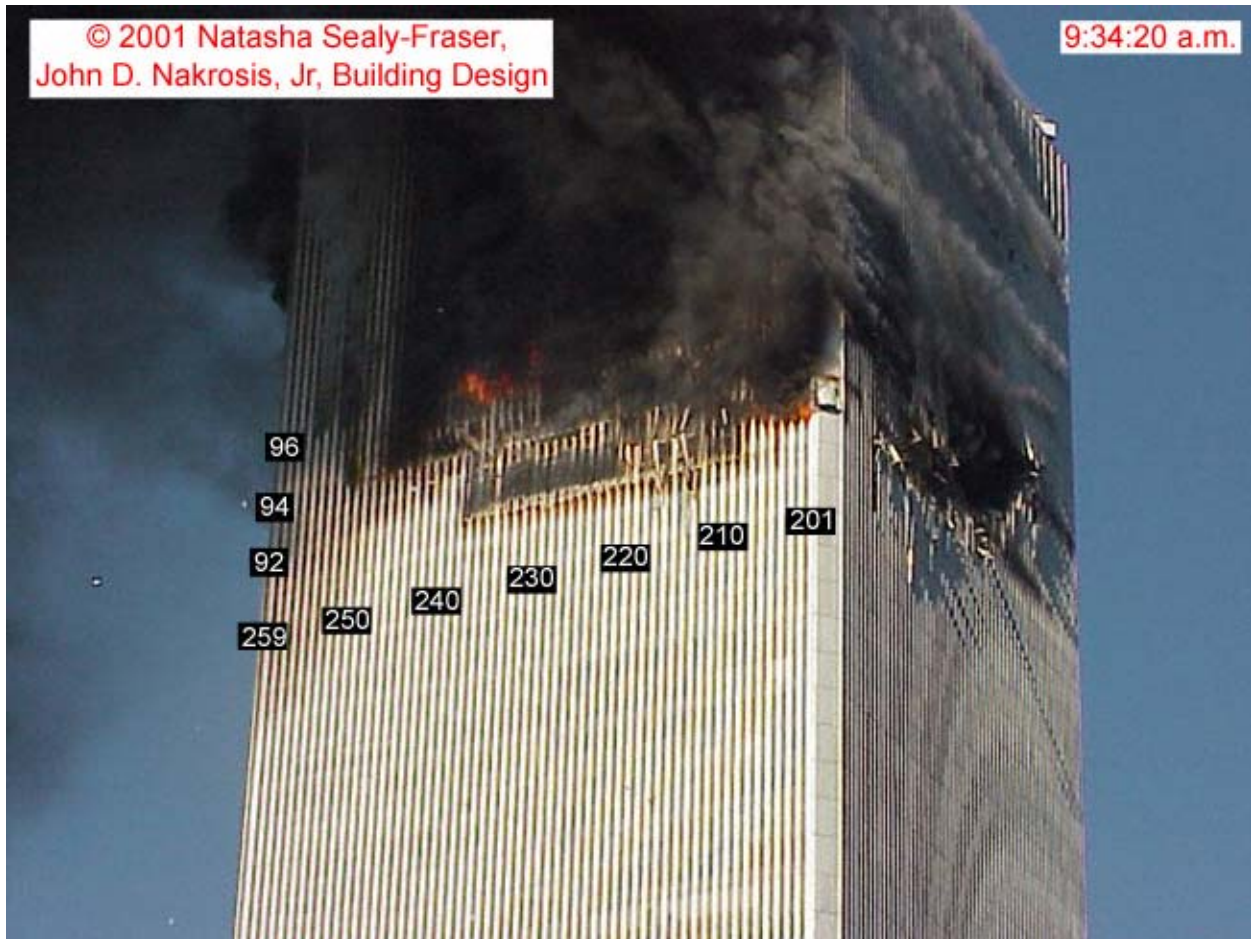
At 9:32:58 a.m., smoke emerged from the northeast corner of the 93rd floor at window 93-205. During the next 31 s, the successive windows toward the north opened, reaching window 93-201. At this time, 9:33:29 a.m., flames appeared in the area. Figure 8–43 shows a photograph of the east face recorded at 9:34:20 a.m. From this angle and distance, only flames extending from windows are apparent. Flames are coming out of windows 93-201 to 93-205. The sudden fire development and flame extension from windows is a strong indication that flashover has occurred within an enclosed space located around windows 93-201 to 93-205. The evidence for an enclosed space with walls that hindered fire spread into the northeast corner of the 93rd floor is quite strong even though the presence of such a room cannot be confirmed from the incomplete floor plan layout shown in Figure B-2.

Intense flaming was also taking place on the 96th floor near windows 96-236 and 96-237. Much more of the façade is now visible through the smoke than earlier. In particular, this is an indication that fires on the 92nd floor and 94th floor, which were generating large quantities of smoke at earlier times, have largely died down.

**Figure 8-43. Photograph of the east face of WTC 1 recorded at 9:34:20 a.m. Column and floor numbers have been added.**

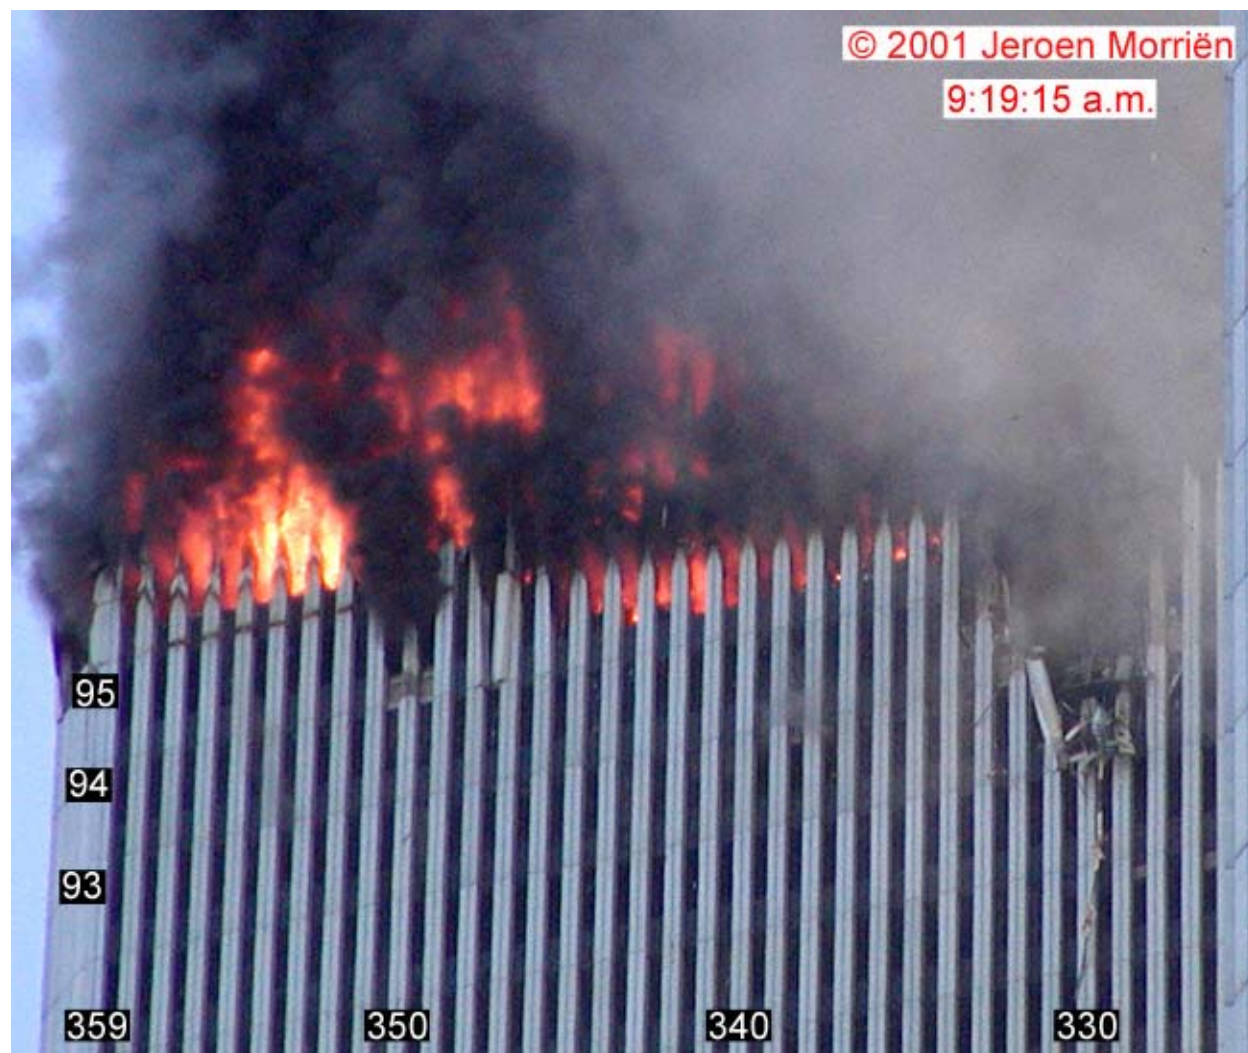
Figure 8-44 provides a view of the south face at 9:19:15 a.m. The general appearance of the fires is little changed from that in Figure 8-27, which was recorded near 9:16:40 a.m. The intense jets of flames coming from windows 96-352, 96-353, and 96-354 on the 96th floor remain a prominent feature. This image provides a particularly good view of the area on the 93rd floor, near column 330, where the steel panel section, which was found near the corner of Cedar and West Streets, is believed to have originated. Extensive damage is evident in the vicinity, but it is not possible to visually confirm that the section is actually missing. There is a long section of what appears to be a pipe hanging below the suspected opening that appears to be attached to a cylindrical object. Recall that a long section of pipe was seen in photographs of the detached panel section lying in the street (see Figure 6-16 and Figure 6-17). The presence of piping near the suspected origin for the panel section provides further support that the panel section actually did come from this spot.

**Figure 8-44.** This cropped image shows a portion of the south face of WTC 1 at 9:19:15 a.m. The photograph has been enhanced and column and floor numbers have been added. The corner of WTC 2 is visible at the far right side of the image.

A line of deposited soot is visible at the top of columns 95-351 to 95-357 at the western side of the 95th floor. These markings can be seen more clearly in Figure 8–44. No smoke is apparent coming from the windows, and it appears likely that the glass is still in place for these windows. The formation of these marks may be an indication that fire gases and smoke were leaking from the tower at locations where windows still had intact glass. Presumably, the leaks took place through the expansion joints located between column covers on different floors.

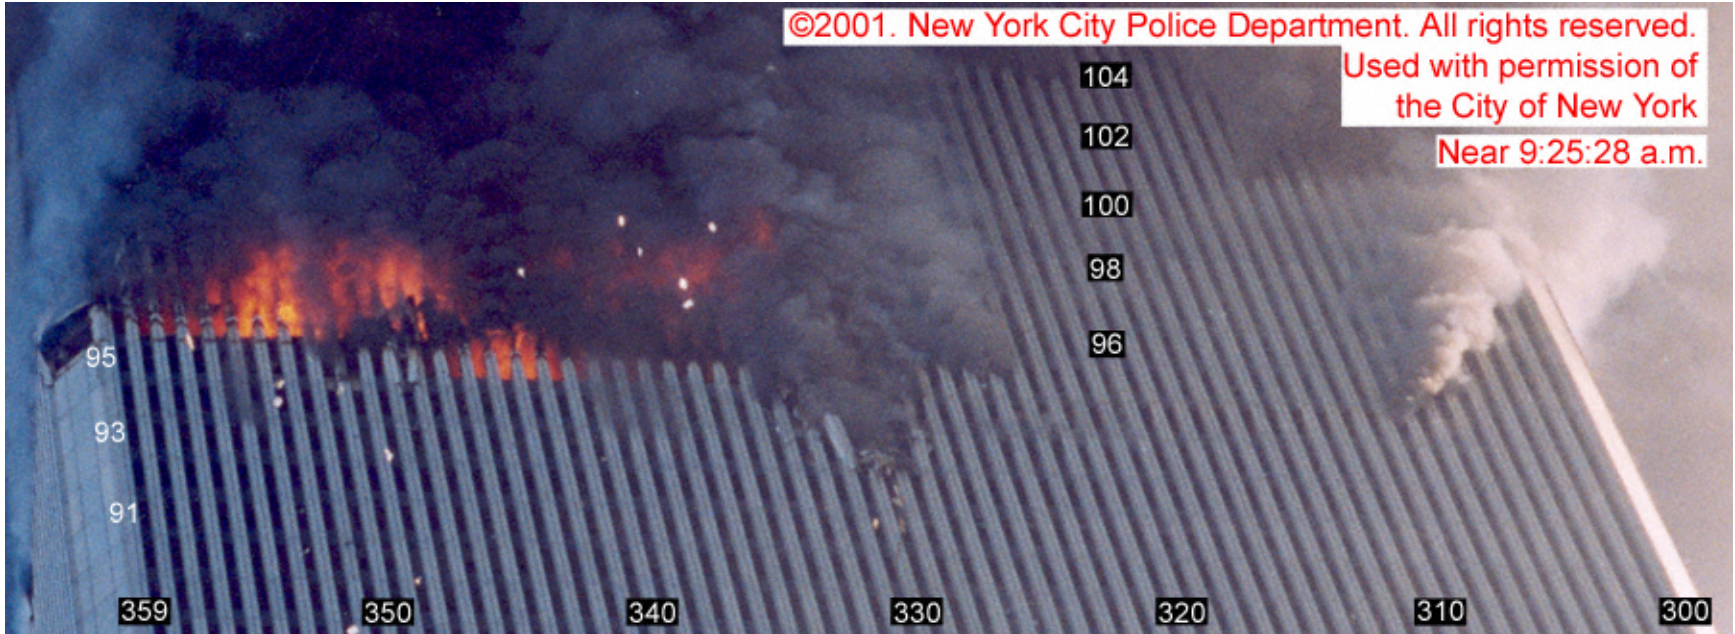
A later view of the burning area on the south face is shown in Figure 8-45, which was recorded around 9:25:28 a.m. There are a large number of pages of paper visible in the photograph. A video of the west face showed that these pages had traveled from the west face of the tower, where they had been released from an upper window. The fires present at this time remain quite intense and extensive, but there have been some changes since 9:19:15 a.m. The fires at the western edge of the 96th floor appear to be dying down and have receded back into the windows, while the strong jets of flame evident in Figure 8-44 on this floor are not as distinct. The fires on the 95th floor appear to have grown stronger. There is now flame extension from windows 95-340 to 95-343. The flames near the center of the face indicate that the fires on either the 96th floor or 97th floor, or both, extend continuously from the west edge of the south face to very near the center, i.e., column 330.

Figure 8-45. This cropped photograph shows the south face of WTC 1. It was taken around 9:25:28 a.m. with an assigned time uncertainty of 15 seconds. The original image has been enhanced and rotated. Column and floor number have been added. A number of pages of paper are present in the photograph.

Even though fires have been burning on the south face for well over a half hour, there is no indication in Figure 8–45 that the flames have begun to spread toward the east. With the exception of broken windows on floors well above the fire, the appearance of the east side of the façade has not changed since the aircraft impact.

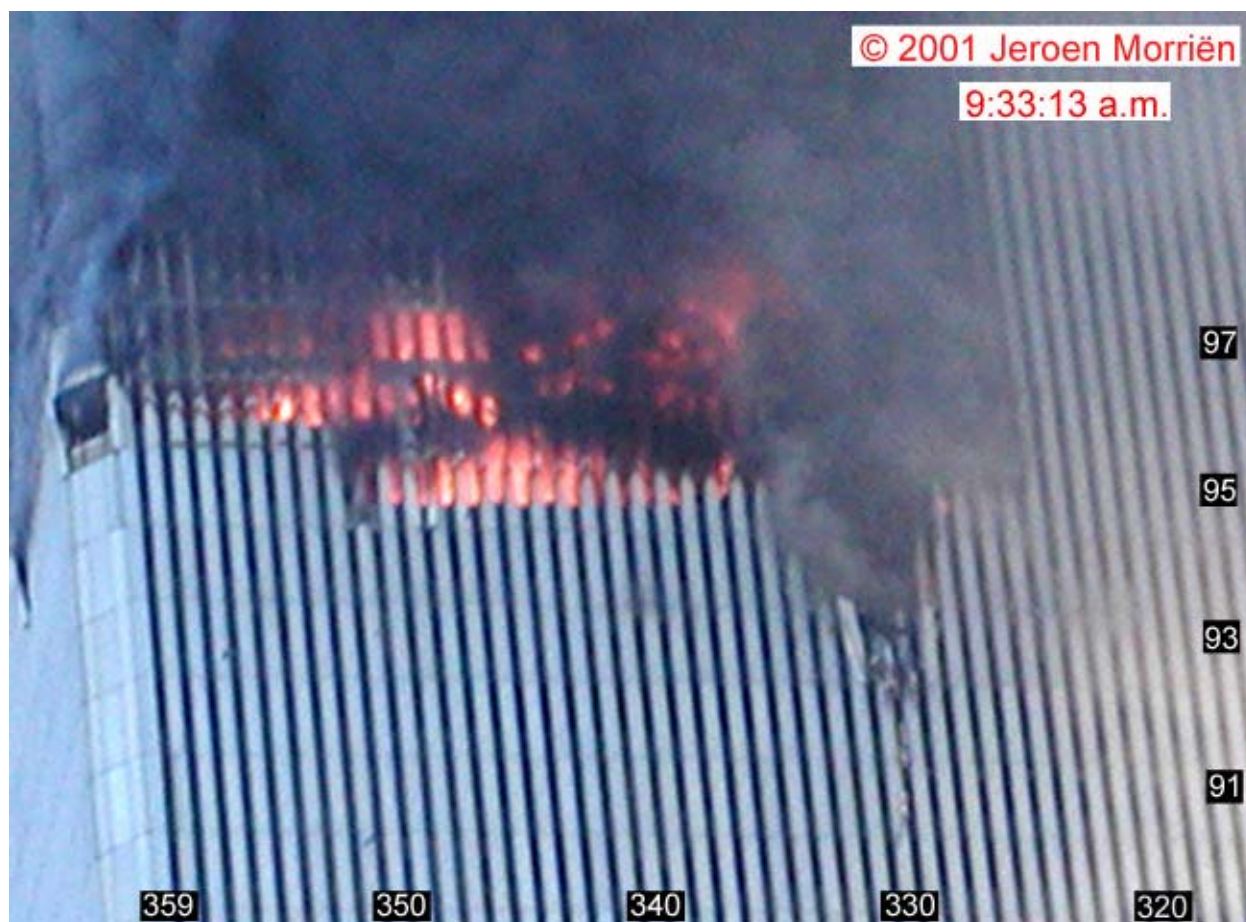
Figure 8–46 shows a view of the south face taken at 9:33:13 a.m. By this time, the intense fires on the 96th and 97th floors near the western edge of the face have diminished greatly, and flames are no longer prominent in the windows nearest the edge, while flames closer to the center have receded back into the windows. It is now possible to observe individual windows on the 96th, 97th, and 98th floors all the way from the western edge to windows 96-344, 97-344, and 98-344. Note that it appears as if these windows on the 98th floor are missing. It is not possible to conclude this definitely, since it is possible that smoke has been deposited on the windows, which would make them dark and thus appear to be missing. In either case, there are no obvious flames present in this area of the 98th floor.

**Figure 8-46.** This cropped image shows a portion of the south face of WTC 1 at 9:33:13 a.m. The photograph has been enhanced, and column and floor numbers have been added.

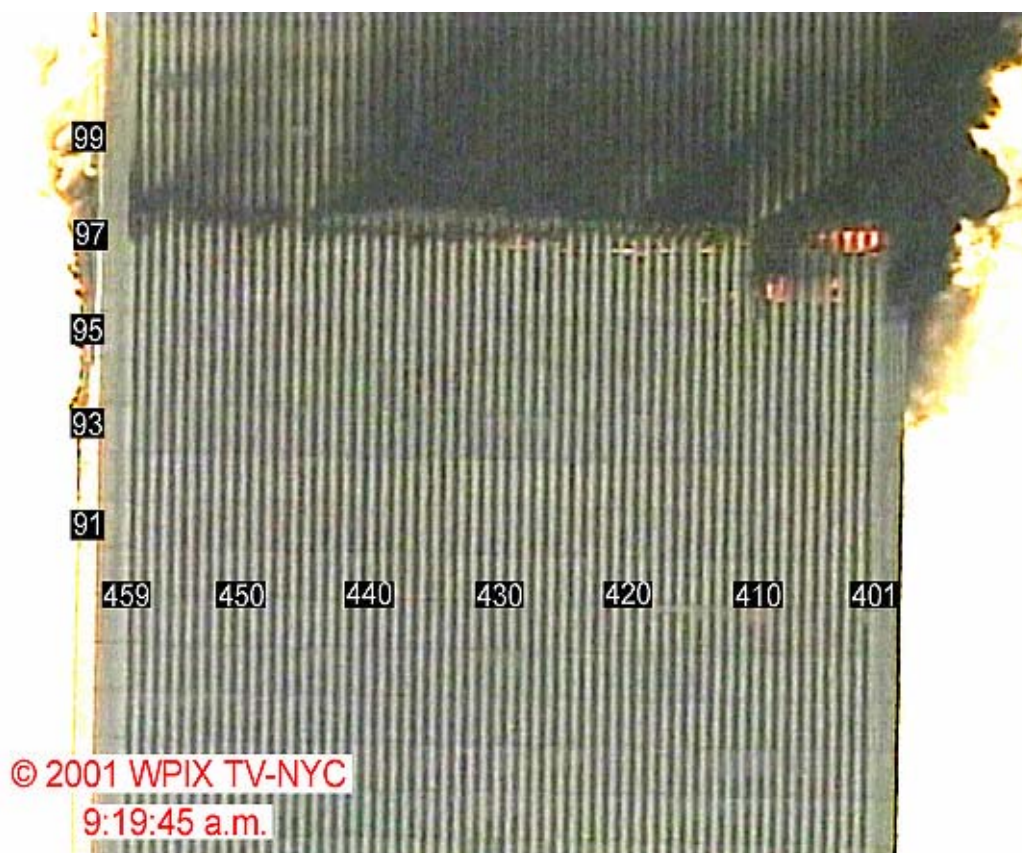
One such image taken from a video recorded at 9:19:45 a.m. is shown in Figure 8-47. The fire distribution is consistent with that observed from the ground at 9:14:46 a.m. in Figure 8-31. A flaming region is prominent at the south edge of the 97th floor over windows 97-401 to 97-405. While these flames appear to fill the windows, they do not seem to extend out of them. Further toward the north on the 97th floor, a number of relatively small fires are visible through the lowest portions of the window openings. Most of these flames are observed between the intensely burning corner and the center of the face. When viewing the video, it appears as if this gentle burning is relatively continuous across this length. The only location on the face where flames are apparent even further to the north is in window 97-455. Keeping in mind that the bases of the windows are raised 15 in. from the floor, it is clear that most of the intense fires that were burning earlier on the west side of the 97th floor have died down to a condition in which widely distributed flames are gently burning near the floor on the remaining fuel. A comparison of Figure 8-47 with Figure 8-30, which was recorded at 9:10:58 a.m., provides a good visual measure of how much the fire intensity on this floor has decreased over this nearly 9 min period.

The only other floor on which flames are apparent in Figure 8-47 is the 96th. A region of fire, which fills the window openings, runs from window 96-404 to perhaps window 96-410. The flames in windows 96-408 and 96-409 extend from these windows. As discussed above, fire was present in the

same general location around 9:11 a.m. (see Figure 8–30). Two regions of small flames around windows 96-412 and 96-414 are visible just to the north of the flaming area. Even though these flames are similar in appearance to the dying flames just above on the 97th floor, there is a major difference. Based on the visual evidence, there has not yet been an intense burning phase in this region of the 96th floor. The absence of smoke marks on the nearby aluminum cladding is consistent with this conclusion.

**Figure 8-47.** This image of the west face of WTC 1 is a frame captured from a video recorded by a news helicopter at 9:19:45 a.m. The image has been enhanced by adjusting the intensity range, and areas to the left and right of the tower are saturated. Column and floor numbers have been added.

It is interesting to compare Figure 8–47 with the view of the south face shown in Figure 8–44. These images were taken approximately 30 s apart. While there are intense flames issuing from numerous windows on the 95th, 96th, and 97th floors on the west side of the south face, from the west flames are only observed near the south corners of the 96th and 97th floors, and they do not appear to be nearly as intense. These observations indicate that either the flames on the south face are isolated near the outer wall or that interior portions of these floors are actually hidden from view by obscuring smoke or walls. There is no indication of fire on the 95th floor from the west. Figure B-4 in Appendix B shows that there were a group of rooms in the southwest corner of this floor with a wall extending to column 95-350. The walls associated with these rooms may still be in place, protecting the west side of the floor from the fire raging on the south face. One piece of visual evidence argues against this conclusion. In Figure 8–44, smoke is observed coming from windows 95-349 and 95-350 on the south face, and there is evidence of façade damage below both of these windows. This suggests that both windows were removed during the

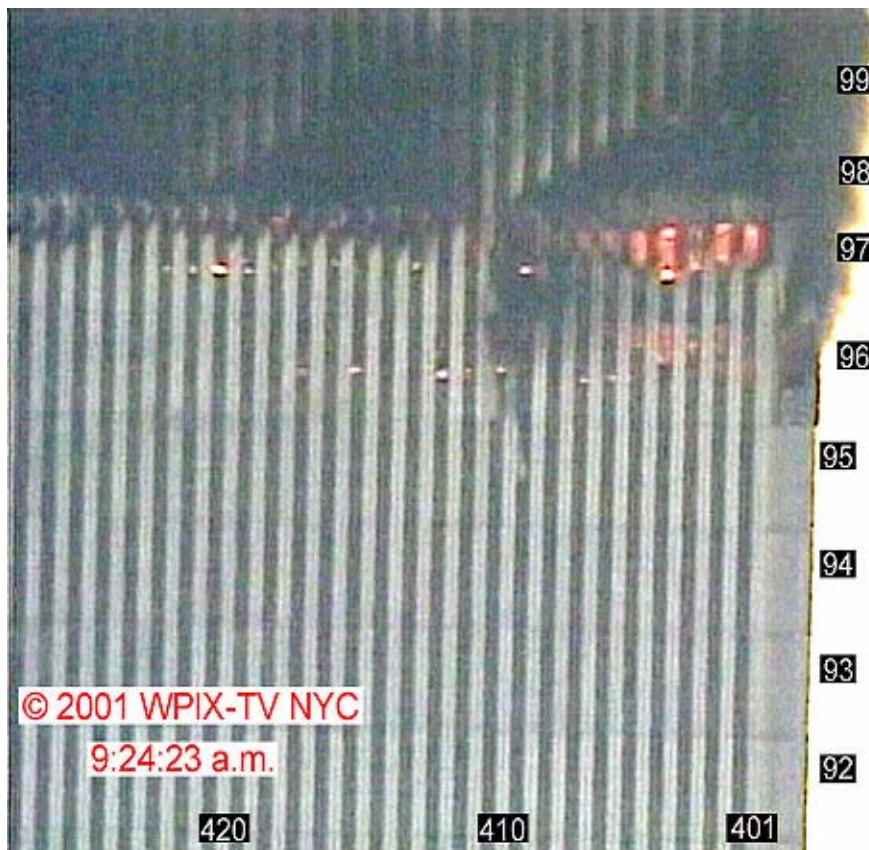
Figure 8–48 shows a closer view of the south side of the west face captured from a news helicopter video recording at 9:24:23 a.m. The general appearance is very similar to that of Figure 8–47. The relatively intense fires burning at the south edges of the 96th and 97th floors are still present. A number of small, apparently isolated, fires can be seen on both of these floors. On the 96th floor there are now indications of fires as far north as window 96-417. This is slightly farther than observed at 9:19:45 a.m. and suggests that these low-level fires are slowly moving toward the north along the outer west wall of the 96th floor. The image has sufficient resolution to just identify, albeit with some uncertainty, whether window glass is still in place. It appears that the glass is missing from those windows where the small fires are visible and is intact in windows at the intervening locations.

**Figure 8-48.** This image of a portion of the west face of WTC 1 is a frame captured from a video recorded by a news helicopter at 9:24:23 a.m. The image has been enhanced by adjusting the intensity range, and the area to the right of the tower is saturated. Column and floor numbers have been added.

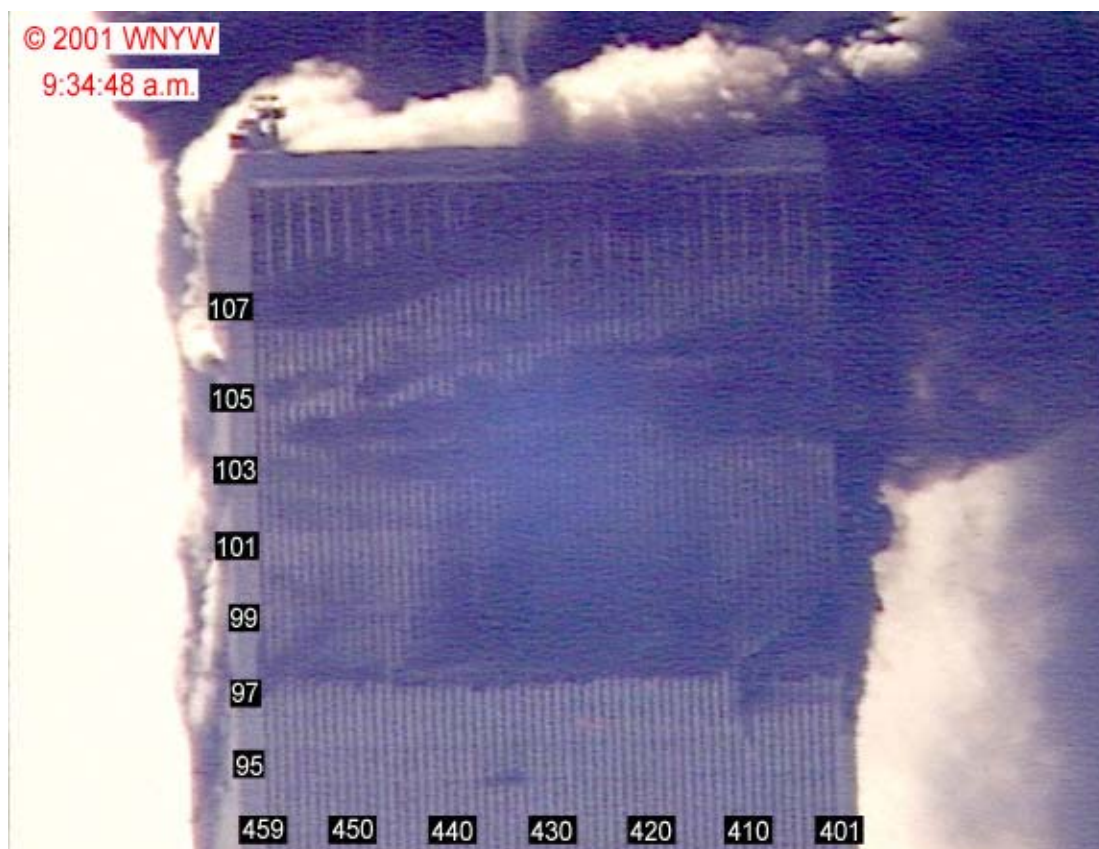
Figure 8–49 shows another view of the west face of WTC 1 taken from a video that was recorded from a helicopter at 9:34:48 a.m. The fires on the south ends of the 96th and 97th floors are no longer as prominent as they were earlier. In fact, at this distance and clarity it is difficult to identify fires in these locations. There is evidence of low-intensity fires further to the north on both the 96th and 97th floors. The most visible flames on the 96th floor are in windows 96-224 to 96-226. This area is north of where flames were observed earlier, indicating that the fires are continuing to spread slowly toward the north.

**Figure 8-49.** This image of the west face of WTC 1 is a frame captured from a video recorded by a news helicopter at 9:34:48 a.m. The image has been enhanced by adjusting the intensity range, and some areas to the left and right of the tower are saturated. Column and floor numbers have been added.

Even at the distance from which Figure 8–49 was taken, a black mark is visible running across the tops of windows 94-433 to 94-436 on the 94th floor. These marks are not evident in Figure 8–47, which was taken at 9:19:45 a.m. This suggests that smoke began to flow from these windows at some point between these two times. A review of video recordings shows that visible smoke was apparent coming from these windows starting around 9:26 a.m. As discussed earlier, windows had been opened in this general area as early as 9:04 a.m. Recall also that several windows are open just to the north on the 95th floor. There is still no indication of smoke coming from these windows.
