**NIST NCSTAR 1-5A**

**Federal Building and Fire Safety Investigation of the  
World Trade Center Disaster**

# **Visual Evidence, Damage Estimates, and Timeline Analysis**

September 2005

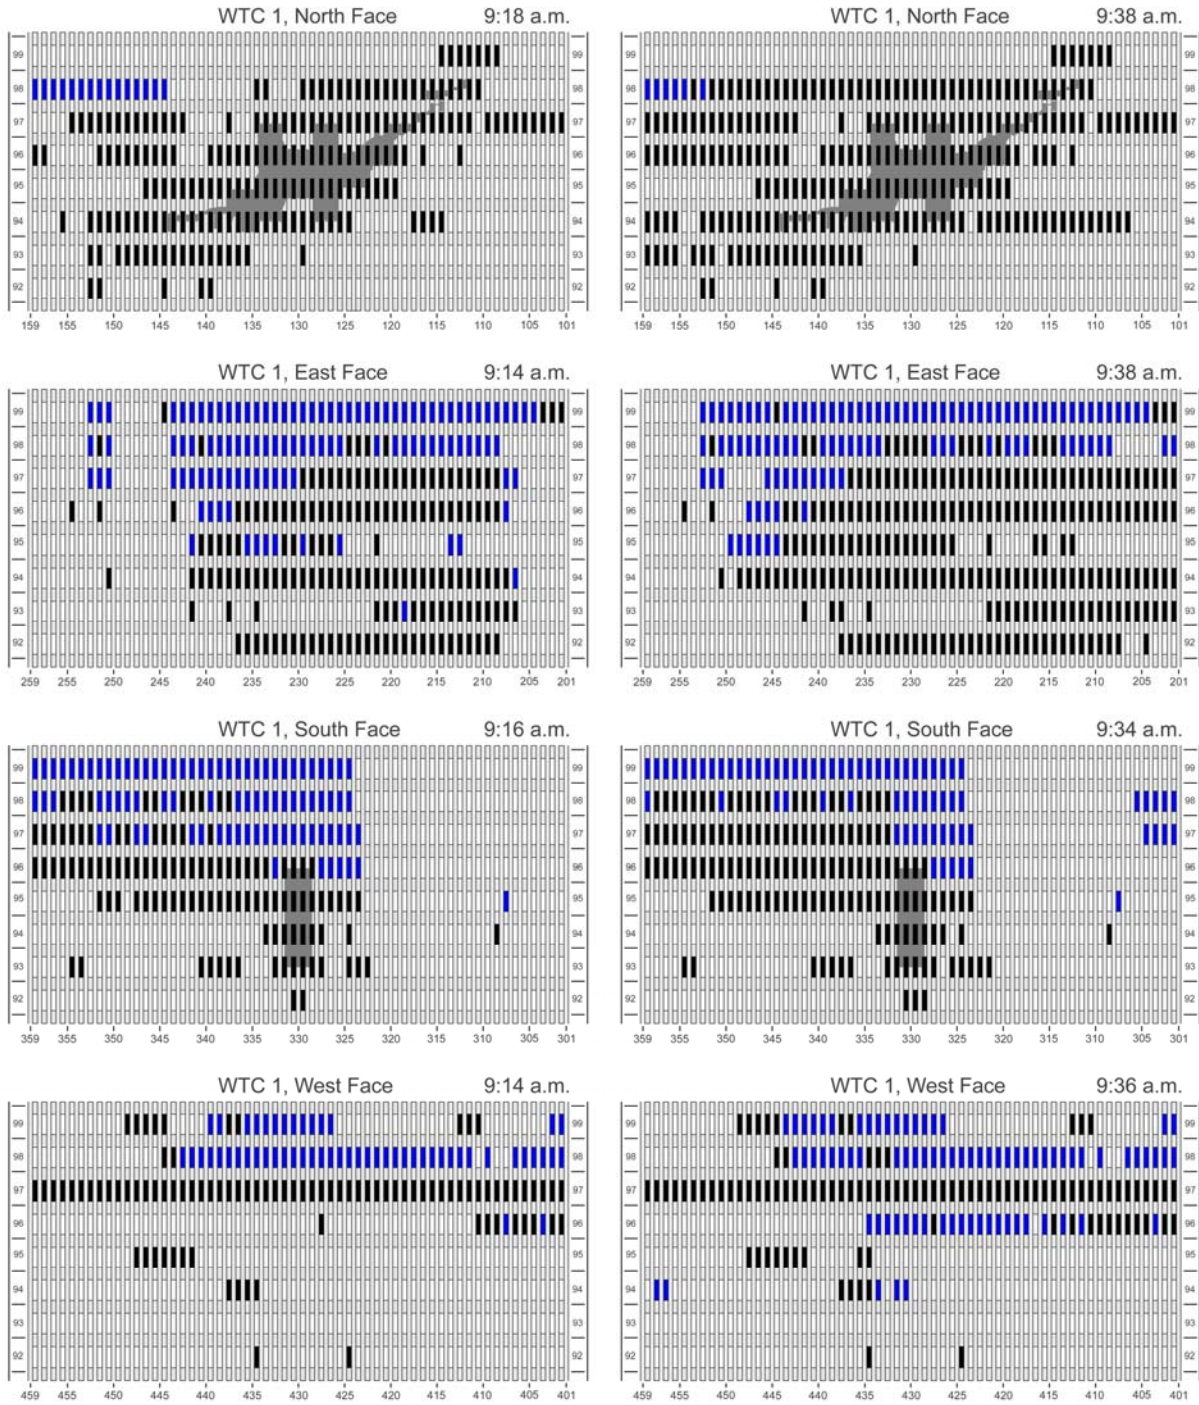
Figure 8–50 compares maps for open windows on the four faces of WTC 1 for times near the start and end of the current time period. These maps capture the general trends that emerge from the detailed discussion of fire behavior during the period. In particular, on the north face fires on the 93rd, 94th, 96th, and 97th floors breached walls and entered northeast corner rooms, and the contents inside began burning. A new region of fire grew along the north face on the 94th floor to the west side of the aircraft impact

**Figure 8-50. Maps for the 92nd through the 99th floors compare missing window glass for the four faces of WTC 1 at two times, around 9:18 a.m. and roughly 17 minutes later. The color coding used for the maps is indicated in Figure 5-1.**

cavity. The changes in window conditions on the east face reveal that the fires that entered rooms at the northeast corners of the 93rd, 94th, 96th, and 97th floors also removed windows on the east faces of the rooms. It is also clear that fires that were originally present near the center of the face on the 94th, 95th, 96th, and 97th floors had begun to slowly spread toward the south. On the south face there was very little fire spread during the period. The same is true for the west face, but there are indications that fires on the 96th floor had begun to spread from the southwest corner back toward the north face.

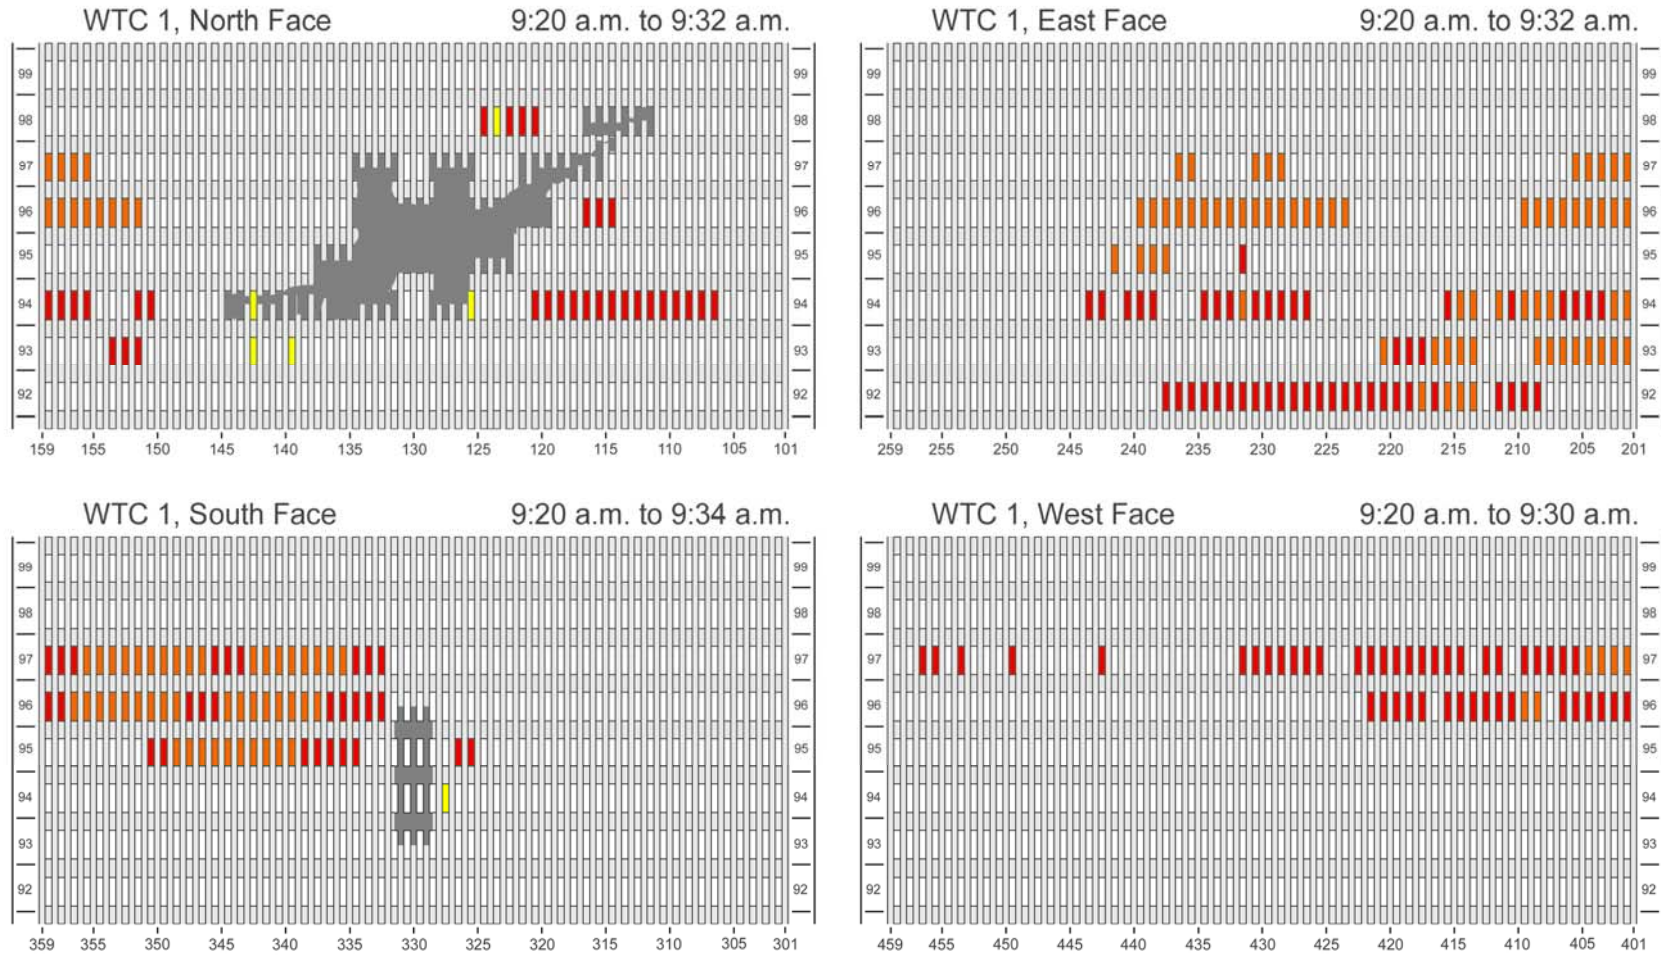
The effects of the life cycle of the fires are also apparent in comparisons of the integrated fire maps prepared for the different time periods. Figure 8–51 shows integrated fire maps on the four faces for the current period from 9:18 a.m. to 9:35 a.m. These maps can be compared with the maps for the two earlier periods shown in Figure 8–33 and Figure 8–14. Such a comparison indicates that there are many windows where fire was observed during the earlier periods where it is no longer visible. These include windows near the aircraft impact area on several floors of the north face, windows on multiple floors around the center of the east face, and many windows on the 97th floor on the west face.

On the north and east faces the windows with observed fire appear to surround areas near the centers of the faces where the fires had already died or were dying down. This suggests that fire spread along the north and east peripheries of these floors has occurred primarily by horizontal fire movement in both directions away from regions initially ignited near the centers of the faces. The fire distribution on the south face indicates that fire spread and growth had occurred differently than on the north and east, with large fires growing and spreading nearly simultaneously on multiple floors at the western side of the face. The integrated fire distribution on the west face reflects both the very rapid fire spread that was observed earlier across the 97th floor and the much slower fire spread from west to east that was observed on the 96th floor.

Figure 8-51. Maps of integrated fire observations between 9:19 a.m. and 9:35 a.m. are shown for the four faces of WTC 1. Colors represent the highest intensity fire observed in a window using the color scale defined in Figure 5-1.

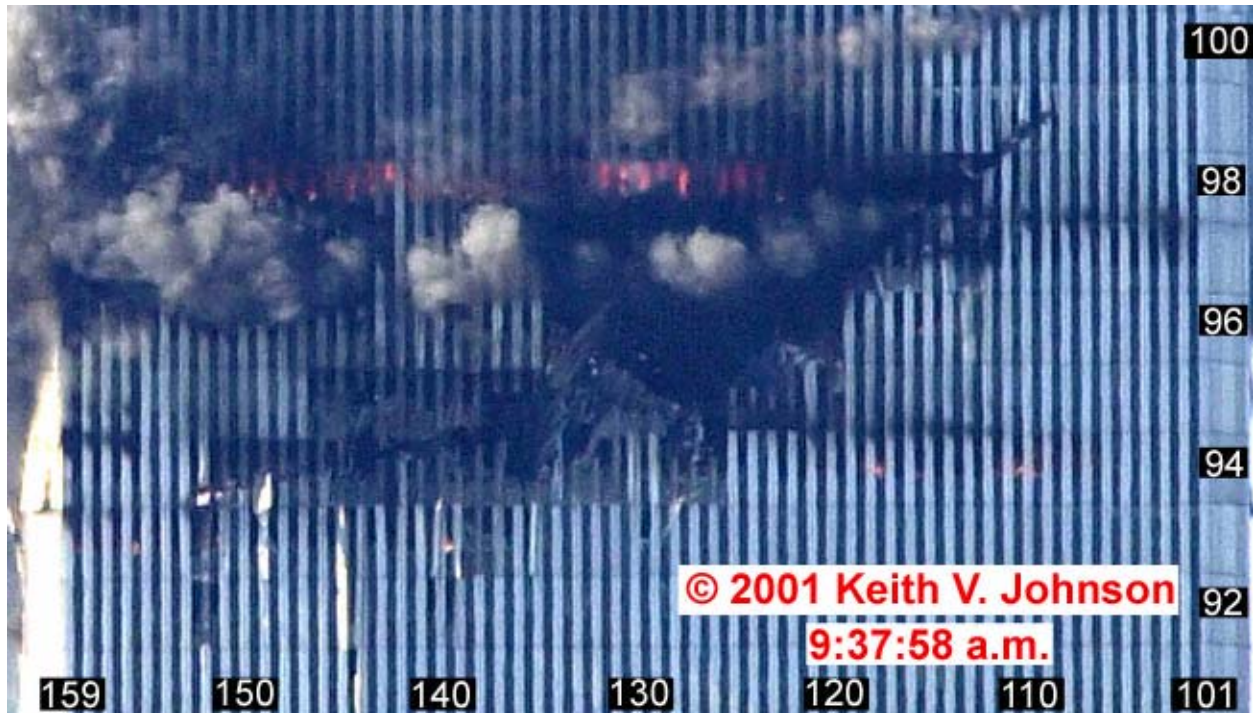
A portion of a photograph showing the fire floors on the north face of WTC 1 at 9:37:58 a.m. is reproduced as Figure 8–52. This photograph was taken just over two minutes later than the image shown in Figure 8–38. The fire on the 98th floor has spread over a wider area and has grown in intensity during this time. Fires are observed (not continuously) from window 98-122 to window 98-150. Even though the flames extend over roughly half the length of the floor, and in some locations appear to fill the volume behind the windows, there is very little smoke and flame evident coming from the 98th floor windows. This is likely another case where the fire gases are exhausting elsewhere than through nearby windows.

**Figure 8-52.** This enhanced and cropped photograph shows the north face of WTC 1 at 9:37:58 a.m. Column and floor numbers have been added.

On the 93rd floor there are two isolated regions of flame visible. One of these is at window 93-139 and the second is at windows 93-151 and 93-152. Many of the windows on this floor are open. The only fire evident on the 94th floor is a small spot fire in the cavity created by the aircraft. The fire on the northeast corner, which developed rapidly around 9:25 a.m. (see Figure 8-36) and filled windows 94-155 to 94-158 with flames, has already died down to a level where it not visible from this vantage point. The image provides sufficient detail to determine that the glass for windows 94-153 and 94-155 is still in place. This is an example where the apparent flame movement does not align with the wall placement indicated by the floor plan layout. The layout in Figure B-3 indicates that the wall for the room in this corner terminated at column 94-154. It is surprising that window 94-154 is not broken. No flames are visible on the 95th to 97th floors.

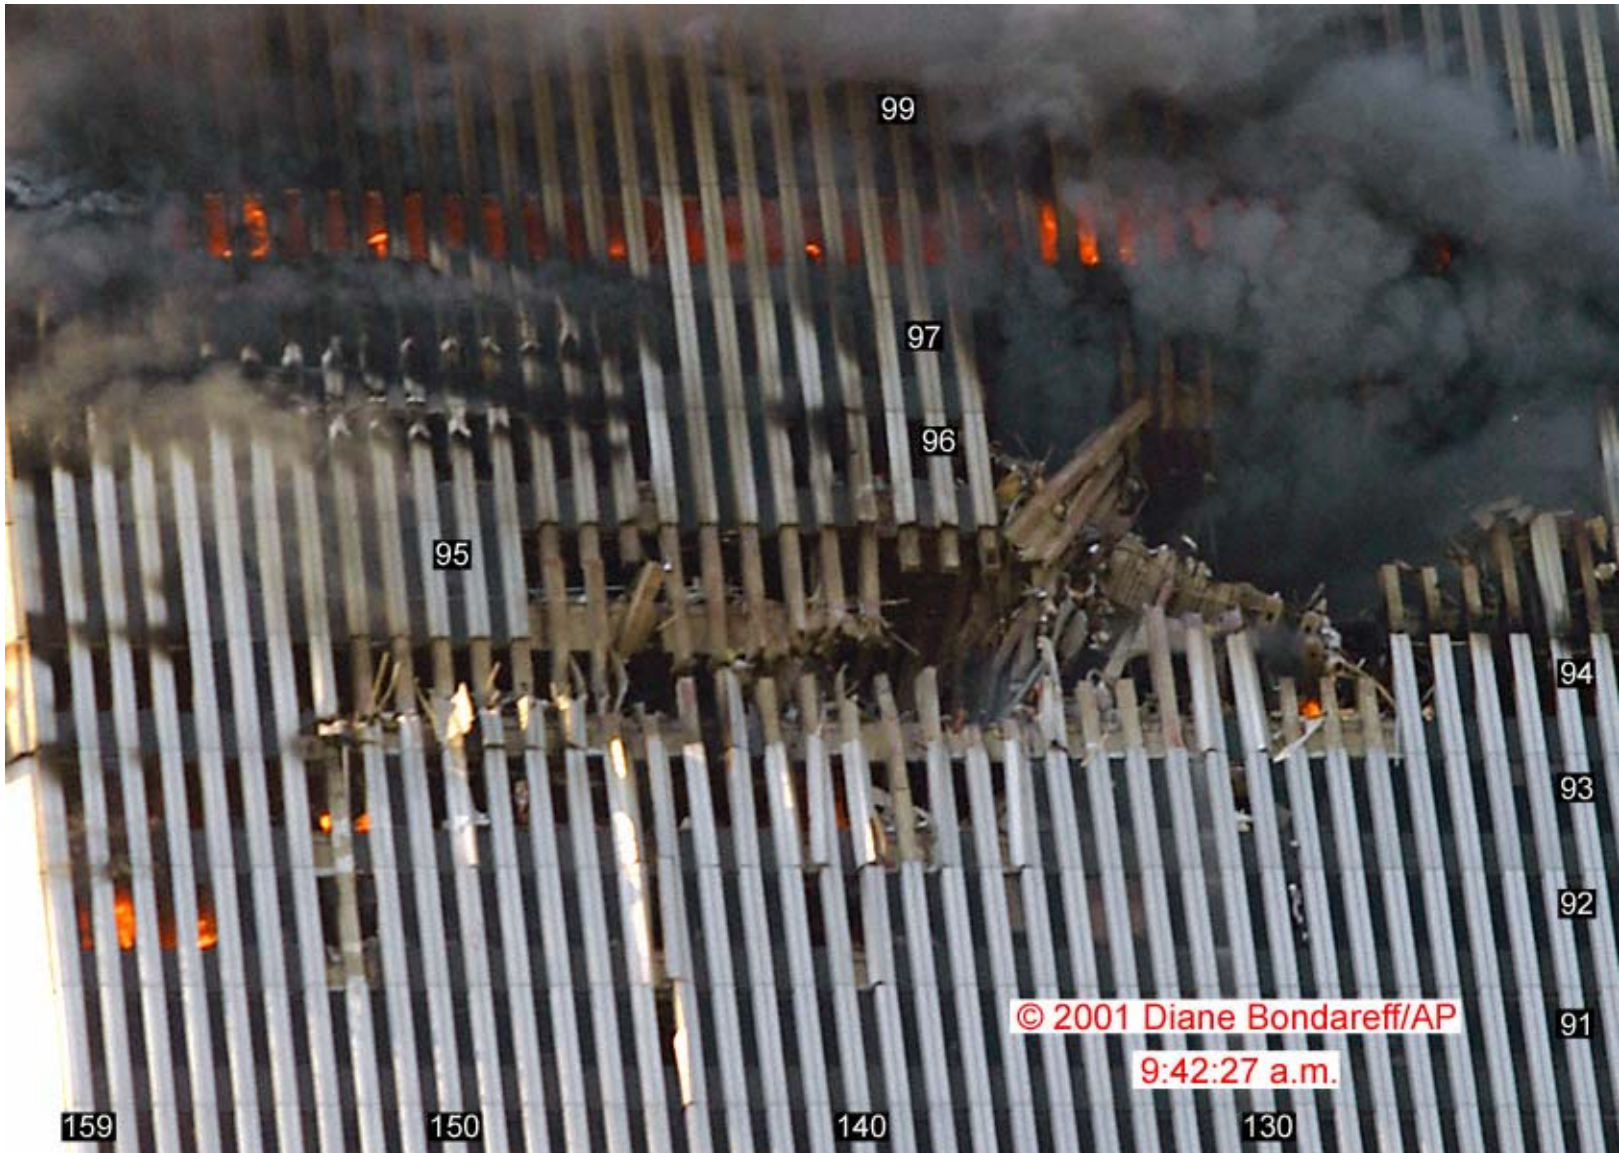
Figure 8-53 provides a clear view of the fires on the 98th floor, which extend from beyond the center of the floor on the west side to at least window 98-154 on the east. Even though the flames appear to be continuous, close inspection shows that in many windows there is simply an orange glow, suggesting that the fires are burning away from the windows at interior locations. The number of windows where flames are directly visible is limited. The only areas where flames appear to fill the windows are near the center of the face and around window 98-153.

Figure 8-53. This sharp photograph shows the eastern portion of the north face of WTC 1 at 9:42:27 a.m. The original version has been cropped and enhanced. Column and floor numbers have been added.

The fires on the north side of the 98th floor do not appear to be as intense as those observed at many other locations on the tower faces. Even so, they were large enough to break out the glass in multiple windows. Windows that were closed prior to the fire are now open. A review of the streamer observations summarized in Appendix L shows that numerous streamers were observed on the north face coming from the 98th floor during the early part of this time period when the fires were growing. Their source locations were spread out across the floor. This provides additional evidence that the streamers formed in regions where fires were breaking window glass.

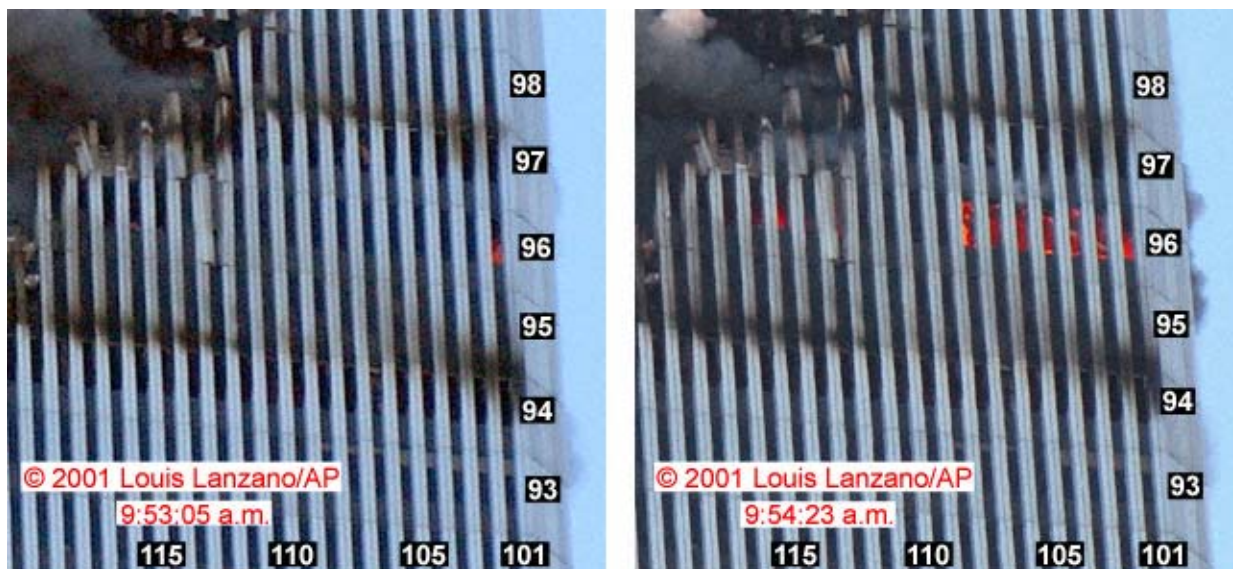
Figure 8-54 includes a photograph of this area taken at 9:53:05 a.m. Windows 94-101 to 94-105 are clearly open. The fires in the corner room have already died down to the point where they are no longer visible from this vantage point. All of the windows on the 94th floor within the view of the image are missing. At the same time, windows on the 92nd, 93rd and 95th floors and windows 98-101 to 98-108 on the 98th floor still have glass panes in place.

**Figure 8-54.** Two photographs of the west side of the north face of WTC1 taken at 9:53:05 a.m. and 9:54:23 a.m. are compared. The original photographs were cropped and enhanced. Column and floor numbers have been added.

In the photograph taken at 9:53:05 a.m., a small fire can be seen at the western edge of the 96th floor in window 96-101, while the glass for windows 96-102 to 96-110 is still in place. Videos show that there was a flash of light at window 96-101 at 9:53:00 a.m., which was likely associated with this window opening. At 9:53:20 a.m. the fire in window 96-101 grew visibly larger. During the following 13 s, fire appeared, moving from west to east over windows 96-102 to 96-107. This fire is evident in the second photograph included in Figure 8–54, which was taken at 9:54:23 a.m. The adjacent window, 96-108, was still in place at this time. According to the floor plan layout shown in Figure B-5, one of the walls for the room at this corner was located at column 96-108.

Even though the glass panes for windows 96-108 to 96-111 are still in place, a fire is visible growing rapidly further to the west in windows 96-112 to 96-115. The fire seen in window 96-113 is one of the few examples where flames are observed through a closed window. As discussed below, a significant fire was observed on the west face near the northwest corner prior to the rapid fire growth in the northwest corner room. This suggests that the fire broke into this corner room through the south wall located at column 96-456 (see Figure B-5). Note that there were two adjacent rooms attached to the south side of this wall. Fire movement from the south is also the likely source for the fire seen in windows 96-112 to 96-115.

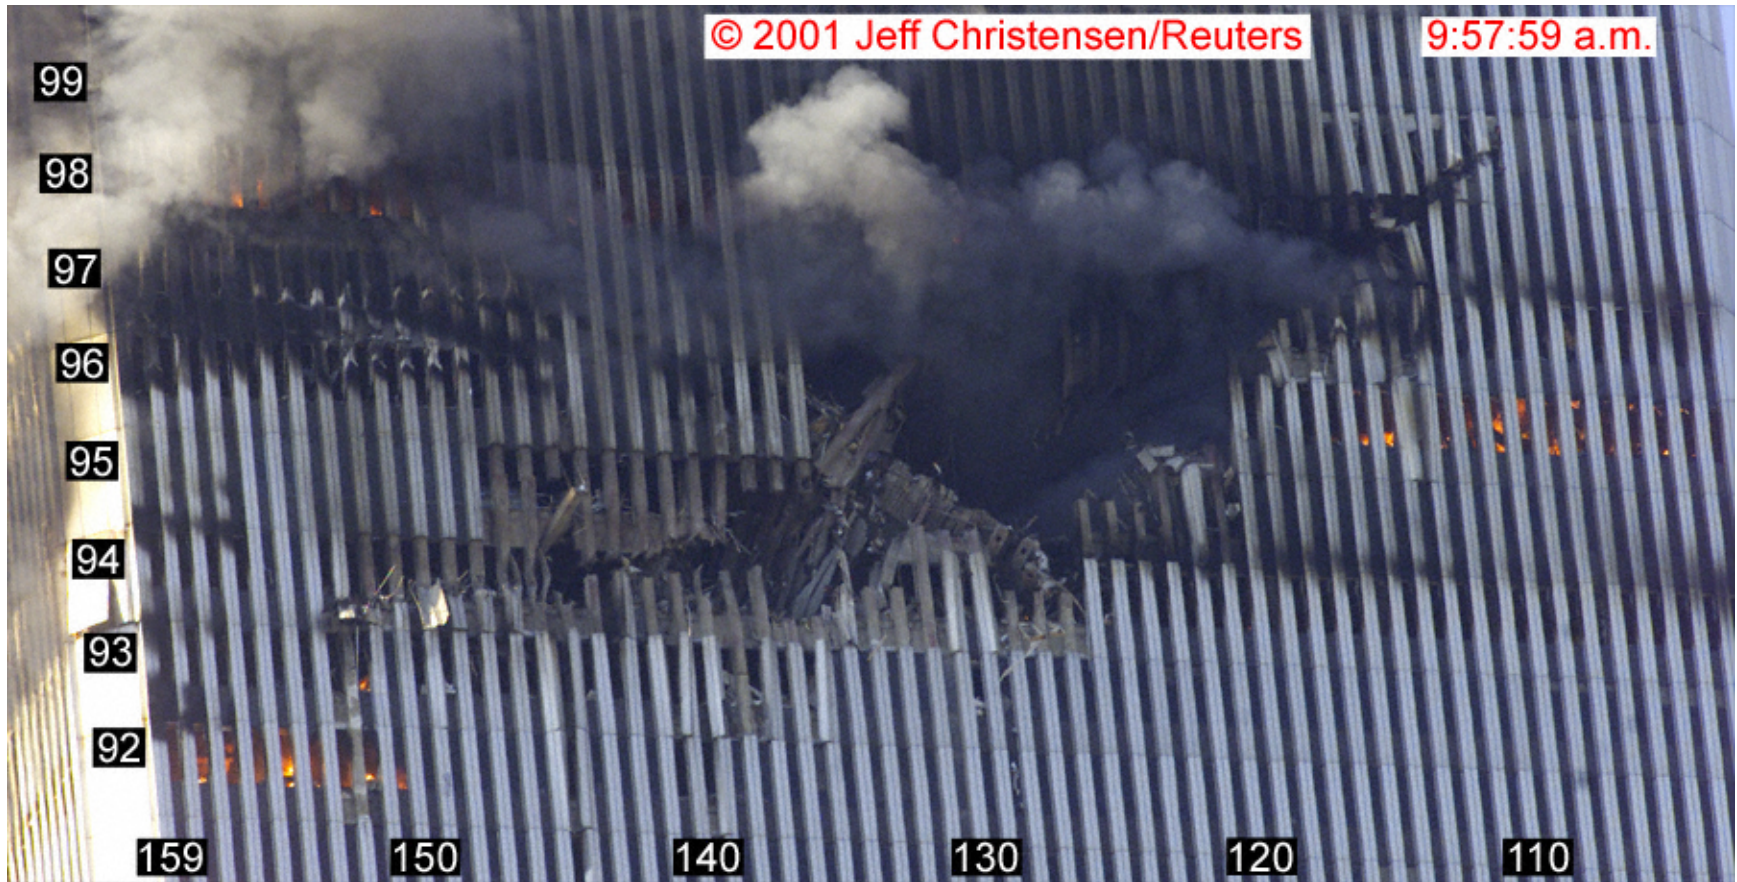
A photograph of the north face of WTC 1 taken at 9:57:59 a.m., i.e., one minute prior to the collapse of WTC 2, is shown in Figure 8–55. Several changes have taken place since the photographs in Figure 8–53 and Figure 8–54 were taken. The fires on the 98th floor have died down considerably, with fire primarily evident on the east side of the north face. The fires on the 92nd and 96th floors have also spread a little further. On the 96th floor, windows 96-108 to 96-111 are now open, and flames are visible in these windows. On the 92nd floor, the panes for windows 92-153 and 92-154 are missing, and flames are visible through these windows, as well as windows 92-151 and 92-152. Recall that walls for rooms in this area were located at columns 92-152 and 92-155 (see Figure B-1). This photograph has sufficient resolution to identify details inside the windows. It appears as if both of these walls are still present.

Figure 8-55. This image shows the north face of WTC 1 at 9:57:59 a.m. The original has been rotated, cropped, and enhanced. Column and floor numbers have been added.

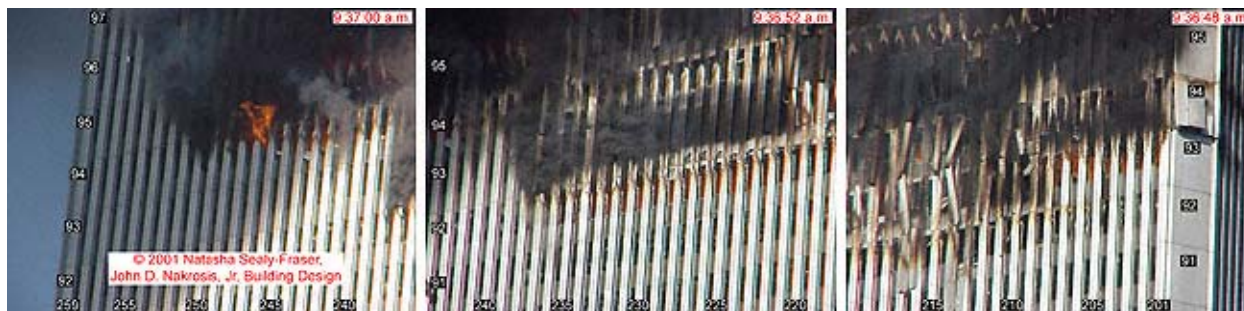
A number of close-up photographs and videos that provide views of the east face are available during the current time period. Figure 8–56 shows a series of three photographs that were taken around 9:37 a.m. They show the lower floors where fires have been burning. Note that the fires that are present on the 96th and 97th floors are not visible. In the right-most photograph fire is visible near the northeast corner of the

**Figure 8-56. This series of three photographs shows various locations along the east face of WTC 1 around 9:37 a.m. Column and floor numbers have been added.**

92nd floor in windows 92-201 to 92-207. Flames first appeared in this area around 9:33 a.m., and at 9:34:20 a.m. flames were coming from these windows. These flames had already begun to die down two and a half minutes later. The smoke markings on the adjacent column covers are interesting. They are a combination of carets and horizontal bands. There is also a smoke band above these windows. These markings suggest that while flames did extend from the windows, they were not intense enough or sustained for a long enough time to create well-defined carets. Well-defined carets are present just above on the 94th floor, as well as on numerous column covers on the 96th floor.

The same photograph provides an indication of the degree to which the flames that were present earlier on the 94th and 96th floors have died down. Only a couple of isolated fires are observed on the 94th floor, and no flames are obvious in windows 96-201 to 96-220.

In the center photograph of Figure 8-56, the fires that were present earlier on the 93rd, 94th, and 95th floors near the center of the east face have also died down and are no longer evident. There is still considerable evidence of interior fires on the 92nd floor, but the flames still do not seem to have progressed beyond window 92-237. As discussed earlier, flames were observed at window 92-237 at 9:21:01 a.m. The fires on the 92nd floor have caused some interesting effects on the surrounding façade. The variations in the types of smoke marks on the column covers adjacent to the windows have already been mentioned. Inspection shows that in the area immediately above windows 92-223 to 92-228, the aluminum spandrel covers have partially disappeared. The shapes of the missing areas indicate that they mostly likely melted due to heating from the hot fire gases flowing from below. In fact, spots of what appear to be solidified drops of aluminum can be seen on windows below this floor. Based on the melting temperature of aluminum, the fire gases leaving these windows must have been well in excess of 600 °C. Even though these gases were quite hot, they have not broken out the glass in the windows immediately above on the 93rd floor, which are heavily coated with soot, but remain in place.

The left-most photograph in Figure 8-56 shows the southern part of the east face. A jet of fire is coming from the 94th floor at window 94-246, and flames are visible in nearby windows. The carets on many nearby column covers indicate that flames have extended from many of these windows. The heavy smoke coming from window 94-149 indicates the fire on this floor has moved slightly toward the west since 9:34:20 a.m. (see Figure 8-43).

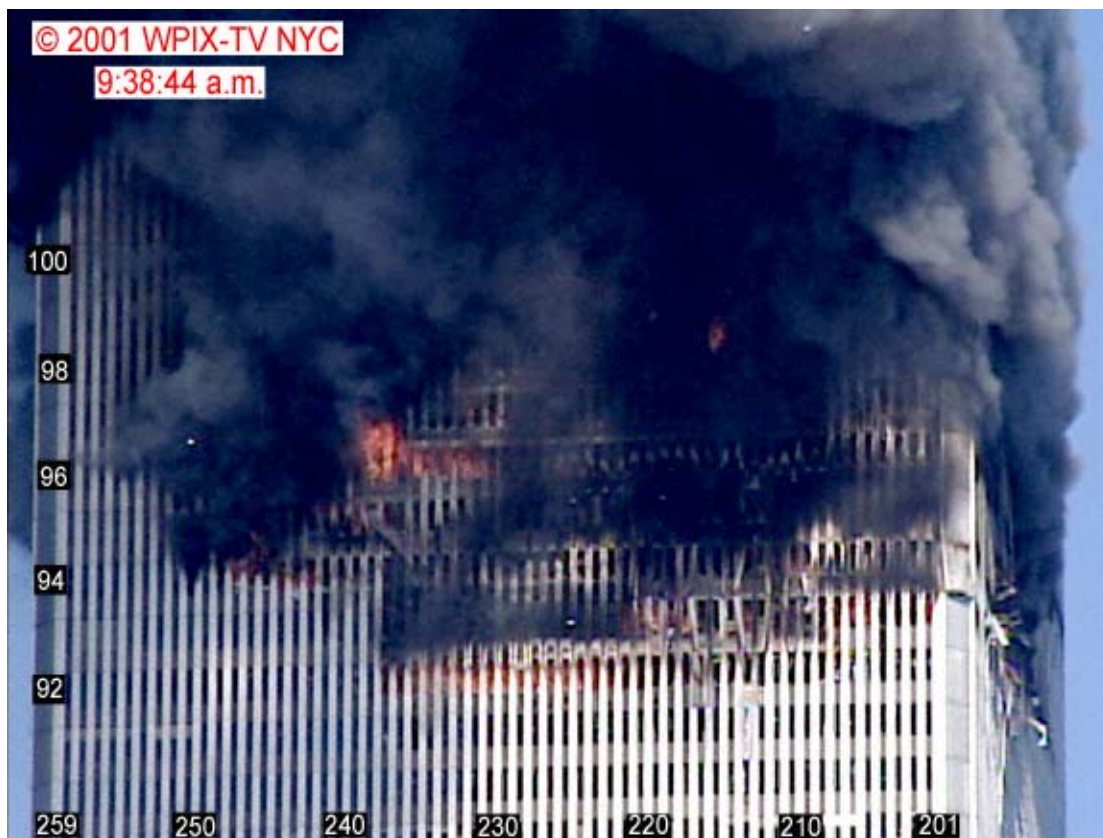
Figure 8-57 is a frame from a video of the east face taken at 9:38:44 a.m., which shows all of the floors with fires. This photograph was taken more directly from the east than Figure 8-56 and, therefore, provides a better indication of fire locations. Starting at the lower part of the figure, the fire on the

92nd floor is visible over a length from near window 92-223 to window 92-238. Despite the extent of the flames, visible smoke is only coming from near window 92-237. On the 93rd floor, flames are evident at the northeast corner and also in a region running from approximately window 93-213 to window 93-221. Flames are coming from the several windows on the 94th floor, centered near window 94-248, and flames extend over at least seven windows. A short flaming region is present on the 95th floor, centered near window 95-239.

**Figure 8-57. This image of the east face of WTC 1 was captured from a video recorded at 9:38:44 a.m. It has been enhanced by adjusting the intensity levels. Column and floor numbers have been added.**

There is an intense flaming region on the 96th floor, with flames extending a large distance from windows 96-237 and 96-238. Videos of this face around this time show that this intense flaming lasted several minutes. The intense region of burning has only moved a few windows to the south since 9:25:27 a.m. (see Figure 8-42). In contrast, very little flame is visible on the 97th floor, directly above, even though fires have burned to roughly the same location as on the 96th floor. Videos recorded at around the same time also indicate there was very little fire on this floor.

On the 98th floor, there is a localized jet of flame coming from window 98-215. A review of photographs and videos recorded around this time reveals that this flame was not apparent in close-up shots taken around 9:37 a.m. and that it is seen for the first time in more distant videos around 9:37:57 a.m. Recall that by this time a wide-spread fire had been observed on the north face of this floor for around 10 minutes. Unlike the fire that has just appeared on the east face, the flames did not extend from the north face and appeared to be of relatively low intensity. It is interesting that the first appearance of

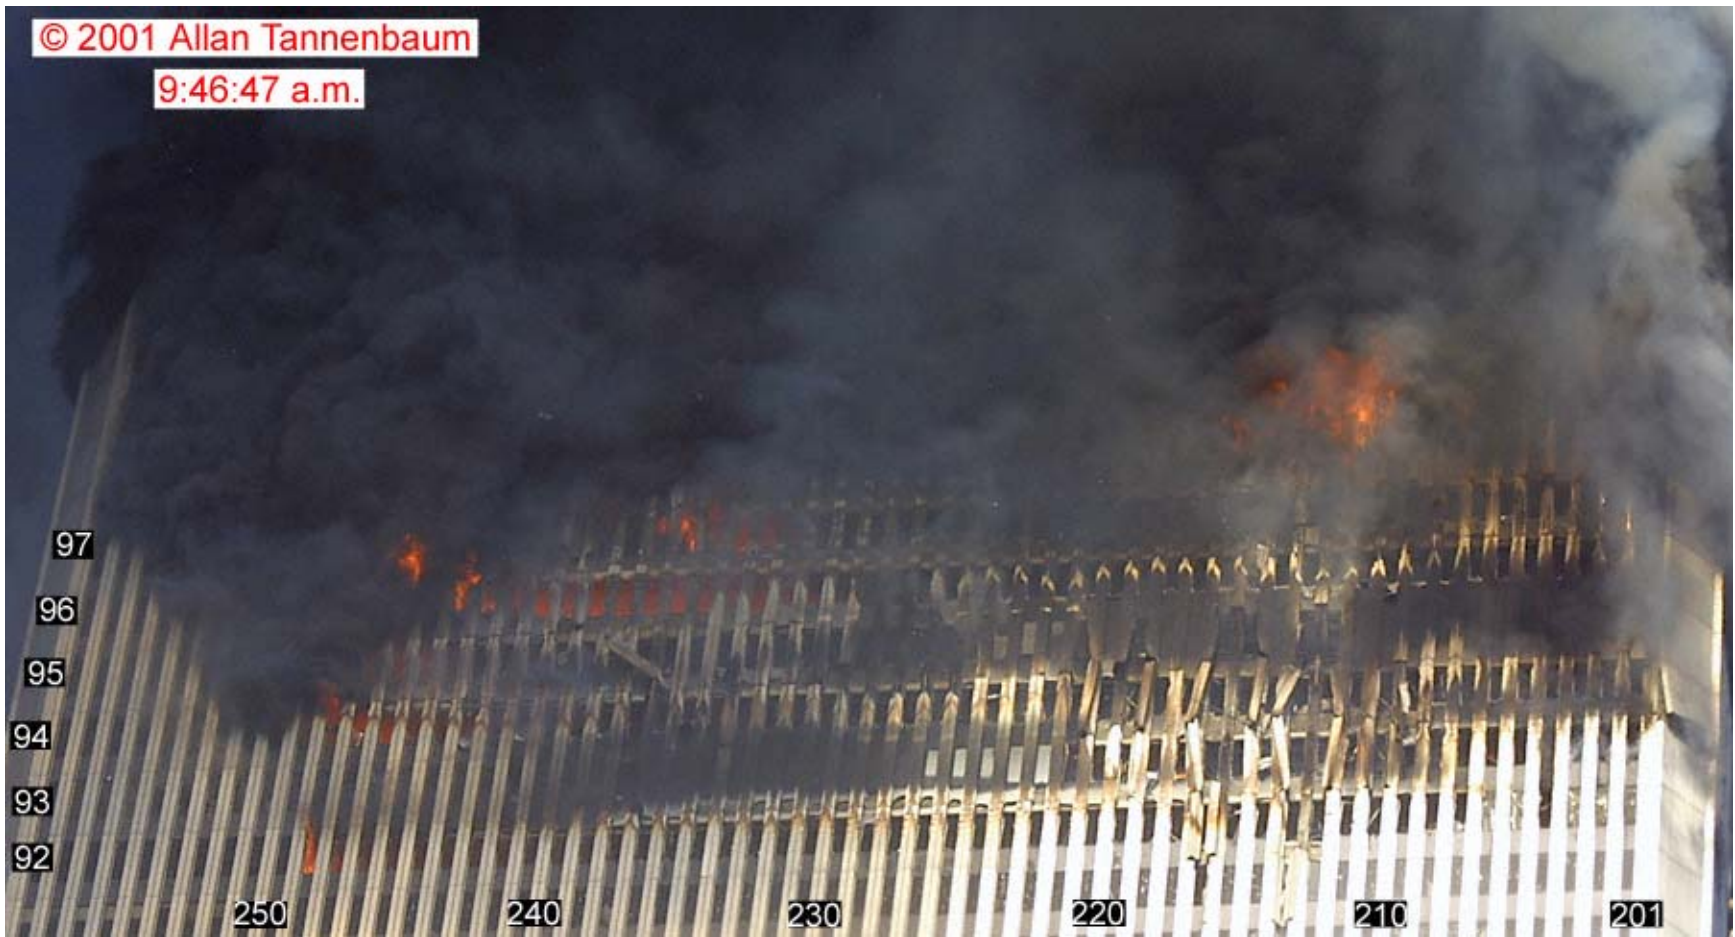
In areas of the face below and to the north of the current active fire areas there is little visual evidence of smoke or flames in the open windows. This indicates that fires observed earlier at these locations have either gone out or are now burning at very low levels. Figure 8–58 provides a good view of the various markings on the face described earlier, including the smoke marks on the column covers and partially melted spandrel covers.

Figure 8-58. This image shows the east face of WTC 1 at 9:46:47 a.m. The original image has been cropped, rotated, and enhanced. Column and floor numbers have been added.

The changes in the appearance of the fire burning on the 96th floor are somewhat surprising. At 9:46:47 a.m. flames were evident all the way to window 96-249, with flame extension from window 96-248. At 9:55:08 a.m. the major flame region has apparently moved back to the north and is centered near window 96-235. Flames extend out of windows 96-234 and 96-235. The floor plan layout in Figure B-5 indicates that the space in this general area was open with no walls that could provide an explanation for this behavior. On the 97th floor there is a long flame coming from near window 97-237. This is roughly the same location where less vigorous flames were observed earlier.

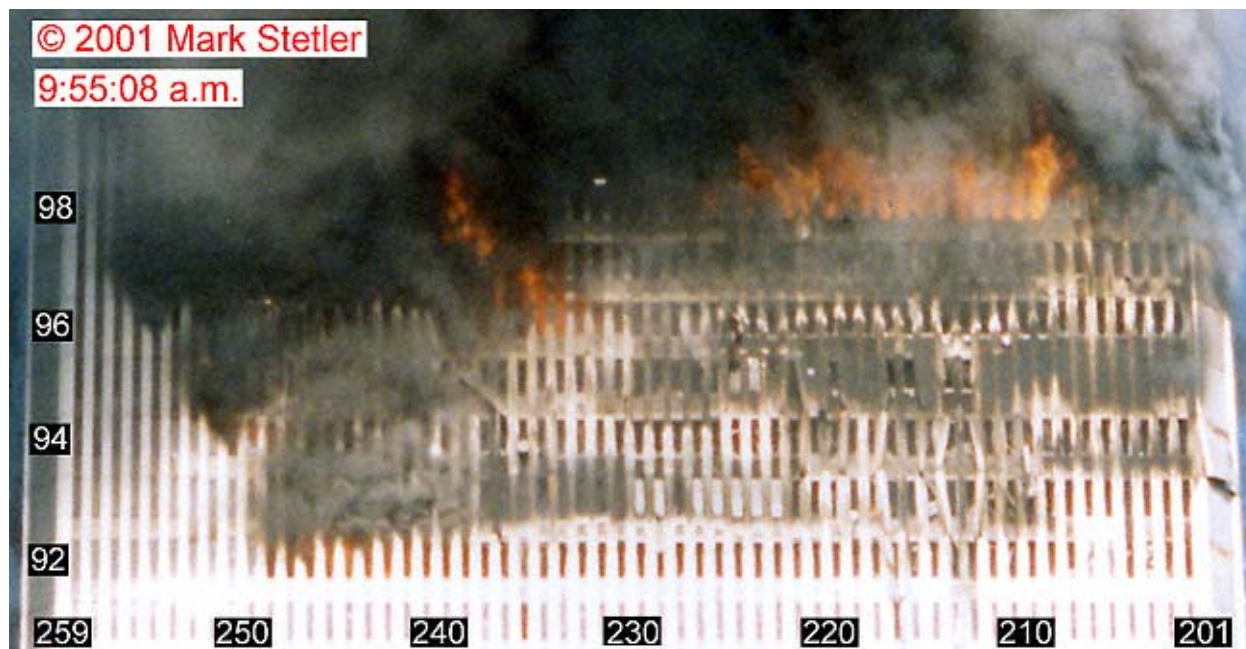
Figure 8–59 includes a photograph of the east face that was taken roughly eight and one half minutes (at 9:55:08 a.m.) after that shown in Figure 8–59. The fire burning on the 98th floor has continued to spread. It now extends from window 98-225 on the south to window 98-201 on the north. There is flame extension from windows 98-208 to 98-223. The fire has clearly moved into the room on the northeast corner, but the fire inside the room is burning at a lower intensity than the main fire region to the south.

**Figure 8-59.** This photograph shows the east face of WTC 1 at 9:55:08 a.m. The original has been rotated, cropped, and enhanced. Column and floor number have been added.

The fire on the 92nd floor has not moved further south than window 92-248 during the interval, but it has grown larger in the immediate area. The windows from window 92-240 to window 92-248 appear to be filled with flames, and there is some flame extension in the area. The fire on the 94th floor also seems to have remained in place, but it has decreased in intensity. The appearance of the fire on the 95th floor is little changed from the earlier photograph.

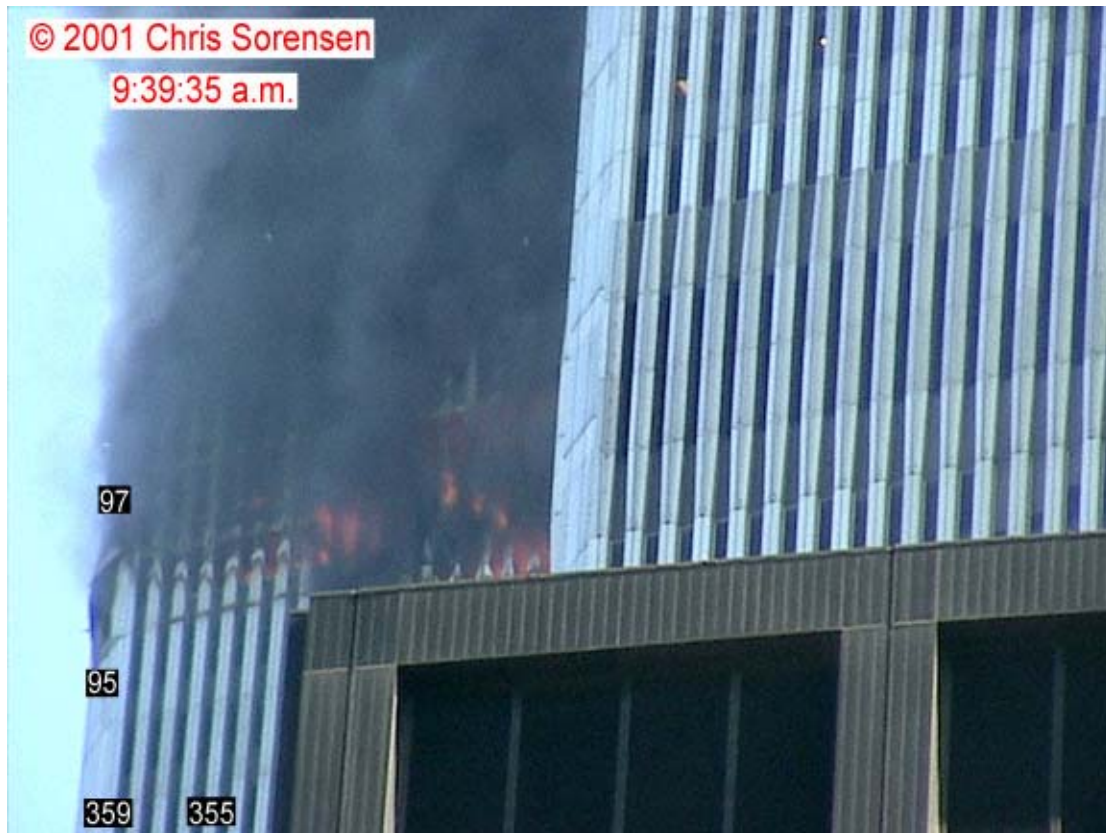
Figure 8–60 shows a partial view of the south face of WTC 1 taken from a video recorded at 9:39:35 a.m. WTC 1 is behind WTC 2, which appears to the right in the image. The first column that is visible on WTC 1 is column 343. The top of the 95th and higher floors are visible. Flames are visible on the 95th, 96th, and 97th floors, but the fire intensity appears to have decreased from that observed in Figure 8–46, which was taken at 9:33:13 a.m. Note that it is possible to see parts of the 98th floor through the smoke, and no flames are apparent.

**Figure 8-60.** This image of the south face of WTC 1 was captured from a video recorded at 9:39:35 a.m. It has been enhanced by adjusting the intensity levels. WTC 1 is on the left behind WTC 2. Another building appears in the foreground. Column and floor numbers have been added.

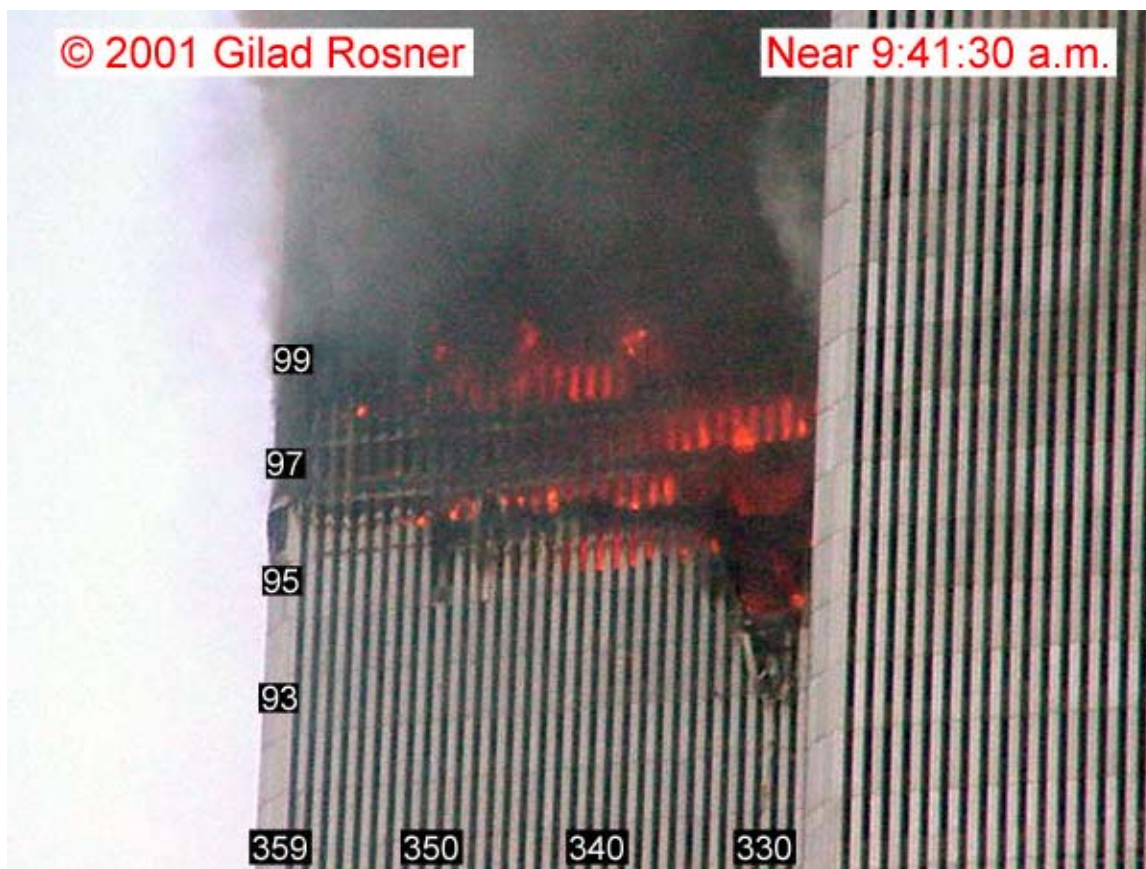
The photograph in Figure 8–61 was taken shortly after the initial rapid fire growth on the south face took place on the 98th floor. The exact time of the photograph is unknown. The assigned time of 9:41:30 a.m. has an uncertainty of just over one minute. The fire on the 98th floor has already covered a number of windows, and flames are extended from many of these. Significant fires are also evident on the 95th, 96th, and 97th floors. The intensities of these fires have continued to decrease relative to earlier times. Burning is also present on the 94th floor near the center of the face, where the panel section is believed to have been displaced during the aircraft impact. Flames were not evident at this location in Figure 8–46, which was taken at 9:33:13 a.m.

**Figure 8-61.** This untimed photograph shows the south face of WTC 1. It is estimated that it was taken between 9:40:40 a.m. and 9:42 a.m. Column and floor numbers have been added.

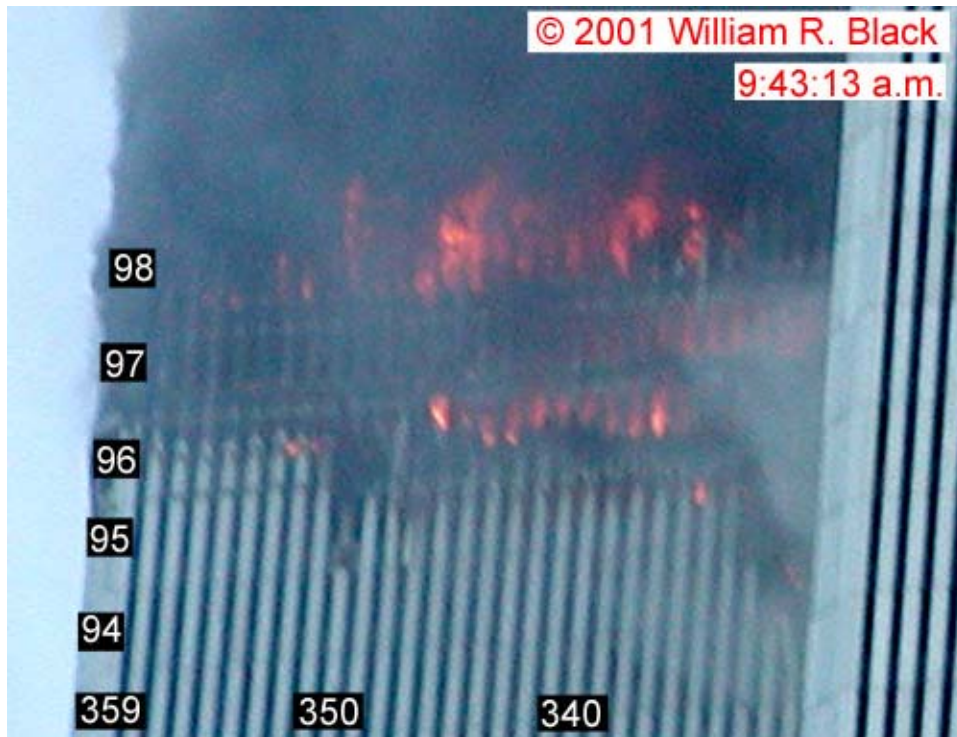
Figure 8–62 shows a partial view of the south face recorded at 9:43:13 a.m. The intensity of the fire on the 98th floor has increased markedly from that seen in Figure 8–61. Fire is now evident from at least window 98-335 to window 98-356. Well over ten of the windows on this floor have large extended flames. Forty seconds later the fire on the 98th floor had grown still more intense as shown in the somewhat closer view of the area reproduced in Figure 8–63. Flames are evident as far west as window 98-357. It is clear from this photograph that, while the intensities of the fires on the 95th, 96th, and 97th floors have decreased from earlier times, vigorous burning is still taking place on each of these floors. A small fire is burning on the 94th floor in window 94-332.

**Figure 8-62.** This cropped photograph of the south face of WTC 1 was recorded at 9:43:13 a.m. The image has been rotated and enhanced. WTC 2 appears at the right. Column and floor numbers have been added.

Comparison of Figure 8–60 to Figure 8–62 verifies the observation from the video that an intense fire appeared on the south face of the 98th floor shortly after 9:40 a.m. and very rapidly covered most of the western half of the face.

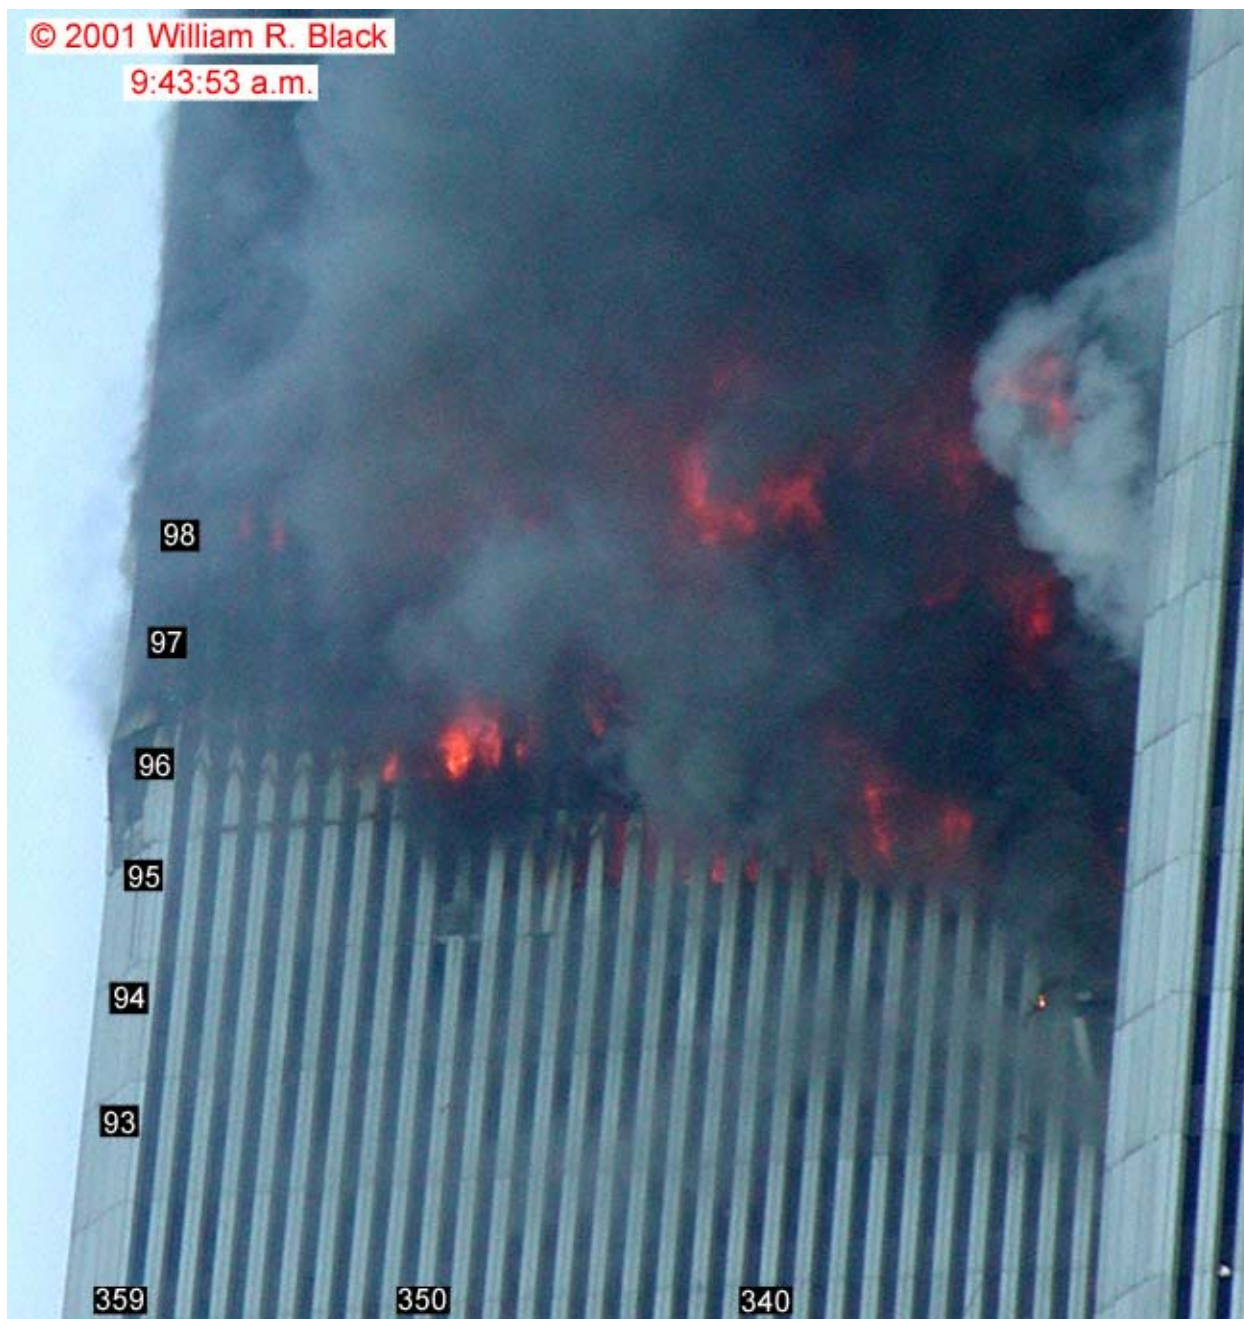
**Figure 8-63.** This cropped photograph of the south face of WTC 1 was recorded at 9:43:53 a.m. The image has been rotated and enhanced. WTC 2 appears at the right. Column and floor numbers have been added.
