**NIST NCSTAR 1-5A**

**Federal Building and Fire Safety Investigation of the  
World Trade Center Disaster**

# **Visual Evidence, Damage Estimates, and Timeline Analysis**

September 2005

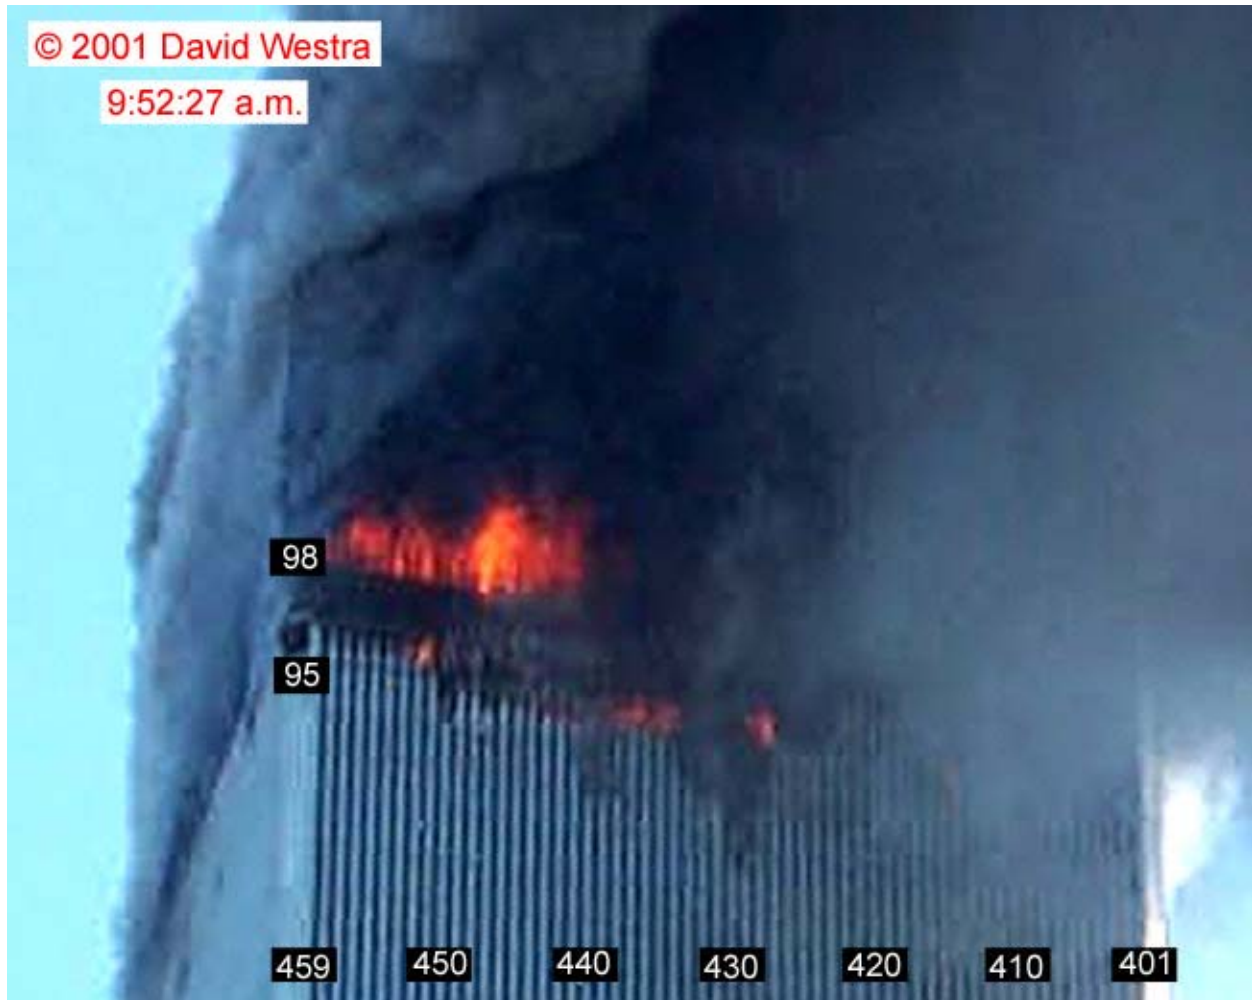
Figure 8–64 shows a long-distance view of the south face taken at 9:52:27 a.m., or roughly eight and a half minutes after Figure 8–63. Compared to the earlier time, fire intensities on floors 95 to 98 have decreased markedly. The fire on the 98th floor is still burning vigorously, but does not seem to have moved significantly following its very rapid spread around 9:41 a.m. The fires on the 96th and 97th floors are much less intense than observed earlier, being evident at only limited locations on the west side of the face, with very little flame extension. While the intensity of the fire on the 95th floor has decreased, there are still relatively intense flames near the center of the face. Flames are evident just to the east of the area where the panel section is missing, i.e. near windows 95-327 and 95-328.

Even though it has been over an hour since the aircraft struck WTC 1, the majority of flames observed on the south face are still present to the left, i.e., west, of column 330. However, unlike earlier times, there are indications that fires have begun to burn in the southeast quadrant of the tower. There appears to be a small fire visible near window 94-315 in Figure 8-64. In another photograph, taken at roughly the same time, flames with a similar intensity are visible at window 94-314. Figure 8-65 provides a view of the south face at 9:53:47 a.m. taken from the southwest. While flames are not apparent in this area of the 94th floor from this angle, smoke is visible coming from at least two locations on the 94th floor to the

east of the center. Window glass appears to be missing in other nearby windows. Taken together, these observations suggest that a relatively low intensity fire is present at this time on the 94th floor on the east side of the south face.

**Figure 8-64.** This cropped photograph shows the south face of WTC 1 at 9:52:27 a.m. The intensity levels have been adjusted and column and floor numbers have been added.

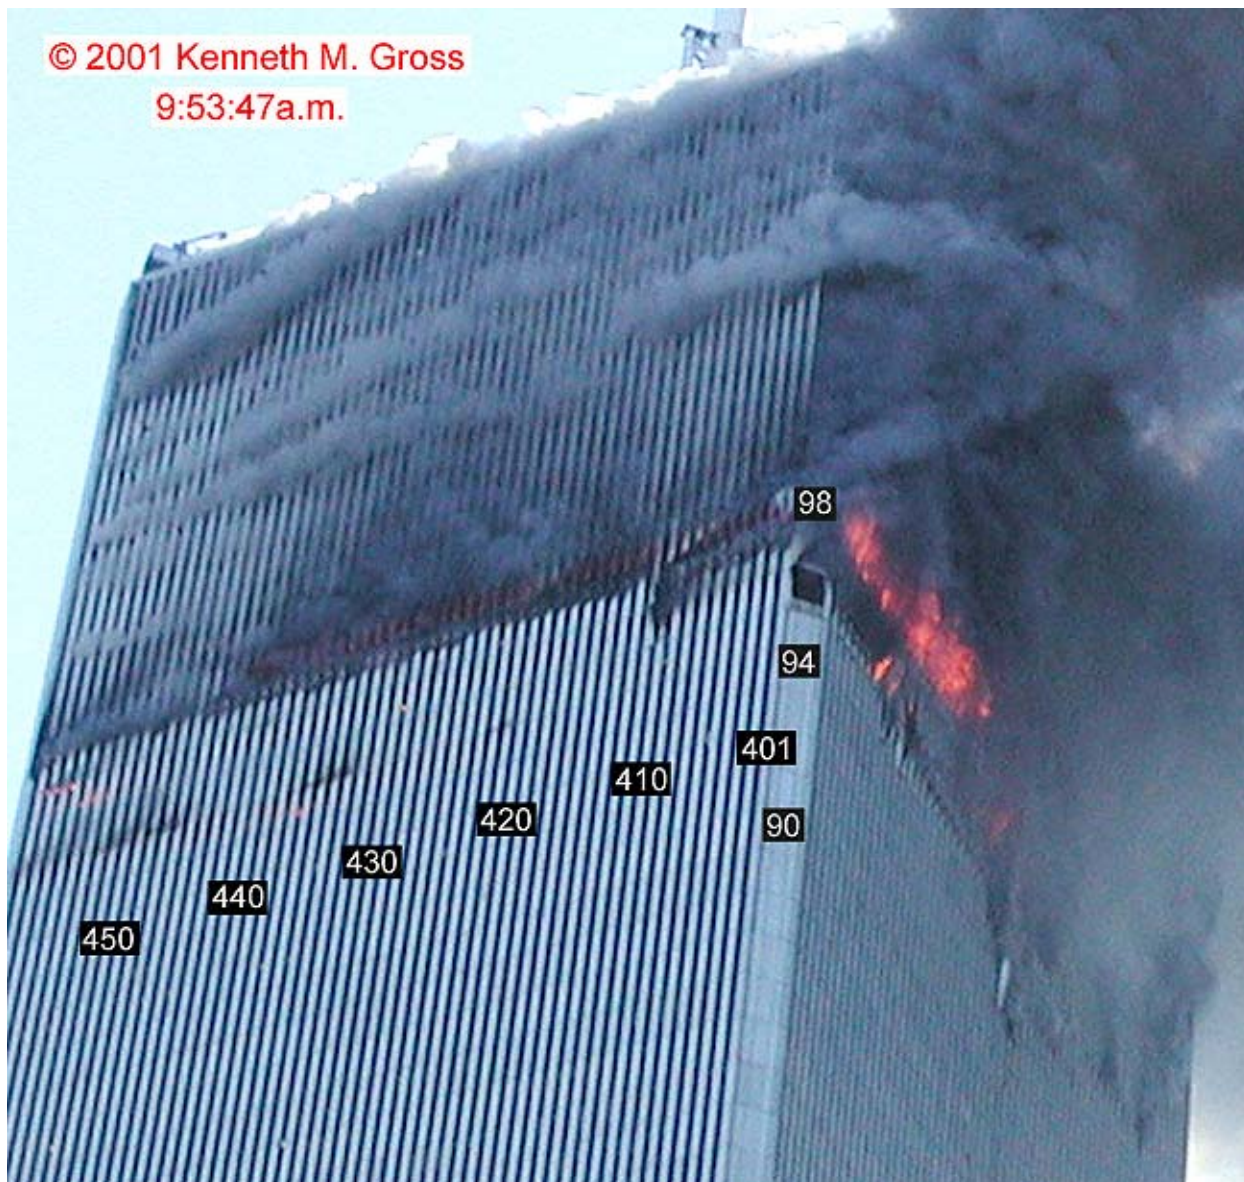
In Figure 8–65 there are indications of smoke coming from windows on the 93rd floor just to the right of the area where the panel section is believed to be missing. Higher floors on the east side are partially obscured by smoke, but there are no indications of intense fires or heavy smoke on this side for levels above the 94th floor. This figure provides a good qualitative indication of the relative intensity of the recently developed fire on the 98th floor as compared to the fires that had been burning longer on the 95th to 97th floors.

**Figure 8-65.** A photograph shot from the southwest shows the west and south faces of WTC 1 at 9:53:47 a.m. The original image has been cropped and enhanced. Column numbers for the west face and floor numbers have been added.

Fires are visible on the west face of the 94th floor in Figure 8–65. The smoke marks at the tops of the covers for columns 94-121 and 94-122 are distinct, indicating that the fire has opened windows in the room with walls at columns 94-421 and 94-425 (see Figure B-3). The dark red glow of the fire on the 98th floor that extends north from the south edge of the west face is also visible in Figure 8–65. This particular photograph provides a graphic illustration of the differences in burning behavior observed on the west and south faces for fires on this floor. Compare the intense flames extending from multiple windows of the 98th floor on the south face with the red glow present on the west face.

The fires on the 98th floor reinforced the trend in which fires burning on the north and west faces of WTC 1 appeared to burn with lower intensity, e.g., without generating external flames or large quantities of smoke, while fires on the east and south faces often appeared to be much more intense. Figure 8-65 shows a particularly striking example of this behavior.

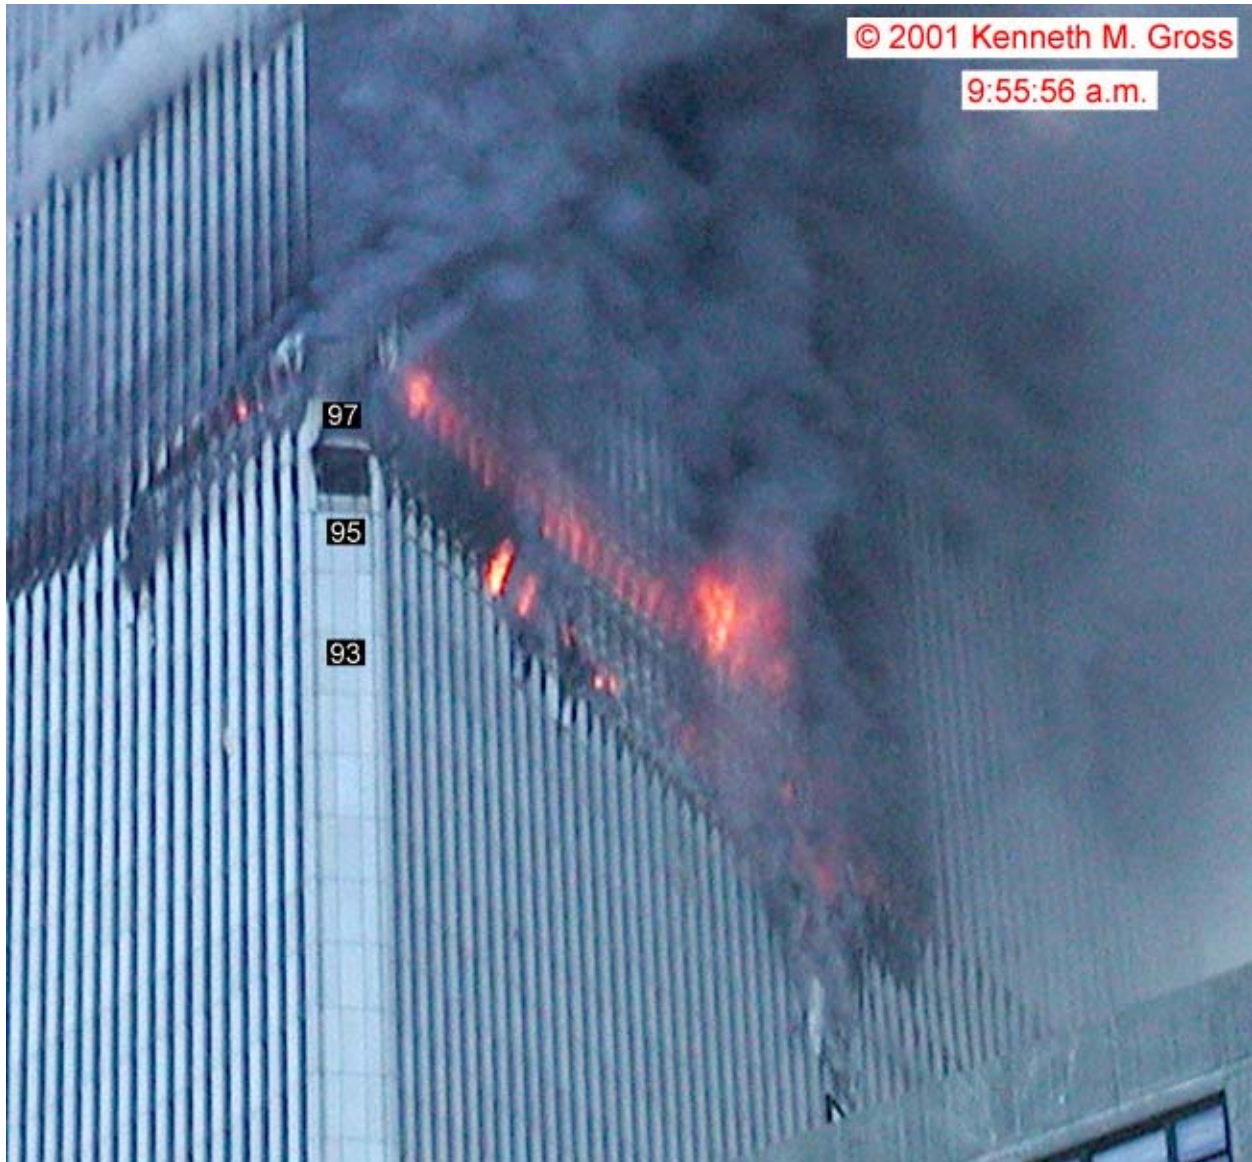
As seen by comparing Figure 8–65 and Figure 8–66, which was taken at 9:55:56 a.m., the intensity of the fire on the west side of the 98th floor decreased rapidly over the next two minutes. Even though bright fires are still evident, the flames have receded back into the building at most windows. In Figure 8–66, it

is clear that intense flames are present over several floors in the area at the center of the face where the panel section is likely missing.

**Figure 8-66. A photograph shot from the southwest shows the west and south faces of WTC 1 at 9:55:56 a.m. The original image has been cropped and enhanced. Floor numbers have been added.**

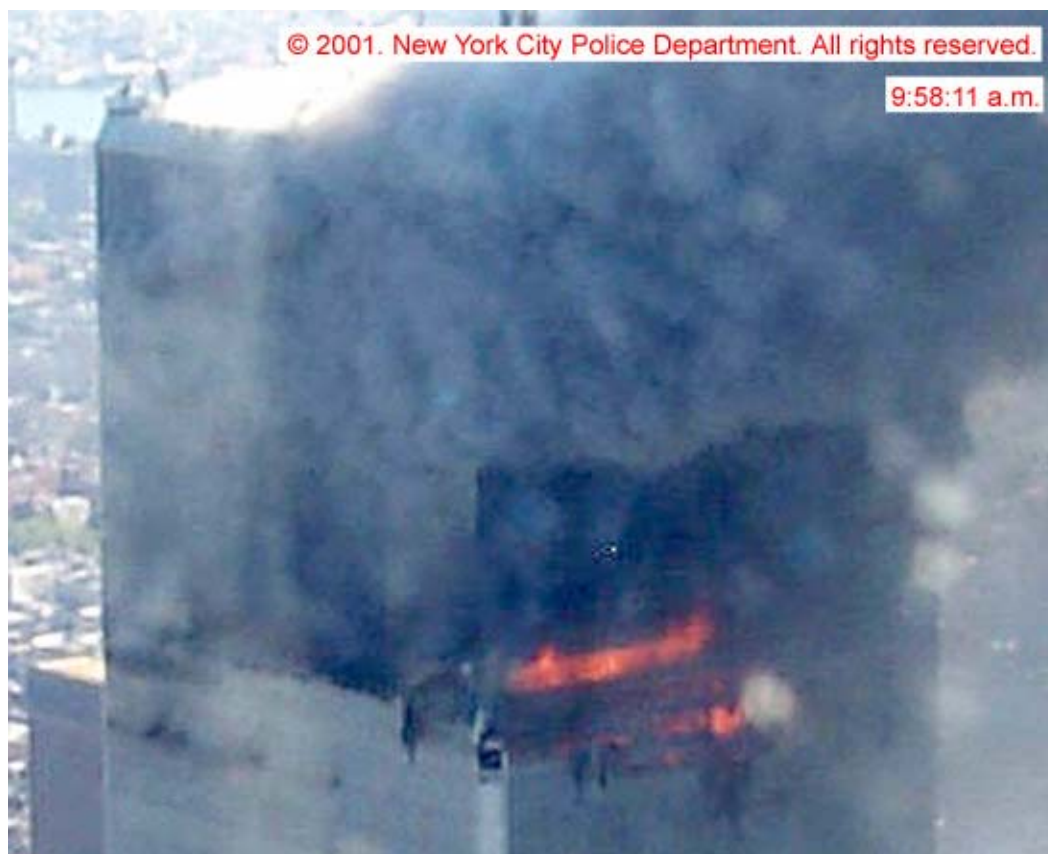
An image of WTC 1, taken roughly a minute prior to the collapse of WTC 2, is shown in Figure 8–67. This photograph was shot from a helicopter looking down on the southwest corner of the tower. The fire on the 98th floor of the south face continues to burn intensely at this time, with limited flame extension from windows. Fires present on the 95th to 97th floors have continued to decrease in size, with one exception. On the 96th floor long flames extend from the area near the center of the south face where the panel section is believed to be missing. From this angle there is no indication of flames on the eastern side of the face.

**Figure 8-67. This cropped photograph showing the southwest corner of WTC 1 was shot from a helicopter around 9:58:11 a.m. The time has an uncertainty of 30 s. The original image has been cropped and enhanced.**

The photograph shot from a helicopter shown in Figure 8–67 was taken less than a minute before the collapse of WTC 2. The appearance of the west face of WTC 1 at this oblique angle is consistent with the fire distributions described above.

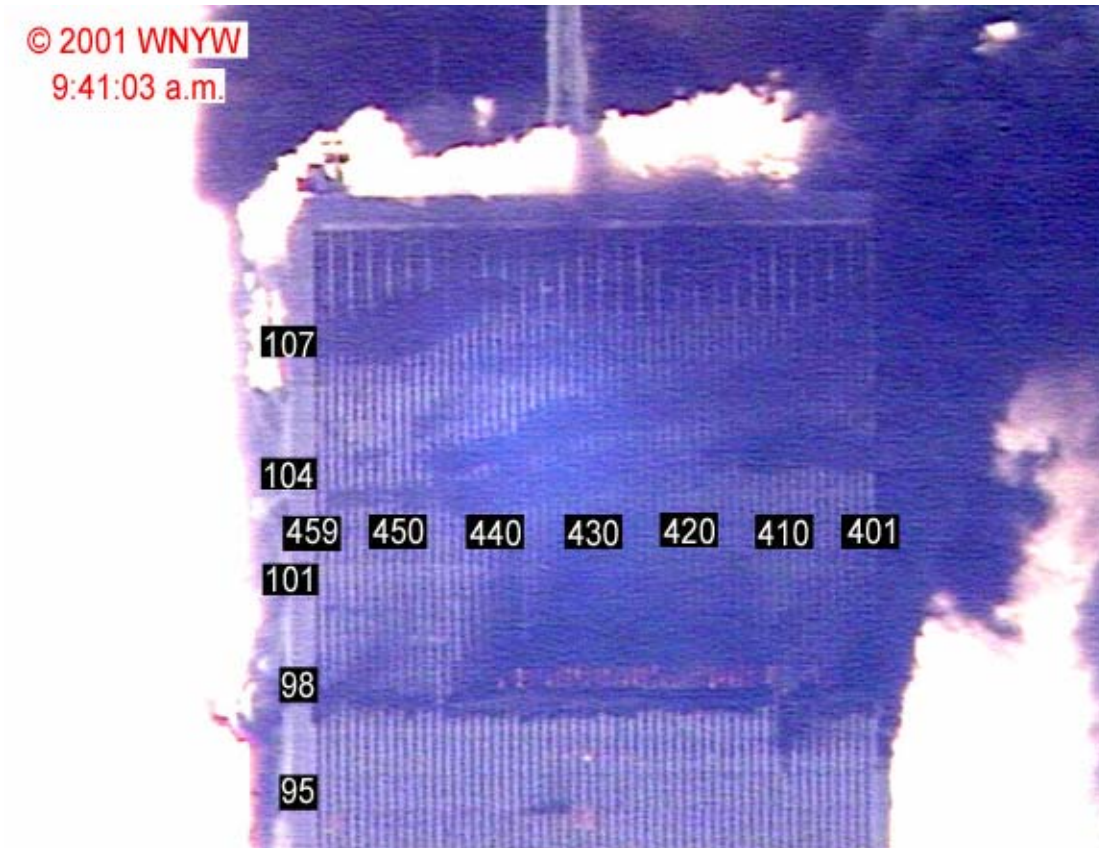
The relative amounts of fire visible on the various floors for the west face of WTC 1 during this period were much less than observed on the other faces. Nonetheless, as will be shown, there were indications of considerable fire movement during this time. In Figure 8-49, which was taken from a helicopter at 9:34:48 a.m., only low-level flames were apparent, primarily on the 96th floor. Figure 8-68 shows a similar image taken at 9:41:03 a.m. The areas where fires are observed have increased dramatically.

Fires are now visible near the center of the 94th floor just to the right of the black mark at the top of the columns covers, which starts at column 94-433, and very close to the north edge of the face. Flames are

also present on the 96th floor near the center of the face. This fire has apparently continued its movement to the north, since at 9:34:48 a.m. its northern edge appeared to be near window 96-426, and it can now be seen at least as far as window 96-433. While the flames are not completely visible in the frozen frame shown in Figure 8–68, by reviewing the video it is apparent that this low-intensity fire covers at least thirteen windows.

**Figure 8-68.** This image of the west face of WTC 1 is a frame captured from a video recorded by a news helicopter at 9:41:03 a.m. The image has been enhanced by adjusting the intensity range, and areas to the left and right of the tower are saturated. Column and floor numbers have been added.

The most dramatic change in the fire distribution is on the 98th floor. At the earlier time there was no indication of fire on the west side of this floor, while in Figure 8–68 flames can be seen over a length running from the south edge of the face to at least window 98-440. From the available imagery, it has proven difficult to determine precisely when this fire appeared, but a review of helicopter video suggests it occurred between 9:38:10 a.m. and 9:39:05 a.m. Given the low intensity of the fire, such apparent rapid fire spread is difficult to understand.

The development of the fire visible in Figure 8–68 on the 94th floor near window 94-430 was sudden. A video shot from a helicopter shows that it appeared at 9:39:08 a.m. The observations of falling people summarized in Appendix M also suggest that fire reached the area shortly after 9:35 a.m. At 9:38:37 a.m. a person was observed falling from this floor near the center of the face. During the next 97 s, at least six more people fell from the same vicinity. Appendix M lists the windows from which some of these people fell. The windows were either 94-435 or 94-437. There was an additional person who came from this

The floor plan layout for the 94th floor in Figure B-3 shows that there were a series of rooms located along the west face. It indicates that window 94-433 was in a room with walls located at columns 94-430 and 94-434, and windows 94-434 to 94-437 were in a second room with walls at columns 94-434 and 94-438. Recall that the glass in windows 94-434 to 94-437 was broken out shortly after 9:00 a.m. and that light smoke was later observed coming from these windows. This smoke flow explains the black band across the tops of the covers for columns 94-433 to 94-437, evident in Figure 8-68.

The other area of fire visible on the 94th floor at the north edge of the west face in Figure 8-68 also appeared abruptly. The video, shot from a helicopter, shows that fire first became visible in window 94-457 at 9:39:54 a.m. This window was located in the northwest corner room, with walls terminating at columns 94-106 and 94-454 (see Figure B-3). Recall that the first visual evidence for fire in this room from the north was at 9:39:51 a.m. The evidence suggests that windows opened on the north and west sides of the room nearly simultaneously, indicating that flashover occurred in the room at this time.

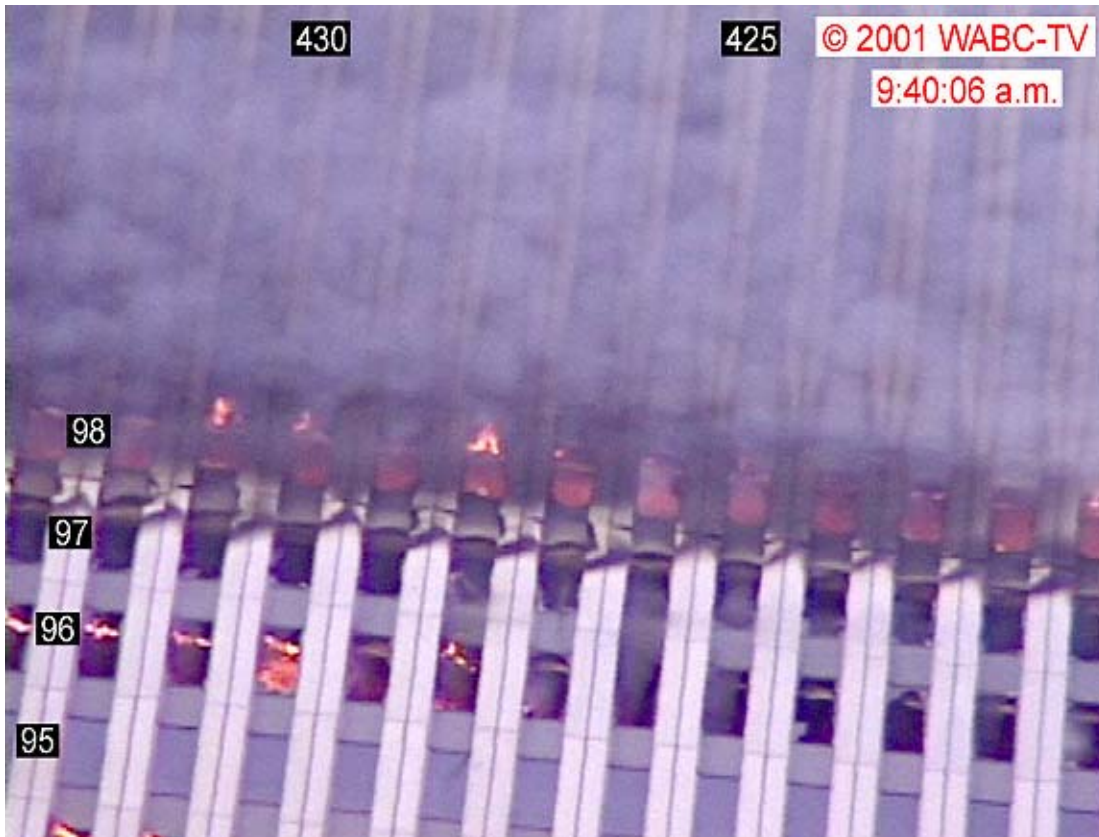
The amount of close-up visual material of the west face is relatively limited, but a close-up video was shot around 9:40 a.m. from just across West Street that provides details concerning the fires and conditions of windows. Figure 8-69 shows a frame captured from this video that was recorded at 9:40:06 a.m. At this time every window visible (windows numbered 420 to 432) on the 96th, 97th, and 98th floors is open, while the glass appears to be intact on the 95th floor and floors above the 98th.

On the 98th floor, a red glow is present in all of the windows, indicating that a fire is burning away from, but near the windows. This is consistent with the appearance of the fires on this floor in Figure 8-68, which was recorded a short time after Figure 8-69. Flames are visible at the tops of several of the windows, particularly windows 98-427, 98-429, and 98-430. It is clear that the flames are positioned just inside of the open windows near the tops of the window frames. The burning material appears to be located on the tops of plates that are hanging down from above. Several of these plates are also visible in windows on the 96th and 98th floors in windows where flames at the tops of windows are not present. It is likely that the plates are actually hanging aluminum head casings (see the discussion in Section 4.2.2) that have dropped down from above the windows as the result of heating. These observations provide additional visual evidence that the burning areas that were frequently observed at the tops of open windows were due to burning polyurethane that was exposed when the aluminum head casings located just inside the tops of the windows at the ceiling dropped down.

There is no indication of active fire on the 97th floor in the video frame. However, the presence of carets at the tops of the aluminum column covers attests to the intensity of the fires that burned on this floor earlier. On some of the columns, portions of the aluminum column covers near the tops of windows appear to have melted.

**Figure 8-69.** This close up view of the west face of WTC 1 was captured from a video recorded at 9:40:06 a.m. It has been enhanced by adjusting the intensity levels. Column and floors numbers have been added.

Even though fires are clearly present on the 96th floor in the vicinity of the windows at 9:40:06 a.m., they appear to be burning with low intensity. This is consistent with videos shot from helicopters that showed that the fires on this floor were visible intermittently and were located close to the floor. With the exception of the fires at the tops of the windows, flames fill only one opening, window 96-429, and there are no indications of flames coming from the windows. There is very little smoke flowing from this floor, and there are no smoke marks at the tops of the column covers.

In the lower left-hand corner of Figure 8–69, flames can just be seen at the tops of windows 94-430 and 94-431 on the 94th floor. These flames appear to be due to burning thermal insulation, similar to the fires visible on the 96th and 98th floors.

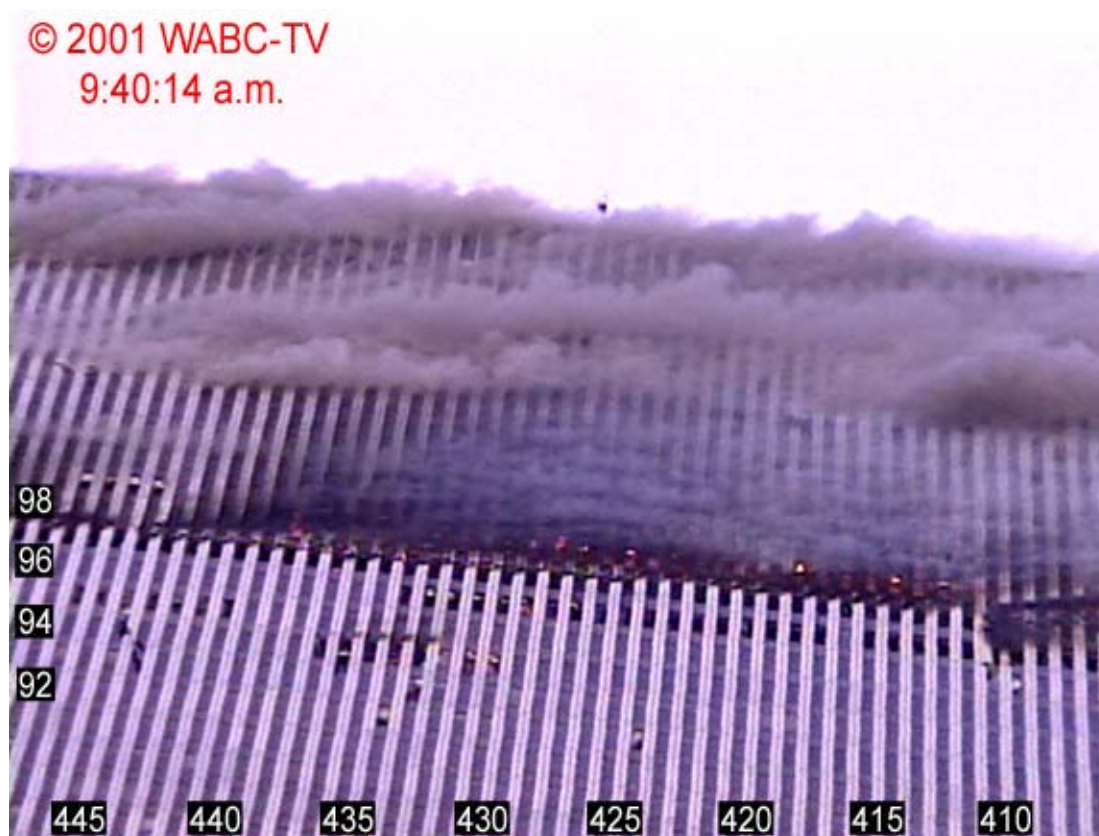
Shortly after the video frame in Figure 8–69 was recorded, the camera zoomed out and revealed a larger area of the west face. Figure 8–70 shows a captured frame from this video recorded at 9:40:14 a.m. The image provides sufficient detail to determine whether windows are open or closed. On the 94th floor the only windows in the image that are open are windows 94-430, 94-431, and 94-433 through 94-437. Fires burning at the tops of windows 94-430 and 94-431 can be seen, along with an orange flame in window 94-434. This image was recorded during the period that people were observed falling and climbing down from windows 94-433 to 94-437. The presence of flames in the immediate vicinity suggests that the people had no other means of escape from the spreading fire.

With one exception, window 96-416, all of the windows on the 96th floor as far north as window 96-434 are open. Light flames are visible at the tops of several of the windows, and flames are present in window 96-429. Despite the fact that these windows have apparently been opened by nearby fires on this floor, there is very little or no smoke coming from any of the windows, and, with the exception of column covers near the south end of the floor, the covers are unmarked.

There are no flames evident in the open windows across the entire extent of the 97th floor visible in Figure 8–70. The carets and smoke marks on the column covers near the tops of the windows on this floor contrast sharply with the appearance of the column covers next to the tops of the 96th floor windows.

**Figure 8-70.** This view of the west face of WTC 1 was captured from a video recorded at 9:40:14 a.m. It has been enhanced by adjusting the intensity levels, and some locations above the building are saturated. Column and floors numbers have been added.

The expanded view of Figure 8–70 shows that fire is visible on the 98th floor from roughly window 98-411 to window 98-439. Further to the north, the window glass appears to be intact. Bright fires are present at the tops of several of the open windows. Larger flames are also present in windows 98-428 and 98-439. Even so, compared to the intense burning observed on the other faces of the tower, these fires appear to be burning relatively gently at this time.

The smoke flows coming from some of the open windows above the 98th floor are quite heavy. At other open windows relatively little smoke is present. The four open windows on the 99th floor, windows 99-445 to 99-448, are an example of the latter behavior.

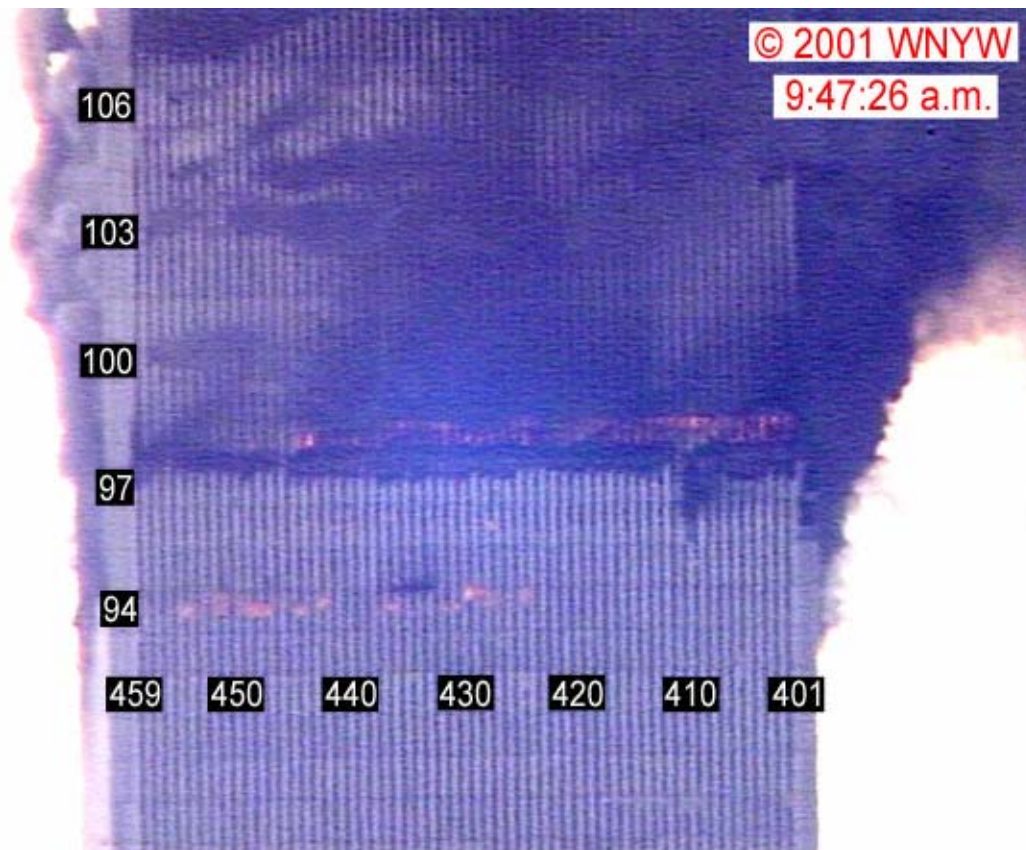
Another view of the west face taken from a video recorded from a news helicopter at 9:47:46 a.m. is shown in Figure 8–71. Since 9:41:03 a.m. (compare with Figure 8–68), the fires on the 94th floor have continued to spread; now appearing at several different locations ranging from the north edge of the face to window 94-425. By comparing the fire locations with the floor plan layout shown in Figure B-3, it is discovered that fires have entered seven of the eight rooms located along the west face, running from the north edge to as far south as column 94-425. The one exception is the room with walls at columns 94-438 and 94-442. Even though the fire area is extensive, the flames are not very vigorous. There is no apparent external flaming, and no smoke is visible coming from the windows.

**Figure 8-71.** This image of the west face of WTC 1 is a frame captured from a video recorded by a news helicopter at 9:47:26 a.m. The image has been enhanced by adjusting the intensity range, and areas to the left and right of the tower are saturated. Column and floor numbers have been added.

Small fires are still evident on the 96th floor. In the video the flames appear intermittently over a range of windows that reaches as far north as window 96-441. As at the earlier time, there is no smoke or flame coming from the windows.

The fire on the 98th floor has continued to spread north. It now extends from the south edge continuously to at least window 98-444. From this distance, the fire still appears to be located away from the west wall. There is little indication of fire or smoke coming from the windows on this floor.

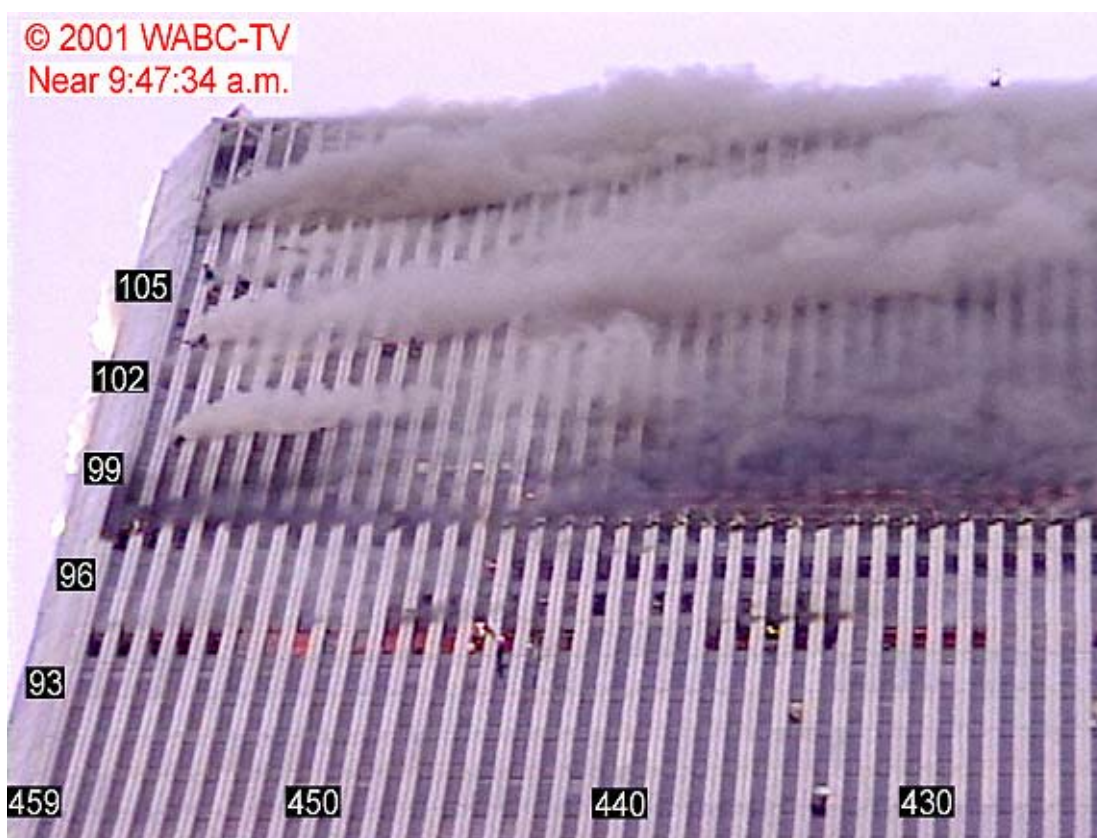
A much closer view of the north side of the west face recorded at roughly the same time as Figure 8–71 is shown in Figure 8–72. Even though this image is assigned a time of 9:47:34 a.m., there is an associated uncertainty of 30 s. The closer image provides confirmation of many of the conclusions drawn from Figure 8–71. On the 94th floor fire is visible at many of the windows, and a number are open from window 94-424 to window 94-459. The glass panes between windows 94-438 and 94-442 are indeed in place, with no indication of fire in the room located between these columns (see Figure B-3). The five windows along the west face in the northeast corner room are open. The adjacent room to the south has walls at columns 94-450 and 94-454 (Figure B-3). The fire is apparently just growing in this room since flames are visible, but three of the four windows are in place. Flames are visible, and most of the windows are missing for the next two rooms to the south. Window 94-424 is open, but the panes are still in place in nearby windows. This indicates that the observed fire has moved one room further south since 9:41:03 a.m.

**Figure 8-72.** This view of the west face of WTC 1 was captured from a video recorded at 9:47:34 a.m. There is a 30 s uncertainty in the assigned time. The image has been enhanced by adjusting the intensity levels, and some locations above the building are saturated. Column and floors numbers have been added.

On the 95th floor, two additional windows (95-438 and 95-439) have opened since 9:40:14 a.m. Since there is still no indication of fire in this area, it is possible that people have broken out the glass. Very

little fire is visible on the 96th floor, but there is an area of flame at the top of window 96-447. Windows to the north of this location are still in place. The northern advance of the fire on the 98th floor has reached roughly the same location. Fire is visible at the top of window 98-444, and window 98-445 appears to be open. A deep red glow on this floor from the windows that are open indicates that burning areas continue to be located well away from the windows.

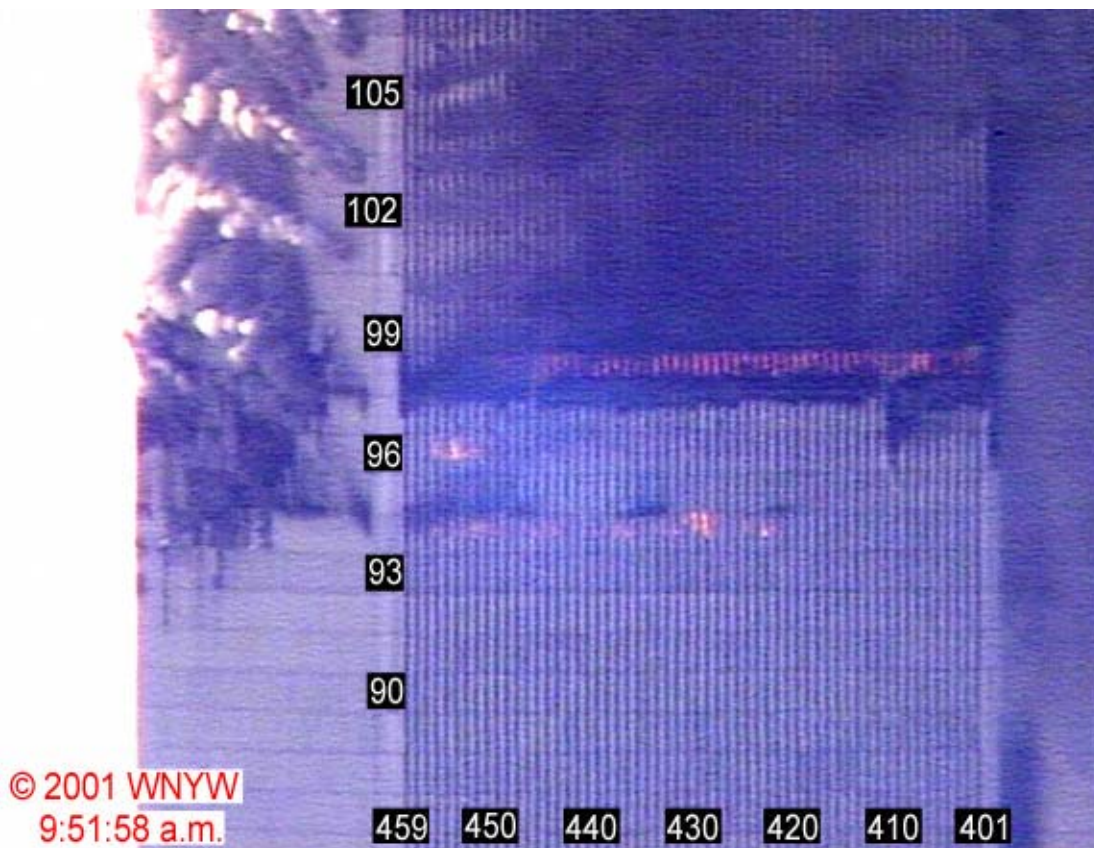
Another frame taken from a video shot from a helicopter at 9:51:58 a.m. is shown in Figure 8–73. Fire development on the west face has continued. The largest differences as compared to Figure 8–71, which was recorded at 9:47:26 a.m., are the appearance of fire at multiple windows on the 96th floor near the north edge of the west face and the spread of the fire toward the south on the 94th floor. It has not been possible to determine exactly when the fire at the north edge of the 96th floor appeared, but it was between 9:50:09 a.m. and 9:51:19 a.m. The flames are visible in windows 96-453 to 96-455. The floor plan layout in Figure B-5 indicates that these windows were inside a room with internal walls at columns 96-452 and 96-456. Fire is not yet visible from windows in the room on the northeast corner with walls at columns 96-456 and 96-108. On the 94th floor flames are now visible in windows 94-423 and 94-424. This indicates that a fire was growing within the room with walls located at columns 94-421 and 94-425. (see Figure B-3) The appearance of the fire on the 98th floor did not change dramatically over the four and a half minute period between the images.

**Figure 8-73.** This image of the north and west faces of WTC 1 is a frame captured from a video recorded by a news helicopter at 9:51:58 a.m. The image has been enhanced by adjusting the intensity range, and areas to the left of the tower are saturated. Column and floor numbers have been added.

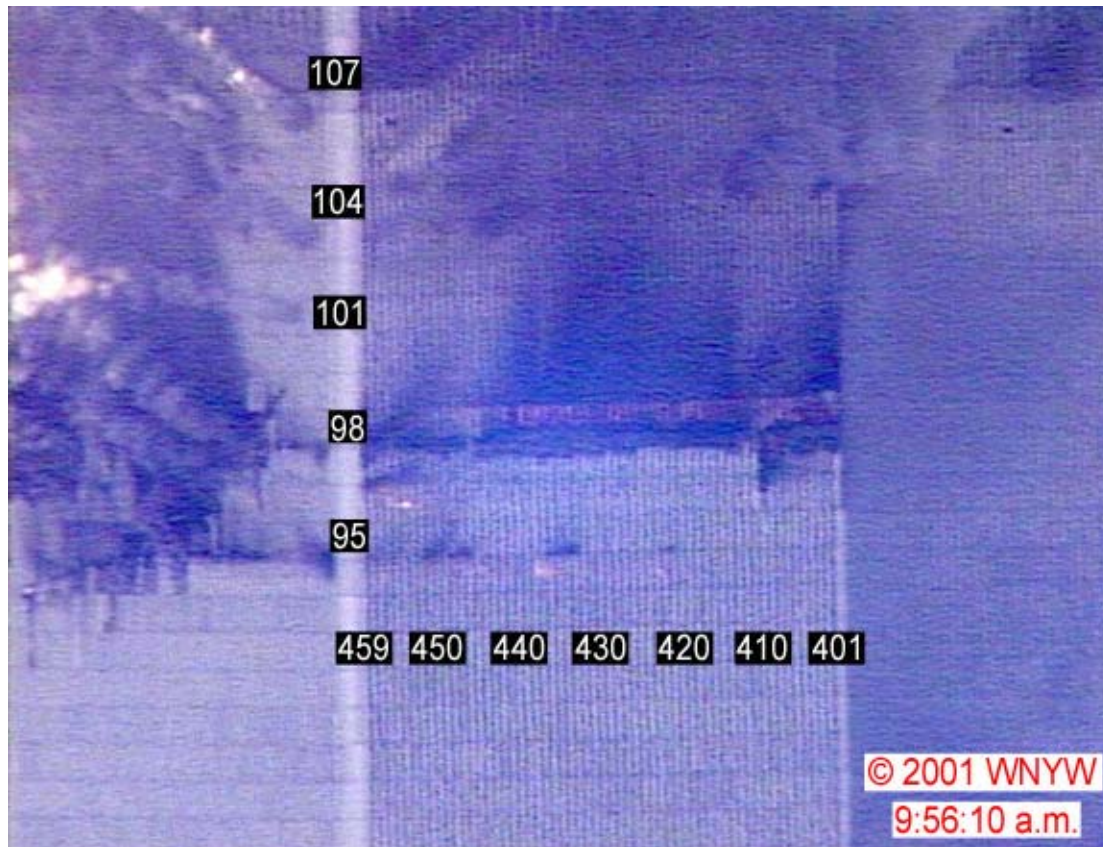
**Figure 8-74.** This image of the north and west faces of WTC 1 is a frame captured from a video recorded by a news helicopter at 9:56:10 a.m. The image has been enhanced by adjusting the intensity range. WTC 2 appears in the background to the right. Column and floor numbers have been added to WTC 1.

Figure 8-89 shows an image of the west face shot from a news helicopter at 10:01:30 a.m. The flames on the 104th floor are coming from several windows centered near window 104-411. Heavy black smoke is venting from multiple windows over a much larger area. It is informative to compare the appearance of the smoke in Figure 8-89 with that in Figure 8-74, which shows the west face at 9:56:10 a.m. The smoke has clearly become much heavier and darker.

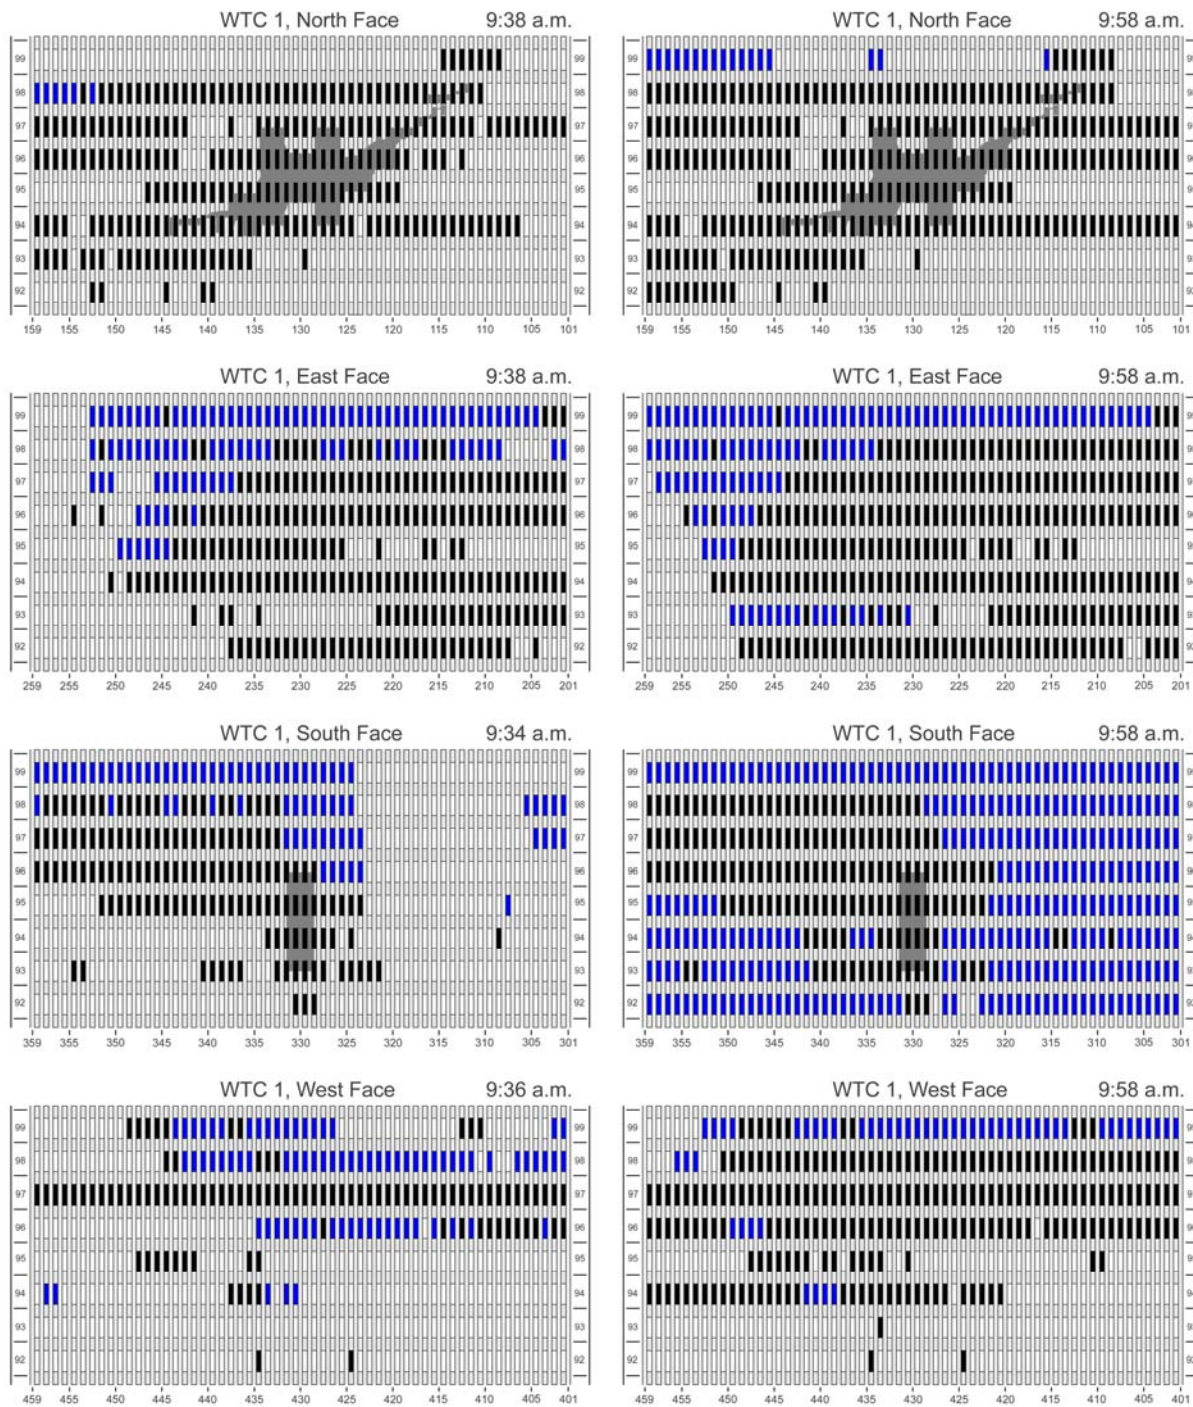
Observed window conditions for the four tower faces at the beginning and end of the period are compared in Figure 8–75. The windows that opened during the period, which generally implies the presence of an active fire, are consistent with the fire-spread observations discussed above. On the north face, windows opened along a long length of the 98th floor and near the eastern edge of the 92nd floor. The growth of the large fire on the east side of the 98th floor is reflected in the large increase in open windows at the later time. On the other floors the fires on the east face appear to be moving relatively deliberately toward the south, but note the large increase in the number of open windows on the 92nd floor. Windows also opened on the east side of the 92nd floor near the north edge. The maps for the south face are consistent with observations that major fire growth during the period was on the 95th and 98th floors. There was evidence of a small fire on the east side of the south face on the 94th floor, but in general, the fires on the south face still have not moved in this direction much beyond the center of the face. Note that most of the windows on the eastern side of the face at the later time are marked as not visible. This is because the imagery available does not allow the conditions of these windows to be assessed. The imagery does indicate that there was no significant smoke or fire coming from windows on the fire floors above the 94th floor. By far, the largest changes in window condition during the period were on the west face. Large numbers of windows have been opened on the 94th, 96th, and 98th floors. These changes are even more remarkable when the nature of the fires, which generally appeared to be gently burning, is recalled.

**Figure 8-75. Maps for the 92nd through the 99th floors compare missing window glass for the four faces of WTC 1 at two times, around 9:35 a.m. and at 9:58 a.m. The color coding used for the maps is indicated in Figure 5-1.**

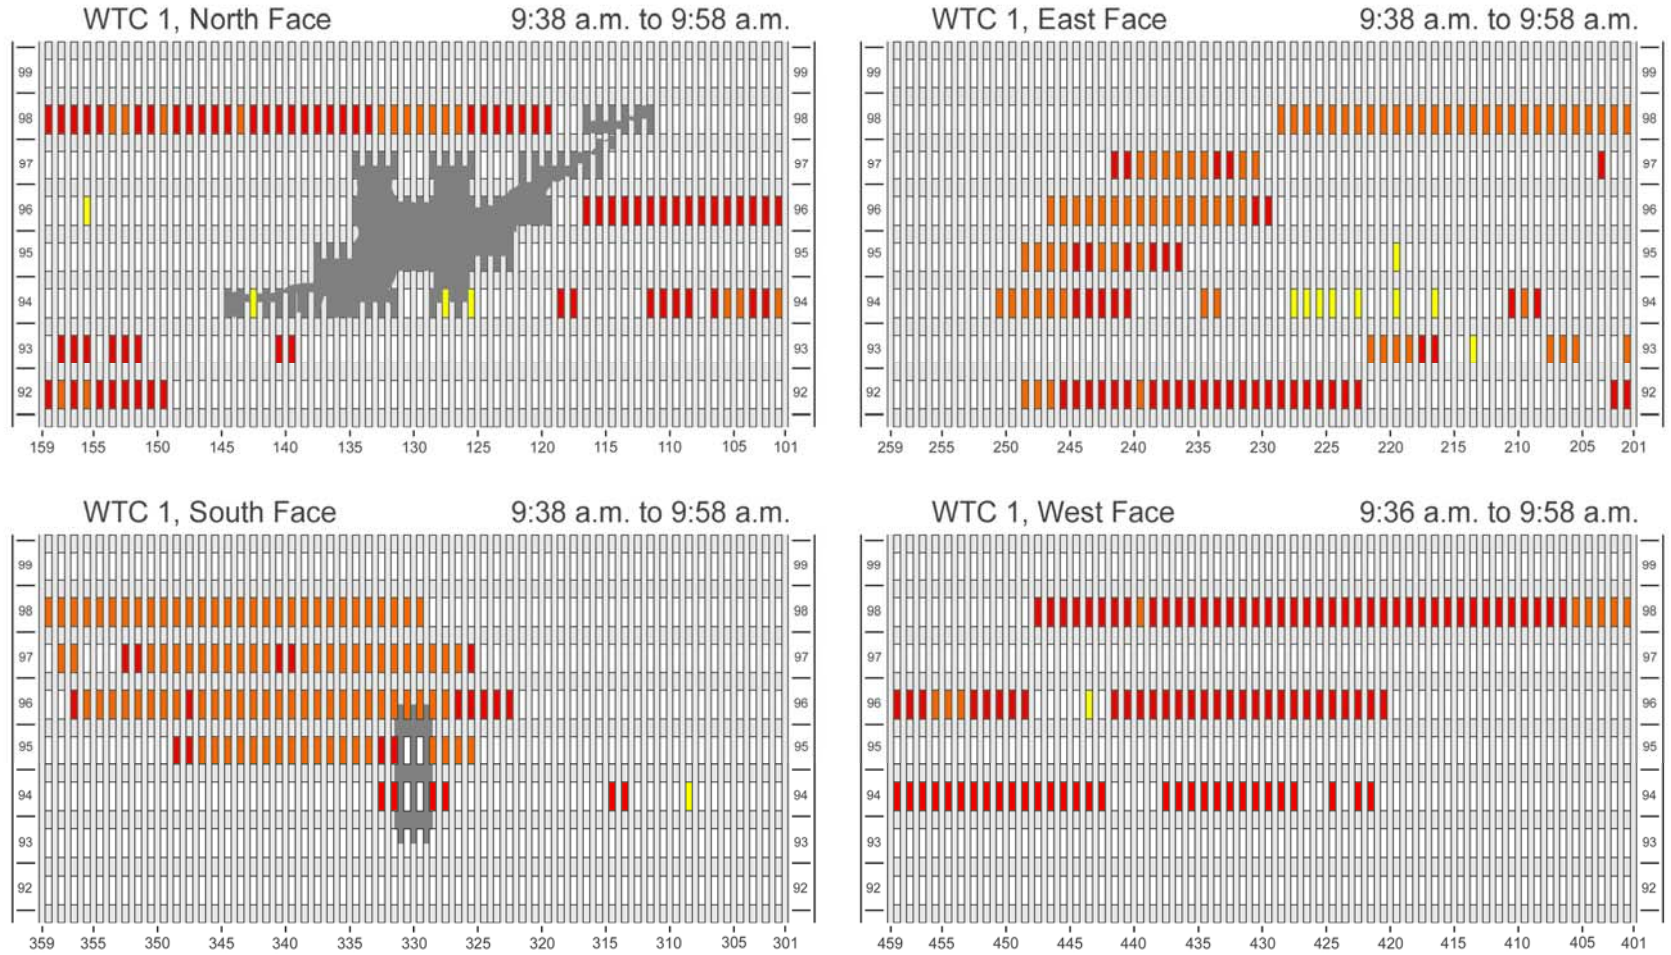
Maps of integrated fire behavior for the four tower faces for the period from 9:35 a.m. to 9:59 a.m. are shown in Figure 8–76. These maps can be compared with the corresponding versions in Figure 8–51 for 9:19 a.m. to 9:35 a.m. This comparison highlights the growth of fires on the north face across much of the 98th floor, on the 96th floor to the west of aircraft impact cavity, and on the 92nd floor near the east edge of the face. Other areas of fire that were identified during the earlier time period were no longer visible during the current period.

On the south face, the fire that appeared near the center of the western half near the end of the previous period continued to spread in both directions and filled in the length of windows between the western edge and center of the face. Extensive fires were still present on the western sides of the 95th through 97th floors, but these fires decreased in both extent and intensity during the period. Relatively small flames were observed briefly in three windows on the east side of the 94th floor.

The changes in the west face integrated fire distributions between the two periods mirror the large changes observed in the window maps. Areas of fire appeared along extensive lengths of the 94th and 98th floors during the period. At the same time, fires on the 96th floor completed their slow migration from the south edge of the 96th floor to the north edge. Fires that were visible on the 97th floor during the earlier periods had died down by the start of the current period.

The most distinctive change in the window condition and integrated fire maps between 9:35 a.m. and 9:59 a.m. was the wide-spread appearance of fire on the 98th floor. By roughly twenty minutes after a growing fire first became evident on the north side of the 98th floor, fire was visible on this floor in two long bands. One of these bands started near the center of the south face, ran to the southwest corner and extended north on the west face to at least window 98-444. The second band began near window 98-119 on the north face and ran around the northeast corner to the vicinity of window 98-223 on the east face. The observed fire behavior of these rapidly developing fires varied from face to face. On the east and south faces very intense flames were observed extending large distances from open windows, while on the west and north sides, the fires appeared much less intense and to be burning at interior locations removed from the outer walls. These observations are reflected in the integrated fire distribution maps shown in Figure 8–76.

**Figure 8-76. Maps of integrated fire observations between 9:36 a.m. and 9:59 a.m. are shown for the four faces of WTC 1. Colors represent the highest intensity fire observed in a window using the color scale defined in Figure 5-1.**
