**NIST NCSTAR 1-5A**

**Federal Building and Fire Safety Investigation of the  
World Trade Center Disaster**

# **Visual Evidence, Damage Estimates, and Timeline Analysis**

September 2005

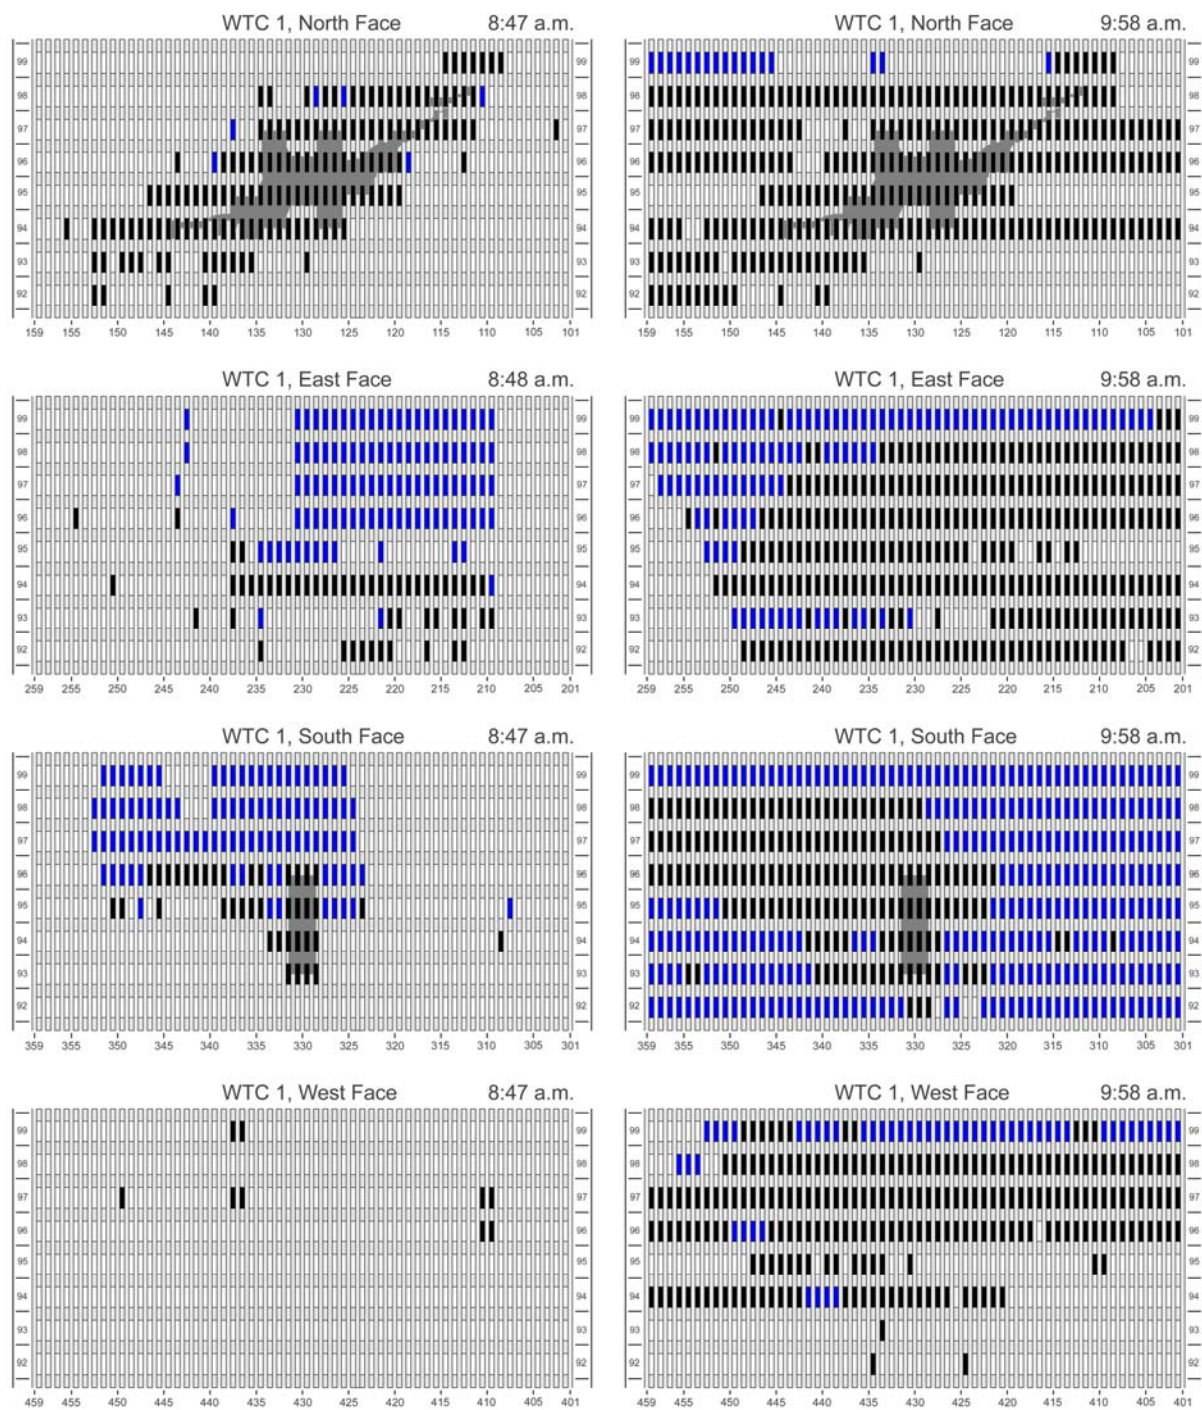
**Figure 8-77. Maps for the 92nd through the 99th floors compare missing window glass for the four faces of WTC 1 at two times, immediately following the aircraft impact on WTC 1 at 8:46:30 a.m. and just prior to the collapse of WTC 2 at 9:58:59 a.m. The color coding used for the maps is indicated in Figure 5-1.**

The changes in the number of open windows on the individual faces of WTC 1 are consistent with the observed fire behaviors. The largest increases were on the east and west faces. The façade maps in Figure 8–77 show how extensive the fire spread was on these faces during the period under consideration. There was also considerable fire spread observed on the north face, but the percentage increase in the number of open windows is smaller due to the large number of windows that were opened when the aircraft struck. The smallest increase in total open windows was for the south face. This reflects the fact that the fires did not migrate substantially into areas on the eastern side of this face during the 1 hr and 13 min period.

The total number of windows opened by the fire is remarkable. The number increased by nearly a factor of four as compared to the number of windows that were broken open immediately following the aircraft impact and subsequent fireballs. This represents an increased total open area of just over 8,300 ft<sup>2</sup>. This large area of open windows substantially increased the amount of outside air available for the fires. This suggests that there was a very strong interaction between the breaking open of the windows and the observed fire spread and growth behavior.

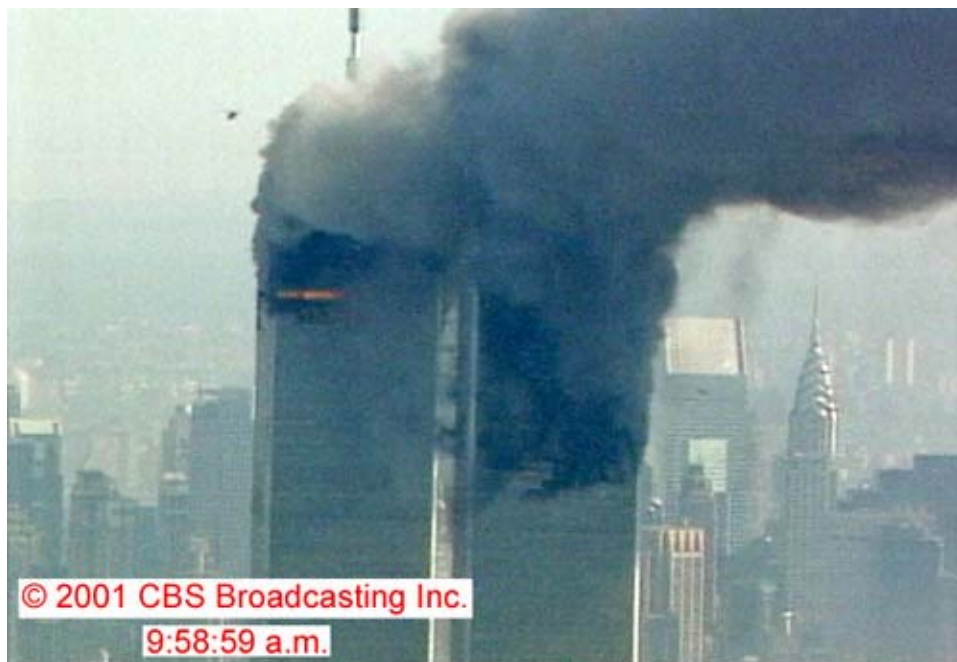
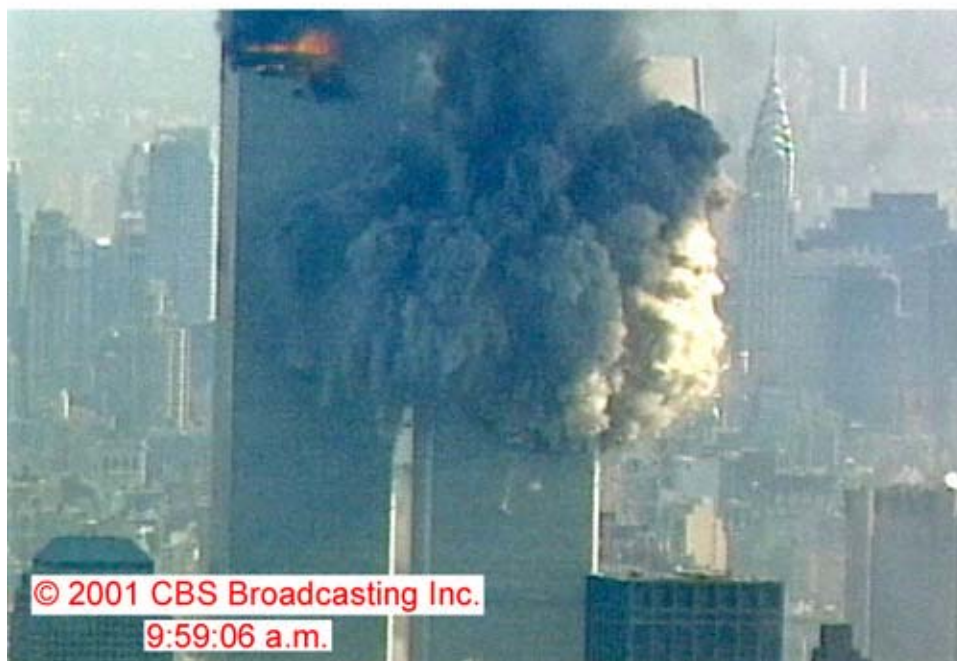
At 9:58:59 a.m. WTC 2 began to collapse, and roughly ten seconds later debris reached the ground. Very shortly after the collapse began, fire and smoke were pushed out of the south face of WTC 1. Figure 8–78 contains two frames taken from a video showing the south faces of the towers. The first frame was recorded just as WTC 2 began to collapse, and the second was shot seven seconds later. In both frames the fire burning on the 98th floor of WTC 1 is very distinct. At the earlier time there does not appear to be external flames, but in the second frame long flames extend from near the center of the face. Review of the video indicates that these flames were pushed out of WTC 1 starting four seconds after collapse initiation. Closer inspection shows that an area of flame is visible on the western side of the 96th floor at the later time that was not evident seven seconds earlier. It is significant that flames do not appear elsewhere on the face at the later time, perhaps indicating that large flames are only present near the periphery of the face at these locations.

**Figure 8-78. Two frames taken from a video shot from a news helicopter show the south face of WTC 1 just as WTC 2 starts to collapse at 9:58:59 a.m. and 7 seconds later. WTC 1 and WTC 2 are to the left and right, respectively. Images have been enhanced by adjusting the intensity levels.**

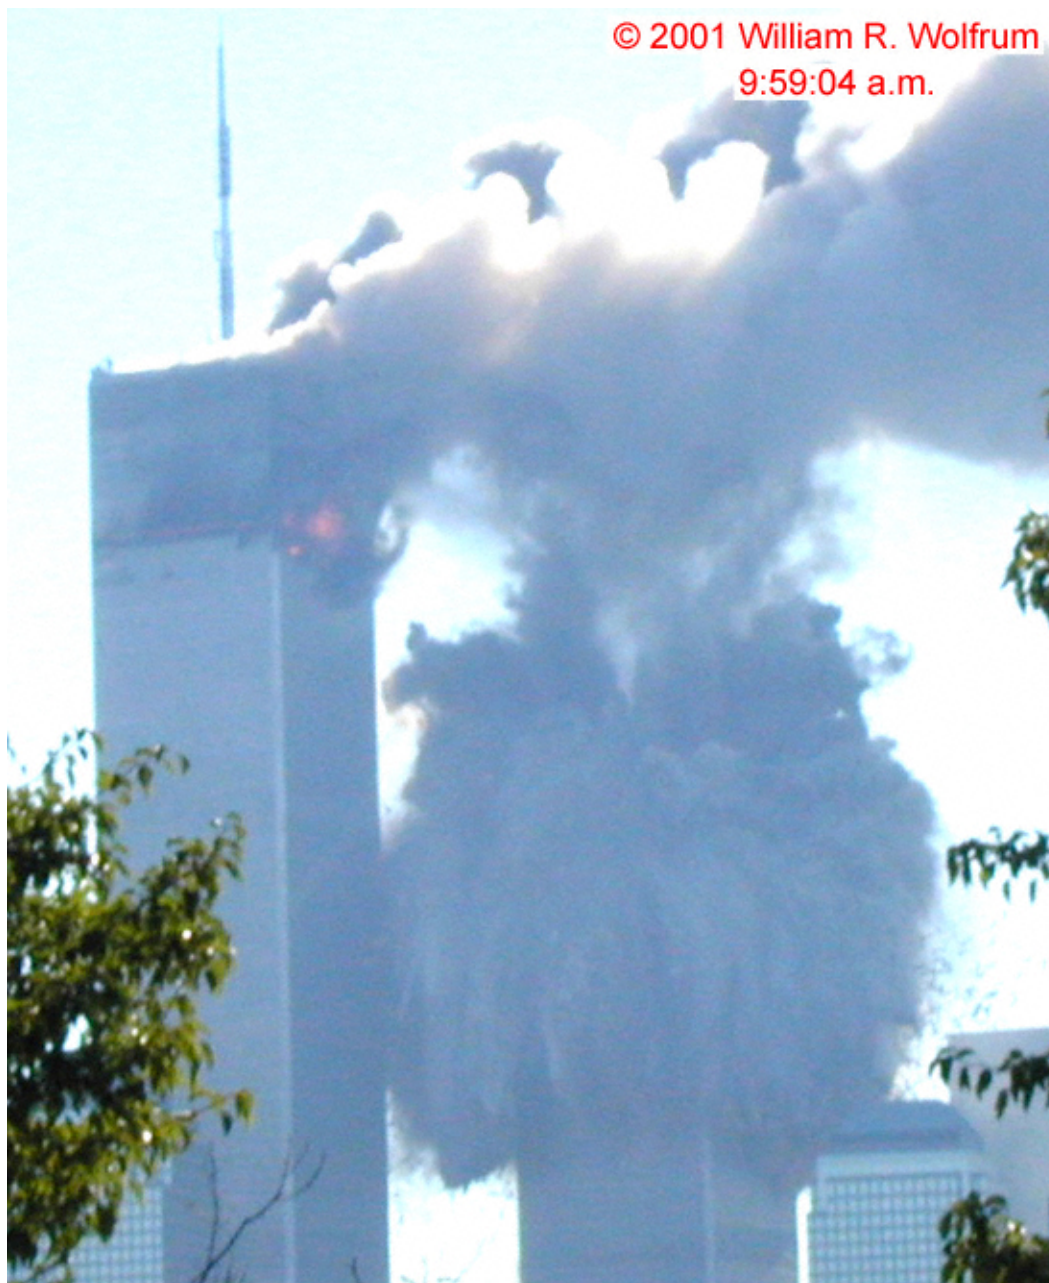
**Figure 8-79. This cropped photograph was shot from the southwest and shows WTC 1 and the collapsing WTC 2 at 9:59:04 a.m. The image was enhanced by adjusting the intensity levels, and some bright areas are saturated.**

Figure 8–79 includes a photograph that was shot at 9:59:04 a.m. and shows the flames coming out of the 98th floor windows while WTC 2 collapses nearby. Flames have also been pushed out of open windows on the 96th floor near the western edge of the south face. Fires are also visible on the west face of WTC 1 on the 94th, 96th, and 98th floors, but flames are not visible outside of the windows. In the photo it appears as if debris from WTC 2 is either striking WTC 1 or just passing by on the east side.

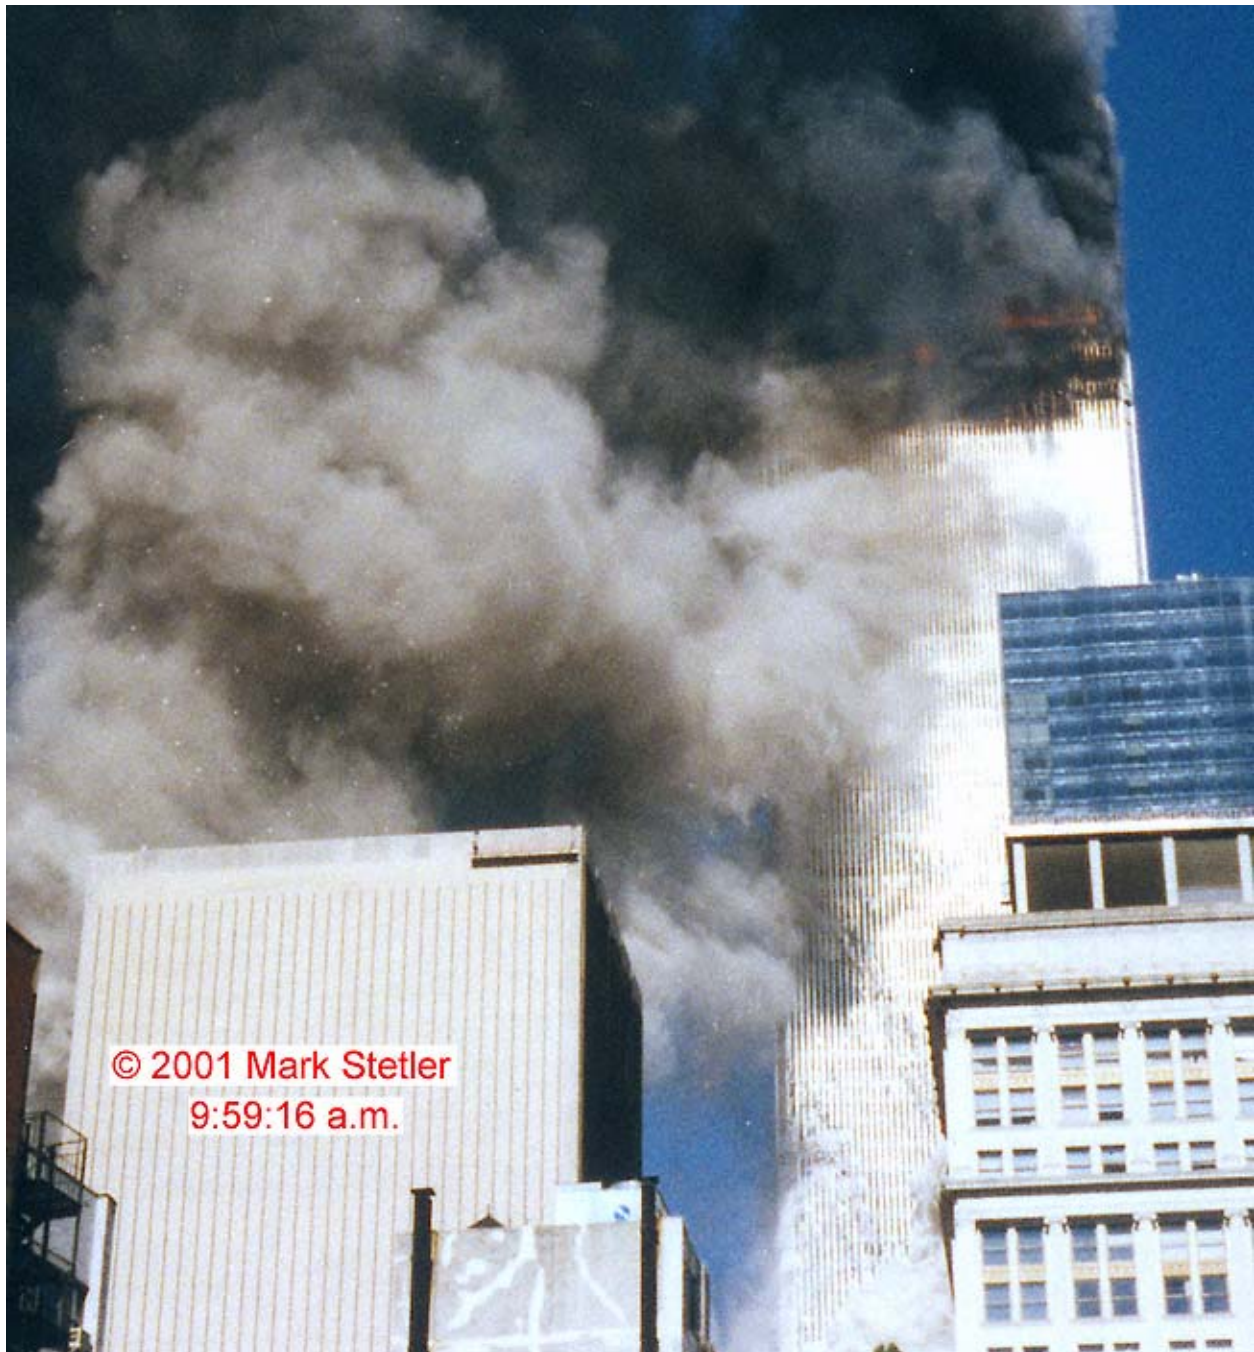
Videos shot from the east show that debris from WTC 2 did indeed pass in an arc across the east face of WTC 1. The damage created by this debris to the façade of WTC 1 can be seen in Figure 8–80 near the bottom of the photograph. This damage was only visible for a short period before dust rose upward from below and hid the area. The highest marks on the building are just below the mechanical equipment room on the 75th and 76th floors. The damage appears relatively superficial, and it is considered unlikely that it affected the subsequent fire behavior. Videos and eyewitness accounts indicate that large amounts of dust and some debris entered the lower floors of WTC 1 during the collapse of WTC 2. It is not known if damage at these lower locations could influence the fires near the top of the tower, but it seems unlikely.

**Figure 8-80.** This cropped photograph shows the east face of WTC 1 at 9:59:16 a.m., i.e., 17 s after WTC 2 began to collapse.

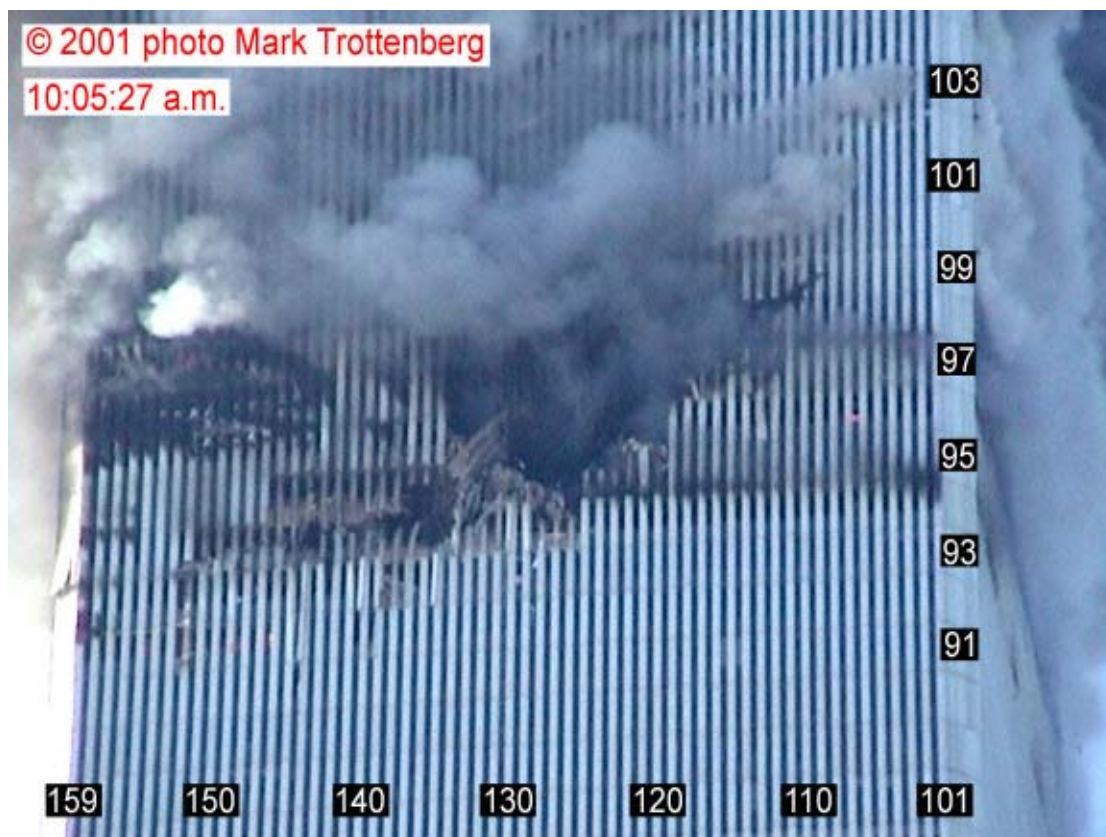
The most complete information during the current period is available for the north face of WTC 1. A view of this face at 10:05:27 a.m. is shown in Figure 8–81, which is a frame captured from a video. Remarkably little fire is visible in the image. Small flames are present near windows 92-146, 96-106, and 98-152. More extensive fires were evident at each of these locations at 9:57:59 a.m. (see Figure 8–55). Apparently, these fires had died down in the intervening seven and a half minutes.

**Figure 8-81.** This view of the north face of WTC 1 was captured from a video recorded at 10:05:27 a.m. The image has been enhanced by adjusting the intensity levels. Column and floor numbers have been added.

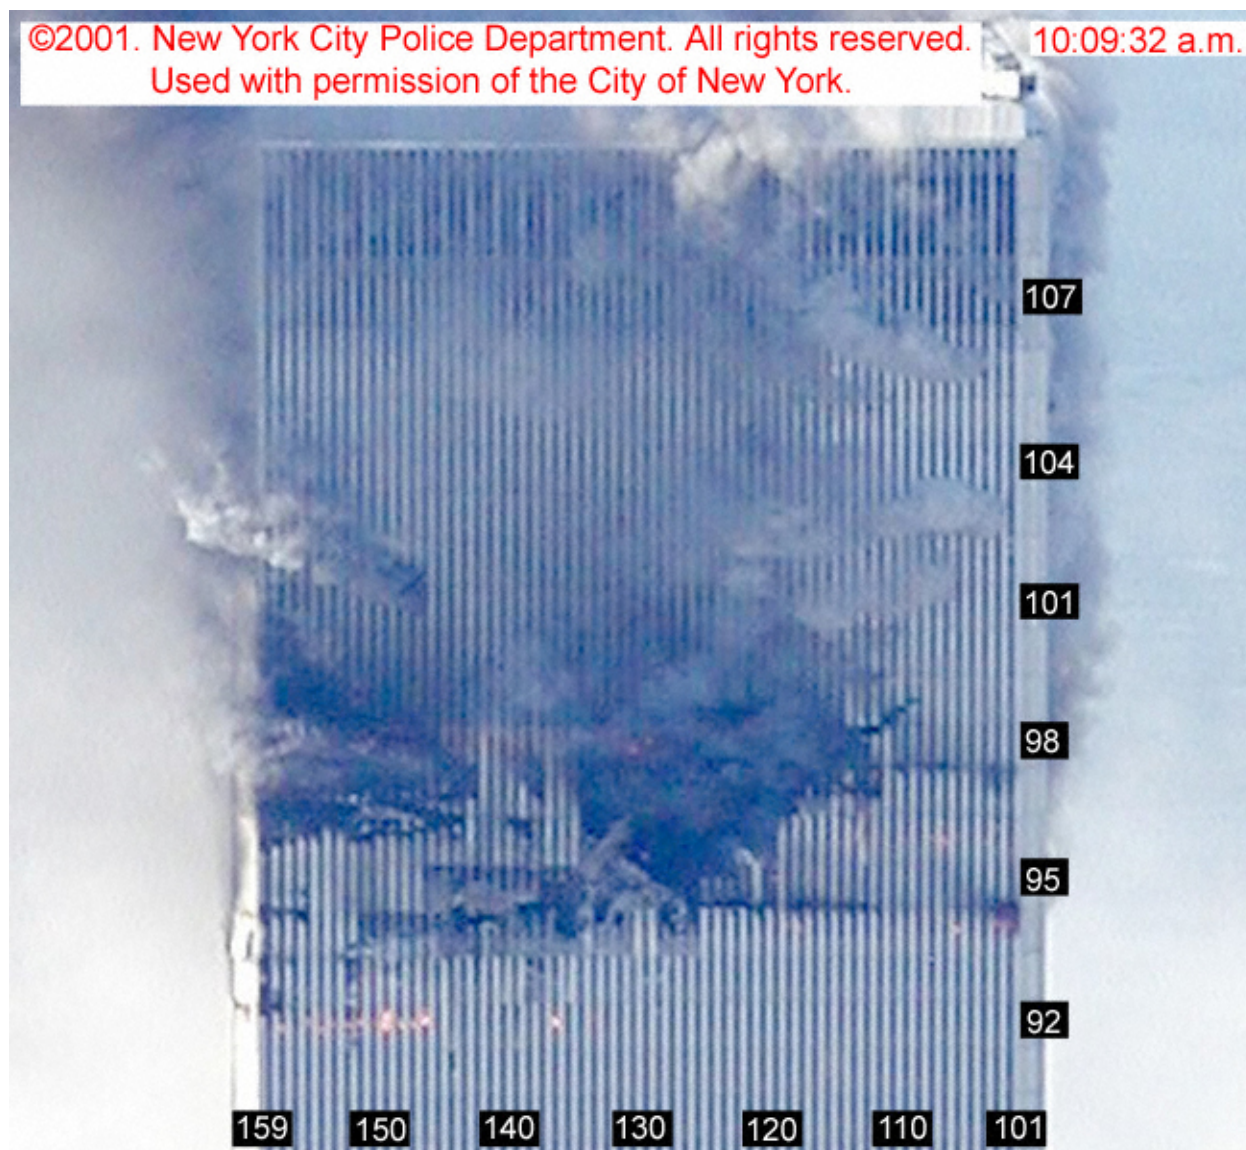
The photograph shown in Figure 8–82 was shot from a helicopter looking down on the north face of WTC 1 at 10:09:32 a.m. Considerably more flame is visible than could be seen in Figure 8–81. The difference is due to the angles from which the images were taken. The video frame shown in Figure 8–81 was taken from the ground a few blocks away from the WTC site, while the photograph in Figure 8–82 was shot from a much greater distance looking down into the windows. In effect, the latter photograph is looking much deeper into the building. On the 92nd floor a length of flames is evident extending from the eastern edge of the tower to window 92-146. At 9:57:59 a.m. flames were only visible as far as window 92-149. Windows further to the west were still intact. The fire has moved into the room that has walls terminating at columns 92-146 and 92-149 (see Figure B-1).

A single isolated flame is also evident at window 92-136, which indicates that the fire has apparently bypassed the next room to the west and entered the room with walls at columns 92-132 and 92-138. It has not been possible to determine exactly when this fire appeared, since it was not visible in videos shot from the ground around 10:08 a.m., but was easily seen just after 10:10 a.m.

Low intensity fires are also visible in Figure 8–82 on the west sides of the 94th and 96th floors and over much of the eastern half of the 98th floor. These are locations where much larger fires were present at earlier times, and these fires are likely the remnants. They were not visible from the ground around this time because they were low intensity and were burning near the floors, where they were hidden from view.

In Figure 8–82 there is no evidence of fire on the north face near the west edge of the 98th floor. At 10:10:15 a.m. a burst of heavy smoke was released from window 98-105, and less than two seconds later smoke came from window 98-102. A series of photographs taken around this time indicates that fire appeared in window 98-102 between 10:10:19 a.m. and 10:10:20 a.m. A photograph recorded at 10:10:55 a.m. showed flames were present in windows 98-101 to 98-108 and that flames were coming from windows on the adjacent west face.

**Figure 8-82. This cropped photograph was shot from a helicopter looking down on the north face of WTC 1 at 10:09:32 a.m. The intensity levels have been adjusted and column and floor numbers have been added.**

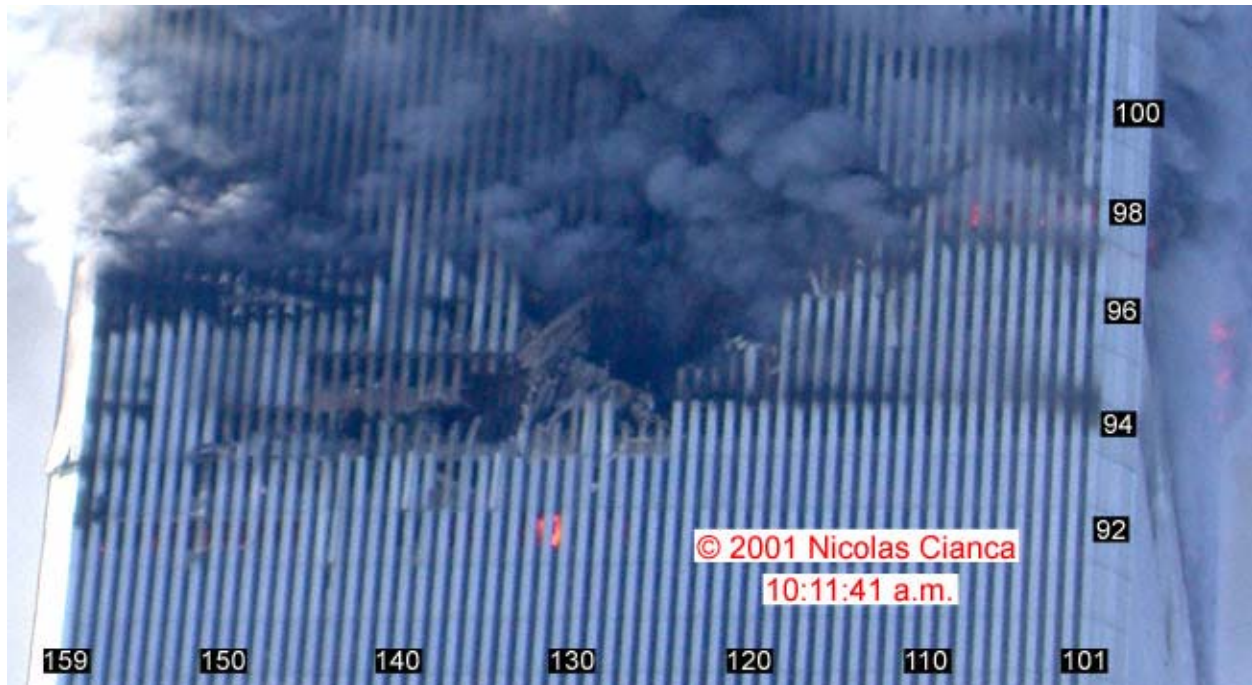
Figure 8–83 shows the north face at 10:11:41 a.m. The fire at the western edge of the 98th floor is visible in windows 98-101 to 98-110. On the 92nd floor there are bright flames present in windows 92-131 and 92-132. These two windows are on the west side of the room on this floor that has walls ending at columns 92-132 and 92-138 (see Figure B-1). The windows to the west of this point appear to still have glass in place. There appear to be some small fires on the east side of the 92nd floor, but flames are not observed elsewhere from this vantage point.

**Figure 8-83. This photograph shows the north face of WTC 1 at 10:11:41 a.m. The original image has been cropped, rotated, and adjusted for intensity levels. Column and floor numbers have been added**

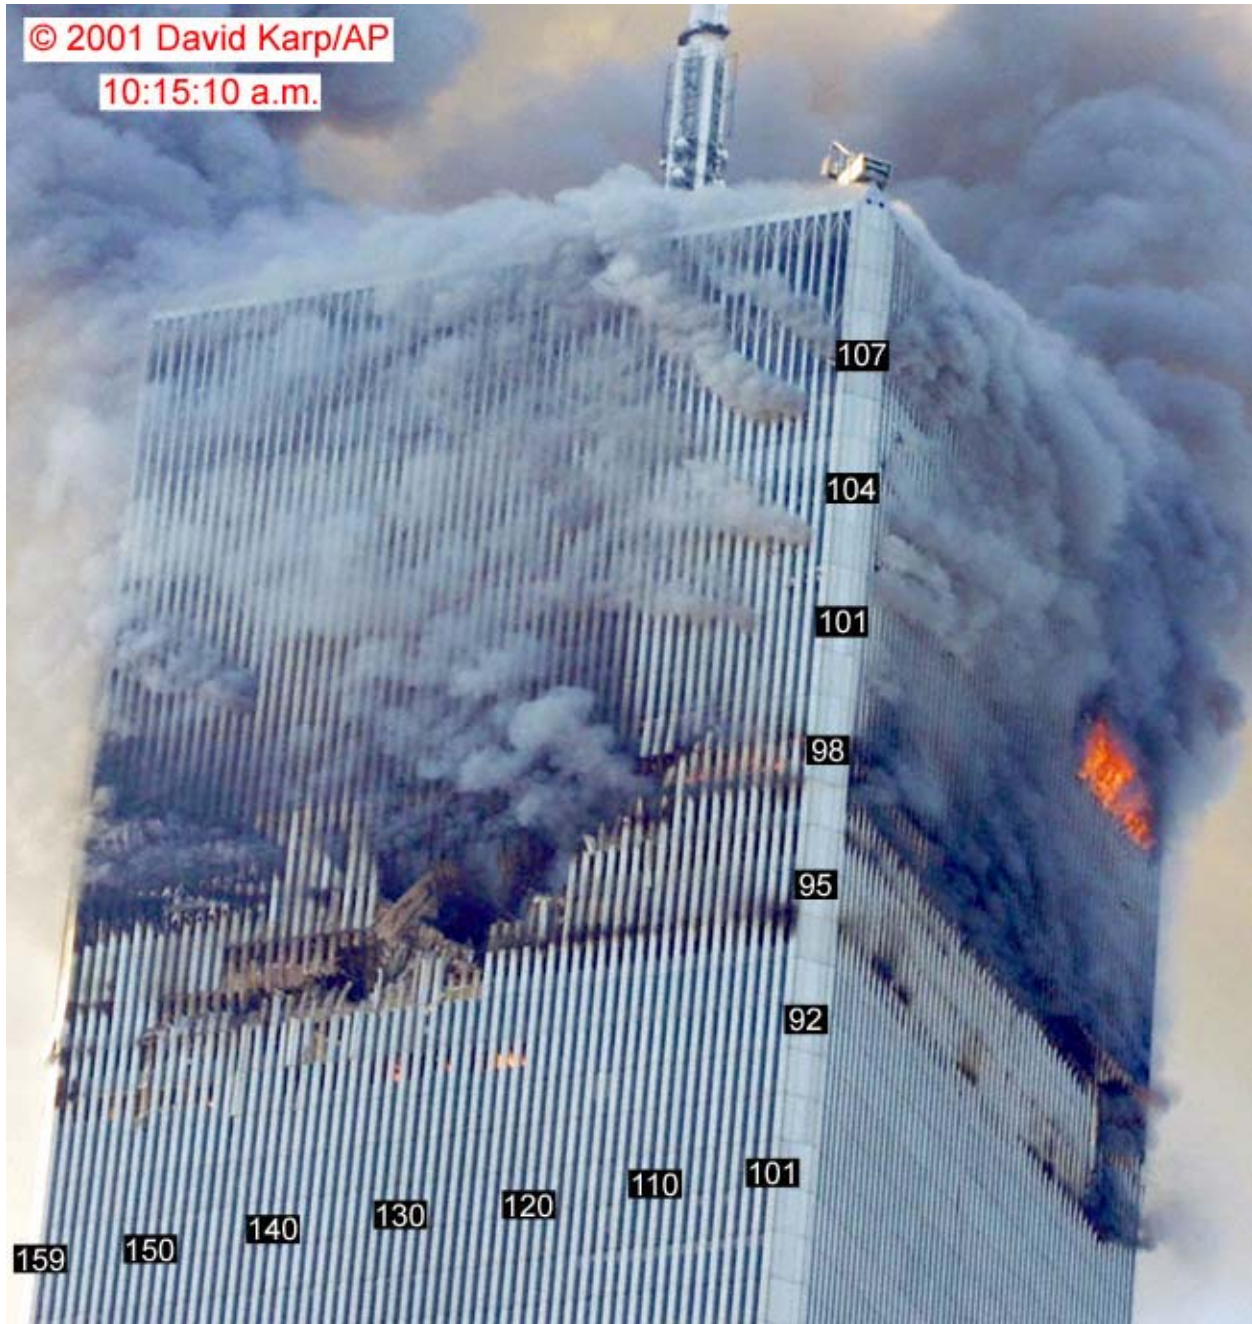
A view of WTC 1 shot from the northwest at 10:15:10 a.m. is shown in Figure 8–84. The fire on the north face of the 92nd floor has grown and moved toward the west. Flames are now visible as far west as window 92-121. As seen in Figure B-1, there was a large open area on the 92nd floor that ran between walls that terminated at columns 92-105 and 92-132. A fire is now burning on the east side of this open area, having apparently appeared in the room around 10:11:14 a.m. (see Figure 8–83). At the time the photograph in Figure 8–84 was taken, the glass for windows to the west of column 92-121 still appeared to be in place. It is interesting that even though a fire was growing in the area, there was no smoke coming from the open windows. This must be another case where the smoke was venting elsewhere.

**Figure 8-84.** This photograph of WTC 1 shows the north and west faces of WTC 1 at 10:15:10 a.m. The image has been cropped and rotated, and the intensity levels have been adjusted. Column and floor numbers have been added.

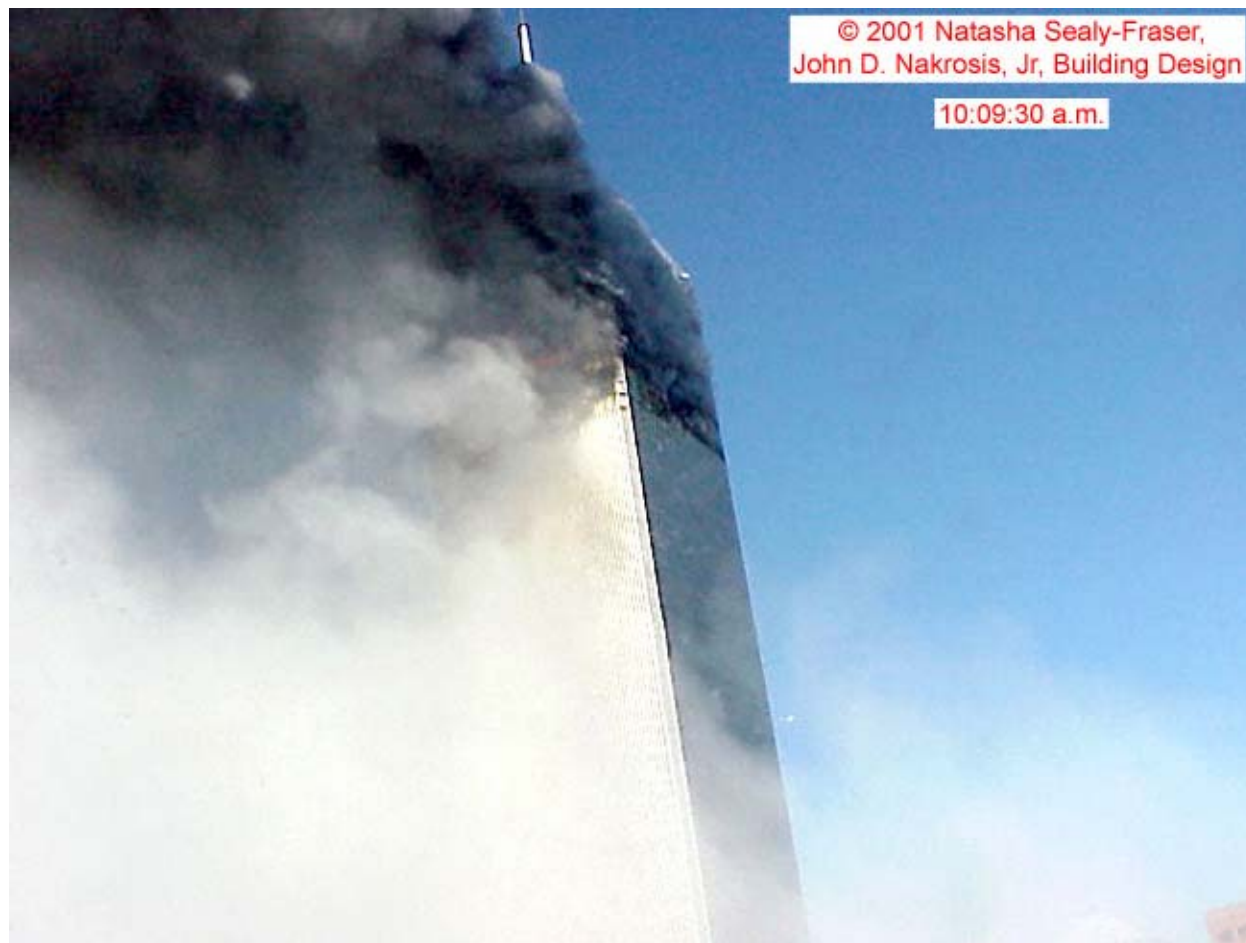
**Figure 8-85. This photograph shows the east and north faces of WTC 1 at 10:09:30 a.m. The intensity levels have been adjusted.**

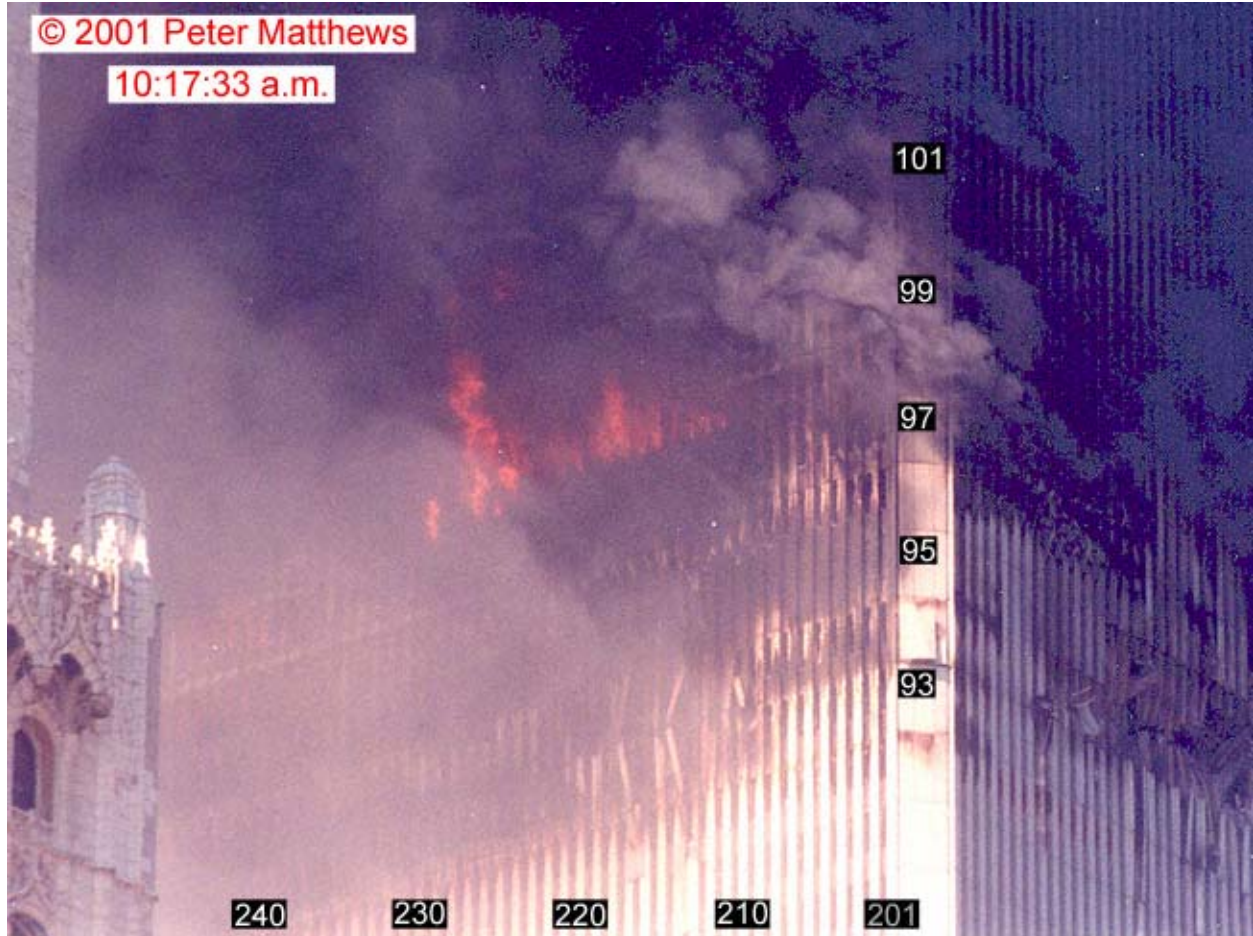
Flames are also visible on the 96th and 97th floor extending south from near windows 96-240 and 97-240 to the last windows (96-245 and 97-245) that can be seen in the image. Closer inspection of Figure 8–86 shows what appears to be a small fire on the 101st floor near window 101-224. There is some ambiguity

because of the flames coming from below, but the fire visible higher up seems to be well isolated. This observation suggests that fire has spread upward on the east face by jumping over a couple of floors.

**Figure 8-86.** This photograph shows the north and east faces of WTC 1 at 10:17:33 a.m. The original has been cropped and enhanced by adjusting the intensities. Column and floor numbers have been added.

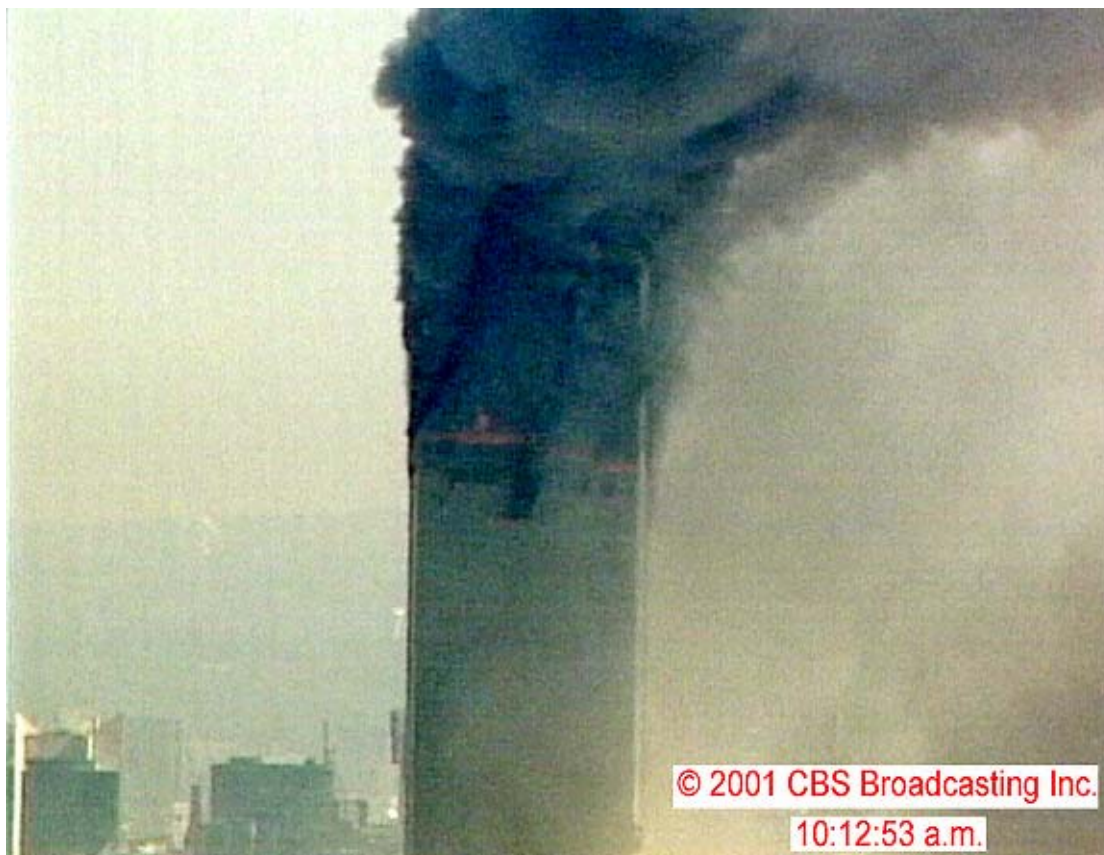
Figure 8–87 shows one of the clearer views of the south face captured from the news helicopter video. It was shot at 10:12:53 a.m. With one major exception, fires are distributed much as described above. The bright flames on the east sides of the 96th and 97th floors and the west side of the 98th floor are easily seen. In addition, an intense jet of flame is apparent on the west side of the face. This external flame, which is over a story tall, appears to be coming from the 99th floor. This is an indication that the fires had now progressed upward to this floor. Near the center of the face, there is a smoke plume coming from one of the lower floors. It is difficult to be sure, but this smoke appears to be coming from the 92nd floor. If correct, this suggests that a fire was burning on the south side of the 92nd floor.

**Figure 8-87. This view of the south face of WTC 1 was captured from a video recorded by a news helicopter at 10:12:53 a.m. The image has been enhanced by adjusting the intensity levels.**

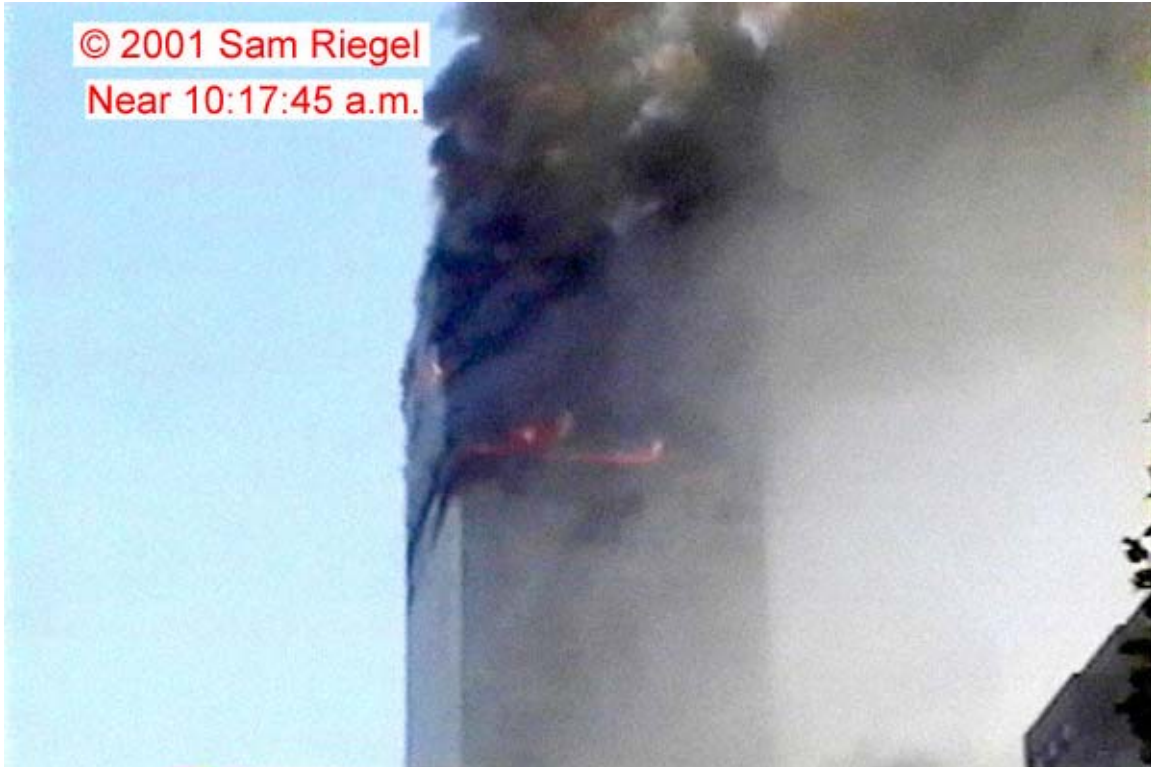
the video shot from a news helicopter. There is a relatively large uncertainty associated with this assignment since many of the views from the helicopter video around this time were taken from such a distance that the fires were not visible. A frame captured from this video is shown in Figure 8–88. It provides additional support for many of the observations based on Figure 8–87.

The line of fire on the 98th floor is still quite distinct. There is an intense external flame on the eastern side of this fire located at a point to the east of the center of the face. This fire appears to be moving toward the east. Two tongues of flame are evident coming from the floor above, i.e., the 99th floor, near the center of the western half of the south face. The video shows that the entire region between the two tongues of external flames is involved. The fire on the 97th floor on the eastern side of the face is just barely visible. Flames are not visible on the 96th floor. The smoke plume coming from windows lower down near the center of the face is also visible. Even though individual floors are not resolved in this image, the location of the smoke relative to other details indicates that it is indeed coming from the 92nd floor.

**Figure 8-88.** This image shows the south face of WTC 1. It was captured from a video shot from the ground and has been enhanced by adjusting the intensity levels. The estimated time of 10:17:45 a.m. is based on a comparison of the fire distribution with a video recorded from a news helicopter and could be off by as much as a few minutes.

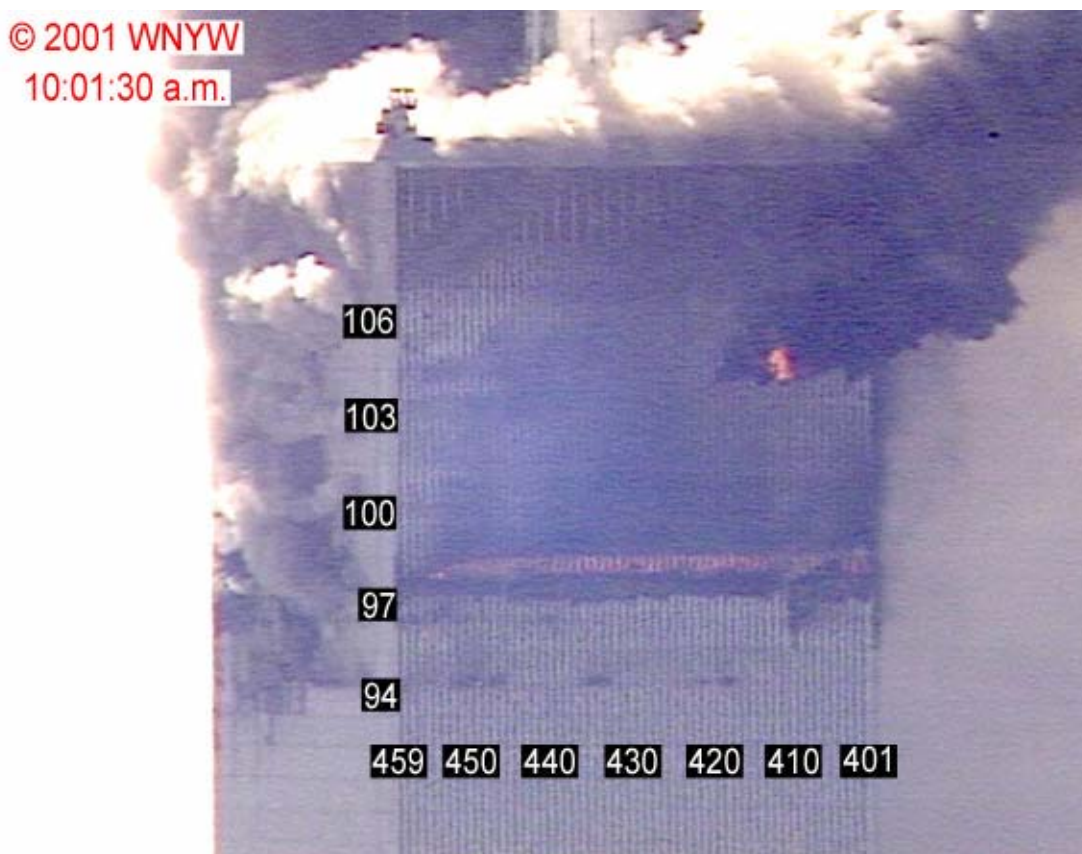
Figure 8-89 shows an image of the west face shot from a news helicopter at 10:01:30 a.m. The flames on the 104th floor are coming from several windows centered near window 104-411. Heavy black smoke is venting from multiple windows over a much larger area. It is informative to compare the appearance of the smoke in Figure 8-89 with that in Figure 8-74, which shows the west face at 9:56:10 a.m. The smoke has clearly become much heavier and darker.

**Figure 8-89.** This image of the north and west faces of WTC 1 is a frame captured from a video recorded by a news helicopter at 10:01:30 a.m. The image has been enhanced by adjusting the intensity range, and some areas are saturated. Column and floor numbers have been added.

The deep orange glow along the 98th floor in Figure 8–89 indicates that the interior fire on this floor is continuing to burn along much of the length of the west face. The fire on this floor has moved north since around 9:58 a.m. Flames can now be seen as far as window 98-455. The floor plan layout shown in Figure B-7 indicates that there were two rooms along the west face in the northwest corner of the 98th floor. Fire has entered the southernmost of these rooms, which had interior walls at columns 98-452 and 98-456. There is as yet no visual evidence for fire on the west side of the corner room with walls at columns 98-456 and 98-108.

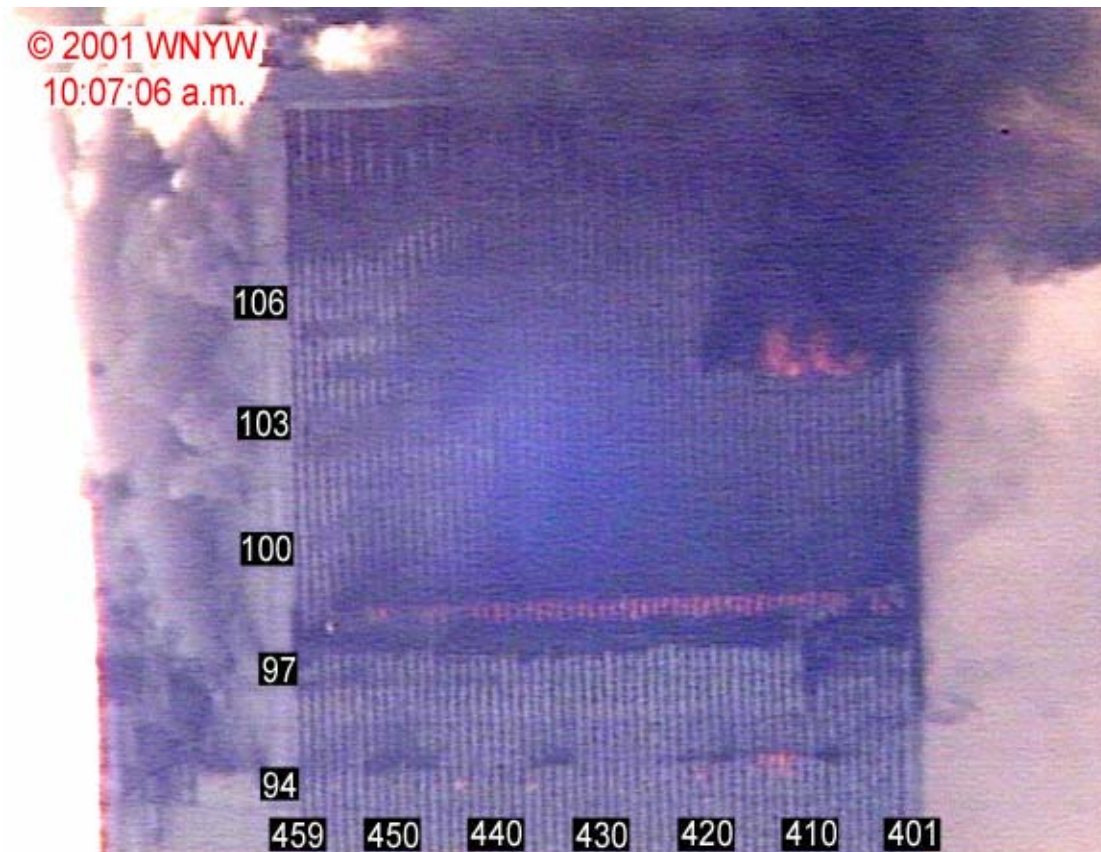
Another view of the west face taken from a video shot from one of the news helicopters at 10:07:06 a.m. is shown in Figure 8–90. The fire on the 104th floor is still raging, with flames coming from windows 104-404 to 104-414. On the 98th floor the deep orange glow from the internal fire is still present along nearly the entire length. A small flame extends from window 98-455, but the fire does not yet appear to have moved into the room on the northwest corner. On the 94th floor the most intense fire is observed in windows 94-412 to 94-414. Smoke is also evident coming from window 94-408. This smoke had appeared abruptly six seconds earlier.

**Figure 8-90.** This image of the north and west faces of WTC 1 is a frame captured from a video recorded by a news helicopter at 10:07:06 a.m. The image has been enhanced by adjusting the intensity range, and some areas are saturated. Column and floor numbers have been added.

In Figure 8–90 there is no visual indication of fire on the west side of the 95th floor. However, the summary of observations of falling people in Appendix M provides evidence that fires were moving into the area. At 10:06:11 a.m. a person fell from the west side of the 95th floor. During the next minute and forty-five seconds 12 more people fell from the same floor. For some of these people, the windows that they fell from have been identified. They ranged from window 95-424 to window 95-428. These windows were closed at 9:40:14 a.m. as seen in Figure 8–70.
