**NIST NCSTAR 1-5A**

**Federal Building and Fire Safety Investigation of the  
World Trade Center Disaster**

# **Visual Evidence, Damage Estimates, and Timeline Analysis**

September 2005

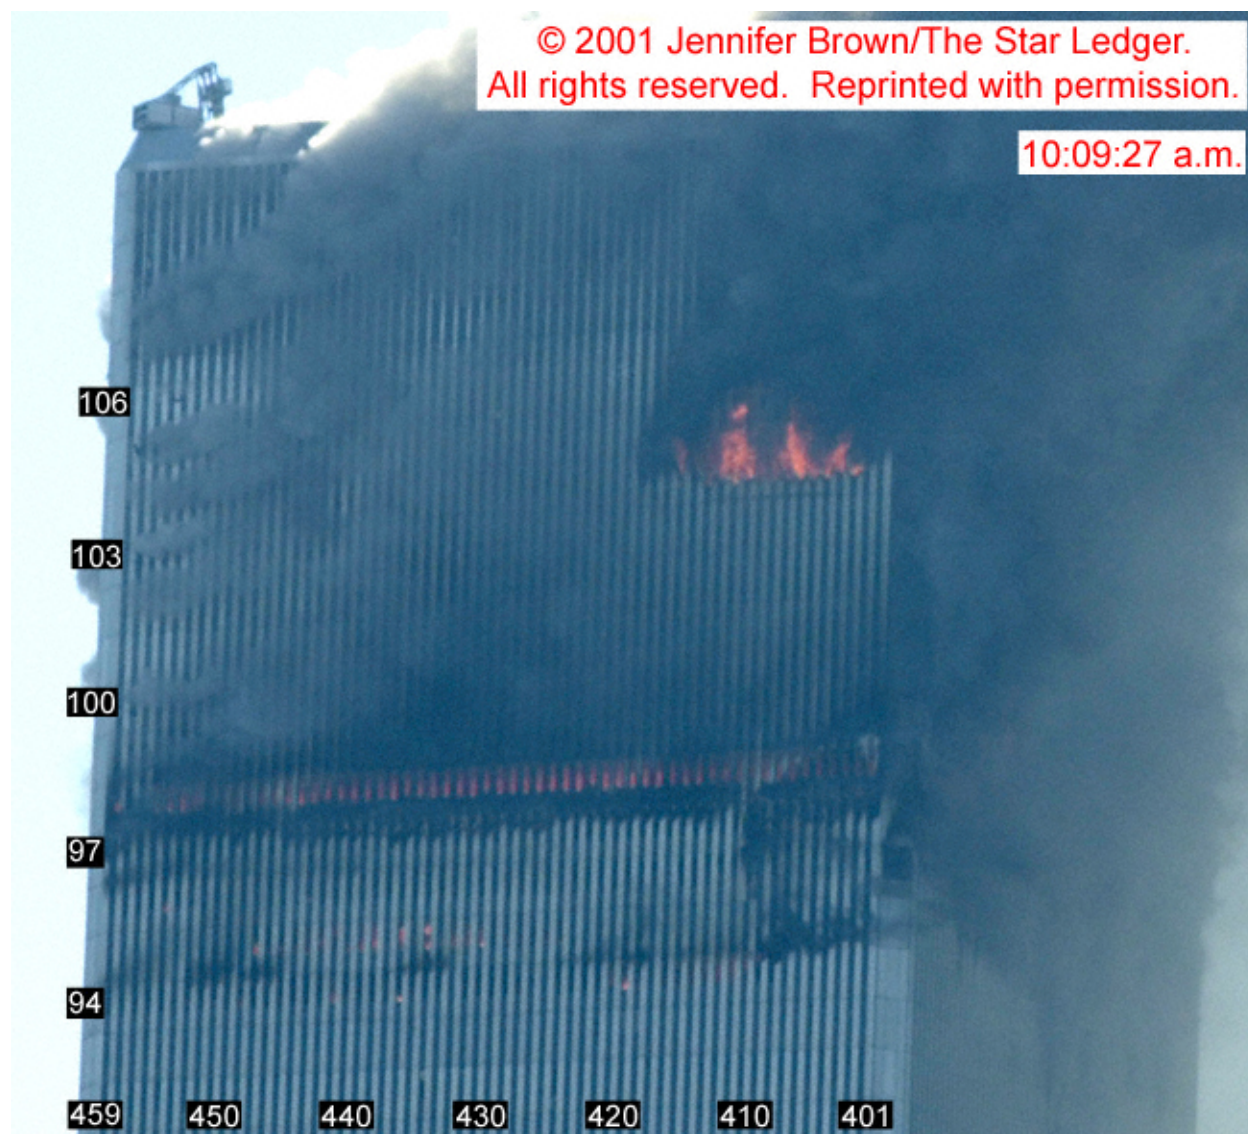
Figure 8–91 shows a photograph of the west face recorded shortly afterward at 10:09:27 a.m. Flames are visible on the 95th floor in windows 95-430 to 95-447. A video of the west face indicates that fire was present as far south as window 95-425 by 10:10:10 a.m. The images indicate that an extensive fire that had not been visible three minutes earlier appeared over a large length of the west side of the 95th floor.

**Figure 8-91.** This photograph, showing the west face of WTC 1 and an oblique view of the south face, was recorded at 10:09:27 a.m. The image has been cropped and enhanced by adjusting intensity levels. Column and floor numbers have been added.

The orange glow seen in Figure 8–91 over much of the 98th floor indicates that the interior fire present on this floor continued to burn at this time. By entering the room on the northeast corner around 10:10 a.m., this fire had completed its spread across the entire west side of the floor. Recall that the fire had entered the adjacent room with walls at columns 98-252 and 98-256 (see Figure B-7) around 10:00 a.m.

Small areas of isolated flames can be seen in several windows on the 94th floor in Figure 8–91. There appears to be a somewhat larger fire present at window 94-408 and windows immediately to the north. The smoke stream that appeared at 10:07:00 a.m. from window 94-408 is still apparent. Windows to the south appear to be intact. The fact that the fire did not appear to move south in the nearly 150 s period between these images is somewhat surprising because the floor plan layout (see Figure B-3) indicates that the fire was burning in a room with walls at columns 94-405 and 94-417. The fire might have been expected to spread to the southern wall of this room. Videos shot from the west indicate that the stream of smoke coming from window 94-408 was present until the end of the current period at 10:18 a.m.

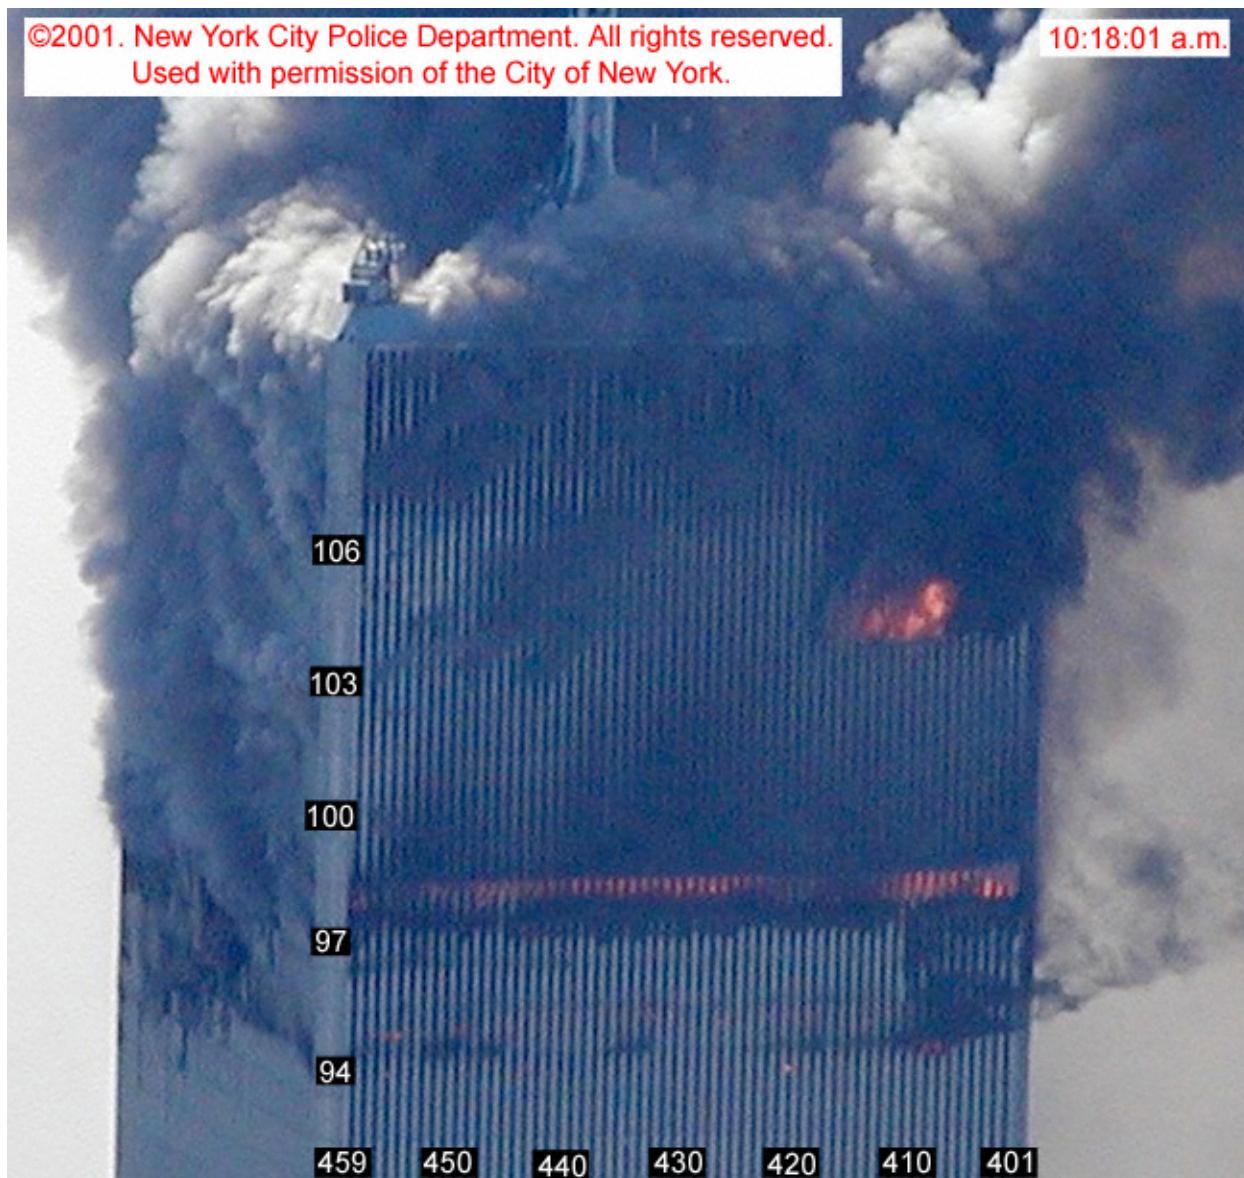
Figure 8–92 shows an image of the west face of WTC 1 recorded at the end of the current time period at 10:18:01 a.m. With a few exceptions, the appearance is similar to that seen around 10:10 a.m. The fire on the 95th floor has spread in both directions across the face. Low intensity flames can be seen in windows over a length from window 95-413 to window 95-455. Even though the fire extends over a long length of the face, there is very little smoke, and there are no flames coming from the windows on this

floor. The absence of significant smoke marks on the column covers near the tops of the windows is consistent with these observations. Based on the floor plan layout shown in Figure B-4, the fire on this floor has penetrated the room with walls at columns 95-452 and 95-456, but there is no indication that it is yet inside the room on the northwest corner with walls at columns 95-456 and 95-108.

**Figure 8-92.** This cropped photograph of the west face of WTC 1 and an oblique view of the north face was shot at 10:18:01 a.m. The image was enhanced by adjusting the intensity levels, and column and floor numbers have been added.

Relatively small fires are observed at several locations on the 94th floor. Heavy smoke continues to come from window 94-108. In fact, heavy smoke and fire are apparent at windows 94-108 and 94-109. The fire on the 98th floor can still be seen across most of the west face, and it is still primarily an interior fire. Heavy smoke and flames continue to come from the fire on the 104th floor. The location of this fire appears to be the same as at 10:10 a.m.

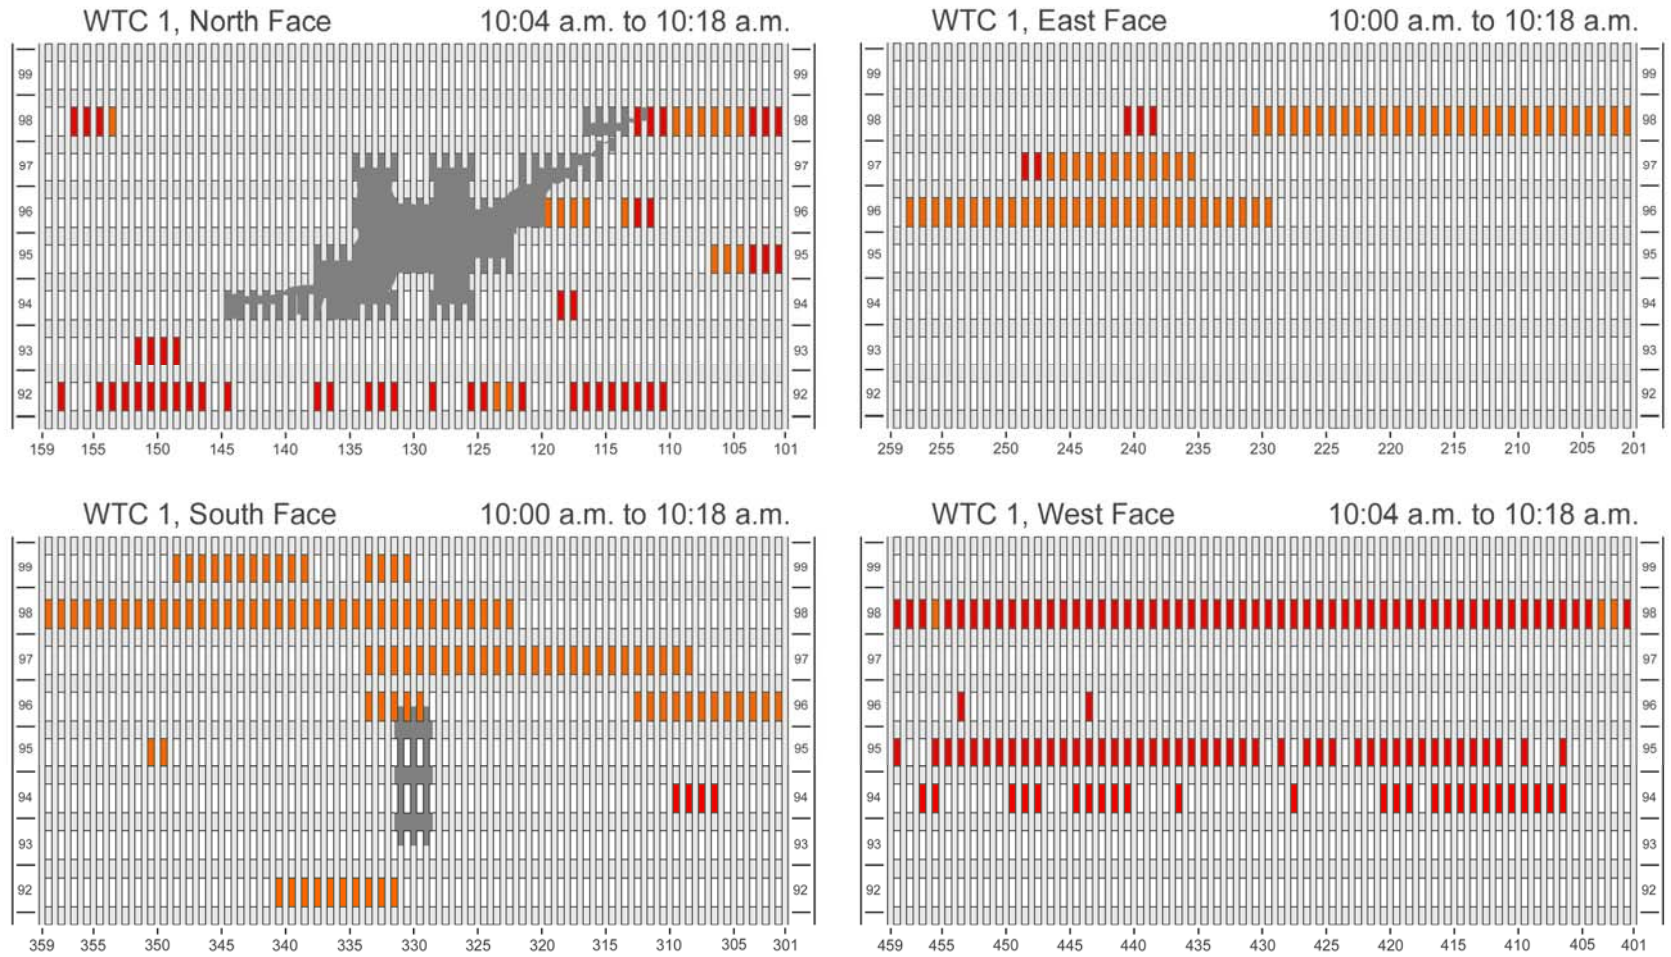
The most prominent feature of the fire growth on the west face was the appearance (not included in Figure 8–93) of an intense fire with extended flames on the 104th floor shortly after the collapse of WTC 2. This fire continued to burn intensely during the entire period. The fire on the 98th floor continued moving toward the north, reaching the north face during the period. A relatively low-intensity fire appeared on the 95th floor and subsequently covered a large fraction of the floor across the face. The fire burning on the 94th floor continued to spread toward the south early in the period, but then seemed to halt near window 94-108 for several minutes.

**Figure 8-93. Maps of integrated fire observations between 10:00 a.m. and 10:18 a.m. are shown for the four faces of WTC 1. Colors represent the highest intensity fire observed in a window using the color scale defined in Figure 5-1.**

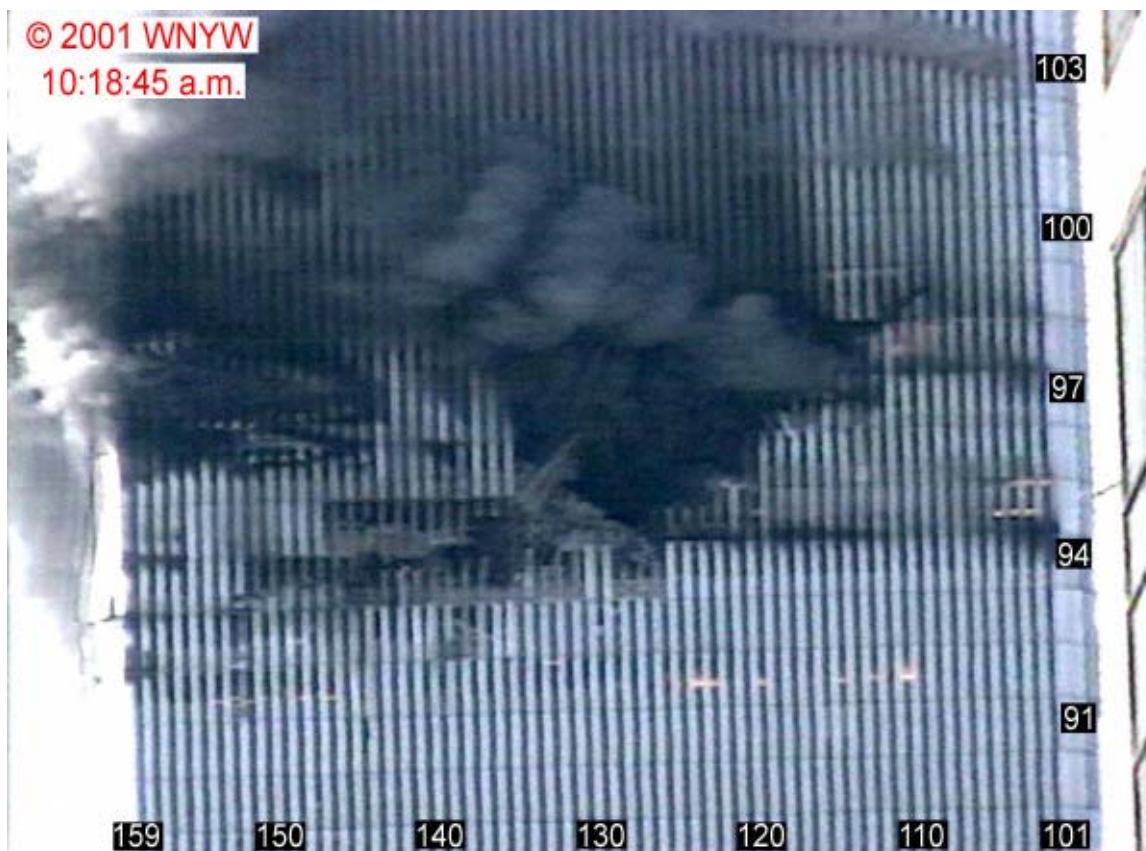
Figure 8–94 provides a view of the north face of WTC 1 at 10:18:45 a.m. Comparison with Figure 8–84 shows that, during the just over three and a half minutes between the images, the fire on the 92nd floor continued to move toward the west. In the later image fire is visible as far west as window 92-110. At the earlier time windows to the west of window 92-120 appeared to be intact, with fire present in window 92-121. Despite the presence of flames over a significant length of the floor, the fires appear to be burning at low levels at separated locations. There is essentially no smoke coming from the open windows on the north side of the floor. This indicates that the smoke is likely venting elsewhere.

**Figure 8-94.** This image of the north face of WTC 1 was captured from a video shot at 10:18:45 a.m. It has been enhanced by adjusting the intensity range. Some portions of the image to the left of the tower are saturated. Column and floor numbers have been added.

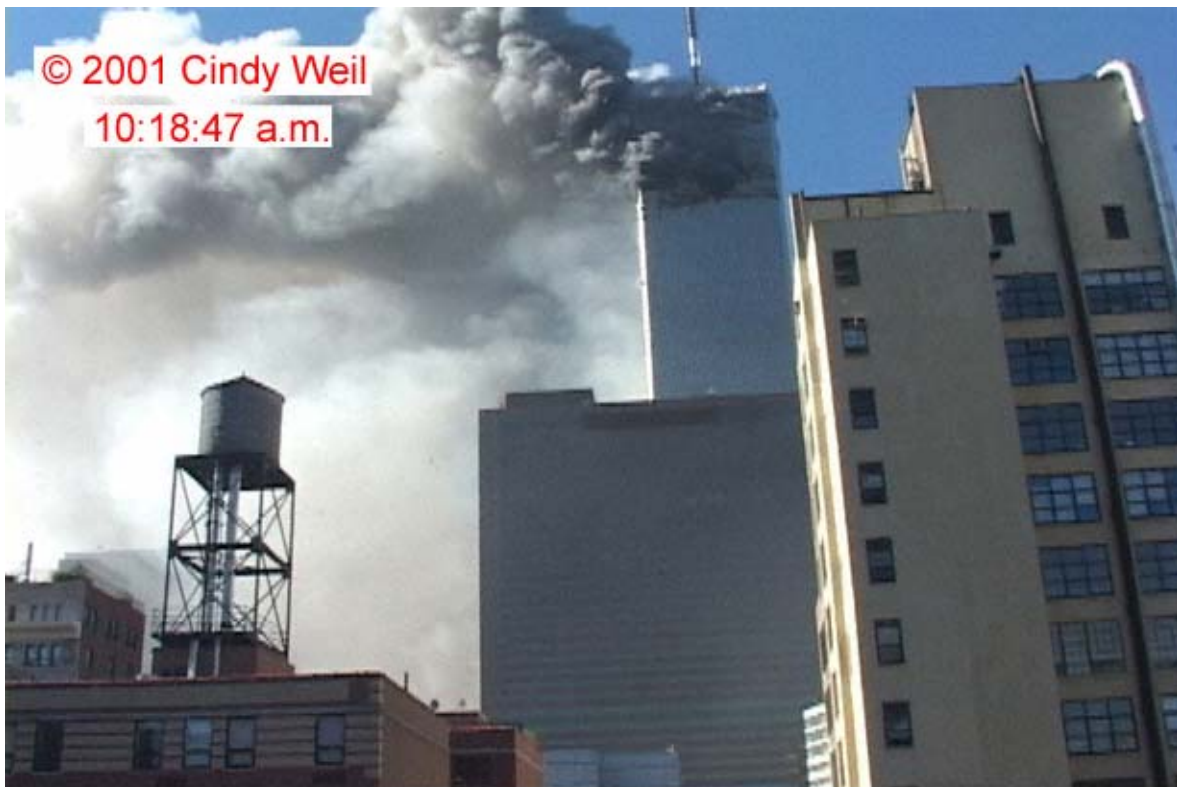
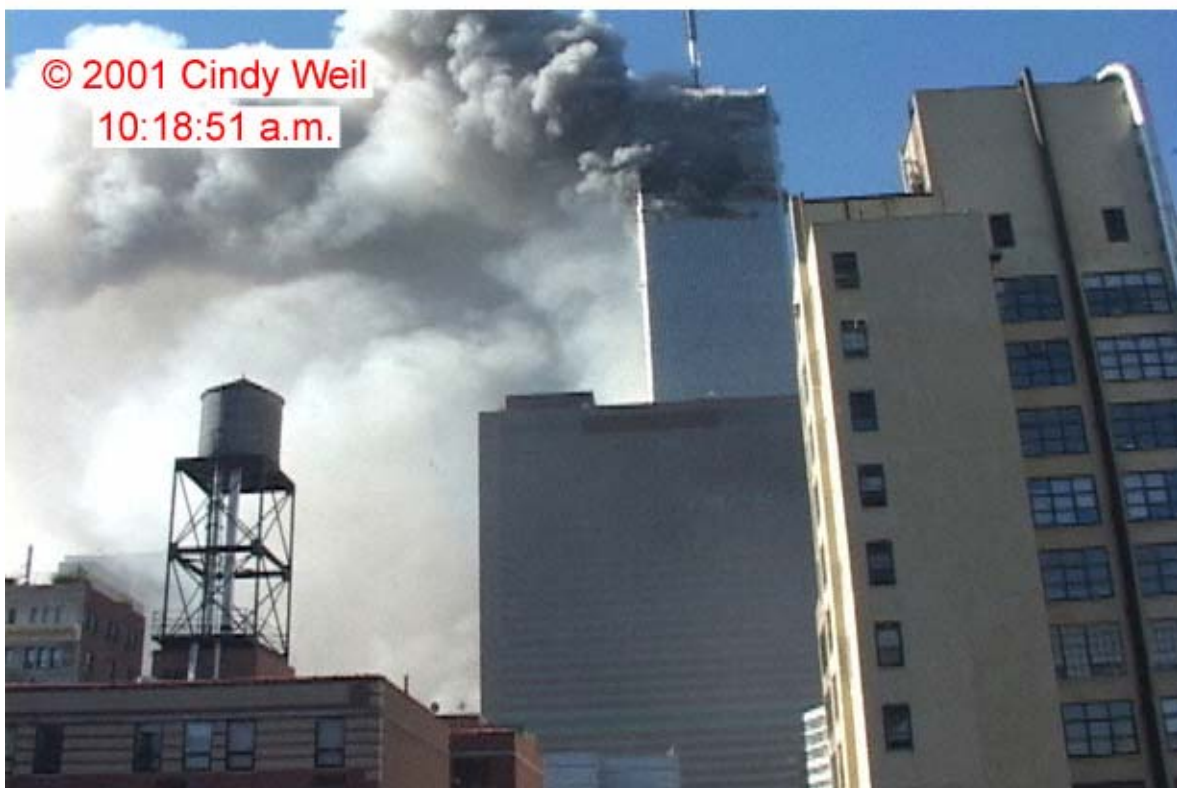
Closer inspection of this video, as well as others, shows many additional effects of the pressure pulse at other locations on the tower. Smoke and/or dust were pushed out of windows on the east side of the north face at the 94th floor. This material is responsible for the light-colored “smoke” seen near the eastern edge of the building immediately above the darker smoke released from the 92nd floor in Figure 8–95.

On the western side of the north face there is a region of increased smoke flow higher up in the vicinity of the 95th to 98th floors. While it is difficult to see in the frame recorded at 10:18:51 a.m., it is clear in the video that a large flame was pushed out of windows on the 95th floor by the pressure pulse. Comparison of the two frames shows that smoke is present on the west face in this same area at the later time, which was not apparent earlier.

**Figure 8-95. Two images of the north face of WTC 1 captured from a video are shown. The times are 10:18:47 a.m. and 10:18:51 a.m.**

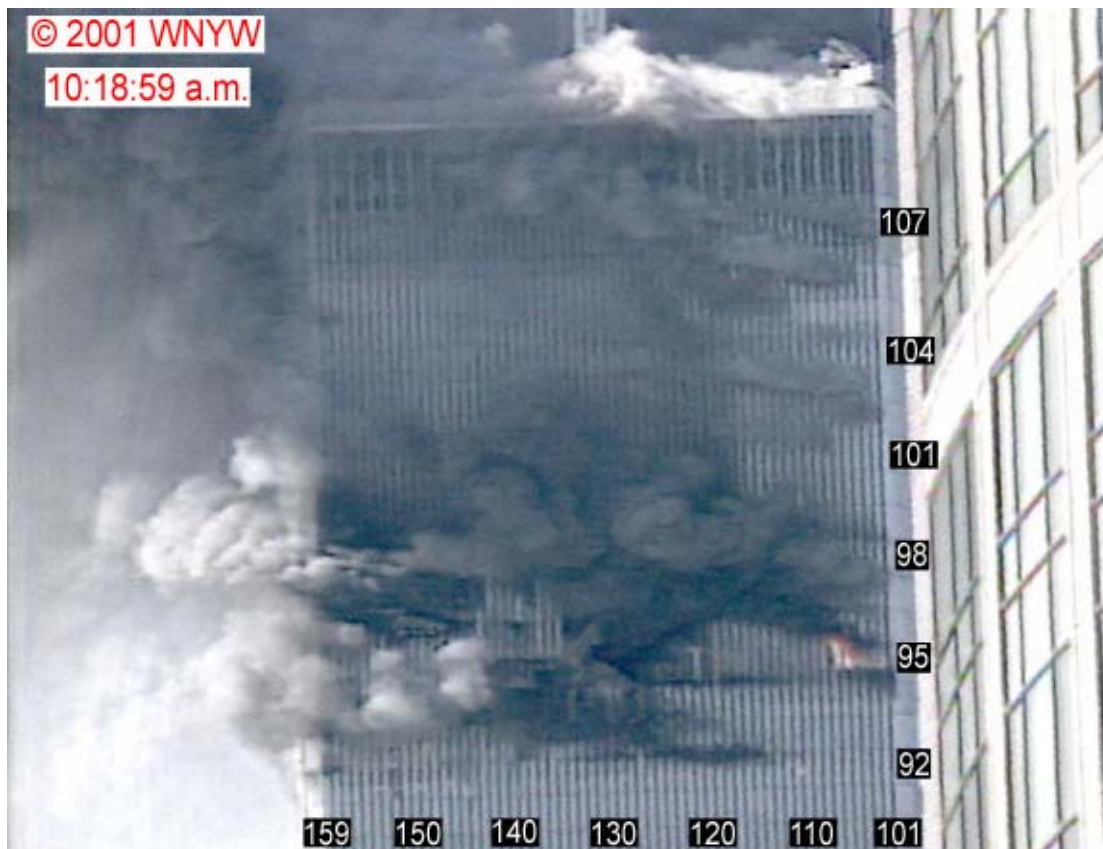
Figure 8-96 shows a closer view of the north face recorded at 10:18:59 a.m. This image is taken from the same video as Figure 8-94, which was recorded 14 s earlier. The effects of the changes in the smoke and fire described above are easily seen. The black line at the tops of the column covers on the 92nd floor created by the smoke release is visible. The fire on the western edge of the 95th floor has grown dramatically, and flames now extend from windows 95-105 and 95-106. Heavy smoke is now coming from windows on the 95th floor as well as windows at the western edge of the face on the 96th and 97th floors. Smoke is also now flowing from window 102-101 on the 102nd floor.

**Figure 8-96.** This image of the north face of WTC 1 was captured from a video shot at 10:18:59 a.m. It has been enhanced by adjusting the intensity range. Column and floor numbers have been added.

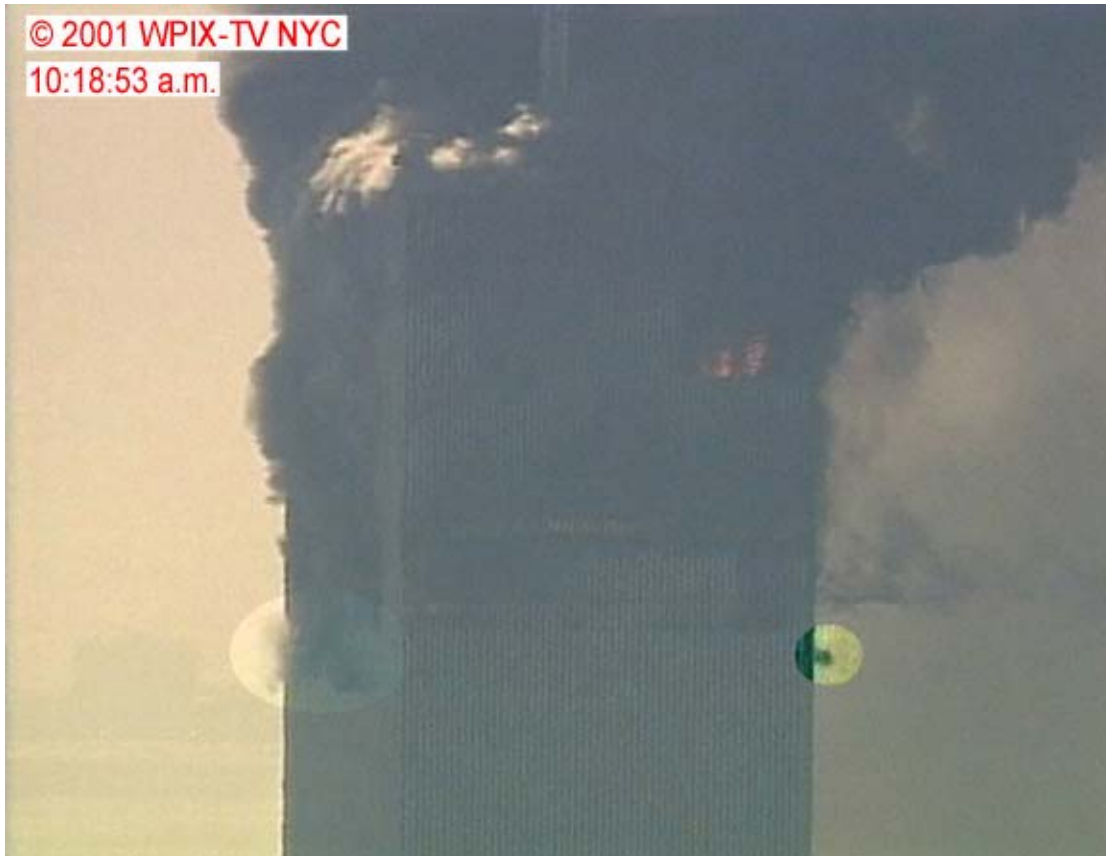
A video shot from the west shows that heavy smoke was pushed out of windows on the 95th and 98th floors on the north side of the west face at the same time the changes were observed on the north face. This video also shows what appears to be a jet of smoke being ejected from a lower floor on the south face of the tower. A view of this jet is highlighted in Figure 8–97, which shows a frame taken from the video 5 s after the start of the pressure pulse, i.e., at 10:18:53 a.m. The smoke coming from the 92nd floor on the north face is also highlighted. The video also shows a large amount of debris falling along the north and south faces of the tower around the time of the pressure pulse.

**Figure 8-97. This image showing the west face and an oblique view of the north face was captured from a video shot from a news helicopter at 10:18:53 a.m. The highlighted areas with adjusted intensities indicate smoke and/or dust plumes that were pushed from the north and south faces by a pressure pulse that passed through the tower at 10:18:48 a.m.**

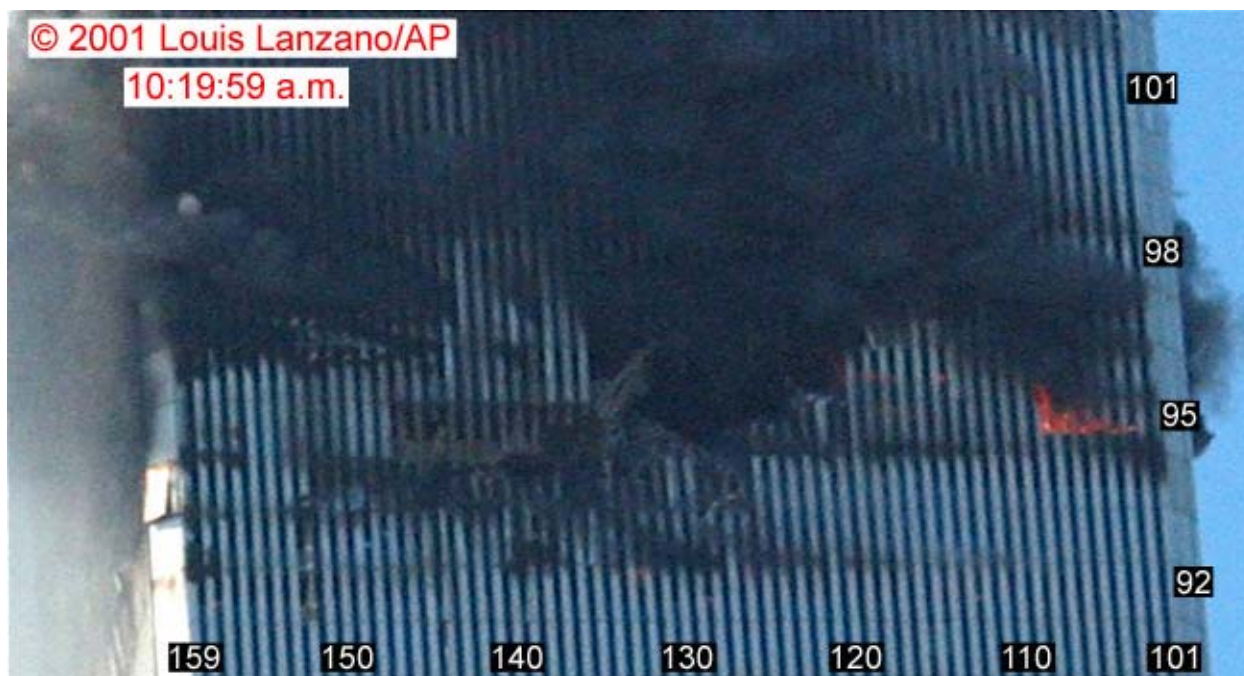
Figure 8-98 shows an image of the north face cropped from a photograph that was taken a minute later than Figure 8-96. Light smoke continues to come from the 92nd floor, where low level fires are apparent in windows 92-112 to 92-132. The fire that grew rapidly on the 95th floor immediately following the pressure pulse is still burning intensely, with flames coming from windows 95-106 and 95-107. A review of the floor plan layout for this floor in Figure B-4 shows that this fire is burning within a corner room with walls located at columns 95-456 and 95-108. Apparently, at this time the wall at column 95-108 has halted the spread of the fire toward the east. There does appear to be a fire even further to the east on this floor near window 95-115. A low level fire continues to burn on the 96th floor, with flames visible from windows 96-113 to 96-118. Heavy smoke is still flowing from windows on the 96th and 97th floors.

**Figure 8-98.** This cropped photograph shows the north face of WTC 1 at 10:19:59 a.m. The image has been enhanced by adjusting the intensity range. Column and floor numbers have been added.

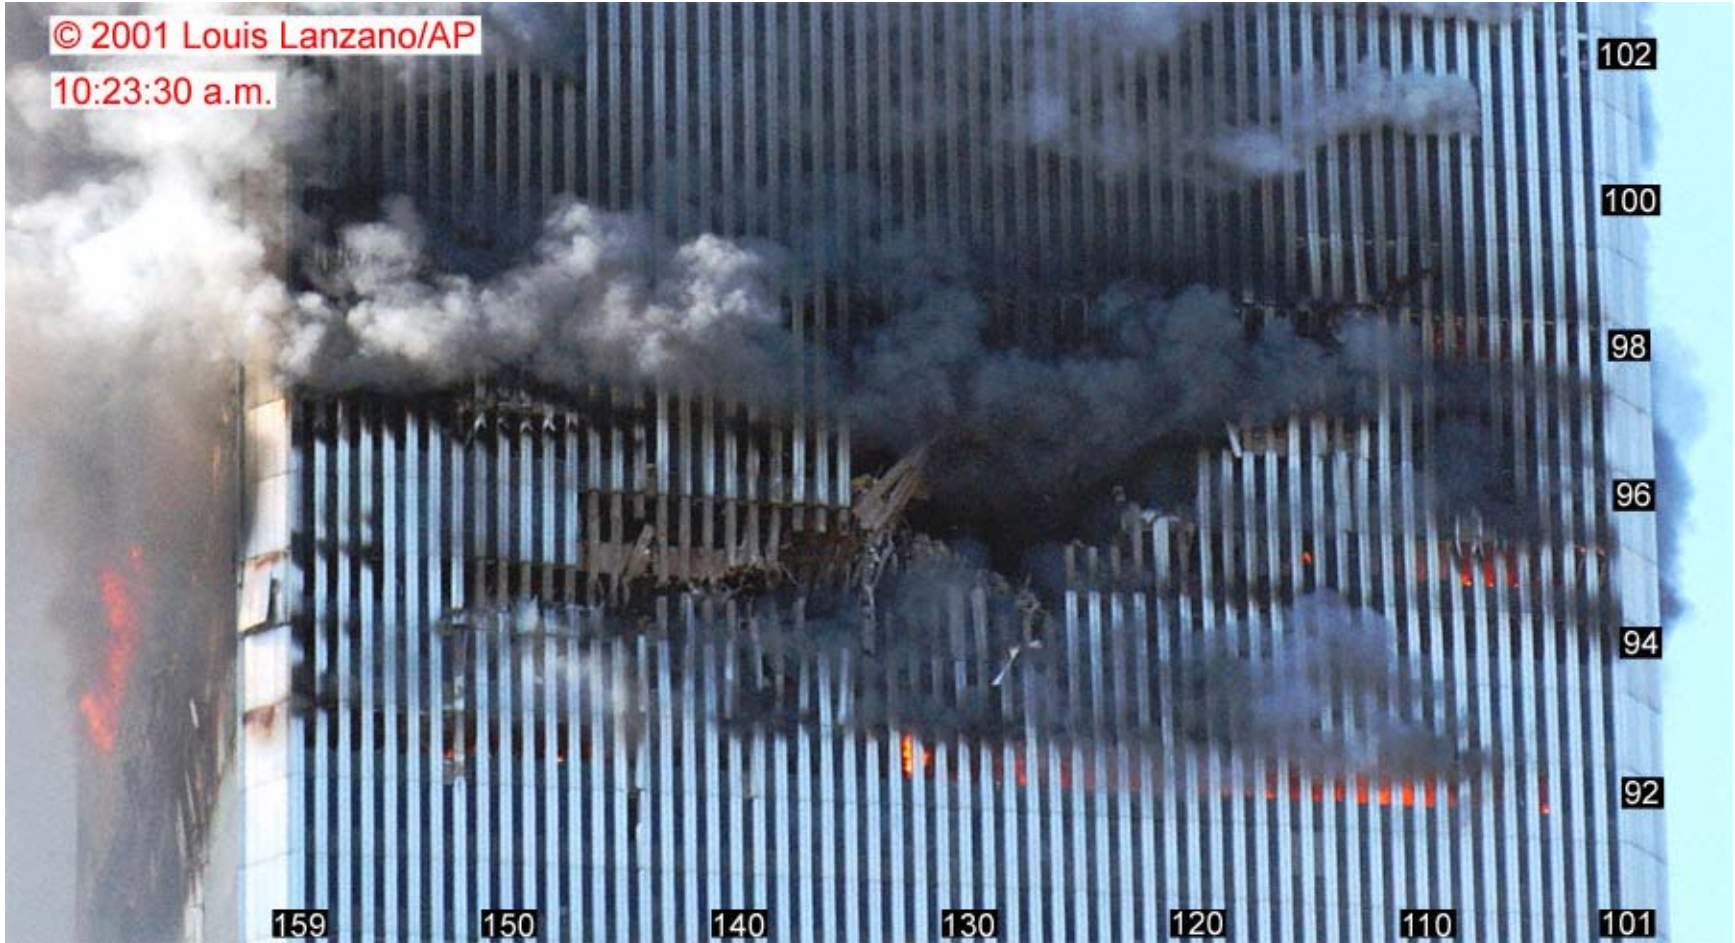
A view of the north face at 10:23:30 a.m. is shown in Figure 8-99. The fire on west side of the 92nd floor has grown dramatically since the photograph in Figure 8-98 was taken, three and a half minutes earlier. Heavy flames fill the openings from window 92-108 to window 92-114, and a nearly continuous region of flame is apparent from window 92-108 to window 92-132. The floor plan layout for the 92nd floor in Figure B-1 shows that a large open area extended along the north face between walls located at columns 92-132 and 92-105. Figure 8-99 indicates that nearly this entire area was involved in fire at this time. A small fire is evident in window 92-104, while windows 92-101 to 92-103 and window 92-105 appear to be closed. This indicates that a fire has moved into the northwest corner room with walls located at columns 92-105 and 92-455. Interestingly, in an almost identical photograph recorded five seconds earlier, the fire in window 92-104 was not visible, and all of the glass for windows in the corner room appeared to be intact. This suggests that the fire in the northwest corner room of this floor has just become large enough to break windows at this time. This close-up photograph also reveals that small spot fires continued to burn on this floor at the eastern side, where larger fires had been present earlier.

Figure 8-99. This cropped photograph shows the north face of WTC 1 at 10:23:30 a.m. The image has been rotated and enhanced by adjusting the intensity range. Column and floor numbers have been added.

By 10:23:30 a.m. the fire in the northwest corner room of the 95th floor had begun to die down, and the flames that were outside of windows at the time of Figure 8–98 had receded back into the building. The carets created by these external flames on the aluminum covers for columns 95-105 to 95-108 are distinct in Figure 8–99. Dull orange flames can be seen through windows 95-108 and 95-109, indicating that a fire was present on the other side of the wall located at column 95-108 (see Figure B-4). It is not clear whether the glass in these windows has broken or not. A small spot fire is also visible in window 95-115. The dying fire on the western side of the 96th floor is not visible in Figure 8–99, but small flames can be seen higher up on the 98th floor.

This area of flame on the southern side of the east face is visible in Figure 8–99, which was taken at 10:23:30 a.m. The fire is burning intensely with extended flames. Figure 8–103 shows a lower-resolution photograph taken at 10:23:41 a.m. that provides a slightly less oblique view of the east face in which it is easier to identify the flame location. The area where flames are visible coming from open windows has been highlighted. Flames can be seen on the 98th floor at two apparently separated locations. One of these is near the center of the face, and the second is well to the south. Even though the flames appear to be separated, videos and Figure 8–99 show that the flaming region was continuous over this length. A small area of fire is also visible on a lower floor. This fire is most likely on the 97th floor near the location where fire was present (near window 97-145) in Figure 8–102 at 10:18:15 a.m.

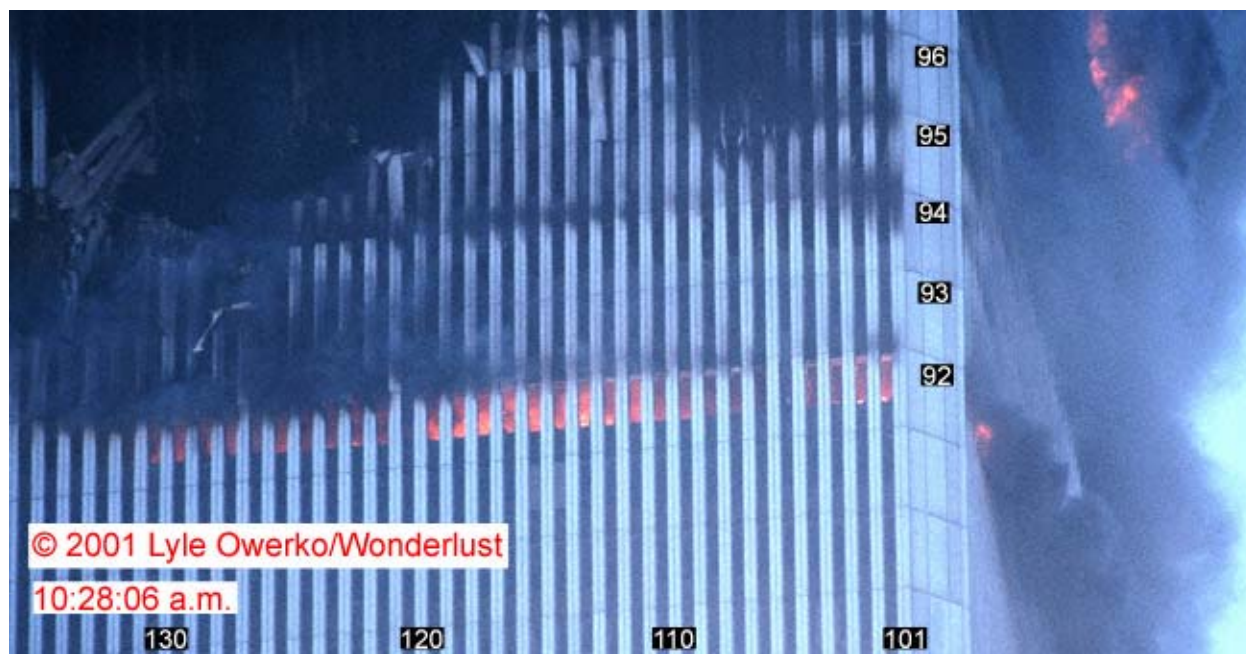
Over the next several minutes, the fire on the western half of the north side of the 92nd floor continued to grow more intense, while the other fires on the north side of the floor continued to decay. Figure 8–100 shows a photograph of a portion of the north face of WTC 1 taken at 10:28:06 a.m. This is roughly 16 s before the tower began to collapse. The large fire burning on the 92nd floor at this time is evident. Flames can also be seen on the north edge of the west face, indicating that the fire has turned the northwest corner and begun moving south on the west face.

**Figure 8-100.** This cropped photograph shows a portion of the north face and an oblique view of the west face for WTC 1 at 10:28:06 a.m. The intensity levels of the image have been adjusted, and column and floor number have been added.

This photograph has sufficient resolution and contrast to allow a determination of whether windows are open or intact. It appears as if three windows on the 92nd floor, windows 92-105, 92-106, and 92-120, still have glass in place. The other windows visible on this floor are open.

The photograph in Figure 8–100 was shot from a ground location relatively close to and slightly west of the tower. For this reason it may not provide as complete a view of interior fires as some of the other images shown earlier. Nonetheless, it is clear that the fires that were easily identified minutes earlier on the 95th, 96th, and 97th floors are not visible and must be burning at relatively low levels. The fact that the fire on the 92nd floor is so prominent supports this conclusion.

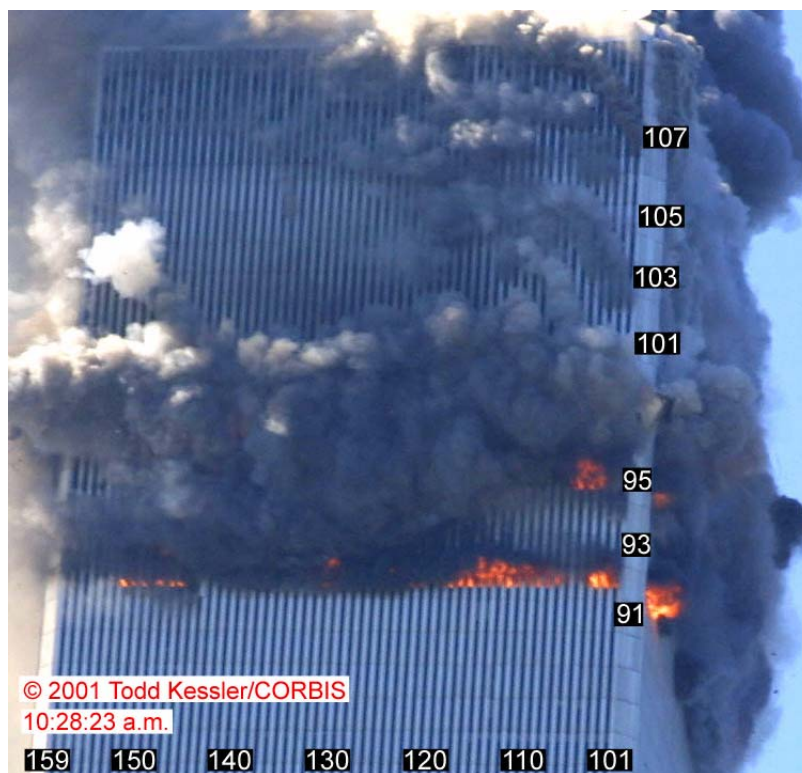
The photograph shown in Figure 8–101 was shot 1.4 s after WTC 1 began to collapse. The lines of dust visible coming from the 98th floor on the north and west faces of the tower may be an indication that the collapse began near this floor. As the building collapsed it acted as a piston, forcing air downward onto other floors. The resulting pressure increase forced gas flows out of open windows on lower floors. As a result of this process, fire and smoke were pushed out of the building.

**Figure 8-101.** This cropped photograph shows the north face of WTC 1 at 10:28:23 a.m. The image has been enhanced by adjusting the intensity levels. Column and floor numbers have been added.

In the photograph a large area of fire is being pushed from windows on the 92nd floor on the west side of the north face and the north side of the west face. This is the region where an intense fire had grown during the previous ten minutes or so. Fire is evident coming from windows across the large room on this floor with walls at columns 92-105 and 92-132 (see Figure B-1), as well as from the room in the northwest corner with internal walls at columns 92-455 and 92-105. The large volume of fire being pushed out of the windows provides an indication of how widespread the flames were in this area of the tower. Smaller flames are also visible coming from windows 92-146 to 92-152 on the eastern side of the

face. This indicates that fires had continued to burn in two of the small rooms located along the north face (see Figure B-1).

Flames were also pushed out of windows located in the northwest corner room on the 95th floor with walls at columns 95-108 and 95-456 (see Figure B-4). This is an area that had been burning earlier, but had appeared to have died down just prior to the initiation of the collapse. It is clear from this photograph that a significant fire was still burning in the immediate vicinity. The absence of visible fire being expelled elsewhere on the north face provides additional evidence that intense fires observed at other locations on the north face at earlier times had either died down or gone out.

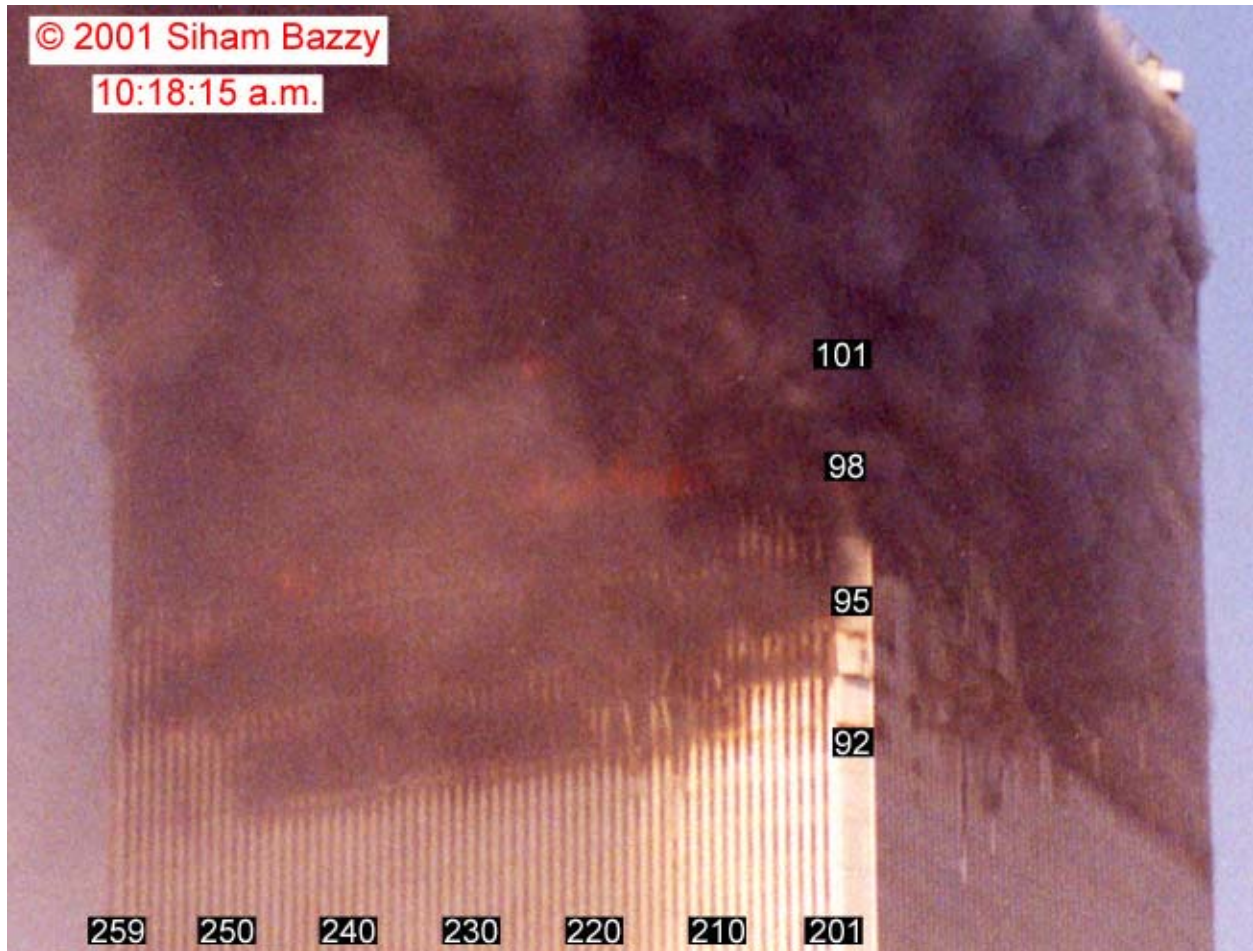
**Figure 8-102.** This cropped photograph showing the east and north faces of WTC 1 was shot at 10:18:15 a.m. It has been enhanced by adjusting the intensity levels. Column and floor numbers have been added.

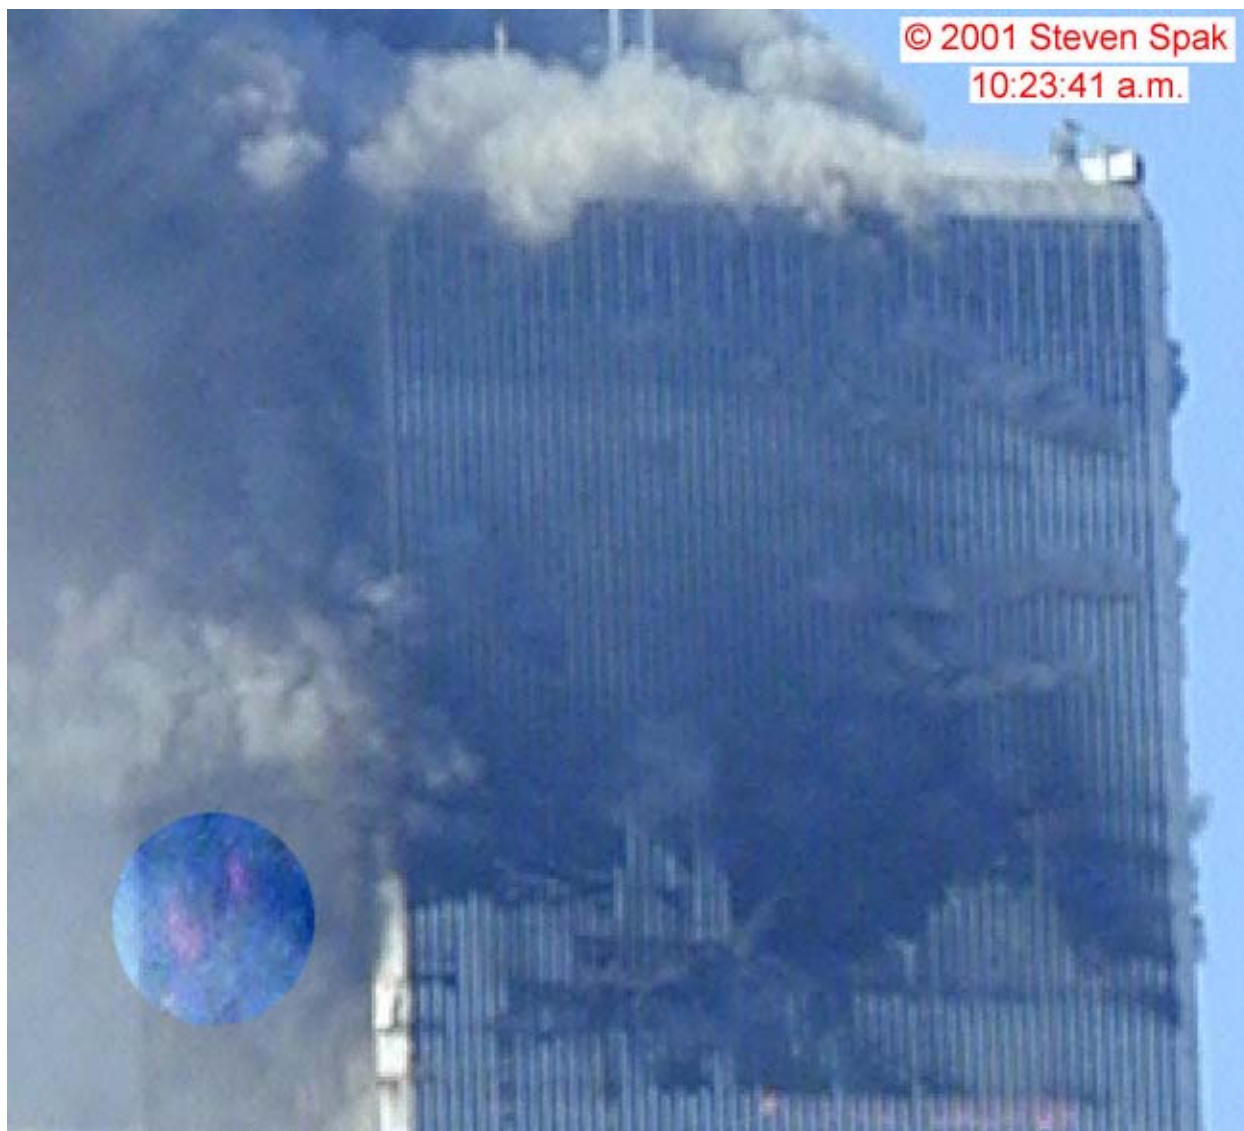
**Figure 8-103.** This cropped photograph shows the north face and an oblique view of the east face of WTC 1 at 10:23:41 a.m. The intensity levels in an area of the east face have been adjusted to highlight an area of extended flame.

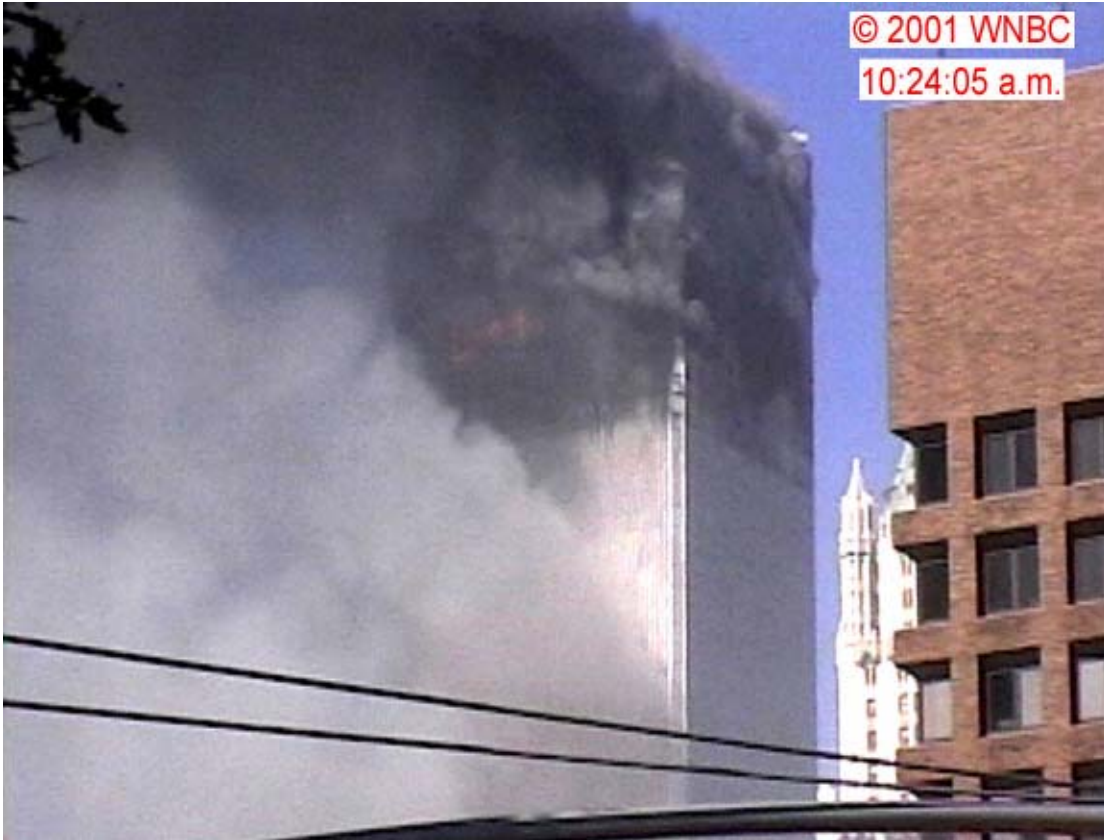
An image of the east face shown in Figure 8–104 taken from a video recorded at 10:24:05 a.m. provides another view of the fire burning on the south side of the 98th floor east face. Since this image was recorded from further east than Figure 8–103, it is easier to identify the location of the burning area. It does extend from near the center of the face toward the south. An area of fire on the 97th floor is visible immediately below. At 10:18:15 a.m. a similar area of fire was visible near window 97-245 (see Figure 8–102). This location is consistent with the apparent position of the fire in Figure 8–104. This suggests the intense fire present on the 98th floor roughly covers windows 98-230 to 98-245.

**Figure 8-104.** This frame was taken from a video recorded at 10:24:05 a.m. It was shot from the northeast and shows the north and east faces of WTC 1. The image has been enhanced by adjusting the intensity levels.

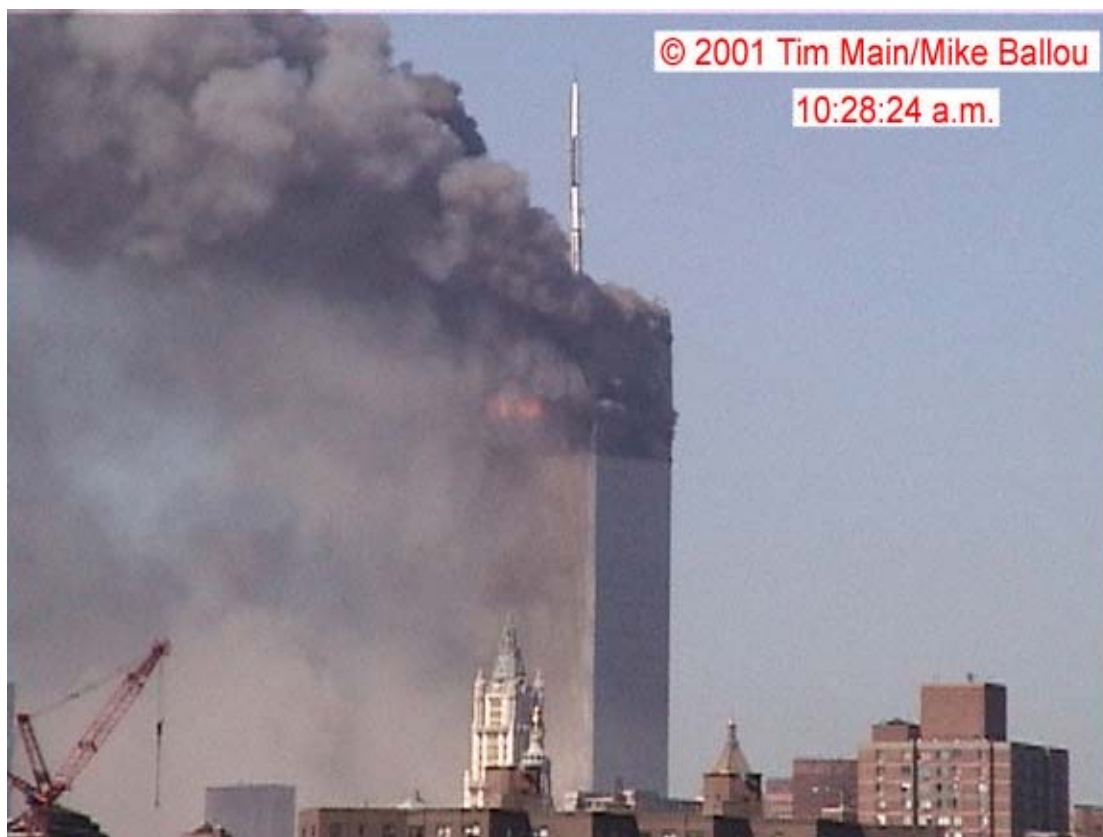
**Figure 8-105.** This frame taken from a video recorded at 10:28:24 a.m. shows WTC 1 from the northeast.
