**NIST NCSTAR 1-5A**

**Federal Building and Fire Safety Investigation of the  
World Trade Center Disaster**

# **Visual Evidence, Damage Estimates, and Timeline Analysis**

September 2005

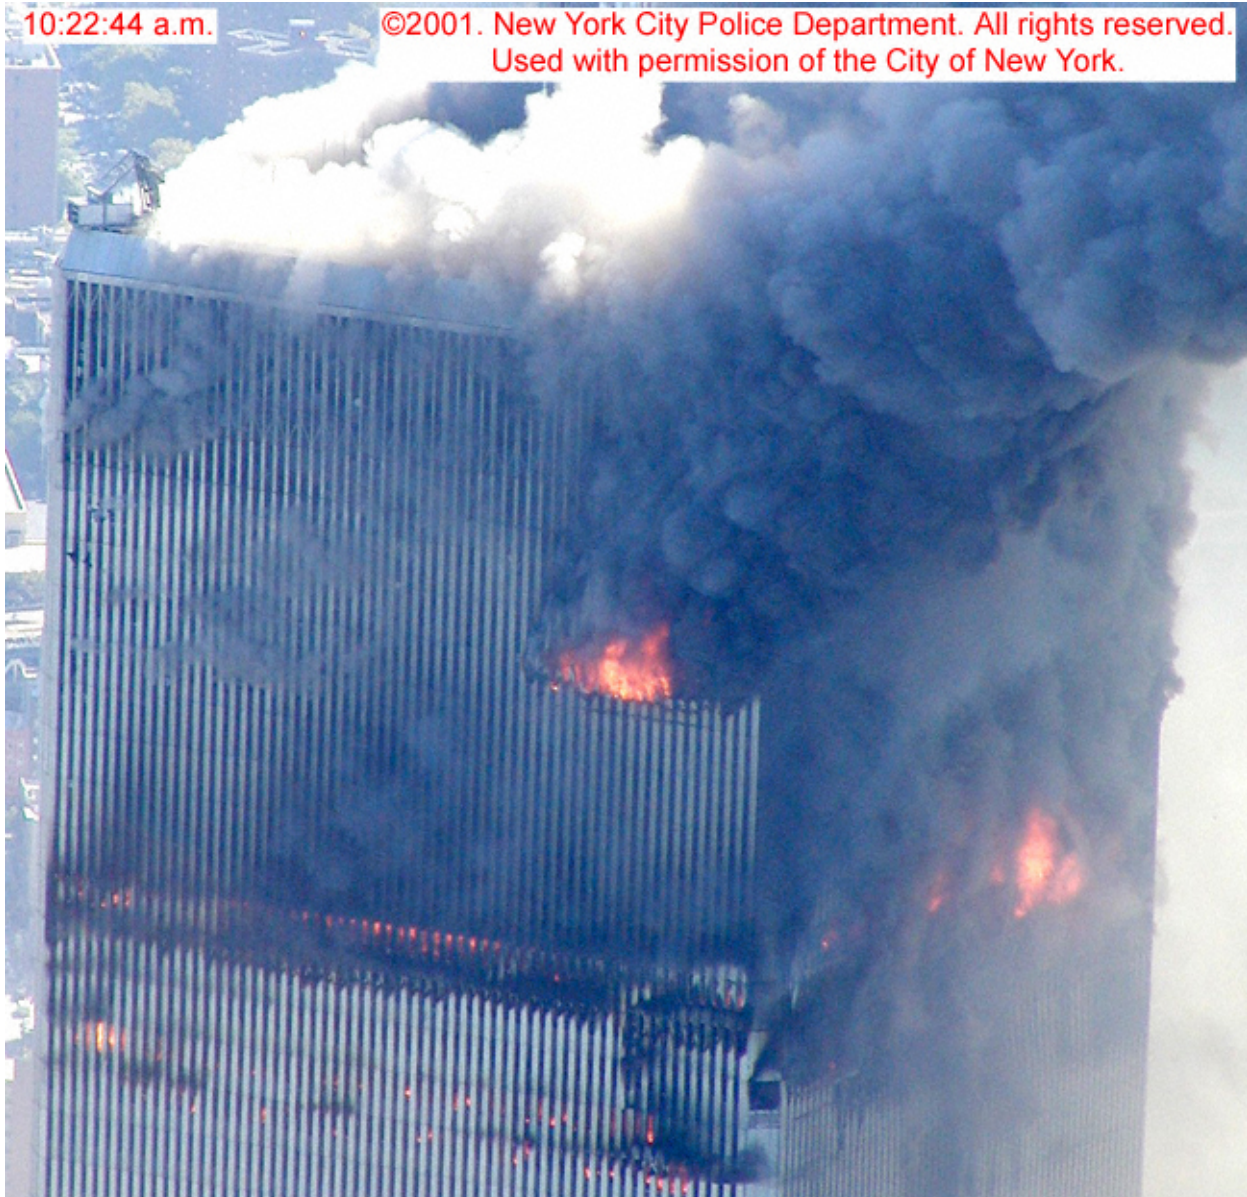
Figure 8-106 shows WTC 1 shot from the southwest at 10:22:44 a.m. The photographer was in a helicopter looking down on the tower. Individual floors are identifiable. Floor numbers can be assigned by noting that the floor with the missing aluminum panel on the southwest corner is the 96th floor. Fires are visible on both the south and west faces. Focusing on the south face, the most prominent feature is a flame jet emanating from an open window on the 98th floor on the east side. Flames are also coming out of nearby windows on this floor. Regions of fire are also visible on the 99th floor at locations starting on the west side of the face and reaching a position just to the east of the center of the face. From this angle, there are no flames evident on the 97th floor. Otherwise, the flame distribution is consistent with that described above.

**Figure 8-106.** This cropped photograph showing the south and west faces of WTC 1 was shot from a helicopter at 10:22:44 a.m. It has been enhanced by adjusting the intensity levels.

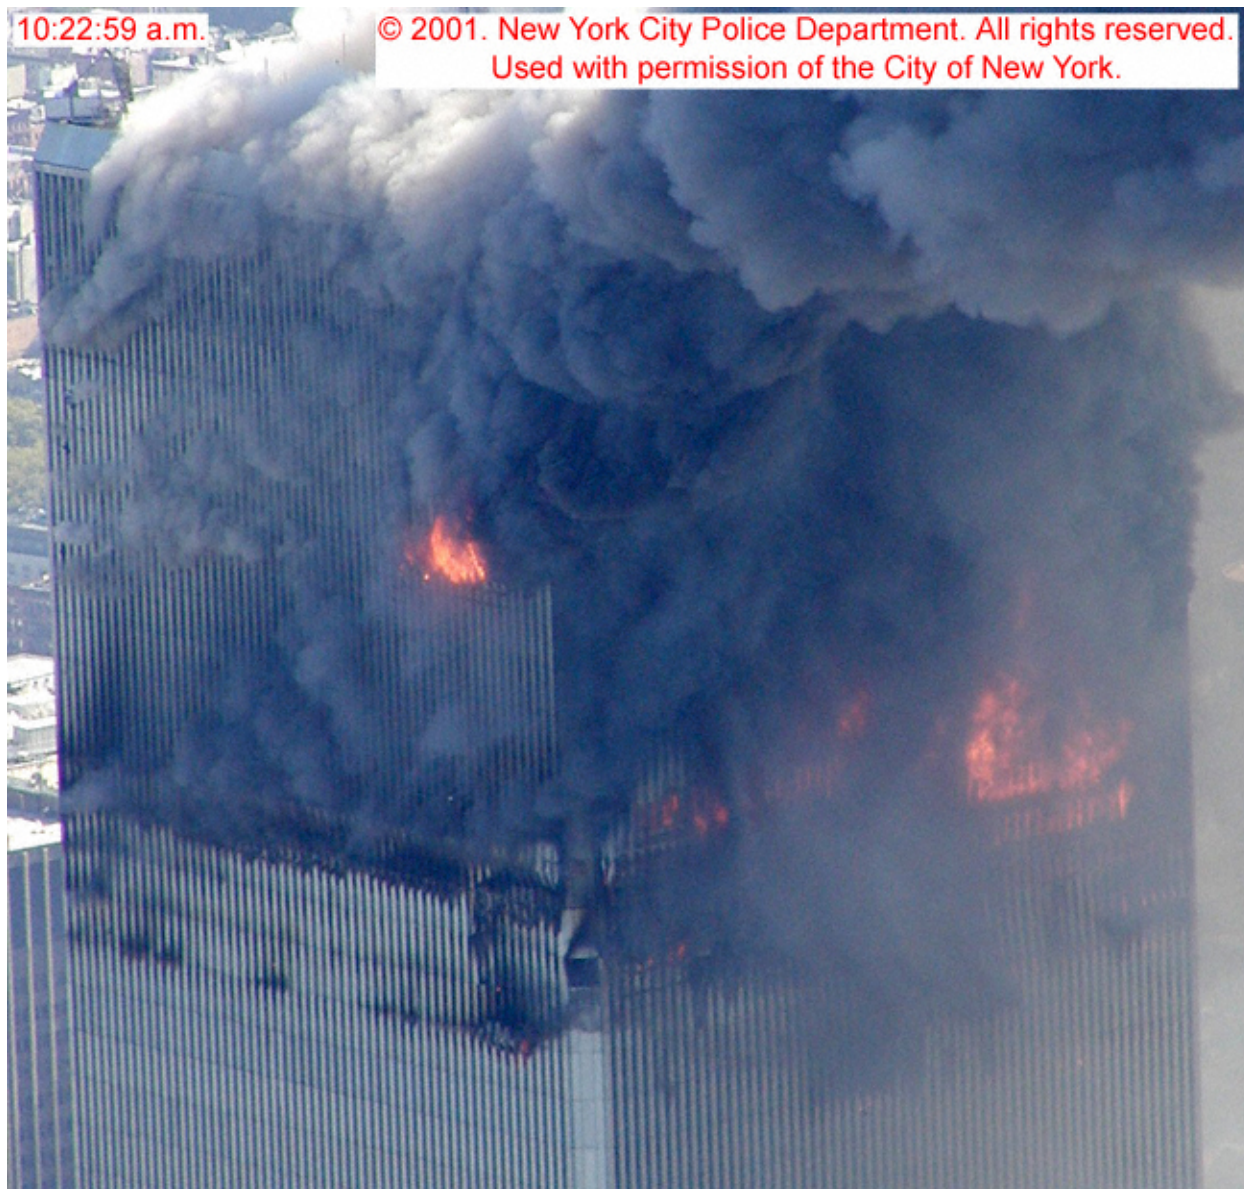
As the helicopter flew toward the south, the photographer continued to take pictures. Figure 8-107 shows a photograph taken 15 s later at 10:22:59 a.m. Since the helicopter was further south, this image has a more direct view of the south face than in Figure 8-106, and the view of the west face is from a more oblique angle. The fire distributions on both faces look quite different in the two photographs. This demonstrates the strong effects that the angle from which an image is taken can have on fire observations.

**Figure 8-107.** This cropped photograph showing the south and west faces of WTC 1 was shot from a helicopter at 10:22:59 a.m. It has been enhanced by adjusting the intensity levels.

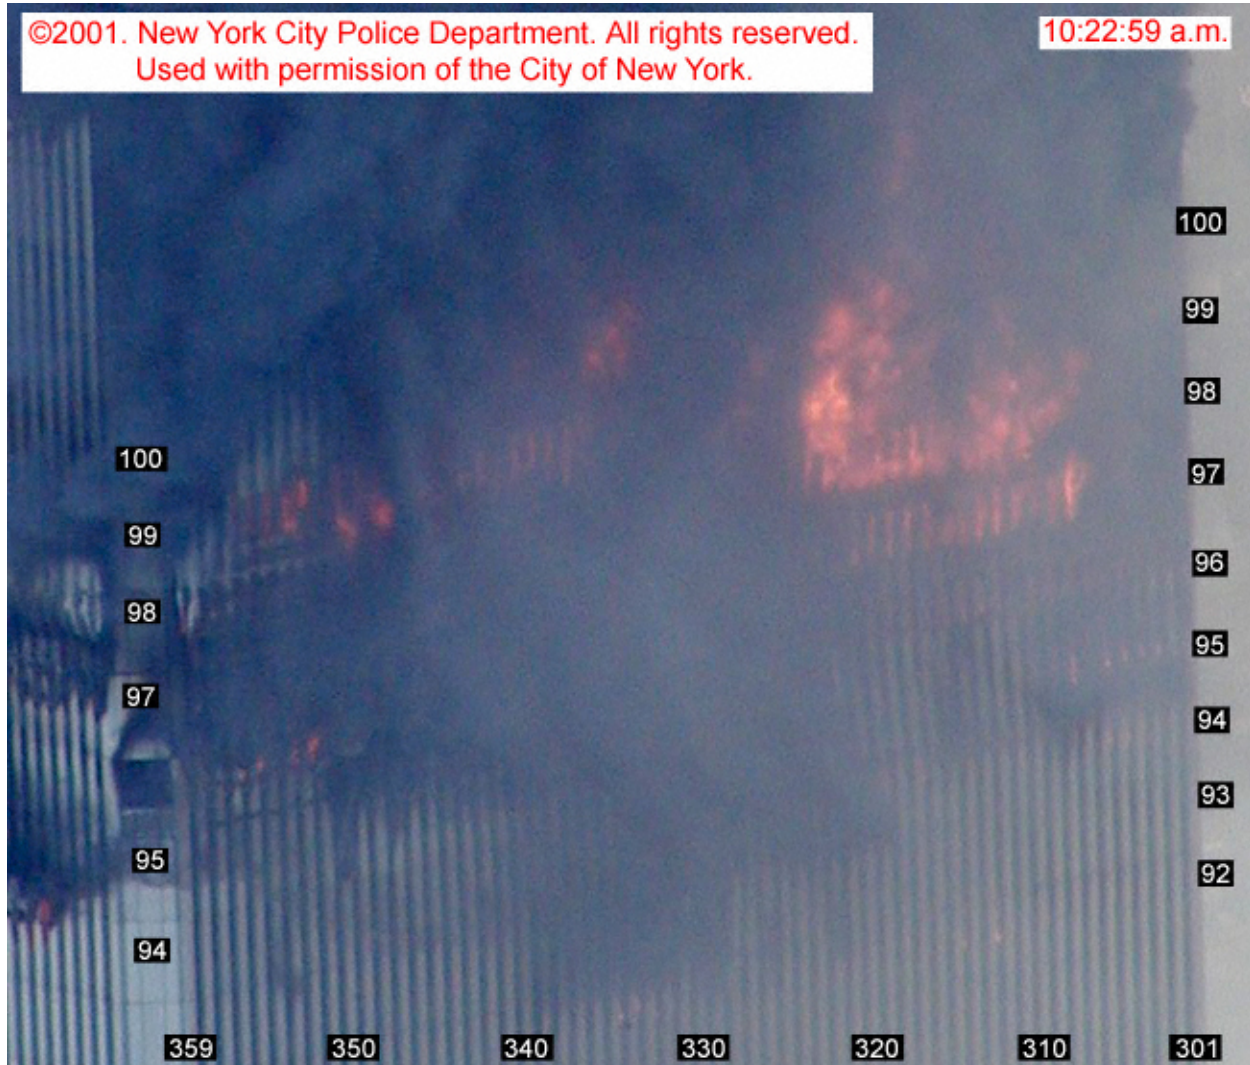
An important observation is readily apparent in Figure 8–108. Many of the columns on the south face in the vicinity of the 95th floor to 98th floors were bowed inward at this time. The easiest way to identify this bowing is to start lower down on the building and use your eyes to follow a particular column upward. The bowing appears as a curvature in the column. The bowing is most apparent on the eastern side of the face. It may be present on the western side as well, but it is more difficult to identify because of angular effects along with the blackening of the column covers on the western side of the face. Recall

that this blackening occurred as a result of the heavy smoke released on this side of the face by earlier fires on the 95th and 96th floors. The degree of column bowing is analyzed in the Investigation report dealing with the structural steel (NIST NCSTAR 1-3C) and compared with building response calculations in NIST NCSTAR 1-6.

Figure 8–108 shows that there were extensive fires on the south face of WTC 1 at 10:23 a.m. There is visual evidence for the presence of active fires on the 92nd floor upward through at least the 101st floor. Consistent with conclusions based on long-range images, the most intense fire is on the east side of the 98th floor. Flames that appear to be at least two stories in height are coming from windows 98-308 to 98-322. There are also large fires visible on the east side of the 97th floor and the west side of the

99th floor. On both floors the flames cover roughly half the width of the tower. In this photograph the flames on these floors do not appear to extend from the open windows. In reviewing the videos, it is clear that flames on both floors occasionally formed large external flares around this time. In fact, such a flare is visible coming from near window 97-308 in another photograph (not shown) taken from the helicopter at 10:22:50 a.m.

**Figure 8-108.** This photograph showing the south face of WTC 1 is a blowup of a portion of Figure 8-107. It was shot from a helicopter at 10:22:59 a.m. It has been enhanced by adjusting the intensity levels, and column and floor numbers have been added.

It is interesting that the fires on the 97th and 98th floors do not appear to have spread to the east end of the face. The last window with fire on the 97th floor appears to be window 97-308. A check of the floor plan layout in Figure B-6 shows that there was a room in the southeast corner of this floor with walls at columns 97-256 and 97-308. Recall that the fire spreading south on the east face of this floor did not appear to have reached the south edge at this time. These observations suggest that the walls of this room were acting as a fire barrier. A similar room was present and acting as a fire barrier on the 98th floor (see Figure B-7).

Smoke appears to be coming from the 93rd floor from roughly window 93-318 to window 93-324. These windows were closed earlier. Even though flames are not visible at this location, this suggests that there may be a fire burning nearby. Smoke is also coming from multiple windows on the 92nd floor, and small spot fires are evident in several windows, including 92-312, 92-314, 92-333, and 92-334. This suggests that fires that were initially ignited on the east side of the tower shortly after the aircraft impact on the 92nd floor have also worked their way to the south face.

At some point between 10:24:20 a.m. and 10:24:55 a.m., heavy smoke began to pour from one or more south face windows on the 94th floor near the west edge. A burst of external flame occurred in the area at 10:25:10 a.m. In Figure 8–108 heavy flames and smoke can be seen coming from window 94-405 on the west face at 10:22:59 a.m. This window was located in a southwest corner room with walls at columns 94-405 and 94-353 (see Figure B-3). These observations indicate that the fire moving south along the west wall of the 94th floor entered this room and created flashover conditions around 10:23 a.m.

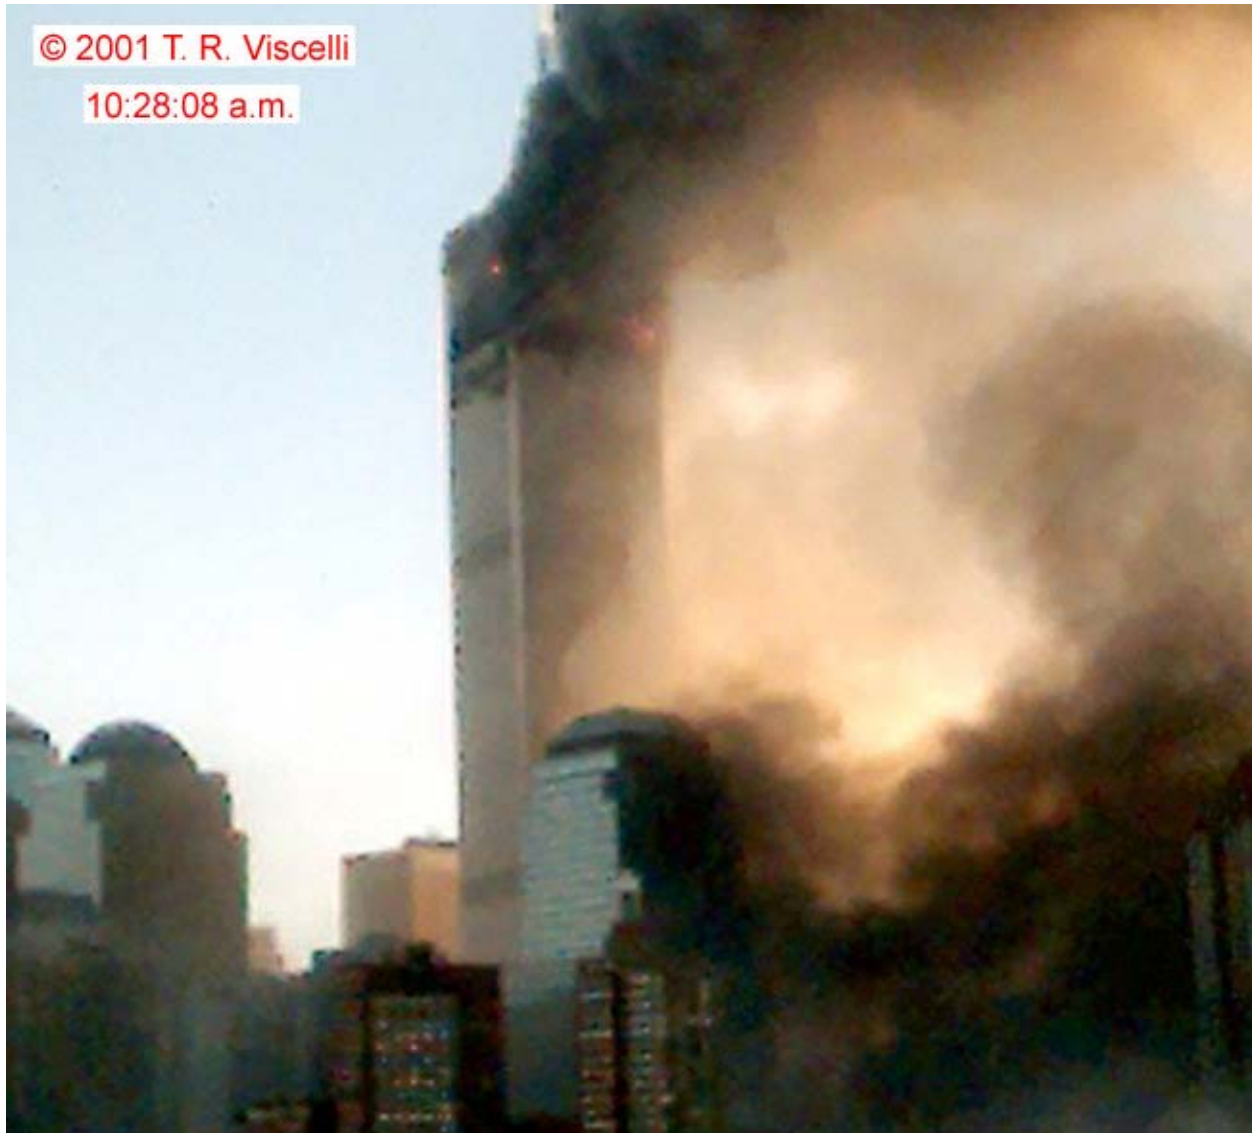
Figure 8–109 shows a long-distance photograph of WTC 1 that was shot at 10:28:08 a.m., i.e., 14 s prior to collapse. Even at this distance the intense fires burning on the east side of the south face on the 98th and 99th floors are readily apparent.

**Figure 8-109.** This cropped photograph taken from the south southwest shows WTC 1 at 10:28:08 a.m.

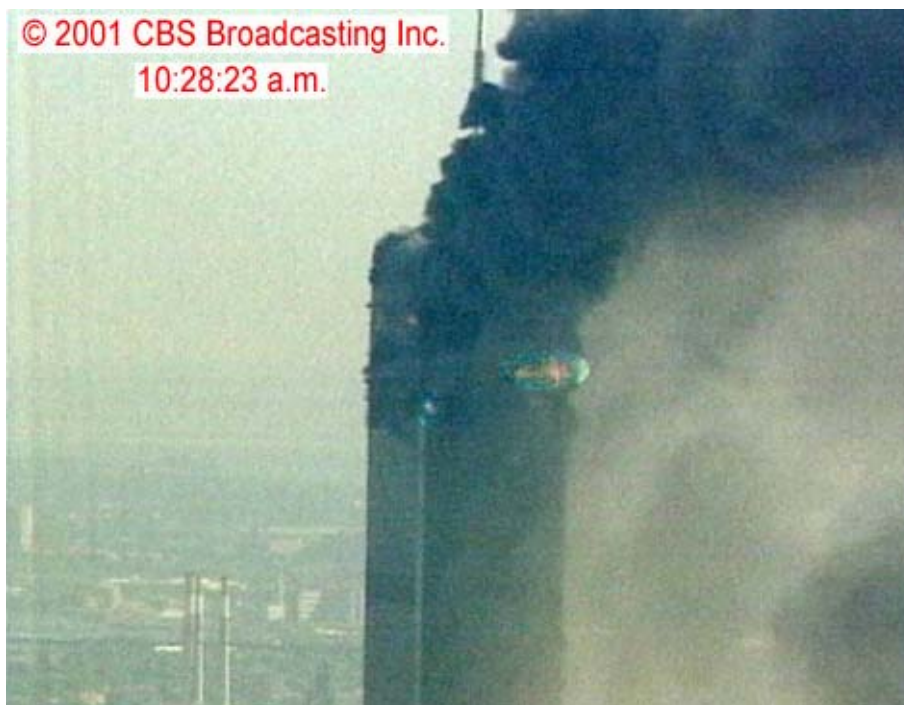
At 10:28:22 a.m. WTC 1 began to collapse. Unfortunately, the long-distance helicopter video is not particularly clear at this time. Even so, it is possible to see a large amount of flame being pushed from the tower on the south face by the pressure increase due to the collapse. The expelled fire appears to come from three separate locations on the south face. The first is from the vicinity of the intense fire burning on the east sides of the 98th and 99th floors. The second is from the fire burning on the western edge of the 94th floor. The location of the third area was more difficult to identify. It appears to come from the center of the eastern half of the face from near the 94th floor. It created a huge flame that at first was driven downward. So much fuel and heat were pushed out of the tower that a fireball formed and began to rise. The fireball burned out nearly 4 s after the collapse began.

**Figure 8-110.** This image showing the south face of WTC 1 was taken from a video shot from a news helicopter at 10:28:23 a.m. The intensity levels of the image have been adjusted. Two areas showing flames that were pushed out of the tower as it started to collapse are highlighted.

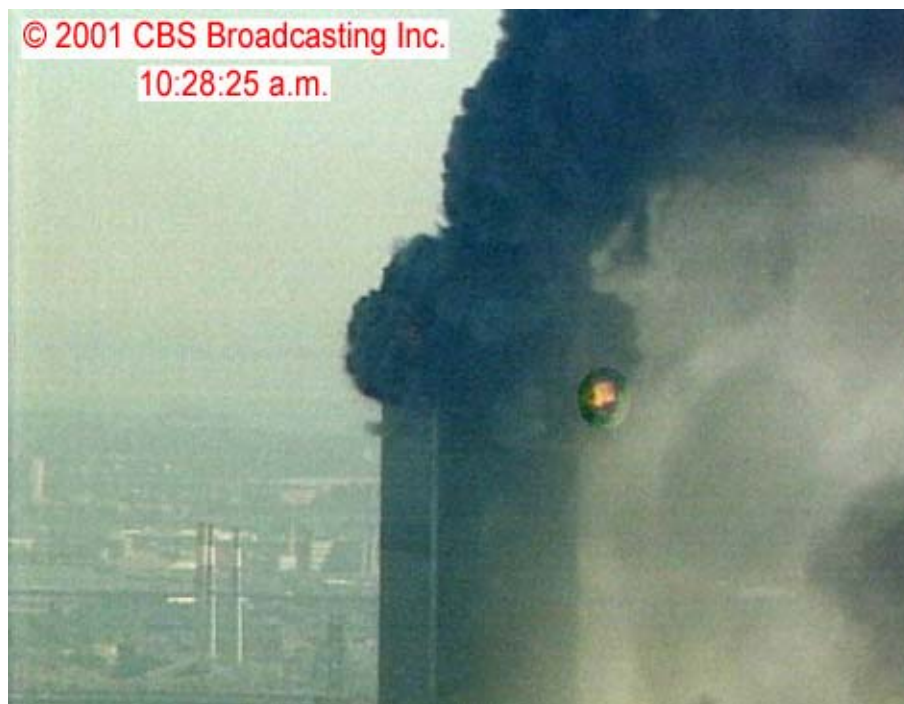
**Figure 8-111.** This image showing the south face of WTC 1 was taken from a video shot from a news helicopter at 10:28:25 a.m. The intensity levels of the image have been adjusted. An area showing a fireball generated by fire pushed from the tower by the collapse is highlighted.

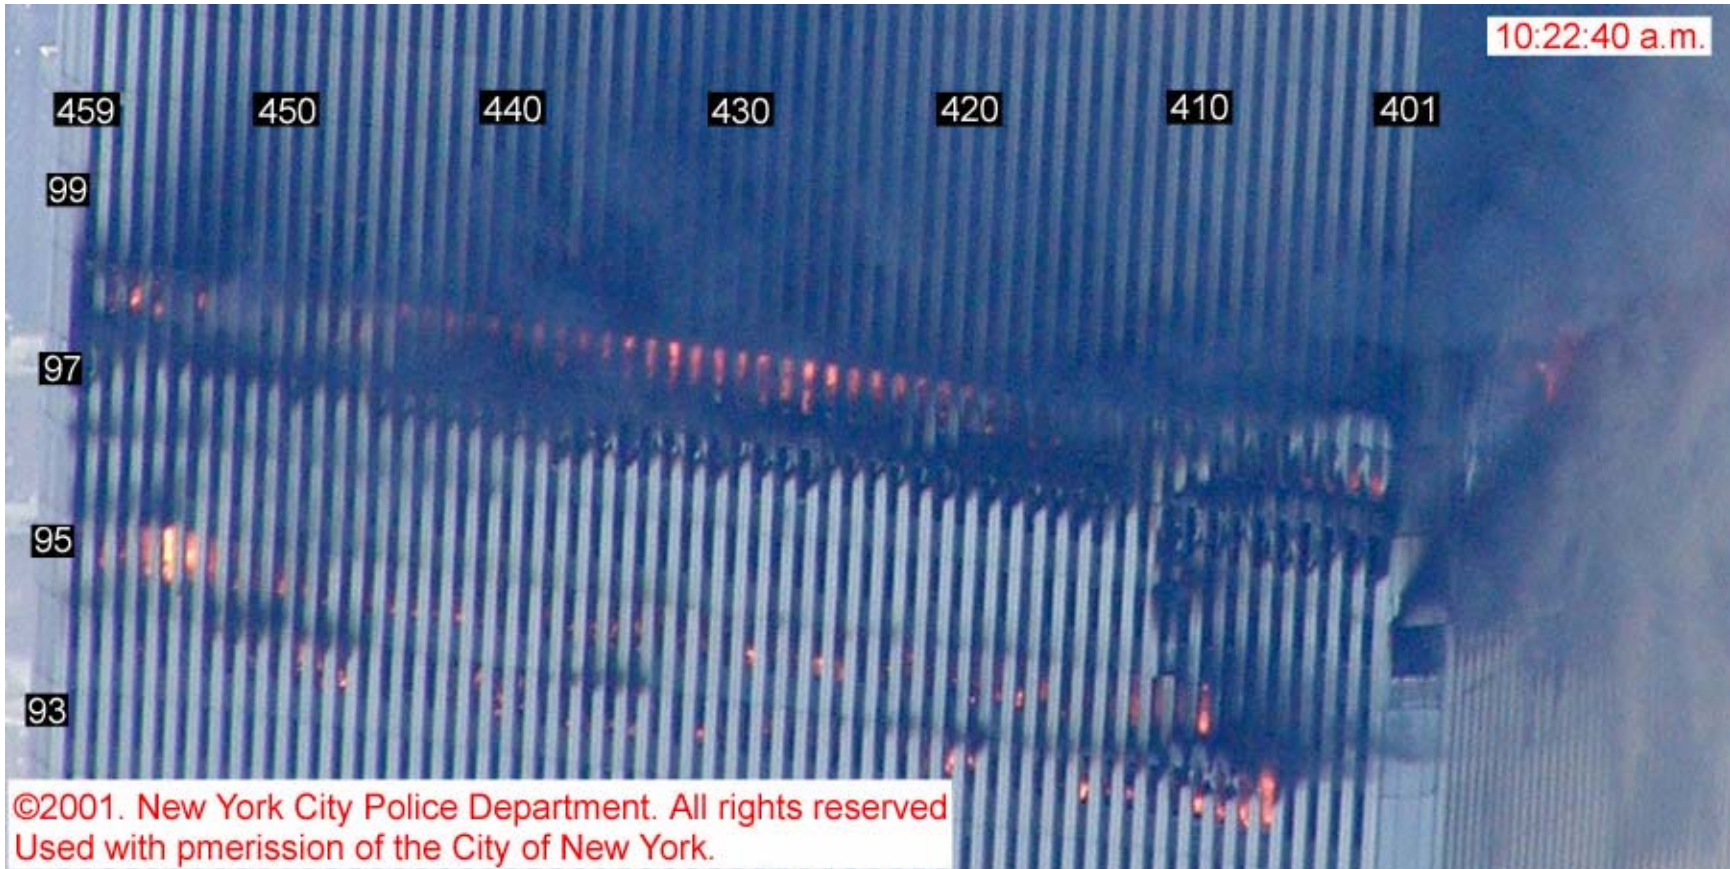
A close-up photograph of the west face taken at 10:22:40 a.m. from a helicopter looking down on the tower is shown in Figure 8–112. Fires are visible on the 94th, 95th, and 98th floors. In general, the fire distributions are consistent with the discussion immediately above.

On the 94th floor fires can be seen at many locations between windows 94-405 and 94-448. Most of the fires are burning at isolated locations near the floor. The only window where flames are protruding out is 94-405. The presence of carets on nearby column covers is consistent with the intense fire seen earlier at windows 94-407 and 94-408. The smoke marks at the tops of the column covers indicate that at many locations only light smoke or no smoke had passed through the open windows. This agrees with earlier observations that the fires burning on the west side of the 94th floor were relatively gentle at most locations. In Figure 8–112 windows 94-438 to 94-441 appear to be open, and flames are visible in windows 94-438 to 94-440. These windows were clearly intact at 9:47:34 a.m. in Figure 8–72. The floor plan layout in Figure B-3 indicates that these four windows were located in a room with walls at columns 94-438 and 94-441. Fire had clearly spread into this room since 9:48 a.m. Many other windows on this floor that had intact glass at the earlier time are also open in Figure 8–112.

Figure 8-112. This cropped photograph was shot from a helicopter at 10:22:40 a.m. and shows the west face of WTC 1 from above. The image has been enhanced by adjusting the intensity levels, and column and floor numbers have been added.

Fires are visible on the 95th floor over most of the length of the west face. At most locations the fires look similar to those on the 94th floor, appearing to burn with low intensities near the floor. Exceptions are the most intense flames located in the room having walls at columns 95-452 and 95-456 (see Figure B-4) and the fire in windows 95-408 to 95-411. The fire on the north side has already been described, while the fire on the south side is located next to a room with walls at columns 95-404 and 95-408. Over most of this floor there are no smoke marks on the column covers despite the wide spread fires. This observation most likely means that the smoke from fires on this side of the 95th floor vented within the building elsewhere.

From the angle from which Figure 8-112 was taken the internal fires on the 98th floor are only visible near the center of the floor and at a few locations on either end. This fire has clearly died down considerably since Figure 8-92 was taken at 10:18:01 a.m. Carets are visible at the tops of the column covers near the two ends, but very little marking is evident elsewhere. This suggests that the only places flames came out of windows were from fires burning inside the corner rooms (see Figure B-7). Consistent with earlier observations, the absence of column cover marks elsewhere indicates that neither fire nor smoke flowed from most 98th floor windows on the west face where fire was present.

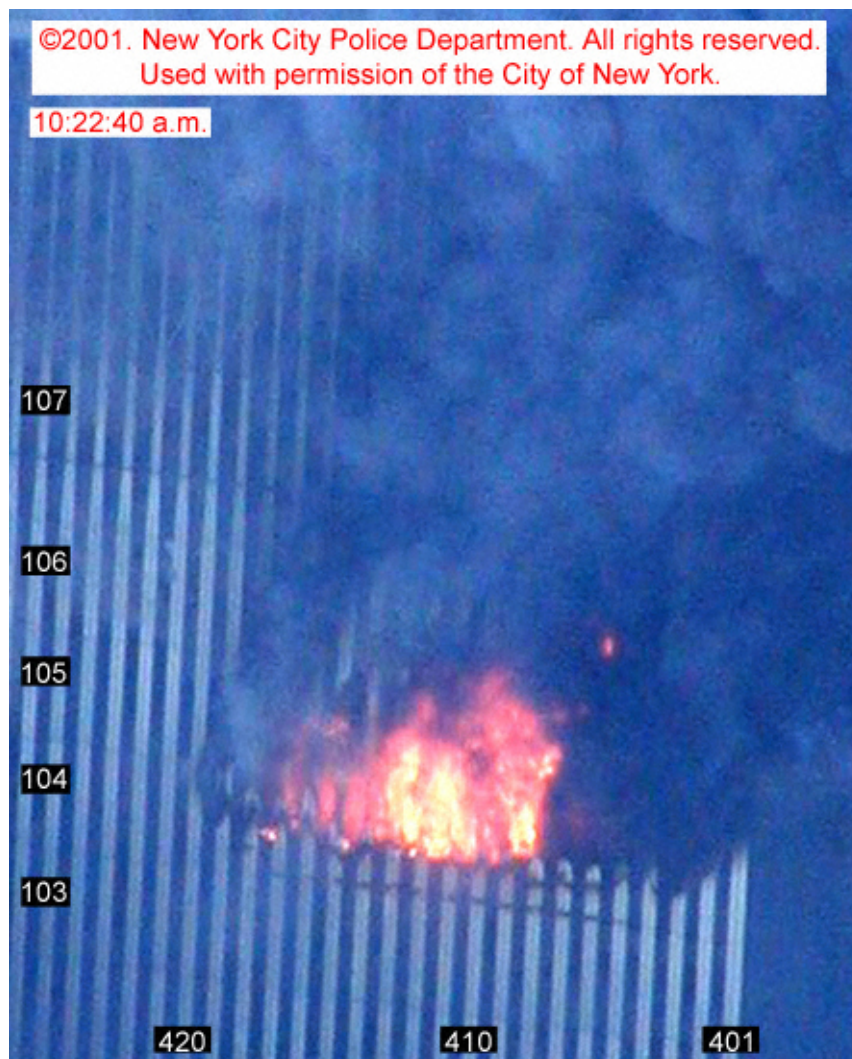
An image of the fires on the 104th floor at 10:22:40 a.m. is shown in Figure 8-113. It was cropped from the same photograph as Figure 8-112. It shows that after first appearing twenty minutes earlier, this fire continues to burn very intensely with long flames extending out of the windows. Visible flames and column cover smoke marks indicate this fire has burned from window 104-403 to window 104-418. Despite the intensity of the fire, it has not spread significantly since its initial growth period, as indicated by comparison with earlier photographs.

**Figure 8-113.** This cropped photograph shows a view of the west face of WTC 1 shot looking down from a helicopter at 10:22:40 a.m. The image has been enhanced by adjusting the intensity levels, and column and floor numbers have been added.

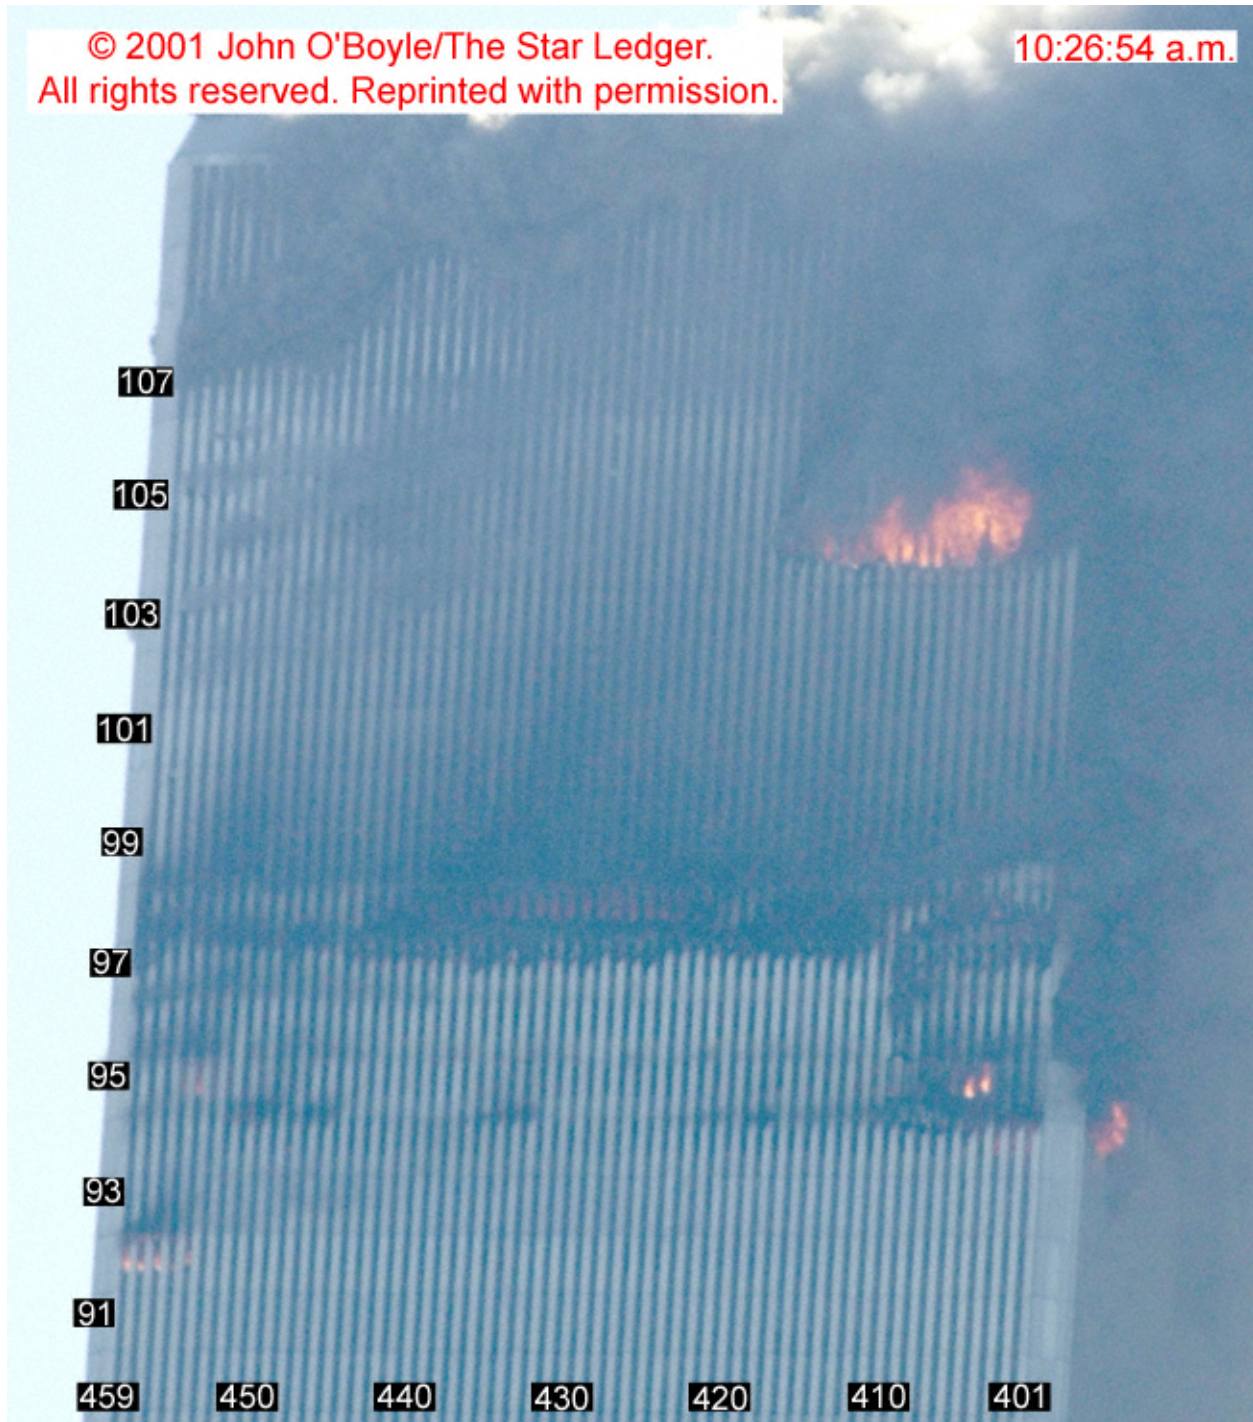
Close-up imagery of the west face over the next several minutes was very limited. Figure 8-114 shows an image of the face recorded at 10:26:54 a.m. that provides sufficient resolution to resolve windows and floors. Fires are visible at several locations on the face. Some changes have taken place since Figure 8-112 was taken at 10:22:40 a.m. Fire has appeared in the two adjacent rooms nearest the northwest corner of the 92nd floor (see Figure B-1), which have walls at columns 92-452 and 92-455 and share an east wall that terminates at column 92-105. Flames are now present in windows 92-454 to 92-458. Videos shot from the northwest and southwest show that heavy smoke first appeared in this area at 10:25:21 a.m. As already discussed, a similar stream of smoke came from window 92-101 on the north face at 10:24:26 a.m. These observations indicate that flashover occurred in these rooms around this time.

Flames are also visible in Figure 8–114 on the 94th floor in windows 94-101 to 94-104 that were not visible in Figure 8–112. This is consistent with the conclusion (discussed above) that flashover occurred in the southwest corner room of this floor (see Figure B-3) around 10:23 a.m. Flames also extend a significant distance from open windows in this room on the south face.

The interior fire near the center of the 98th floor is still visible in Figure 8–114. Flames are also visible in the windows located in the room on the 95th floor that had walls at columns 95-452 and 95-456, but the flames appear to have died down somewhat since 10:22:40 a.m. The flames seen at other locations on the

94th and 95th floors in the earlier photograph are not apparent at the later time. This is not surprising since this photograph was shot from the ground, albeit at a large distance, and fires burning near the floors should not be visible.

Figure 8-114. This cropped photograph showing the west face of WTC 1 was taken at 10:26:54 a.m. The image has been enhanced by adjusting the intensity levels, and column and floor numbers have been added.

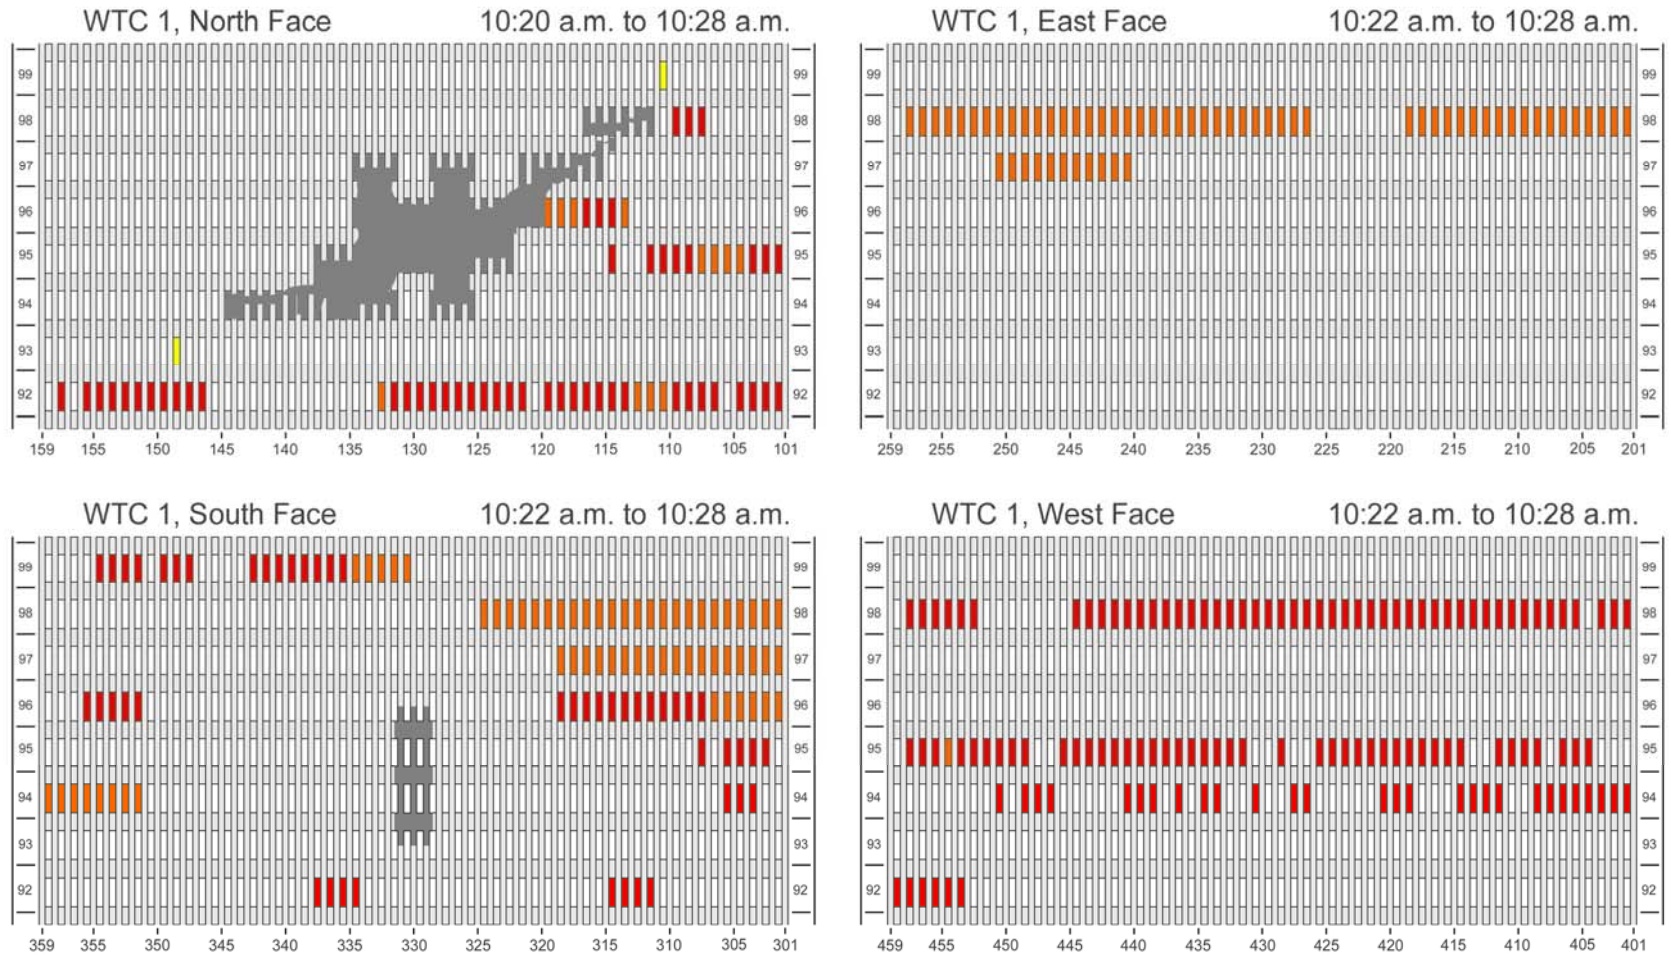
On the east face a very intense flame developed on the south side of the 98th floor during the final ten minutes of the event. The external flames generated by this fire were some of the largest observed coming from WTC 1. It is likely that fires continued to burn on other floors on this side of the tower, but the imagery was not sufficient to create a complete record of these fires. There is evidence that a fire developed on this side of the 101st floor (not shown in figure).

During the final ten minutes before collapse very large fires were burning on multiple floors on the eastern side of the south face. This was the area that had been relatively isolated from fire during the first hour of the event. The fires on the 98th and 99th floors were particularly intense. The fire on the 99th floor appeared to have migrated from the west side of the face. The source of the 98th floor fire is more problematic since intense fires were observed earlier on this floor on the west side of the south face and at roughly the same time on the nearby east face. Whatever the source, the presence of extended regions of external flames on both the east and south faces shows that the fires in the southeast quadrant of the 98th floor were particularly intense during the period immediately prior to collapse.

Figure 8-115. Maps of integrated fire observations between 10:20 a.m. and 10:28 a.m. are shown for the four faces of WTC 1. Colors represent the highest intensity fire observed in a window using the color scale defined in Figure 5-1.

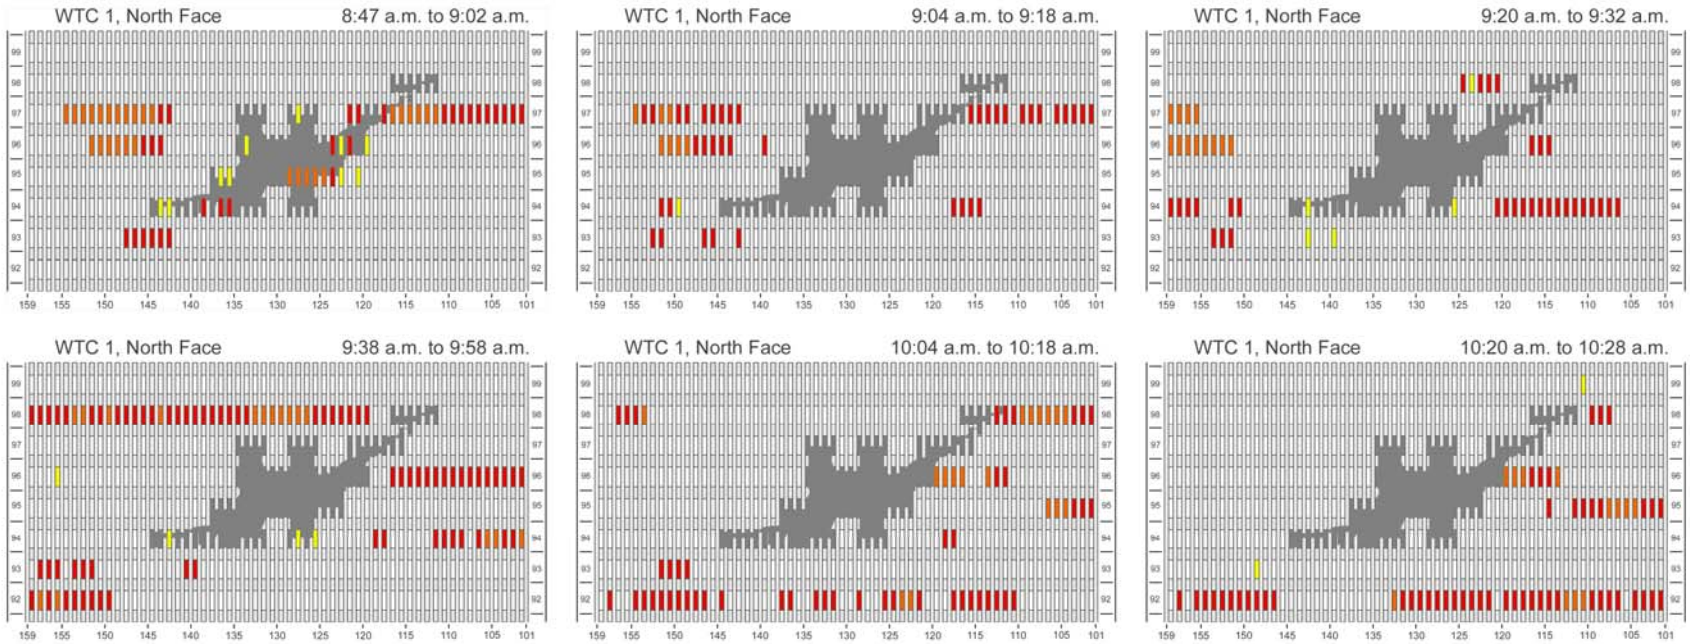
**Figure 8-116.** Maps of integrated fire intensity data for the north face of WTC 1 are plotted in sequence for the six time periods. Colors represent the highest intensity fire observed in a window using the color scale defined in Figure 5-1.

During the 17 min period after 9:18 a.m., a considerable amount of fire spread was observed on the north face of WTC 1. Fires first appeared in the northeast corner rooms on the 96th and 97th floors, after

Unlike the fires that developed on the north face shortly after the aircraft impact, the fires that grew and spread during the 9:18 a.m. to 9:35 a.m. period generally did not generate external flames or release heavy smoke through the windows. The exceptions were fires burning inside the rooms on the northeast corner rooms.

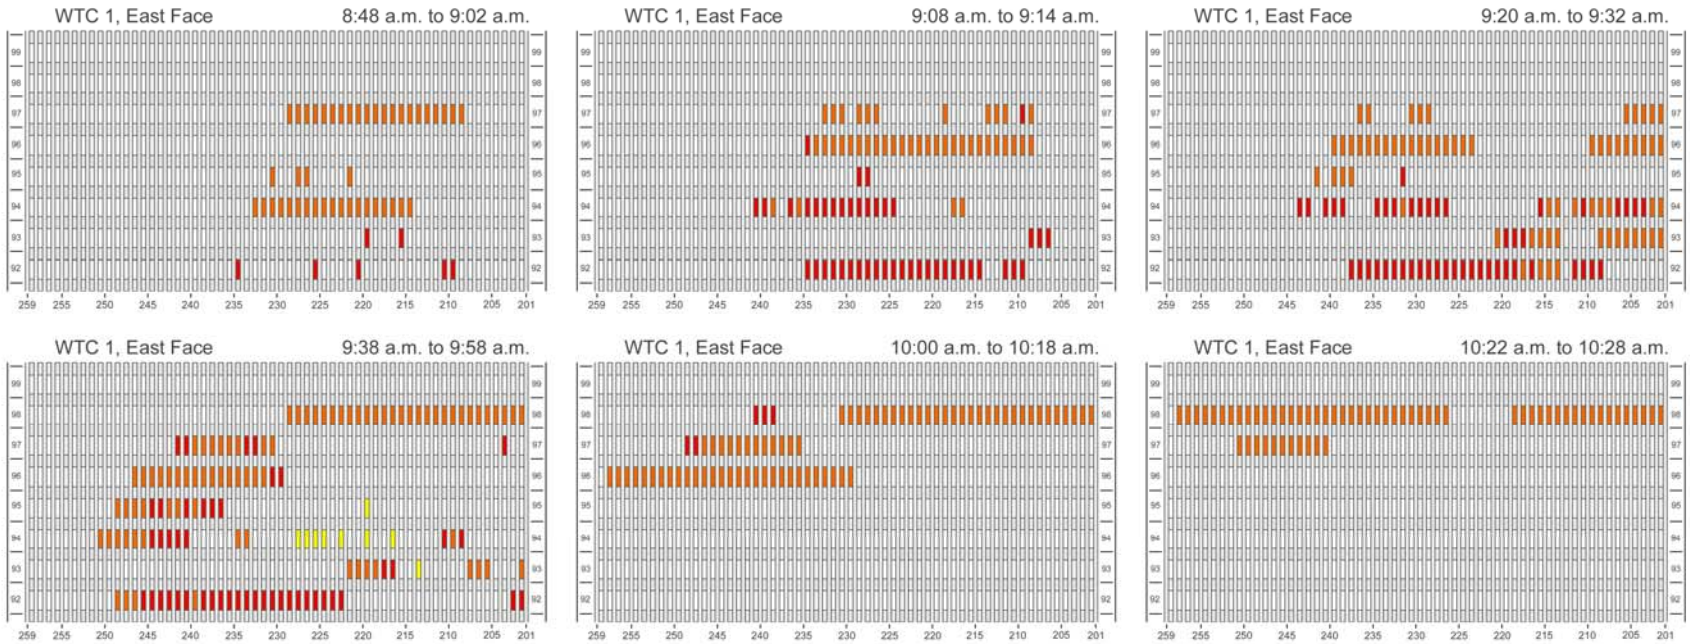
**Figure 8-117. Maps of integrated fire intensity data for the east face of WTC 1 are plotted in sequence for the six time periods. Colors represent the highest intensity fire observed in a window using the color scale defined in Figure 5-1.**

The fires burning in the northeast corner rooms on the 93rd, 94th, 96th, and 97th floors also opened the windows on the east sides of these rooms. At the beginning of the period, large fires were burning near the centers of the 92nd and 96th floors on the east side of the tower. Similar fires that had started earlier on the 94th and 97th floors were beginning to die down. By the end of the period, most of the fires near the center of the face were decreasing in intensity. On the 94th, 96th, and 97th floors the fires had begun spreading relatively slowly toward the south edge of the face. The life cycle of these fires—initial growth, intense burning, and decay phase—caused the fires moving toward the south to develop a wave-like appearance. Unlike the fires on the north face, fires burning on the east face often extended out of the windows and created heavy smoke flows.

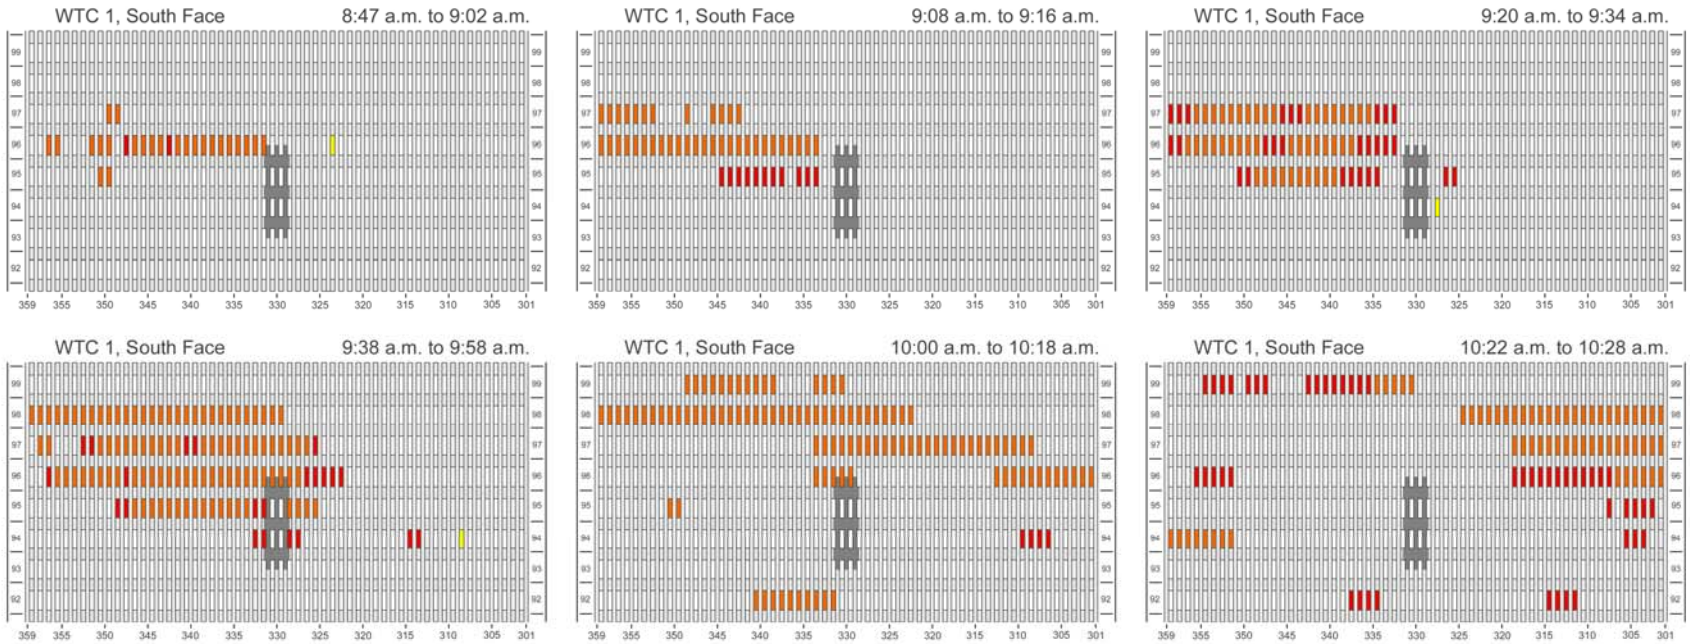
**Figure 8-118.** Maps of integrated fire intensity data for the south face of WTC 1 are plotted in sequence for the six time periods. Colors represent the highest intensity fire observed in a window using the color scale defined in Figure 5-1.

Intense fires generating external flames and copious quantities of smoke burned over the western halves of the 96th and 97th floors on the south face between 9:18 a.m. and 9:35 a.m. During the period, the burning on both floors appeared to pass through a maximum intensity, and the fires were beginning to subside by 9:35 a.m. A fire of similar intensity had grown to cover over 40 % of the length of the 95th floor, extending as far west as window 95-350. A small fire was also visible on the 95th floor just to the east of the center of the face. This was an early indication of fire spread from the center of the south face towards the east.

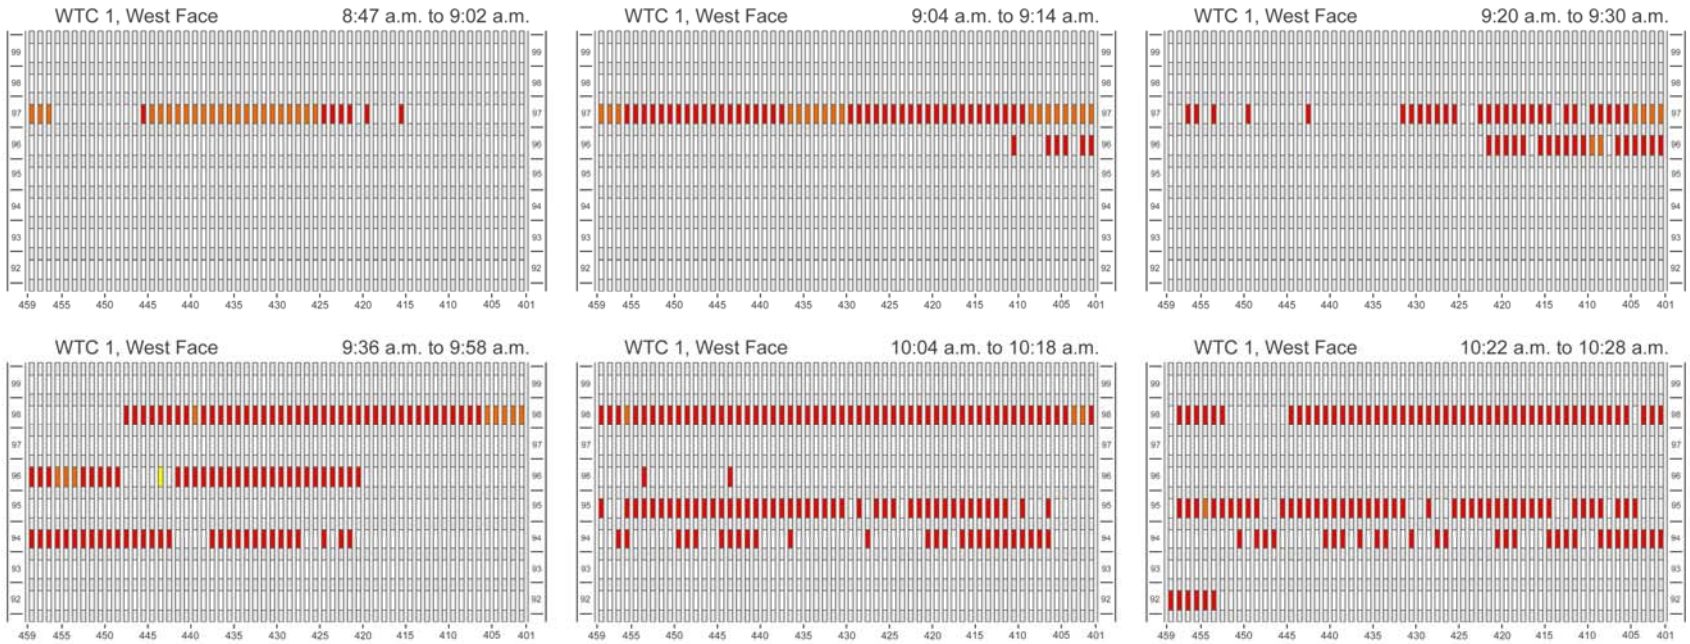
**Figure 8-119. Maps of integrated fire intensity data for the west face of WTC 1 are plotted in sequence for the six time periods. Colors represent the highest intensity fire observed in a window using the color scale defined in Figure 5-1.**

Fires were visible on the west face on the 96th and 97th floors. Large fires were present at the southern edge of the face on both floors. Elsewhere on the 97th floor, the intense fires that had earlier covered the entire face continued to die down, and only low intensity flames were visible. Flames with similar intensities were visible burning on the 96th floor, but, unlike on the 97th floor, this fire was spreading slowly to the north. By 9:35 a.m., the flames had reached a location near the center of the face. The difference in burning behaviors between the intense fire that had earlier spread rapidly south on the 97th floor and the relatively low intensity fire that was spreading north on the 96th floor is notable.
