**NIST NCSTAR 1-5A**

**Federal Building and Fire Safety Investigation of the  
World Trade Center Disaster**

# **Visual Evidence, Damage Estimates, and Timeline Analysis**

September 2005

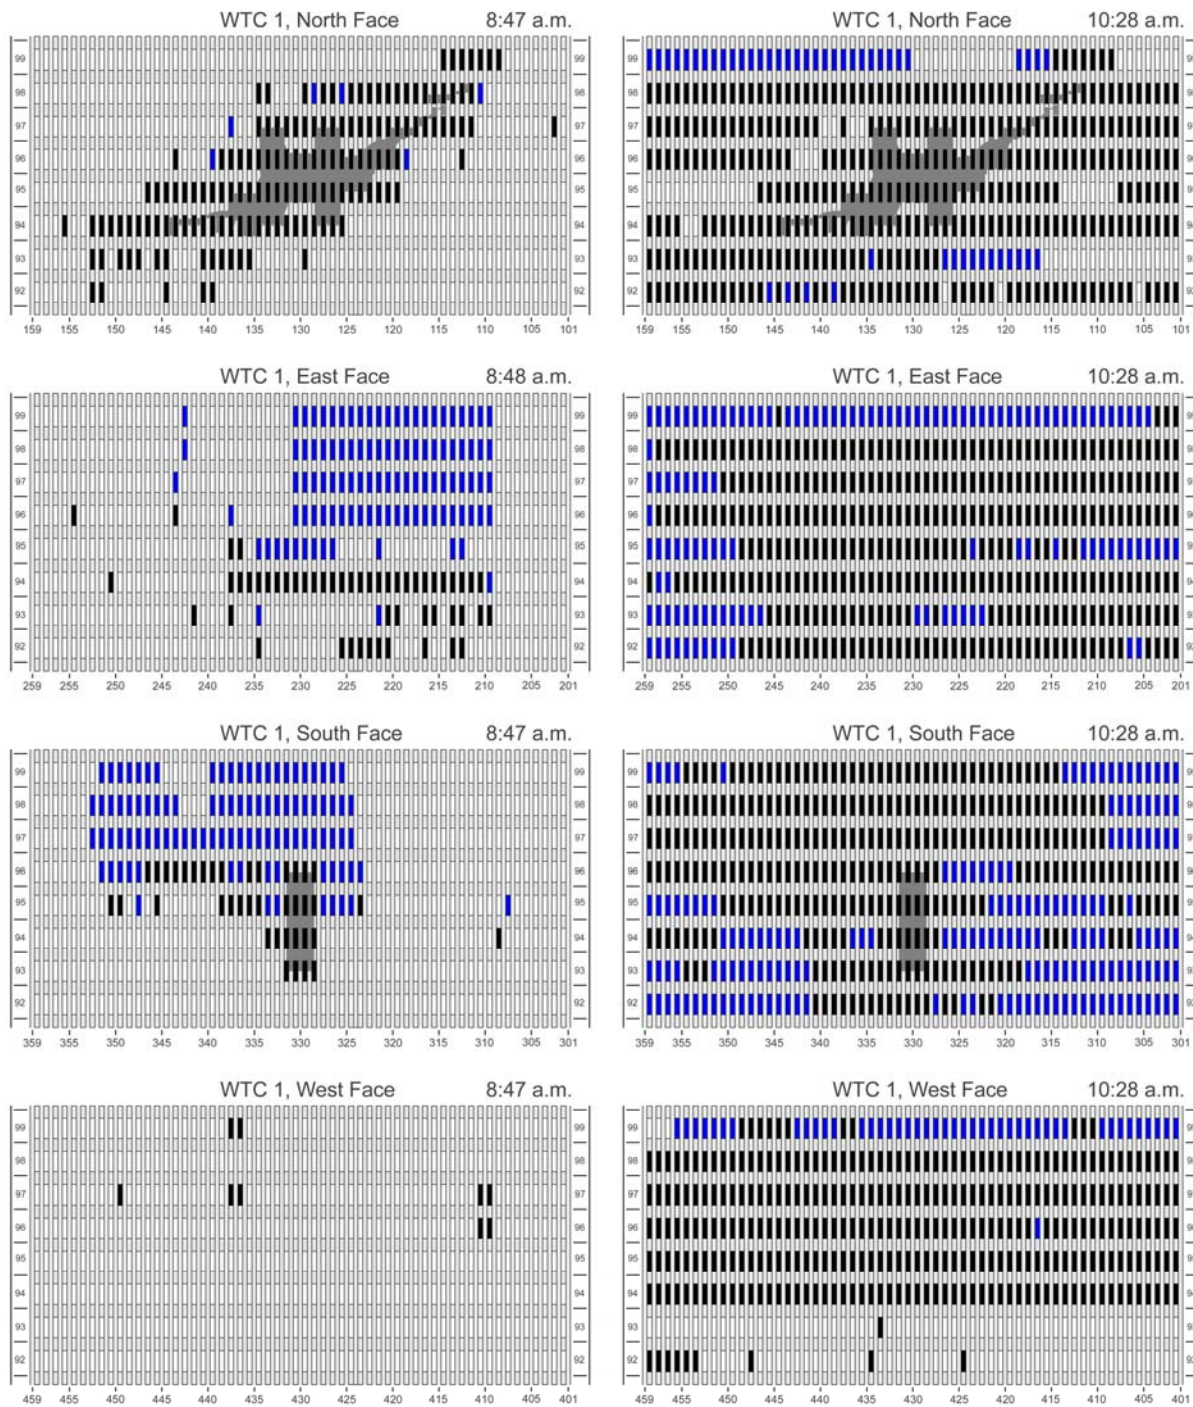
The information shown visually in Figure 8–120 is summarized numerically in Table 8–4 and Table 8–5. These two tables are similar to Table 8–2 and Table 8–3, which were generated using data from shortly after the aircraft impacted WTC 1 and just prior to the collapse of WTC 2. The results indicate that the total number of open windows on these floors increased by roughly 333 windows between 9:59 a.m. and 10:28 a.m. The increase in the number of open windows between the time from shortly after the aircraft struck WTC 1 and the collapse of the tower was approximately 1,048 windows, or a factor of 4.2. This corresponds to an increase in the open area on the façade available to provide air to the fires on these floors of around 12,190 ft<sup>2</sup>.

**Figure 8-120. Maps for the 92nd through the 99th floors compare missing windows for the four faces of WTC 1 at two times, immediately following the aircraft impact at 8:46:30 a.m. and just prior to the collapse of WTC 1 at 10:28:22 a.m.**

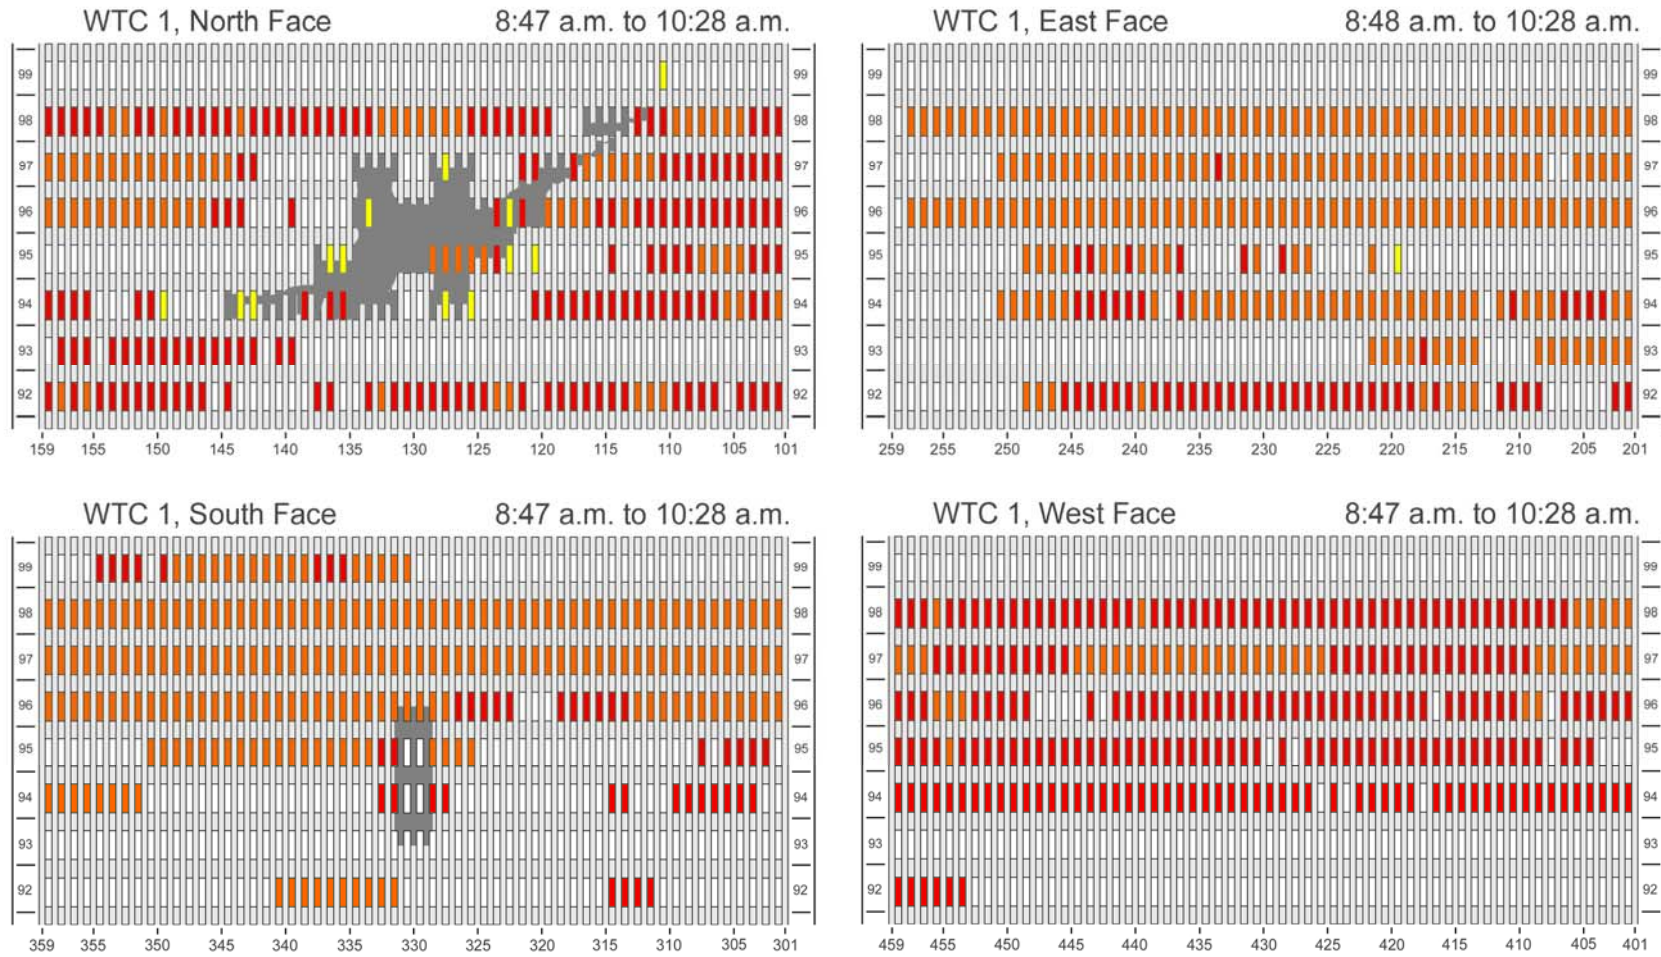
The results in the fire data sheets have been utilized to generate integrated fire data for the entire period between the aircraft impact and the collapse of WTC 1. The results are shown graphically in Figure 8–121 for the four faces of the tower. These maps demonstrate the extensive area of WTC 1 that was subjected to fire. Comparison with Figure 6-19, which shows the fire distribution on the four faces shortly after the aircraft impact, provides a graphic illustration of the amount of fire spread and growth that occurred. The relative numbers of windows in Figure 8–121 where external flames (orange) were observed compared to the total number of windows with observed fire reflects the differences between fire behaviors on the west and north faces as compared to the east and south faces, where external flaming was much more likely.

In contrast to the behavior on the west and north faces, fires burning on the east and south faces often generated heavy amounts of smoke and external flaming at nearby windows. It was common to observe many adjacent open windows with long extended flames. The tops of nearby column covers were often marked with carets. Examples of such fires were observed on the 94th, 96th, 97th, and 98th floors on the east face and on the 95th, 96th, 97th, 98th, and 99th floors on the south face. Exceptions to the general behavior included fires that developed on the 92nd floor on the east face and fires burning on the east side of the south face on the 92nd and 94th floors.

Various explanations for the different fire behaviors were considered. The most plausible is based on the effects of the prevailing wind. On September 11, 2001 the wind was striking WTC 1 from the northwest and then flowing down the north and west faces. This wind created positive pressures at the windows on these faces that tended to resist gas flows out of the tower. On the east and south faces the effect of the wind was the opposite, creating low pressure areas at the windows that tended to pull gases out of the building. The net effect of these pressure forces would be a tendency for gases to flow internally on a floor, if a pathway was available, from the west and north faces to the east and south faces. Such internal flows provide a possible explanation for the observed fire behaviors.

Figure 8-121. Maps of integrated fire observations between 8:47 a.m. and 10:28 a.m. are shown for the four faces of WTC 1. Colors represent the highest intensity fire observed in a window using the color scale defined in Figure 5-1.
