Frontier Analysis, Ltd.

TECHNICAL SERVICE RESPONSE NO.: UT011

Subject: Analysis of Residue That Resulted After an Unknown Basketball-Size Object Impacted a Car

Date: April 6, 2001

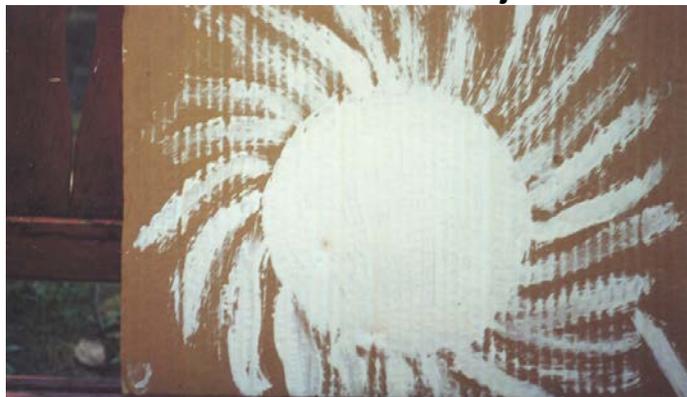
The Basketball Size Object

Background/Objective: On November 27, 1998 between 7:00 – 7:30 p.m. a driver “Shirley” was driving east on 25 Mile road (six miles north of Mt. Clemens, Michigan). It was just getting dark and she noticed a highly intense, white, basketball sized light/object rapidly coming toward her. There was no sound, and it hit the car with a slight thump or bang. It is unknown what happened to the object after the impact. A cream/gray colored residue was observed where the impact occurred. The object is to identify the residue. It is a 1992 Ford Escort station wagon with a 1.9 l engine. Recently, the car was examined. There is no evidence of the impact on the car, i.e. no residue remained, and there was no dent. Following are photographs of a drawing by the driver of the object and the residue left on the car soon after the event.

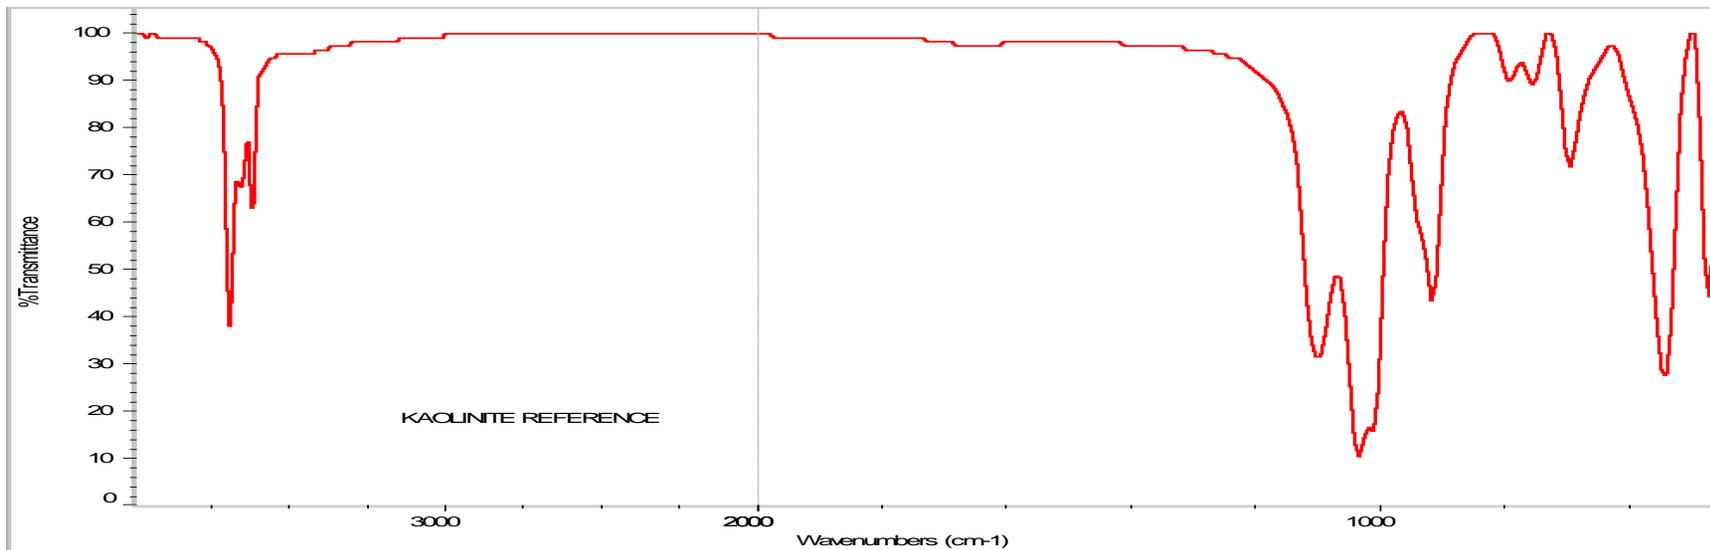
Figure 3. Infrared reference spectrum of a silicate mineral, specifically kaolinite – an aluminum silicate.
