Frontier Analysis, Ltd.

TECHNICAL SERVICE RESPONSE NO.: UT011

Subject: Analysis of Residue That Resulted After an Unknown Basketball-Size Object Impacted a Car

Date: April 6, 2001

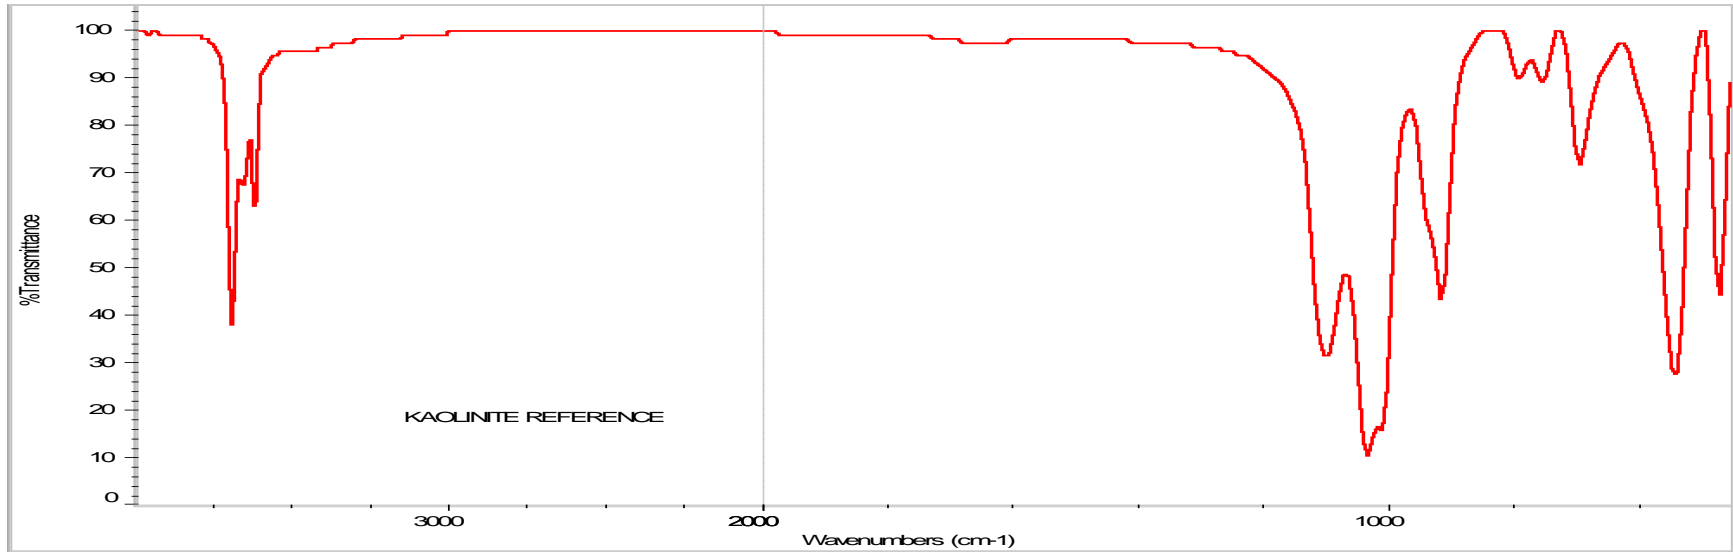
Figure 3. Infrared reference spectrum of a silicate mineral, specifically kaolinite – an aluminum silicate.

| Spectrum | Identification | Spectrum Figures |
|---|---|---|
| Cream - Gray Colored Material | The spectra show indications of a mixture of silicate mineral (kaolinite, an aluminum silicate) and a metal oxide. One or both the inorganics (silicate and metal oxide) appear to be hydrated. These materials are in the presence of the car finish layers, i.e. epoxy resin based on bisphenol A and residual methyl methacrylate/styrene/urethane. Computer massaging of the data to remove paint interference enhances the mineral absorption for one spectrum (Fig. 2) which is also shown. (Five spectra contain evidence of this material.) A kaolinite reference (Fig. 3) is also included for comparison. | 1, 2, 3 |
