**AIRCRAFT
ACCIDENT INVESTIGATION BOARD
REPORT**

**US ARMY UH-60
BLACK HAWK HELICOPTERS
87-26000 AND 88-26060**

TECHNICAL OR ENGINEERING EVALUATIONS

AMSEL-RD-NV-SE-EWD (SFAE-AV-AEC/25 Apr 1994) (70-1r) 1st End
Mr. R. Paolella and Ms. P. Lum/x44697 and x43211
SUBJECT: Failure Analysis on Crash Damaged Electronic Equipment

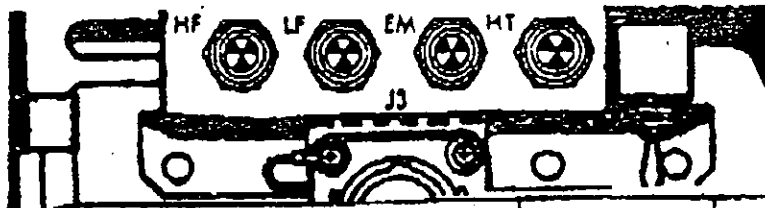
2. The only component of the AN/ALQ-144(V) IRCM that was delivered to NV&ES Directorate was the transmitter assembly, for failure analysis. The other major components, such as the operator control unit (OCU), and transit/carrying cases, were not delivered. The transmitter was so badly burnt and damaged, even though intact, that a failure analysis could not be made other than to say that with all the 4 Built In Test (BIT) indicators not tripped (normal operation), meant that the system experienced an instantaneous total failure of electrical power or the system may not have been turned on. This could only be verified by the position of the ON/OFF switch of the OCU which was not available and also by the setting of the IRCM circuit breakers located in the A/C cockpit. See the photo of BIT indicators of the transmitter upon receipt and the BIT functions NORMAL versus FAILURE shown below:

Indicator	Function	Normal	Malfunction
HF	Indicates whether the high frequency modulator is operating properly.	HIGH FREQUENCY 	
LF	Indicates whether the low frequency modulator is operating properly.	LOW FREQUENCY 	
EM	Indicates whether the source temperature is within the proper range.	EMISSION 	
HT	Indicates whether the transmitter operating temperature is within the proper range.	HIGH TEMPERATURE
