**AIRCRAFT  
ACCIDENT INVESTIGATION BOARD  
REPORT**

**US ARMY UH-60  
BLACK HAWK HELICOPTERS  
87-26000 AND 88-26060**

**VOLUME 7**

## **TECHNICAL REPORT F-15 MAINTENANCE**

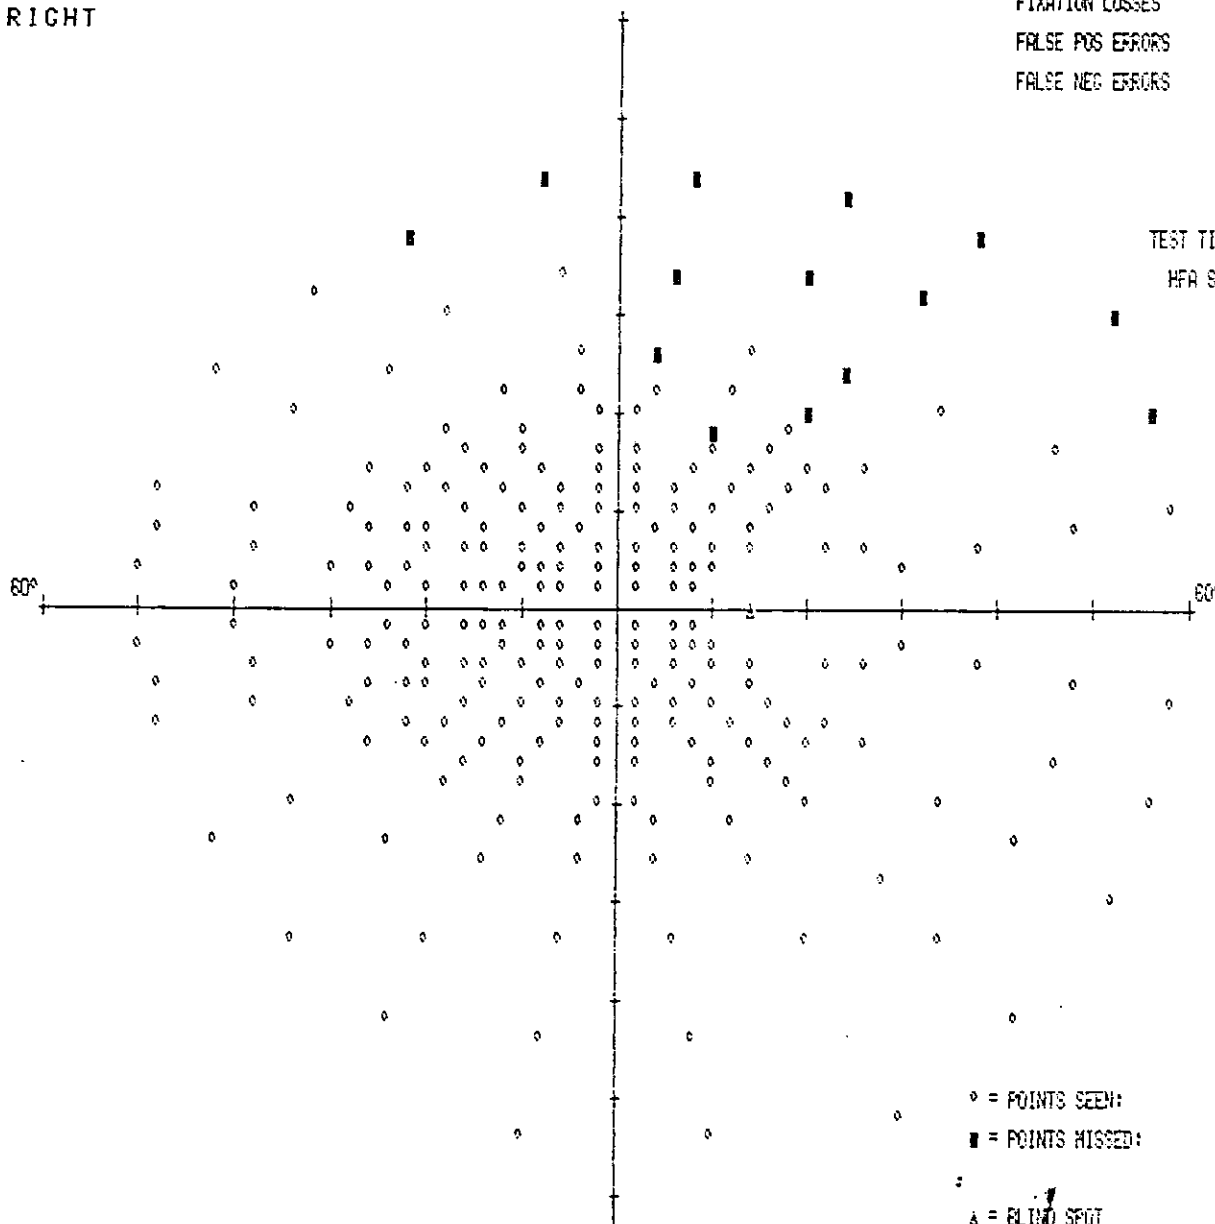
○ = POINTS SEEN: 232/246  
 ■ = POINTS MISSED: 14/246  
 ▲ = BLIND SPOT

His exam boiled down to his prominent brow ptosis, or drooping, which caused a significant superior visual field defect when tested. His central vision in the same eye was perfectly normal (actually better), but any object (or part of an object) greater than 5 degrees above the horizontal would be occluded from view. This would only be significant if he was only using that eye, since his other eye is perfectly normal in both central vision and visual field. CR

*Imp: Vis. sig. brow ptosis O.D. No other ophthalmologic abn.*  
*Re: Consider surg. repair.*

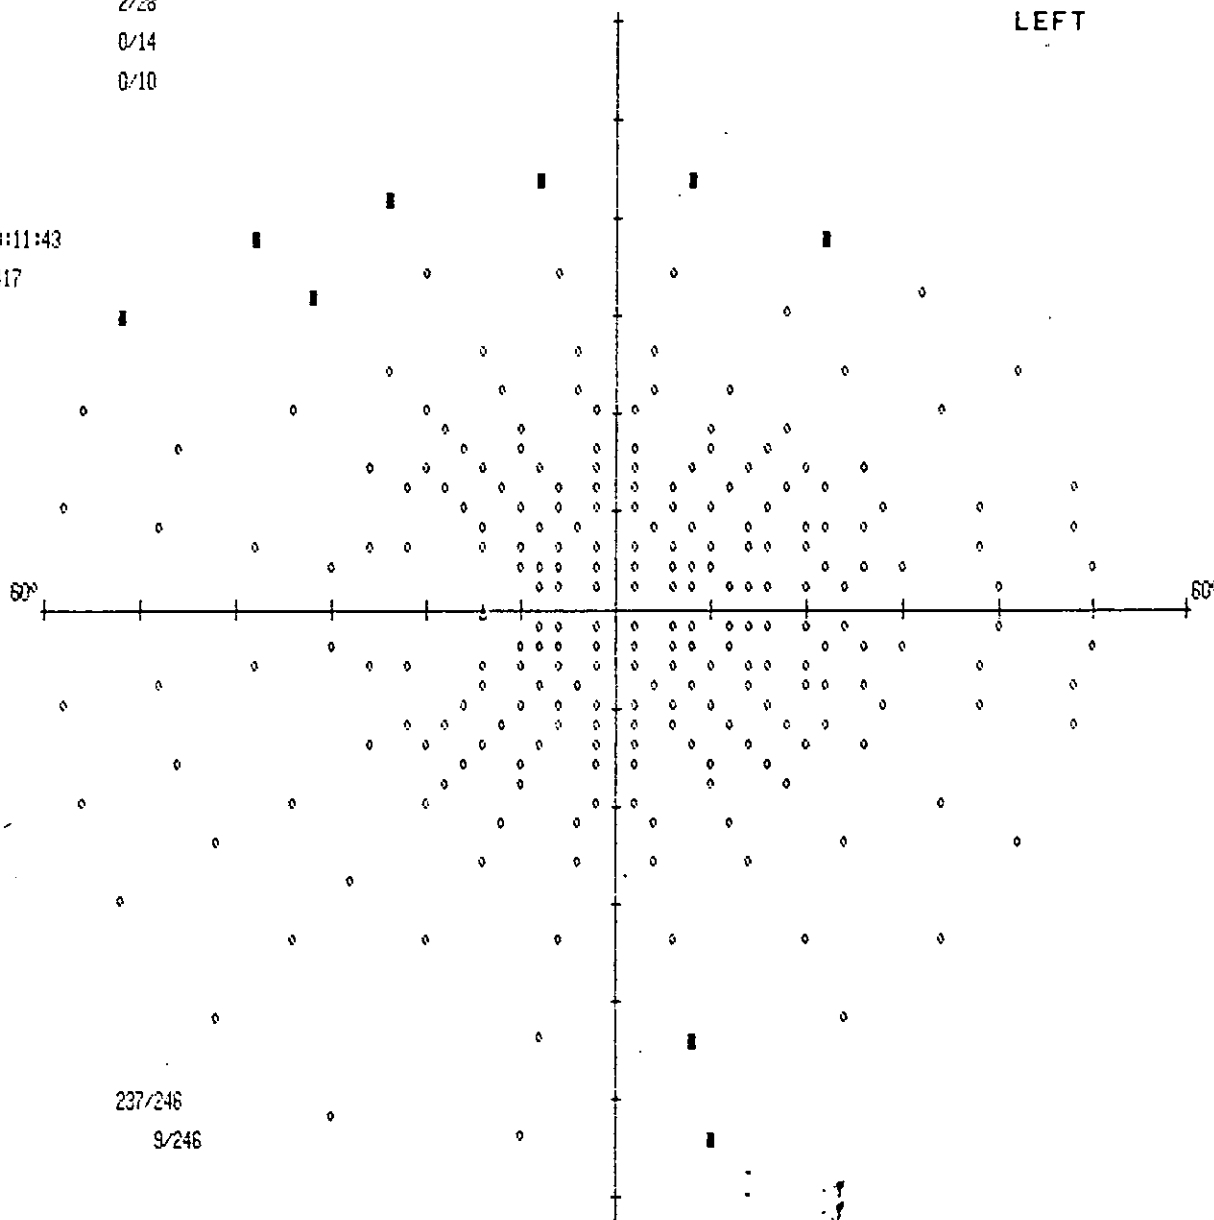
LEFT

° = POINTS SEEN: 237/246  
 ■ = POINTS MISSED: 9/246  
 Δ = BLIND SPOT

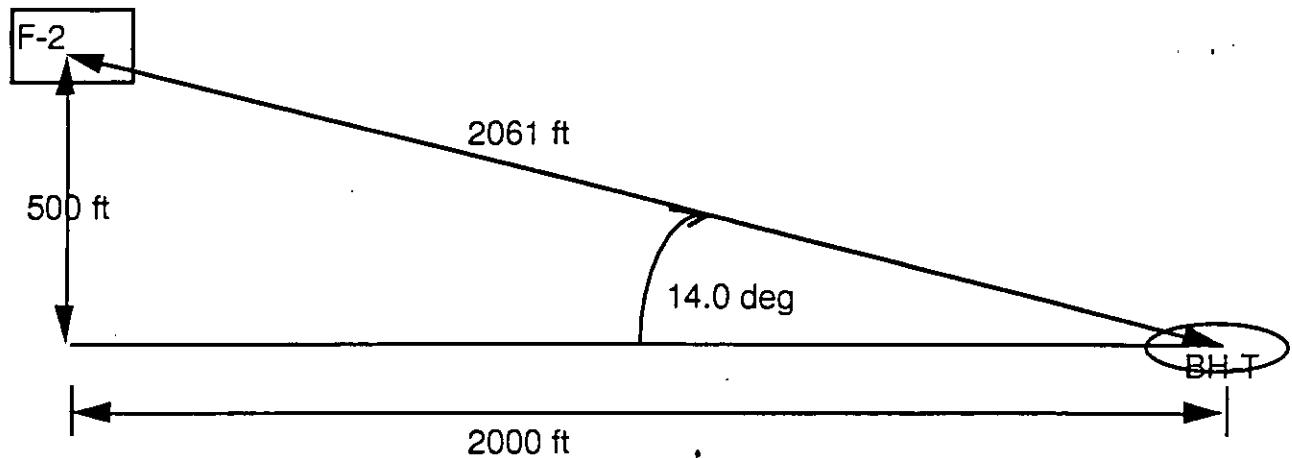
Figure 3. F-2 is at a slant range of 2061 feet from BH-T, and the look down angle is 14.0 degrees.

For a slant range of 2061.6 ft, Figure 3 shows the dimensions of the flag would be reduced by a factor of 0.54 compared to the dimensions in Figure 1. For the geometries of figures 2 and 3, with low slant angles, the BH is being viewed more from the side, and the vertical dimension of the flag is not as reduced as for a higher slant angle. For the stripes to subtend 1 arc-min, the fighter would have to view the stripes perpendicularly from a range of 501 ft. For the stars to subtend 1 arc-min, the viewing range would have to be 322 ft.

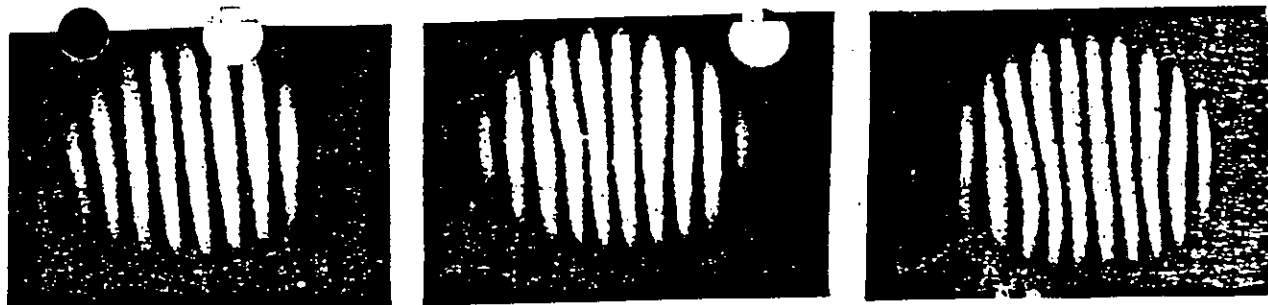
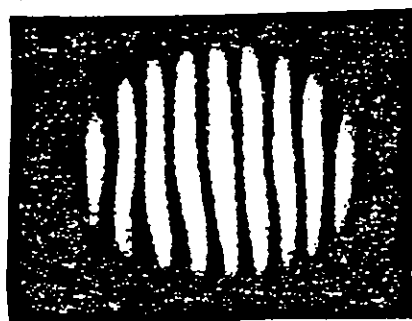
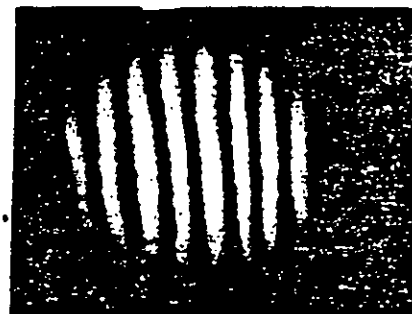
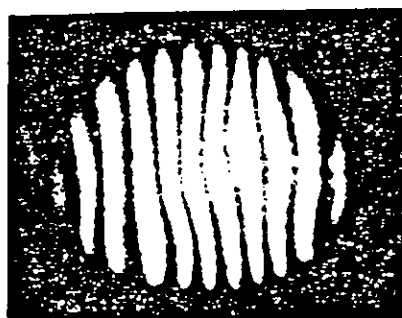
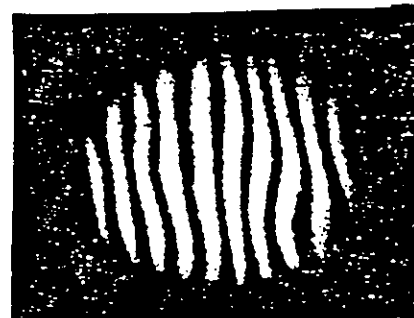
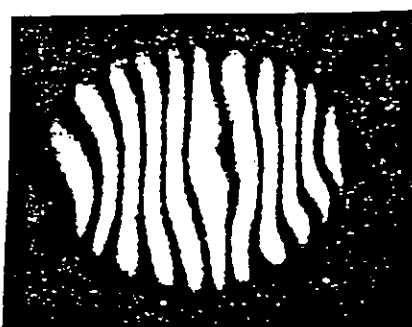
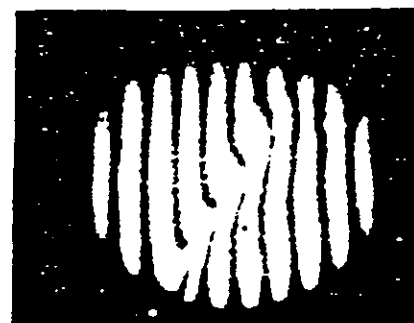
Figure 7. Examples of acceptable (1-5) and unacceptable (6-9) shearing interferometric optical distortion patterns as stated in MIL-V-43511C.

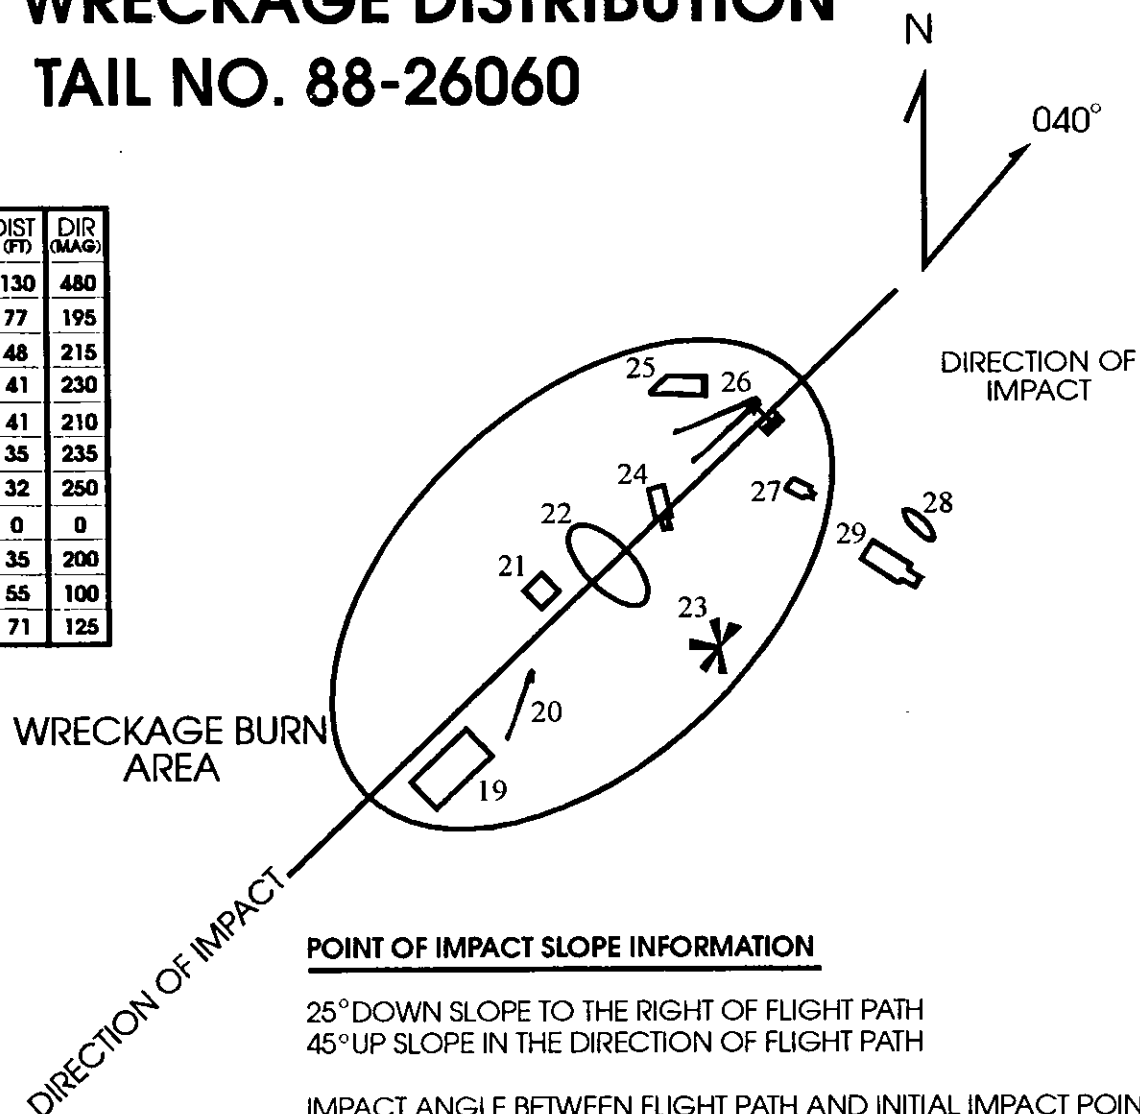
25° DOWN SLOPE TO THE RIGHT OF FLIGHT PATH  
45° UP SLOPE IN THE DIRECTION OF FLIGHT PATH

IMPACT ANGLE BETWEEN FLIGHT PATH AND INITIAL IMPACT POINT: 56°  
DISTANCES ARE MEASURED IN FEET  
DIRECTIONS ARE MEASURED IN DEGREES MAGNETIC  
DISTANCES AND DIRECTIONS ARE MEASURED FROM MAIN TRANSMISSION (26)
