**Federal Building and Fire Safety Investigation of the
World Trade Center Disaster**

**Structural Fire Response and
Probable Collapse Sequence of
World Trade Center Building 7**

VOLUME 1

November 2008

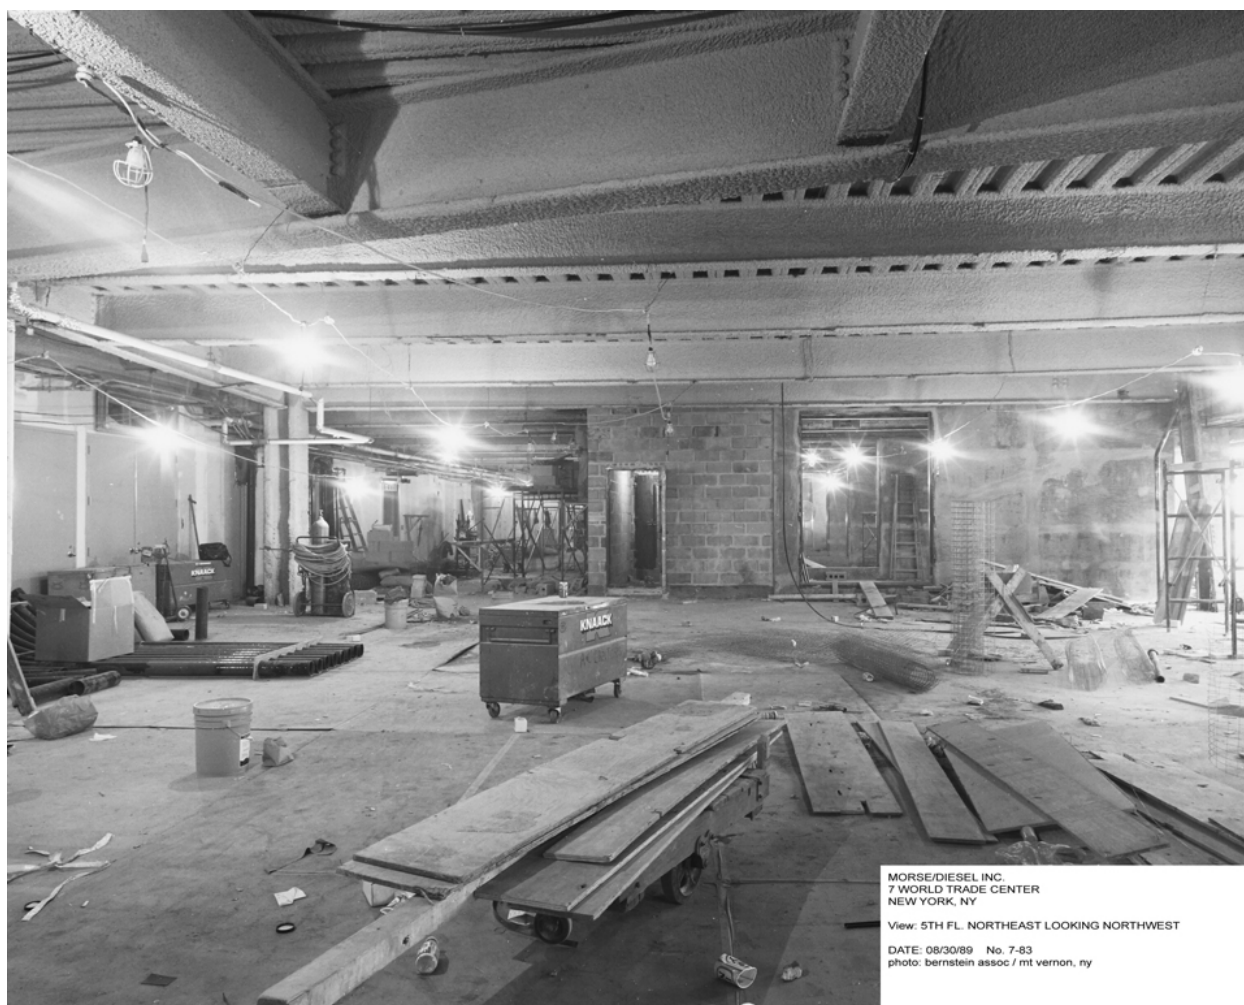
Source: Bernstein Associates

The review of available documents and witness accounts indicated that the condition of the SFRM in WTC 7 prior to the events of September 11, 2001, was adequate and well-maintained. The photographs in Figure 2–27 through Figure 2–29 show the condition of the SFRM on Floors 5, 33, and 36 during renovations in 1989. Review of similar photos showed SFRM removal in selected areas for construction purposes, but the general condition of the SFRM in the photos reviewed was adequate, with an even application and no visible gaps.

Figure 2–27. Photograph of Floor 5 during renovations showing SFRM on steel beams and metal deck, dated 08/30/89.

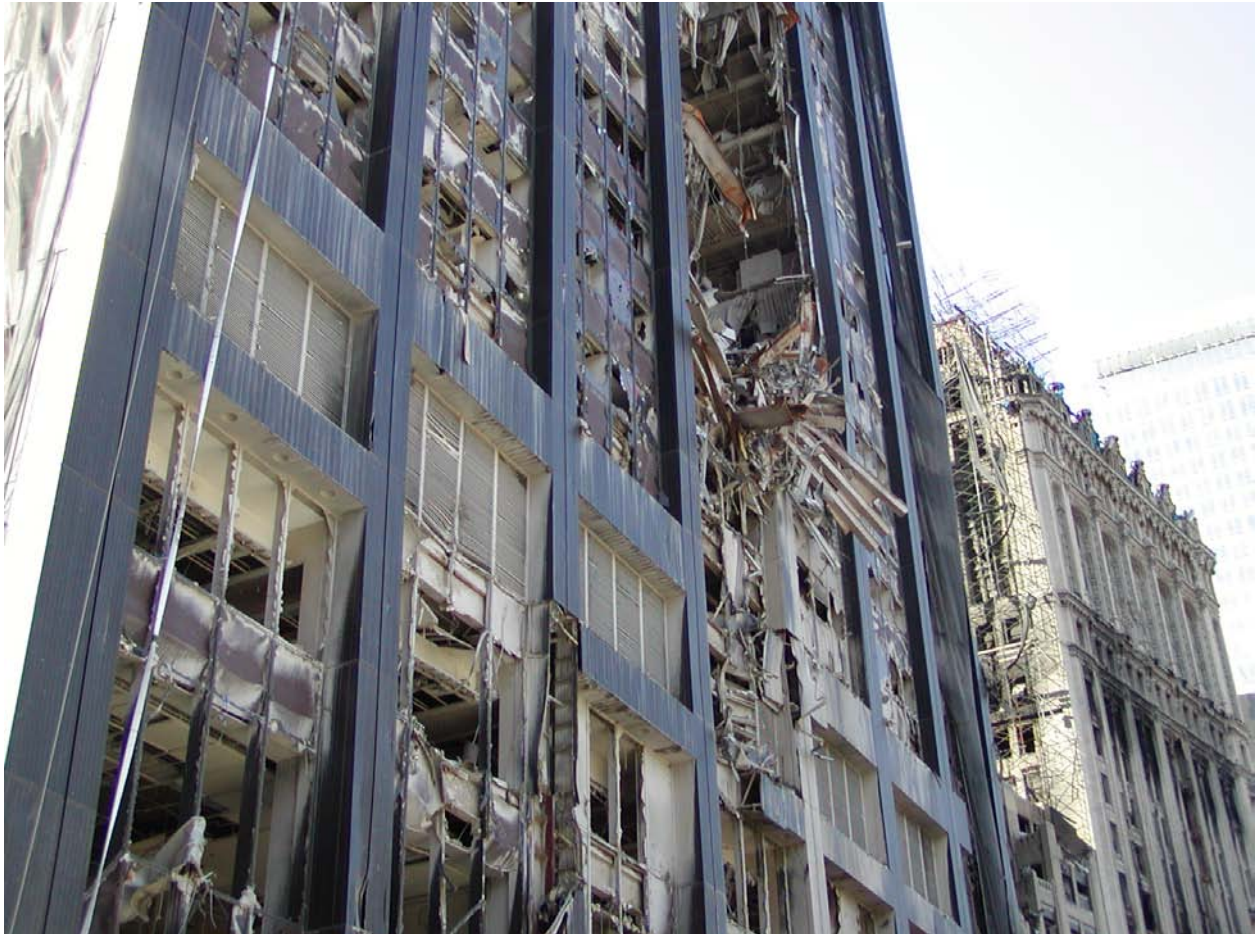
The WTC 7 structural damage resulted from debris falling from WTC 1. In a similar fashion, the building located at 130 Liberty Street (referred to as Deutsche Bank or the Bankers Trust building), was damaged by falling exterior panels from WTC 2 as it collapsed. NIST was granted access to inspect floors where damage occurred in the building on 130 Liberty Street on August 21 and 22, 2006. The debris from WTC 2 had penetrated the north face of the 130 Liberty Street building and caused damage to Floors 9

through 22, as shown in Figure 2–30 and Figure 2–31. The north face had severed spandrel beams between exterior columns, with the damage extending into the interior that grew in magnitude as the debris fell. Figure 2–31 shows that the floor beams framing into intact exterior columns remained in place, but the SFRM in the immediate vicinity of the damage was dislodged.

Figure 2–30. Exterior view of damage to the north face of 130 Liberty Street by debris falling from WTC 2.

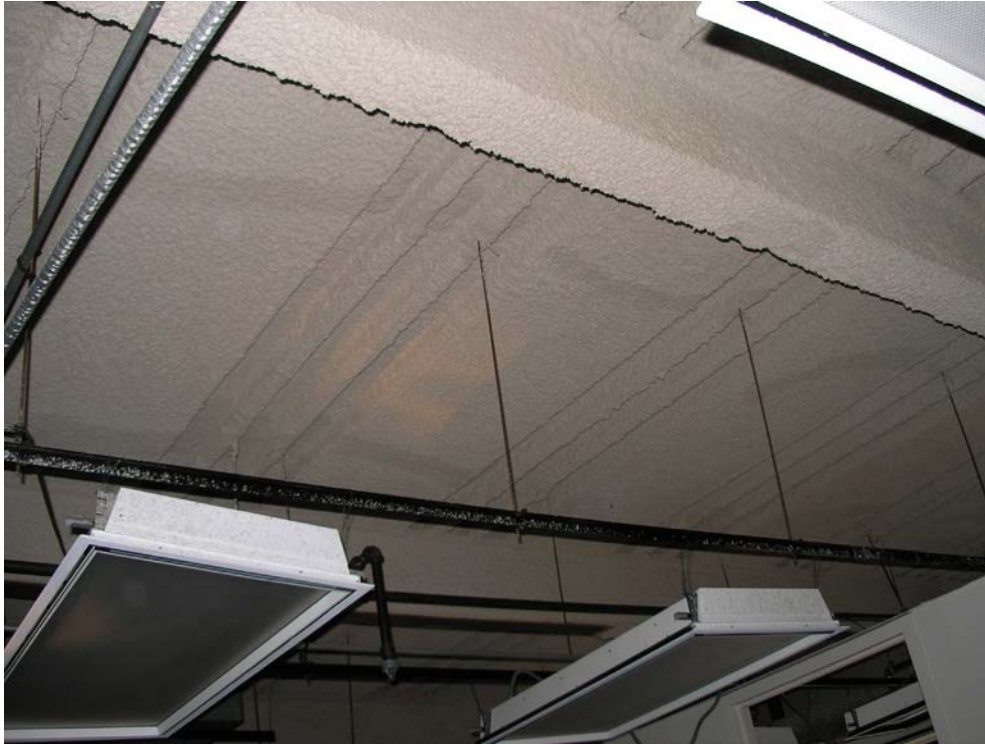
Figure 2-34.
Floor beams
with intact
SFRM.

In general, the SFRM was observed to be intact a few feet away from the area of structural damage. In some locations, SFRM had been removed and sampled for tests of contaminants in the building (e.g., square shape of removed area). There were also some areas where SFRM was missing from the bottom surface of the lower flanges of floor beams. It was not always clear whether the SFRM had fallen off due to an event unrelated to the sampling or if it had been dislodged while samples were being taken.

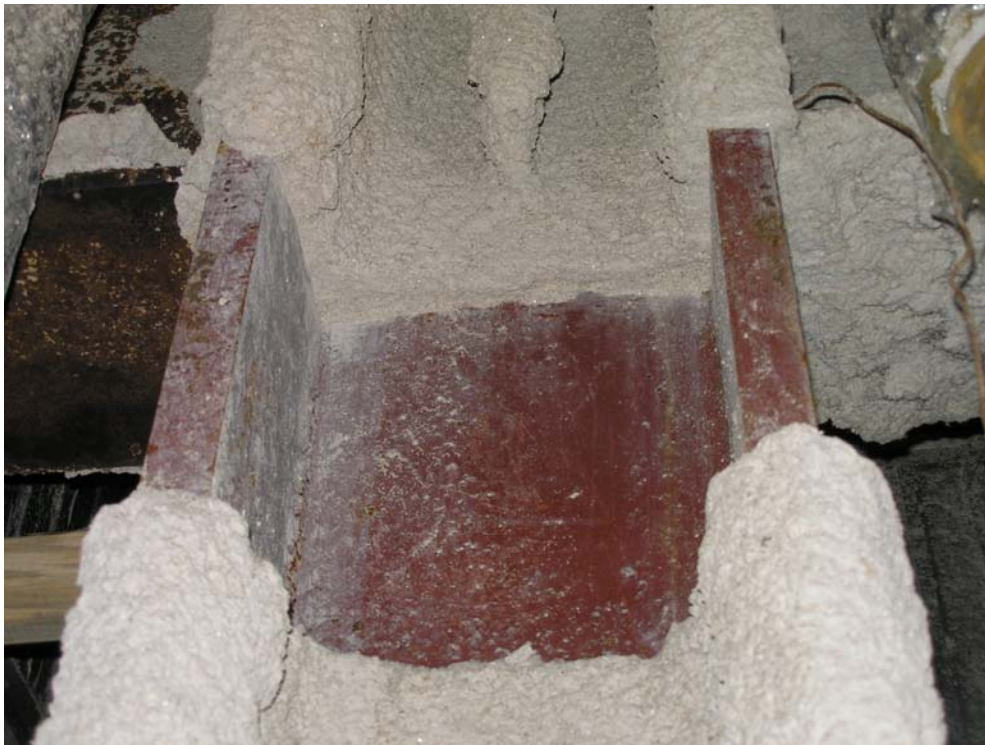
Figure 2–33 shows a typical floor plan with the column line numbering that was used to indicate the locations that were examined. SFRM had been applied to all columns, floor beams, and steel deck observed. The floor beams and metal deck appeared to have had a uniform coating of approximately 3/8 inch to 1/2 inch (visual estimate), as shown in Figure 2–34. The location of the photograph was near F2 on Floor 16. The columns appeared to have had heavier coatings that ranged from approximately 1 in. to several inches (visual estimate). Figure 2–35 was taken at location B6 on Floor 16. In the photograph, the column coatings tended to be thicker at the flange tips. Primer was observed on floor beams and columns in some areas with missing SFRM.

Figure 2-35.
Column with
removed SFRM
and intact
primer.

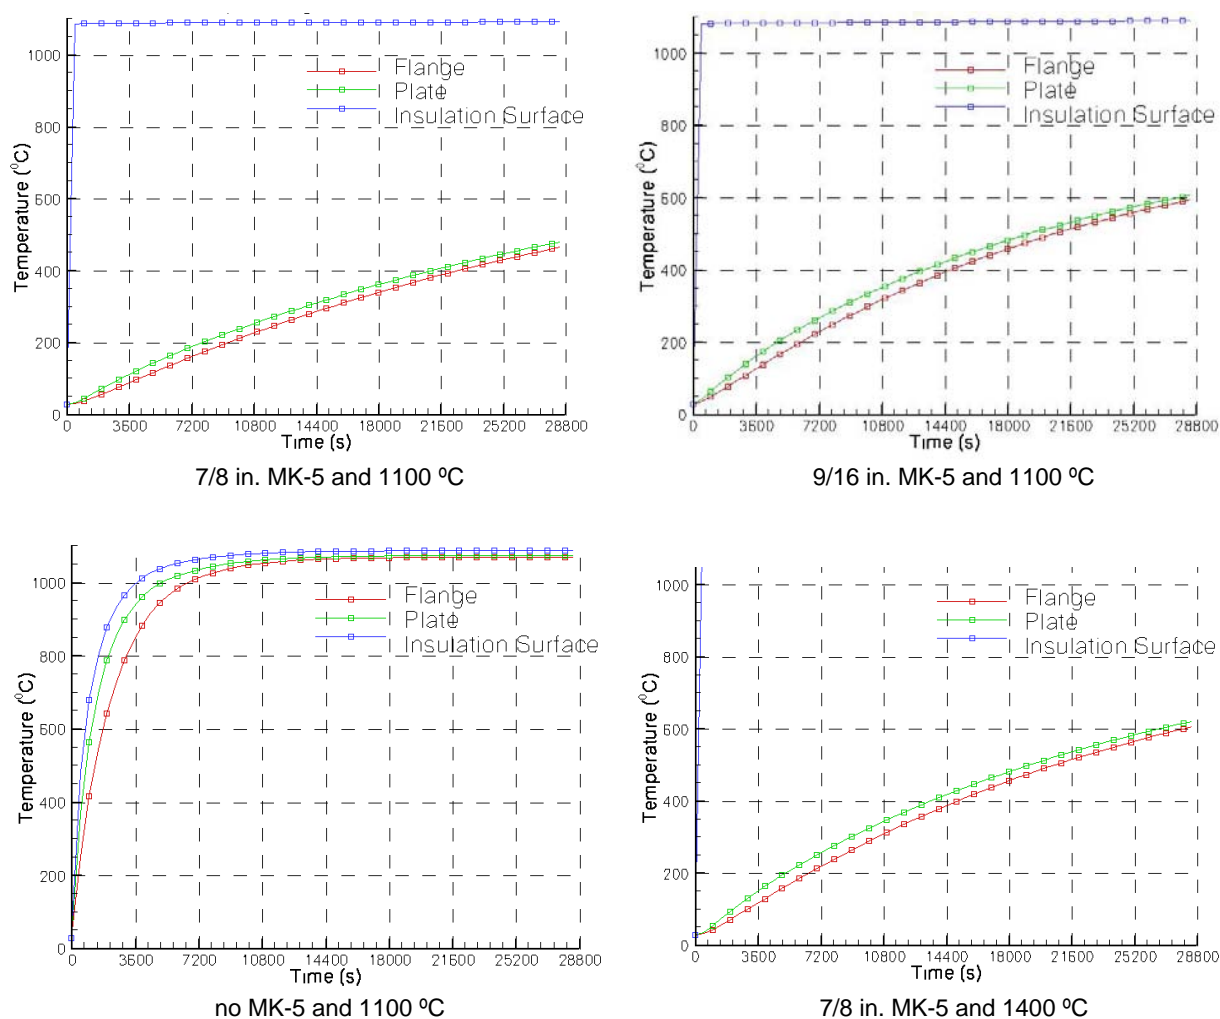
Figure 4–4 shows the temperature rise in the heavy column.

- In the upper left graph, the column is insulated with 7/8 in. of Monokote MK-5 (based on the specified fire rating) and exposed to an air temperature of 1100 °C.
- The upper right graph shows the rise in steel and insulation temperatures for a thinner, 9/16 in., layer of insulation.
- The lower left graph shows the rise in steel and insulation temperatures with no applied insulation.
- The lower right graph is a repeat of the upper left graph, but with a higher exposure air temperature of 1400 °C.

Figure 4–4. Calculated temperature rise in Column 79 at varying insulation thicknesses and thermal exposures.

With either thickness of insulation applied, it would take at least 7 h (3,600 s = 1 h) for the steel to reach 600 °C, the temperature at which the steel would have lost approximately 50 percent of its strength. (See NIST NCSTAR 1-3D for a thorough description of the loss of strength as a function of temperature.) For the fires in the WTC towers and in WTC 7 (see Chapter 9 of this report), the compartment air temperatures typically were near 1100 °C for less than 2 h. Even if the room temperature from the fires reached 1400 °C, a temperature that might be realized in a wind-aided fire and an extreme upper limit to the air temperatures probable in the types of fires experienced in WTC 7, the steel temperature would remain low enough after 4 to 5 h of such intense fire exposures for the steel to preserve its strength. By contrast, with no thermal insulation, the column would lose much of its strength within the first half hour of exposure to 1100 °C.

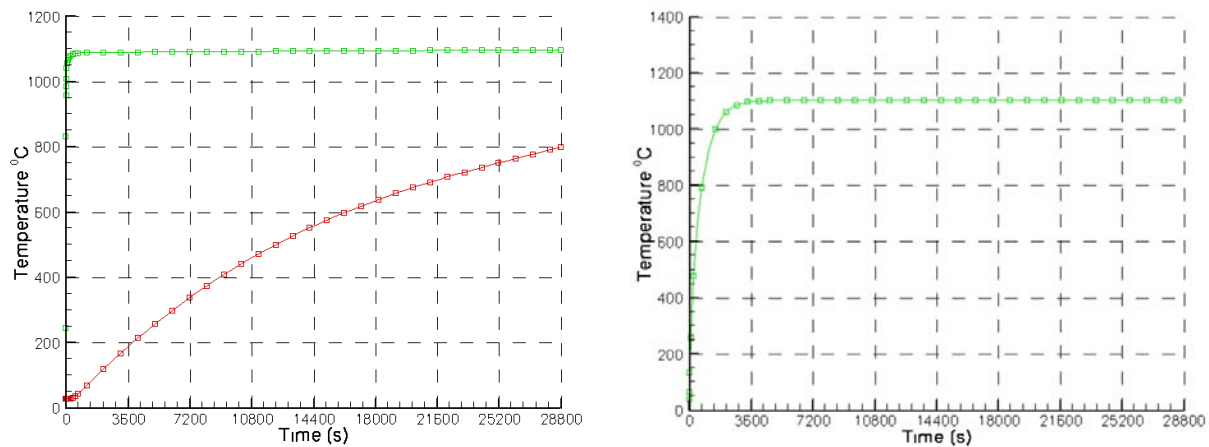
Figure 4–5 shows the results of similar calculations for the lighter, W14 x 500, column. The green data represent temperatures at the outer surface of the thermal insulation; the red data represent temperatures at the interior of the center of the web plate. For the insulated column, shown in the left plot, the web temperature reaches 600 °C in about 4 h. With no insulation (right plot), this temperature is reached in a matter of minutes. As expected, the lighter columns heat somewhat more rapidly, but, if properly insulated, the steel temperature would remain low enough after 3 h of such intense fire exposures for the steel to preserve its strength.

Figure 4–5. Calculated temperature rise in a typical core or exterior column exposed to 1100 °C air temperature.

Left: insulated with 7/8 in. Monokote MK-5; right: uninsulated.

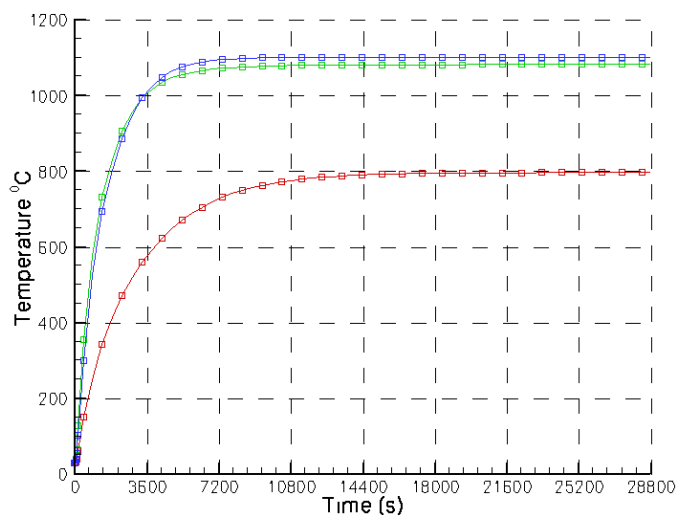
Each composite floor, with one of three representative beam sections, was exposed to an 1100 °C air temperature from below. Figure 4–6 shows the result of heating the floor with the insulated lightest steel section. The lower flange of the steel reached compromising temperatures in about 15 min, the upper flange in about 1 h. Figure 4–7 and Figure 4–8 show the slower temperature rises in the insulated midweight and heaviest beams, respectively. The lower flange temperatures are virtually identical to the web plate temperatures. Figure 4–9 shows the temperatures reached at the top and bottom of a typical floor slab at the thinnest sections located at the top of the steel deck corrugation.

Figure 4–6. Calculated temperature rise in a W14 x 22 floor beam in an insulated composite floor assembly exposed to 1100 °C air from below.
Blue: lower flange; green, web plate, red: upper flange.

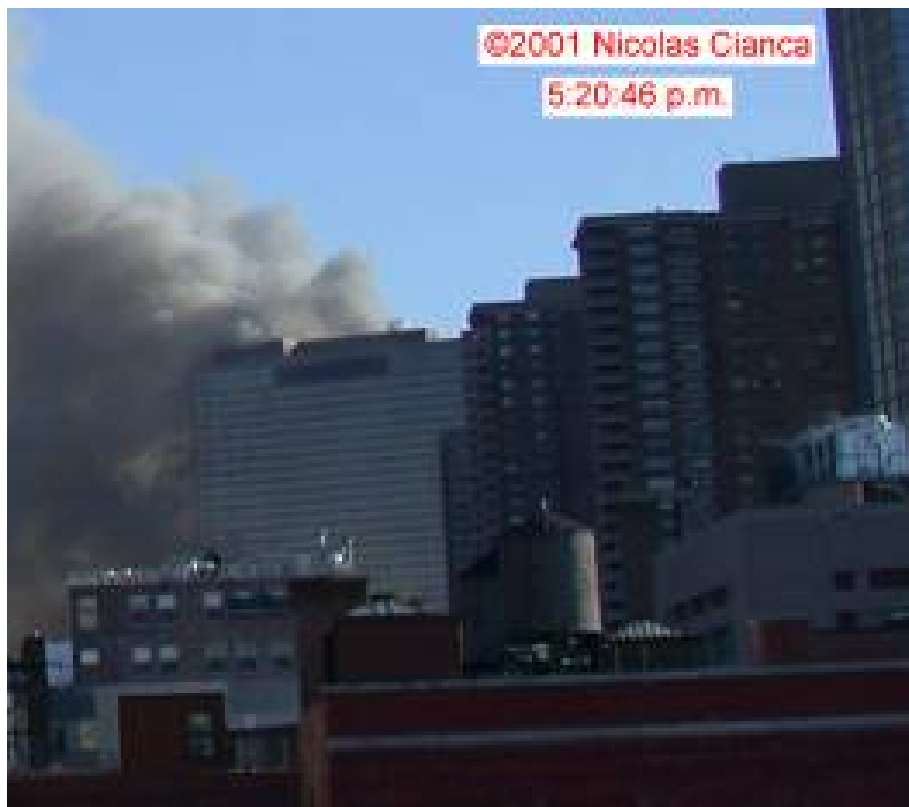
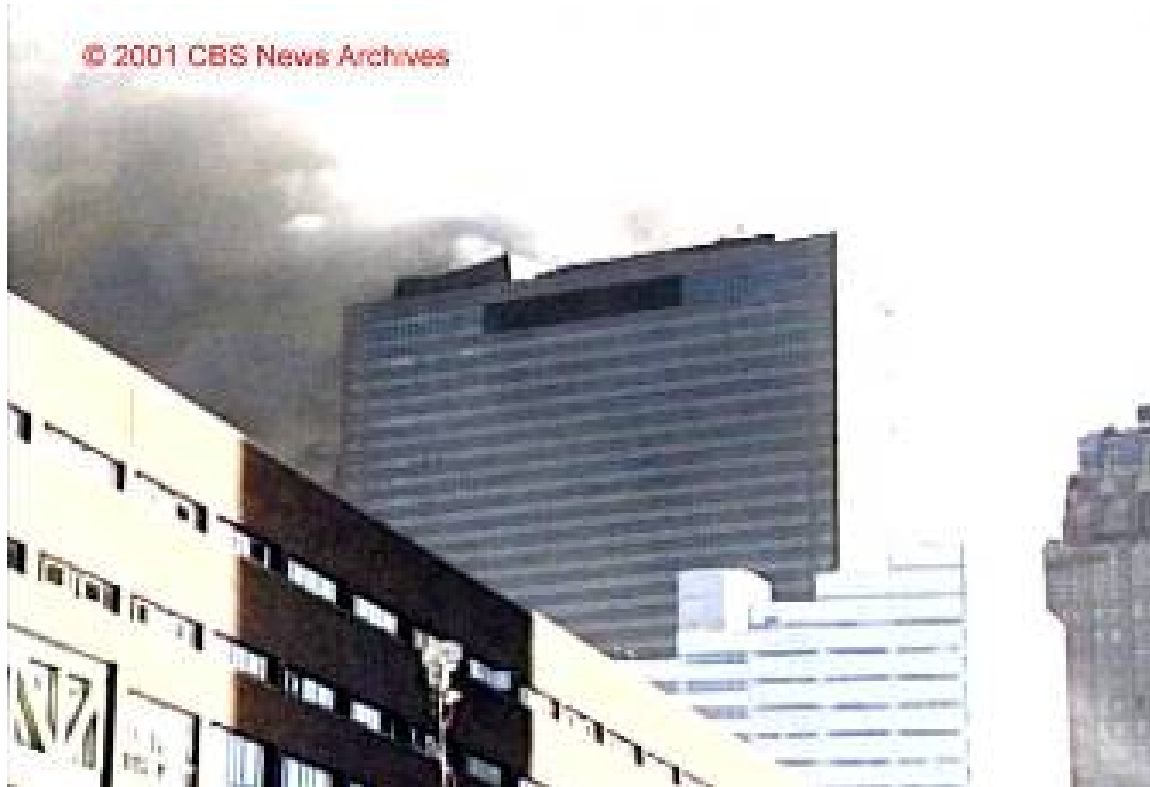
The probable reason for the time difference between the NIST time and the LDEO result with regard to the collapse of WTC 7 is discussed in Appendix B. The seismic signal that was 10 s prior to the time derived from the television broadcasts was likely due to the falling of debris from the structural damage that preceded the descent of the east penthouse.

Figure 5–1. A photograph (top) and a frame from a video clip (bottom) showing the east penthouse of WTC 7 beginning to sink into the building.

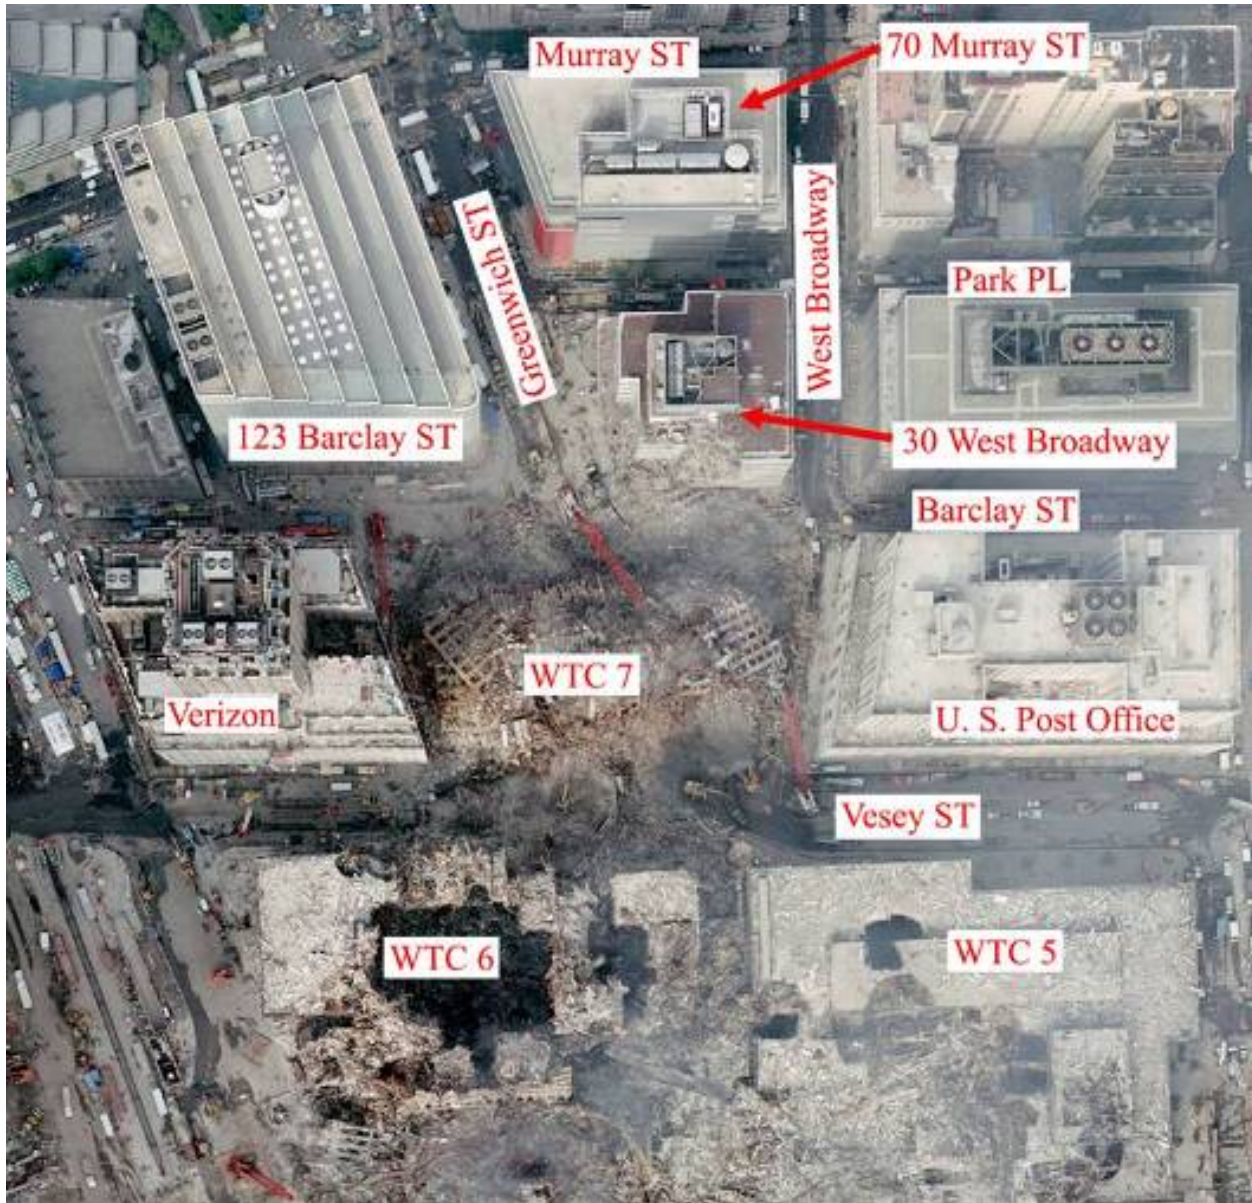
Figure 5–4. Overhead view of the area in the immediate vicinity of the collapsed WTC 7. This photograph was taken by a NOAA aircraft on September 23, 2001. It has been enhanced and labels have been added.

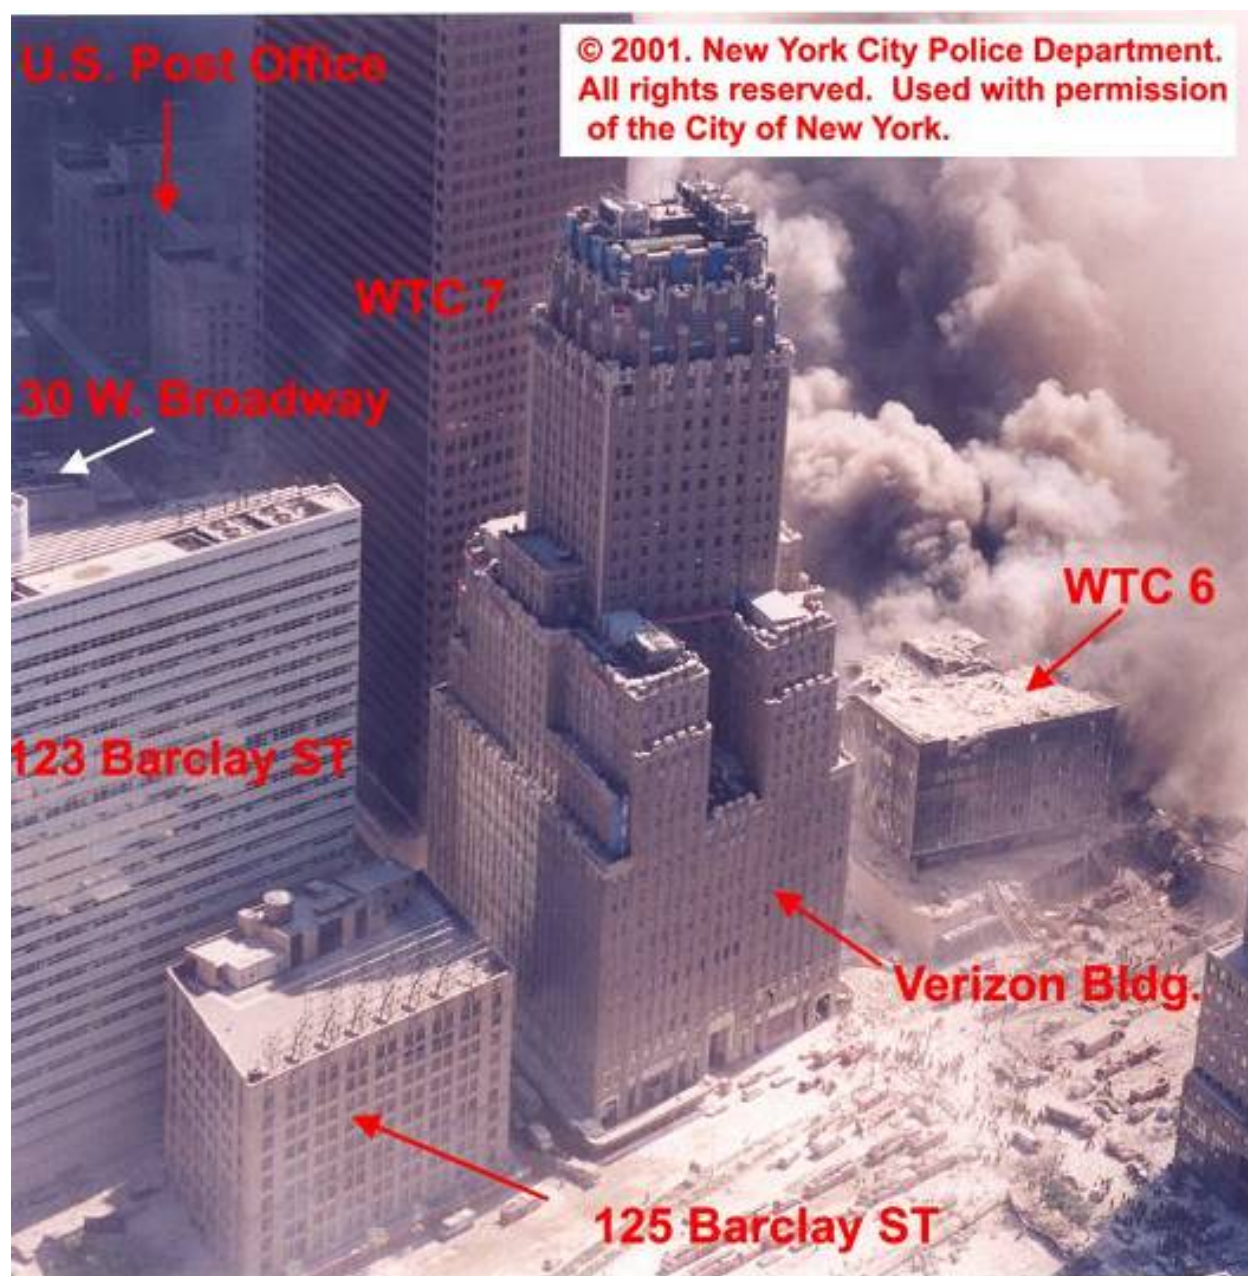
Figure 5-5. Photograph of WTC 7 and the immediate vicinity taken before noon on September 11, 2001.

The original image has been cropped and labels identifying buildings have been added.

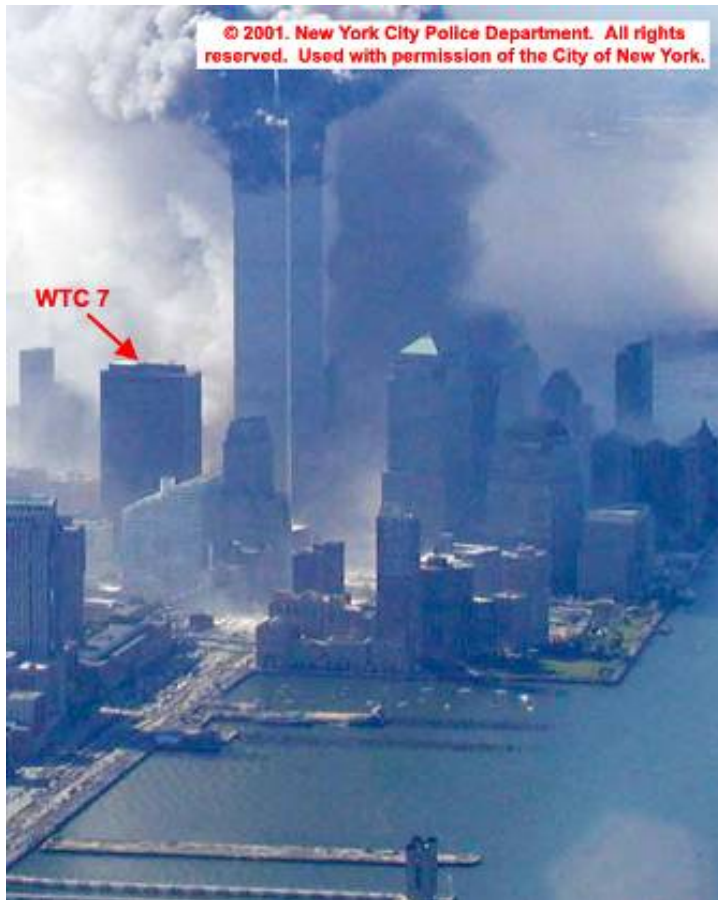
Wind behavior is strongly influenced by the presence of upstream structures. On September 11, the wind was coming from across the Hudson River. (See Figure 5–3.) Figure 5–6 shows a view of the WTC site shot from a helicopter around 10:21 a.m. from roughly the same direction that the wind was blowing. At this time WTC 2 had already collapsed and WTC 1 continued to burn. WTC 7 is indicated by an arrow. The lower portions of WTC 7 are at least partially shielded from the wind by buildings located between WTC 7 and the Hudson shoreline, while upper portions were directly exposed.

Figure 5–6. Photograph of the WTC site taken around 10:21 a.m. from roughly the same direction as the wind was blowing on September 11. The image has been cropped and enhanced.

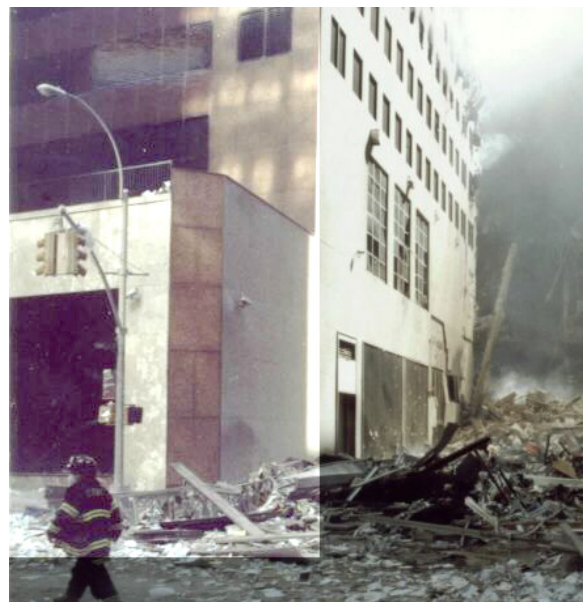
Figure 5–25. Cropped photograph showing the lower floors of the west face and a small section of the north for WTC 7, taken on September 11 sometime after 12 p.m.

To the immediate right of the large ground floor louvers, an area is visible on the 2nd floor where the granite cladding has been knocked off. Immediately below the damaged area there is a set of inactive vertical louvers. Immediately below these louvers, there was a 2.49 m (8 ft 2 in.) high vestibule with two entry doors. The doors led to a stairway that provided employee access to the 2nd through 4th floors.

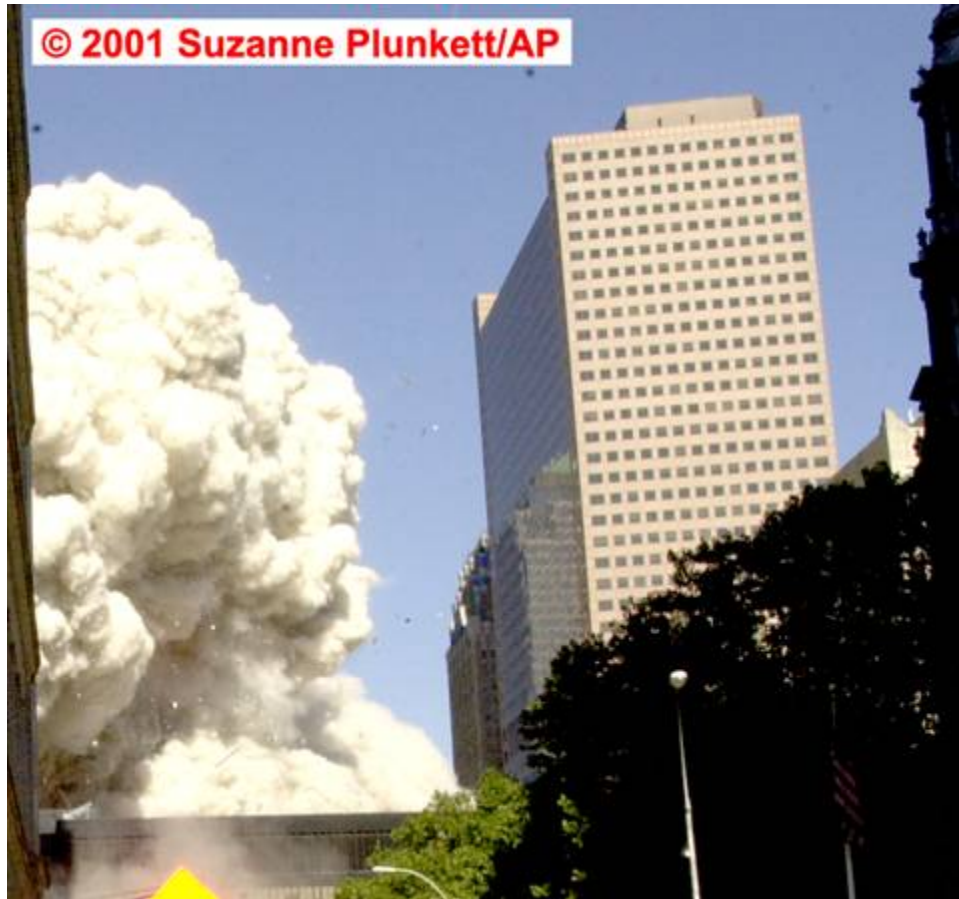
Figure 5–35. Cropped photograph showing the dust cloud from the collapse of WTC 2 approaching the south face of WTC 7, taken from just east of the corner of Fulton Street and Broadway at 9:59:24 a.m. (estimated uncertainty of 5 s). The intensity levels have been adjusted.

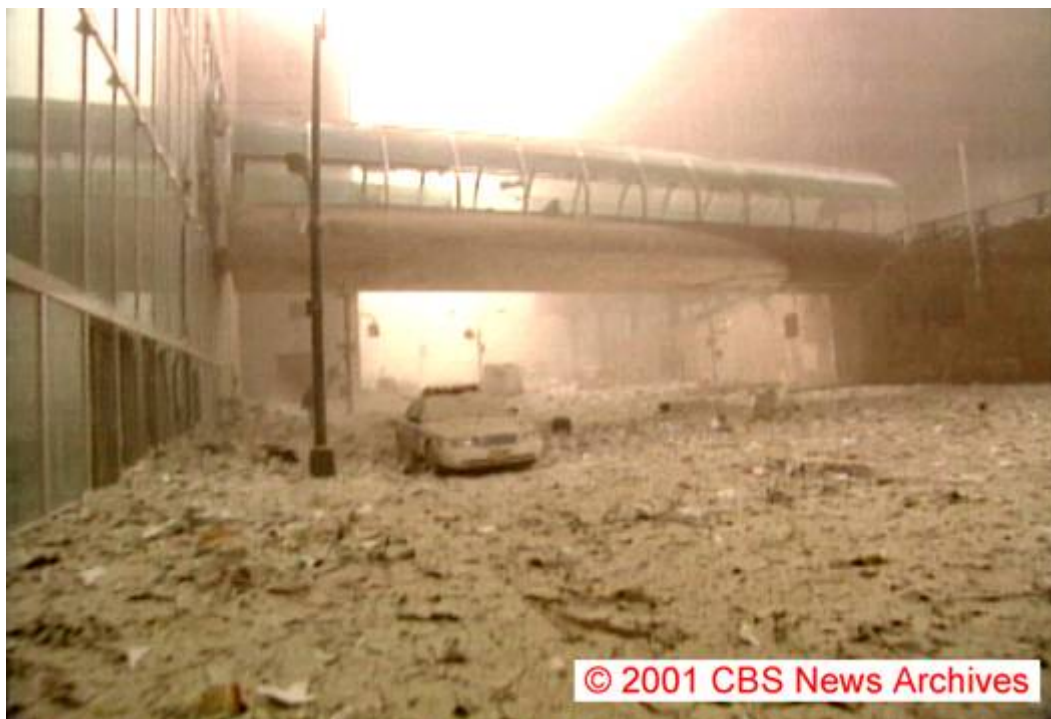
Another frame from this video taken closer to WTC 7 is shown in Figure 5–36. The amount of dust and debris is greater than seen further west on Vesey Street. It appears to be several inches deep. Most of the debris appears to be paper. A portion of the south face of WTC 7 is visible to the left. Numerous plate glass windows at the ground floor are broken out between Column 24 and Column 26. There appears to be some light façade damage higher up near the Pedestrian Bridge. There is no indication of any structural damage on WTC 7. The covering on the Pedestrian Bridge appears to be intact following the collapse of WTC 2. There are no indications of fire in the image.

Figure 5–36. Frame from a video filmed just outside of WTC 7 looking east up Vesey Street around 10:15 a.m.

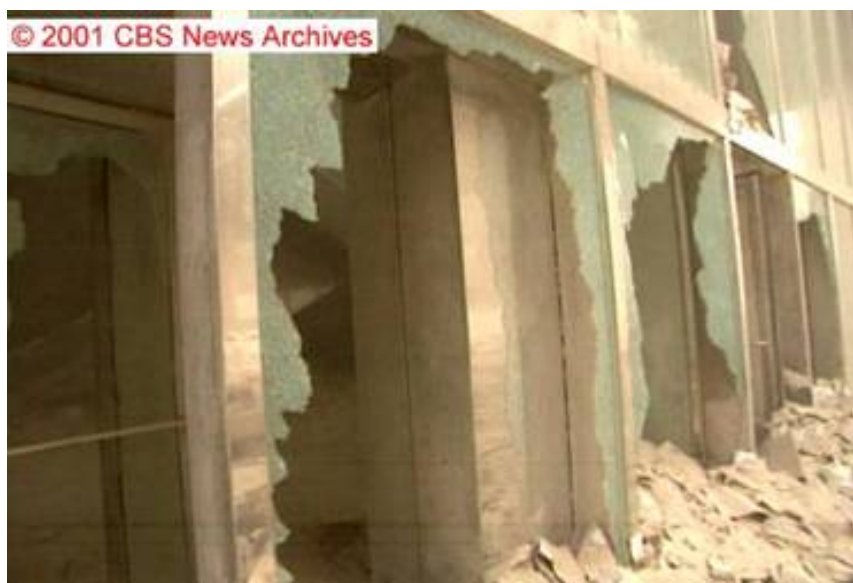
A closer view of the broken windows on the ground floor of WTC 7 is shown in Figure 5–37. A broken window is apparent above the door on the right side. An enclosed Column, 25, is visible near the center of the image. It is clear that this column was undamaged at this time. The deep piles of dust and light debris have been pushed through the broken windows at the base. As the videographer entered the 1st floor lobby, the video shows that the entire floor was also covered by a thick layer of dust and light debris.

Figure 5–37. Video frame showing the ground floor of the south face of WTC 7, taken around 10:15 a.m. The column visible near the center is the base of Column 25. The intensity levels have been enhanced.

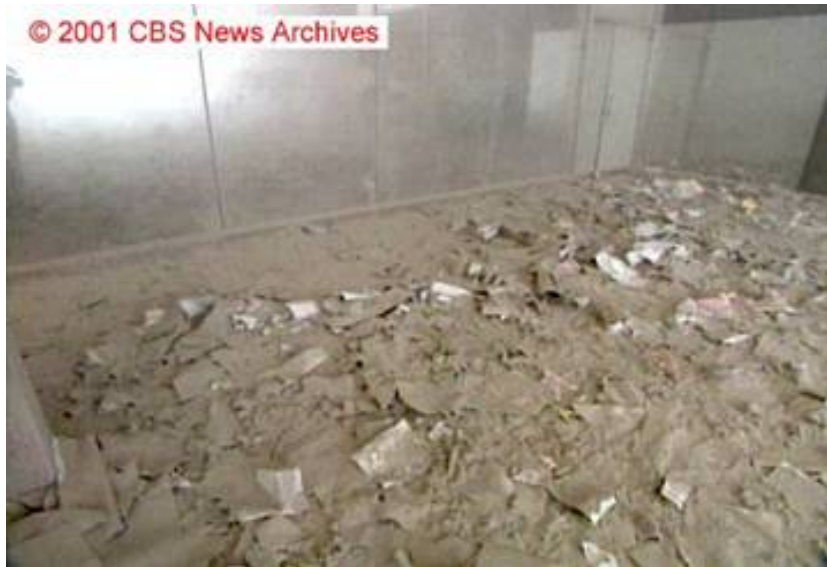
The main entry lobby for WTC 7 was located on the south side of the 3rd floor. The videographer went up a nonoperating escalator from the ground floor lobby to this area. Emergency alarms were sounding and emergency lighting seemed to be operational. On the east side of lobby, there was heavy dust and light debris, as can be seen in Figure 5–38, which shows the rear corner of the lobby that was roughly 20 m (60 ft) across from the revolving door that opened onto the Pedestrian Bridge. (See Figure 5–20.) The large amount of debris suggests that windows were also broken out at this level, even though there are no images that confirm this.

Figure 5-38. Video frame showing a corner of the main lobby on the 3rd floor of the south side of WTC 7, taken around 10:15 a.m. The intensity levels have been enhanced.

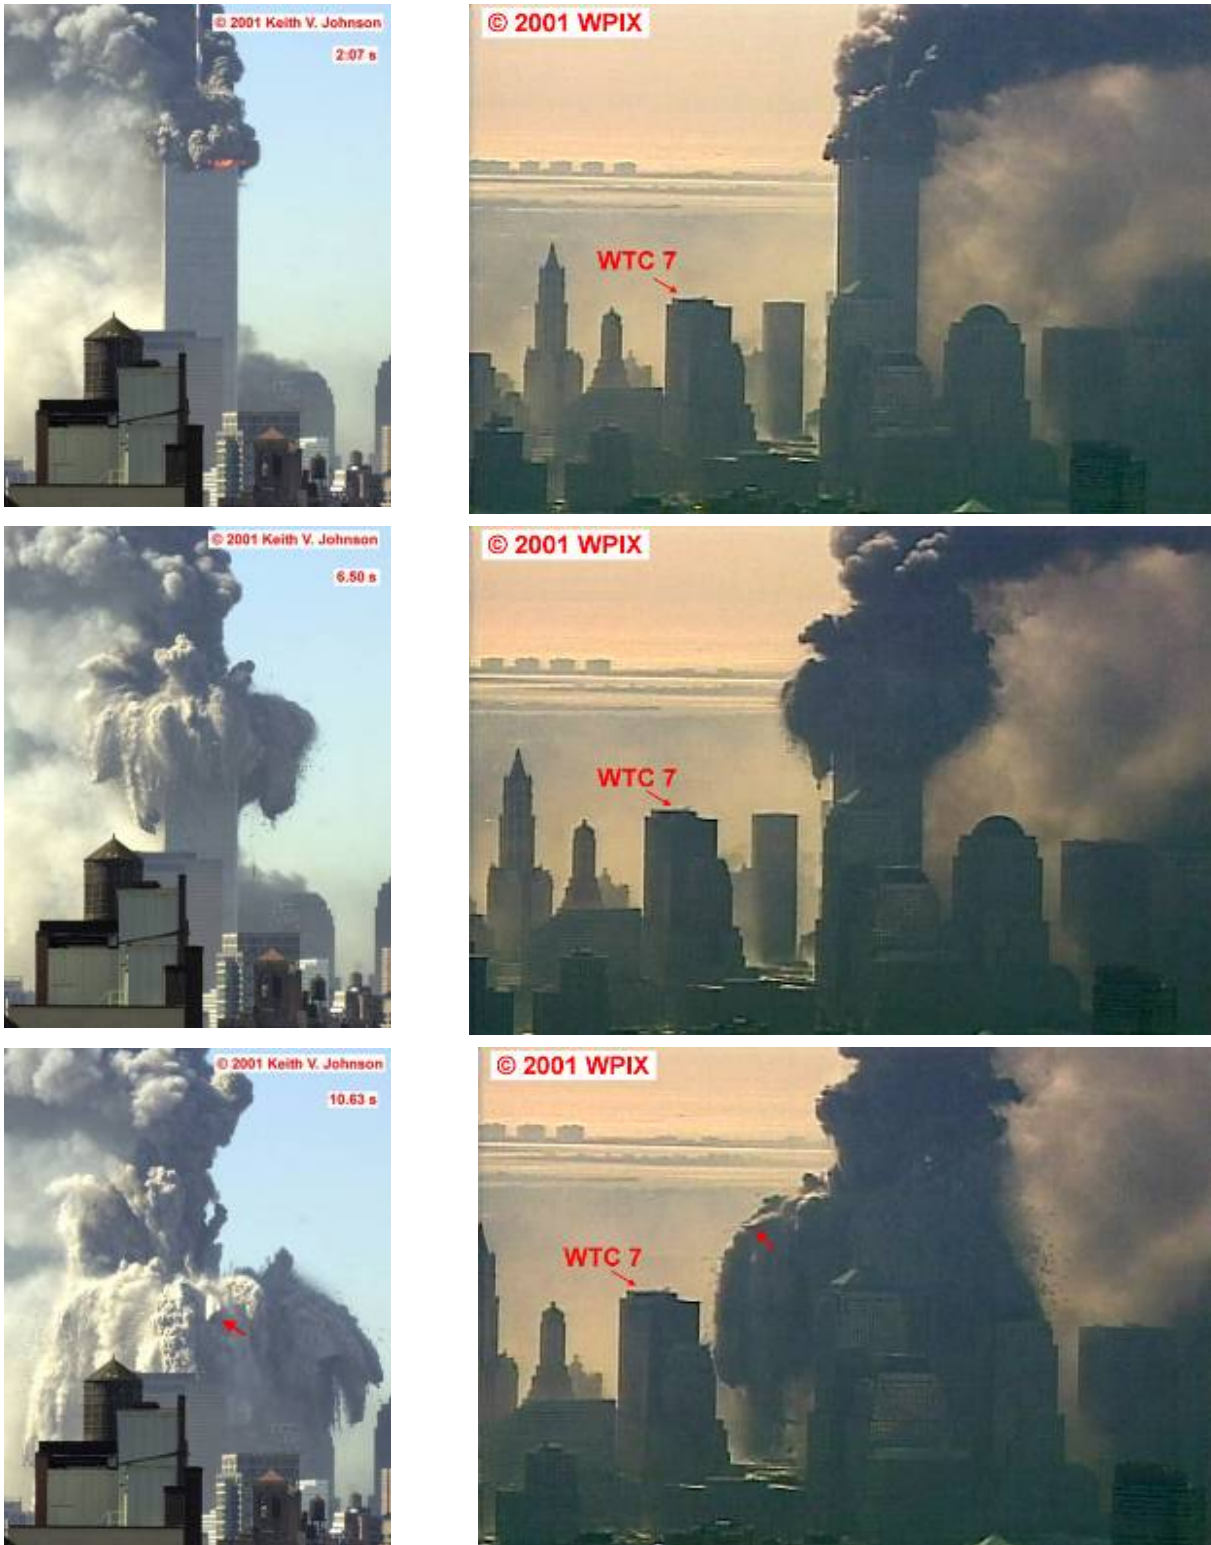
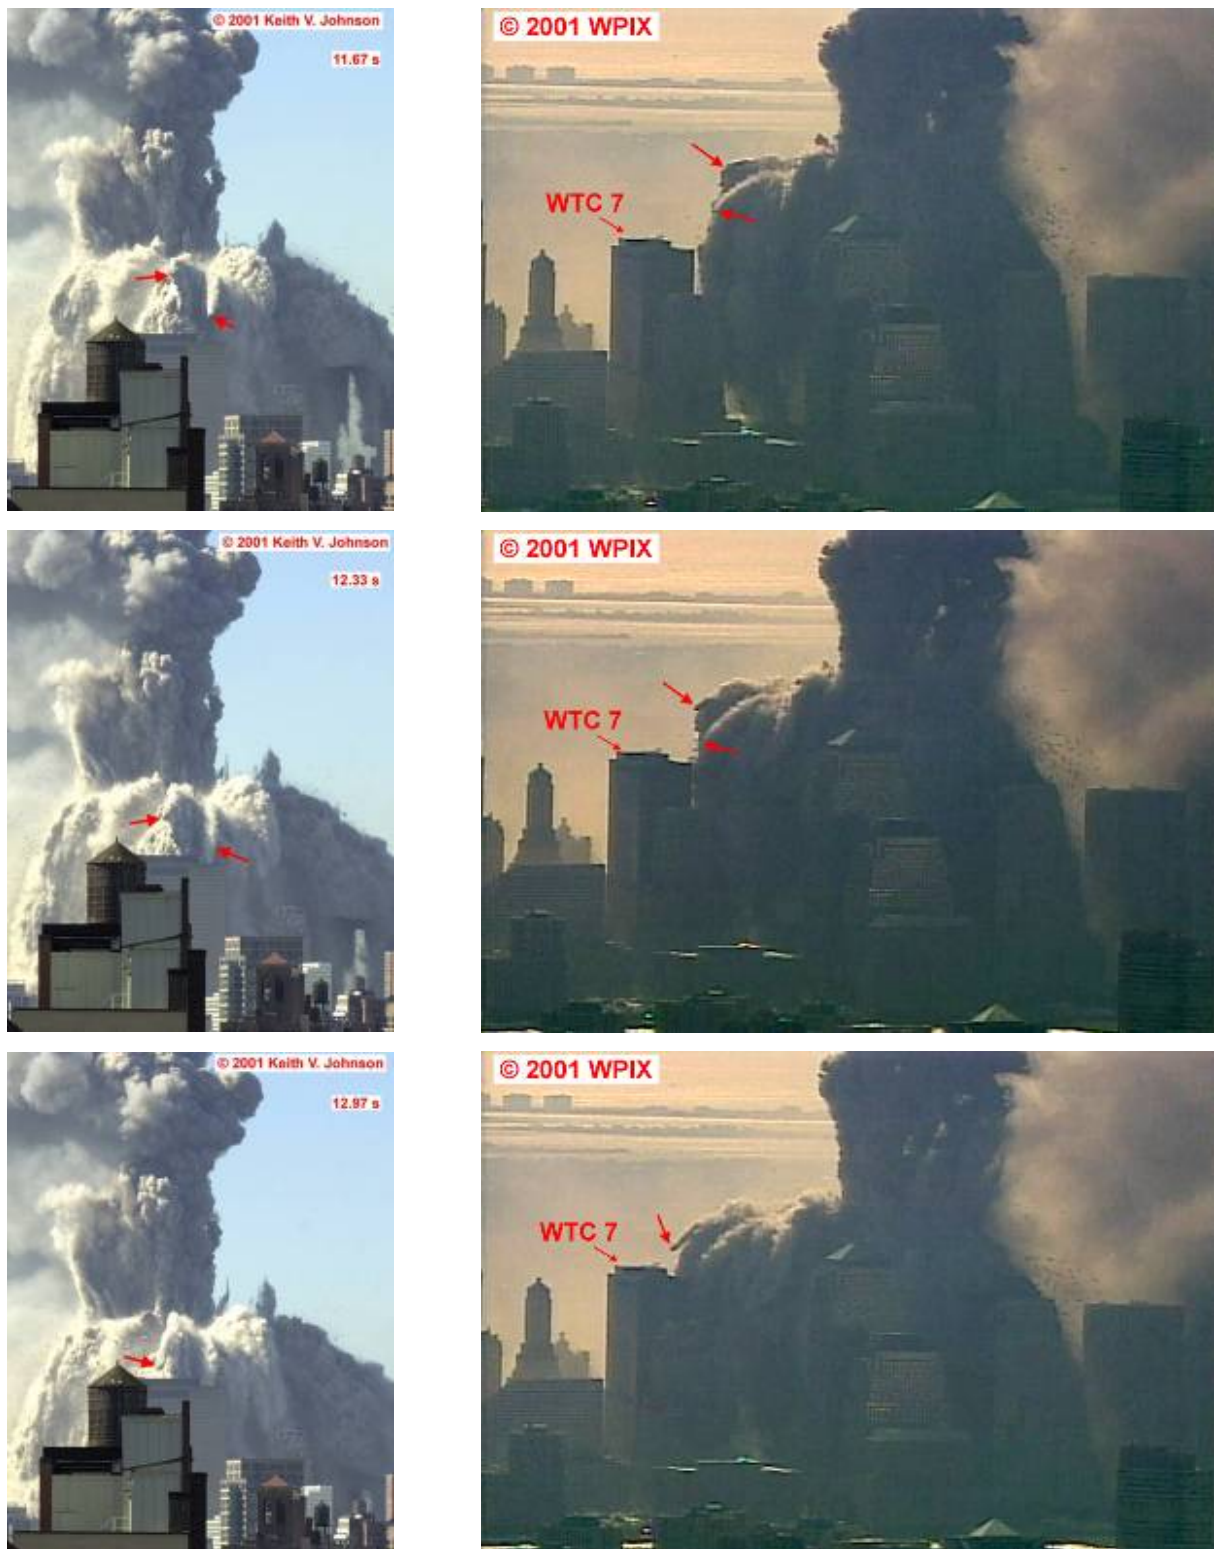
The video frame taken 6.50 s after the collapse started shows that the initial large debris created by the collapse fell close to the outer wall of WTC 1. As the collapse continued, the debris extended further outward from WTC 1, but the west view shows that the majority of the debris was still falling well away from WTC 7 10.63 s after the collapse began and 0.5 s after the first debris reached the ground. However, starting around this time, several substantial pieces of debris were expelled outward toward WTC 7 from the main cloud of the falling material. The first of these is visible in the images taken at 10.63 s (marked with arrows). Several of these pieces appeared to arc downward toward the south face of WTC 7.

In the images taken at 11.67 s, the arc (marked with arrows) formed by the initial ejected building section is distinct in both views. In the north photograph, this falling debris is visible above WTC 7 just to the right of the west penthouse. An additional piece of debris (also marked with arrows) is just beginning to emerge from the cloud. The western view at 12.33 s shows that the arc from the initial ejected debris is approaching WTC 7. The additional debris to the left and above has fully emerged and is moving outward from the main debris cloud. By 12.97 s, the later ejected material (marked with arrows) has formed a distinct arc as seen from the west, and appears just above the west penthouse in the corresponding photograph from the north.

Figure 5–40. A series of cropped photographs shot from the north and frames from a video shot from the west show the collapse of WTC 1.

the first large debris that was ejected from the dust cloud toward WTC 7. Its trajectory, visible in Figure 5–40 and Figure 5–41, suggests that it may have reached the south face of WTC 7.
