**Federal Building and Fire Safety Investigation of the
World Trade Center Disaster**

**Structural Fire Response and
Probable Collapse Sequence of
World Trade Center Building 7**

VOLUME 1

November 2008

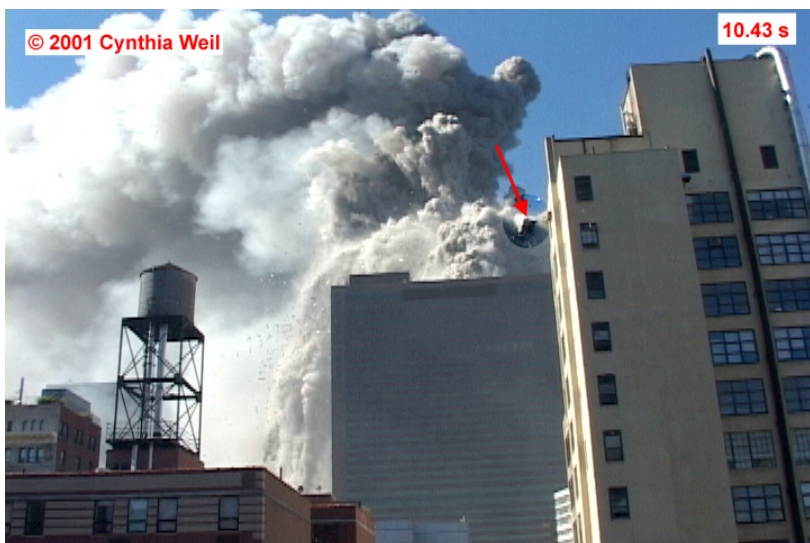
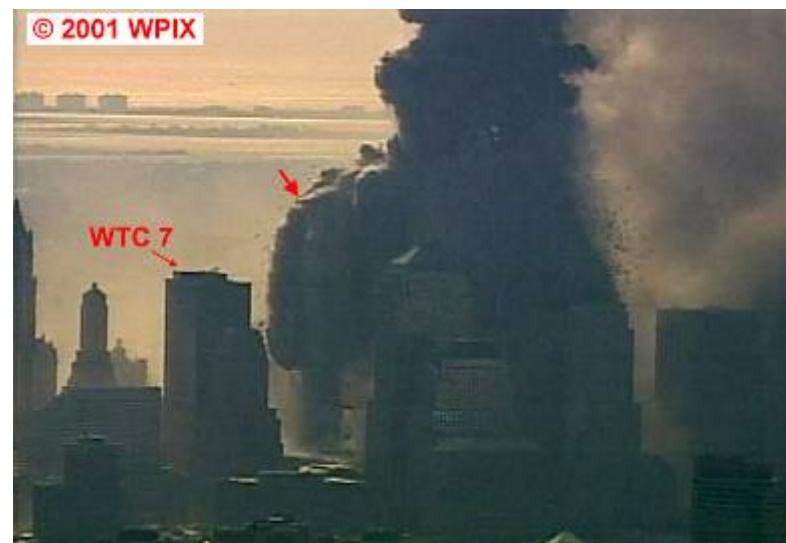
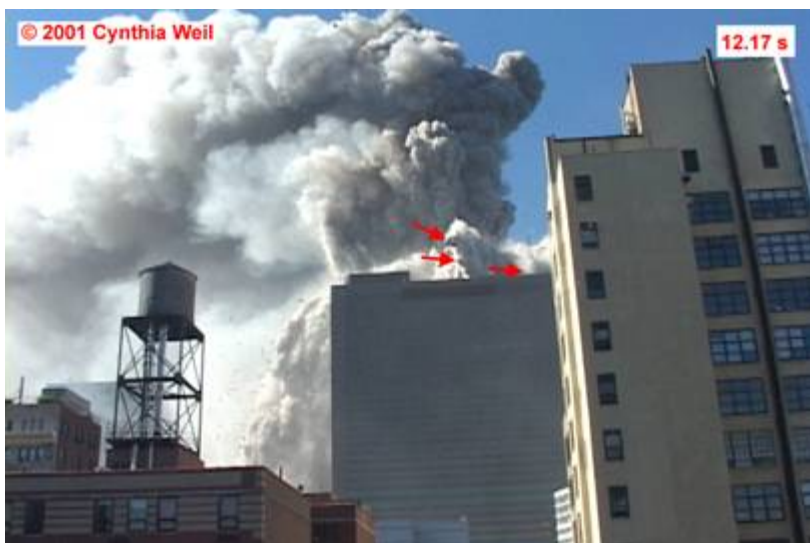
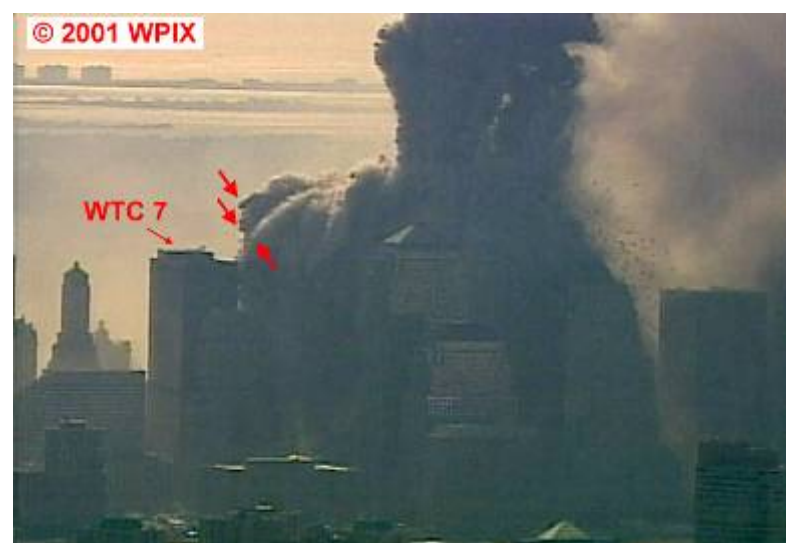
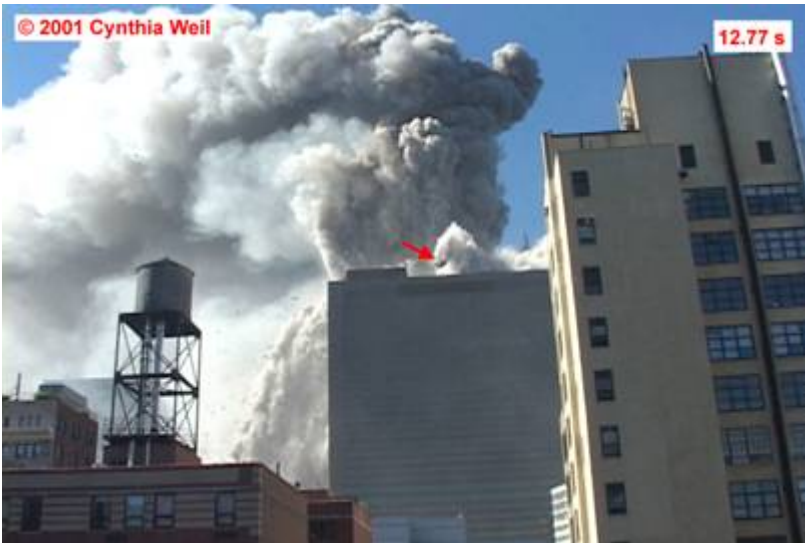
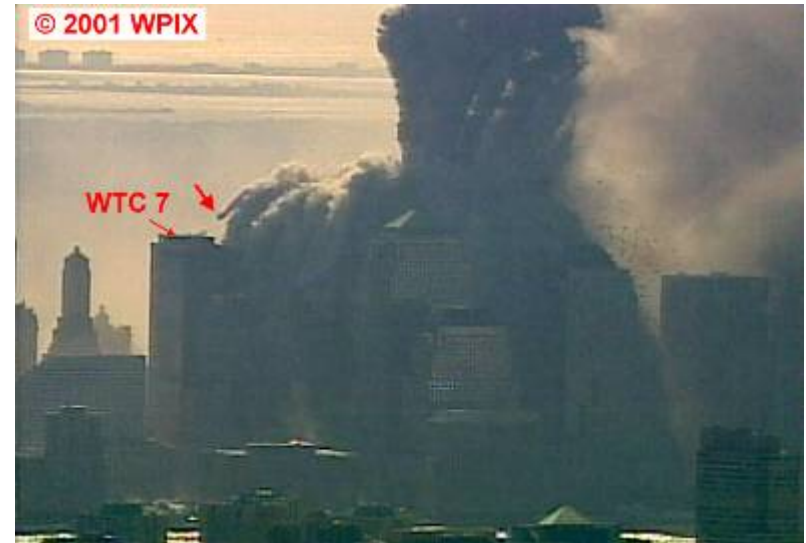
The next pair of images was recorded 12.17 s after the collapse started. The arcing path formed by the object observed at 10.43 s is visible from both directions (marked with arrows), even though the object itself has moved behind WTC 7 by this time in the north view. Note that this object appears to have passed behind WTC 7 at a location roughly halfway between the end of the west penthouse and the edge of the building. The two arrows to the left in the north view indicate additional objects that are just beginning to emerge from the dust cloud. These objects are also visible in the west view. The upper object is the same as observed for the three latest times in Figure 5–40. It ultimately formed the distinct arc seen in the images taken at 12.77 s that seemed to travel further outward. The videos show that the debris marked by the lower arrows in the images taken at 12:17 also arced downwards and had apparently disappeared behind WTC 7, just to the west of the building center, by 12.77 s.

Figure 5–41. Three pairs of frames taken from videos shot from the north and west, showing the collapse of WTC 1.
 Times are relative to the start of the collapse. Arrows indicate large objects that were projected toward WTC 7.
 The intensities of the video frames have been adjusted.

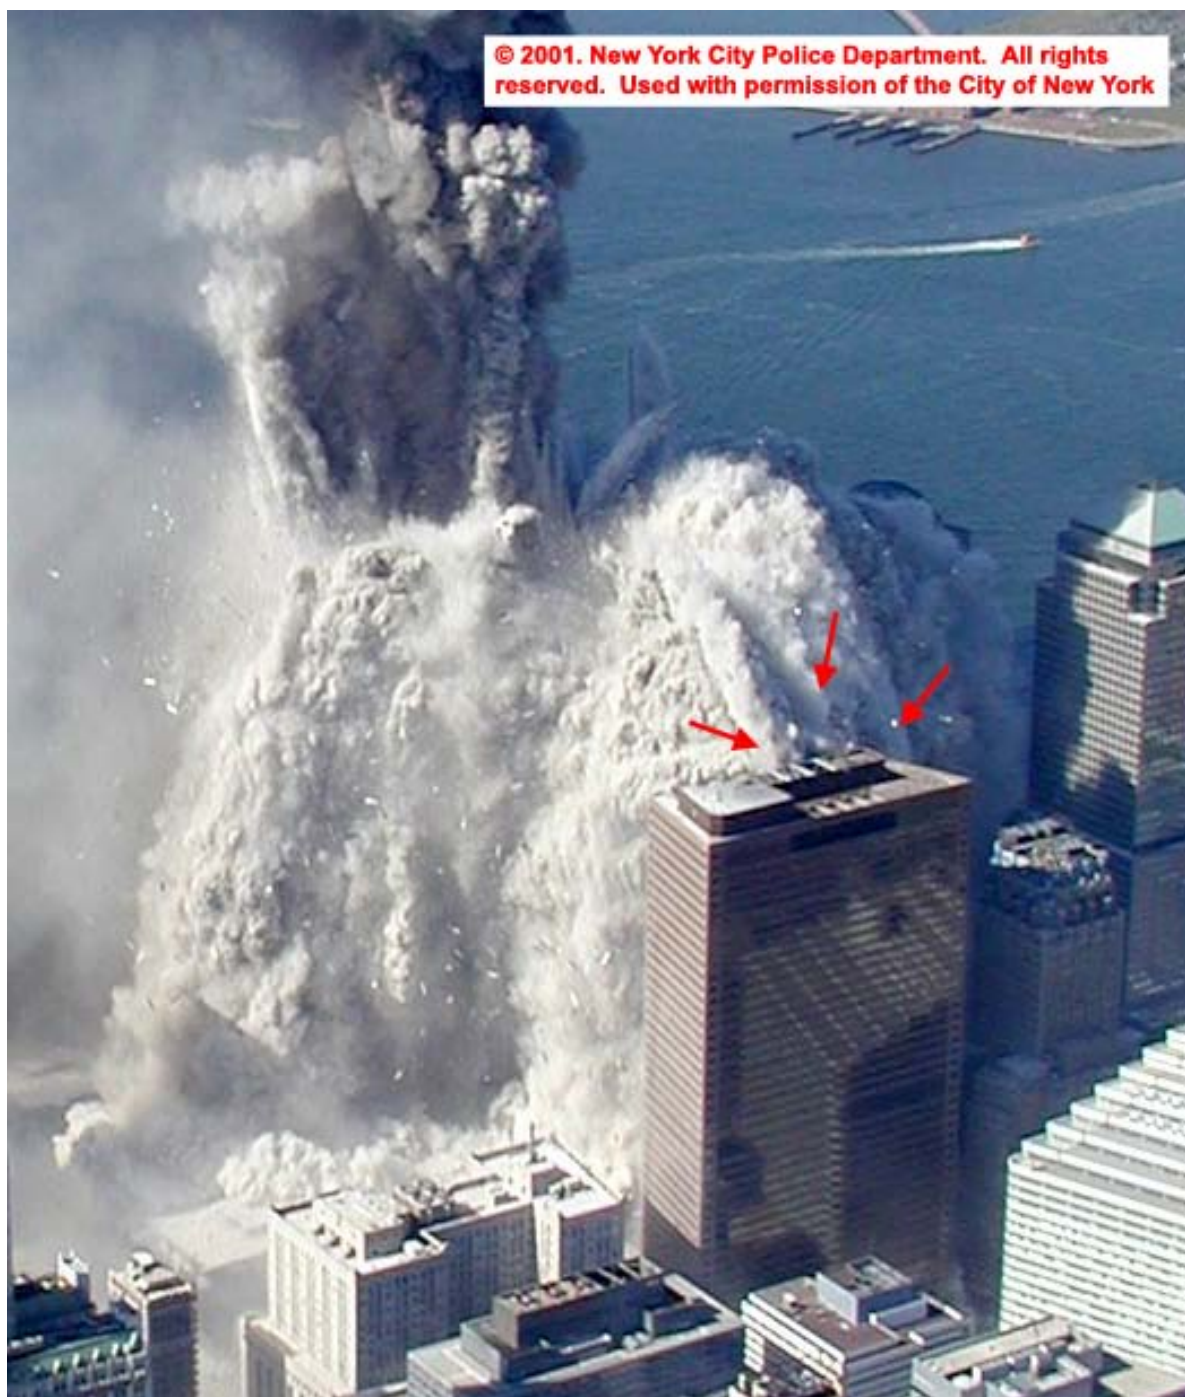
The positions of the debris relative to WTC 7 are more accurately indicated by Figure 5–42, since it was shot looking down on the scene at a time when the debris was closer to WTC 7.

Figure 5–42. Aerial photograph shot $14\text{ s} \pm 0.5\text{ s}$ after WTC 1 began to collapse.
Arrows mark arcs formed by debris that seemed to be ejected outwards from the debris cloud.

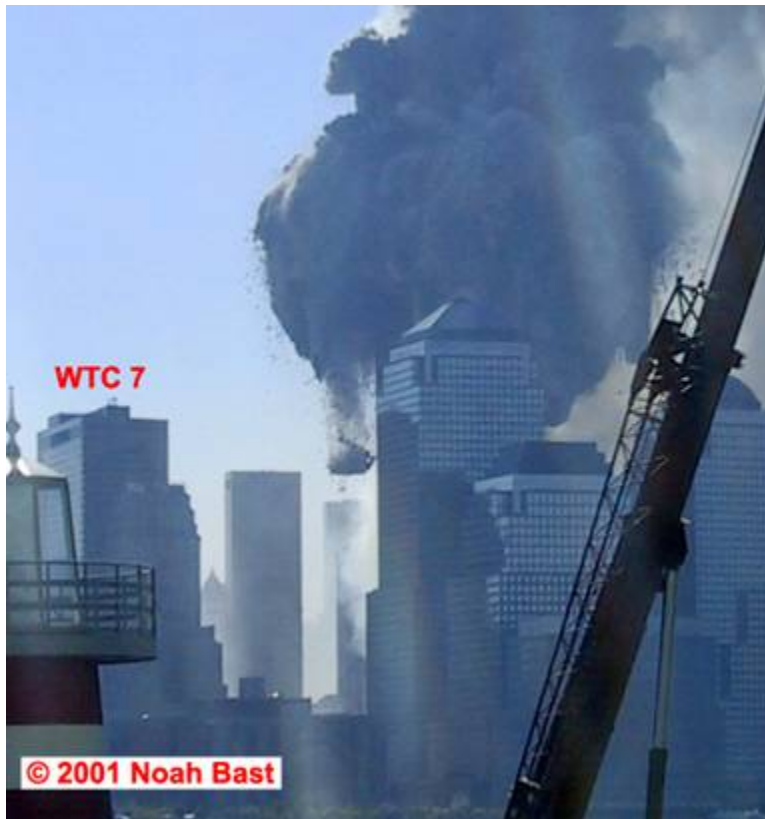
that was taken from just north of due west about 7.3 s after the collapse started. This is shortly after the second pair of images shown in Figure 5–40. WTC 7 is indicated. The building visible between WTC 1 and WTC 7 is the Millennium Hotel, and the taller building in the foreground on the right is World Financial Center 3. (See Figure 5–2 for locations.) A large piece of falling debris is visible. The image has sufficient resolution to identify the individual columns and spandrels that formed the external wall of WTC 1. This particular piece appears to be at least two panel sections high and six panel sections wide, corresponding to about 18 m × 18 m (60 ft × 60 ft).

Figure 5–43. Cropped photograph showing the collapse of WTC 1, taken from just north of west of the WTC site 7.3 s ± 0.2 s after initiation of the collapse.

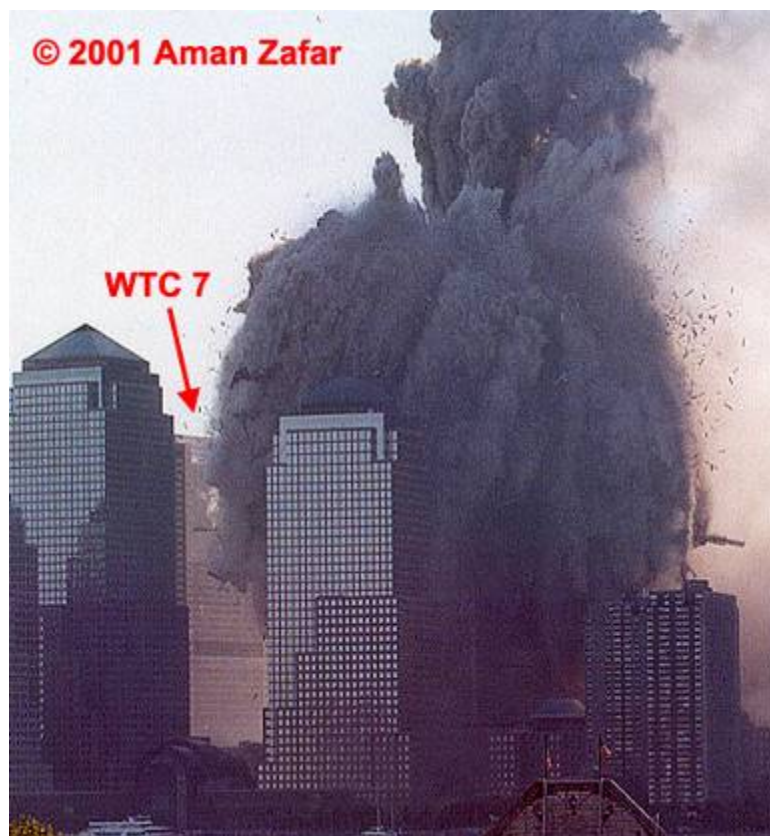
Figure 5–44. Cropped photograph showing the collapse of WTC 1, taken from southwest of the WTC site 10.6 s \pm 0.2 s after the collapse initiated.

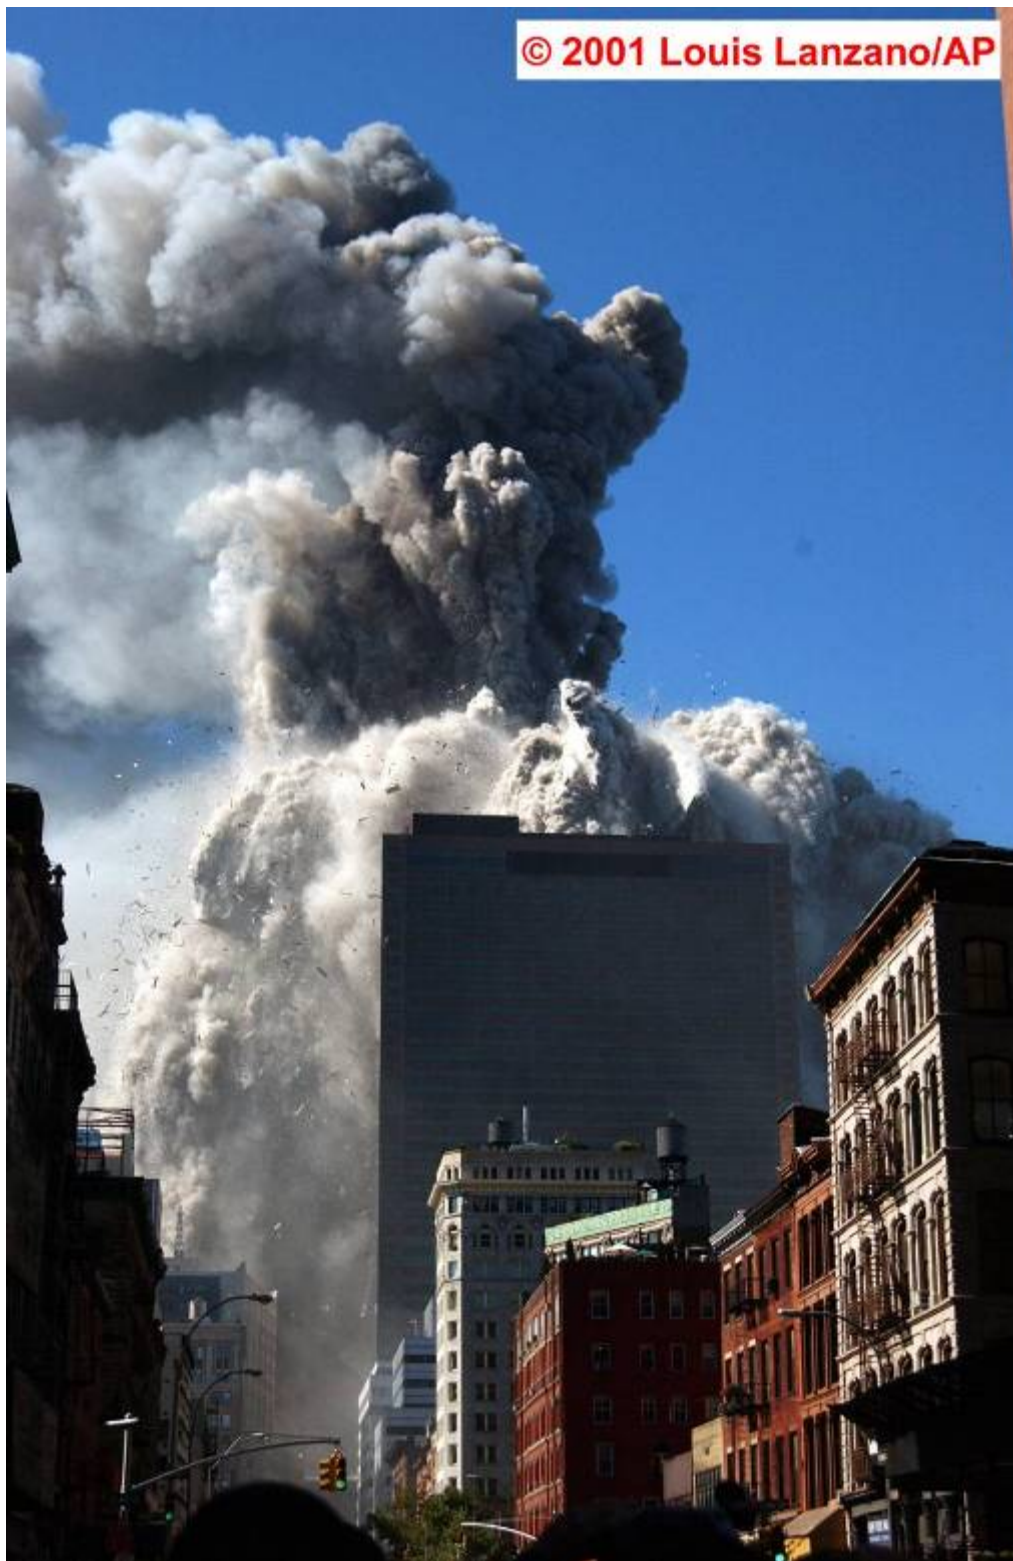
Figure 5–45 is a high resolution photograph of the collapse of WTC 1 taken 11.7 s after initiation. This is very close to the time when the fourth pair of images in Figure 5–40 were taken and between the times for the first and second pairs of images in Figure 5–41. This is around the time when the large pieces of debris were expelled toward WTC 7. The section of this photograph above WTC 7 is enlarged in Figure 5–46. Several large sections of steel are visible. On the right side of the photograph, a falling piece of WTC 1 wall is visible that is at least three panel sections wide and two high. There is another large portion of exterior steel frame visible immediately above WTC 7 just to the right of the west penthouse. It is difficult to make out the individual columns and spandrels, but this piece appears to be roughly the same size as the one further to the right. Comparison with videos shows that this large steel section was

When the photograph in Figure 5–45 was taken, pieces of debris were also appearing from the dust cloud higher up and to the east of the large steel section. (See the fourth pair of images in Figure 5–40 and the second pair in Figure 5–41.) In Figure 5–46, it is apparent that several other large pieces of debris were present in this area. The highest piece visible was ejected the furthest and formed the distinct arc visible in the last image pairs of Figure 5–40 and Figure 5–41. As noted above, the large debris below the highest piece was also thrown toward the south face of WTC 7 on a somewhat lower trajectory.

Figure 5–45. Photograph taken from the north of WTC 7 $11.7 \text{ s} \pm 0.1 \text{ s}$ after WTC 1 began to collapse.

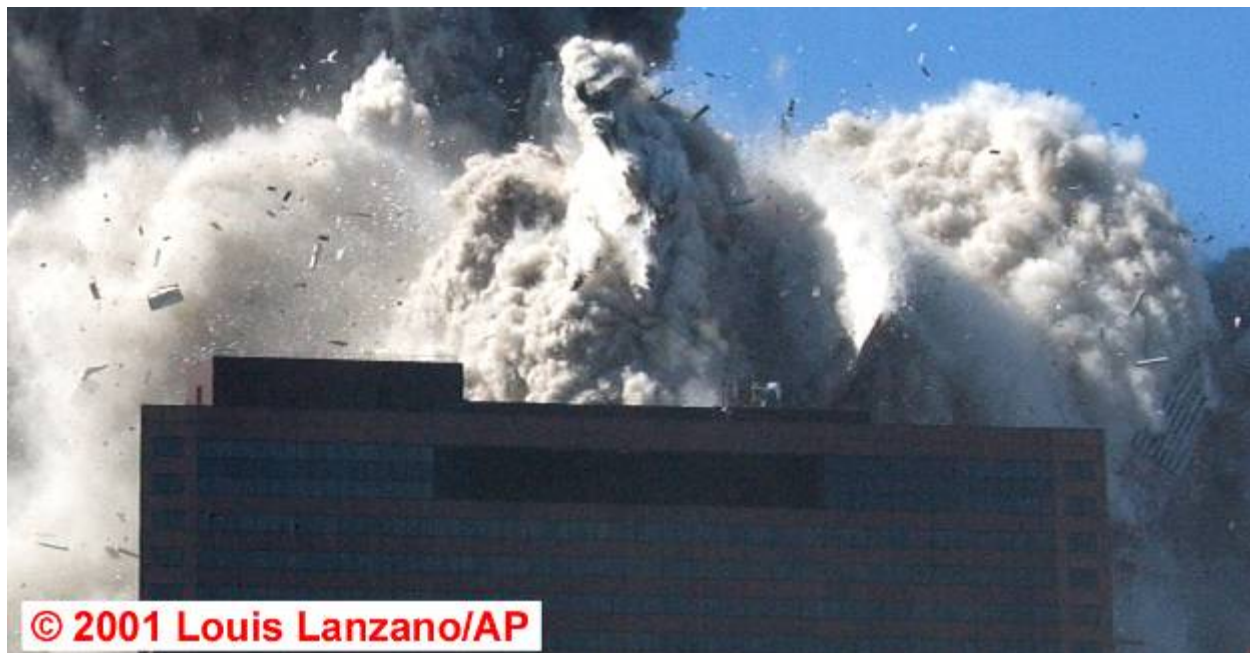
A large amount of smaller debris is visible outside of the primary debris field in Figure 5–46. Their size and shape suggest that many of these smaller pieces are individual 3.6 m (12 ft) long aluminum cladding that covered the outer steel skeleton of the towers. These are described in NIST NCSTAR 1-5A. The opacity of the dust cloud created by the collapse of WTC 1 is also evident in the photograph.

The imagery of the collapse of WTC 1 indicates that the vast majority of debris fell relatively close to the tower and did not impact WTC 7 directly. However, there were at least a few substantial pieces of the exterior steel frame that were expelled far enough to impact the south side of WTC 7. A substantial amount of dust and small debris is likely to have struck the south face.

Figure 5–46. Enlarged section of Figure 5–45 focused on the area above WTC 7.

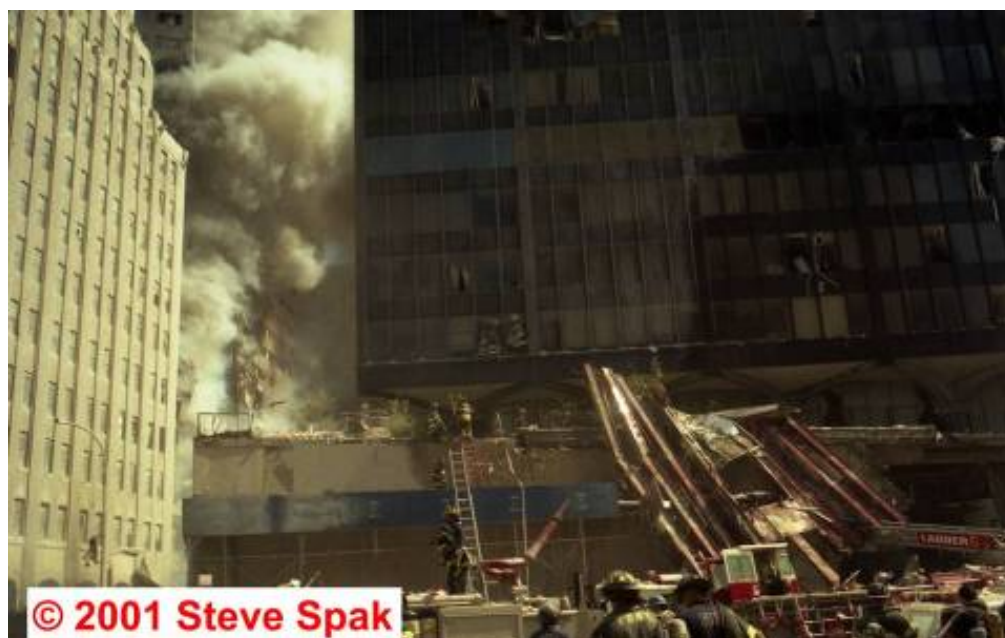
Figure 5–47. Photograph showing a portion of the south face of WTC 7, taken just after 1:30 p.m.

A damaged area is visible on the south face of WTC 7, and an opening has been created on the left side of the visible part of the face. Heavy smoke appears to be coming from this opening. A closer inspection shows there is an area to the right where the alternating spandrels and windows, characteristic of the south face (see the earlier discussion), are visible. A series of white vertical lines are also present. These lines reveal the locations of the steel columns that were located along the south periphery of the building, immediately behind the windows. These columns appear white because of their enclosures.

In Figure 5–47, the four sets of columns to the immediate right of the damaged area have roughly the same spacings, but the distance to the next set of columns appears to be somewhat larger. In fact, the spacing between Columns 24 and 25 was about 1.8 m (5 ft 10 in.) larger than the spacings between Columns 21, 22, 23, and 24. On this basis, the five sets of columns visible to the right of the damaged area were tentatively assigned as Column 21 to Column 25.

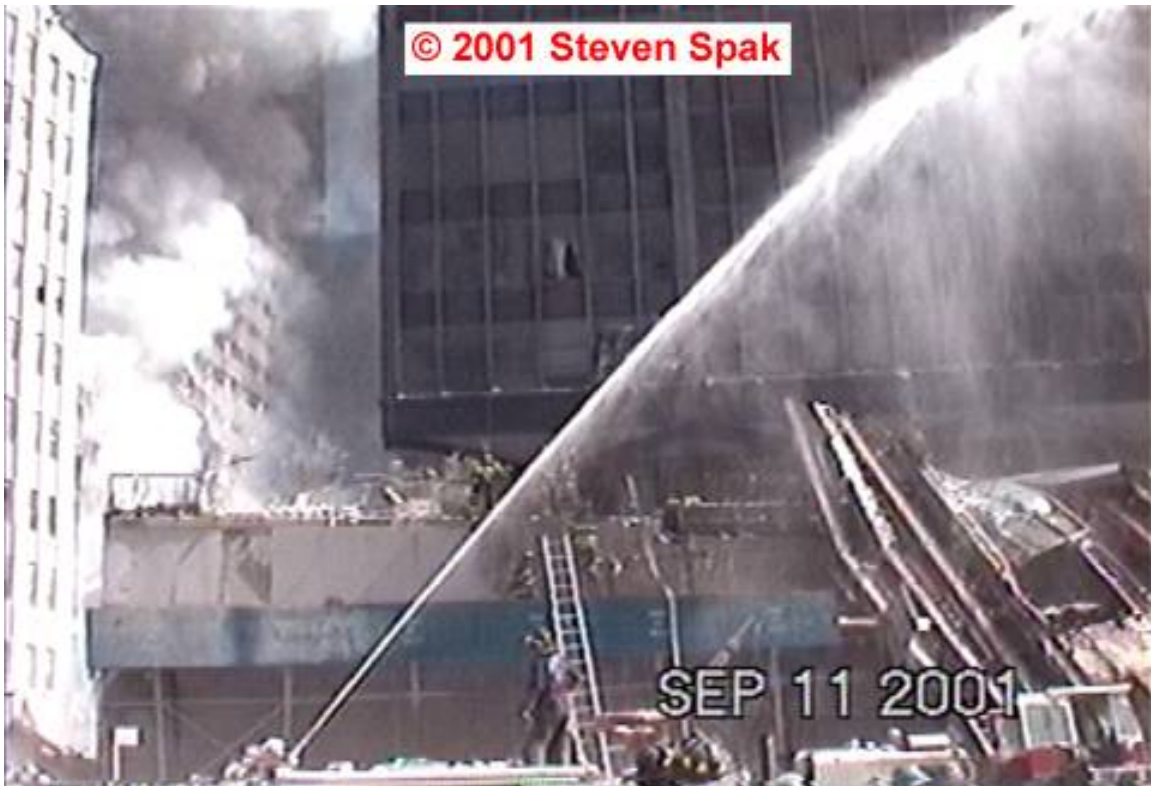
This photographer also recorded a short video segment of the south face from near the same location at roughly the same time as the photograph in Figure 5-47. As the smoke rolled across the south face in the video, additional areas on the south face (primarily on the east side) were momentarily revealed. Figure 5-48 shows a frame taken from this video. By appropriate scaling (the video has much lower resolution) and rotation of such frames, it was possible to obtain good overlap of the captured video frames and the image shown in Figure 5-47.

Figure 5-48. Frame taken from a video recorded shortly after 1:30 p.m., showing a partial view of the south face of WTC 7.

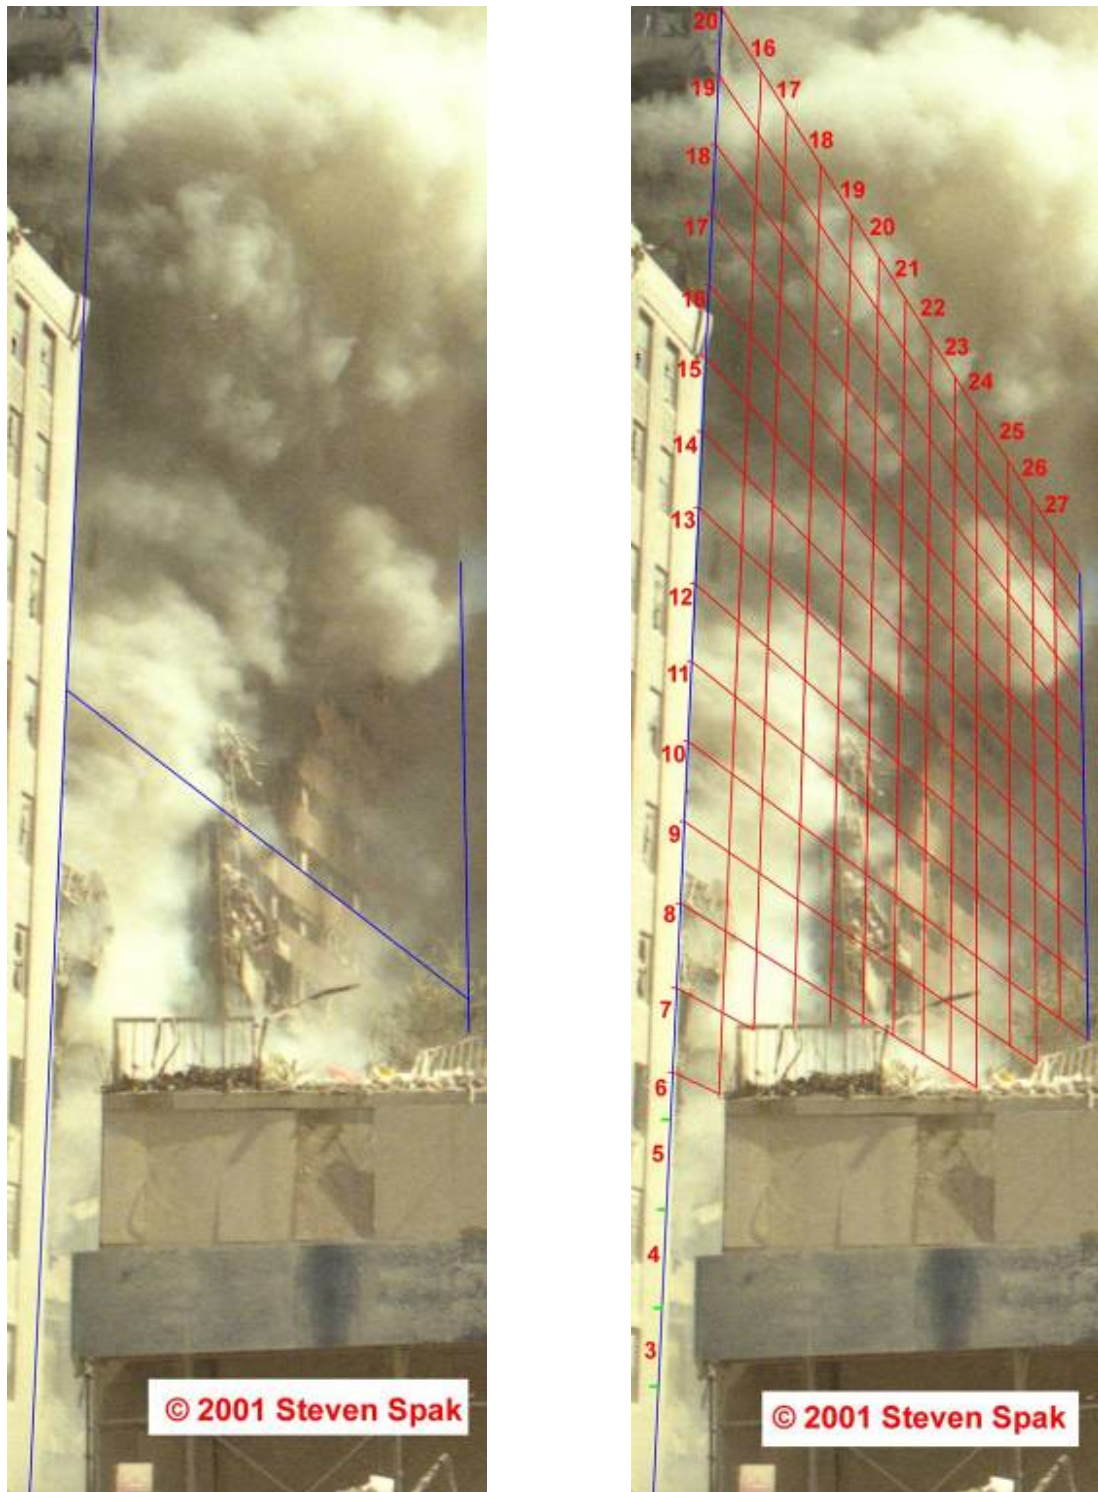
Figure 5-49. Enlarged sections of the photograph shown in Figure 5-47.

In the view on the left, blue lines have been added that indicate projected locations for the southwest and southeast corners and for a baseline aligned along the bottom of windows located on the 11th floor. A superimposed grid indicating column positions and lines for the top edges of windows on given floors is shown on the right.

In Figure 5-49, the area to the immediate right of Column 20 on the 11th and 12th floors appeared dark, as if it was an opening, while the higher floors were hidden by smoke. However, it is clear from Figure 5-63 that the columns between Column 20 and Column 23 were intact on the 11th through 14th floors, along with the spandrel beams and at least part of the granite cladding on the 12th through 14th floors. In Figure 5-49, the granite cladding appears to be damaged below the 13th floor near Column 23.

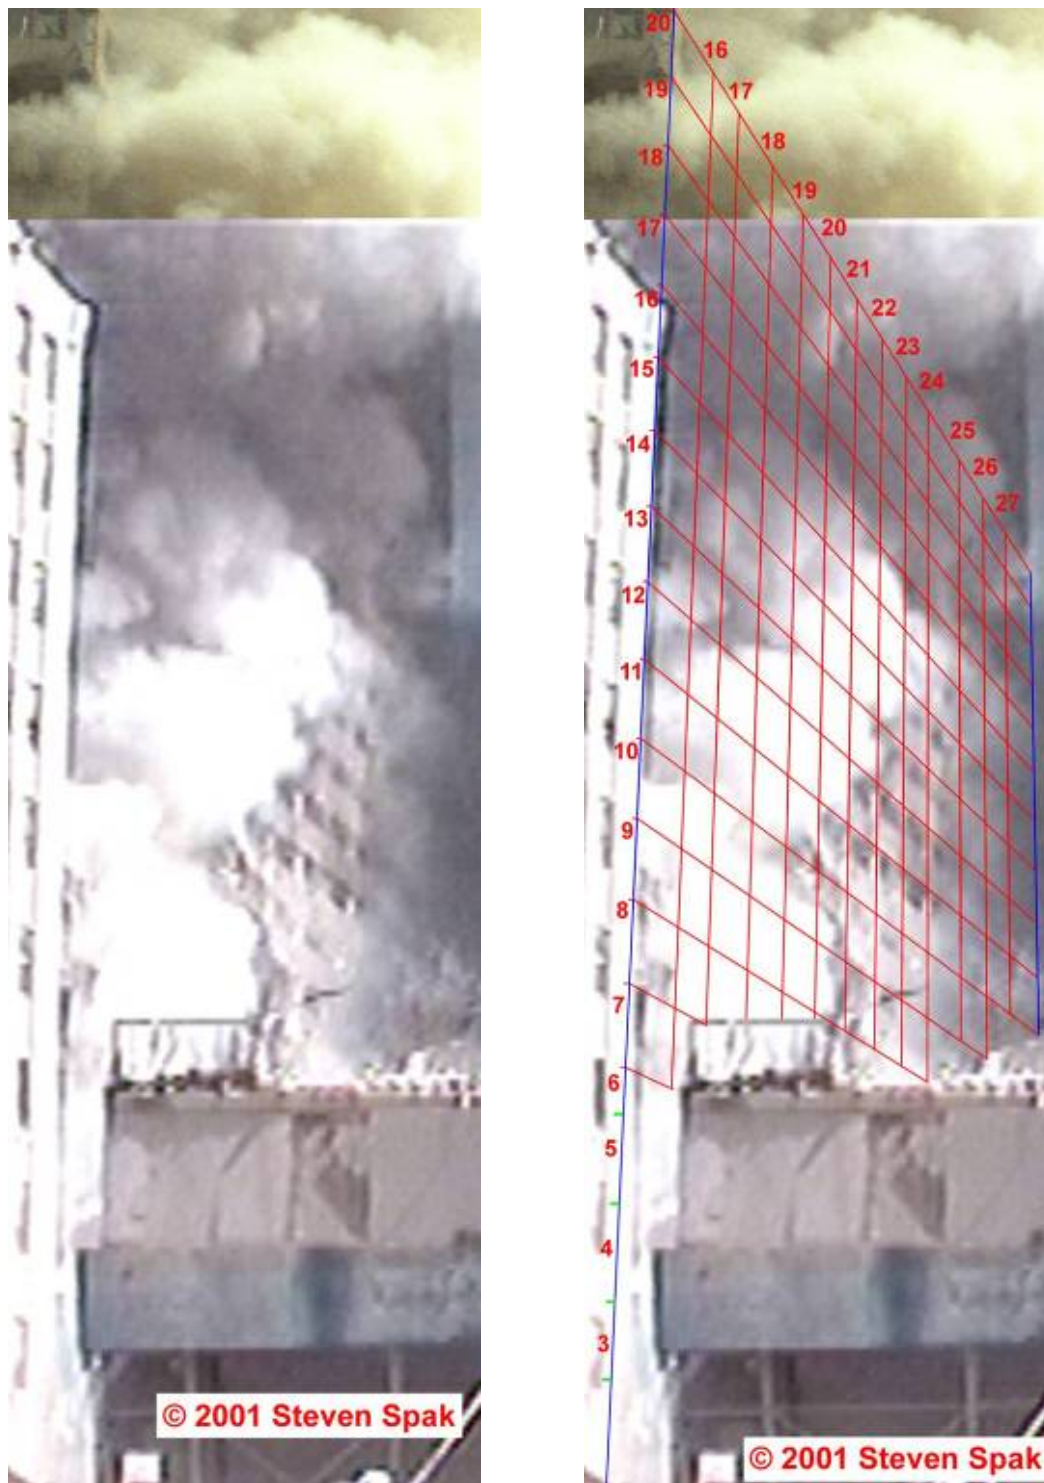
Figure 5–50 shows an enlargement of the damaged south face from the video frame shown in Figure 5–48 overlaid on the photograph shown in Figure 5–49. On the right, the grid taken from Figure 5–49 has been superimposed on the same image. While the image has a relatively low resolution, it is clear that the columns and spandrels to the right of the damaged area were essentially intact, but that most of the window glass had been broken out.

Figure 5–50. An enlarged section of the south face of WTC 7 from the video frame in Figure 5–48.

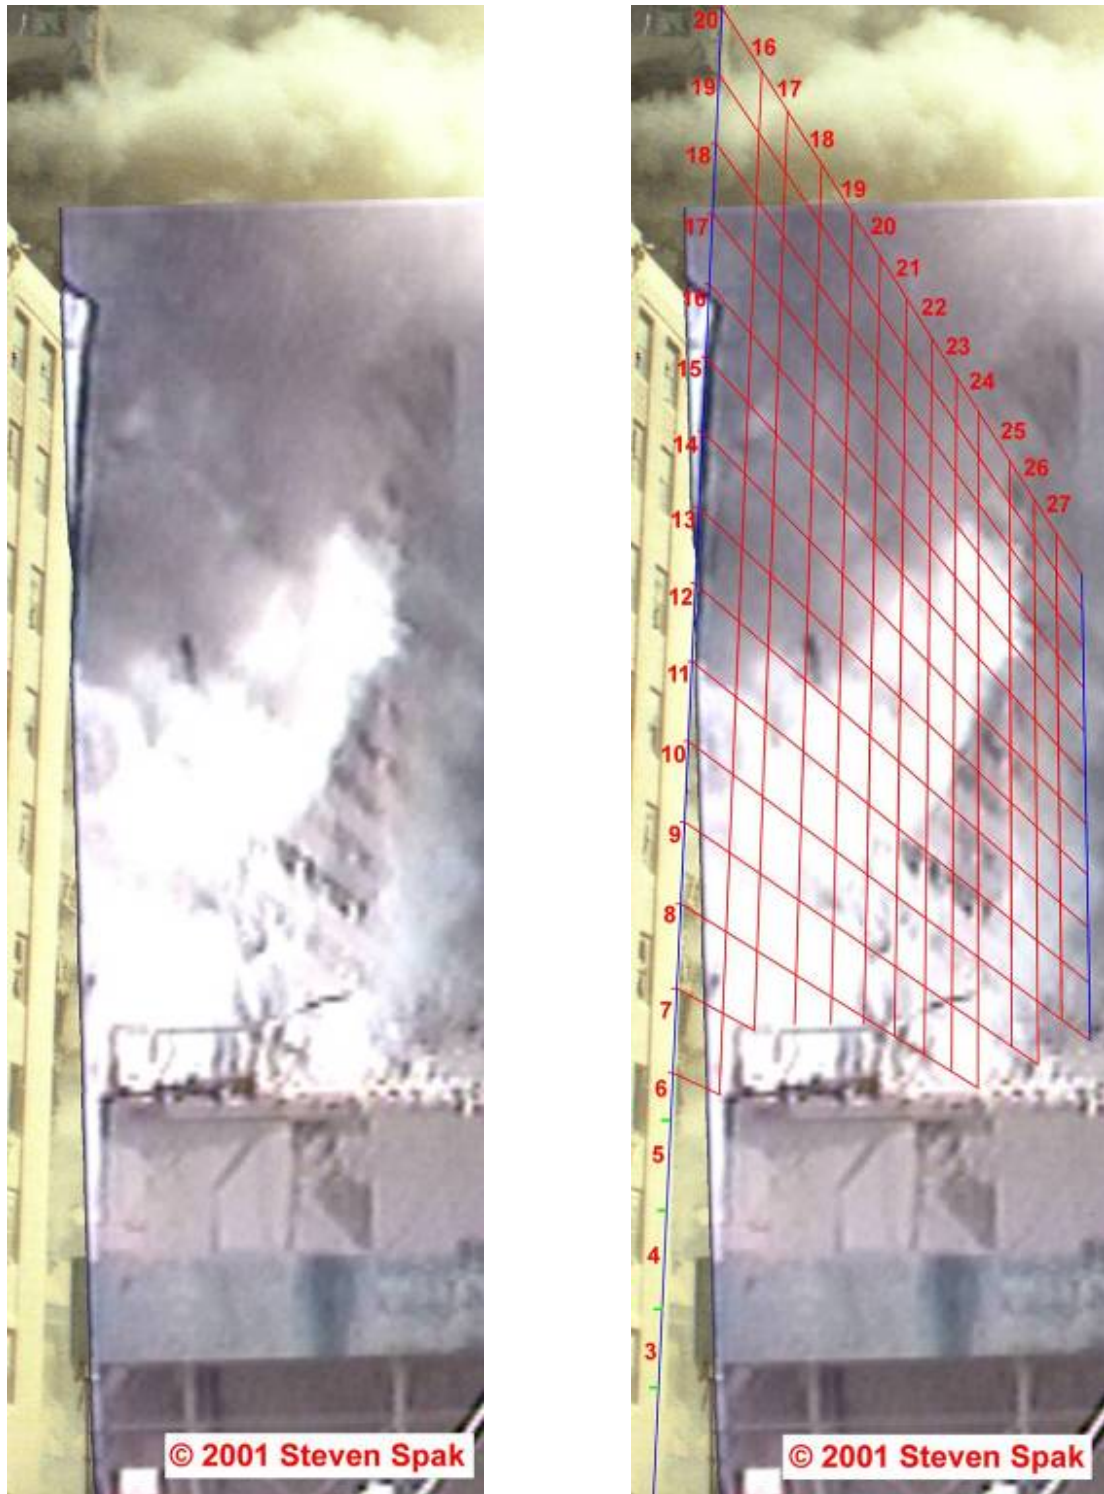
Figure 5-51. An enlarged section of the south face of WTC 7 from a second video frame.

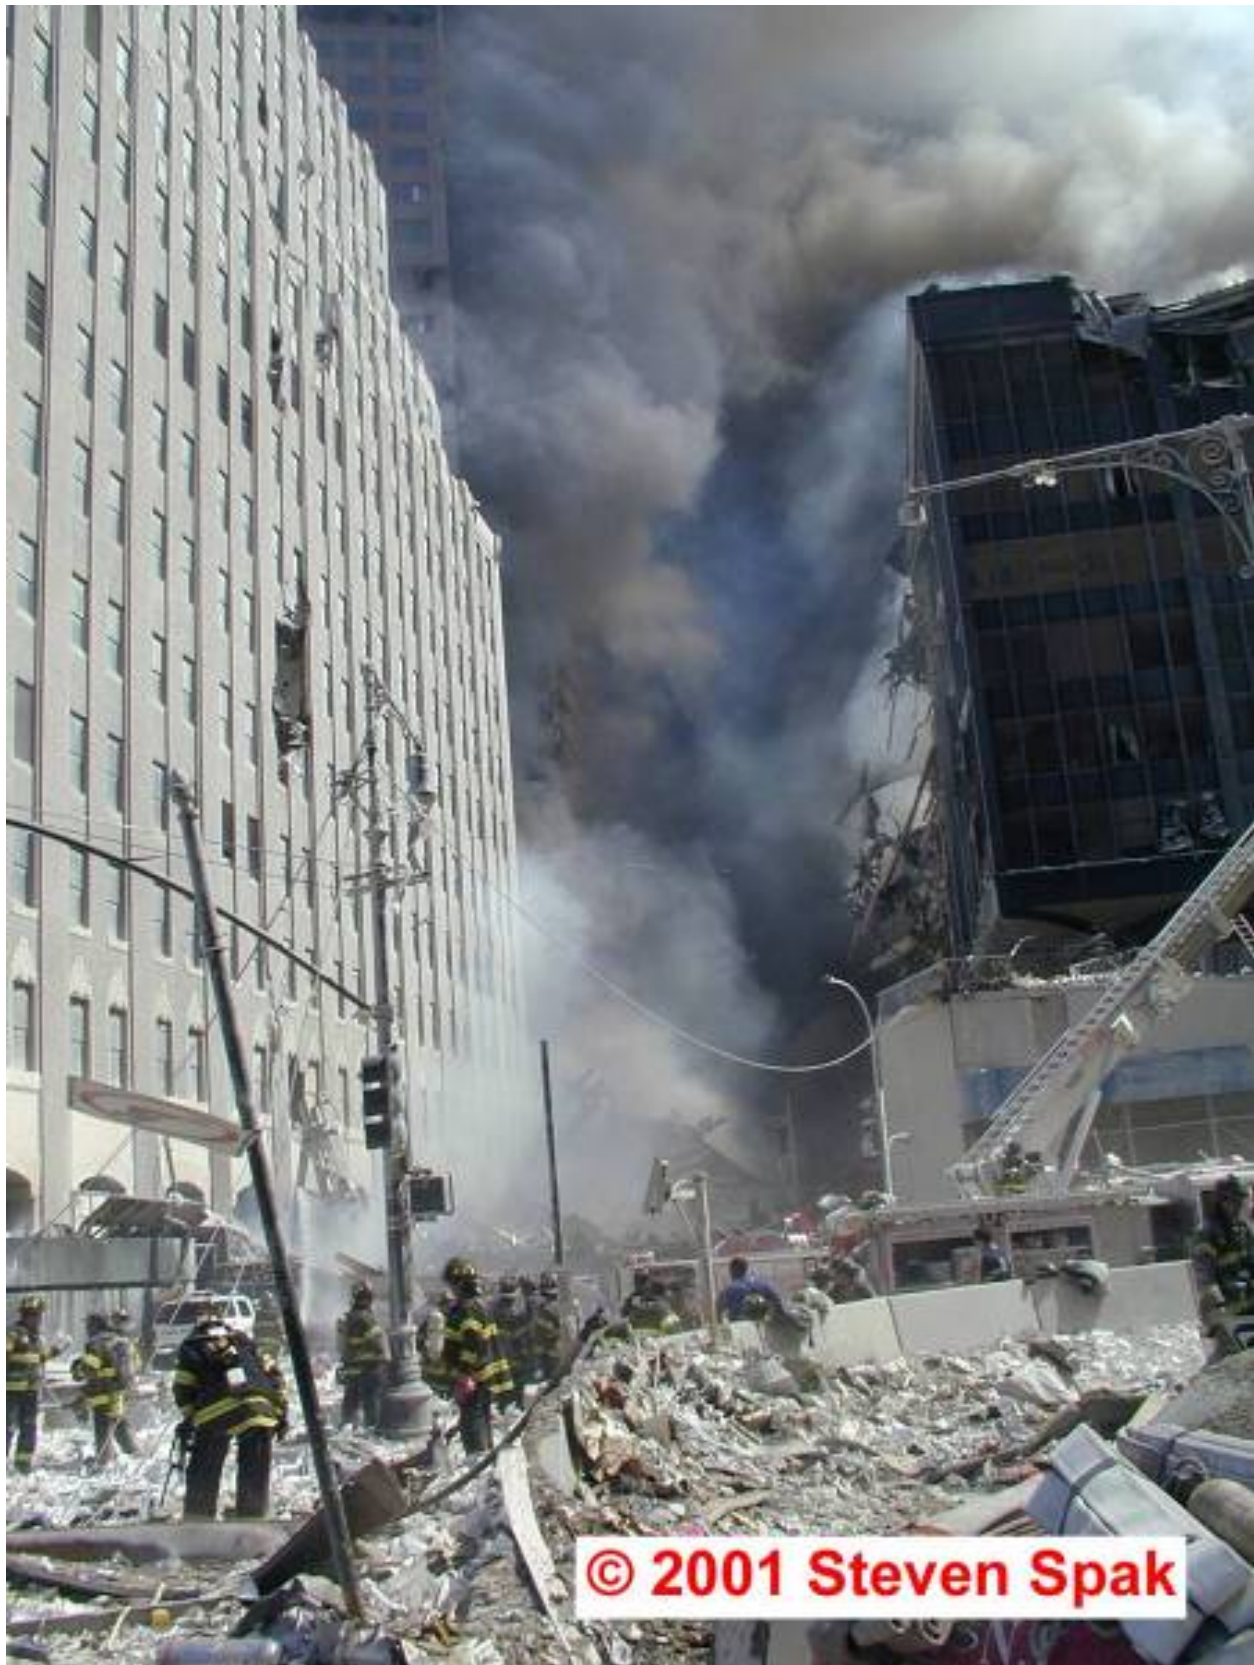
Figure 5–52 is another photograph showing damage to the south face of WTC 7. It was shot from West Street looking down Vesey Street. The Verizon Building is on the left, WTC 7 is behind it, and WTC 6 is on the right. Even though this image provides a more oblique view than the photograph in Figure 5–48, it is possible to see locations closer to the street.

Figure 5–52. Photograph showing a portion of the south face of WTC 7 at 12:46:39 p.m.

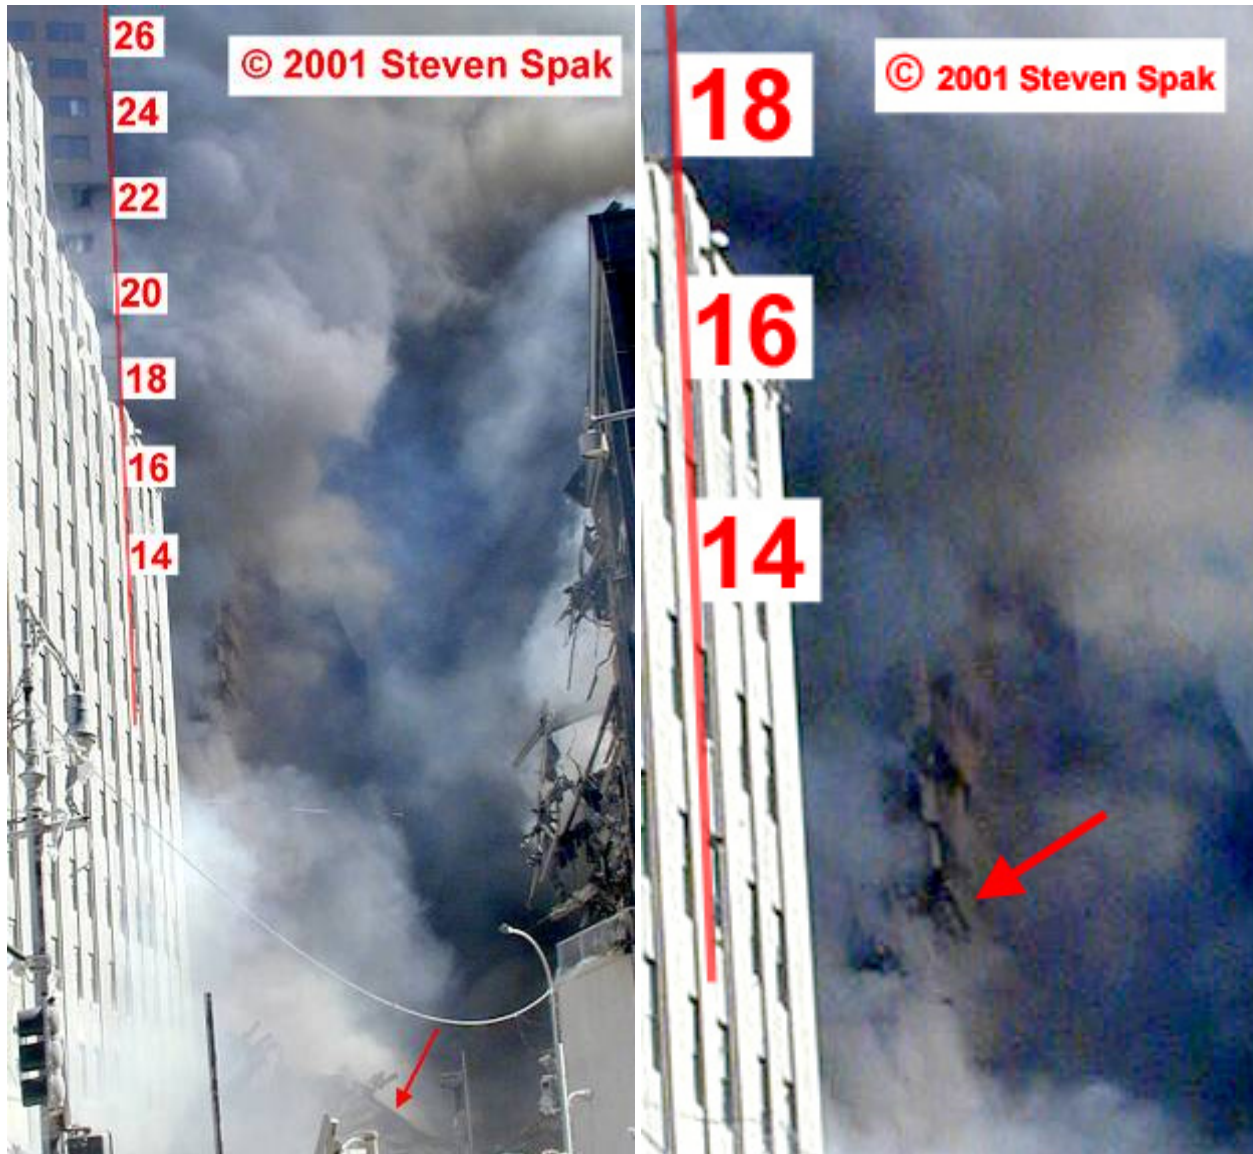
Figure 5–53. Two enlargements from Figure 5–52, showing the south face of WTC 7.

The vertical red line indicates the location of the southwest corner of the building. Floor number locations were determined as described in the text. The red arrow in the left enlargement identifies debris that may be from the Promenade, and the arrow on the right indicates a characteristic damage pattern.

The damaged area visible on the south face is enlarged further on the right side of Figure 5–53. The arrow indicates a distinct damage feature in the granite. Sighting along the tops of the windows immediately above the arrow indicates that these windows are on the 14th floor. An analysis similar to that employed to create the grid shown in Figure 5–49 was used to estimate the locations of columns

visible in Figure 5–53. These assignments indicated that the damage was located near Column 22 or Column 23. Figure 5–53 shows that the façade damage extended up to at least the 15th floor. In the images of the area shown earlier, the 14th and 15th floors had been hidden by smoke.

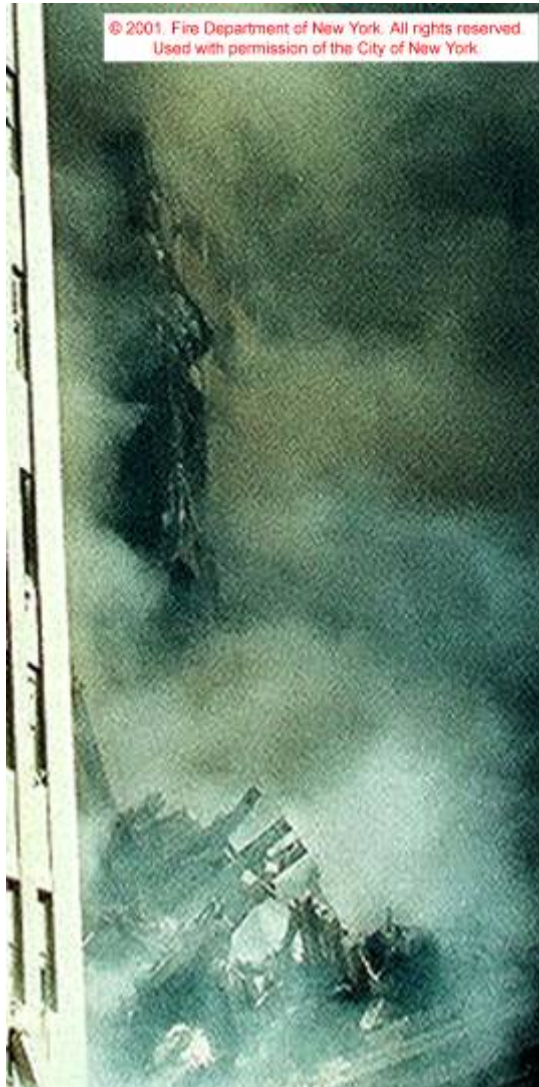
The smoke near the base of WTC 7 had momentarily cleared at this time, and it is possible to observe a damaged area on the lower part of the south face. An opening in the building spanning several floors is apparent. This part of the image has been enlarged in Figure 5–57. A row of several windows with some columns visible can be seen near the top of the visible damage. Closer inspection reveals that there is another row of windows immediately below. A single window is visible just to the right of the curved damage section. Lower down a single rectangular opening is present to the left of the opening in the face. This opening is much taller than the windows visible above. Its shape indicates that it is one of the vents that spanned the 5th and 6th floors. Thus, the damage visible in the image spans the 5th to 8th floors.

There is insufficient information in the image to identify the exact horizontal location of the damage on the face. However, it is likely that the damage area is a downward extension of the opening visible in Figure 5–47 and Figure 5–49 to the immediate left of Column 20. If this is correct, the opening in this area extends from at least the 5th floor to the 15th floor.

Figure 5–57. Expanded portion of Figure 5–56 showing damage on the south face of WTC 7.
The contrast of the image has been enhanced.

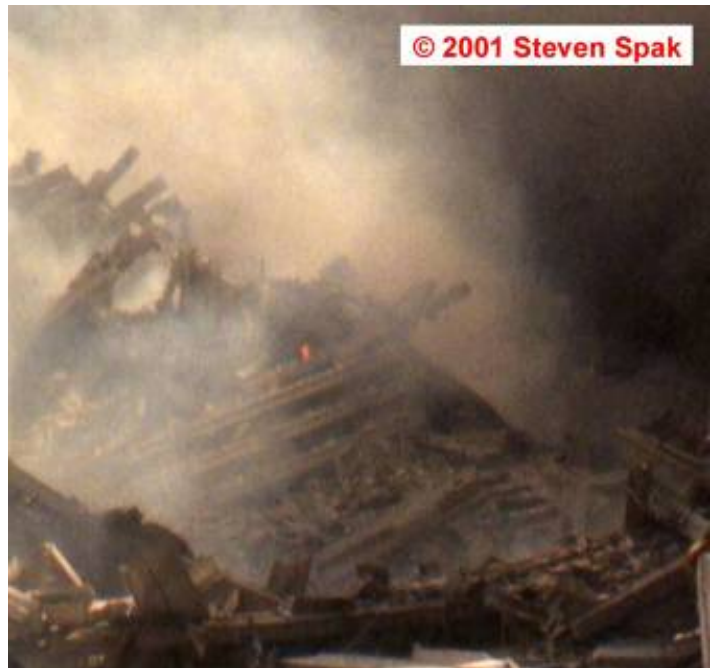
Another view of the debris piled up at the base of WTC 7 is shown in Figure 5–58. The large number of steel panel sections from WTC 1 is evident. A small fire is burning in the pile. The large amount of debris in Vesey Street is consistent with the large areas of WTC 1 panel sections that were described earlier as falling toward WTC 7.

Figure 5–58. View of the rubble at the base of the south face of WTC 7.
The original image was cropped, and the intensity levels and contrast were adjusted.

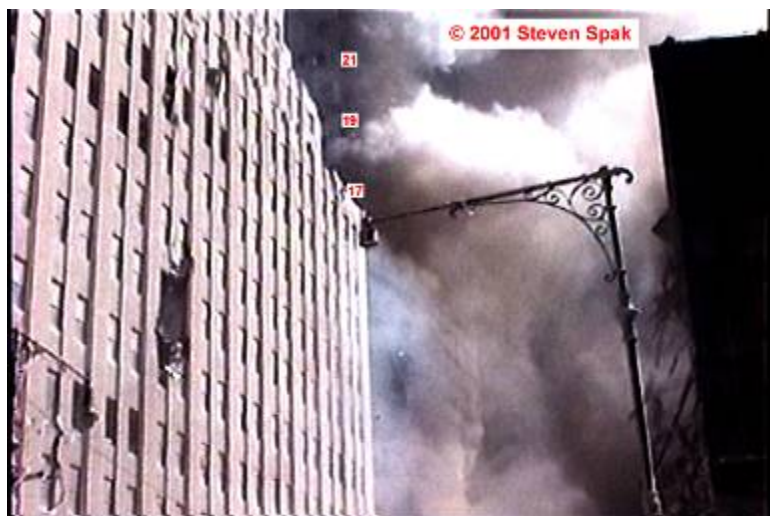
Another frame from a video clip showing the south face of WTC 7 taken looking up Vesey Street is shown in Figure 5–59. Visible floors along the south edge of the west face are indicated. The hole near the center of the south face is only partly visible, but this image is noteworthy because the smoke is clear enough to confirm that the spandrels and columns are intact over a large area to the east of the hole. By using lines running along the tops of the windows to extrapolate to the west edge, it was possible to identify this area as extending from the 11th floor to the 15th floor.

Figure 5-59. Frame from a video clip shot shortly after 12:30 p.m. showing the south face of WTC 7 framed by the Verizon Building and WTC 6. The intensity levels have been adjusted and floor numbers have been added.
