**Federal Building and Fire Safety Investigation of the
World Trade Center Disaster**

**Structural Fire Response and
Probable Collapse Sequence of
World Trade Center Building 7**

VOLUME 1

November 2008

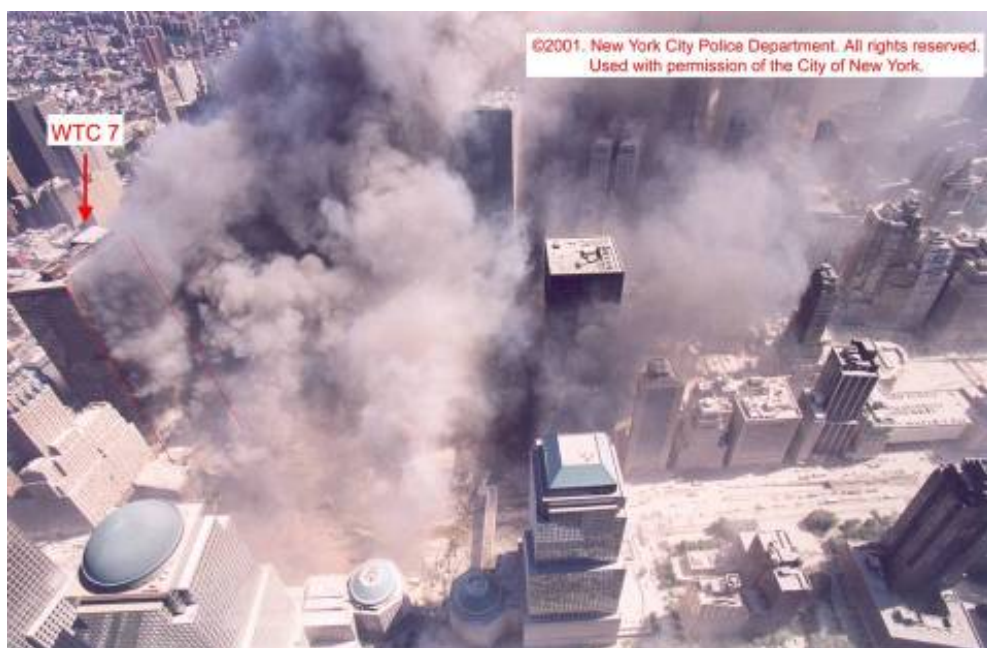
Figure 5-60 shows a long-distance photograph shot from a helicopter just after 12:30 p.m., in which the south face of WTC 7 is partially visible. Red lines have been added indicating the west and east edges of the face. The west edge was easily identified, but, due to the presence of smoke, the east edge line had to be drawn by starting at the upper corner, which is just visible, and assuming the east edge was parallel to the west edge.

Figure 5-60. Photograph of the WTC site shot around 12:35 p.m. from a helicopter. The red lines identify the west and east edges of the south face of WTC 7.

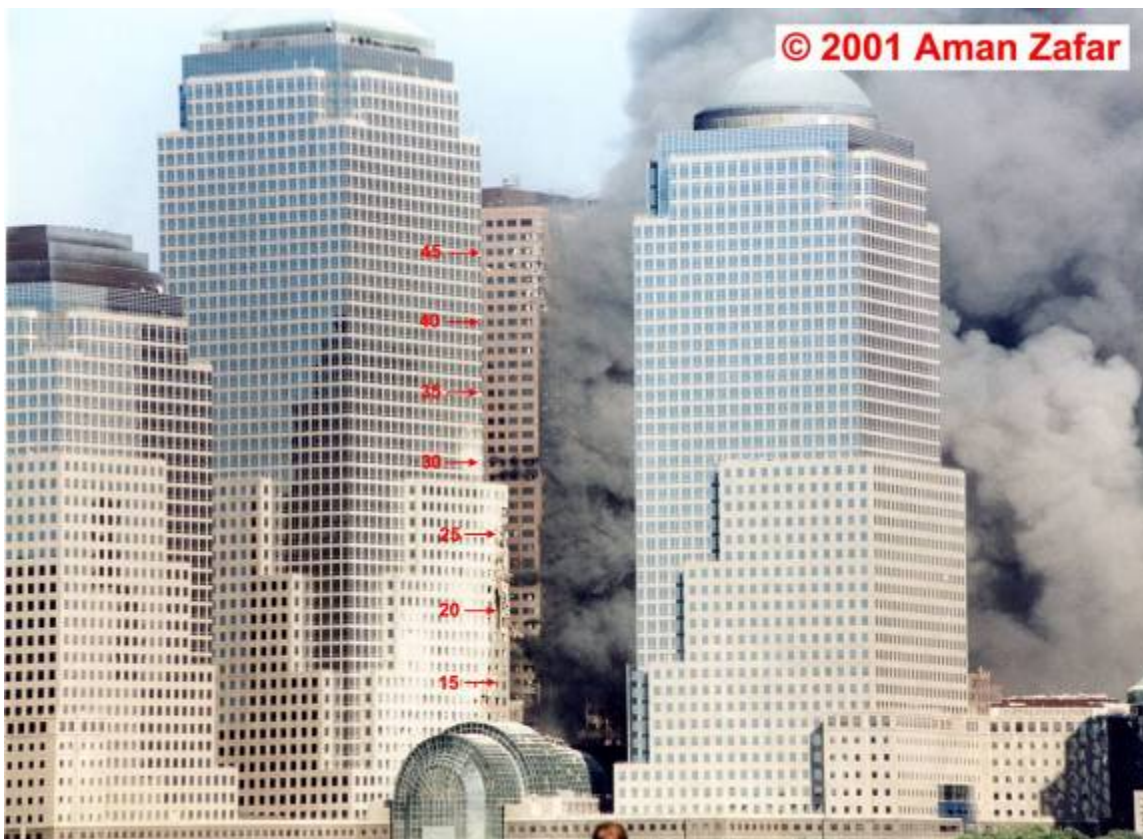
Figure 5–62 was shot from Jersey City on the opposite side of the Hudson River. It shows portions of the southwest corner and adjacent faces of WTC 7, flanked by World Financial Center 3 on the left and by World Financial Center 2 on the right. The Winter Garden lies at the base of WTC 7. The roofline of WTC 6 is visible just above the Winter Garden, and a small corner of the Verizon Building is also visible just to the right of World Financial Center 3. WTC 7 floor numbers have been added to the photograph.

Figure 5–62. Photograph showing the southwest corner of WTC 7 in the early afternoon. The buildings visible on the right and left are World Financial Center 2 and World Financial Center 3, respectively. The structure in the foreground is the Winter Garden. The base of WTC 7 is also hidden by WTC 6. Numbers and arrows indicate WTC 7 floors.

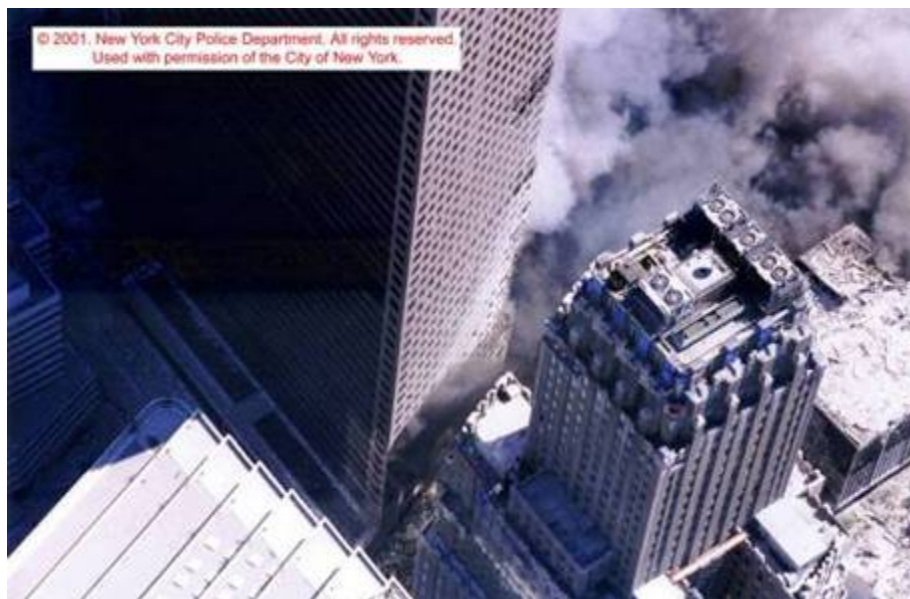
Figure 5-64 shows a photograph of WTC 7 shot from a helicopter between 2:15 p.m. and 2:45 p.m. Damage is visible low on the southwest corner of the building. This area has been enlarged in Figure 5-65, and arrows and numbers have been added that identify the floors corresponding to given rows of windows.

Figure 5–64.
Photograph showing
the north and west
faces of WTC 7, shot
from a helicopter
between 2:15 p.m.
and 2:45 p.m.

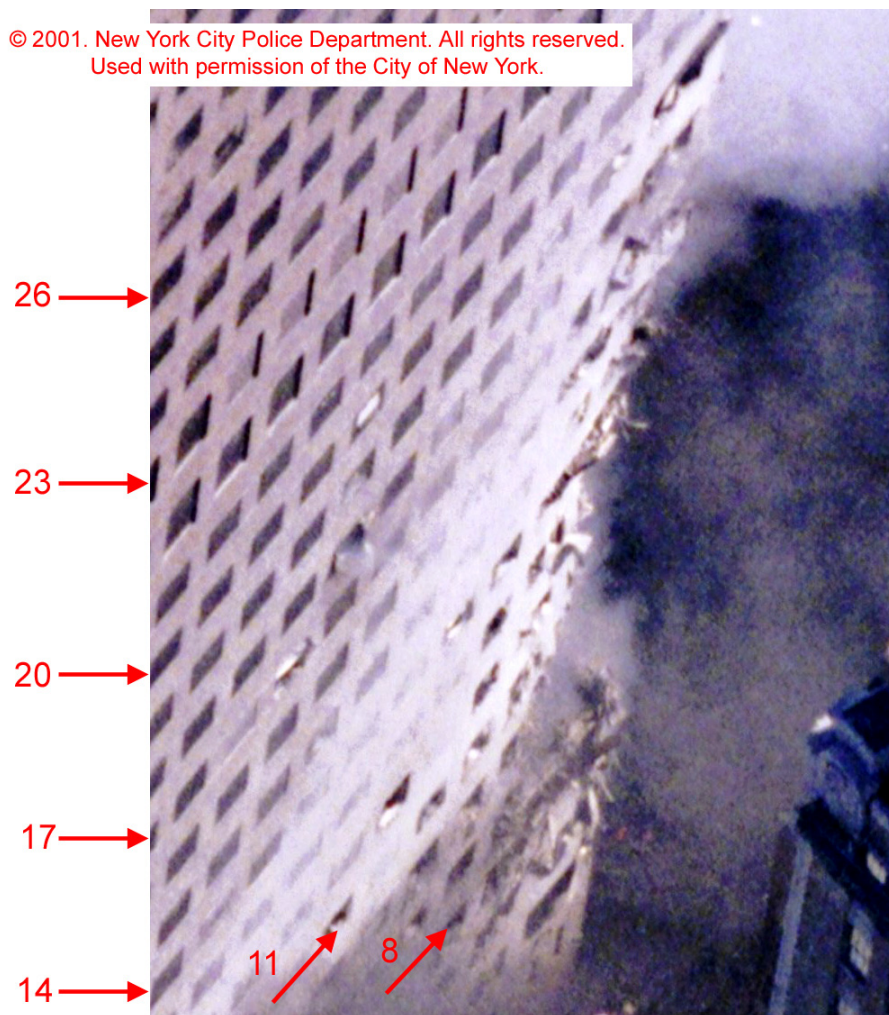
Figure 5–65.
Enlargement of an
area from the
photograph in Figure
5–64 showing part of
the west face of
WTC 7.
The image intensity
has been adjusted, and
arrows and floor
numbers have been
added for the
corresponding rows of
windows.

The image shows considerable damage to the southwest corner, starting at the 17th floor and extending downward to at least the 8th floor. Below the 17th floor, the corner of the building appears to be missing. At a minimum, the granite cladding and its supports have been removed. Figure 5–66 shows a photograph taken at 12:48 p.m. from West Street showing the same area of WTC 7 and an enlargement of the southwest corner. In this image, it is clear that the corner granite has been removed, and it appears that the corner Column 15 (Figure 5–20 and Figure 5–26) has been exposed, but is still in place down to the 12th floor. This column was located just behind the southwest corner. The dull color of the steel indicates that its insulation had been stripped away.

In Figure 5–65, it can be seen that damage to the corner of the 14th floor extends further along the west wall than on higher floors. It is clear in Figure 5–68 that the corner at this floor had been pushed inward,

In Figure 5–66, the southwest corner is not visible below the 13th floor. In Figure 5–65, the corner column certainly appears to be absent from the 12th floor down to the 9th floor. Closer inspection of this image provides strong evidence that this is the case. The southwest corner area of WTC 7 from Figure 5–64 is enlarged further in Figure 5–69, and circles and arrows have been added indicating features discussed in the following paragraphs.

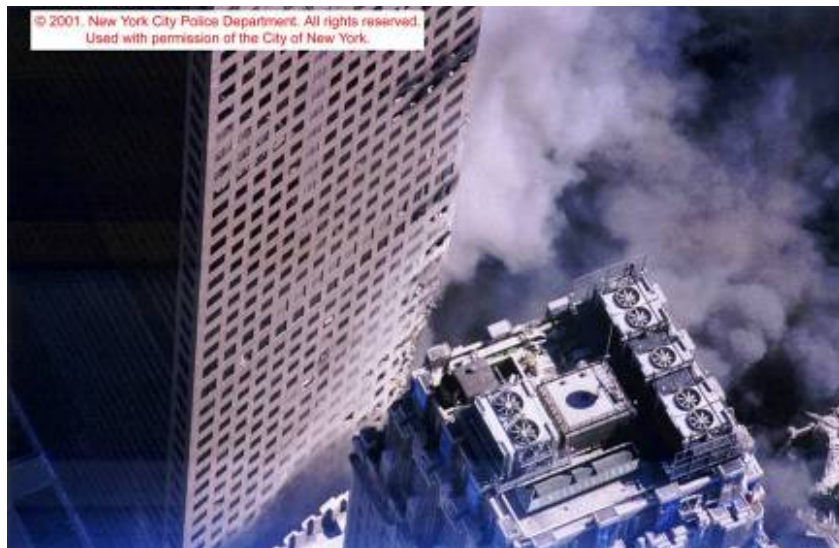
A second aerial photograph (Figure 5–67) provides a partial view of the damaged area from a closer location and a less oblique angle than those in Figure 5–64 and Figure 5–65. The damaged area from this photograph is enlarged in Figure 5–68 with floor numbers indicated. In this image, the end of the horizontal member at the base of the 17th floor windows can be seen clearly, and there is no indication that Column 15 is attached to it.

Figure 5–67. Photograph showing the north and west faces of WTC 7, shot from a helicopter between 2:30 p.m. and 3:00 p.m.

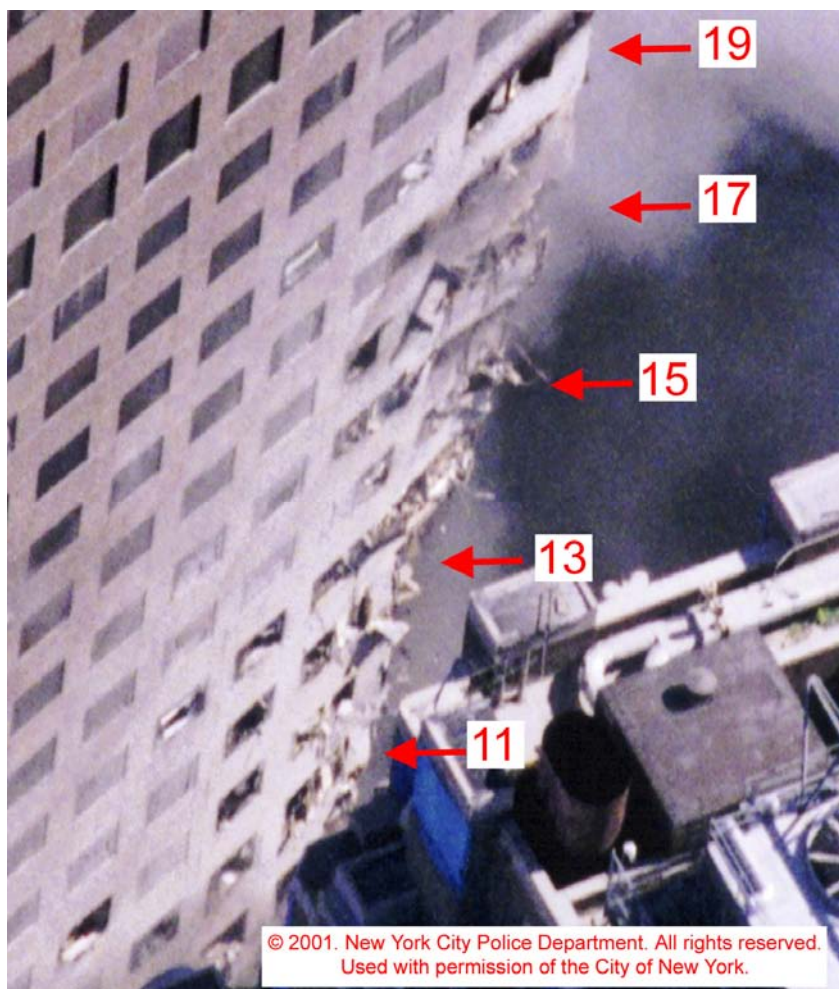
and that there was considerable façade damage. The aerial views in Figure 5–65 and Figure 5–68 suggest that there was substantial damage between Column 14 and the south edge on the 13th floor. There is no sign of corner Column 15 in these images. Although this column appears to be present in ground shots shown in Figure 5–63 and Figure 5–66, it was likely displaced.

Figure 5–68. Enlargement of an area from the photograph in Figure 5–67 showing part of the west face of WTC 7.

Arrows and floor numbers have been added for the corresponding rows of windows.

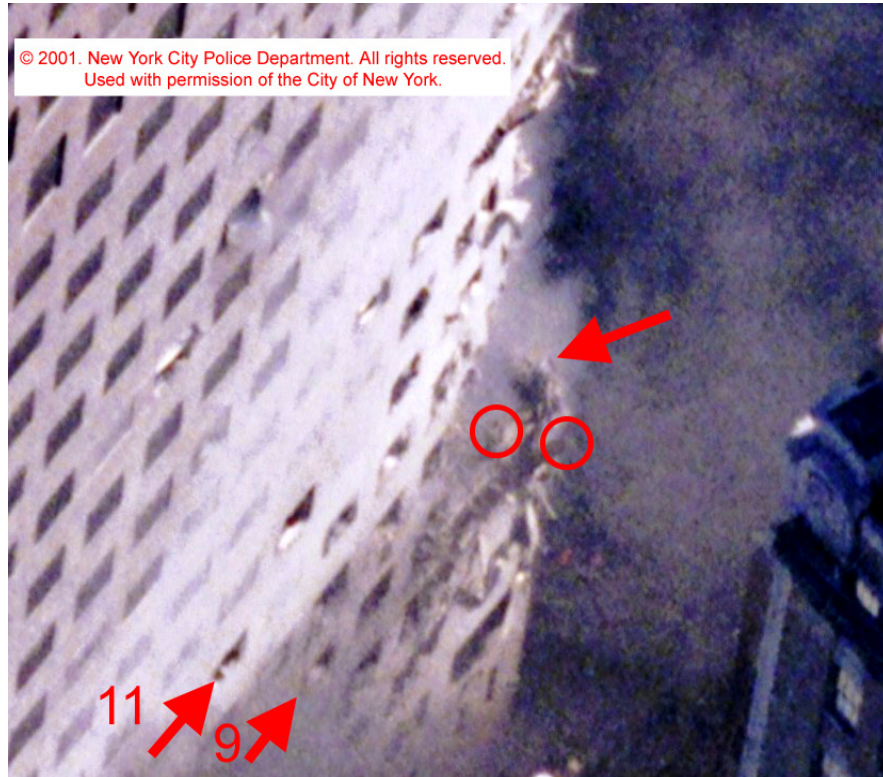
Figure 5–69. Enlargement of an area from the photograph in Figure 5–64 showing the damaged southwest corner of WTC 7.

The image intensity has been adjusted and arrows and floor numbers have been added for the corresponding rows of windows. The circles and arrow indicate features discussed in the text.

The right circle in Figure 5–69 encloses the end of a column near the corner that appears to have been dislodged from the steel spandrel and pushed outward. The arrow in the image points to a third object near the corner that also appears to be a column that has been cut off. In this case, the column is located close to the corner, suggesting that it is corner Column 15. If correct, the spacings indicate that the two circled locations are Columns 14 and 14A. It was important to determine whether it was reasonable to have observed three severed columns at this location. The design drawings indicate that two story steel

column sections were connected with bolted splices at the odd floors. The connections were 1.07 m (3 ft 6 in.) above the floor. Failures could occur at splice connections, so the locations of the ends on Floor 9 for the three severed columns visible in the image are consistent with their expected locations.

There is considerable damage to the façade on the 8th floor. The misalignment of Column 14A certainly extends to this level. There seems to have been some damage to the corner of the building as low down as the 6th and 7th floors. For some reason, the window at the far end of the 6th floor, which contained vents, stands out in Figure 5–69. It is likely that the vents were broken out.

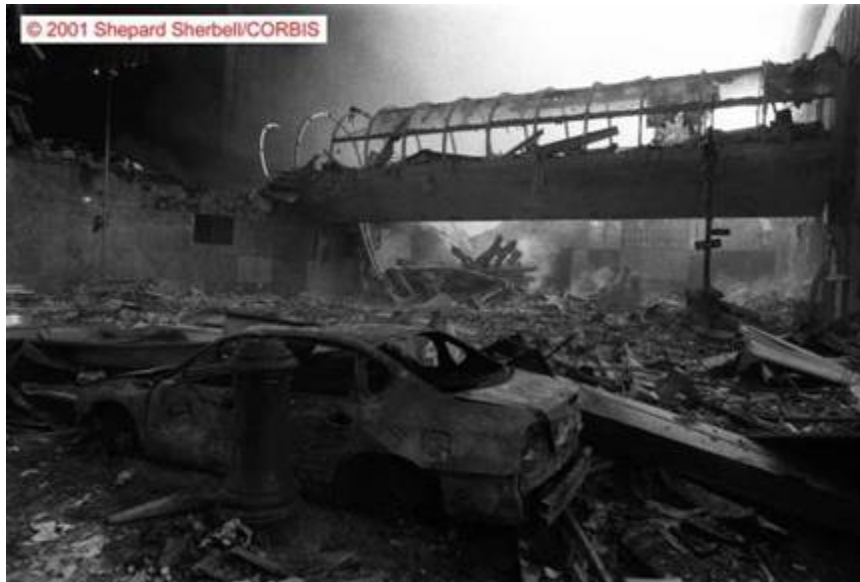
The Promenade is visible behind the Pedestrian Bridge. There is a large pile of steel formed by several panel sections from WTC 1 located between the Pedestrian Bridge and the Promenade near the base of WTC 6 on the south side of the street. There appears to be either a part of or a single panel section located near the center of the street. There is also a single piece of large debris visible near the base of the Pedestrian Bridge that seems to be leaning against the south face. It is not clear if this is structural steel from the towers. These are the only indications of large steel pieces between the Promenade and the corner of West Broadway and Vesey Street. The large pieces of steel observed on Vesey Street from the west are beyond the view of this photograph.

Figure 5–70. Black and white photograph shot from the corner of Vesey Street and West Broadway looking west down Vesey Street.

The time of the photograph is unknown, but it was taken prior to the time when flames appeared on the east face of WTC 7 around 2:00 p.m.

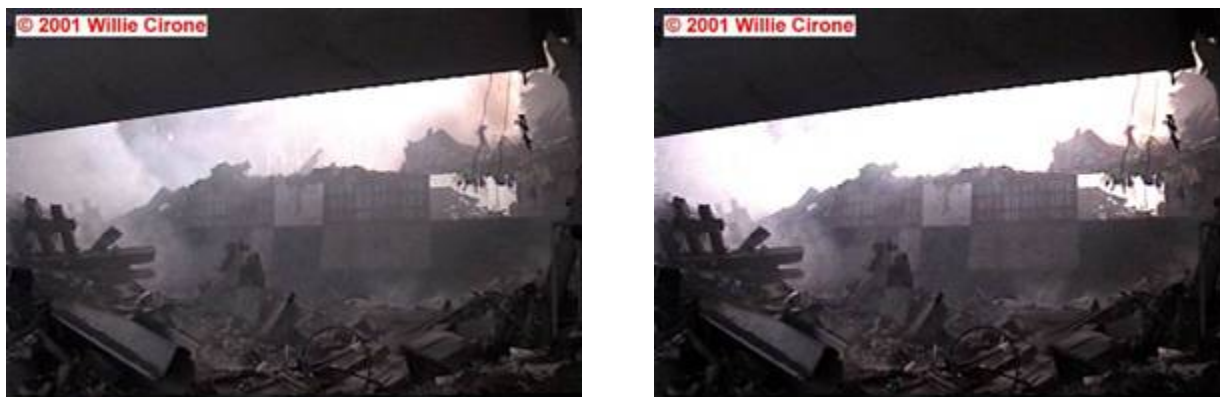
A second view of Vesey Street and the Promenade taken from a short video clip is shown in Figure 5–72. The dark area at the top of the image is the bottom of the Pedestrian Bridge. In the unaltered left view, large amounts of smoke are visible on the far side of the Promenade. In the right view, the intensity levels have been adjusted to emphasize the darker areas in the image. A number of steel panel sections are visible on the left side of the street between the Pedestrian Bridge and the Promenade. It is also possible to see that several panel sections landed on or near the south end of the Promenade, and this end may be partially collapsed. The portion of a panel section near the center of the street is visible, but is not as easily identified as in Figure 5–70. A part of the large piece of debris observed earlier leaning up against the south face of WTC 7 is visible at the far right of the image. The size and shape of the object suggest that it was a steel column or beam. In all, the main portion of the east side of the Promenade, with the possible exception of the far south end, was not collapsed by the steel from WTC 1, although the raised side structures had suffered considerable damage.

Figure 5–72. Two versions of a frame from a video taken from the corner of Vesey Street and West Broadway in the early afternoon.

Left: the frame as captured; Right: the image with intensities adjusted to emphasize the darker areas.

The south face of WTC 7 was just beyond the right side of this image. Nonetheless, a pile of debris several stories high is visible rising above the Promenade at the right hand edge of Figure 5–72. Recall that there was evidence of debris in the same area from ground and aerial views taken from the west. The presence of this debris is consistent with the south face damage observed at higher floors at roughly the same location.

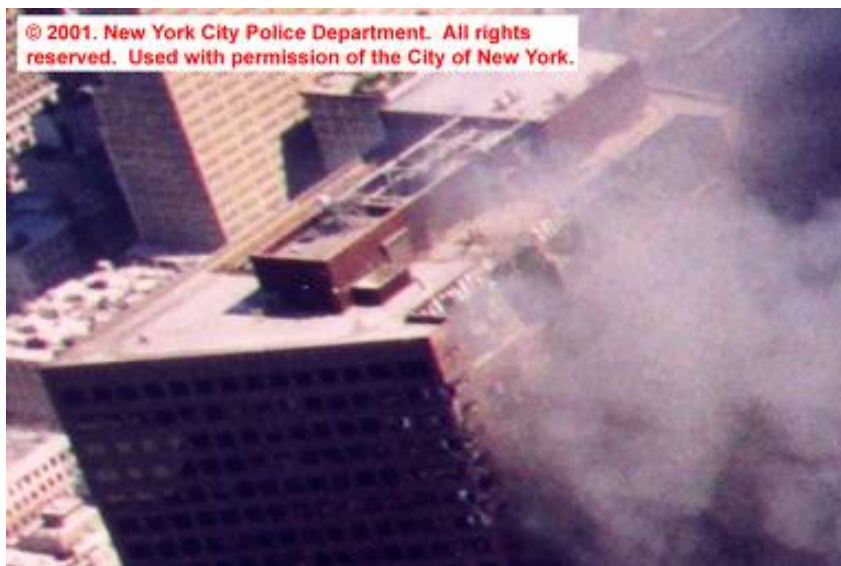
Another view of the upper portion of WTC 7 is shown in Figure 5–76. This is roughly the same view as shown in Figure 5–8, which was taken just prior to the collapse of WTC 1. The two damaged areas on the roof are visible in the later photograph. The debris projecting from the roof appears to consist of at least two separate columns. This suggests that it was a part of a panel section from WTC 1. Comparison of the two photographs indicates that a substantial fraction of the screenwall near the east penthouse was dislodged.

Figure 5-76. Cropped photograph showing the upper portion of WTC 7 as viewed from the southwest.

It was shot around 12:30 p.m. from a helicopter.

A large opening in the sloped curtain wall running between the 46th and 47th floors is apparent in Figure 5-76 immediately below the damaged area on the roof. Less damaged areas are also visible on either side of this opening. The damaged area has been enlarged in Figure 5-77.

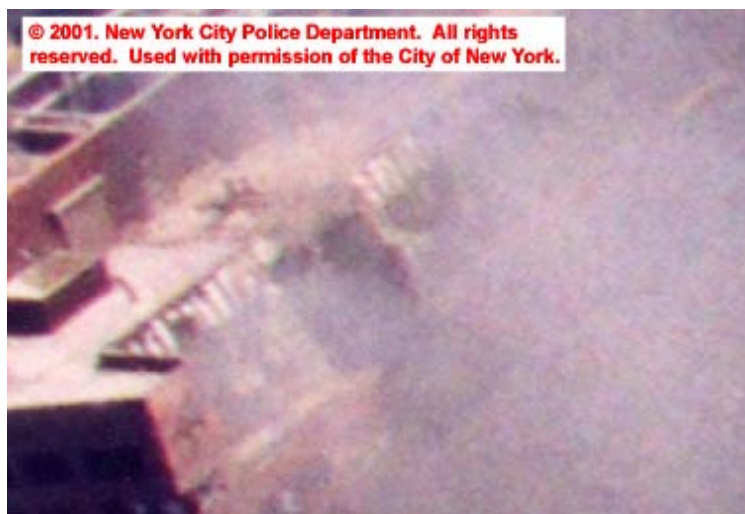
A number of white rectangles are visible running along the upper edge of the face. This is in the area of the 4 ft high parapet where sloped glass had been placed to create the effect of a top row of windows in front of the parapet, as can be seen in Figure 5-8. The different appearances of the area between Figure 5-8 and Figure 5-77 suggests that the glass was broken out during the collapse of WTC 1.

The recessed windows on the south face at Floors 46 and 47 allowed the exact locations and sizes of the damaged areas to be determined. The damage began at the 12th window opening from the west and extended to the east for roughly eight windows. Based on Figure 5-20, the principal damage falls

Figure 5–77. Enlargement of the area of damage on the roof and south sides of the 46th and 47th floors of WTC 7 in Figure 5–76.

between Column 19 and Column 21. Smaller openings in the curtain wall are evident at the 5th and 6th windows from the west and over a width of six windows just to the east of the largest opening. While it is clear that the curtain wall has been removed, it is not possible to discern whether or not structural damage occurred. It appears that the recessed concrete roofline at the base of the 46th floor between Column 20 and Column 21 was cut through.

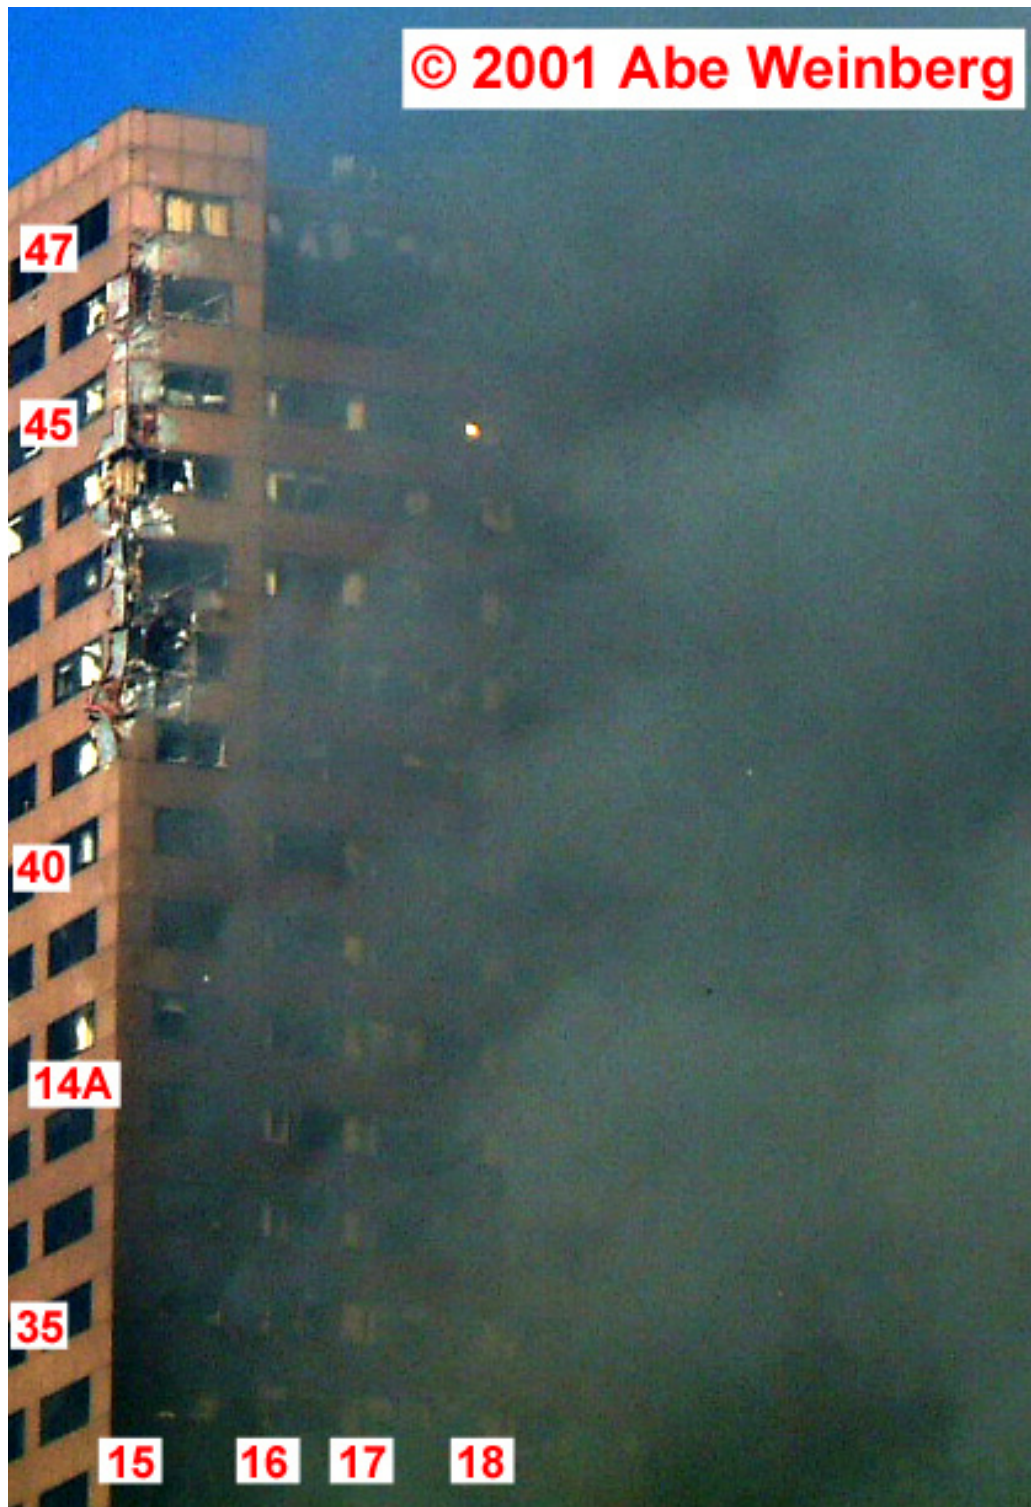
Figure 5–79 shows the upper west side of the south face of WTC 7 around 4:45 p.m. The façade damage on the southwest corner can be clearly seen on the 41st to 47th floors. The façade damage is particularly heavy on the 42nd to 44th floors. It appears that an object may have entered window 15A on the 42nd floor. The end of the box structure that supported the corner granite spandrel cover on the western edge of the face is visible on this floor. It is possible to discern the area between Columns 15 and 18 from the 34th floor up to the top of the building. While the façade appears to be intact at locations away from the southwest corner, the four columns are visible on most floors, indicating the window glass was broken at most of these locations.

A large area on the west side of the south face was visible down to the 26th floor. Columns were visible at many locations, indicating that most of the window glass in this area was broken. In the same frame it was possible to see a section of the south face from the 35th floor to the 40th floor, east of Column 19, where it appeared that the spandrel covers on these floors abruptly stopped, and Column 19 was not visible on these floors. There was a dark band between the locations where the granite spandrel covers appeared to end and an area to the east that was hidden by a foreground building. It was not clear whether this vertical dark band was due to the presence of smoke or was a feature on the face of the building. As discussed further below, additional images suggest that the band was likely damage to the building.

Figure 5–79. Cropped photograph showing the west side of the south face of WTC 7, taken between 4:30 p.m. and 5:00 p.m. from near the corner of West Street and Liberty Street.

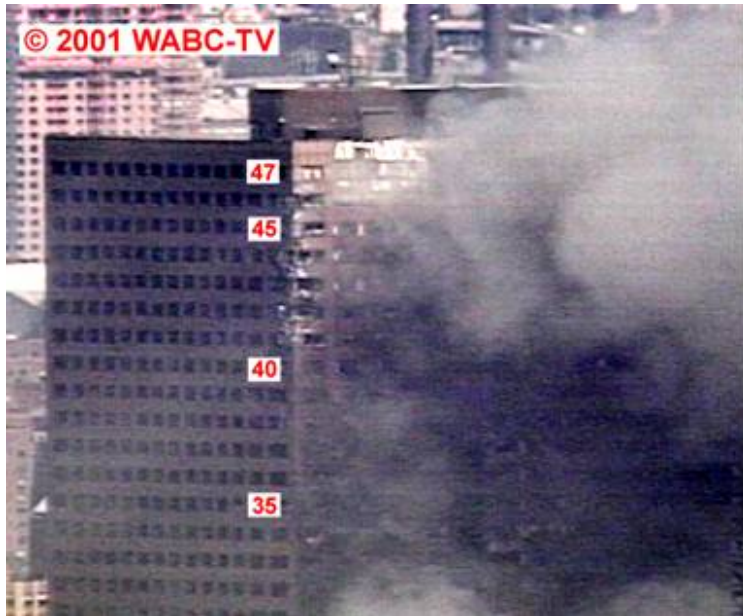
Figure 5–80 shows a similar view of the south face taken from another video shot from a helicopter. Heavy smoke covers part of the face, but portions are visible elsewhere. The vertical dark band between Columns 19 and 20 is visible between the 34th floor and 37th floor. While Column 21 is visible on each of these floors to the immediate right of the dark band, it is not clear whether Columns 19 and 20 remain in place. The alternating granite panels and windows are visible further to the east. Columns are visible through a limited number of windows in this area.

Figure 5–80. Cropped view of the south face of WTC 7 taken from a video shot from a helicopter hovering to the southwest of the WTC site around 1:00 p.m.

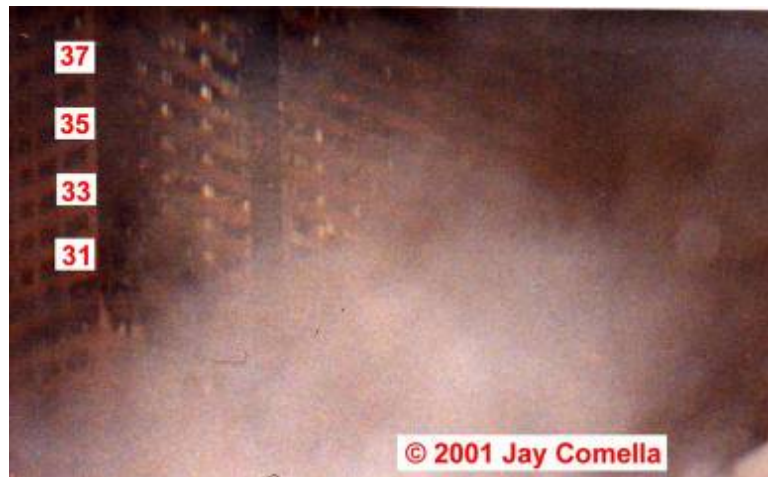
The cropped photograph shown in Figure 5–81 provides a better view of the dark vertical band on the south face of WTC 7. It was taken from West Street at a location north of Liberty Street. The distinct vertical dark band can be seen from the 32nd floor to the 40th floor. Most of the columns between the band and southwest corner are easily distinguished and confirm that the band lies between Columns 19 and 20. It appears that both of these columns are in place on some of these floors, particularly Column 19 on the

Figure 5–81. Cropped photograph showing the south face of WTC 7, shot from West Street in the mid to late afternoon.

33rd and 34th floors. At other locations, it is difficult to identify the columns on either side of the dark band. There is no visible indication that the granite spandrel covers are in place between Columns 19 and 20, even though the covers on either side are very distinct. Even though the granite spandrel cover between Columns 20 and 21 on the 34th floor appears to be damaged, in general the granite panel covers seem to be in place to the east of the dark band.

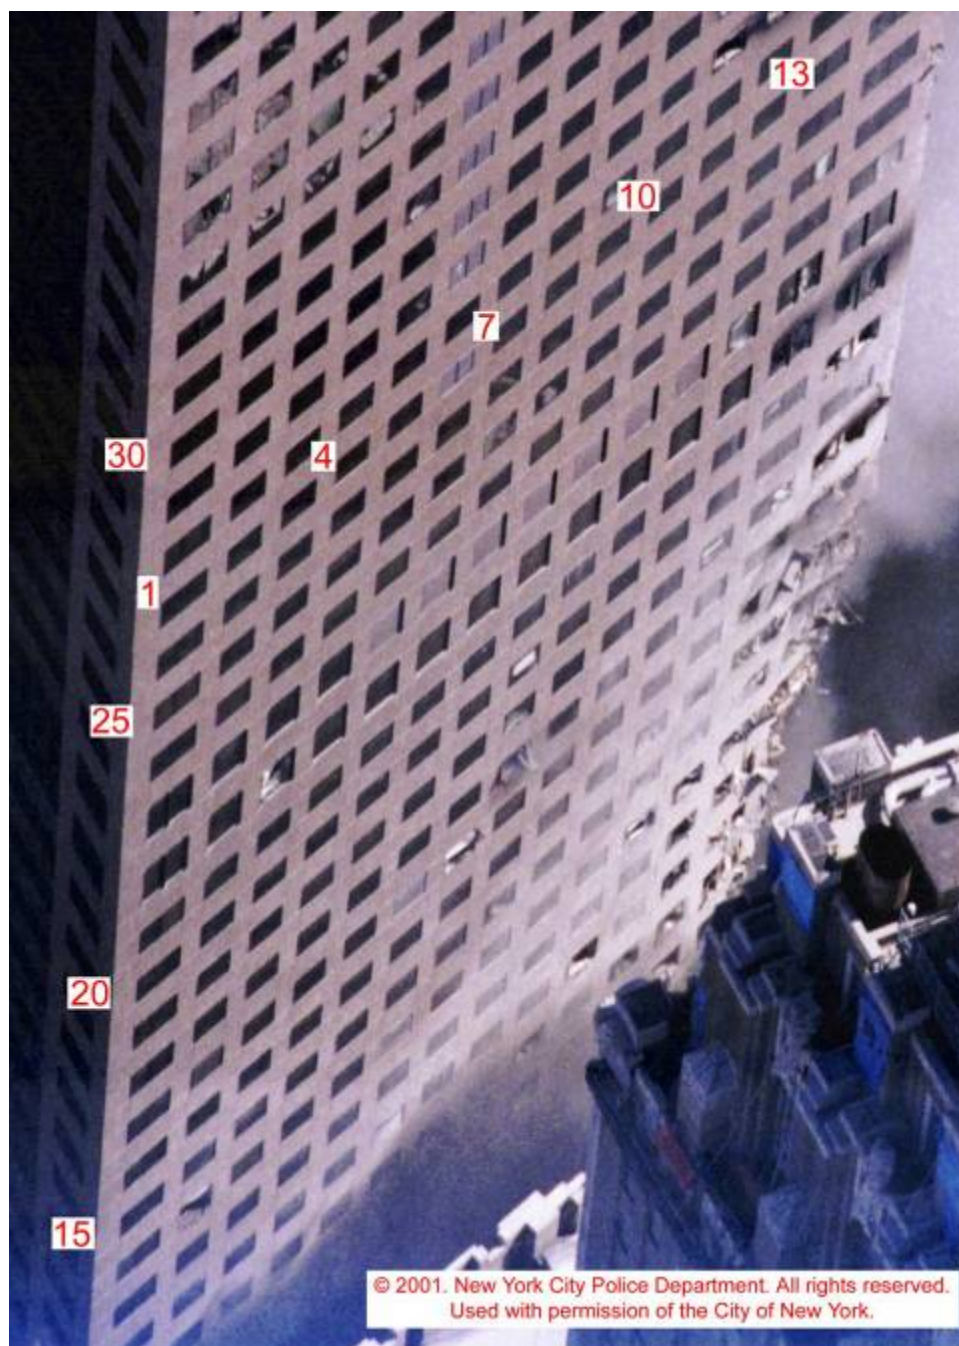
The area on the west face between the 23rd floor and 11th floor can be seen Figure 5–86, which was cropped from the aerial photograph shown in Figure 5–67. The damaged southwest corner starting at the 17th floor will be discussed further below.

Figure 5–86. Image, cropped from Figure 5–67, showing the west face of WTC 7, shot from a helicopter between 2:30 p.m. and 3:00 p.m. Column and floor numbers have been added.

There is no façade damage apparent on the 19th to 22nd floors, but glass or louvers are broken or missing in multiple windows. On the 22nd floor, glass is missing from window 3 and from the four windows near the south edge, where a fire had evidently been present earlier. The earliest photograph of this region in the NIST database was taken just before 12:30 p.m. It shows a fire in window 22-14A, but the window glass further to the north was intact on this floor. The initial condition for window 22-14A is assigned as unknown. The following windows were open or damaged: 21-13A, 21-14, 21-14A, 20-8, 20-14A, 19-8,

19-12, and 19-13B to 19-14A. There are indications that a fire burned in windows 19-14 and 19-14A. Since the window glass immediately below and to the left was broken, it is considered likely that the glass in the two windows closest to the south edge was also broken during the collapse of WTC 1. There appears to be minor façade damage immediately below windows 14 and 14A on the 18th floor, which are open. This damage is also visible in Figure 5–66. Windows 18-8 and 18-13B were also broken.

On the 14th floor, the structural damage extended further toward the north, reaching at least Column 14, and there appears to be façade damage to Column 13. Glass in windows 14-2, 14-11, and 14-12 was broken. The damage at the southwest corner of the 13th floor was similar to that on the 14th floor. The glass in window 13-11 was cracked, and the glass was broken in window 13-12. On the 12th floor, the structural damage also appears to reach as far as Column 14, with façade damage as far as Column 13. Windows 12-10 and 12-12 were broken. On the 11th floor, the structural damage at the southwest corner extended beyond Column 14, and the façade damage seemed to extend to Column 13. All of the windows on the 11th floor cannot be seen clearly in Figure 5–86, but it is clear that the glass in windows 11-9, 11-11, and 11-12 was broken.

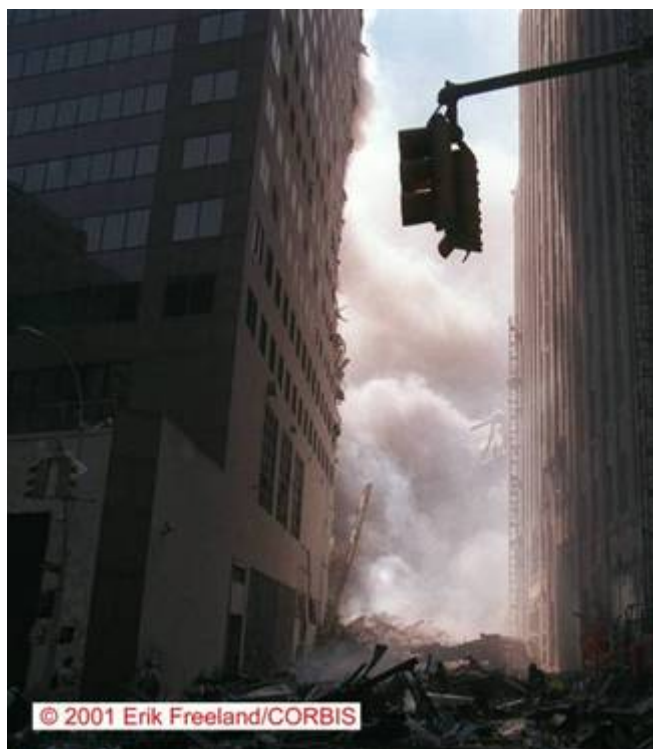
Figure 5–87 shows the lower portion of the WTC 7 west face from the corner of Barclay Street and Washington Street, looking south down Washington Street sometime around or prior to 12 p.m. Figure 5–25 was taken from roughly the same location. A great deal of debris is evident on Washington Street. In particular, a steel panel section can be seen embedded in the ground near the southwest corner of WTC 7. This panel section was also visible in the aerial photograph reproduced in Figure 5–61. There is another panel section lying on its side in the street near the Verizon Building. Additional steel can be seen piled up on Vesey Street beyond the buildings. On September 11, the Verizon Building was undergoing renovation and scaffolding was present on the east side. Some of the supports are still standing, but most of the scaffolding has collapsed, contributing to the debris lying in the street.

Figure 5–87. Cropped photograph of a partial view of the west face of WTC 7 looking down Washington Street between WTC 7 on the left and the Verizon Building on the right.

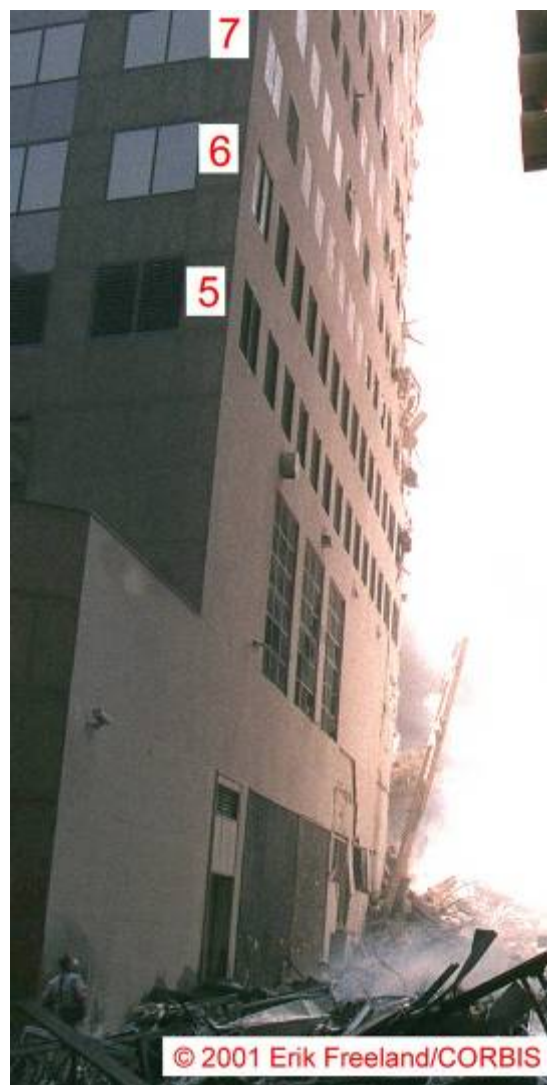
The portion of Figure 5–87 showing the west face of WTC 7 is enlarged in Figure 5–88. The façade damage on the 8th floor extends at least as far as window 13A. Façade damage is also evident on the 6th and 7th floors extending to at least Column 14. Window glass or louvers are broken or missing for windows 9-6, 9-7, 9-10 to the south edge on the 9th floor, for windows 8-6, 8-8, and 8-10 to the south edge on the 8th floor, and for windows 7-5 and 7-9 to the south edge on the 7th floor. On the 6th floor, most of the windows contained louvers. All seem to be in place except for windows 14 and 14A near the southwest corner. On the 5th floor, there is no indication that any louvers were broken.

Figure 5–88. Enlarged view of the west side of WTC 7 from Figure 5–87. The intensity levels have been adjusted, and floor numbers have been added.

Some minor façade damage is visible on the southwest corner extending from the 5th floor down to the ground. A section of granite was dislodged above the doorway, just to the south of the center of the face. See Figure 5–26 for the configuration in this area. To the left of this doorway, it appears that the underlying truss that held the granite was partially dislodged. Some of the screens in the large windows near the center of the face on the 3rd and 4th floors were removed, but this is the only evidence of damage to this part of the face.

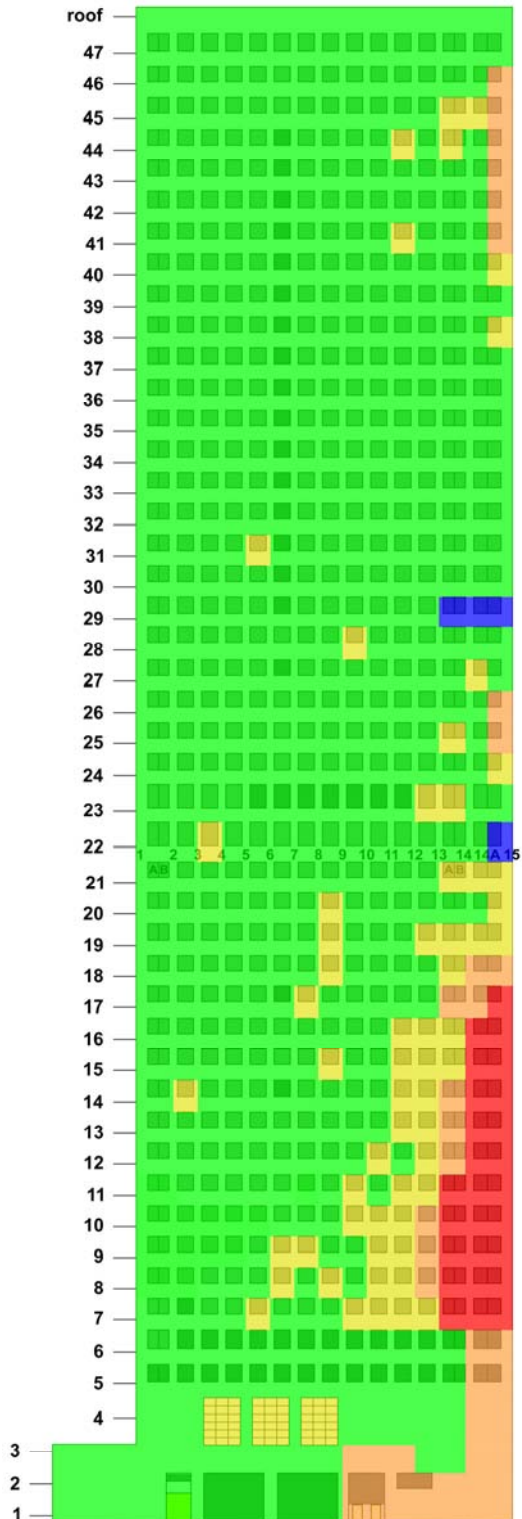
A diagram summarizing the observed damage to the west face of WTC 7 is shown in Figure 5–89. This diagram reflects the damage observations from the south face for the southwest corner near the top floors and from the 17th floor down to the 9th floor. The extent of broken windows on the lower floors suggests that the force associated with the event that removed this wedge was large.

Figure 5–89. Observed damage on the west face of WTC 7 following the collapse of WTC 1 is shown.

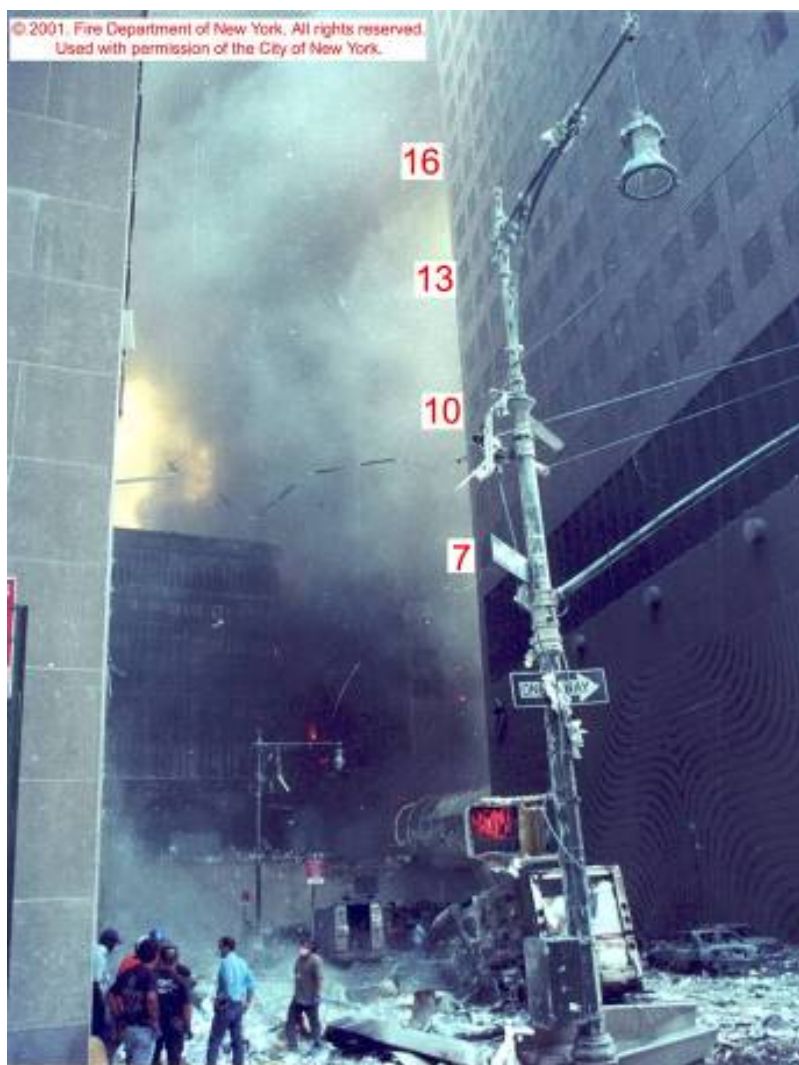
Not surprisingly, given the visual evidence concerning the distribution of the large sections of falling debris from WTC 1, no window breakage, façade damage, or structural damage were observed on the east and north faces of WTC 7 following the collapse of WTC 1. Figure 5–90 shows a view of the lower portion of the east face of WTC 7 shot from the corner of West Broadway and Barclay Street, looking down West Broadway. Another, closer view of the face was shown in Figure 5–22. Both figures show that there was a large amount of small debris deposited on West Broadway between the Post Office Building and WTC 7. In Figure 5–90 several larger pieces of debris can be seen. Most of these seem to be the aluminum that covered the exterior steel columns of the towers (NIST NCSTAR 1-5A).

Figure 5–90. Photo showing the east face of WTC 7, taken from the southeast corner of Barclay Street and West Broadway looking down West Broadway, likely around 12:00 p.m.

In Figure 5–90, windows are visible on a portion of the east face up to the 20th floor. There is no indication of façade damage or, with one exception, broken window glass in the image. The only broken glass is the center window on the 8th floor, to the right of Column 36. This open window is also visible in Figure 5–22. Investigation interviews indicated that this window was broken out by people who were trapped on this floor when WTC 1 collapsed (Chapter 6). Video clips in the database show one of these people inside an open window (8-42A) on the eastern edge of the north face.

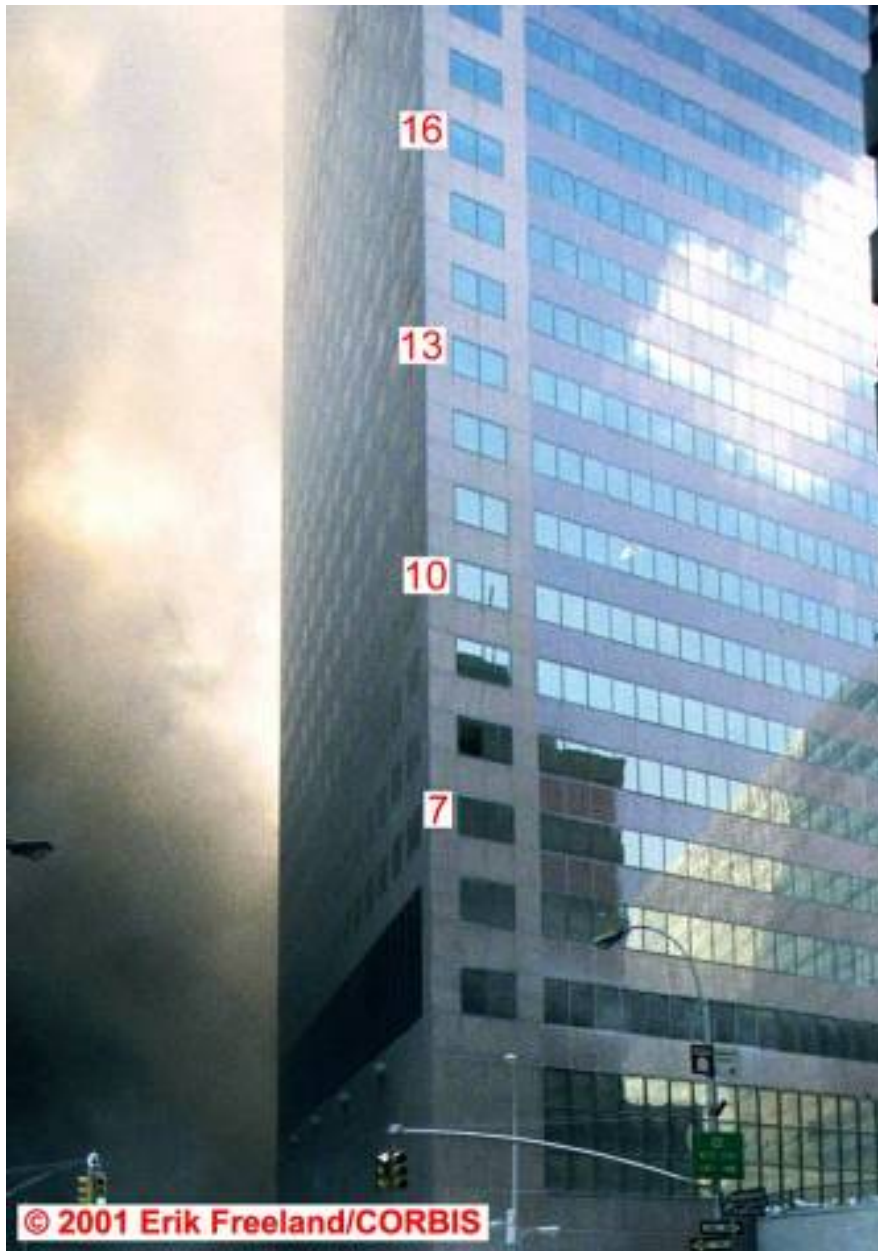
Review of various images of the north face of WTC 7 revealed that the face appeared undamaged, with the exception of two locations on the 8th floor, where window glass was broken out prior to the time when fires began breaking windows on the face. A view of the undamaged lower nine floors at the northwest corner was shown in Figure 5–87. As noted above, window 8-42A was open on the northeast corner of the 8th floor. This window is visible in Figure 5–91. This cropped image is taken from the same photograph as Figure 5–12. The other open window observed on this side of the building was 8-47B. This open window is visible in Figure 5–30 above the left hand edge of the fire burning on the 7th floor. This window was also broken out by people trapped in the building after WTC 1 collapsed.

Figure 5–91. Cropped photograph showing the east side of the lower floors of the north face and an oblique view of the east face. Image intensities were adjusted and floor numbers were added.

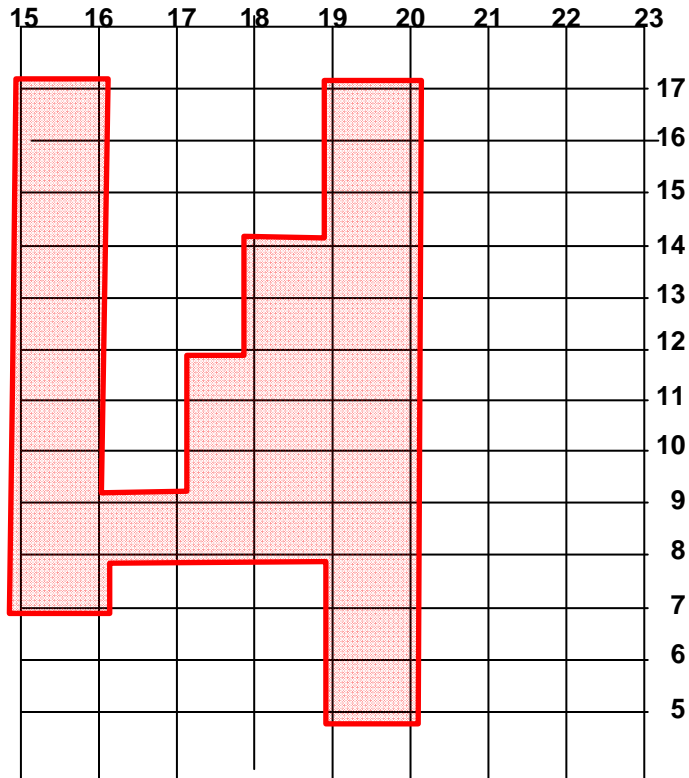
Figure 5-92 and Figure 5-93 show elevation views of the estimated interior damage below Floor 18 in the southwest region, looking from the south and the west directions, respectively. Figure 5-94 through Figure 5-101 show schematics of the damage estimates for each floor, from Floors 5 to 17, and Floor 44 to the roof.

Figure 5-92 Elevation view of the estimated debris impact damage for the structural analysis of WTC 7, viewed from the south.

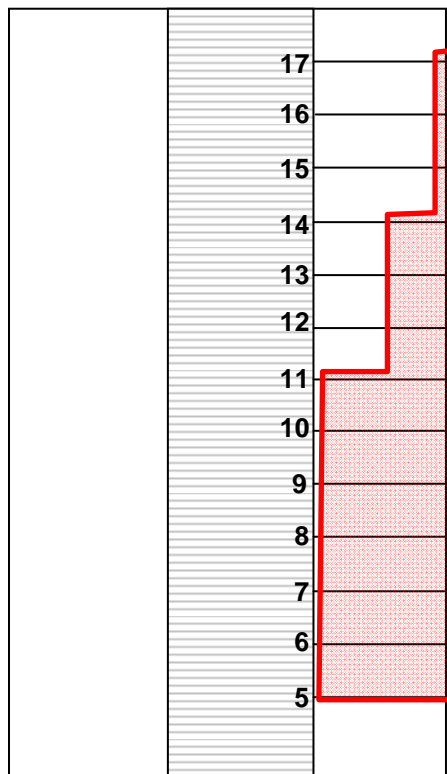
Figure 5-93 Elevation view of the estimated depth of interior debris impact damage to the south face of WTC 7, viewed from the west.

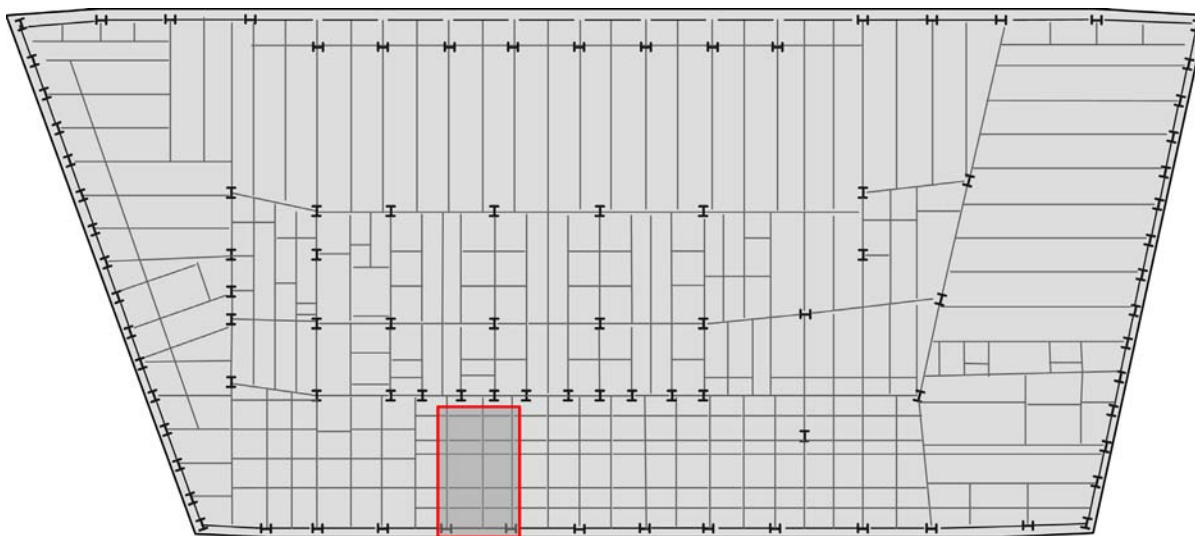
Figure 5-94 Estimated debris impact damage to Floors 5 and 6 of WTC 7.
Marked area indicates removed columns and floor segments.
