**Federal Building and Fire Safety Investigation of the
World Trade Center Disaster**

**Structural Fire Response and
Probable Collapse Sequence of
World Trade Center Building 7**

VOLUME 1

November 2008

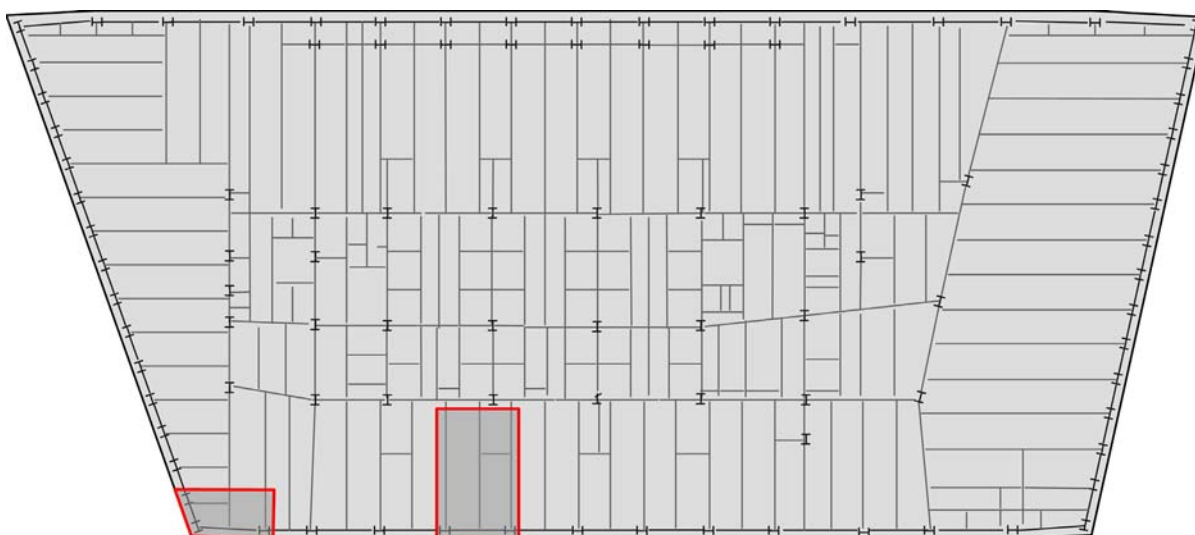
Figure 5-95 Estimated debris impact damage to Floor 7 of WTC 7.
Marked areas indicate removed columns and floor segments.

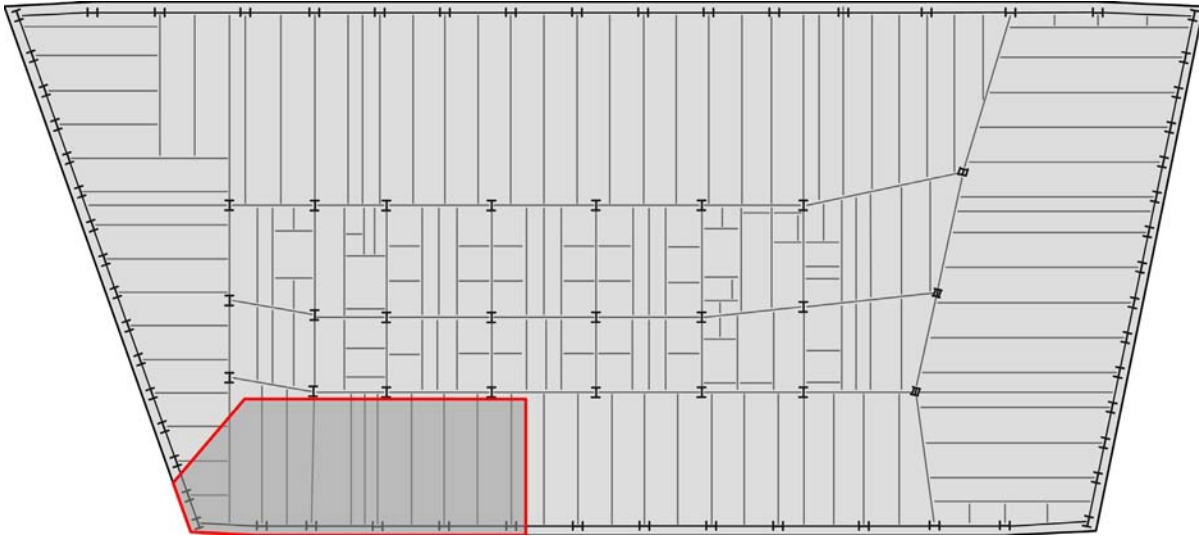
Figure 5–96 Estimated debris impact damage to Floor 8 of WTC 7.

Marked area indicates removed columns and floor segments.

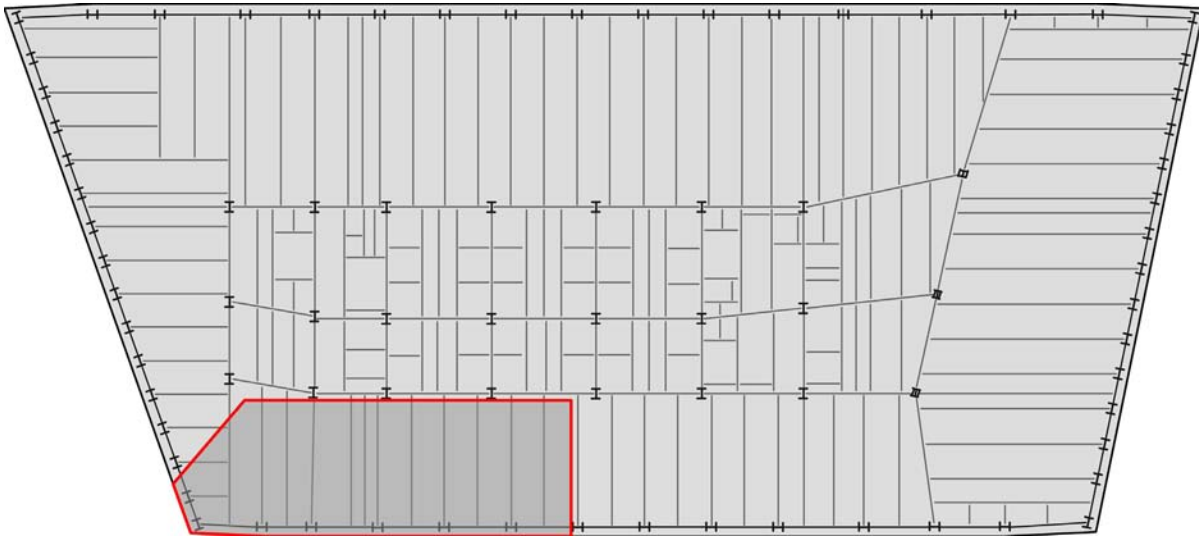
Figure 5–97 Estimated debris impact damage to Floor 9 of WTC 7.

Marked area indicates removed columns and floor segments.

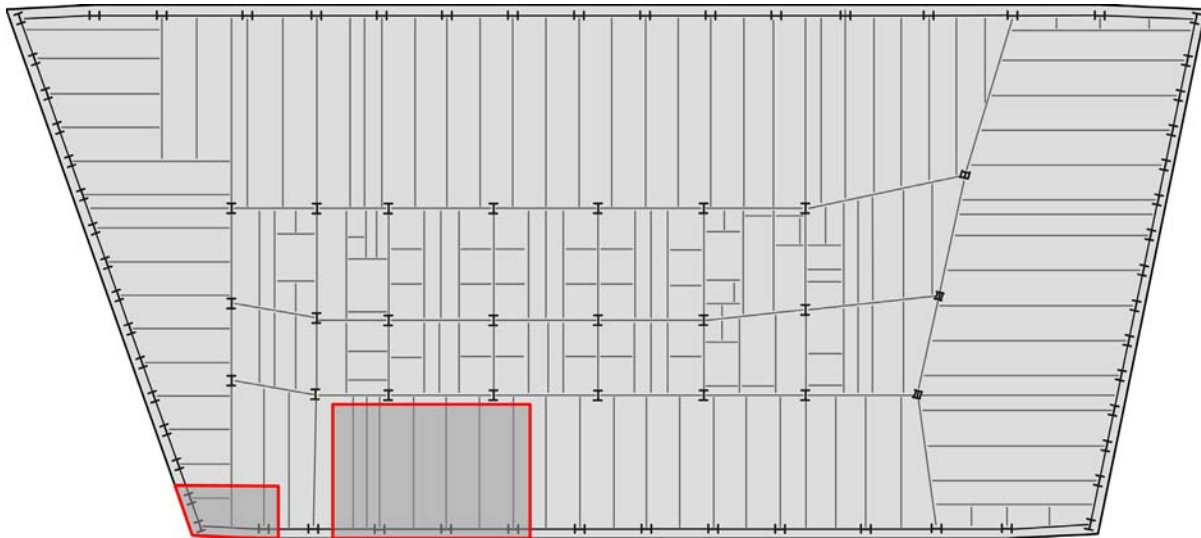
Figure 5–98 Estimated debris impact damage to Floors 10 and 11 of WTC 7.
Marked areas indicate removed columns and floor segments.

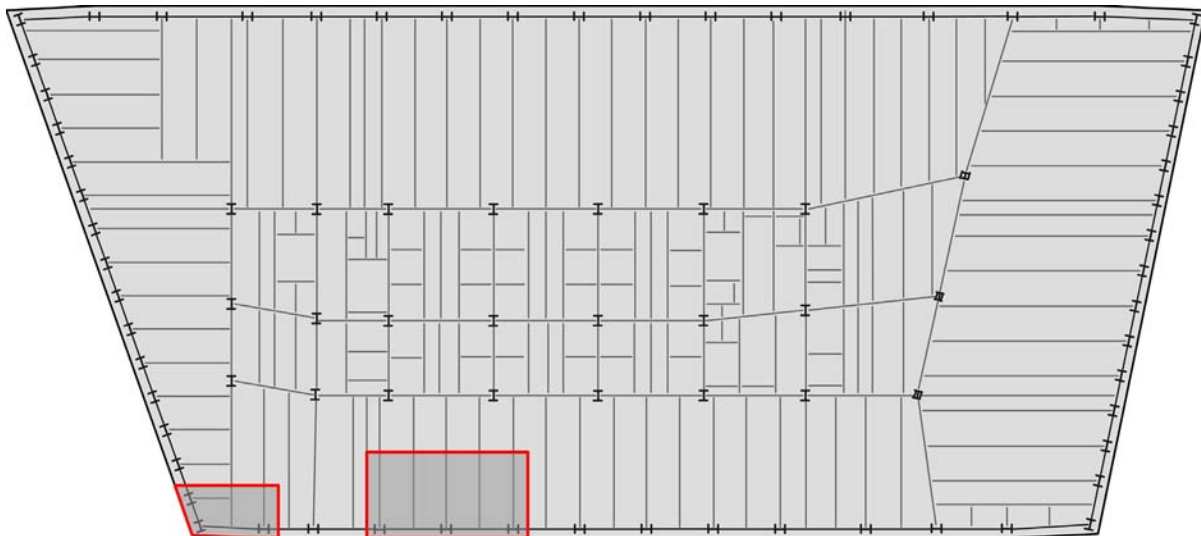
Figure 5–99 Estimated debris impact damage to Floors 12 to 14 of WTC 7.
Marked areas indicate removed columns and floor segments.

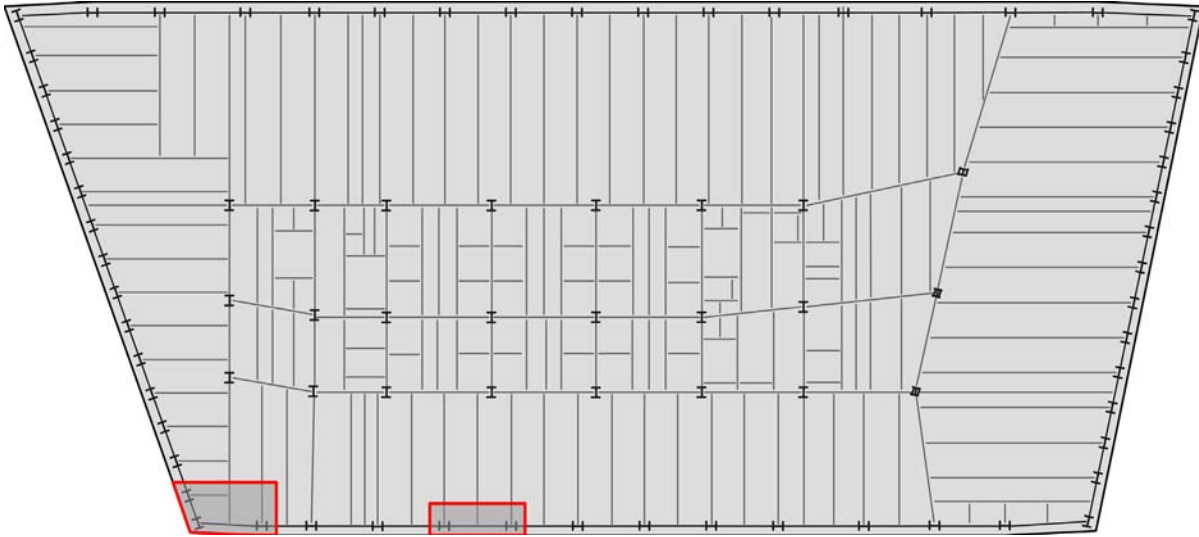
Figure 5-100 Estimated debris impact damage to Floors 15 to 17 of WTC 7.

Marked areas indicate removed columns and floor segments.

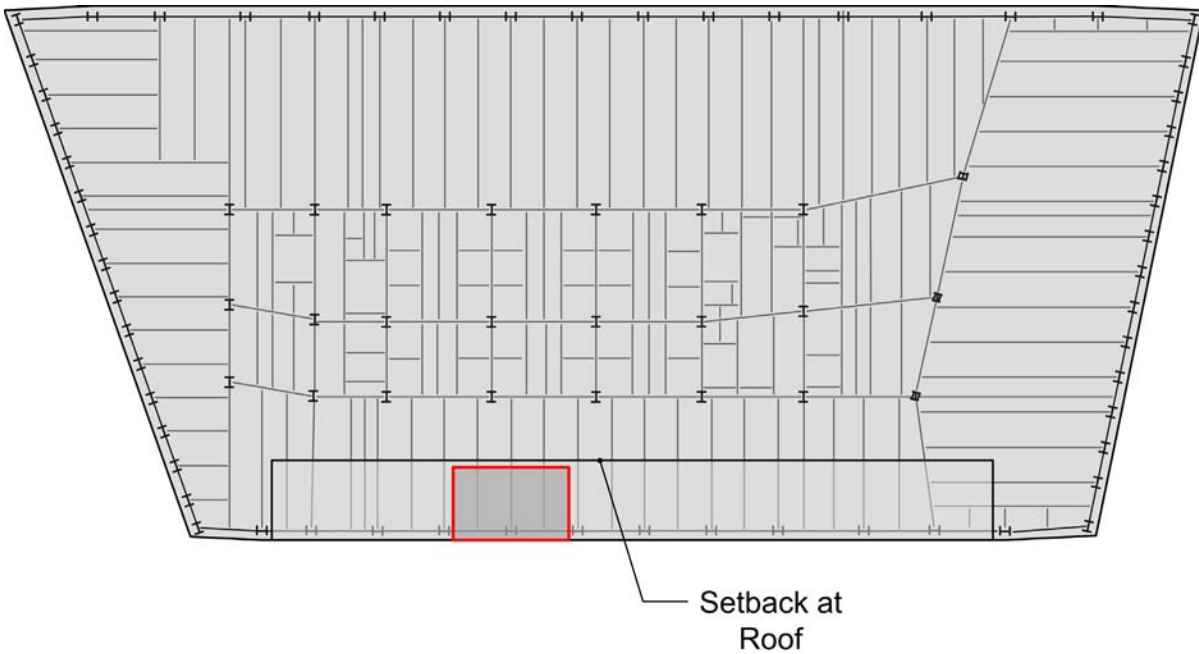
Figure 5-101 Estimated debris impact damage to Floor 44 to the roof of WTC 7.

Marked areas indicate removed columns and floor segments. Damage is shown on the Floor 44 floor plan.

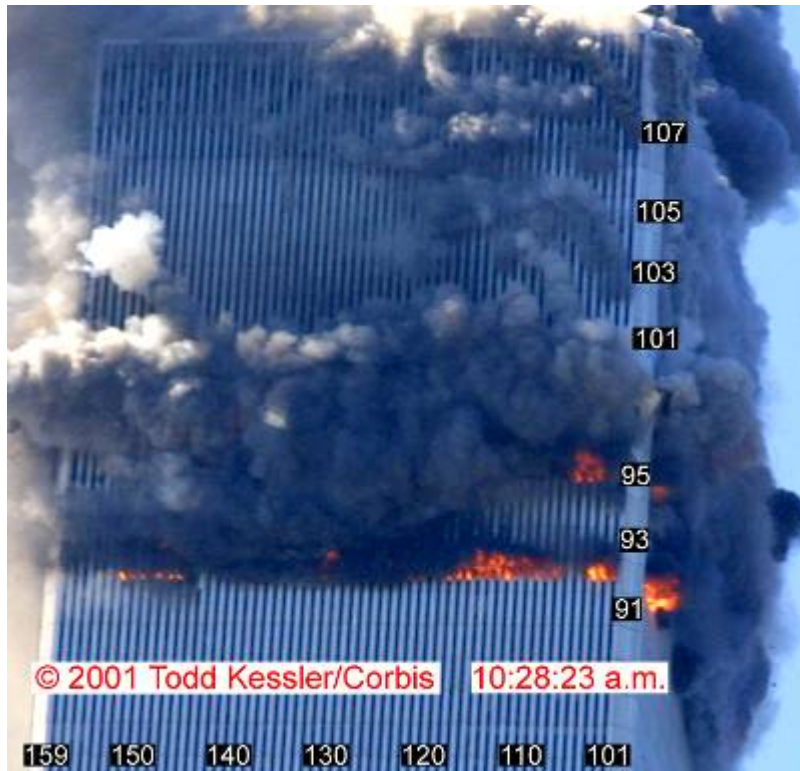
windows, thus revealing the extent of the fires. This is evident in Figure 5–102 which shows the upper floors of WTC 1 roughly one second after the collapse started. The significant fire on the west side of the 92nd floor is evident. The expelled flames formed a large fireball before extinguishing.

Figure 5–102. Cropped photograph showing the north face of WTC 1 at 10:28:23 a.m.

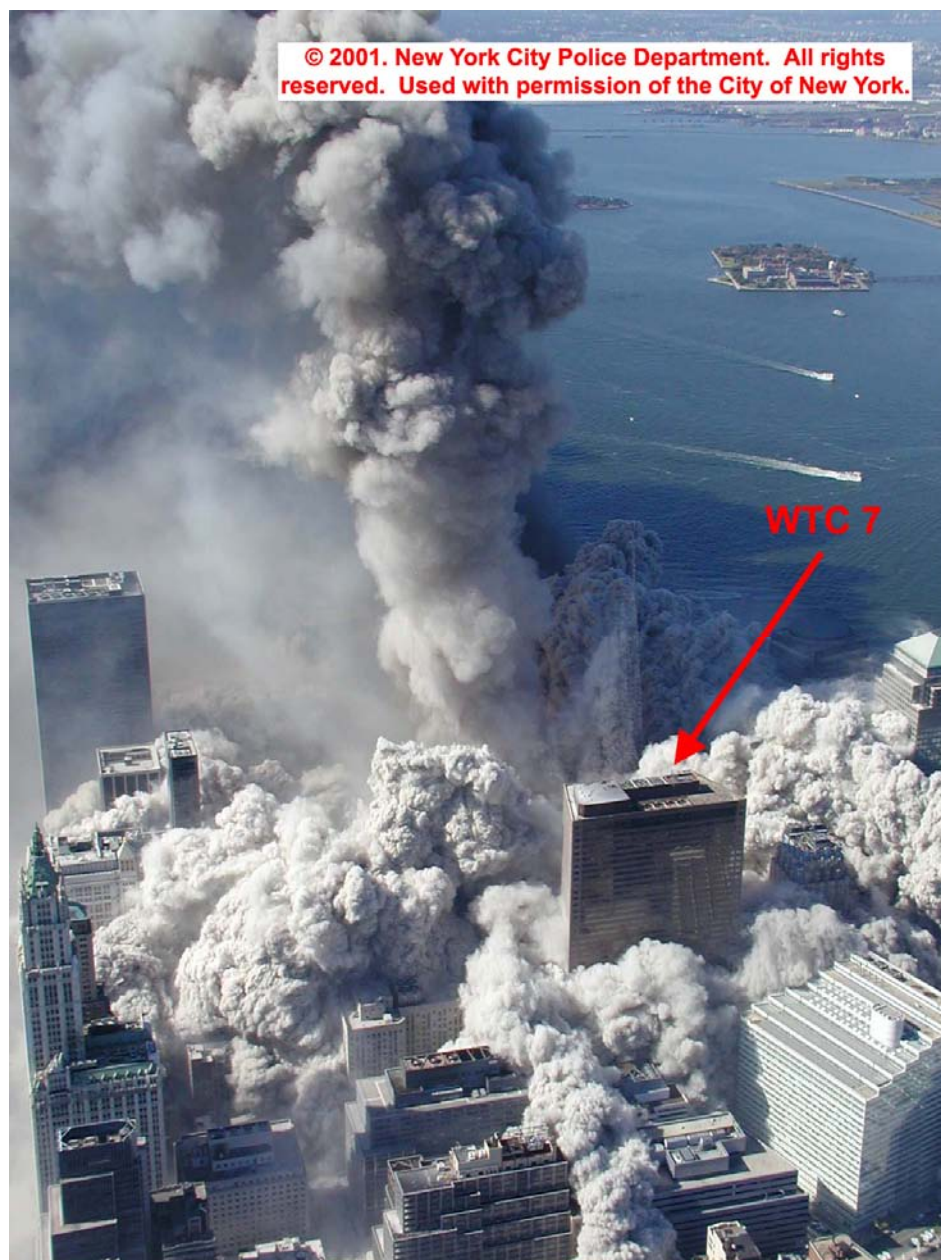
Figure 5–103.
Photograph
showing the dust-
laden flows
spreading away
from WTC 1
following its
collapse.

It was taken 32 s
after the start of the
collapse.

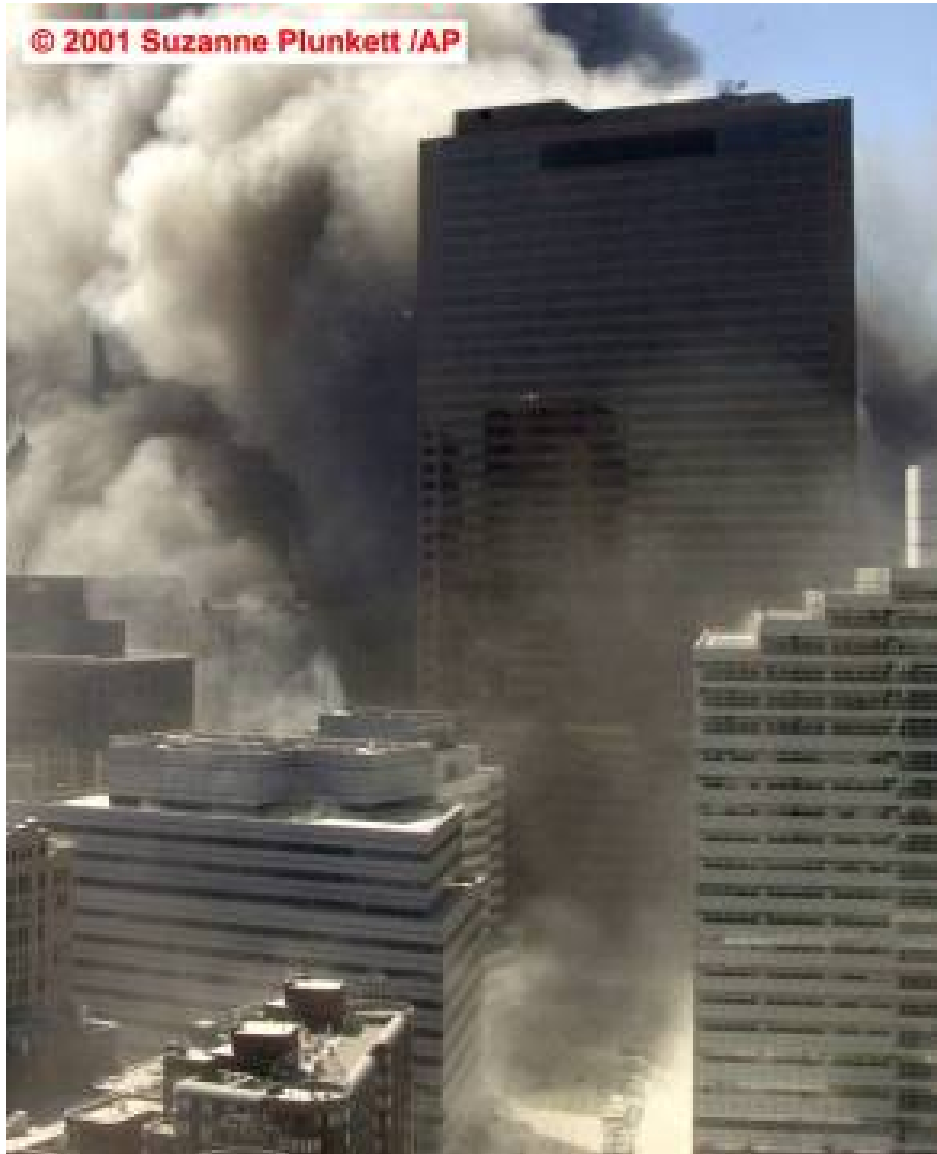
The large dust clouds generated by the collapse of WTC 1 hid the lower portions of WTC 7 from view for over 20 min following the collapse. However, as time passed, the dust began to settle, and the faces became less obscured. Figure 5–104 shows a view of the north face of WTC 7 taken at 11:28:15 a.m., i.e., close to one hour after the collapse of WTC 1. Even though some light dust is evident in front of the face, it is possible to discern the base of the building. There is no sign of fire or heavy smoke on the portion of the north face that is visible.

In Figure 5–104, there appears to be a heavy smoke column rising from an area just to the north and east of WTC 7. The location of the smoke relative to the buildings in the area suggests the smoke was coming from or near West Broadway.

Figure 5–104.
Cropped
photograph
showing the north
face of WTC 7, shot
at 11:28:15 a.m.
from the upper
story of a nearby
building looking
down Greenwich.
The intensity levels
have been adjusted.

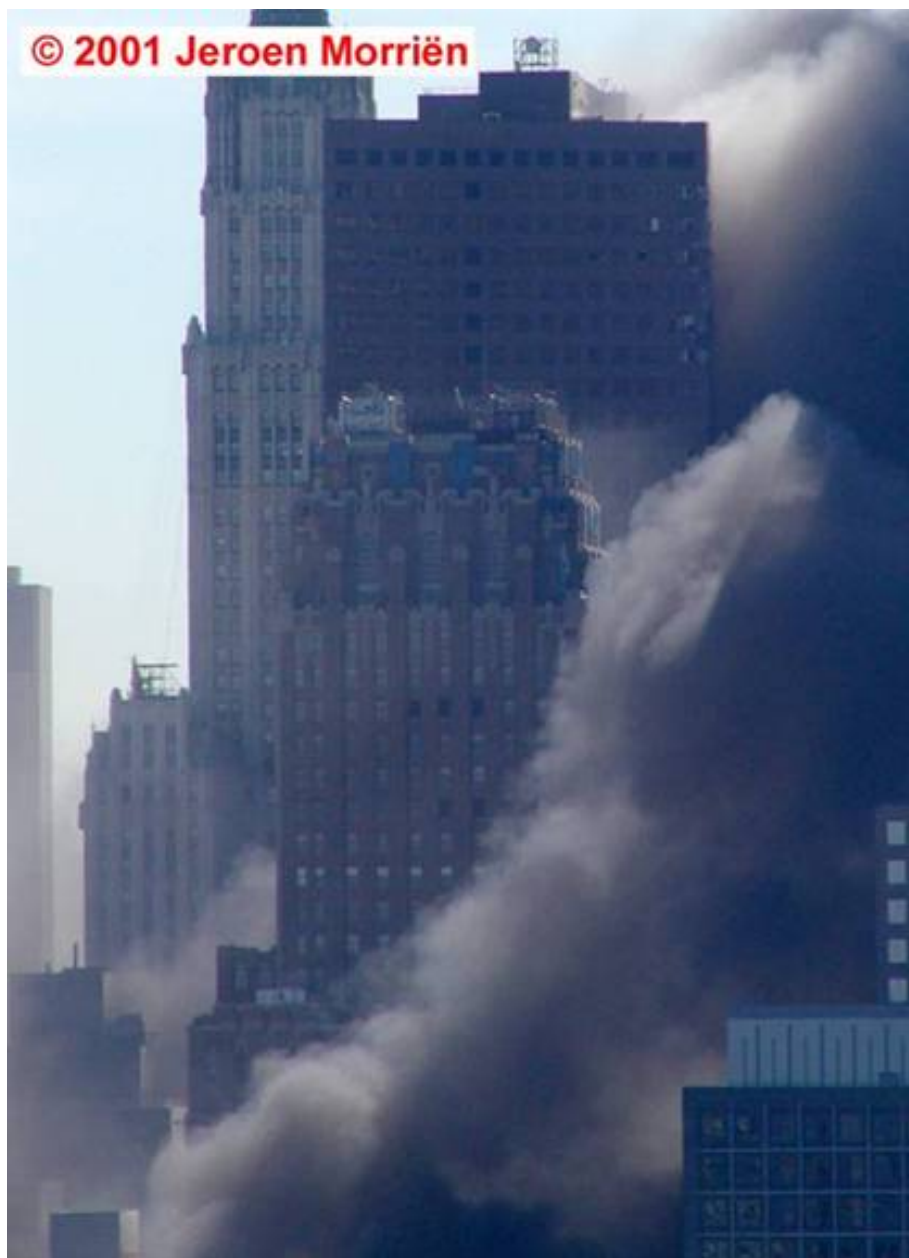
A view of WTC 7 from the west, taken roughly 15 minutes earlier, is shown in Figure 5–105. The upper portion of WTC 7 is visible at the top of the photograph. A heavy smoke plume was passing in front of the Verizon Building at this time. A second smoke plume can be seen beyond the Verizon Building to the north of WTC 7. It is likely that this smoke is coming from the same general area as the plume in Figure 5–104. Photographs taken from the same location show that the heavy smoke to the west of the Verizon Building was present as early as 10:54 a.m. and was observed as late as 11:19 a.m. By 12:10 a.m., the two smoke plumes visible in Figure 5–105 had dissipated, and the areas to the north of the Verizon Building and WTC 7 could be easily seen through a light veil of smoke and/or dust.

Figure 5–105.
Cropped photograph
showing the west face
of WTC 7, shot at
11:13:51 a.m. from
New Jersey looking
across the Hudson
River.

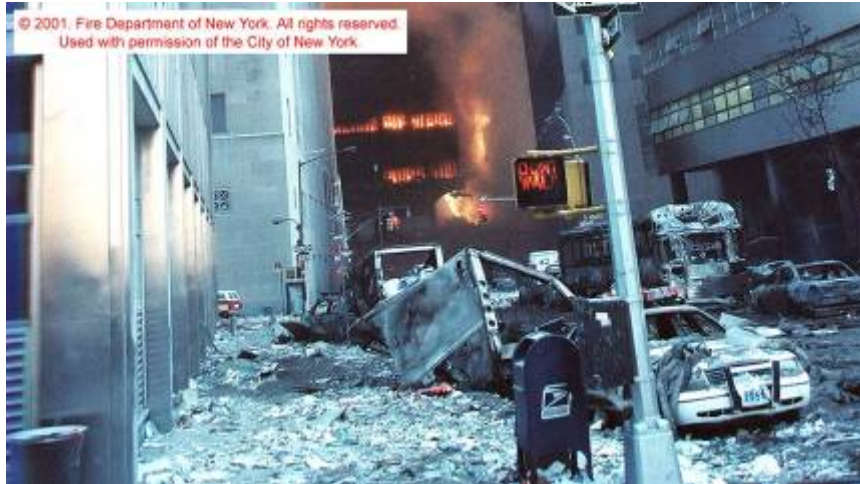
Figure 5-106.
Photograph taken
looking down West
Broadway towards WTC 7
from its corner with Park
Place.

The burning buildings in the background are WTC 5 and WTC 6. The intensity levels have been adjusted.

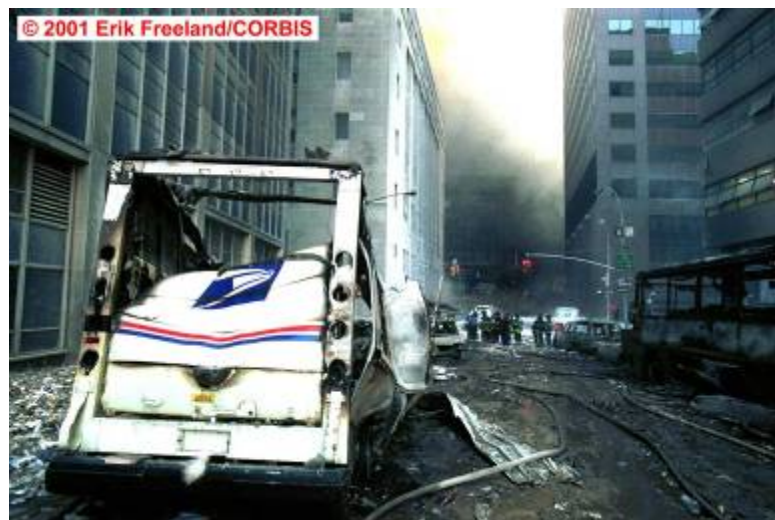
Figure 5-107. Photograph taken
looking down West Broadway
towards WTC 7 from near its
corner with Park Place.

Several fire hoses are visible on the street in Figure 5-107. One of the photographers who provided images for the Investigation reported that he was a fireman visiting from out of town and had joined with a FDNY engine company to extinguish the burning vehicles along West Broadway. They started at the corner of Park Place and West Broadway and moved south until they reached Vesey Street. Based on the smoke plume observations, this must have taken place between roughly 11:00 a.m. and 12:00 p.m.

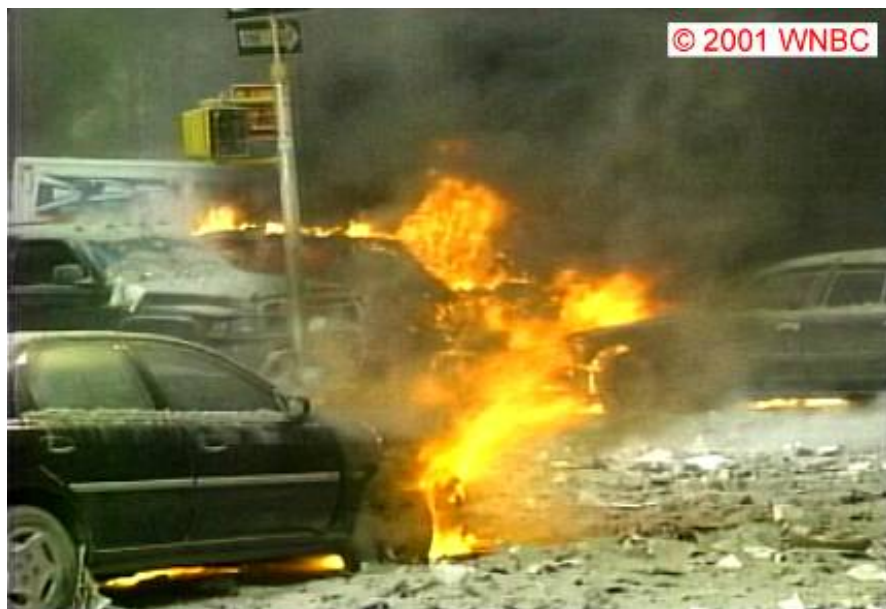
A video crew managed to reach the area of West Broadway and Barclay Street while the vehicles were still burning. Figure 5-108 shows a frame taken from a video recorded looking from the west of the West Broadway/Barclay Street intersection. The exact time is unknown, but it was likely between 11:00 a.m. and 12:00 p.m. Multiple vehicles were burning at this time. This image provides an indication of the burning intensities and smoke generation by these vehicle fires.

Figure 5–108. Frame taken from a video clip filmed near the corner of West Broadway and Barclay Street showing flames burning on a number of vehicles.

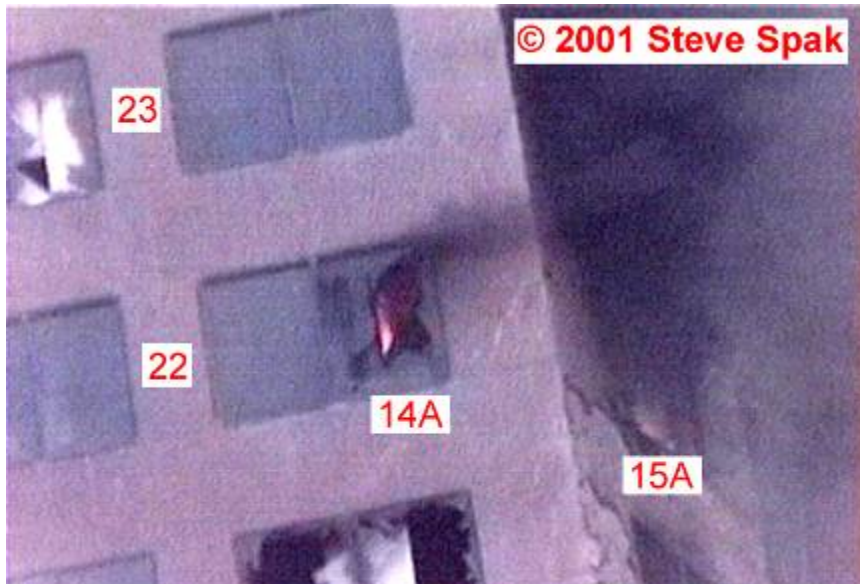
The earliest visual evidence showing flames in WTC 7 is a video clip of the southwest corner that was recorded between 12:10 a.m. and 12:25 p.m. Figure 5–109 is a frame from this video. Flames are visible in open windows 22-14A and 22-15A. Some smoke is visible flowing from both of these windows, with the heaviest flow on the south face. Windows to the north of window 22-14A were intact at that time. In

this close up it is easy to identify Column 14 through window 23-13B on the 23rd floor and Column 14A through windows 21-14 and 21-14A on the 21st floor.

Figure 5-109. Frame from a video clip showing the southwest corner of WTC 7 around the 22nd floor.

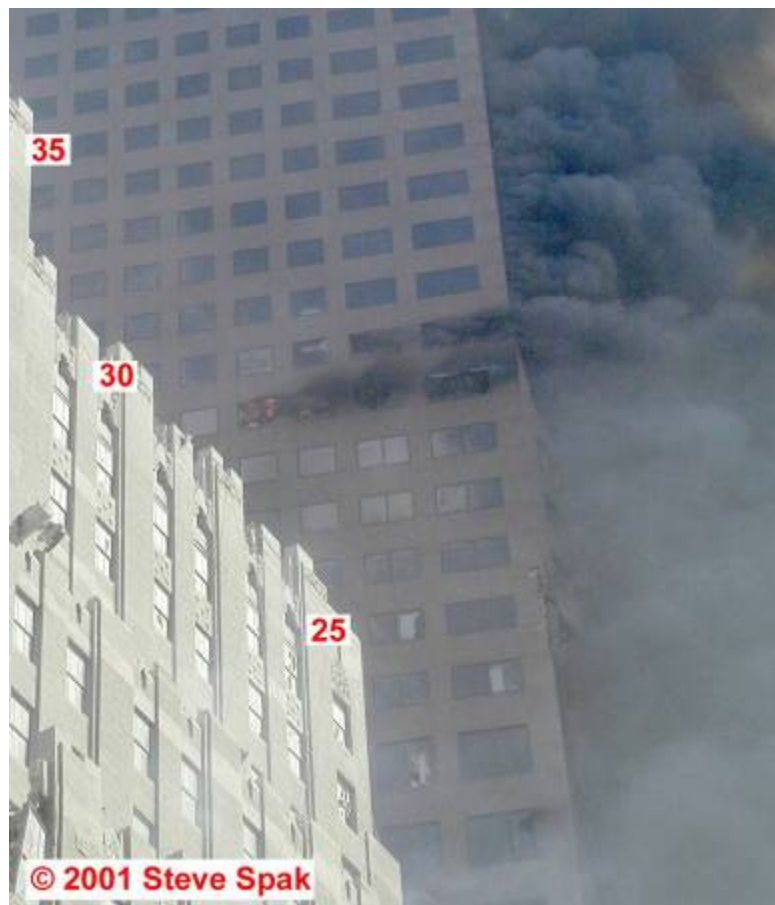
Figure 5-110. Cropped photograph showing a portion of the west face of WTC 7 near the south edge at 12:27:30 p.m. ± 1 s from near the corner of Vesey and West Streets.

A larger area of the west face near the south edge is visible in the photograph shown in Figure 5–110, which was taken shortly after Figure 5–109 at 12:27:30 p.m. At this time flames were not evident in window 22-14A, but light smoke continued to flow from the window. Higher up on the face, smoke was coming from the six adjacent open windows 29-11 to 29-14A on the 29th floor, with heavy flames filling windows 29-11 and 29-12. As discussed in Section 5.5.2, the condition of windows 29-13A to 29-14A immediately following the collapse of WTC 1 could not be determined, while the glass was intact in windows 29-11 and 29-12. This suggests that the fire burning on this floor had opened windows 29-11 and 29-12 by 12:27:30 p.m.

Heavy smoke was also coming from open windows 30-13A to 30-14A on the 30th floor at this time. This suggests that a fire was also burning on this floor, but flames are not apparent in Figure 5–110. In a long distance view from the same short video clip from which Figure 5–109 was taken, these windows appeared to be intact. This indicates that the fire burning on this floor broke the glass from these windows during the short time period between the times when Figure 5–109 and Figure 5–110 were taken.

The appearance of the smoke on the south side of WTC 7 in Figure 5–110 demonstrates a difficulty that plagued attempts to use smoke to provide qualitative information about fire behavior. There appears to be relatively light-colored smoke on the south face at all of the floors visible in the image, while much denser and darker, rapidly rising smoke appeared to be flowing from windows near the west edge of the 30th floor. Due to the wind direction, it was common for smoke to “bank up” against the south face. For this reason, it was usually not possible to differentiate different types of smoke or to identify smoke source locations on the south face. Viewing difficulties resulting from the large amount of smoke on the south face were discussed earlier.

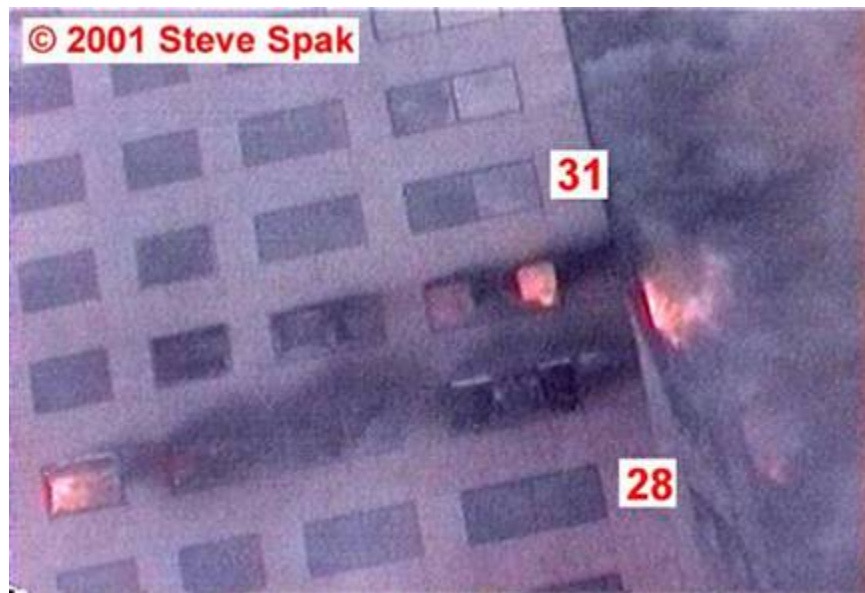
Figure 5–111 shows another view of the fires at the southwest corner on the 29th and 30th floors taken within a few minutes of Figure 5–110. At this time flames were visible on both floors. The appearance of the fires on the 29th floor is similar in both images. However, unlike in Figure 5–110, intense flames are visible on the 30th floor. Flames are apparent in windows 30-14, 30-14A, 30-15, and 30-16A to 30-16C. In the video it is clear that flames were coming from multiple windows on the south face. This is an indication that a fully developed flashed over fire was present in the corner of this floor at this time.

Figure 5–111. Frame from a video clip showing fires near the southwest corner of WTC 7 on the 29th and 30th floors around 12:28 a.m. ± 3 min.

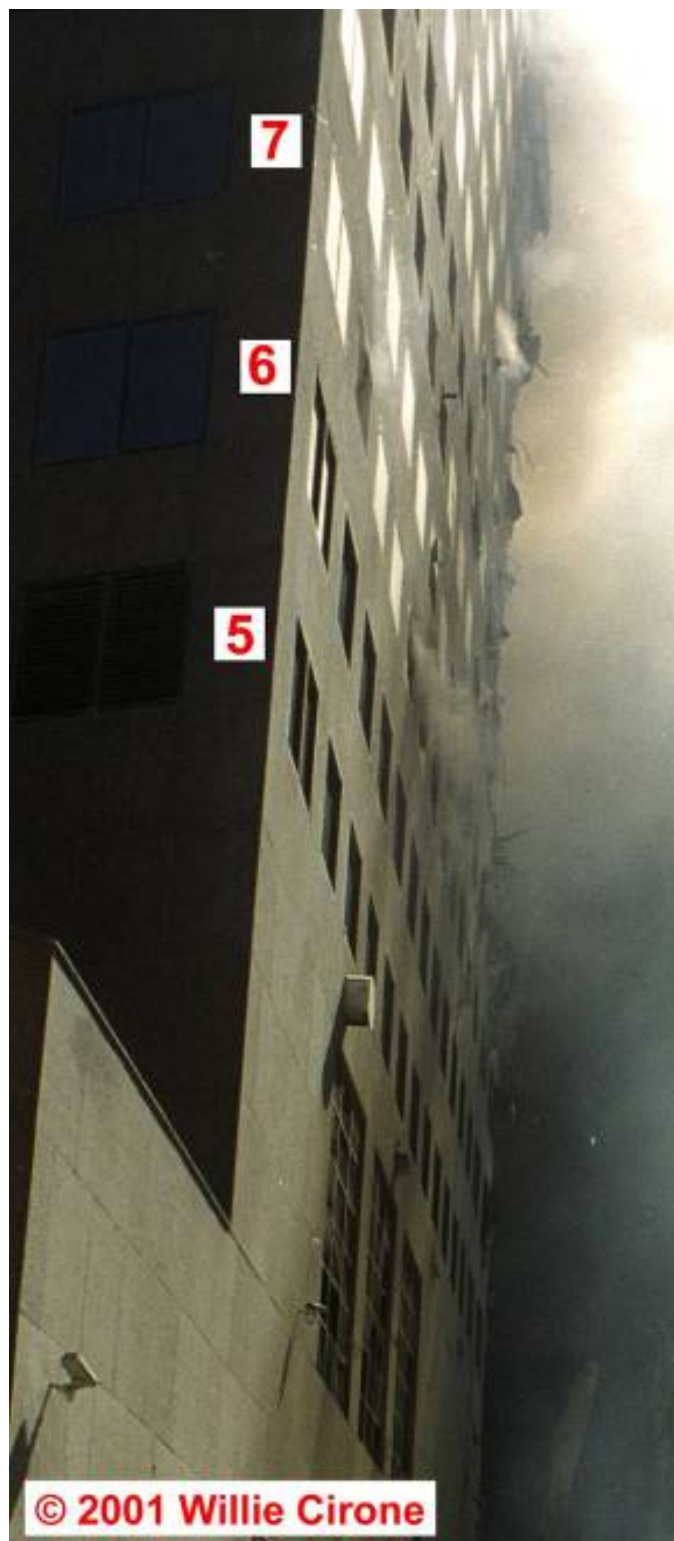
In Figure 5-112 smoke is visible coming from open windows 7-5 and 7-7 on the 7th floor, and windows 7-6 and 7-8 appear to be open as well. In the earlier photograph, no smoke was evident coming from windows on this floor, and glass was in place in each of the open windows mentioned above. Light smoke is also visible coming from the louvers in window 7-2 in Figure 5-112. The glass in windows 7-1A, 7-1B, 7-3 and 7-4 was still intact when the photograph was taken. The presence of smoke and additional broken windows indicates that a fire had progressed toward the north edge of the west face on the 7th floor by the time the photograph in Figure 5-112 was taken. Even though a fire was present that was capable of breaking out window glass, no flames are visible. It is possible that flames were present

earlier and had died away or that the prevailing wind on the face pushed the flames into the building and that the smoke and possibly flames exited primarily through openings on the south face.

Smoke is also visible coming from open windows at a few other locations on the west face in Figure 5–112. Relatively heavy smoke appears to be coming from an open window on the 8th floor near the southwest

Figure 5–112. Cropped photograph shot from near the corner of Washington and Barclay Streets shows lower floors on the west side of WTC 7 between 1:30 p.m. and 2:30 p.m. The intensity levels have been adjusted, and floor numbers have been added.

corner. This window was likely 8-10 or 8-11. Smoke is also coming from a window on the 12th floor near the same corner. There does not appear to be significant smoke flow from other open windows at this time.

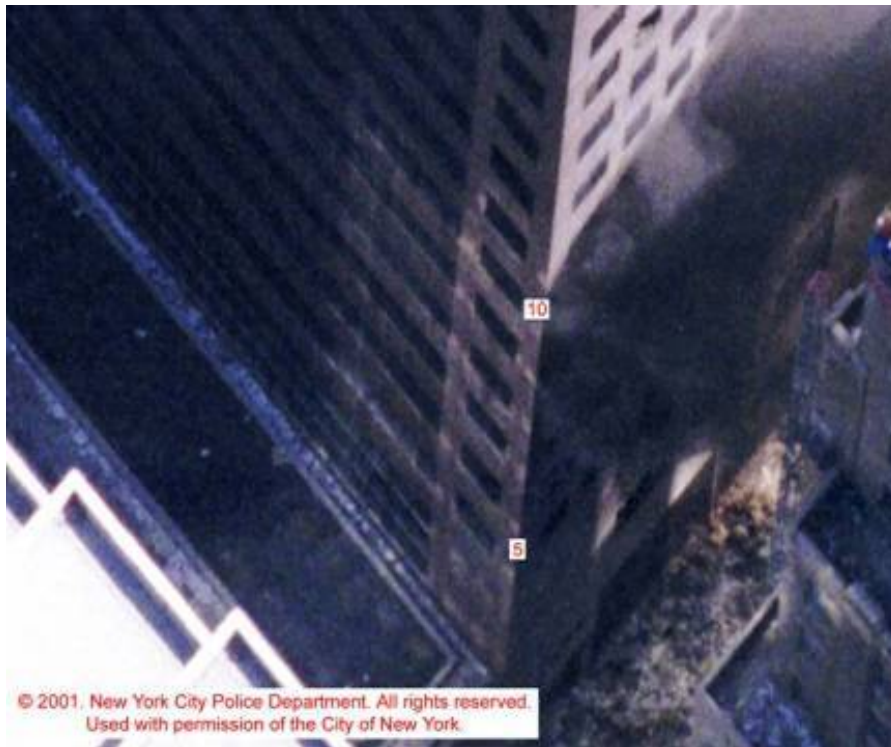
Figure 5–113 shows a portion of the aerial photograph in Figure 5–64, enlarged to emphasize the areas on lower floors near the northwest corner of WTC 7. This image was estimated to have been taken between 2:15 p.m. and 2:45 p.m. by relating it to other photographs taken earlier that show fires on the east side of WTC 7 and the south side of WTC 5 and by using shadows at various locations around the site.

Figure 5–113.
Enlargement of a
portion of the
photograph shown
in Figure 5–64
emphasizing areas
on the lower floors of
WTC 7 near the
northwest corner.

Heavy smoke is visible passing over the west face, starting at a point close to the north edge of the building. This smoke appears to be coming from windows on the 7th or 8th floor. It likely was coming from windows on the 7th floor, since fire appeared on the north side of this floor shortly after Figure 5–113 was taken, and there were indications of earlier burning to the south of this location on this floor. Note that there were no visual signs of fire or broken windows on the north face at that time.

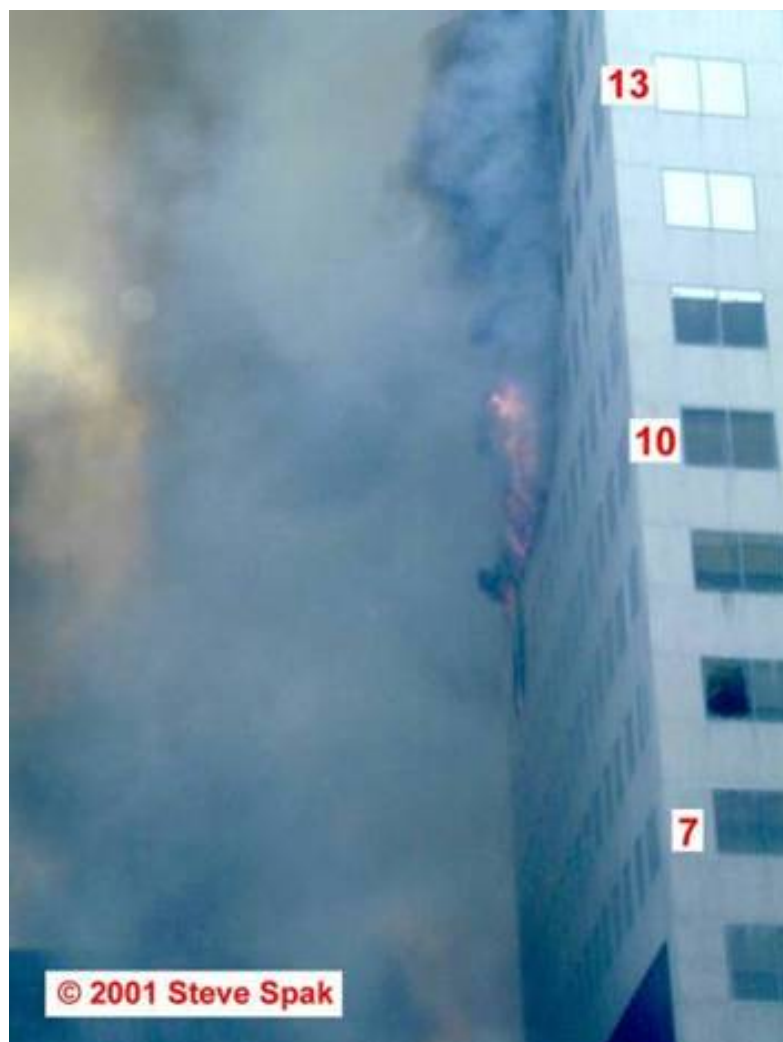
Figure 5–114. Oblique view of the east face of WTC 7, taken at 2:08:28 p.m. ± 1 s from West Broadway near its corner with Park Place.

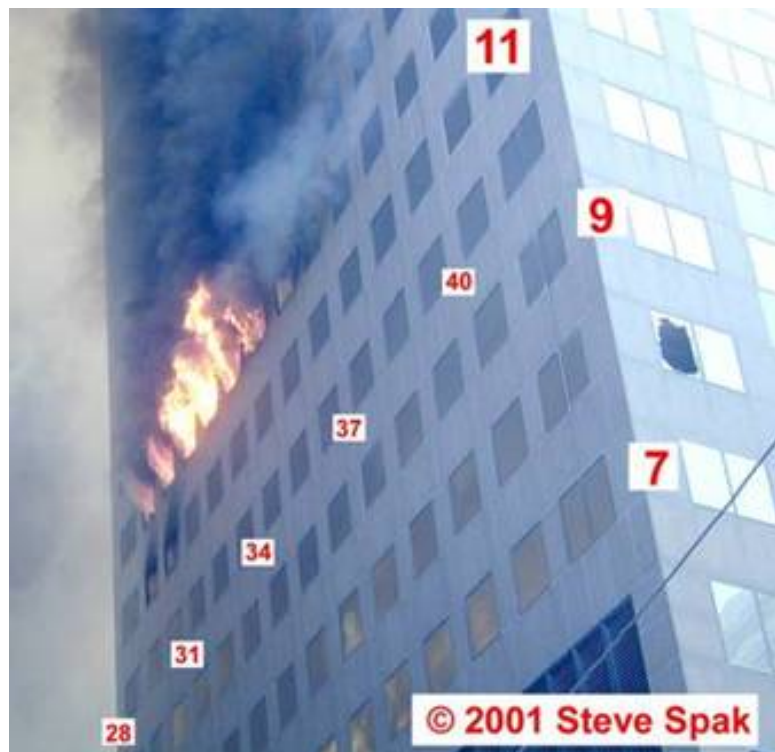
Two windows, 11-29 and 11-30, were also open on the 11th floor at 2:11:09 p.m. Upon closer inspection, it is possible to identify a dull red glow through these open windows. The smoke patterns visible above these windows indicate that a more intense fire had burned there earlier and had subsequently died down. The floor plan for the 11th floor (Chapter 3) was similar to that for the 12th floor, and interior walls were present on either side of these two windows. Apparently, these walls slowed the fire spread into enclosed spaces on either side.

Figure 5–115. Cropped photograph showing fires on the east face of WTC 7 at 2:11:09 p.m. ± 1 s.

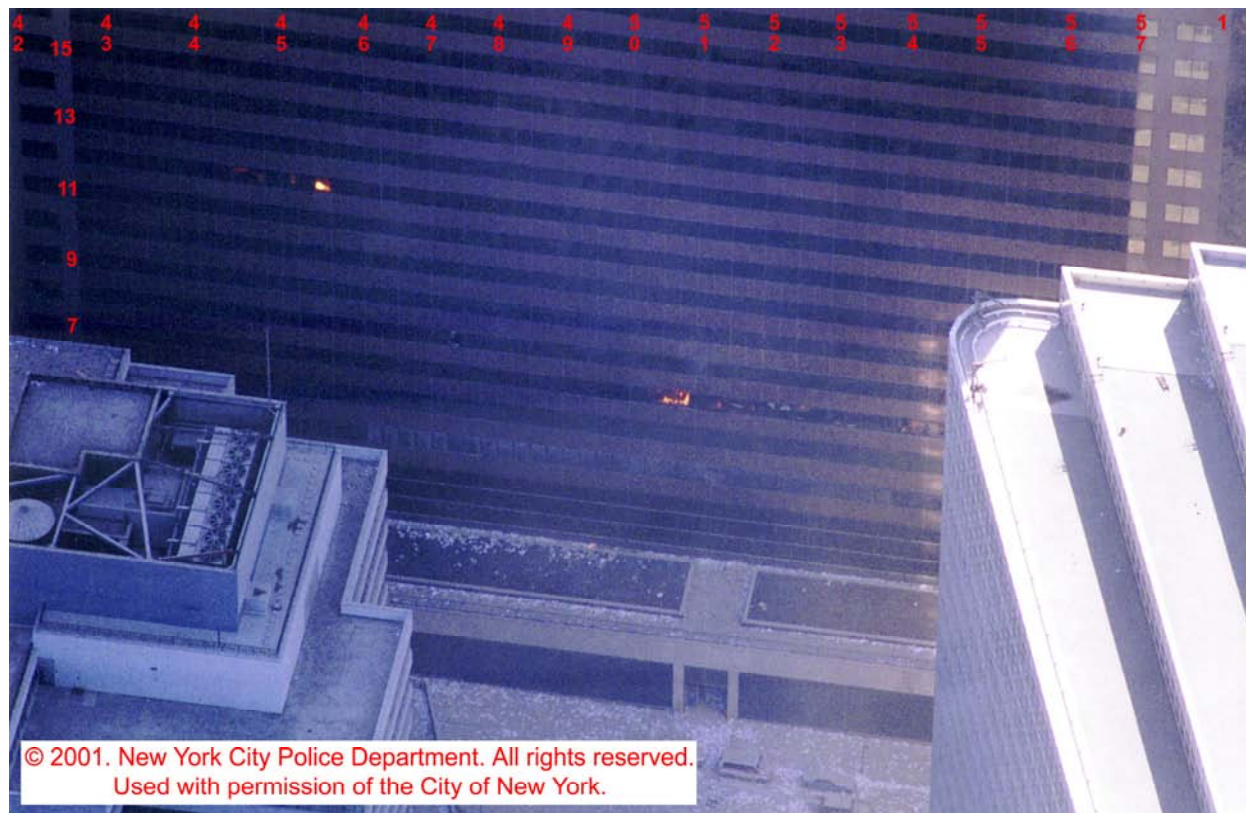
Figure 5–119. Photograph showing the north face of WTC 7 taken from a helicopter around 2:57 p.m. \pm 5 min.

Only very light smoke can be seen coming from the open windows on the 7th and 12th floors. Even though the fires were relatively small, they would be expected to release much more smoke than was observed. It is likely that this smoke was being vented elsewhere from the building, perhaps at locations on the east or south faces. This would be the expected behavior if internal flow pathways were available to these faces due to the positive pressure created at the open windows on the north side by the ambient wind flowing over this face and the corresponding low pressure areas created on the leeward faces.

Flames were also visible from at least the two windows on the east face adjacent to the northeast corner, indicating that the flames had engulfed the small unburned island in this corner of the floor. On the west side the flames had moved beyond Column 46. This was the first substantial apparent fire spread in this direction since fire first appeared on the face shortly before 3:00 p.m. (See Figure 5-119.)

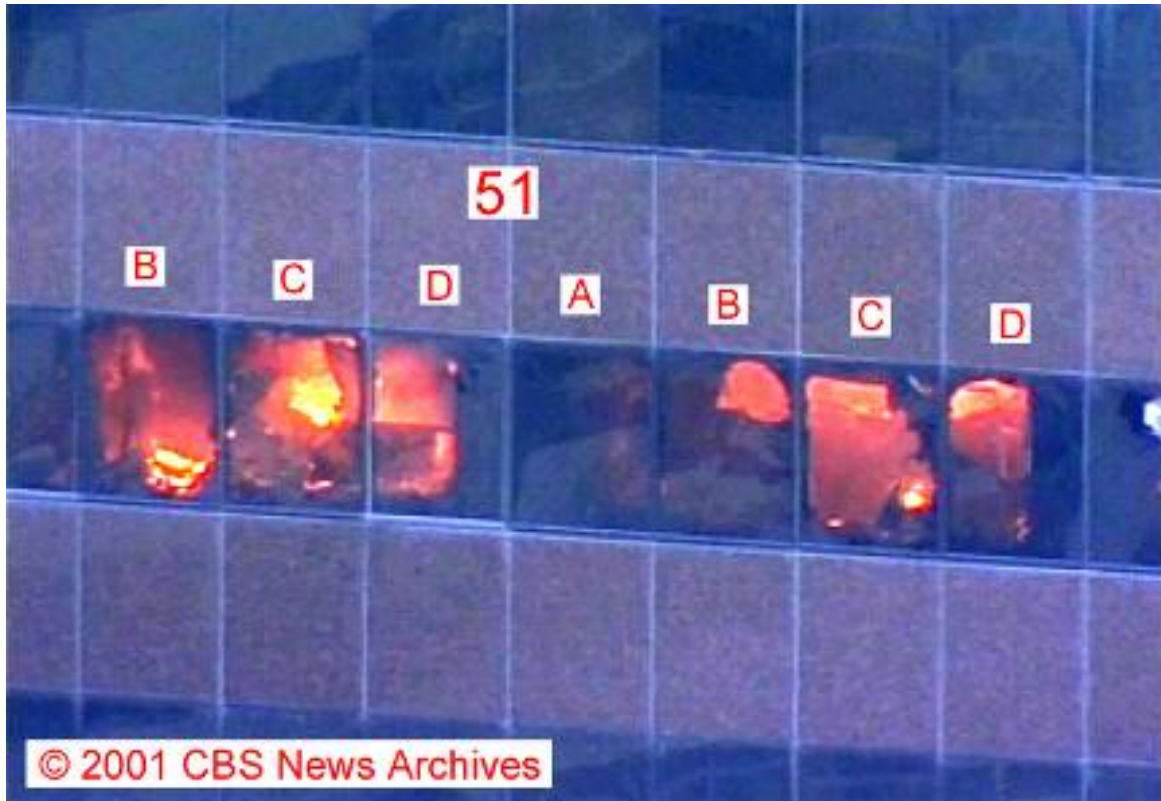
A much closer view of the windows near Column 51 on the 7th floor is shown in Figure 5–120. This image is taken from a video clip that was recorded shortly after the photograph in Figure 5–119. The fire visible through window 7-50B had grown somewhat. The flames in this area appear to fill the volume. For some of the windows, only a portion of the glass was broken. It is possible to make out some interior details. For instance, a burning desk is visible through windows 7-50C and 7-50D. In the video, a large object was observed falling from the ceiling through windows 7-51B to 7-51D. Even though the flames are locally heavy, little smoke or flame exited through nearby open windows.

The observations indicate that a relatively low intensity fire with sufficient heat release to break nearby windows spread rapidly across the north edge of the building on the 7th floor. As noted earlier in this chapter, the tenants had been relocated from the western half of the floor, probably reducing the fuel load.

Consistent with this, the apparent low fire intensities suggest that the fuel load or burning rate was insufficient to induce flashover in this large space.

Figure 5-120. Frame taken from a video clip shot looking down on WTC 7 from a building to the northwest showing the fires along a length of the north side of the 7th floor of WTC 7.

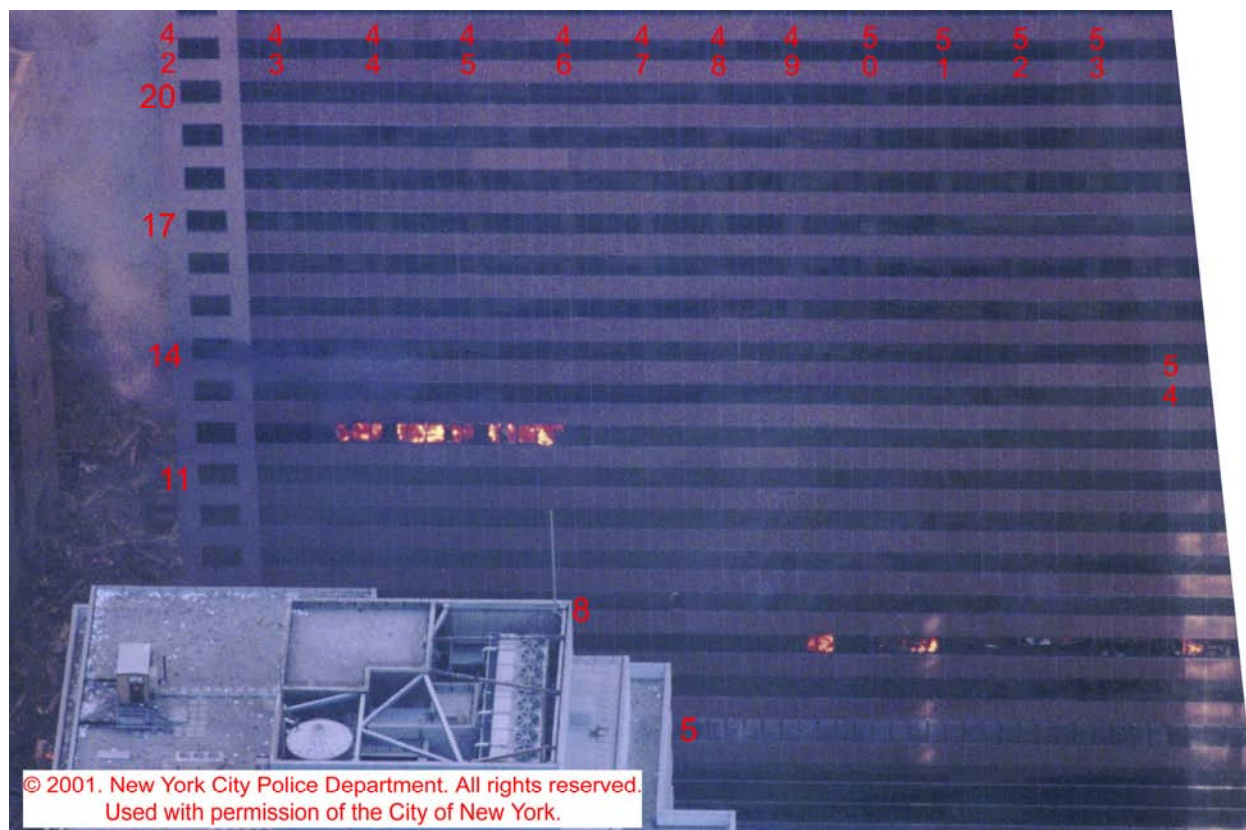
Figure 5-121. Cropped photograph of the north face of WTC 7, taken from a helicopter around 3:05 p.m. ± 5 min.

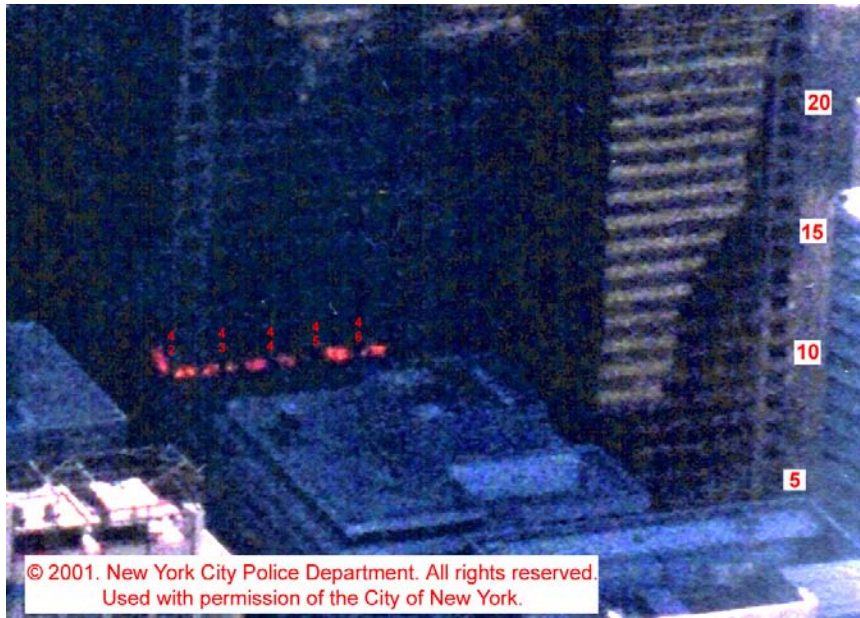
An aerial view of the north face of WTC 7 taken from a much longer distance than Figure 5-119 and Figure 5-121 is shown in Figure 5-123. The time of this photograph was estimated in the same way as the earlier aerial shots as 3:10 p.m. with a ± 5 min uncertainty. Flames were only visible on the 12th floor from this distance and angle. The fire had spread to the east and west in the roughly 5 min period following the photograph in Figure 5-121. The flames had spread all the way to the east face.

Figure 5-123. Enlarged section of a long distance aerial shot of the north face of WTC 7 taken around 3:10 p.m. \pm 5 min.

The fires on the north side of the 12th floor were extensive, covering a length running approximately from window 12-41A to 12-46C, and intense. Close inspection of Figure 5-123 shows that the fire in the vicinity of windows 12-44C to 12-44E had begun to die down. This area is close to where the fires first appeared just before 3:00 p.m., indicating that, for this location, the period of intense burning lasted for roughly 15 min.
