**Federal Building and Fire Safety Investigation of the
World Trade Center Disaster**

**Structural Fire Response and
Probable Collapse Sequence of
World Trade Center Building 7**

VOLUME 1

November 2008

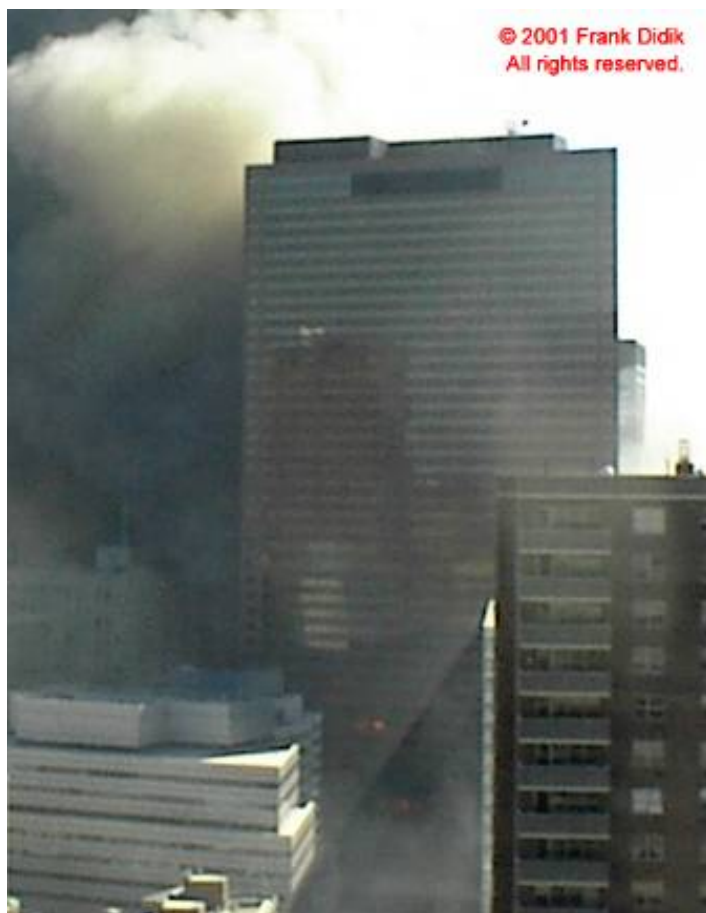
Figure 5-124 provides a view of the north face of WTC 7 taken from the northwest at 3:10:46 p.m. It shows an example of the shadow and sunlight distributions on the roof of the building at 70 Murray Street (the stepped white building at the lower left of the photograph) used for timing the aerial photographs described earlier. Flames are visible on the 7th and 12th floors of the north face of WTC 7. Light smoke or dust is visible on the north side of the building. Heavy smoke is also visible rising from the east face, indicating that fires were burning near by or that the effluent from more distant fires was being vented through the face.

Figure 5–124. Cropped photograph of the north face of WTC 7 taken from a building located to the northwest looking down Greenwich Street at 3:10:46 p.m. \pm 3 s. The intensities were adjusted.

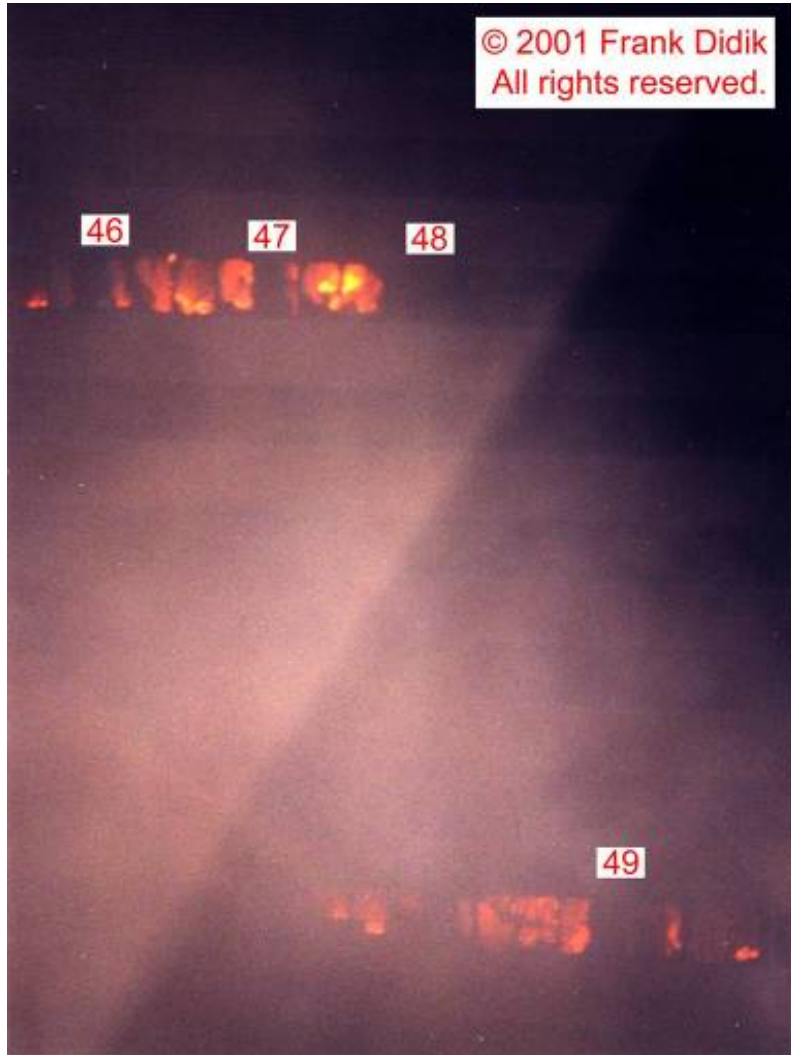
A much closer view of the fires visible on the north face in Figure 5-124 is provided by the photograph reproduced in Figure 5-125, which was taken within a few minutes of Figure 5-124. The north face is partially obscured by smoke or dust, but it is possible to make out fires in individual windows on the 7th and 12th floors. Columns are visible inside the windows, and these have been identified on the image. On the 7th floor, windows are open, and flames are visible from windows 7-47B to 7-49C. In Figure 5-121, which was taken at roughly 3:05 p.m., fires on this floor had reached only as far east as window 7-49A. Longer distance photographs indicate that the extended area of intense fire to the east of Column 49 became visible between 3:09:42 p.m. and 3:10:46 p.m. Clearly, fire was continuing to spread toward the east on the 7th floor at this time.

On the 12th floor, intense flames are visible in Figure 5–125 as far west as window 12-47C, indicating that this image was taken shortly after the photograph shown in Figure 5–123, in which flames were not yet evident to the west of Column 47. The flames completely fill the open windows, suggesting that flashover had taken place within the offices at these locations. As noted earlier, very little smoke or flames are coming from the open windows on this floor, again suggesting that the smoke was venting elsewhere from the building due to the ambient wind direction.

Figure 5–125. Cropped close-up photograph of the north face of WTC 7 taken within a few minutes of the image in Figure 5–124.

Fires are visible on the 7th and 12th floors. Column numbers are indicated, and the intensity levels were adjusted.

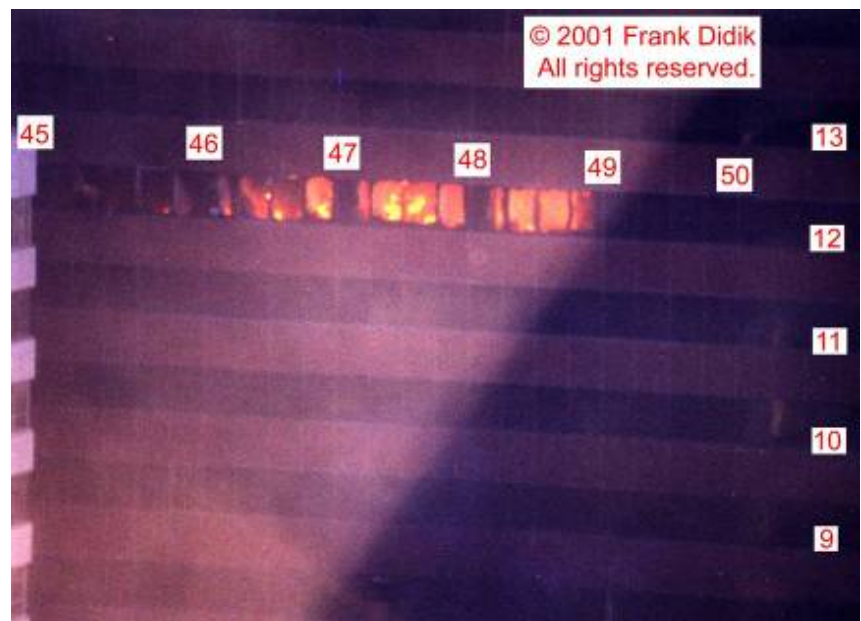
Another close up view of the north face taken from a building to the northwest between 3:11:15 p.m. and 3:16:51 p.m. is shown in Figure 5–126. The fires on the 12th floor are visible, but the image did not extend low enough to show the 7th floor. During the short period between when the images in Figure 5–125 and Figure 5–126 were taken, the fires on the 12th floor broke windows 12-48A to 12-48D, and heavy flames appeared. This indicates that the fires on this floor were continuing to spread toward the west.

Figure 5–126. Cropped close-up photograph of the north face of WTC 7 taken between 3:11:15 p.m. and 3:16:51 p.m.

Fires are visible on the 12th floor. Column and floor numbers are indicated, and the intensity levels were adjusted.

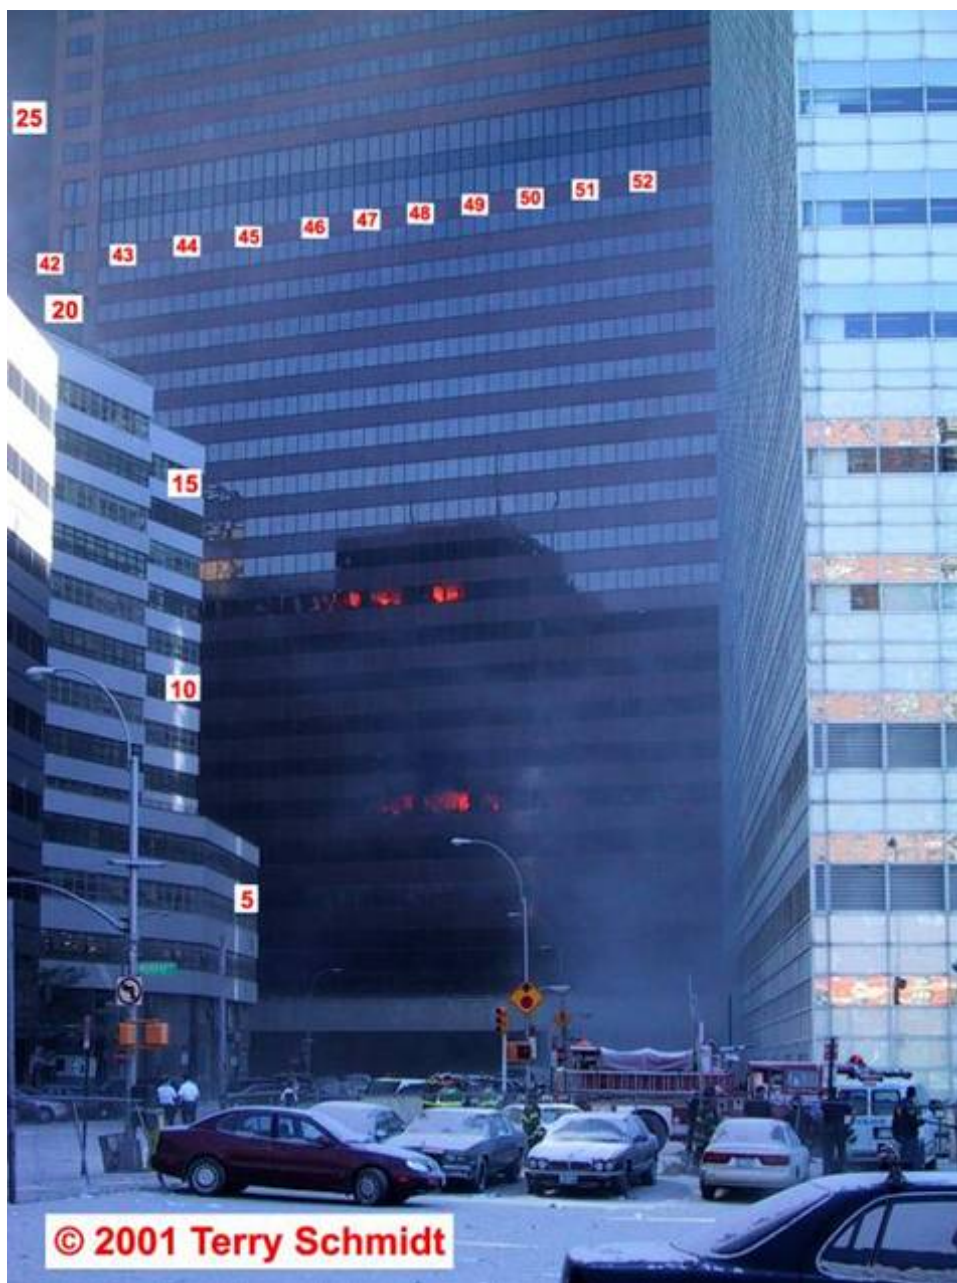
In Figure 5–127, the fires observed earlier on the 12th floor between Columns 44 and 46 have died down substantially. Only small flames are visible near windows 12-44B and 12-45E. On the other hand, the flames further to the west are more intense at this time and appear to fill the open windows, indicating that flashover had occurred. As observed earlier, very little smoke and flame are coming from the open windows, likely indicating that the effluent is being vented elsewhere.

Figure 5–127. Photograph showing the north face of WTC 7, taken around 3:12:50 p.m. with an estimated uncertainty of ± 5 min from near the corner of Murray and Greenwich Streets.

Figure 5–127 provides a good view of the fires on the 7th floor around 3:13 p.m. As noted previously, these fires appear to be less intense than those observed on the 12th floor. There are indications of low intensity flames through windows between Columns 50 and 51. Further west, the fire appears to have gone out. The most visible flames extend from windows 7-47B to 7-49B. Window 7-47A appears to be broken, while the glass in windows 7-49C and 7-49D appears to be intact. Comparison with Figure 5–125 indicates that, during the few minutes between the two photographs, the fires on the 7th floor had died down somewhat, while not spreading further to the east.

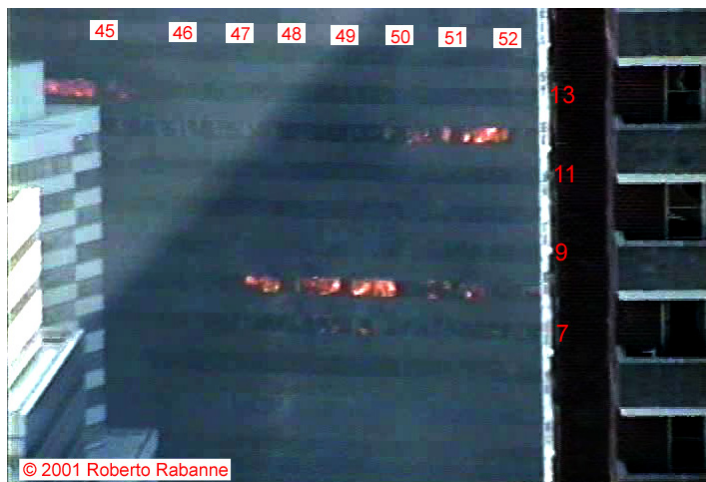
An overhead view of the north face looking down Greenwich Street from a building to the northwest is shown in Figure 5–128. It was taken around 3:42:30 p.m. \pm 2 min. Fires are visible on the 8th floor between Columns 47 and 52, with the most intense burning toward the east, on the 12th floor between Columns 50 and 52, and on the 13th floor between Columns 44 and 46, with intense burning visible between Columns 44 and 45. The greatest length of fire is on the 8th floor. An earlier frame from the same video shows fire present on this floor at least one minute earlier. This was the earliest observation of a fire present on the 8th floor.

Close inspection shows that a dull red glow is visible in windows 13-45C to 13-45E on the 13th floor. These windows can just be seen at the side of the building at 30 West Broadway, which hides windows further to the east. This image provides the earliest visual evidence that fires on the 13th floor, which were identified much earlier on the east face, had spread to the north side of WTC 7. Based on Figure 5-128, it is likely that fire was present to the east between Columns 44 and 45 at this time.

Figure 5-128. This frame from a video shot from a building to the northwest of WTC 7 was taken around 3:42:30 p.m. with an uncertainty of ± 2 min.

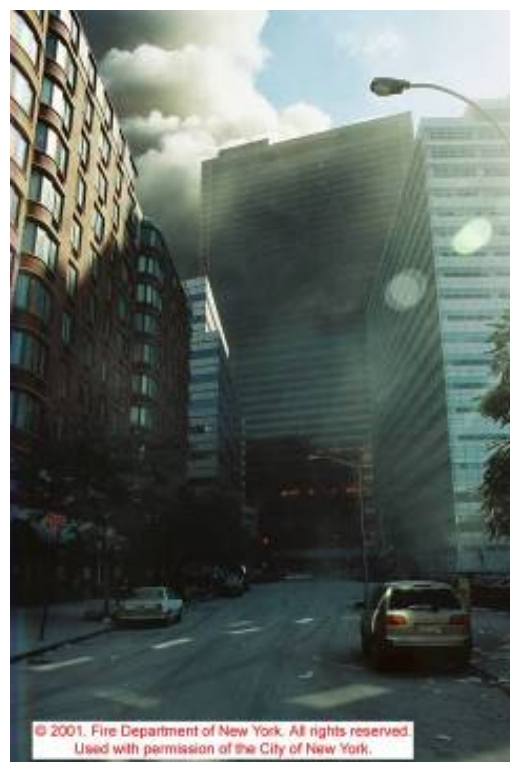
Figure 5-129. Photograph showing the north face of WTC 7 shot looking down Greenwich Street from near the corner of Greenwich and Warren Streets at around 3:41 p.m.

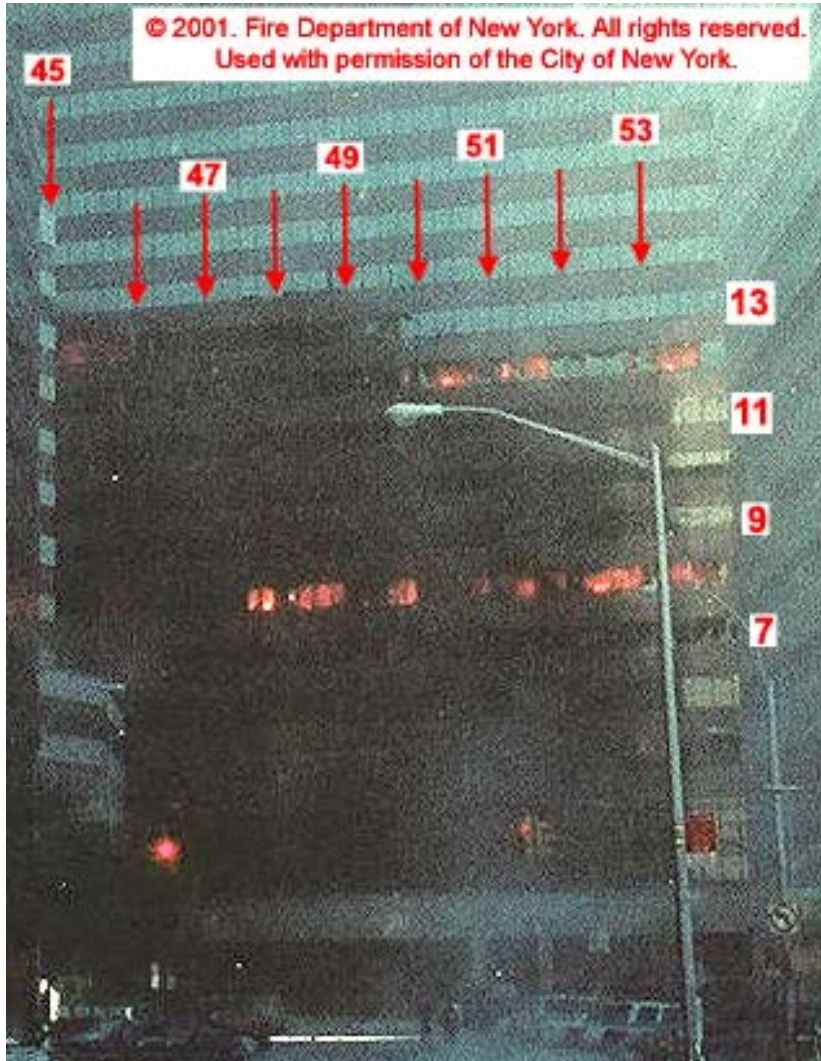
Flames are also visible through open windows on the 12th floor. At around 3:14 p.m., fires on this floor were observed as far west as window 12-48D, and the distribution was little changed roughly 5 min later. In Figure 5–130, fire had spread at least as far west as window 12-53C during the roughly 20 min between close up images. At the later time, flames are only visible as far east as window 12-48D, indicating that the fires visible earlier had mostly died down. The flames visible on the 12th floor around

3:41 p.m. seem to fill the open windows, suggesting flashover conditions, but several windows still appear to have glass in place. This may be an indication that the fire on the north face was not spreading systematically to the west, but at times jumped over adjacent offices which then ignited somewhat later.

Figure 5–130. View of the north face of WTC 7 taken around 3:41 p.m. ± 3 min, enlarged from Figure 5–129. The intensities have been adjusted, and column and floor numbers have been added.

While difficult to discern in Figure 5–130, a number of windows are open on the 7th floor. Most, if not all, of the windows between window 7-47A and 7-53D are open. There is no indication of fire on the floor in this photograph. Apparently, fire present in this area around 3:13 p.m. had stopped spreading and had died down by 3:41 p.m.

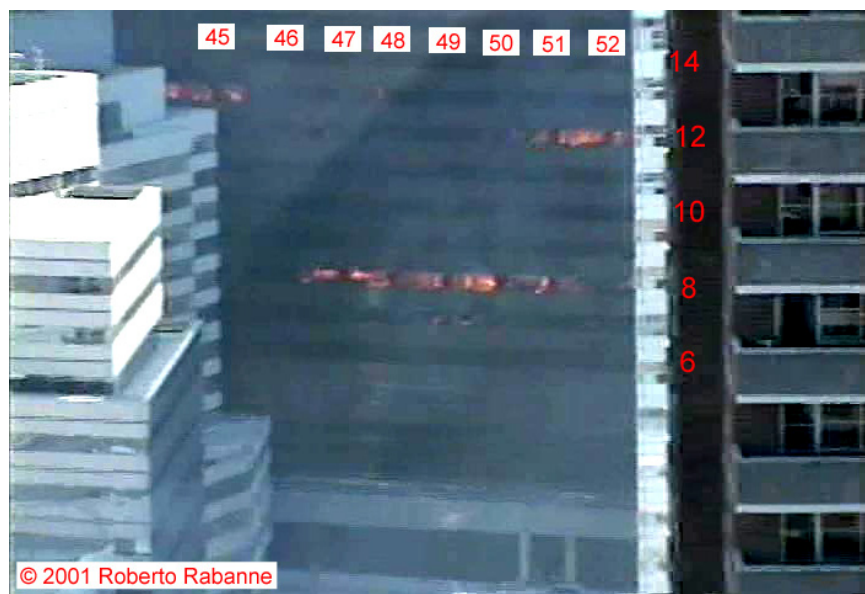
Figure 5–131 shows a view of the central region of the north face taken from the video shot from a building to the northwest of the site looking down Greenwich Street at a time estimated as 3:50:13 p.m. with an uncertainty of ± 3 min. During the approximate 7 min 45 s period between the time when Figure 5–128 and Figure 5–131 were taken, the fire on the 8th floor had spread towards the east and was burning vigorously between Columns 46 and 47 at the later time. Windows on this floor around Column

Figure 5–131. This frame from a video shot from a building to the northwest of WTC 7 was taken around 3:50:13 p.m. with an uncertainty of ± 3 min. The intensities have been adjusted and column and floor numbers added.

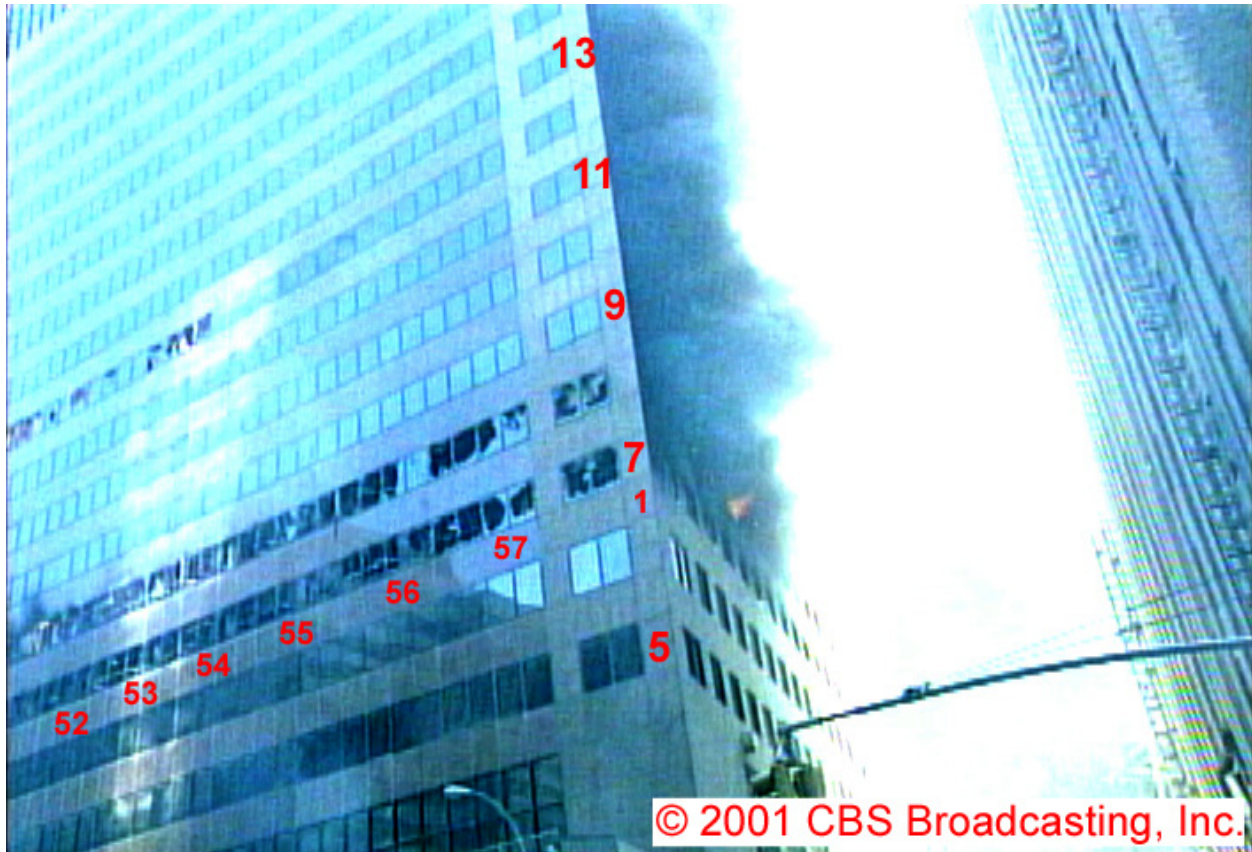
Figure 5-132. View of the northwest corner of WTC 7 from a video recorded from inside the lobby of 123 Barclay Street around 3:42 p.m. \pm 5 min.

On the north face, every window on the 7th and 8th floors to the west of Column 51, with the exception of window 8-56A, was open at the time Figure 5–132 was taken. This is the first visual evidence that fires had burned on these floors between Column 54 and the west edge of the face. The only locations where flames can be seen are near Column 51 on the 8th floor. Other clips shot around the same time show fire in windows 8-57B and 8-57C. In Figure 5–130, intense burning was present between Columns 51 and 54. The fact that these fires had died down by the time of the later video clip indicates that many minutes separate the images in Figure 5–130 and Figure 5–132. This is consistent with the assigned times.

Even though the open windows on the north sides of the 7th and 8th floors visible in Figure 5–132 were clearly subjected to high temperatures, little blackening of the building façade above the windows is evident. The only substantial blackening was near Column 51 on the 8th floor. As observed at other

Closer inspection of Figure 5–132 reveals that while the glass in window 12-55C was still in place, it had apparently cracked. This is an early indication that fire was nearby. Another video clip taken from the same location a short while later shows that windows 12-55B and 12-55C had opened and flames filled both windows. After a brief lull, the fires burning on the north side of the 12th floor continued their spread to the west. As noted earlier, the fires on this floor seemed to occasionally skip some closed windows and appear further west. This suggests that instead of spreading continuously along the north edge, the fires were penetrating a series of offices and then growing to the point where windows were broken. Each of these office fires was apparently somewhat independent, which is consistent with the floor plan shown in Figure 3–4.

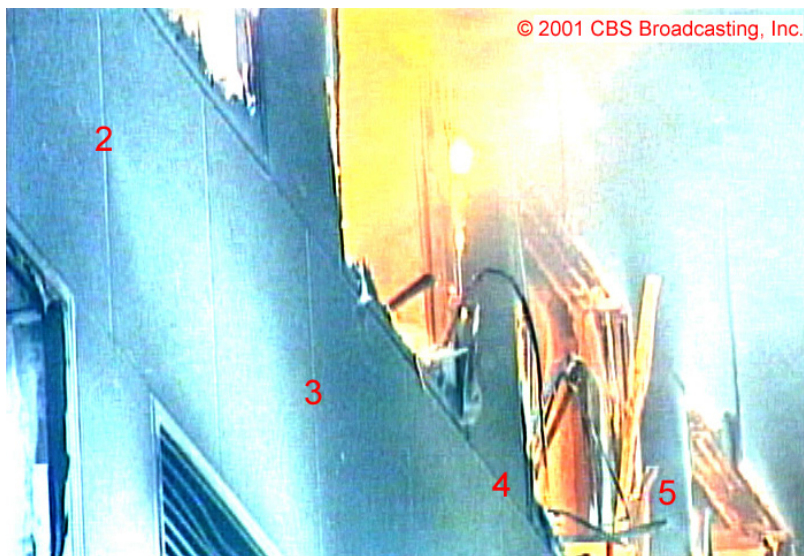
Figure 5-133. View of the west face of WTC 7 taken from a video recorded from inside the lobby of 123 Barclay Street around 3:41:30 \pm 5 min.

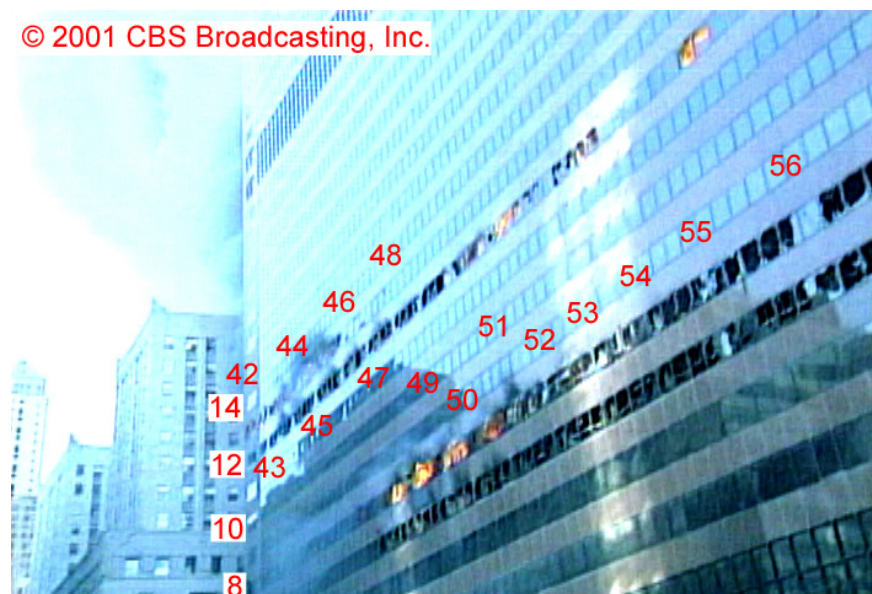
Figure 5–132 and Figure 5–134 together show that every window on the 7th floor between Column 47 and the western edge of the north face was broken out at this time. No flames are visible on this floor in either image. As shown by Figure 5–127, fire had spread as far east as window 7-47A as early as 3:13 p.m. No further eastward fire spread was observed over the following 45 min, and the fires appeared to have died down.

On the 8th floor, heavy flames are visible between Columns 47 and 51 in Figure 5–134. Comparison with Figure 5–130, which was taken somewhere between 2 min to 10 min earlier, indicates that the flaming area had not moved further east during the intervening time, but that substantial fires, present earlier between Columns 51 and 54, had died down. Several windows that earlier had glass in place between Columns 49 and 51 were open at the later time. Even though no fire is evident to the east of Column 47 in Figure 5–134, there are indications that window glass in several windows to the east of this point had

begun to break. Despite the heavy fire on this floor, only light white smoke was coming from the open windows.

Figure 5-134. View of the north face of WTC 7 taken from a video recorded from inside the lobby of 123 Barclay Street at 3:44 p.m. ± 4 min.

On the 12th floor, the flames that had recently appeared in windows 12-55B and 12-55C stand out. Further east, heavy flames are visible near Column 51. Flames were also visible at the same location in Figure 5-132. All of the windows to the east of Column 51 appear to be open, but there are no indications of active fire. Despite the heavy fire, essentially no smoke or flames were coming from open windows on this floor.

In Figure 5-130, low level flames were visible on the 13th floor immediately to the west of Column 45. In Figure 5-134, it is clear that windows between the east edge and Column 46 were open at the later time, and there are indications that glass was beginning to break in windows further to the west. It is not possible to observe flaming in these windows at this severe angle.

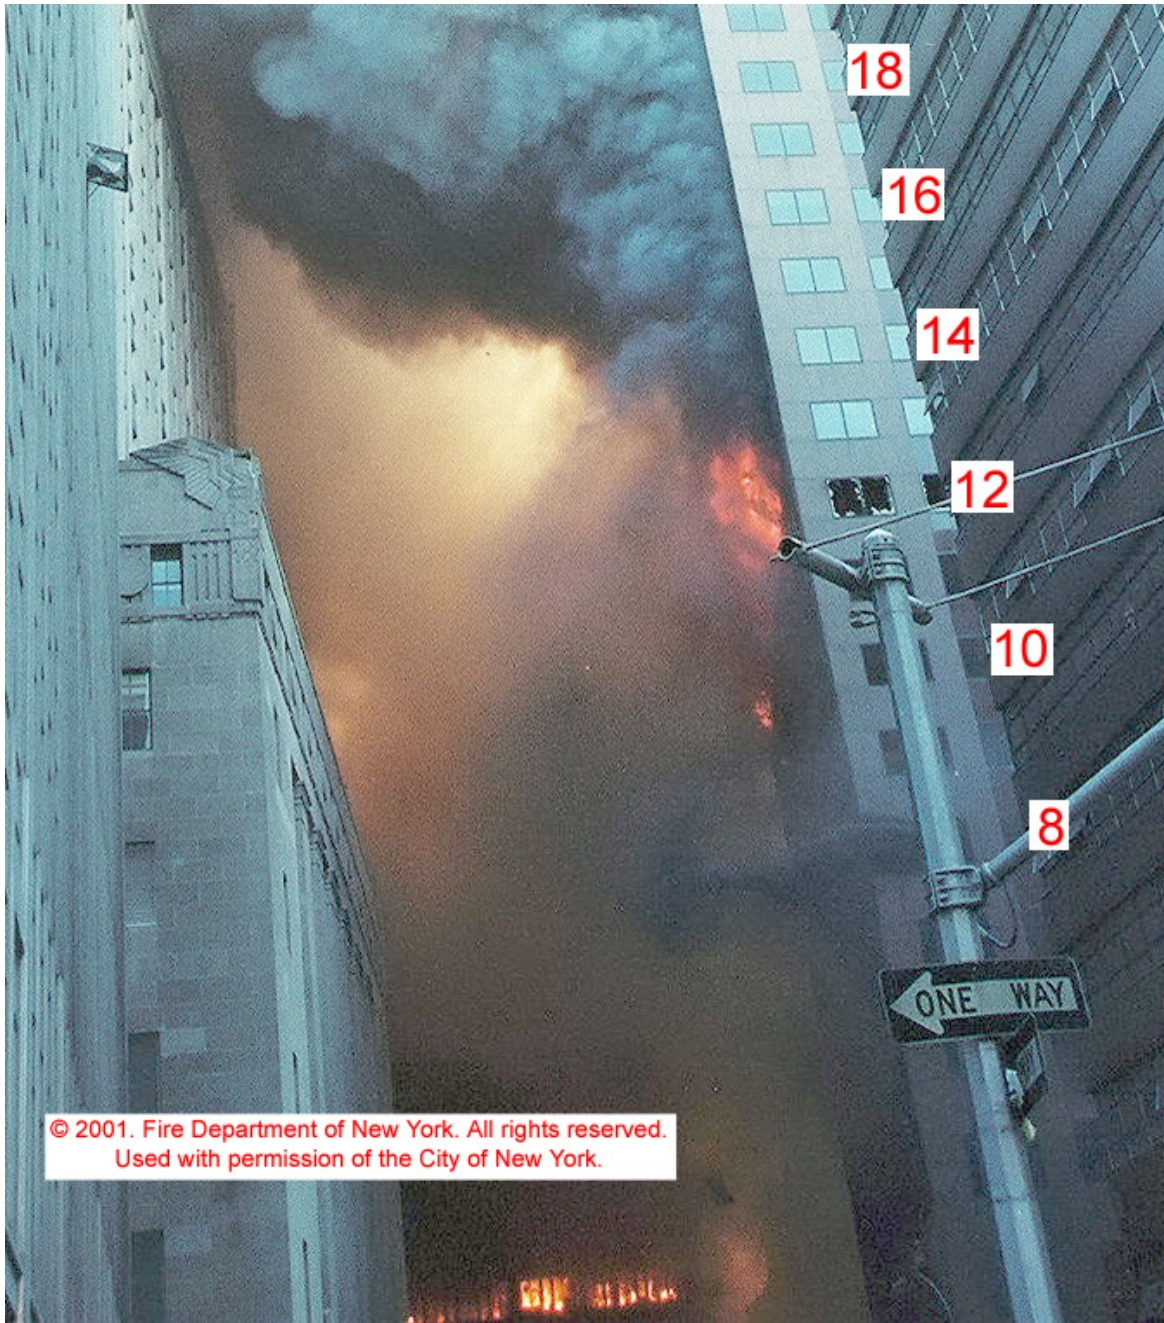
It is difficult to identify how fire moved onto the north side of the 13th floor from Figure 5-130 and Figure 5-134. A photograph (Figure 5-135) taken at an unknown earlier time, estimated as between 3:20 p.m. and 3:40 p.m., provides an important clue. This image, shot from near the corner of West Broadway and Park Place, shows an oblique view of the east face. Intense flames appear to be coming from windows 13-39 to 13-41 on the 13th floor. A much smaller flame can be seen in window 13-41A. Despite the steep viewing angle, there seems to be a line of flames extending across most of the east face on the 13th floor. Heavy smoke is rising from these fires. There also appears to be lighter smoke lower down on the east face, but it is not possible to identify its source.

Windows at the east edge of the north face are also visible in Figure 5-135. Windows 13-42A to 13-42C still have glass in place on the 13th floor, which means that this image was taken prior to Figure 5-134. The heavy smoke pouring from open window 8-42A on the 8th floor indicates that a significant fire was burning on this floor at this time, even though it is clear from Figure 5-134 that nearby windows still have intact glass. Windows 12-42A to 12-42C are open on the 12th floor with no sign of flames nearby, indicating that this photograph was taken well after the aerial view in Figure 5-123, which was taken around 3:10 p.m. and shows heavy flames in these corner windows.

Figure 5–135. Cropped photograph showing the east edge of the north face and an oblique view of the east face of WTC 7, taken from near the corner of West Broadway and Park Place.

It was likely taken between 3:20 p.m. and 3:40 p.m. The buildings burning in the background are WTC 5 (left) and WTC 6 (right), and the U.S. Post Office is on the left. Floor numbers have been added and intensity levels have been adjusted.

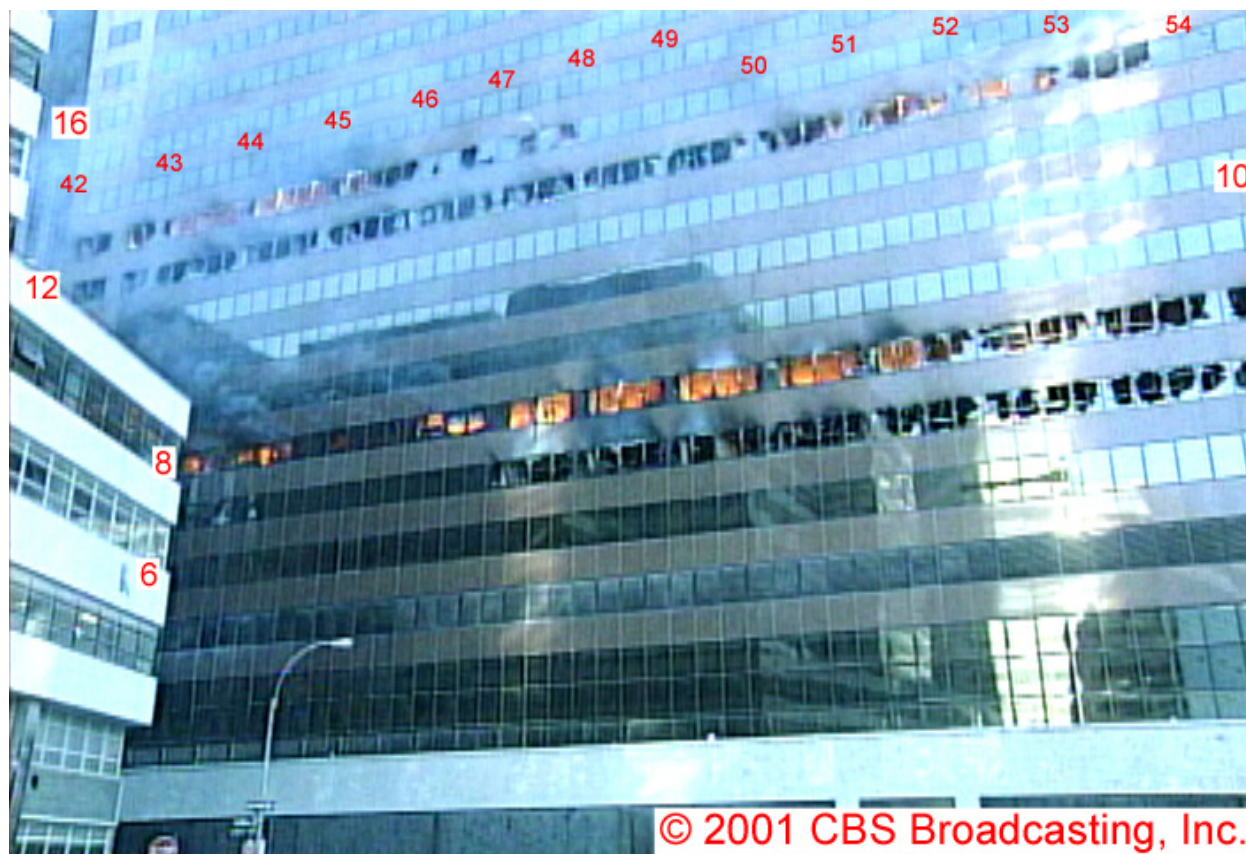
Figure 5-136. Frame taken from a video shot from near the corner of Greenwich Street and Park Place showing the north face of WTC 7 between 3:49 p.m. and 3:54 p.m.

After leaving the lobby of 123 Barclay Street, the news crew moved out onto Greenwich Street, where they filmed the north face of WTC 7 from near the corner of Greenwich Street and Park Place. As before, the exact arrival time is unknown, but an assumed 5 min travel time yields an estimate somewhere between 3:49 p.m. and 3:54 p.m. Figure 5-136 shows a frame extracted from this video clip that provides a good head-on view of much of the 7th, 8th, 12th, and 13th floors. All of the open windows visible on the 7th floor are dark, providing additional confirmation that the fire that had spread as far as window 7-47A died down before covering the entire north face. A couple of the windows near Column 44 appear to have broken glass, but there are no indications of fire in this area.

The appearance of the windows on the 8th floor changed substantially between the times when the video frames shown in Figure 5-134 and Figure 5-136 were taken. At the earlier time, fire was visible as far east as window 8-47A, while in Figure 5-136, fire is not only apparent at the adjacent windows between Columns 46 and 47, but intense flames have appeared much further to the east in windows 43E to 44E. It is possible that the fire is even further to east, but these windows are hidden by the building in the

foreground. Closer inspection shows that the glass in window 8-45B has also broken, and a telltale orange glow reveals that flames are also growing nearby. The west edge of the fire area is in roughly the same location as earlier.

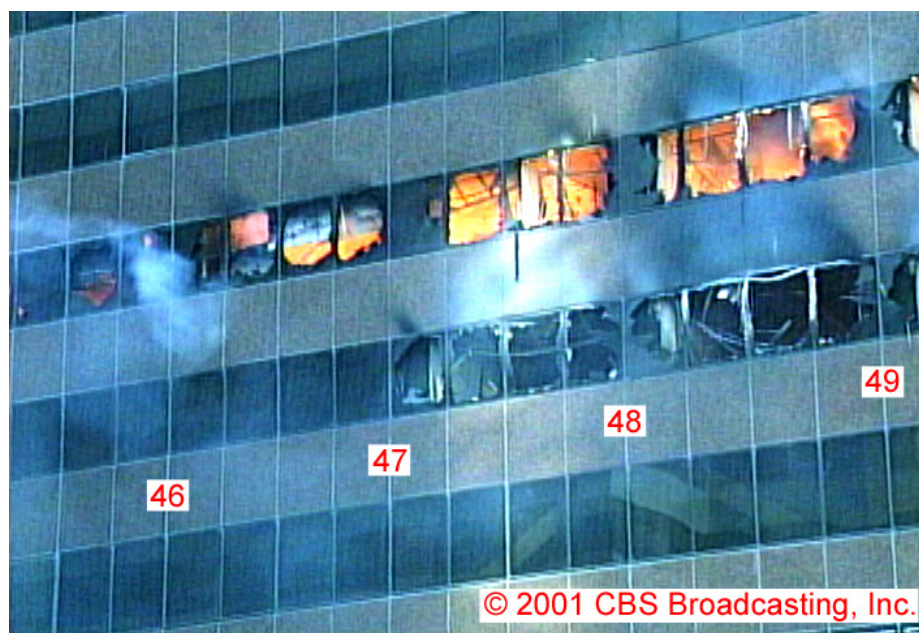
A closer view of the 7th and 8th floors, taken from a video clip recorded shortly after the one from which Figure 5-136 was taken, is shown in Figure 5-137. The frame includes the location on the 7th floor where fire spread had stopped. There appears to be a wall visible through windows 7-47A and 7-47B that terminates at Column 47. If this wall extended far enough inward, it might have stopped the fire as it spread eastward across the north face. The glow through the open windows on the 8th floor reveals the presence of a substantial fire within this area. However, the only actual flames that could be seen were in window 8-48D. Either the flames responsible for the glow were hidden below the window sill or were located further inside the building. It does not appear that the upper portion of the interior space near the windows was filled with flame. It is thus not possible to identify whether this fire was flashed over.

Figure 5-137. Close up of the 6th through 9th floors of the north face of WTC 7 from a video shot between 3:49:30 p.m. and 3:54:30 p.m. near the corner of Greenwich Street and Park Place.

Figure 5-137 provides a good indication of how window glass breakage occurred in this area of the north face. It seems that the glass would first break near the center, leaving a band of glass in the window frame. Later, the remainder of the glass would fall out, leaving a fully open window frame. The column enclosures were located about 6 in. behind the window glass. Even so, they provided some protection for the glass since jagged-edged pieces with widths roughly the same as the enclosed columns often remained in the window frames. A much closer view of this type of breakage is shown in Figure 5-138 for the glass around Column 48 on the 8th floor. This type of glass breakage near columns was widespread, as is evident in Figure 5-136.

Some light smoke is visible coming from open windows on the 8th floor in Figure 5-137, but it is not as dense as would be expected for the amount of fire present. Light blackening of the façade above windows on the 7th and 8th floors suggests that only light smoke had come from the area earlier. Support for the hypothesis that smoke was being vented elsewhere comes from Figure 5-138. Smoke is visible rising upward in windows 8-47B and 8-47D, while flames are visible in 8-47B. Even though this internal smoke is easily seen, the only smoke flowing from the nearby open windows is coming from small flames

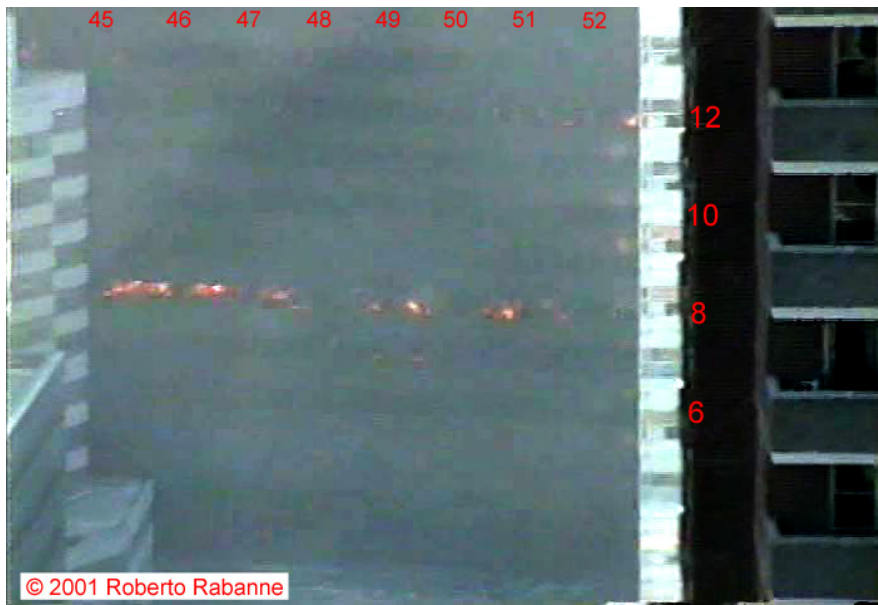
Figure 5–139 shows another view of the WTC 7 north face looking down Greenwich Street from a building to the northwest of WTC 7. The time for this video frame is estimated as 3:54:14 p.m. with an uncertainty of 3.5 min. Comparison with Figure 5–131 indicates that the fire on the 8th floor has moved to the east in the roughly 4 minutes between the two video frames, with an intense fire now visible in windows 8-45a to 8-45e. Note that the time assignment for Figure 5–139 is consistent with the times assigned for Figure 5–136 to Figure 5–138 since window glass was still in place in these windows when those video clips were recorded.

Figure 5–139. This frame from a video shot from a building to the northwest of WTC 7 was taken around 3:54:14 p.m. with an uncertainty of ± 3.5 min.

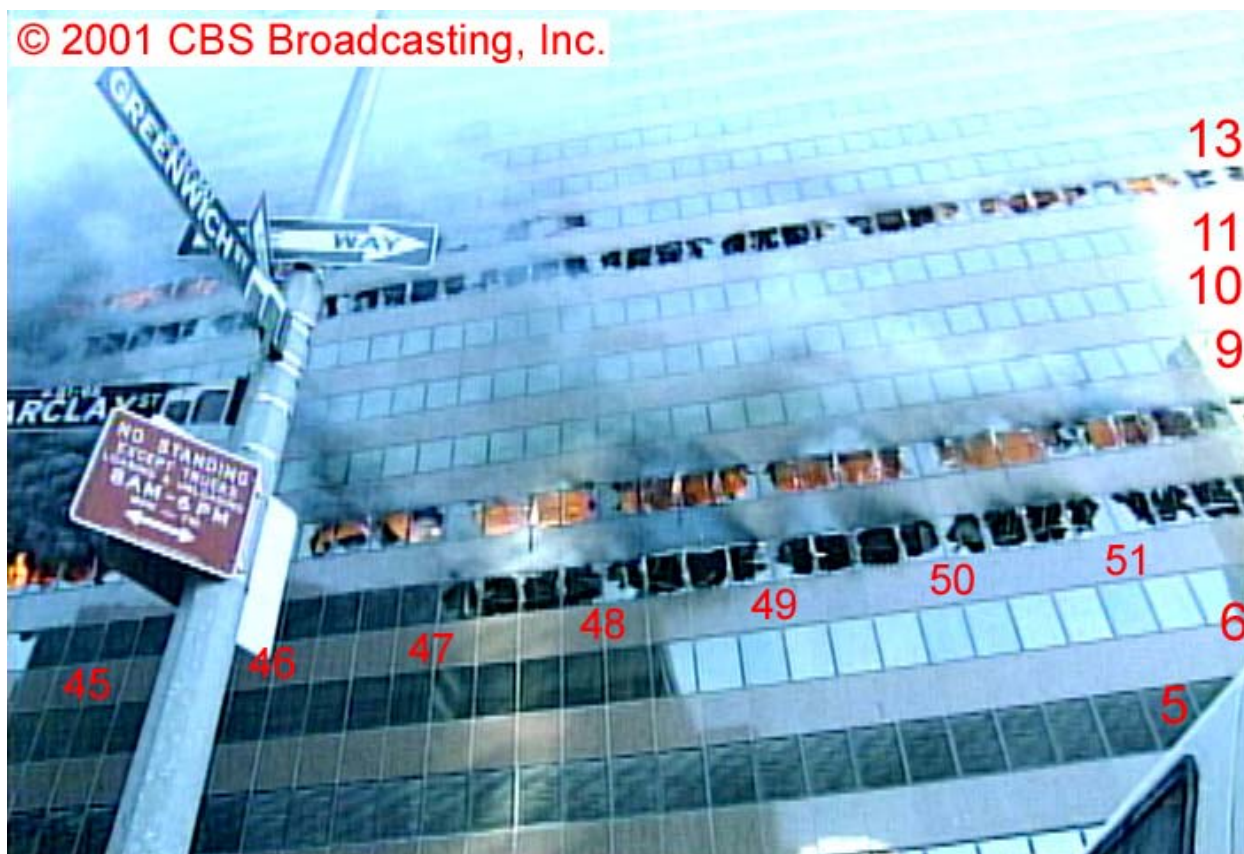
The appearances of the open windows and fires on the face are similar in Figure 5–136 and Figure 5–140, with one major exception. In the later frame, extremely heavy flames and dense smoke are coming from windows 8-44B to 8-44E. This is the first observation of large amounts of effluent flowing from fires on the north side of the 8th floor and suggests that an internal flow pathway to the east or south faces from these windows was not available. This intense fire had grown rapidly, since in the earlier clip only relatively small fires were evident through windows 8-44B and 8-44D, and the glass for window 8-44E, along with window 8-45A, was still in place. Unfortunately, the view of windows 8-45A to 8-45E is

blocked by a street sign. Determining whether or not these windows were open at this time would have allowed the time uncertainty for this clip to be reduced somewhat.

Figure 5–140. Frame taken from a video shot from near the corner of Greenwich and Barclay Streets showing the north face of WTC 7 between 3:51 p.m. and 3:58 p.m.
The intensities have been adjusted, and column and floor numbers have been added.

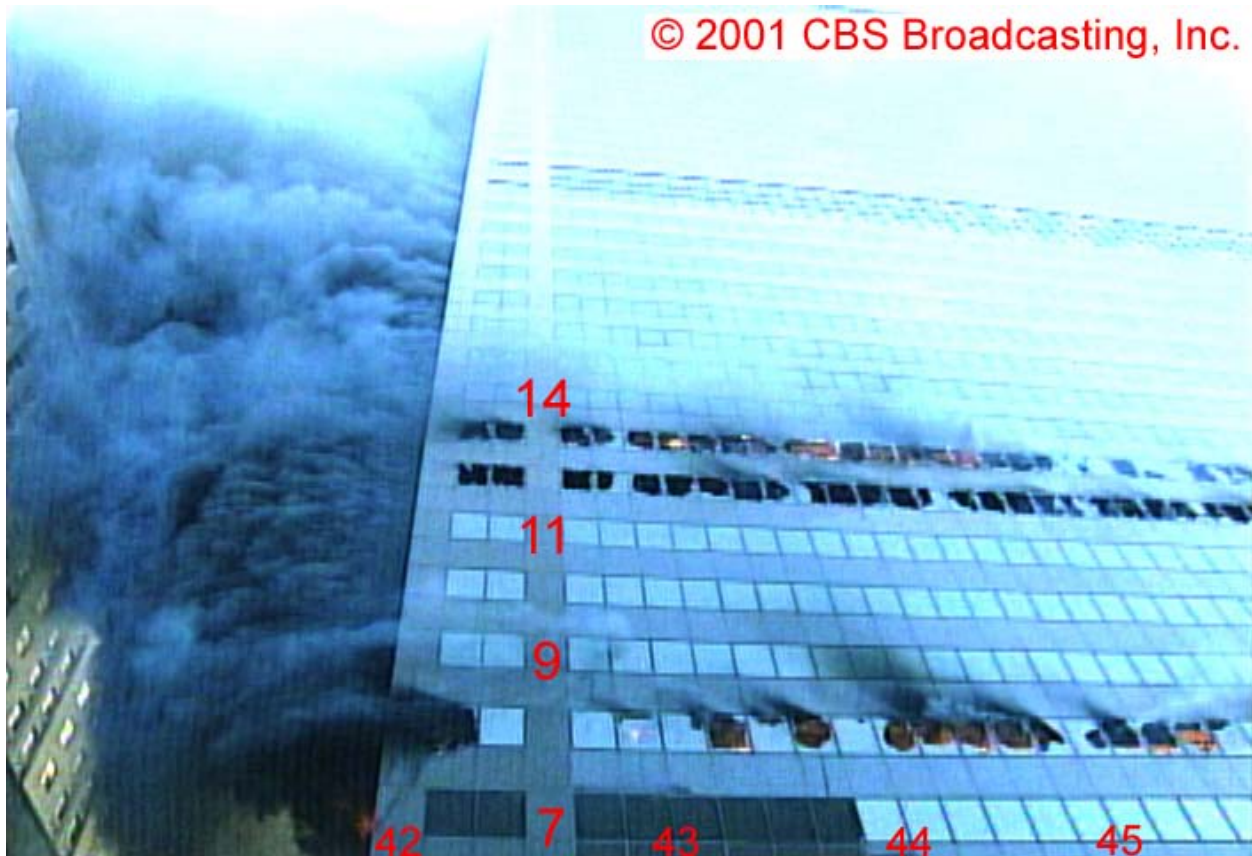
Figure 5–141. Frame from a video shot from near the corner of West Broadway and Barclay Street showing the eastern side of the north face of WTC 7 between 3:53 p.m. and 4:02 p.m.

The fire spreading to the east on the 8th floor had apparently reached the east face by the time Figure 5–141 was recorded. Multiple window panes are broken, heavy fire is visible between Columns 43 and 44, and window 8-42D is open at the top with flames visible through the remaining glass. A small flame has also appeared on the east face, indicating windows were beginning to break on this side of the 8th floor. Within a few seconds this small flame grew much more intense.

Flames are also visible on the 13th floor in Figure 5–141. Review of the video clips indicated that flames were periodically observed from window 13-42C to window 13-45C. Only light smoke is coming from the open windows on the north side of this floor. As observed earlier, there is no indication of fires burning on the east side of the 12th floor at this time. Elsewhere, window glass on the east side of the north face on the 7th floor, 9th through 11th floors, and above the 13th floor is intact.

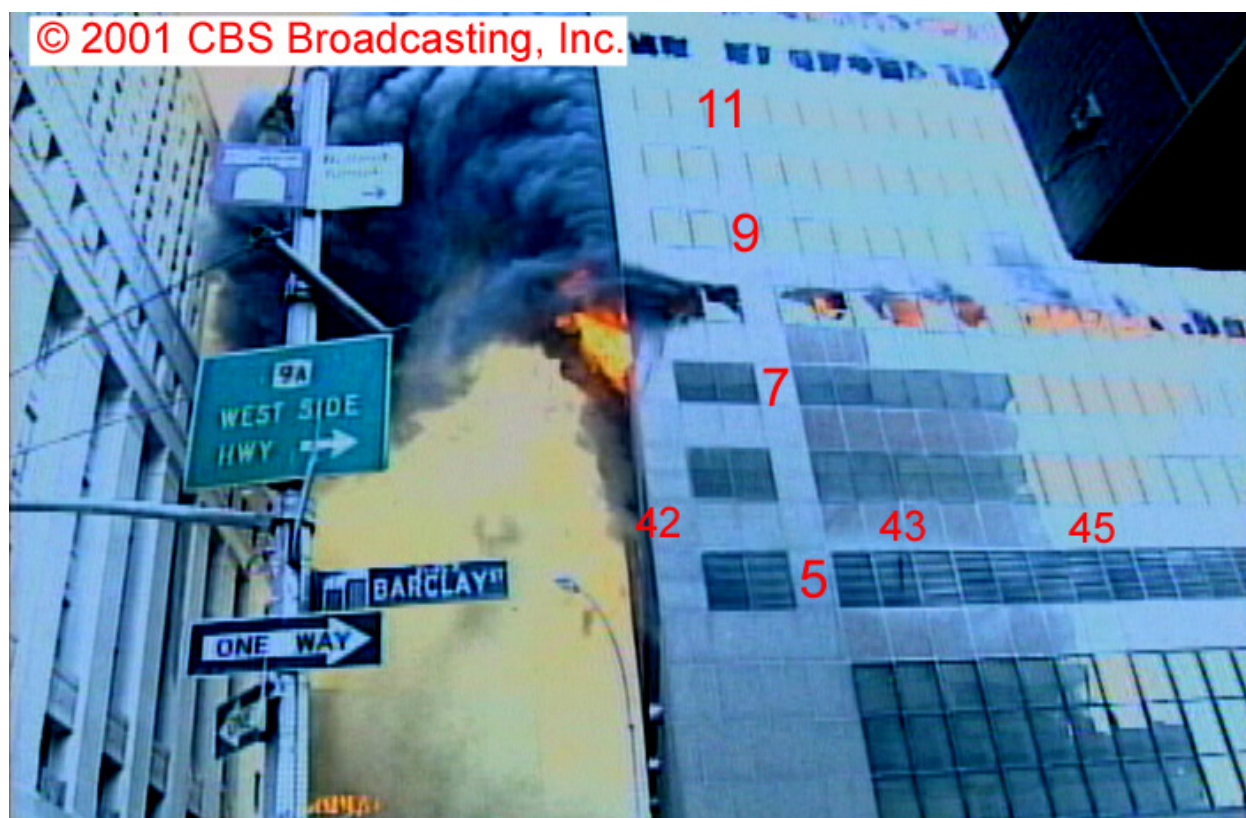
Another frame from a video clip recorded roughly 2 min later showing the lower northeast corner of WTC 7 is reproduced in Figure 5–142. The changes on the north side of the 8th floor were substantial over this short period. Additional windows have opened near the eastern edge, and the fires have grown substantially in intensity. While not readily apparent in Figure 5–142, flames were visible in window 8-42A during the short video clip.

Figure 5–142. Frame taken from a video shot near the corner of West Broadway and Barclay Street showing the lower northeast corner of WTC 7 between 3:55 p.m. and 4:04 p.m.

Some of the more interesting observations from Figure 5–142 are on the east face. Very intense flames were coming from multiple windows on the 8th floor at this time. A close-up of these flames, taken from a video clip recorded about a minute later is shown in Figure 5–143. Note that additional glass has broken out of window 8-42C during the short period between the two frames. Comparison of the flames near the northeast corner on the north and east faces provides a vivid demonstration of the different burning behaviors on these two faces. On the north face, the flames are mostly inside the windows, which was generally true for fires observed on this face, while very intense external burning, similar to that observed on the east side of the 12th floor much earlier, is taking place on the east face. These observations provide additional evidence that pressure differences generated by the ambient wind affected the local fire behaviors observed on different faces.

Closer inspection of Figure 5–142 reveals what appears to be a relatively light plume of white smoke rising from near the top of the louvers that spanned the 5th and 6th floors on the east face. It was not possible to identify the exact location of the plume relative to the edge of the building. At a minimum, the presence of this plume suggests that smoke had been transported to the 5th or 6th floors before being vented. It is also possible that the source of the smoke was a fire burning somewhere on these two floors. The available imagery does not provide evidence indicating which of these two alternatives is correct.

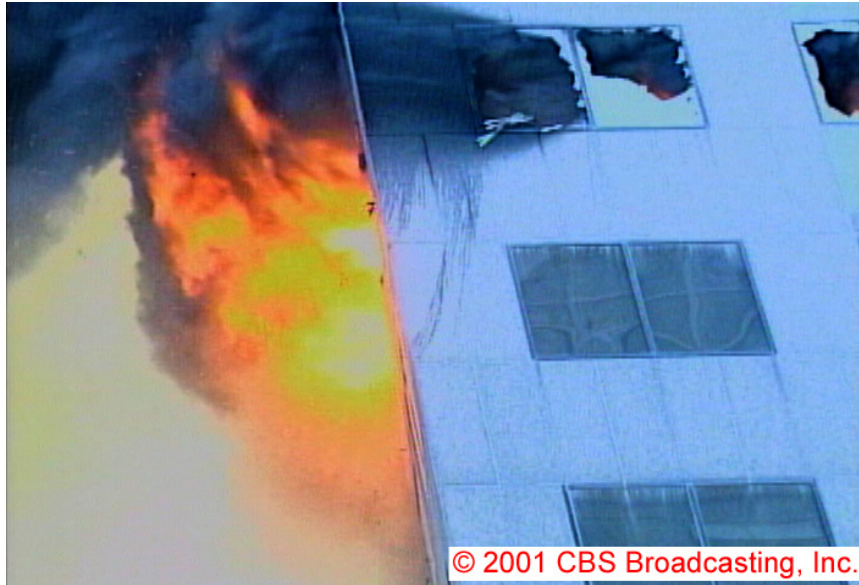
Figure 5-143. Frame from a video shot near the corner of West Broadway and Barclay Street showing a close up of the northeast corner of WTC 7 at the 8th floor between 3:56 p.m. and 4:05 p.m.
