**Federal Building and Fire Safety Investigation of the
World Trade Center Disaster**

**Structural Fire Response and
Probable Collapse Sequence of
World Trade Center Building 7**

VOLUME 1

November 2008

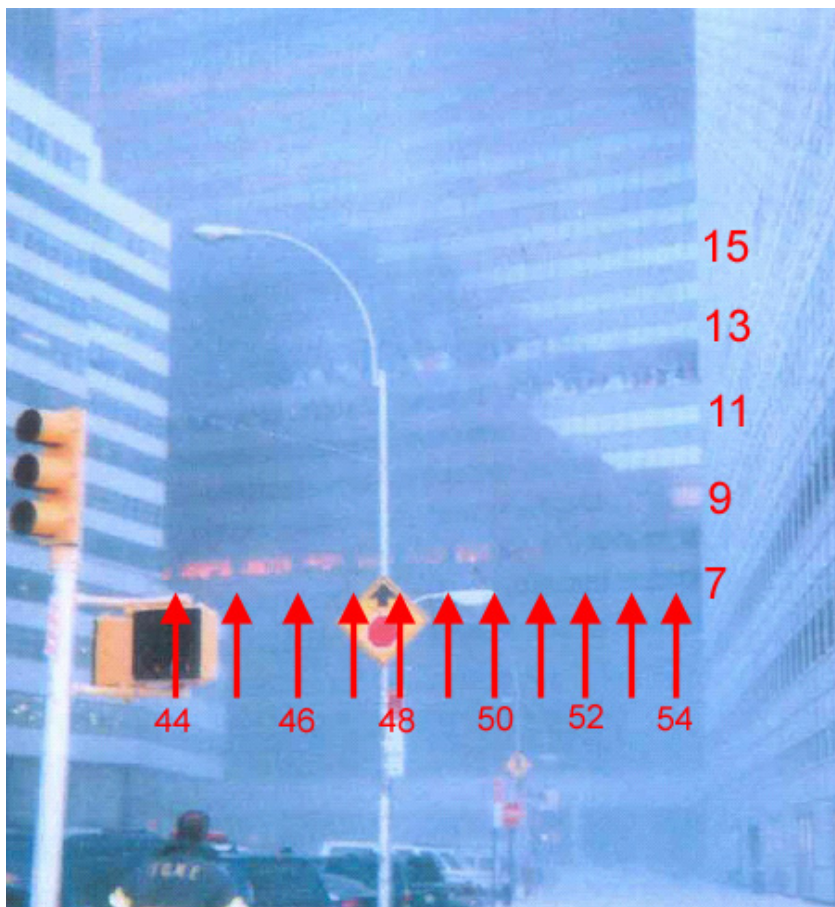
Figure 5-144 shows another view of the north face of WTC 7 taken looking down Greenwich Street from a location near its corner with Murray Street. The time of this photograph could not be determined, but comparison of the fire distributions with Figure 5-139 indicates that it was likely taken around 3:55 pm.

Figure 5-144. Cropped photograph showing the north face of WTC 7, shot from near the corner of Murray and Greenwich Streets near 3:55 p.m.

On the 12th floor, windows 12-53D, 12-54A, and 12-54B were opened between the times when Figure 5-136 and Figure 5-144 were taken. Recall that at the earlier time, flames had been observed further to the west. Apparently, the burning was filling in offices that the fire had previously bypassed. Only light burning is apparent in the immediate vicinity. On the 13th floor, windows appear to be open as far west as Column 50 in Figure 5-144, with flames visible to the west of Column 48. In Figure 5-136, the open windows only extended as far west as Column 48. Clearly, the fire on this floor was continuing to spread to the west.

The fire on the 13th floor has burned westward as far as Column 55. In Figure 5–144, which was estimated to have been taken around 3:55 p.m., flames were observed as far west as Column 50. This fire was continuing to work its way to the west. There are no indications of fire burning in this area on floors higher than the 13th floor. In the video clip, some light smoke was visible blowing across the north face, but there was apparently little smoke coming from the open windows on the 12th and 13th floors, consistent with earlier observations that the effluent for fires on these floor vented at remote locations on other faces.

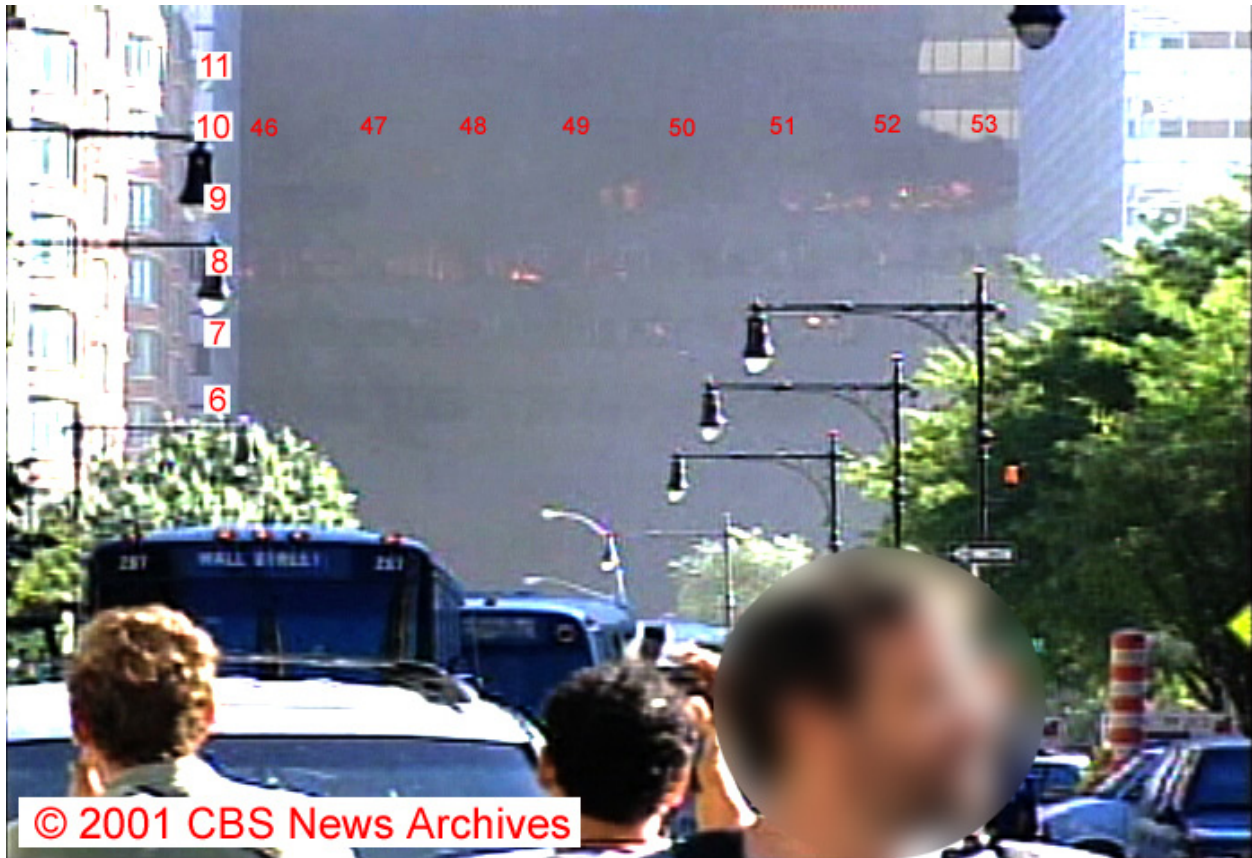
A frame from a video clip taken from a location much further north on Greenwich Street than the view in Figure 5-144 is reproduced in Figure 5-145. The fire distribution indicates the clip was taken later than the photograph in Figure 5-144. Relatively low intensity flames are visible on the 8th floor from window 8-45E to window 8-49B. In Figure 5-144, the flames were in general more intense and extended to window 8-50D. Since fully developed fires typically burn intensely for about 20 min, it is likely that the time between the two images was less than 20 min. Assuming a 15 min difference yields an estimated time of 4:10 p.m. with at least a 5 min uncertainty.

The most dramatic change in the fire distributions between the two images is on the 9th floor. In the earlier image, there was evidence of a fire growing in windows 9-54A and 9-54B. In the later image, flames and heavy smoke are visible between windows 9-51A and 9-53B. In the video clip and others recorded around the same time, it can be seen that significant external burning was taking place. Such burning was not typical of most locations on the north face. This observation not only suggests that the fire had flashed over at this location, but also that there was no internal path available within WTC 7 for the fire effluent to vent on the east or south faces. In Figure 5-145, isolated flames have reached as far east as windows 9-49B and 9-49C, indicating that the fire was spreading from west to east.

Small isolated flames are evident at several locations on the 7th floor in Figure 5-145. This is somewhat surprising since the fires on this floor had stopped spreading and died down much earlier. There is still no indications that fire has spread to the east beyond Column 47. No fires or broken windows are apparent on the 6th, 10th, and 11th floors.

Figure 5–145. Frame taken from a video clip shot from near the corner of Greenwich and Jay Streets around 4:10 p.m. ± 5 min.

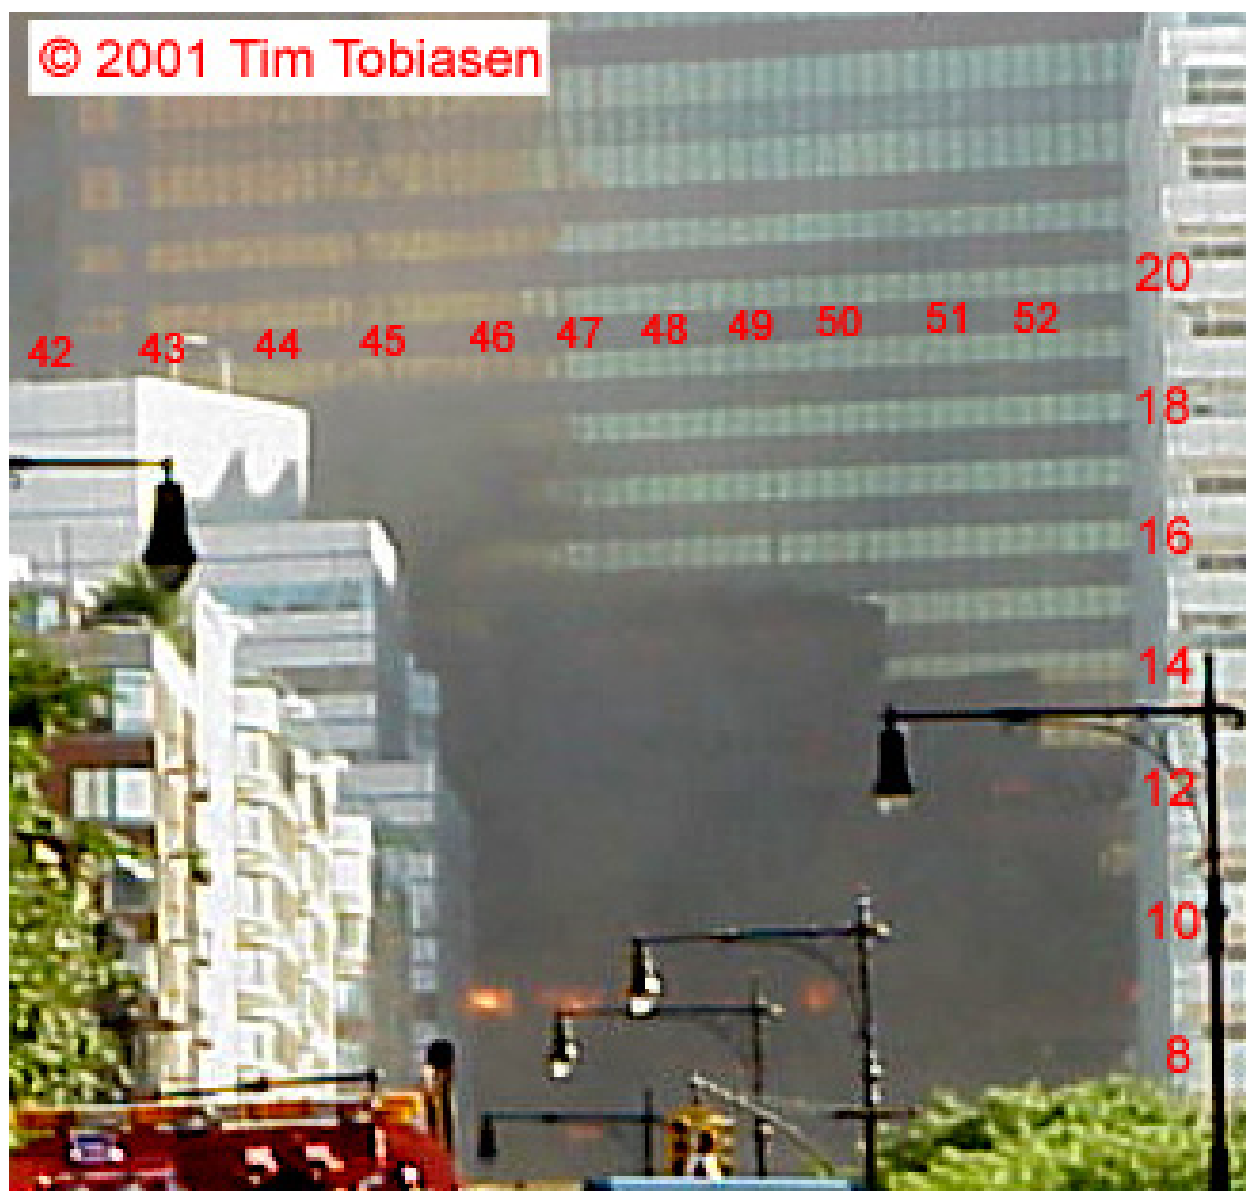
The north face of WTC 7 can be seen in the photograph reproduced in Figure 5-146. The time for this image could not be accurately determined, but it was clearly taken after the video frame shown in Figure 5-145. Even though the video was taken from a long distance, it provides useful information about the fire distributions. The most intense fires are on the 9th floor. Flames can be seen on this floor at both ends of the visible length running from window 9-45C to 9-52D. Continuous flames are present between Columns 45 and 50. Apparently, the fire observed between Columns 49 and 50 in Figure 5-145 grew and spread rapidly to the east. Interestingly, there is still no sign of fire between Columns 50 and 51. This may be an indication that there was a room in that location that had not yet been breached by the fire. As seen earlier, heavy smoke is rising from the fire on this floor.

Low intensity flames continue to burn on the 8th floor between Columns 47 and 49. Similar flames are also visible on the 12th floor between Columns 51 and 52. In Figure 5–145 it appeared that some of the glass was still in place for some of these windows. This seems to be no longer the case in Figure 5–146.

The amount of fire spread and growth between the times when the images in Figure 5–145 and Figure 5–146 were taken would be expected to require many minutes. Assuming a period of 10 min yields a crude estimate of 4:20 p.m. for the timing of Figure 5–146.

Close inspection of Figure 5–146 reveals that there is an area of flame on the 7th floor between Columns 46 and 47. After a long period of inactivity, fire has clearly made its way to the other side of the obstacle that had earlier halted its spread across the face. Note that there is no indication of how fire arrived at this location. It could have spread from the west, south, or east.

Figure 5–146. Cropped photograph showing the north face of WTC 7 from near the corner of Greenwich and Harrison Streets at a roughly estimated time of 4:20 p.m.
The intensities have been adjusted, and column and floor numbers have been added.

In Figure 5-146, intense fires were visible on the 7th and 9th floors in the same windows visible in the video around 4:38 p.m. A less intense fire was also present on the 8th floor. All of these fires had died down significantly by the time Figure 5-148 was recorded roughly 25 min later. Since the typical intense flaming peak for most of the fires observed in WTC 7 lasted about 20 min, it seems safe to conclude that the photograph shown in Figure 5-146 could not have been taken later than 4:28 p.m., consistent with the estimate of 4:20 p.m. for the earlier image.

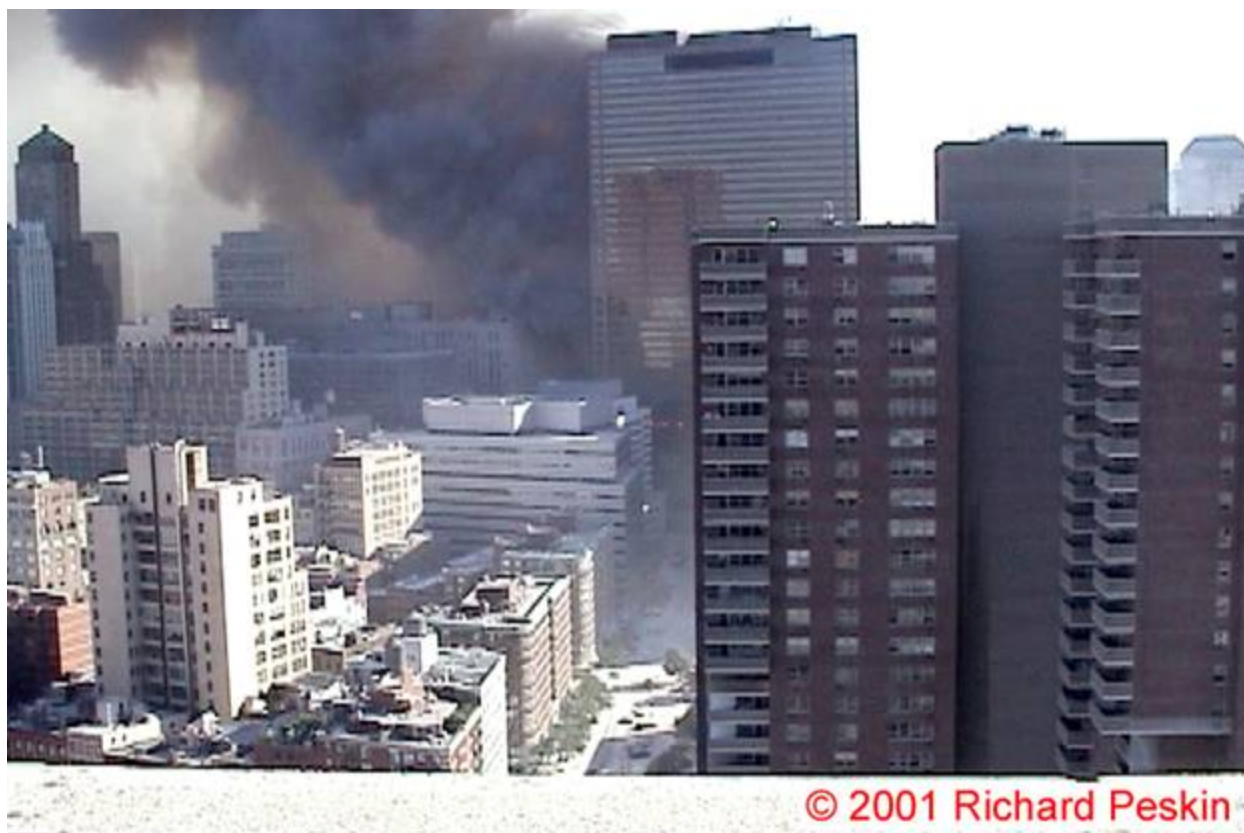
Figure 5–147 provides a view of the north face of WTC 7. The image is a frame taken from a digital video that was accurately timed. This frame was recorded just before 4:38 p.m. Even from the long distance from which the video was filmed, it is possible to see a heavy fire burning on one of the floors. Little or no smoke is evident on the north face, but dense black smoke is rising from the east face. This appears to be another example of fires burning on the north face exhausting through openings on a different face of the building.

Figure 5-147. Frame from a video clip shot from the top of a nearby building to the northwest, providing a view of the north face of WTC 7 at 4:37:46 p.m. \pm 1 s.

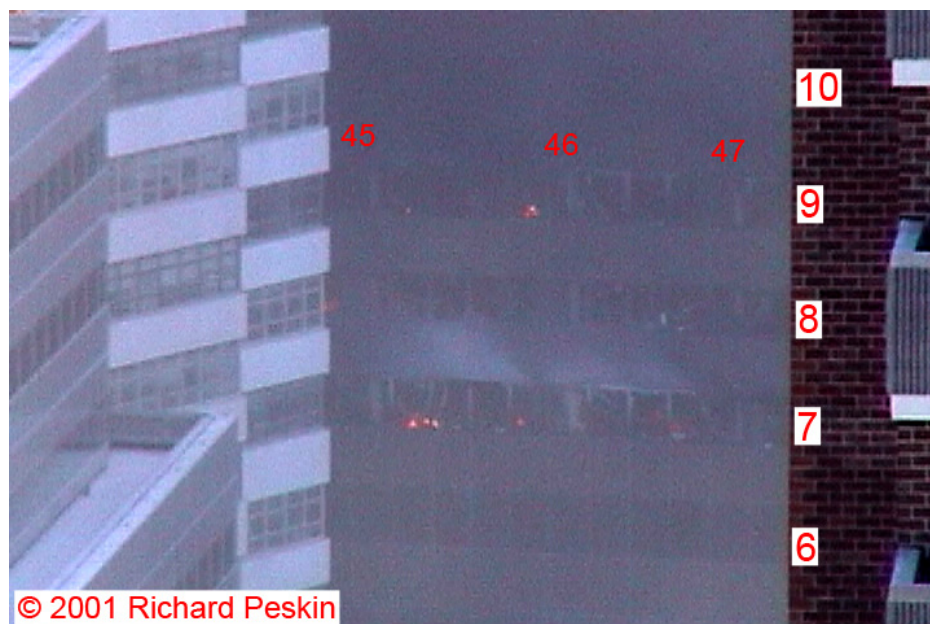
The videographer zoomed in on the north face of WTC 7 during the same clip from which the frame in Figure 5-147 was taken. Figure 5-148 and Figure 5-149 are two spatially overlapping close-up frames that, taken together, show portions of the 6th through 14th floors just after 4:38 p.m. In Figure 5-149, the visible lengths of the floor extend from just east of Column 45 to just west of Column 47. All of the visible windows on the 7th, 8th, and 9th floors were open at this time, while all of the windows on the 6th and 10th floors still had glass in place. Small spot fires are visible at numerous locations on the three floors with open windows.

Figure 5-148. Frame from a video clip showing a close up view of the north face of WTC 7 at 4:38:11 p.m. \pm 1 s. The video was shot from the same location as the frame in Figure 5-147. The image intensities were adjusted, and column and floor number have been added.

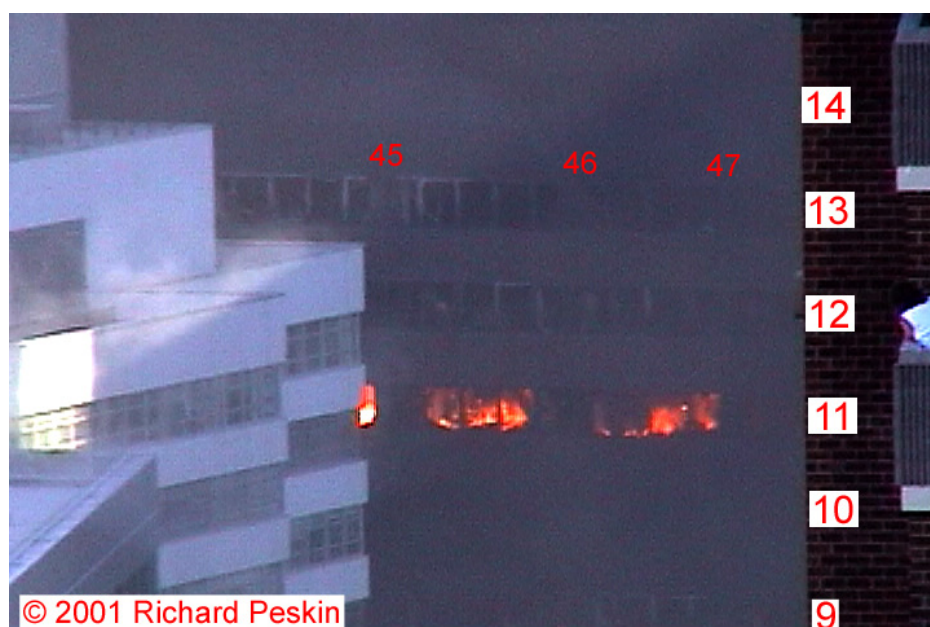
Figure 5-149. Frame from a video clip showing a close up view of the north face of WTC 7 at 4:38:14 p.m. \pm 1 s. The video was shot from the same location as the frame in Figure 5-147. The image intensities were adjusted, and column and floor number have been added.

Figure 5-149 shows the visible portions of the 9th to 14th floors. The most prominent feature is the extensive fire present on the 11th floor between windows 11-44E and 11-46D. A dull red glow is visible through window 11-47A. This image provides the earliest evidence that the fire on this floor had reached the north face. There was no sign of a fire on this face in earlier images. Recall that a growing fire was observed on the east side of this floor as early as 2:08 p.m. It is remarkable that nearly two and a half hours were required for fire to finally appear on the north side. Even though there is substantial fire present on the floor, no smoke is visible coming from the open windows. This is another example where the fires were venting elsewhere.

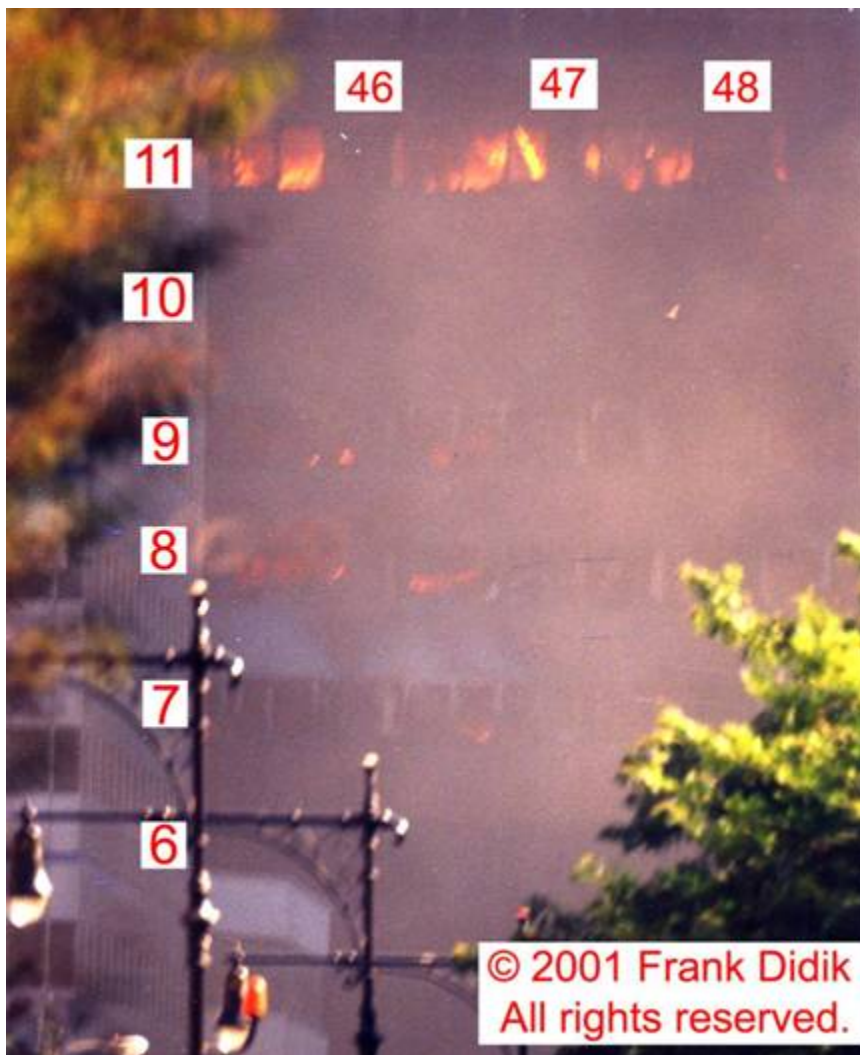
Another partial view of the north face taken from street level at nearly the same time as Figure 5–148 and Figure 5–149 is shown in Figure 5–150. The photograph was shot on film, so a precise time could not be assigned. However, the same photographer shot an accurately timed digital photograph from nearly the same location at 4:39:19 p.m. The time for the film picture was therefore assigned as 4:39 p.m. with an uncertainty of ± 2 min. In Figure 5–149, the intense fire on the 11th floor did not extend beyond Column 47, while in Figure 5–150 it appears to have moved beyond Column 48, suggesting that the photograph may actually have been shot after the video frames.

More flames are evident on the 7th, 8th, and 9th floors in the ground-level photograph than in the video frames shot looking down on the face. In Figure 5–150, the flames on these floors appear to be reddish and to be well removed from the windows. It is possible that these fires were actually so deep inside the building that they were hidden from the view looking down through the windows. As before, there are no indications of burning on the 10th floor in Figure 5–150.

Figure 5–150. Cropped photograph showing part of the north face of WTC 7, shot from near the corner of Harrison and Greenwich Streets at 4:39 p.m. ± 120 s.

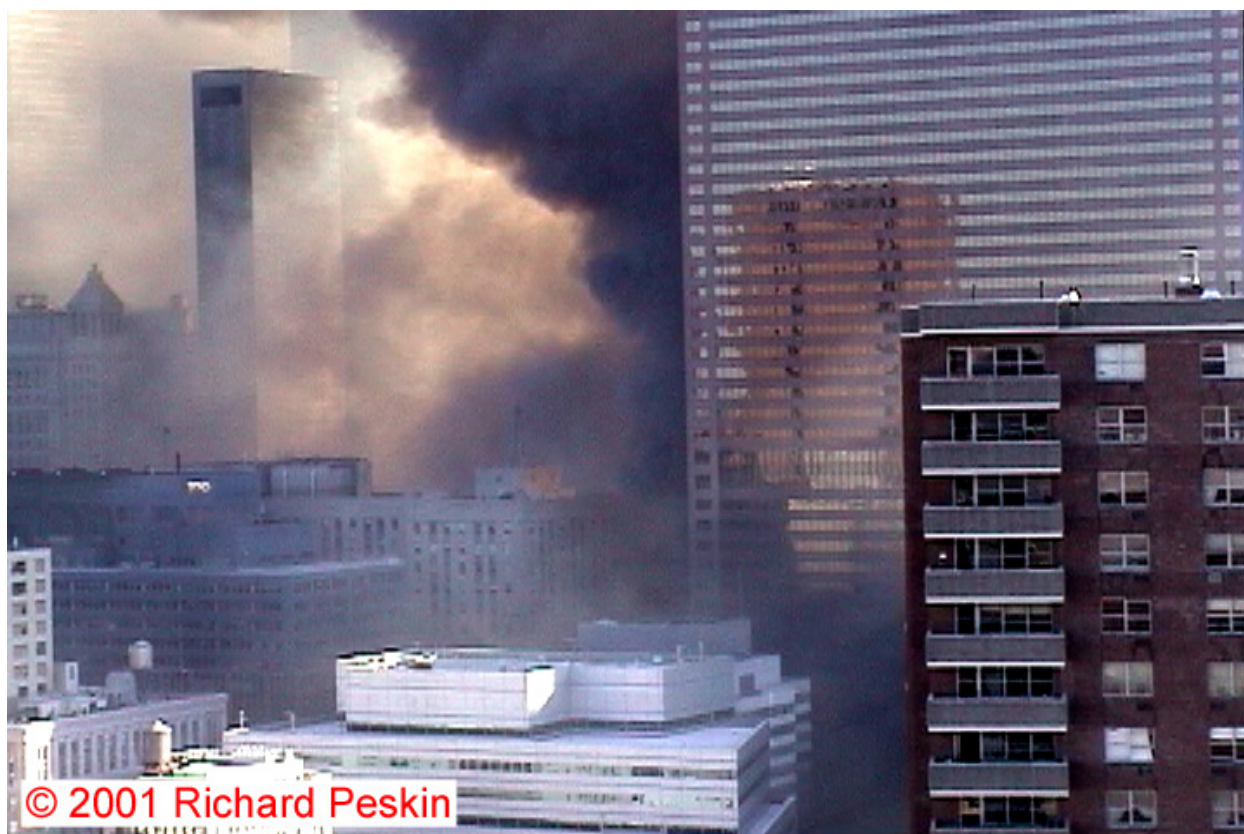
After roughly 4:40 p.m., imagery in the Investigation database showing the north face of WTC 7 is more limited. Figure 5–151 shows a long distance shot of the north face of WTC 7 taken at 4:52:24 p.m. from the same vantage point as Figure 5–147. In the video clip it can be seen that smoke is passing across the lower part of the north face. Unlike Figure 5–147, there is no fire visible on the north face from this distance. It seems the fires on the 11th floor have died down, but it is possible that fire was present, but hidden by the smoke. Heavy, dark smoke is still visible rising from the east face of the building.

Figure 5–151. Frame from a video clip shot from the top of a nearby building, showing the north face of WTC 7 at 4:52:24 p.m. \pm 1 s.

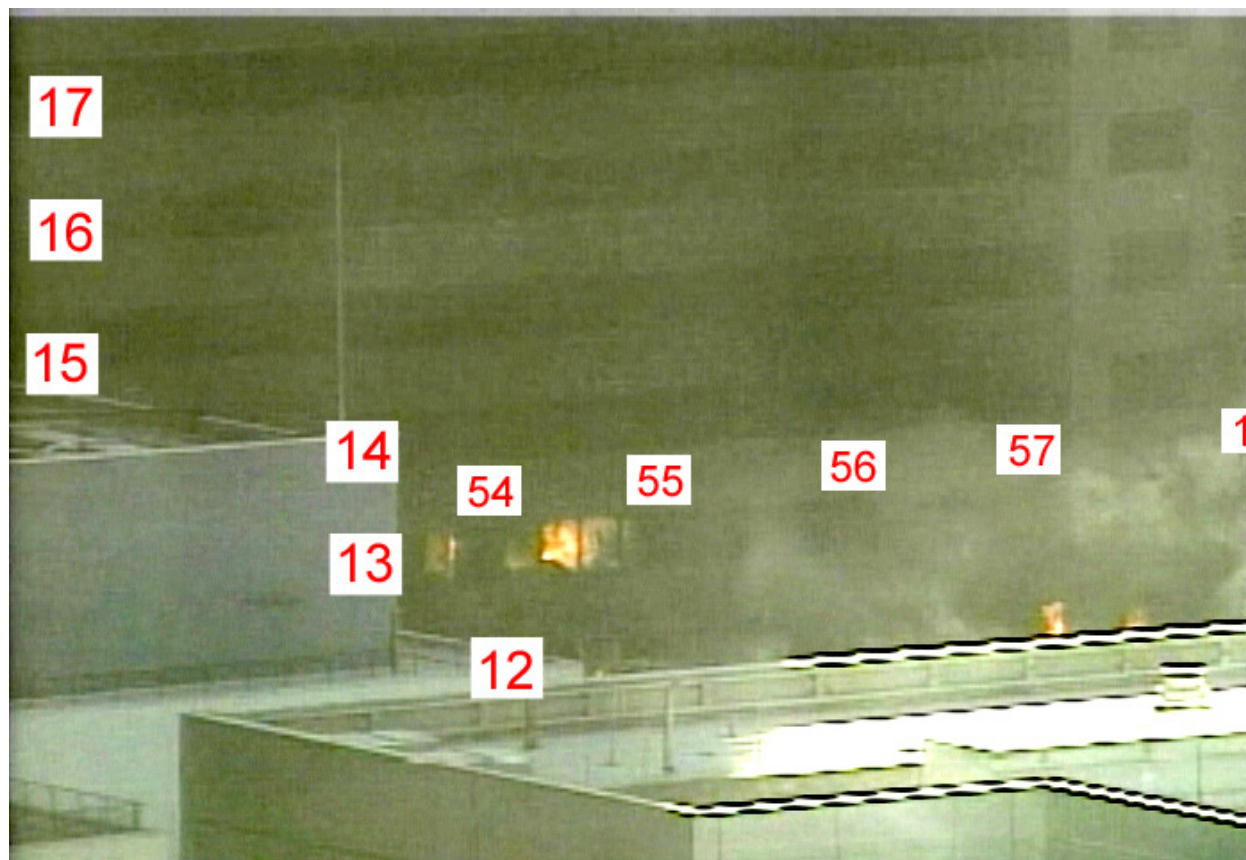
Figure 5–152 shows a limited view of the north face shot from the northeast over the tops of the two buildings to the north of WTC 7. The time was crudely estimated as being around 5:00 p.m. based on the pattern of sunlight and shadow on the building to the immediate north of WTC 7. Only the 12th to 17th floors are visible. Fires are burning on the 12th and 13th floors. On the 12th floor, the fires that were slowly spreading across the north face to the west have reached the northwest corner, with flames barely visible in windows 12-57A and 12-57B. Recall that fire was observed between Columns 55 and 56 around 4:00 p.m. At 2:00 p.m., the 12th floor was burning near the southeast corner. Apparently it took roughly three hours for fire to spread all of the way from the southeast corner to the northwest corner.

Figure 5–152. Frame taken from a video clip shot over the buildings at 30 West Broadway and 70 Murray Street, showing the western edge of the north face of WTC 7 at about 5:00 p.m.

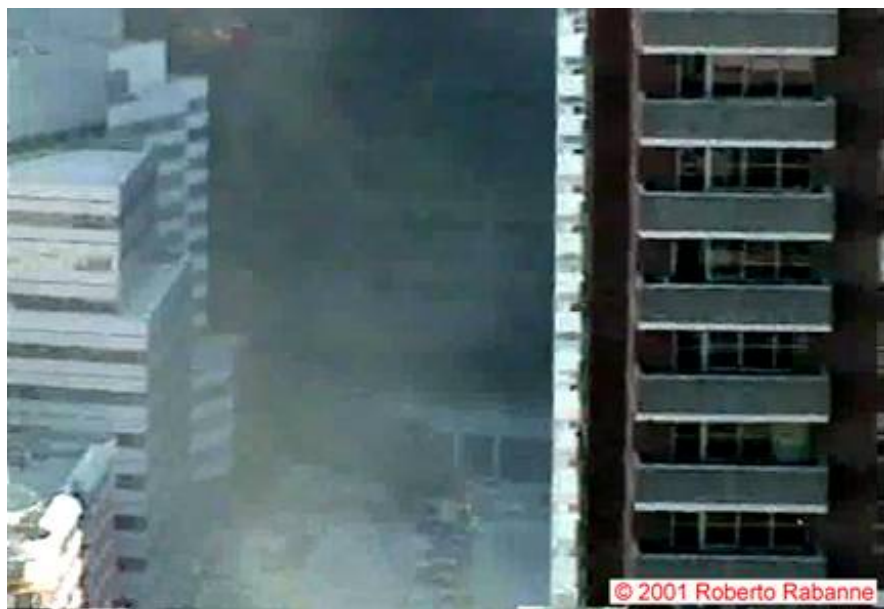
Figure 5–153 shows a view of the north face of WTC 7 looking down Greenwich Street at 5:03:00 pm. ± 2 min. The image is from a digitized video converted from film and is noisy. For this reason, column and floor numbers have not been added. Nonetheless, by comparison with Figure 5–139, which was shot from roughly the same location, some details concerning the fires can be discerned. Flames are only visible at one location on the face, namely near the top of the frame on the left side near the building at 30 West Broadway. Reference to Figure 5–139 suggests that this location is on the 14th floor between Columns 45 and 46. If correct, this represents the first and only visual indication of a fire on this floor.

Figure 5-153. This frame from a video shot from a building to the northwest of WTC 7 was taken around 5:03:00 p.m. with an uncertainty of ± 120 s.

Light smoke is apparent, moving across the face from west to east in Figure 5-153. From the video, it is clear that this smoke is rising from the street just in front of WTC 7. In the figure flames are barely visible on a vehicle parked near the center of the building on Barclay Street. There is no indication of when or how this vehicle was ignited.

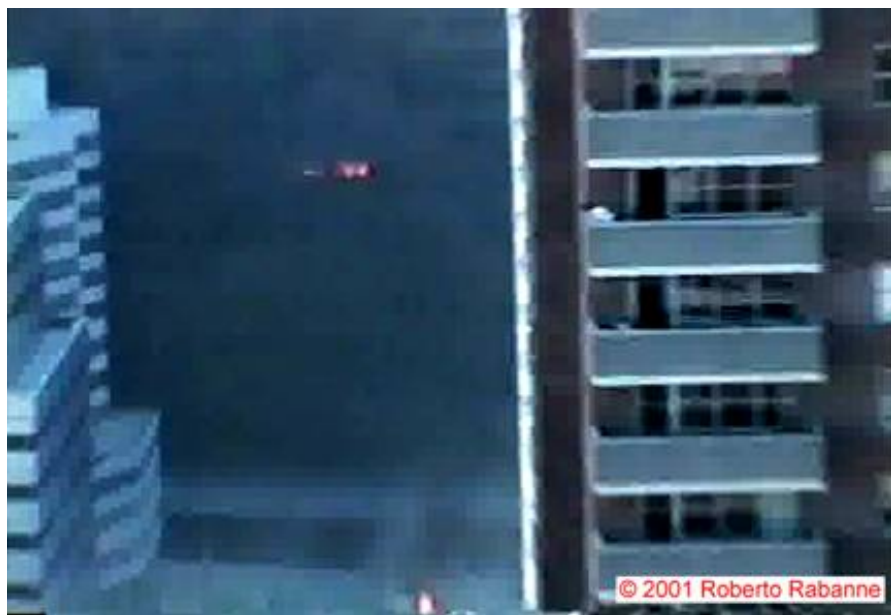
Another frame from the same video as Figure 5-153 is shown in Figure 5-154. This view is somewhat clearer. It was shot from roughly the same location at 5:09:03 ± 120 s., or roughly 6 min later. In this image the fire present at the upper left-hand corner is no longer apparent, but a fairly intense fire has appeared further down on the face near the center of the visible area. Comparison with Figure 5-139 suggests this fire was located on the 11th floor near Column 49. This location is just to the west of windows where fire was observed on the same floor in Figure 5-150 at 4:39 p.m. Apparently the fire on this floor paused briefly before continuing its movement to the west. Smoke can still be seen rising from the vehicle fire on the street below the face.

Figure 5-154. This frame from a video shot from a building to the northwest of WTC 7 was taken around 5:09:03 p.m. with an uncertainty of ± 120 s. The intensities have been adjusted.

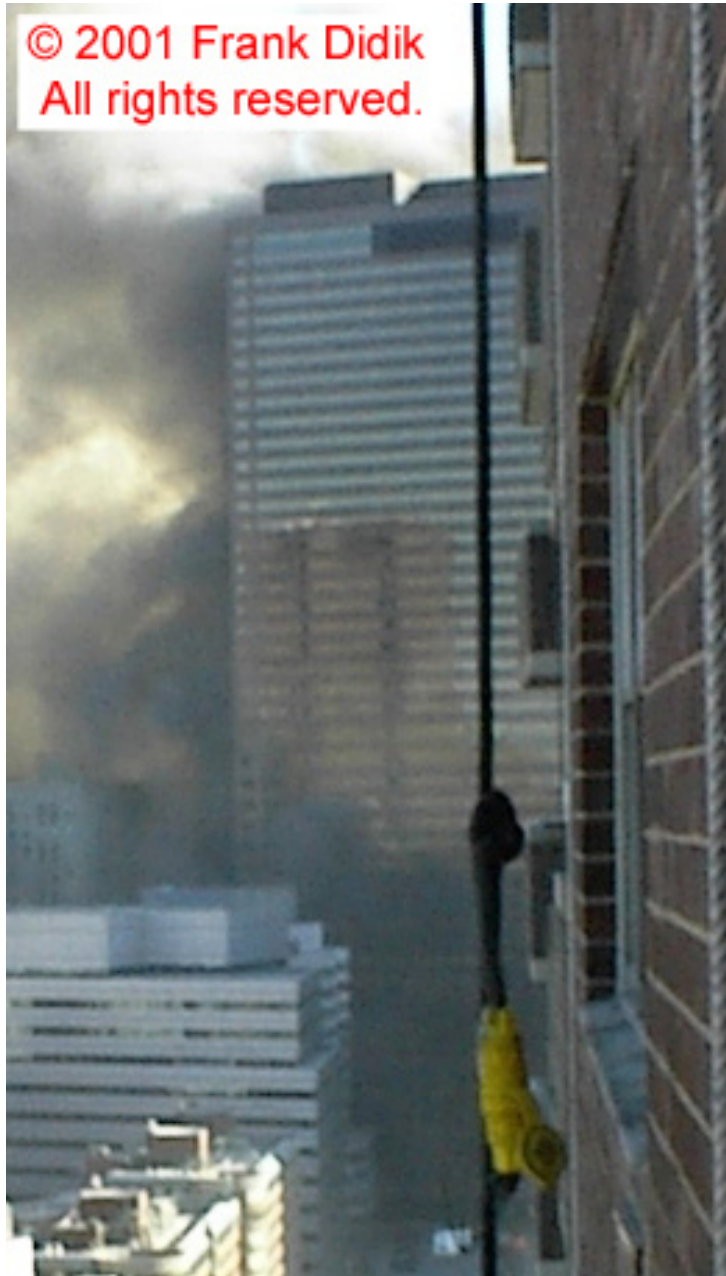
Figure 5–155. Cropped photograph of the north face of WTC 7, taken from a building located to the northwest looking down Greenwich Street at 5:13:58 p.m. \pm 3 s.

A long distance partial view of the north face of WTC 7 shot at 5:13:58 p.m. is shown in Figure 5–155. No flames are visible except on the street at the base of the north face. While some smoke is visible passing over the north face, it is possible to discern the alternating granite spandrel covers and windows on the lower floors. This suggests that no major fires were present over the visible width of the floors. Smoke is still visible rising from the east face, but comparison with earlier similar views indicates that the smoke flow had decreased markedly.

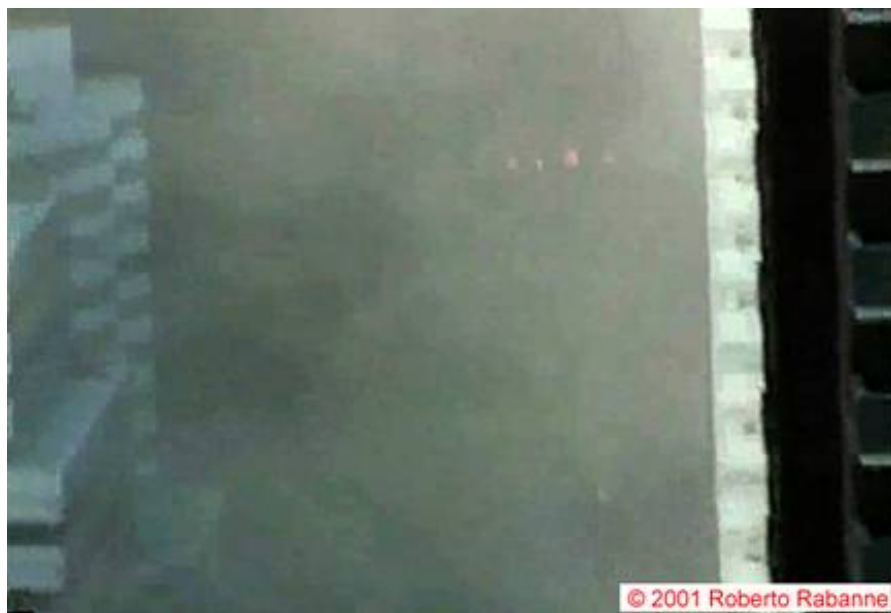
Figure 5–156 shows a frame taken from a video shot at 5:19:45 \pm 2 min from roughly the same location as Figure 5–154. Even though the north face appears to be partially obscured by smoke or dust, fires are evident in multiple windows on the right side of the visible part of the north face. Comparison with

Figure 5–156. This frame from a video shot from a building to the northwest of WTC 7 was taken around 5:19:45 p.m. with an uncertainty of ± 120 s. The intensities have been adjusted.

Figure 5–139 indicates these windows lie around Columns 50 and 51 on the 11th floor. In the roughly 11 min between Figure 5–154 and Figure 5–156, the fires on this floor have continued to spread toward the west.

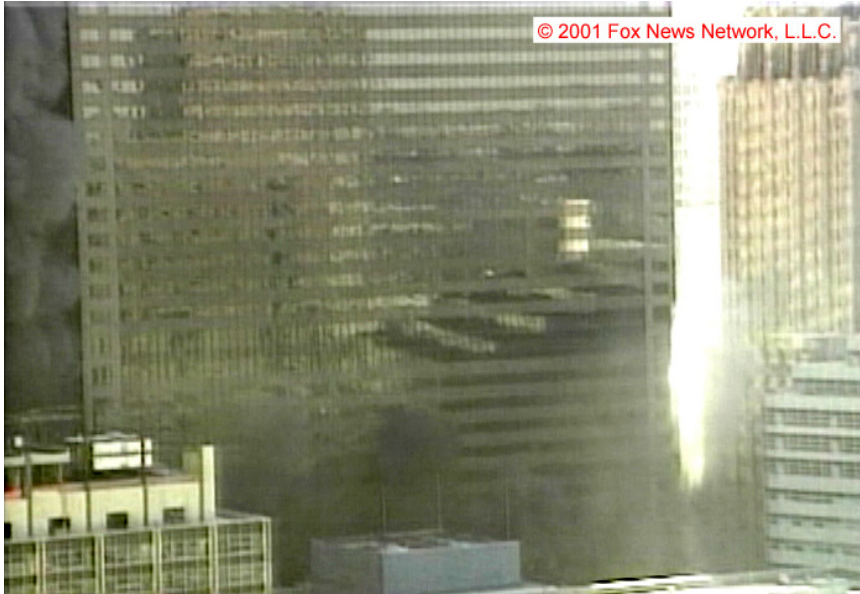
Figure 5–157. Frame taken from a video clip shot from the northeast, showing the north face of WTC 7 within a few minutes of the WTC 7 collapse at 5:20:52 p.m. The intensity levels have been adjusted.

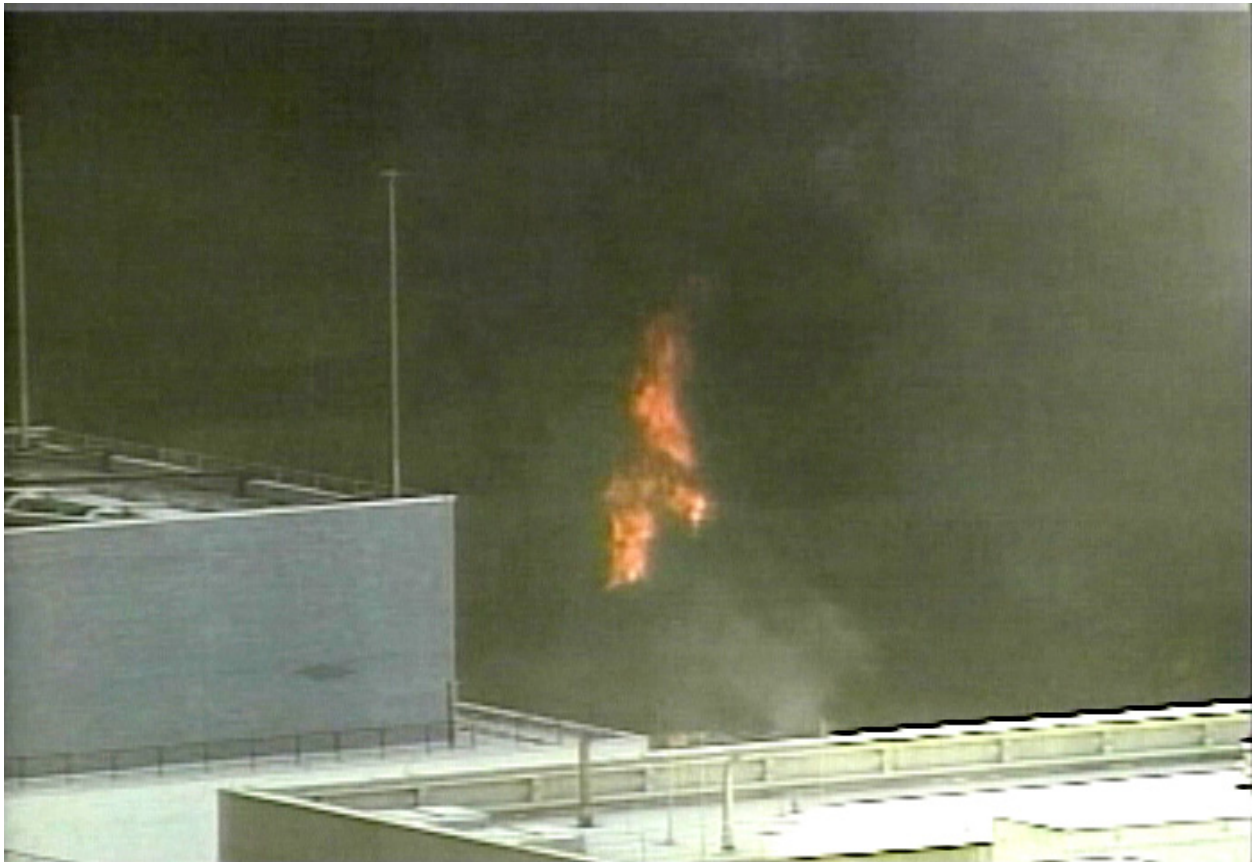
Figure 5–158. Frame taken from a video clip shot over the buildings at 30 West Broadway and 70 Murray Street, showing the western edge of the north face of WTC 7 within a few minutes of the WTC 7 collapse at 5:20:52 p.m.

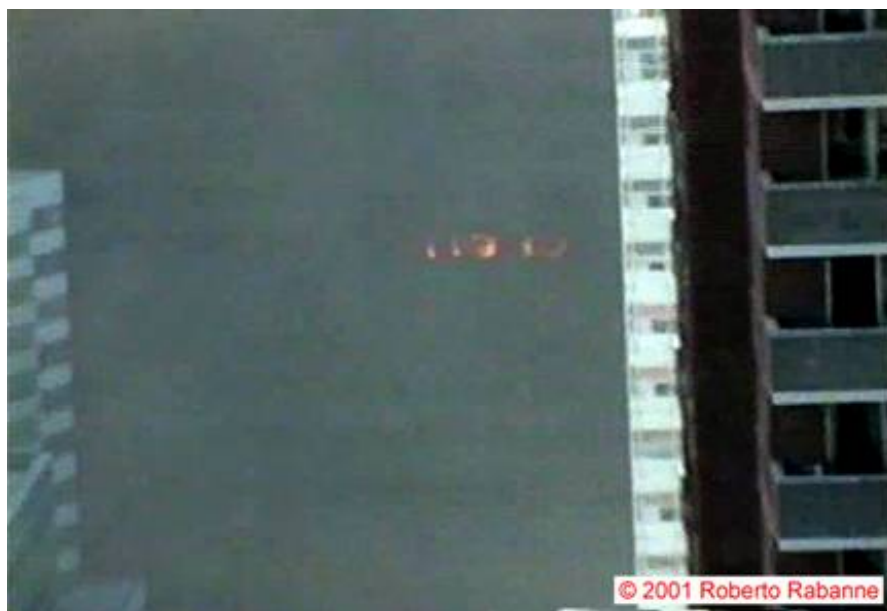
Figure 5–159 shows a view of the north face of WTC 7 just seconds before it began to collapse. It is a frame from a video clip shot from the northwest at 5:20:17 p.m. ± 15 s. Comparison with Figure 5–139 indicates that the fires visible in the image were located on the 11th floor between Columns 50 and 52, showing that the fire on this floor was continuing to spread to the west just prior to the collapse of the building.

Figure 5–159. This frame from a video shot from a building to the northwest of WTC 7 was taken around 5:20:17 p.m. with an uncertainty of ± 15 s. The intensities have been adjusted.

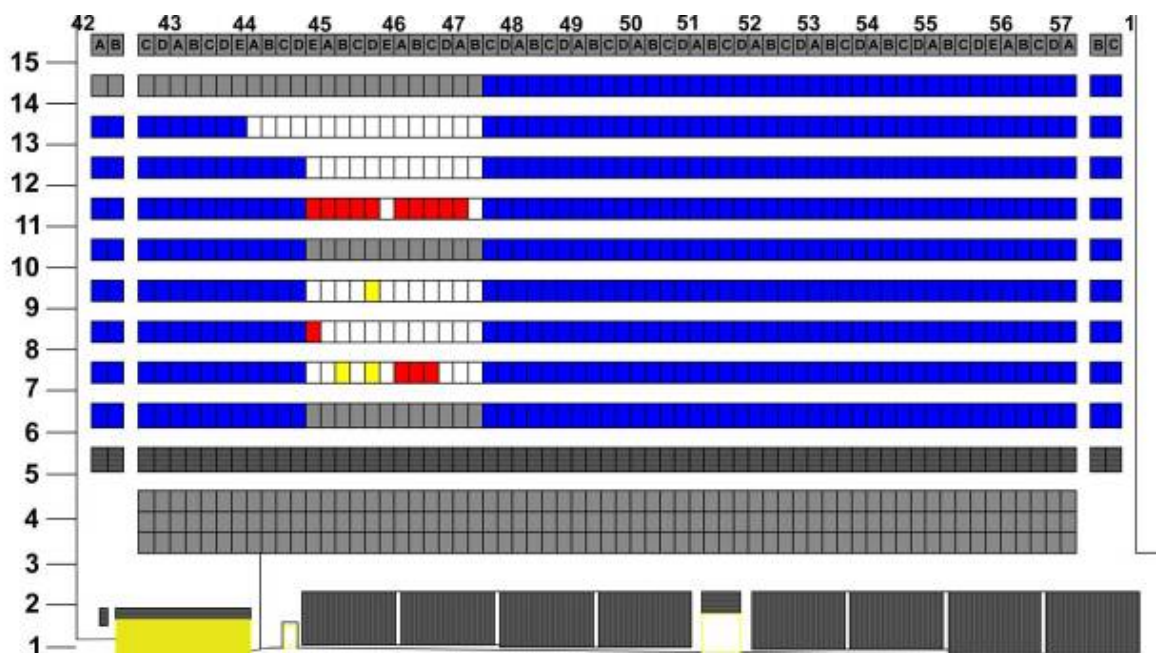
Figure 5-176. Façade map summarizing observations of fires and open windows on the north face of WTC 7 at 4:38:11 p.m.

Based on Figure 5-148 and Figure 5-149 and the video clip from which these frames were taken.

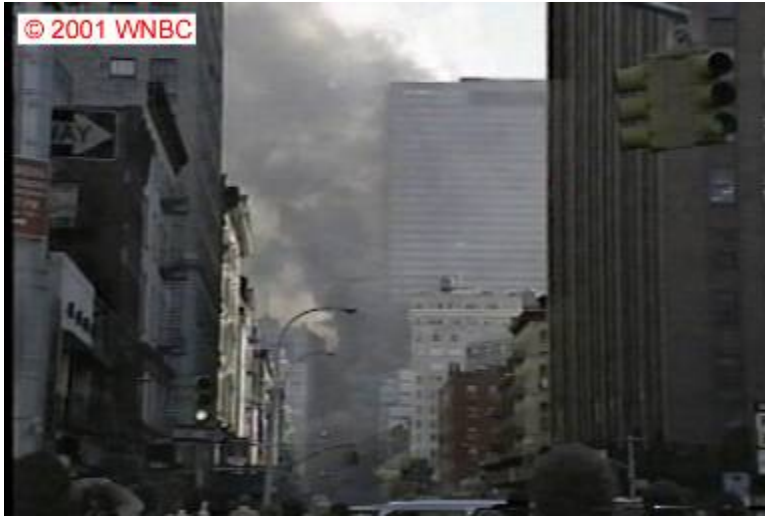
Figure 5-187. Earliest frame from the Camera 4 video, showing the north face of WTC 7.

It was shot $3.7 \text{ s} \pm 0.2 \text{ s}$ after the east penthouse began to sink into the building. The intensity levels have been adjusted.

Perhaps the most interesting feature of Figure 5–187 is the flow of what appears to be dark smoke across the visible part of the northeast corner as high as the 23rd floor. The actual composition of the material is not known. It could have been smoke from the fires on lower floors and/or escaping dust generated within the building by ongoing structural changes. Later during the WTC 7 collapse, a debris flow similar to those generated by the collapses of the towers (see Figure 5–27, Figure 5–34, Figure 5–35, and Figure 5–42) formed due to the dust released by the collapse. Due to the shadowing of the area, the dust cloud had a very similar appearance to the dark flow in Figure 5–187. The flow in Figure 5–187 appears to extend out to and across West Broadway and perhaps even somewhat north along this street.

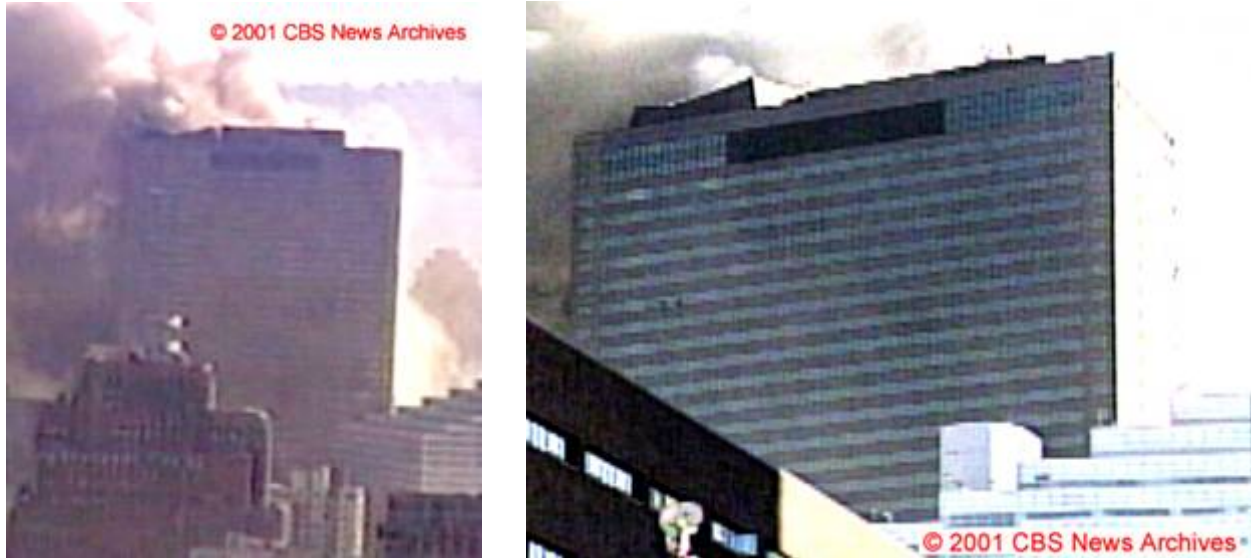
Figure 5-193. Cropped frames from the Camera 2 video clip and the Camera 3 video clip, showing the north face of WTC 7 $1.0 \text{ s} \pm 0.1 \text{ s}$ after the east penthouse began to move downward.
The intensities have been adjusted.

Figure 5-193 shows the appearance of the east penthouse 1.0 s after it began to descend. A photograph recorded at roughly the same time is included in Figure 5-1. The east-west location where the penthouse split was estimated to be 42 percent of the way across the penthouse roofline using the Camera 2 video. A similar result was obtained from the photograph in Figure 5-1. This location lies close to the vertical line of windows on the north face numbered 44B.

From the two perspectives shown in Figure 5-193, the entire lengths of the east and west walls of the east penthouse began to rotate downward into an apparent opening in the roof of WTC 7. The west wall of the penthouse pulled away from the north and south screenwalls that connected the east and west penthouses as it rotated counterclockwise.

Comparison of the Camera 3 frame in Figure 5-193 with the earlier frame in Figure 5-186 reveals some subtle changes in the appearance of the north face of WTC 7. On the 40th floor, it appears that two glass panes have broken out of windows 40-44B and 40-44D. In the video, window 40-44B began to break 0.6 s after the penthouse began to move downward, followed by window 40-44D 0.1 s later. On the 45th floor, two brighter areas have appeared near windows 45-43D and 45-46A even though the window glass appears to be intact. These brighter areas developed nearly simultaneously with the downward movement of the penthouse roof. The changes in appearance are due to local variations in the light reflected from the façade, suggesting local distortions of the façade at these locations. Although faint, similar light variations are evident along a line running vertically near windows 43D and extending over the visible portion of the face from the 37th to 45th floors.

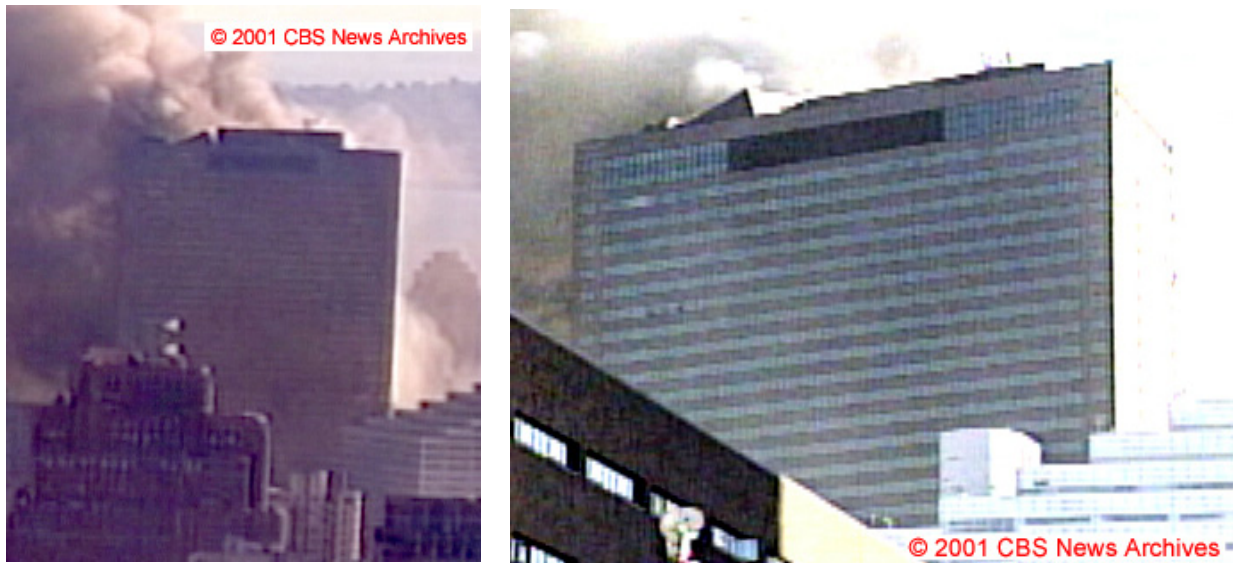
Figure 5-194. Cropped frames from the Camera 2 video clip and the Camera 3 video clip, showing the north face of WTC 7 $1.3 \text{ s} \pm 0.1 \text{ s}$ after the east penthouse began to move downward.
The intensities have been adjusted.

Figure 5-194 shows two frames from the same video clips, recorded 0.33 s later than those in Figure 5-193. The east penthouse has continued moving downward into the building. The Camera 3 video shows that the northeast corner of the penthouse was falling faster than the other three corners. In the Camera 3 view in Figure 5-194, a small section of the northeast corner, which appears to be black in the frame, is about
