**Federal Building and Fire Safety Investigation of the
World Trade Center Disaster**

**Structural Fire Response and
Probable Collapse Sequence of
World Trade Center Building 7**

VOLUME 1

November 2008

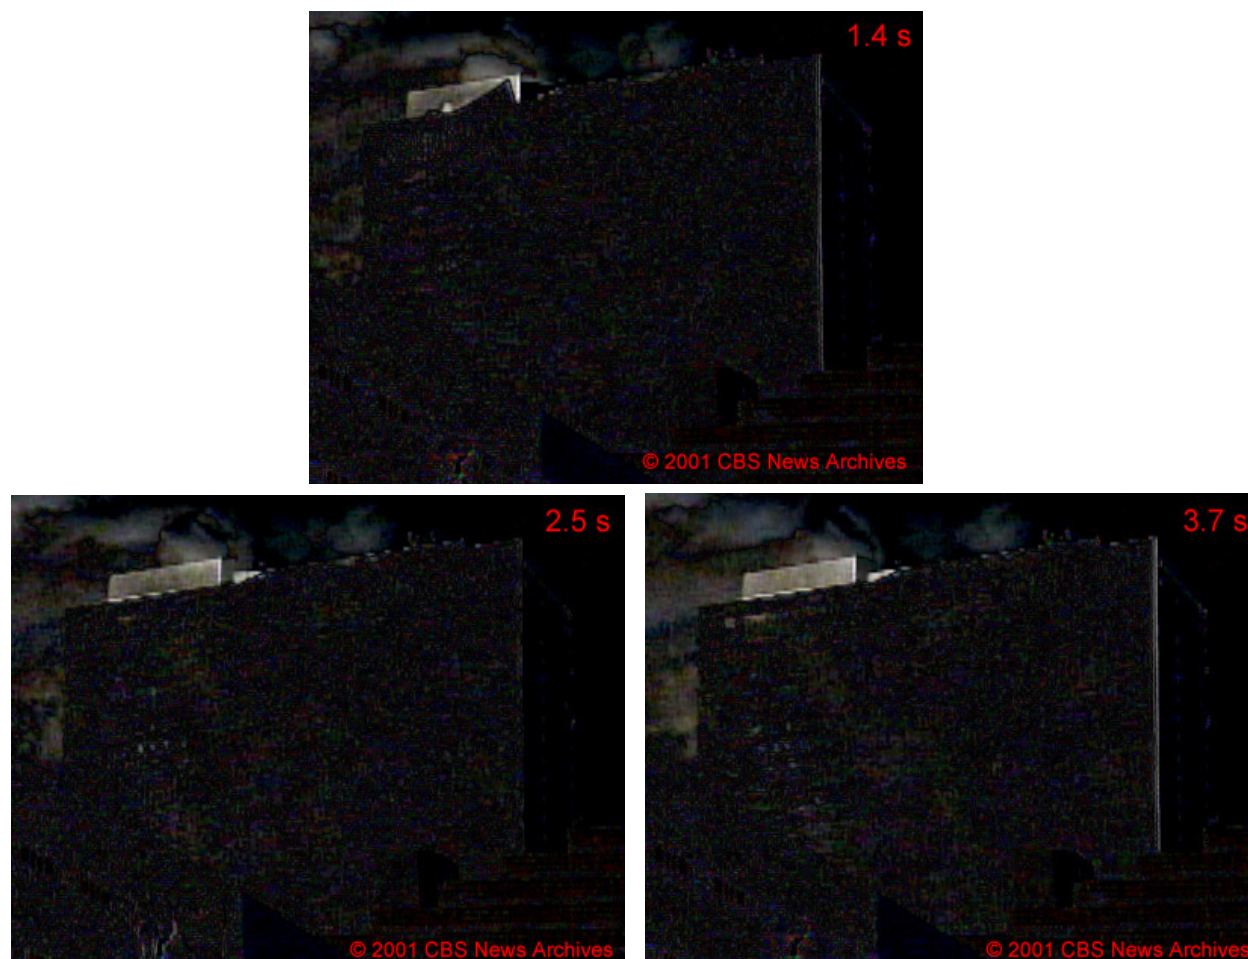
Figure 5–198. Three cropped difference frames based on the Camera 3 video clip shown in Figure 5–186 created by subtracting a frame from before the east penthouse started downward from each frame in the clip.

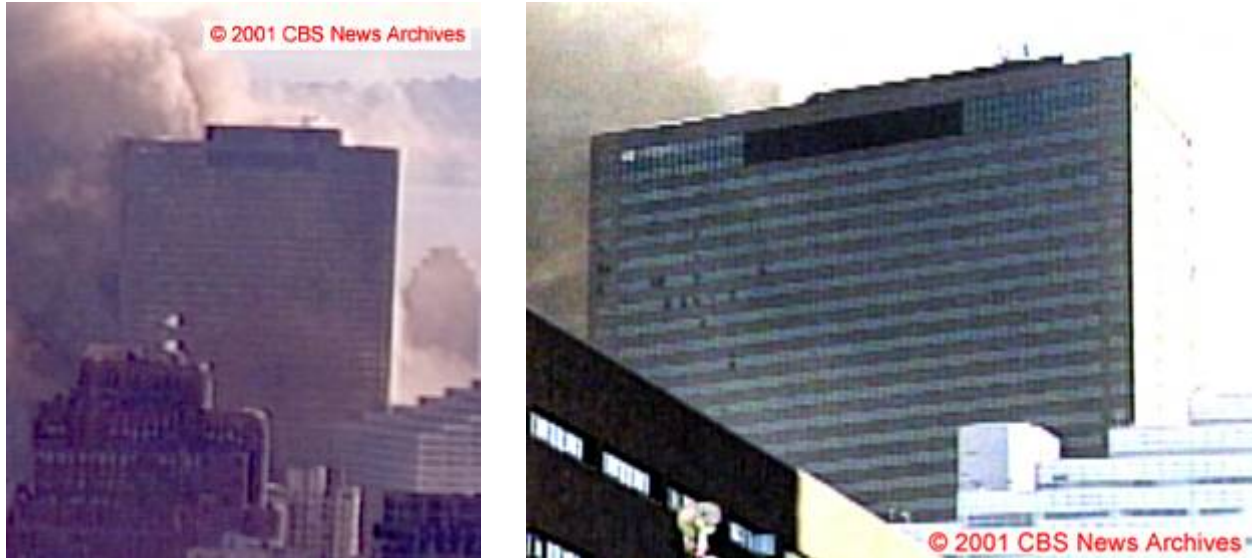
Figure 5–199 shows the north face 5.0 s after the east penthouse began moving downward. These two frames were taken from the Camera 2 long distance and Camera 3 West Street views. The time is 1.5 s after the corresponding views shown in Figure 5–197. There have been relatively minor changes in the appearance of the north face over this period. In the Camera 3 shot, it can be seen that additional glass has broken out of windows on the east side of the face. Open windows are visible at multiple locations from the 37th floor to the 43rd floor. The light coming through the open roof is apparent for windows on the 46th and 47th floors. In the longer distance view, the top of the tear-drop shaped light area that was observed moving down the north face is just visible above the buildings in the foreground. Most of the shape has already moved out of view. No other major visible changes were evident over the 1.5 s period.

Figure 5–199. Cropped frames from the Camera 2 video clip in Figure 5–185 and the Camera 3 video clip in Figure 5–186, showing the north face of WTC 7 5.0 s \pm 0.1 s after the east penthouse began to move downward.

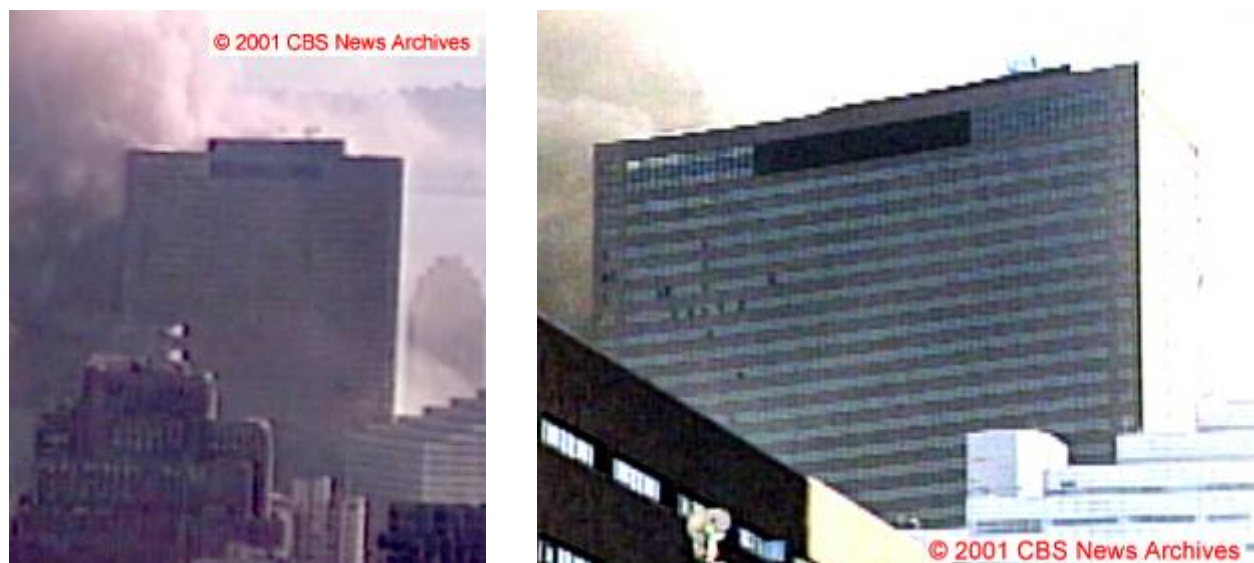
Comparison of the Camera 3 frames in Figure 5–199 and Figure 5–200 shows that changes in the appearance of the visible upper floors of the north face were minimal during the 2.5 s between the frames. In particular, the number of broken windows appears to be unchanged.

Figure 5–200. Cropped frames from the Camera 2 video clip in Figure 5–185 and the Camera 3 video clip in Figure 5–186, showing the north face of WTC 7 7.5 s \pm 0.1 s after the east penthouse began to move downward.

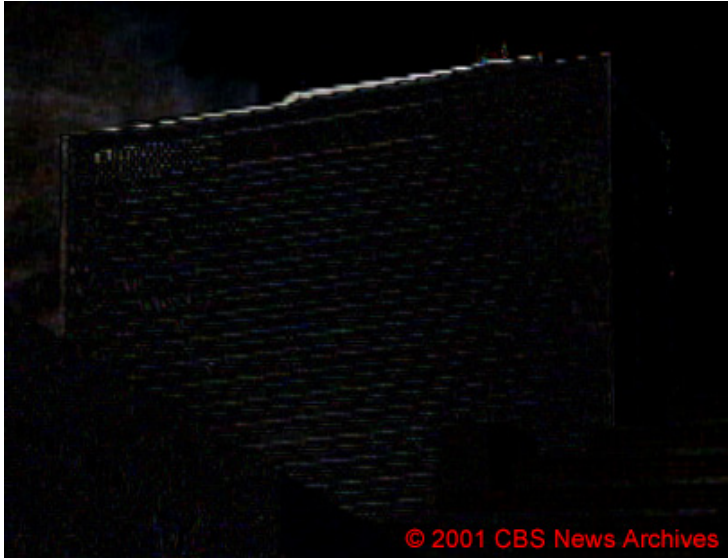
Figure 5–201. Cropped difference frame at $7.5 \text{ s} \pm 0.1 \text{ s}$ after the east penthouse began to move, created by subtracting the frame reproduced in Figure 5–199 from the Camera 3 video clip shown in Figure 5–200.

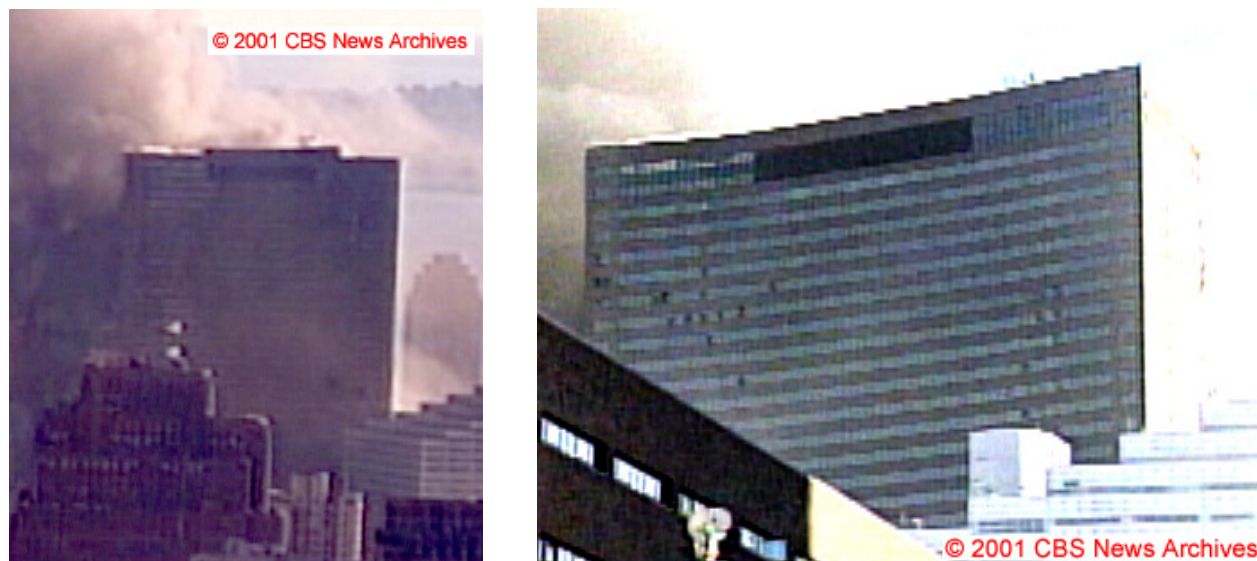
Direct comparison of Figure 5–200 and Figure 5–202 shows that WTC 7 moved downward during the 0.6 s period between the images. It also appears that the east end of the north face is rotating to the north relative to the rest of the north face.

It is clear from the distant view in Figure 5–202 that, even though the screenwall and west penthouse have partially sunk into the building, they are still well above the roof and parapet. Close inspection of this image reveals a darker area at the eastern end of the sloping line formed by the screenwall and the west penthouse on the roof. This dark area is the falling object that is about to disappear into the building. On the east side there is a white cloud rising above the roofline. Later frames reveal that this is a dust cloud that is being pushed upward from the opening in the roof as the building collapses.

Figure 5–202. Cropped frames from the Camera 2 video clip in Figure 5–185 and the Camera 3 video clip in Figure 5–186, showing the north face of WTC 7 8.1 s \pm 0.1 s after the east penthouse began to move downward.

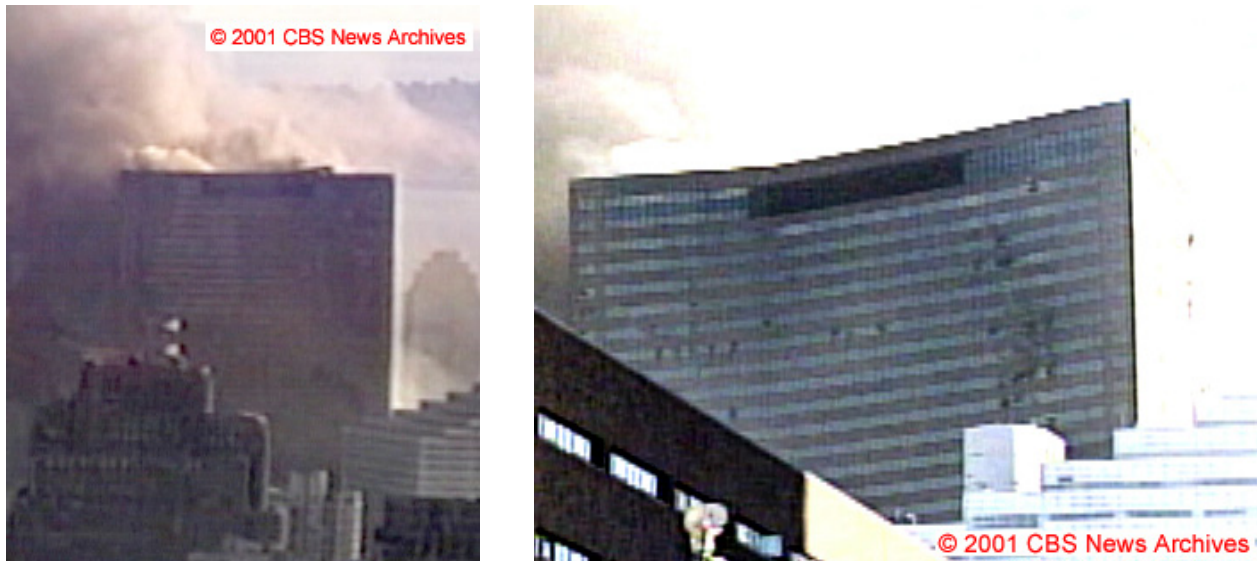
Camera 2 and Camera 3 views of the north face of WTC 7 recorded 0.9 s after those in Figure 5–202, i.e., 9.0 s after the east penthouse began to move, are shown in Figure 5–203. By this time, the entire north face that is visible above the foreground buildings was clearly falling as a unit. By counting the visible floors above the foreground building in the view from West Street, it was found that WTC 7 had fallen nearly two stories in the 2.1 s since the global collapse started. The façade damage on the west side of the face has increased and seems to extend over most of the visible floors between Columns 54 and 55. What appears to be dust has begun to flow from the open windows. A few additional windows have opened near the center of the face since the frame in Figure 5–202 was taken. The distribution of open east-side windows looks similar at the two times. The rotation of the east edge of the north face has become more evident, and a distinct kink has begun to develop just to the left of the east end of the louvers on the 46th and 47th floors. This location is close to perimeter Column 47.

Figure 5–203. Cropped frames from the Camera 2 video clip in Figure 5–185 and the Camera 3 video clip in Figure 5–186, showing the north face of WTC 7 $9.0 \text{ s} \pm 0.1 \text{ s}$ after the east penthouse began to move downward.
The intensities have been adjusted.

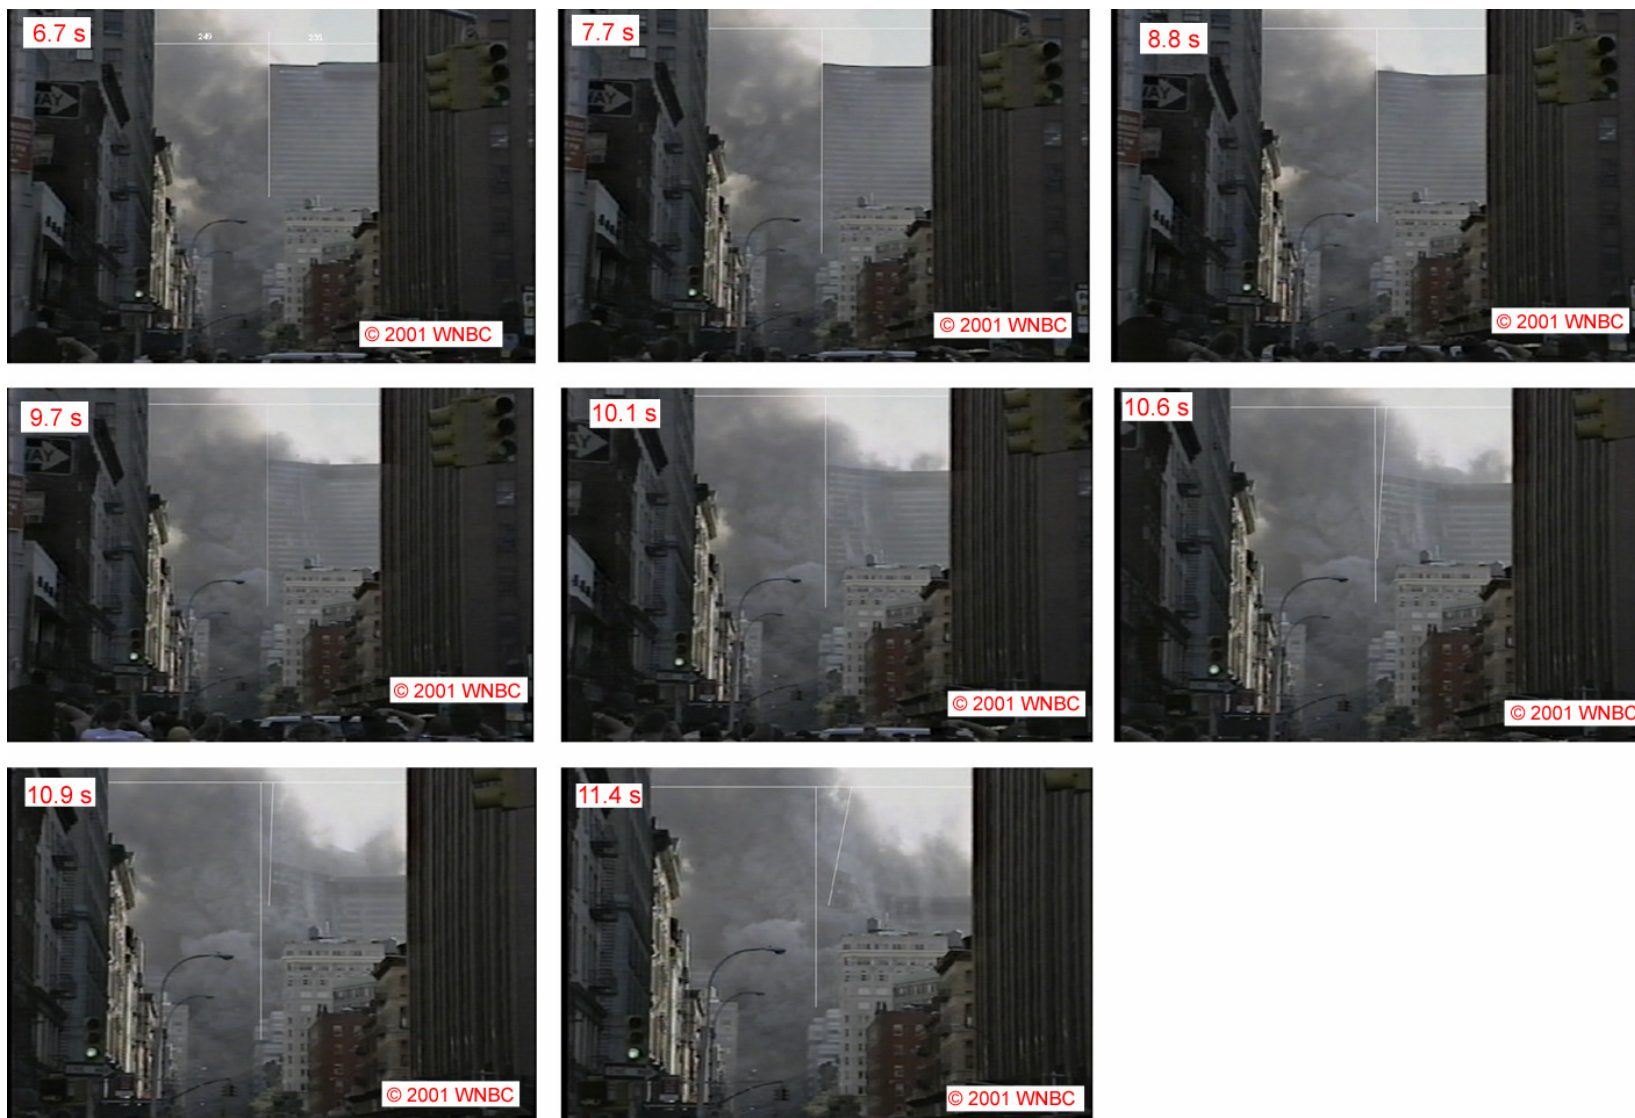
By utilizing video clips from the Camera 3 and Camera 4 videos it was possible to characterize the motions of the northeast and northwest edges of WTC 7 in more detail. A sequence of images from the Camera 4 video is shown in Figure 5–204. This camera was hand held, and during the collapse the camera moved and the operator began to zoom in. As a result, the line corresponding to the pre-collapse location of the northeast edge of WTC 7 moved within the video frames with time. However, the two buildings in the foreground were fixed and provided a means to identify this location in frames after the collapse began. In the first image of Figure 5–204, a vertical line has been drawn tracing the northeast edge of WTC 7, and a horizontal line was drawn to the two buildings in the foreground. Using the foreground building edges as guides, these same lines were imposed on subsequent frames, in effect

identifying the original location of the northeast edge in the frame. Onto each subsequent image, the same lines have been added that trace the evolving location of the northeast edge of the building. In the first five frames the original line and the edge of WTC 7 at the later time coincide within the resolution of the image, showing that the visible northeast edge had not moved perpendicular to a line running between the camera position and the edge of the building. During this time, WTC 7 had begun to collapse, and the roofline had already descended about 10 stories. Thus, well into the building collapse, the northeast corner of the building fell either straight down, directly toward, or directly away from the video camera. In the next frame at 10.6 s following initial movement of the east penthouse, the top of the northeast corner of the building has tilted sharply to the west, and it appears that the building has begun to break apart. This motion continued to grow until the northeast edge became hidden by the rising dust cloud.

Figure 5–204. Images from the Camera 4 video clip showing relative movement of the northeast edge of WTC 7 during its global collapse.

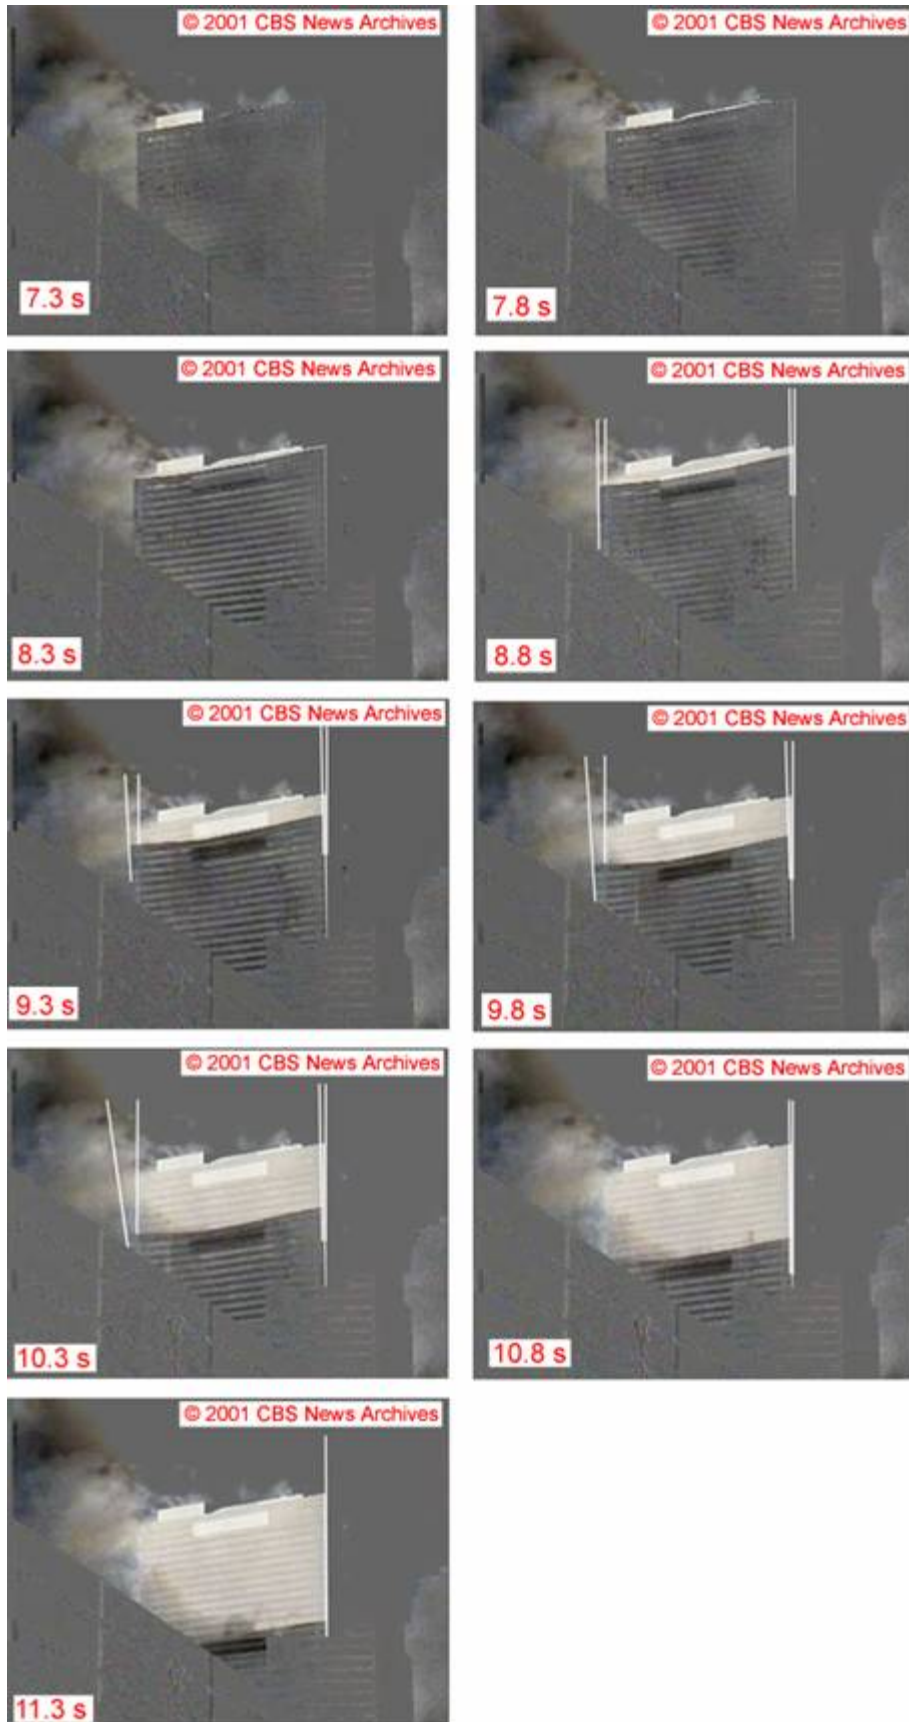
The Camera 3 video provided additional information about the movement of the building edges due to its view of the full width of WTC 7 and a more oblique viewing angle. The image differencing technique used to visualize the movement of WTC 7 in Section 5.7.3 was again applied. Figure 5–205 shows several frames from the difference video at the indicated times following initiation of downward movement of the east penthouse. White lines denoting both the original and displaced edges of the building are drawn on the image to emphasize the relative displacement and rotation. In this sequence of images, both the northeast and northwest edges began to tilt toward the north shortly after the building began to move downward. The northeast edge tilt continued to increase until the edge was obscured by dust and smoke. The northwest edge initially tilted in a similar manner, but then settled back to its original line and fell nearly vertically (or directly toward or away from the camera).

Figure 5–205.
Difference images
from the Camera 3
video clip showing
the rotation of the
northeast edge of
WTC 7 during the
global collapse.

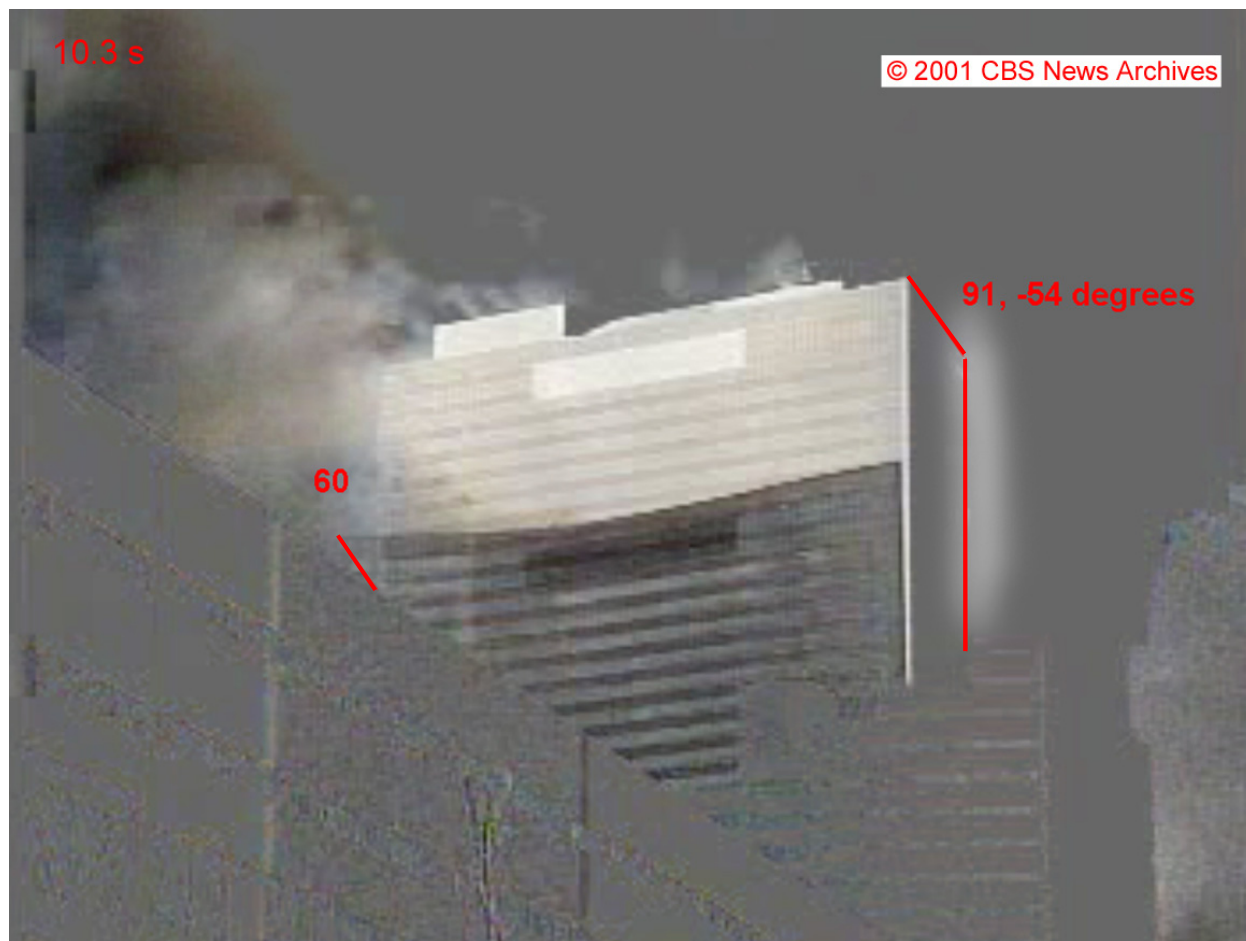
The extent of the northeast edge motion was estimated using the Camera 3 video frame in Figure 5–206, at which time the top of the building had descended about seven stories. The two red lines on the right trace the west roofline and the southwest edge of WTC 7. The red line at the left is parallel to the west roofline and passes through the top of the northeast corner of the descending roofline. A geometric calculation was performed, involving the angle between these two lines, the dimensions of the building, the distance between the camera and the building, and the viewing angles of the northeast and southwest corners. The calculation led to an estimate that, at this point in the collapse, the top of the northeast corner roofline was displaced $11 \text{ m} \pm 3 \text{ m}$ from its original footprint. In combination with observations from Figure 5–204, it is possible to determine that the motion was primarily due north.

Figure 5–206. Heavily processed difference frame from the camera 3 video, used to estimate the lateral distance the northeast corner of WTC 7 moved from its original footprint during the collapse.

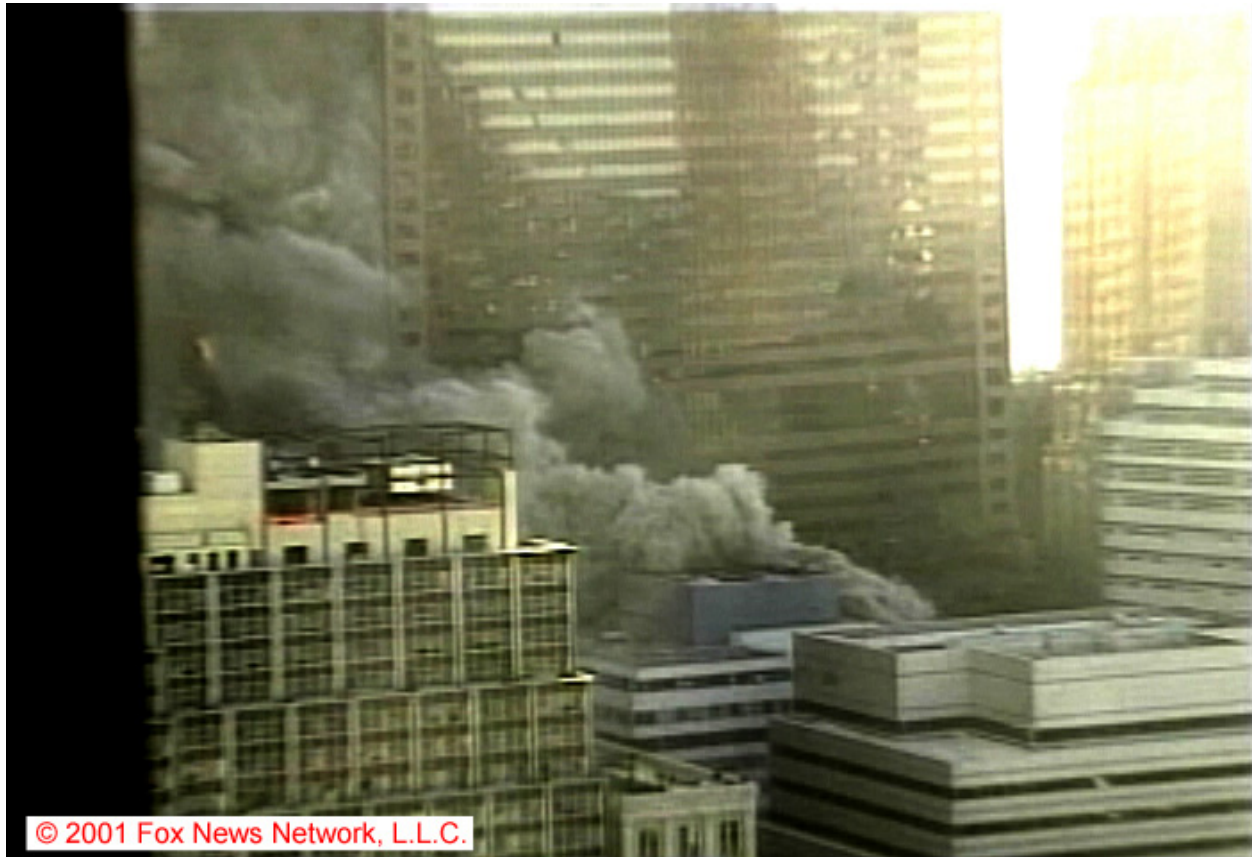
The Camera 6 videographer, who shot the clip from which Figure 5–189 was taken, zoomed in on the north face of WTC 7 as it collapsed. Figure 5–207 shows a frame taken from this clip at about the same time (± 0.2 s) that the frames in Figure 5–203 were recorded. In this image, there appears to be both smoke (black) and dust (white) flowing across the north face just above the building in the foreground. Most of the material appears to be dust. It is possible to make out the window damage on the west side of the face between Columns 54 and 55. This damage extends at least as far down as the 22nd floor. Only a few open windows are visible on the east side of the face.

Figure 5–207. Frame from the Camera 6 video clip in Figure 5–189, showing the north face of WTC 7 $9.0 \text{ s} \pm 0.2 \text{ s}$ after the east penthouse began to move downward.

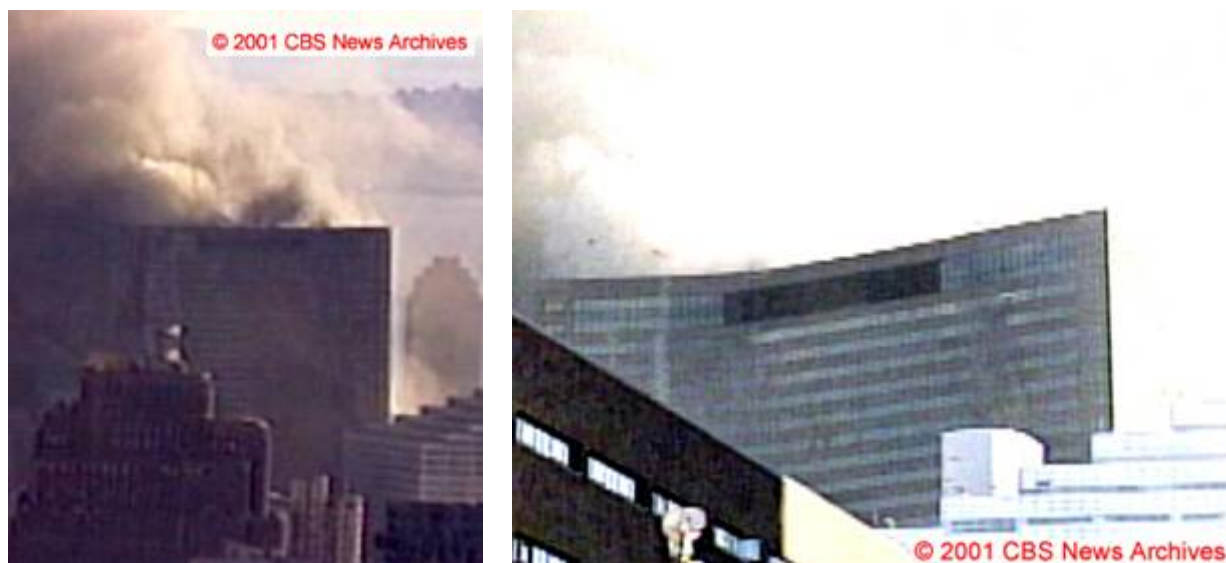
During the period between 9.0 s and 10.0 s after the east penthouse began to descend, the north face fell downward slightly more than four stories. Camera 2 and Camera 3 views, recorded 10.0 s following the start of downward movement for the east penthouse, are shown in Figure 5–208. The West Street view shows a large amount of dust flowing from open windows on the face. This dust first appeared around

9.2 s after the east penthouse started moving. The kink near Column 47 is still prominent. The dust plume being forced from the roof opening on the east side of the building is visible. In the distant view, the entire west penthouse has disappeared below the north wall parapet. This took place around 9.3 s. A dust cloud, similar to that being ejected from the opening in the roof on the east side, has begun to form just to the west of the center of the north face. This suggests that the roof has also opened at this location.

Figure 5–208. Cropped frames from the Camera 2 video clip in Figure 5–185 and the Camera 3 video clip in Figure 5–186, showing the north face of WTC 7 10.0 s \pm 0.1 s after the east penthouse began to move downward.

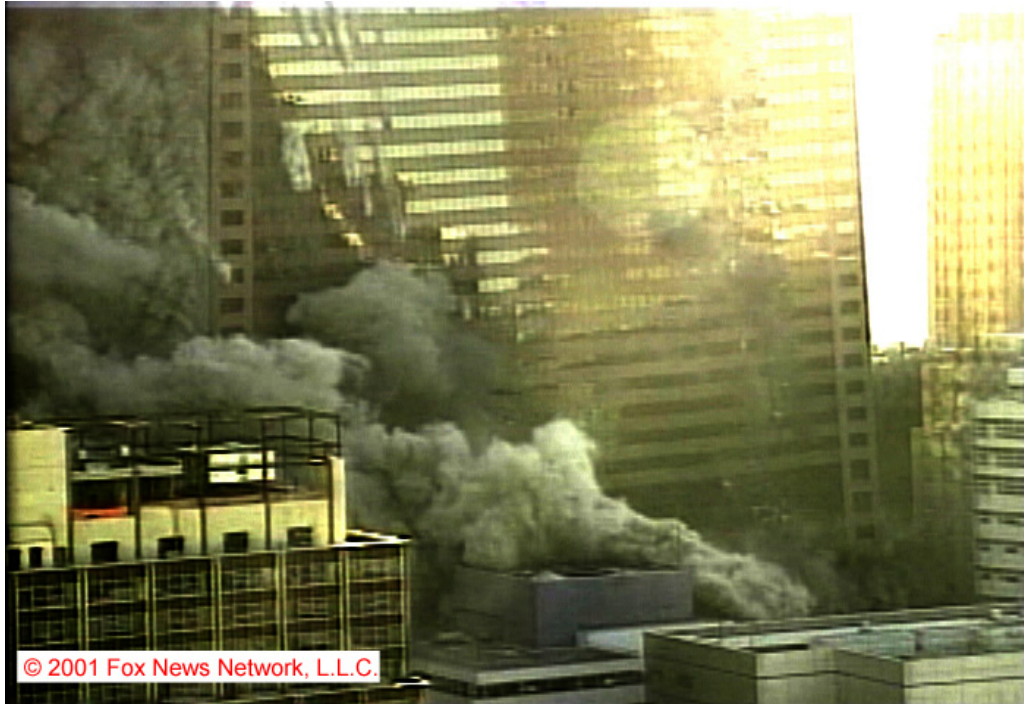
Figure 5–209 shows a frame from Camera 6 of the north face of WTC 7 recorded 10.0 s after the east penthouse began to collapse. Dust trails are flowing from the open windows on the east and west sides of the building. Numerous windows are open near the center of the face, but no dust flows are evident from these windows. The kink in the face near Column 47 observed near the top of building in Figure 5–208 appears to extend at least as far down as the mechanical floors on the 22nd and 23rd floors.

Figure 5–209. Frame from the Camera 6 video clip in Figure 5–189, showing the north face of WTC 7 $10.0 \text{ s} \pm 0.2 \text{ s}$ after the east penthouse began to descend. The intensities have been adjusted.

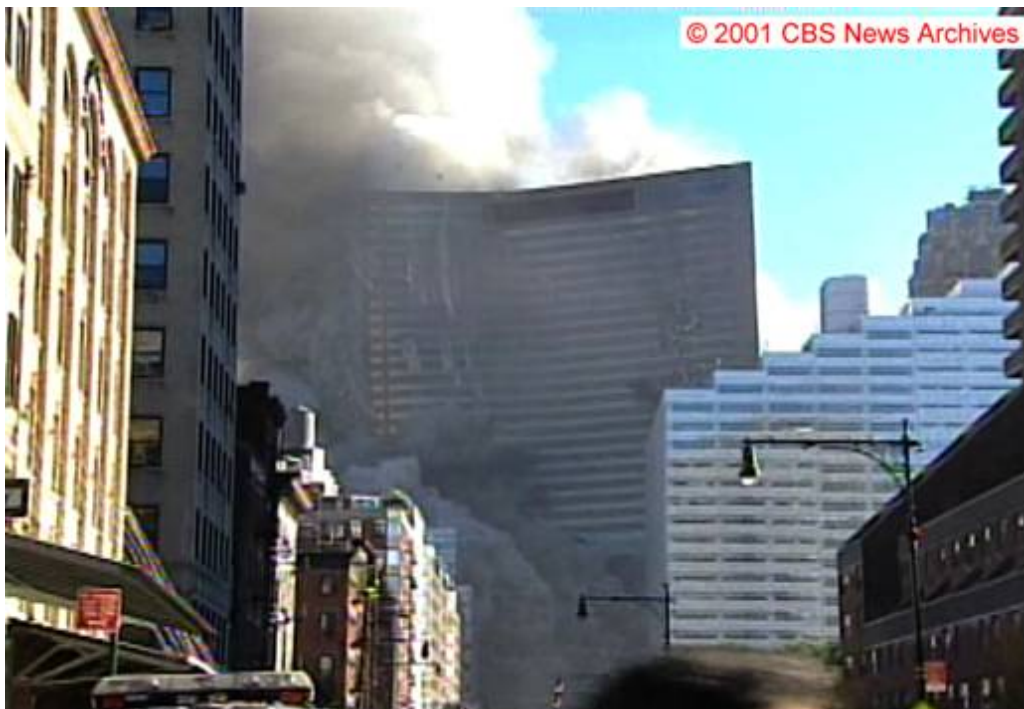
Figure 5–210 is a frame from the Camera 9 video showing the collapse at the same time looking up Greenwich Street. The appearance of the collapsing north face is consistent with the descriptions above. The appearance of the dust cloud at the base of the building has not changed markedly from that seen in Figure 5–192.

Figure 5–210. Frame from the Camera 9 video clip in Figure 5–192, showing the north face of WTC 7 $10.0 \text{ s} \pm 0.2 \text{ s}$ after the east penthouse began to move downward. The intensities have been adjusted.

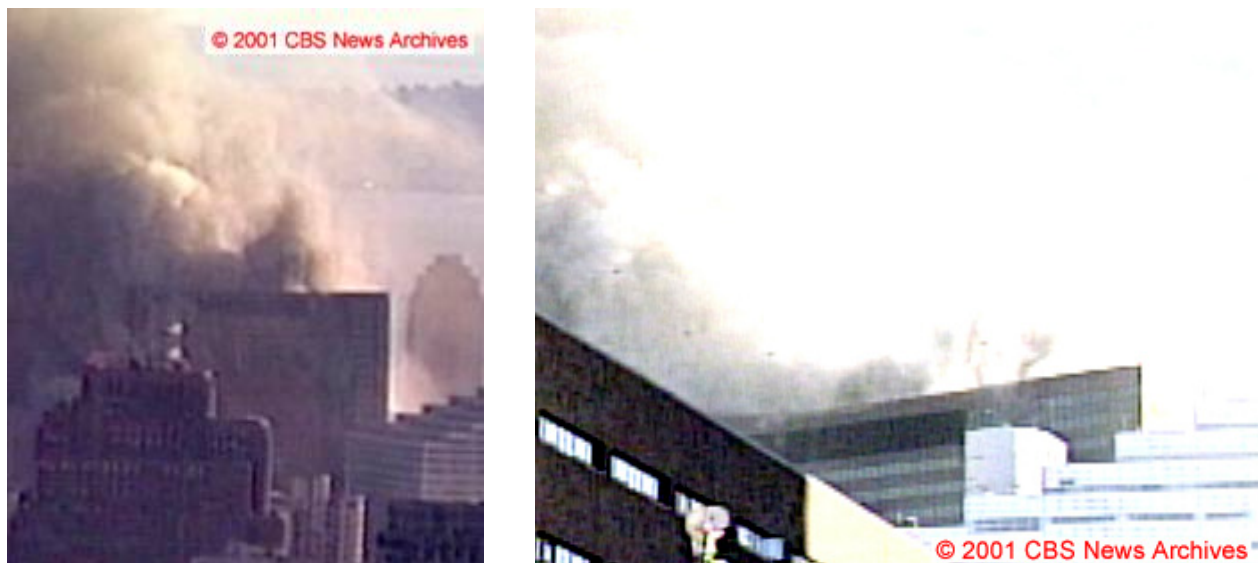
During the next second, the north face of WTC 7 moved downward nearly 6 stories. Figure 5–211 shows the Camera 2 distant and Camera 3 West Street views at 11.0 s following the initial downward movement of the east penthouse. WTC 7 is just about to pass out of sight behind the foreground building in the West Street view. While dust clouds continue to pass over the face, it is remarkable how many windows are still intact at the top of the building. The amount of dust pouring from the open windows of the falling north face is more evident in the distant view. It is also clear that a large amount of dust has been ejected through the roof at the two locations on the east side and near the center.

Figure 5–211. Cropped frames from the Camera 2 video clip in Figure 5–185 and the Camera 3 video clip in Figure 5–186, showing the north face of WTC 7 $11.0 \text{ s} \pm 0.1 \text{ s}$ after the east penthouse began to move downward.
The intensities have been adjusted.

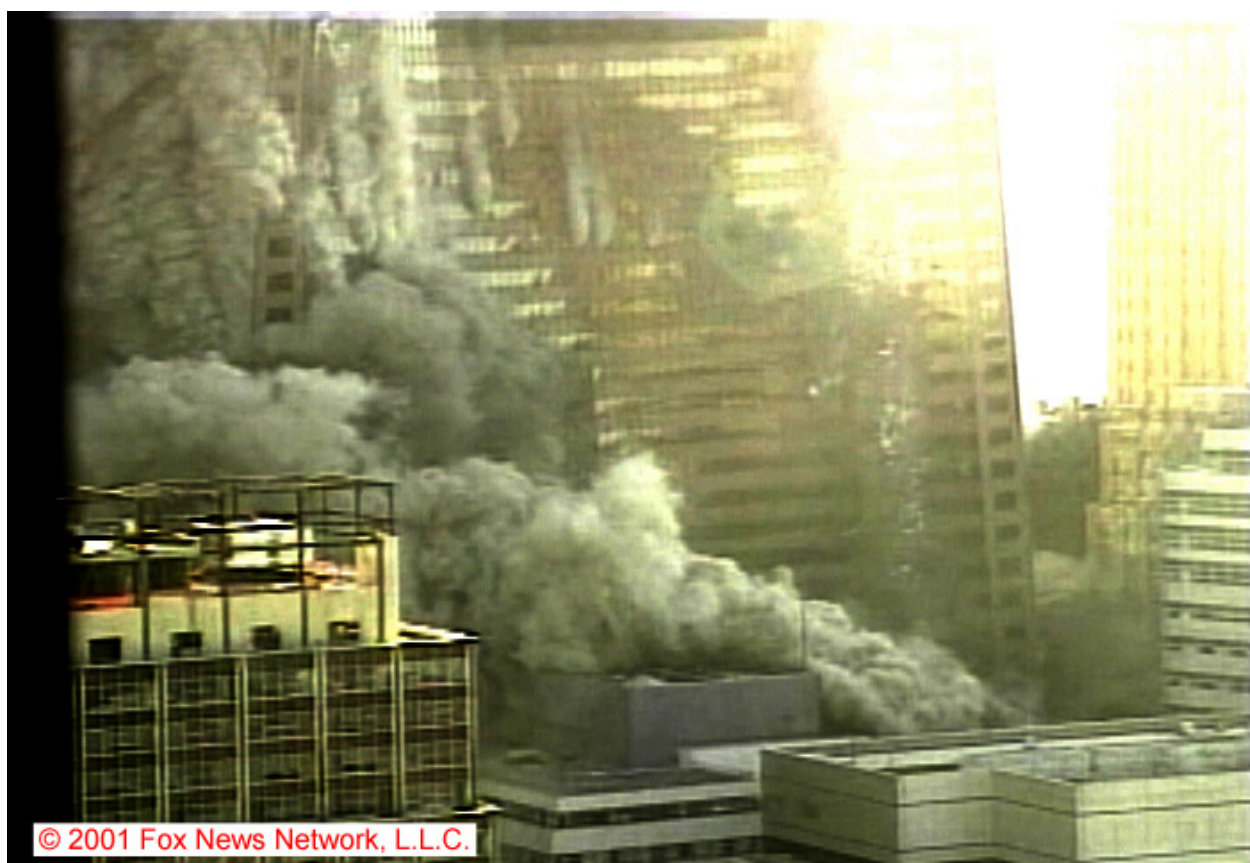
Figure 5–212. Frame from the Camera 6 video clip in Figure 5–189, showing the north face of WTC 7 $11.0 \text{ s} \pm 0.2 \text{ s}$ after the east penthouse began to move downward.
The intensities have been adjusted.

Figure 5–212 and Figure 5–213 show frames from the northeast (Camera 6) and Greenwich Street (Camera 9) video clips for the same time as the images in Figure 5–211. In both frames, the distortions of the falling building stand out. The kink near Column 47 is prominent in Figure 5–213, while in Figure 5–212, a strong distortion is present near the east edge of the north face. Both frames also show the large amount of dust being pushed out of open windows higher up in the building and the huge dust clouds forming near its base. In Figure 5–212, large amounts of dust have been pushed from near the base of the building on the east, north, and west sides. A prominent feature in Figure 5–213 is the large pulses of dust flowing upward through the roof on the east side and near the center.

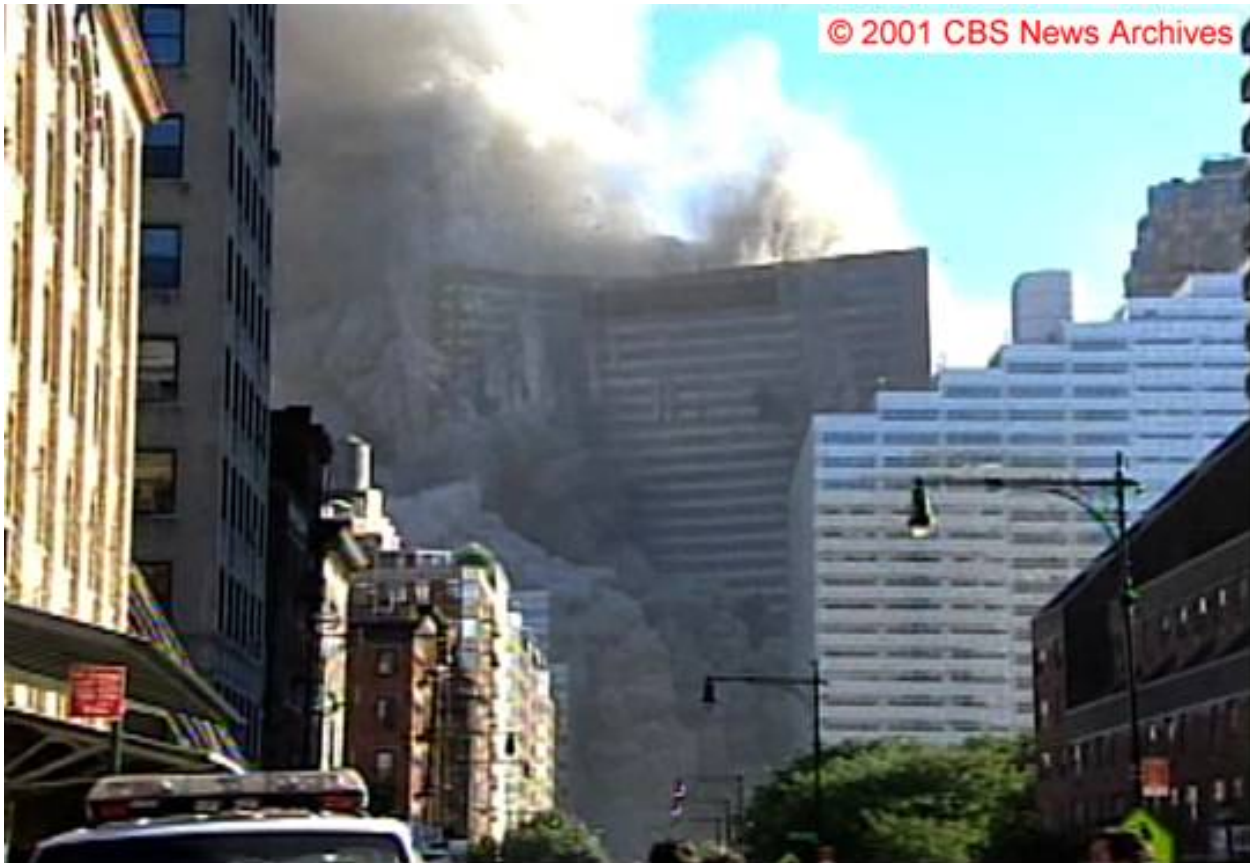
Figure 5–213. Frame from the Camera 9 video clip in Figure 5–192 shows the north face of WTC 7 $11.0 \text{ s} \pm 0.2 \text{ s}$ after the east penthouse began to move downward.

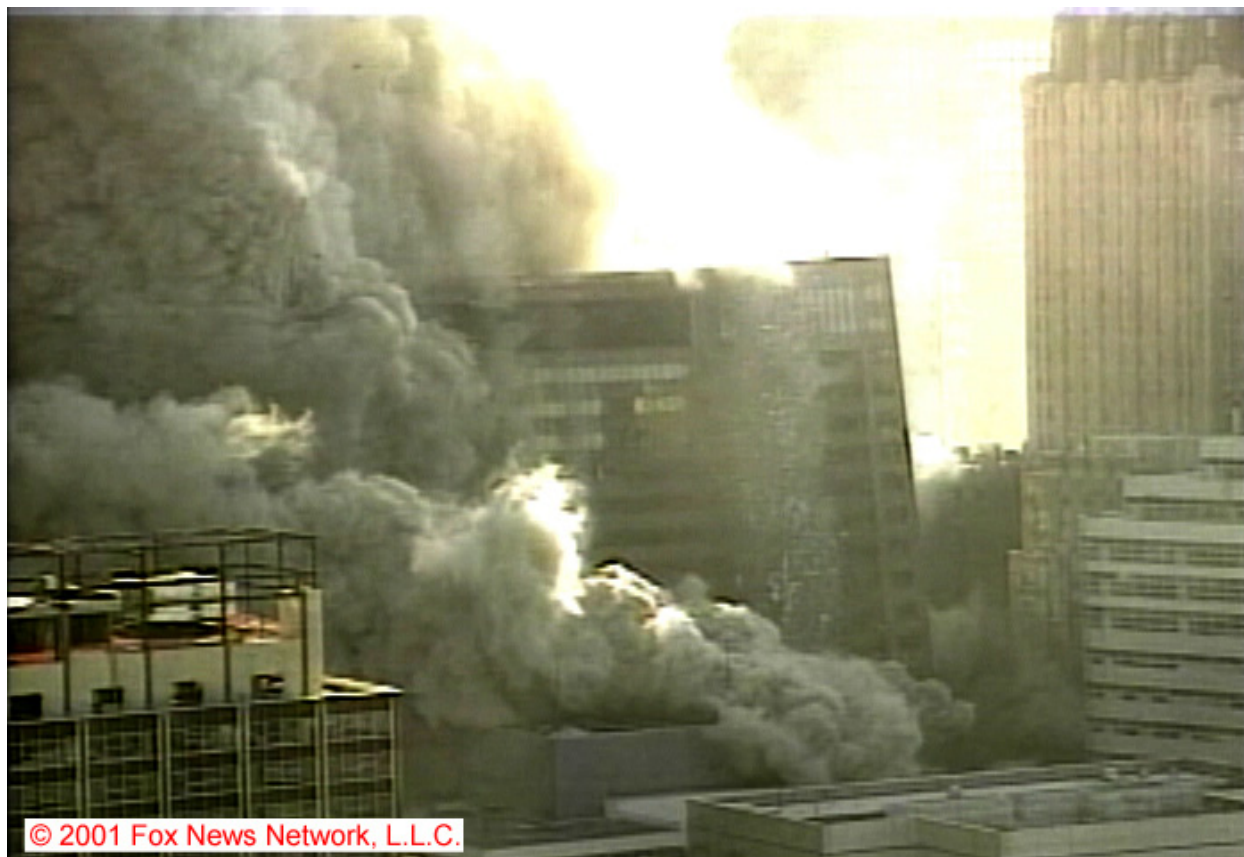
Between 11 s and 12 s following the initial movement of the east penthouse, WTC 7 fell an additional eight stories. By 12 s, there is clear evidence that the collapsing building is breaking apart. Figure 5–214 shows the northeast Camera 6 view of the north face 12 s after the east penthouse began to move. Several sections of the parapet on the west side of the building are missing and light is streaming through the openings. The building appears to be breaking apart on the west side of the north face. A large amount of dust and debris is coming from this area. The Camera 9 view of the building from Greenwich Street at the same time is shown in Figure 5–215. A section of the northeast corner of WTC 7 (indicated by an arrow) is visible well above the remaining roofline for the building. As suggested by the image in Figure 5–212, this corner apparently separated from the remainder of the building and collapsed at a different rate.

Figure 5–214. Frame from the Camera 6 video clip in Figure 5–189, showing the north face of WTC 7 12.0 s \pm 0.2 s after the east penthouse began to move downward.

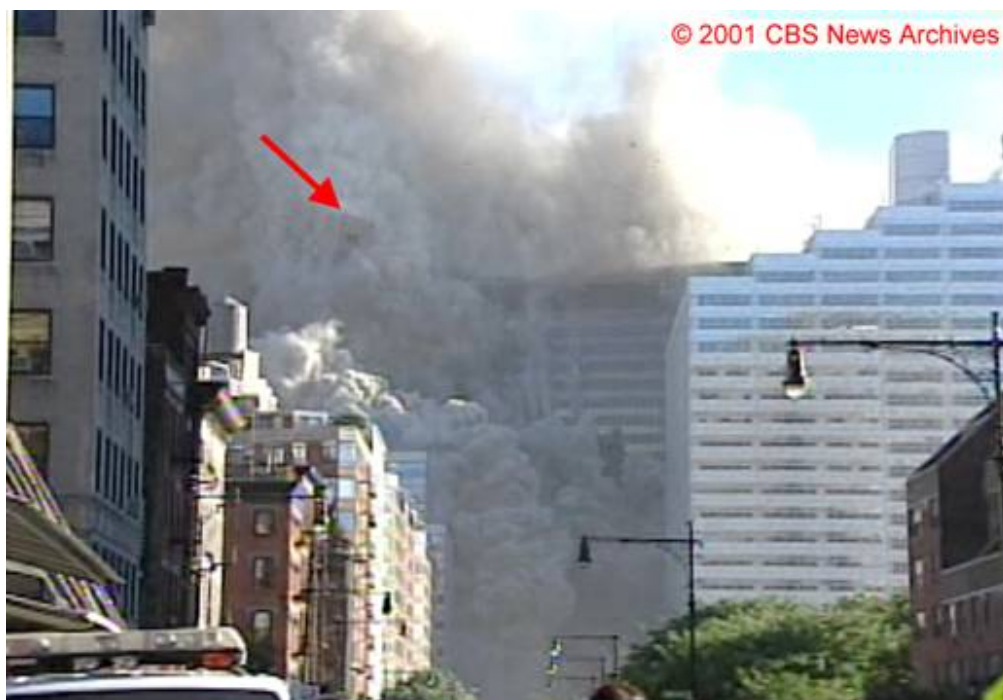
Figure 5-215. Frame from the Camera 9 video clip in Figure 5-192, showing the north face of WTC 7 $12.0 \text{ s} \pm 0.2 \text{ s}$ after the east penthouse began to move downward.

The arrow indicates a section of the northeast corner of the building that has broken away from the main section of the building. The intensities have been adjusted.

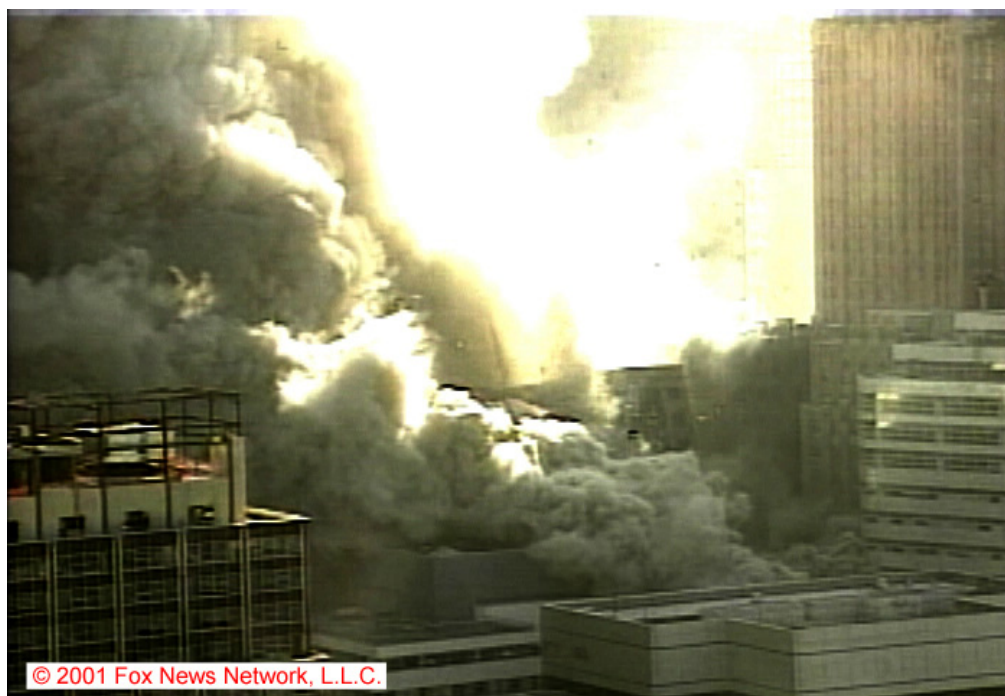
Figure 5–216 shows a frame taken from the Camera 6 video shot looking at WTC 7 from the northeast. It was recorded 13 s following the initiation of east penthouse movement. The remainder of WTC 7 is just about to disappear into the dust cloud. Shortly after most of the building disappeared into the dust cloud, a piece of debris several stories tall appeared from the east side (where it had been hidden by the dust cloud) and fell toward the center of the building. This section of WTC 7 may have come from the northeast corner which had earlier separated from the remainder of the building.

Figure 5-216. Frame from the Camera 6 video clip in Figure 5-189, showing the north face of WTC 7 $13.0 \text{ s} \pm 0.2 \text{ s}$ after the east penthouse began to move downward.
