**Federal Building and Fire Safety Investigation of the
World Trade Center Disaster**

**Structural Fire Response and
Probable Collapse Sequence of
World Trade Center Building 7**

VOLUME 1

November 2008

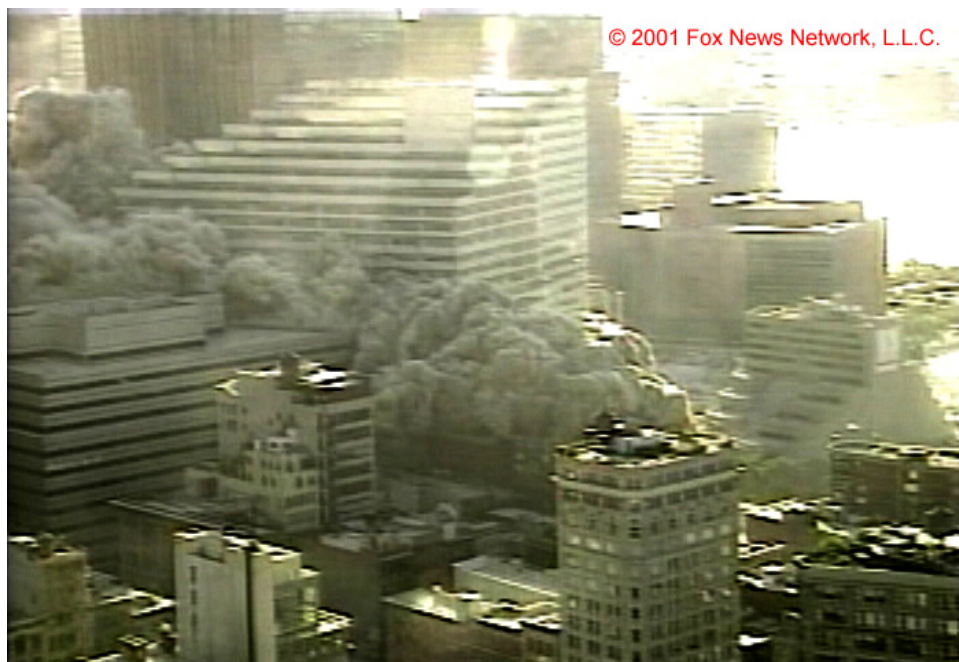
When WTC 7 collapsed, the dust that was generated mixed with air to create a dense mixture that flowed away from the site. The resulting dust- and debris-laden flow spread over many blocks of lower Manhattan. Figure 5–217 and Figure 5–218 show two views of the dust cloud as it spread northward along Greenwich Street after being channeled between the taller buildings at 123 Barclay Street on the west side and 30 West Broadway and 70 Murray Street on the east side.

Figure 5–217. Frame from the Camera 6 video clip in Figure 5–189, showing the dust-laden flow generated by the collapse of WTC 7, $22.0\text{ s} \pm 0.2\text{ s}$ after the east penthouse began to move downward. The intensities have been adjusted.

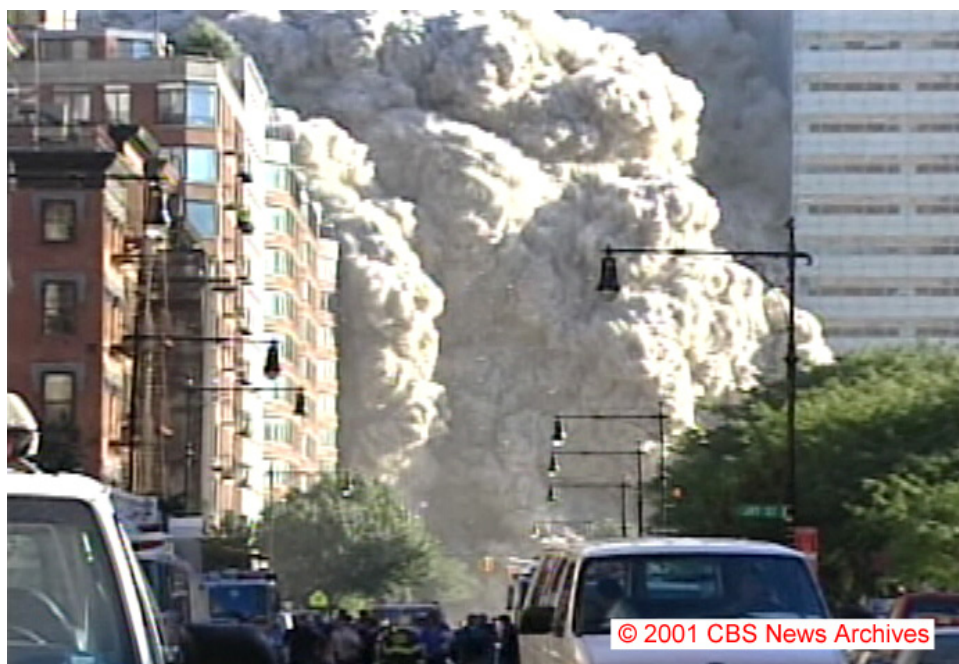
Figure 5–218. Frame from the Camera 9 video clip in Figure 5–192, showing the dust-laden flow created by the collapse of WTC 7, $22.0\text{ s} \pm 0.2\text{ s}$ after the east penthouse began to move downward. The intensities have been adjusted.

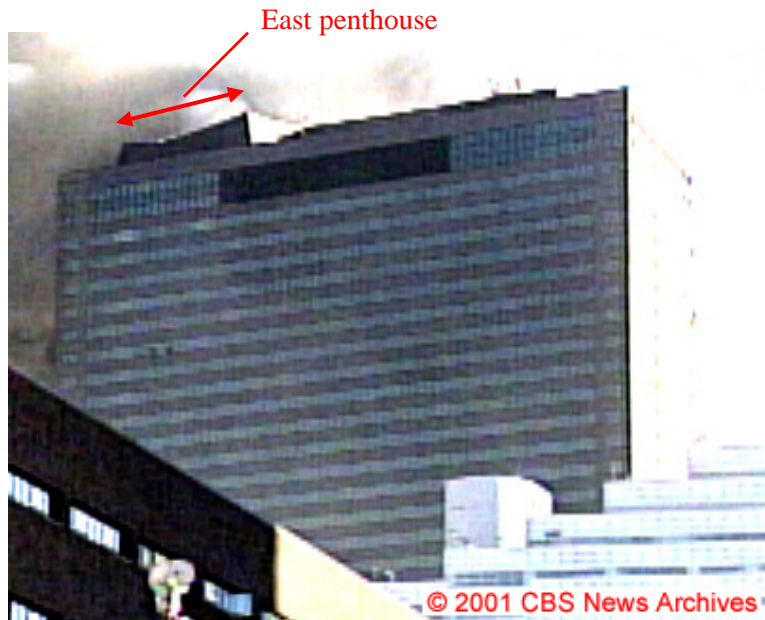
Figure 8–1. East penthouse kinks and begins to collapse.

A video taken from essentially due north was used to measure the location of the kink that formed in the roof of the east penthouse at the onset of collapse (Section 5.7.2). The kink formed approximately 40 percent of the distance from the east edge of the penthouse to the west edge of the penthouse (Figure 8–1). Plotting this location on the penthouse framing plan shows that the kink was located essentially at Post 17 (indicated as “P17” in Figure 8–7). This post was supported directly on the roof girder spanning between Column 79 and Column 44. Since exterior Column 44 was observed in the video to not fail, and the entire penthouse moved downward, not just the north portion, it was likely that initiation of the collapse of the east penthouse was preceded by the initial local failure of Column 79.

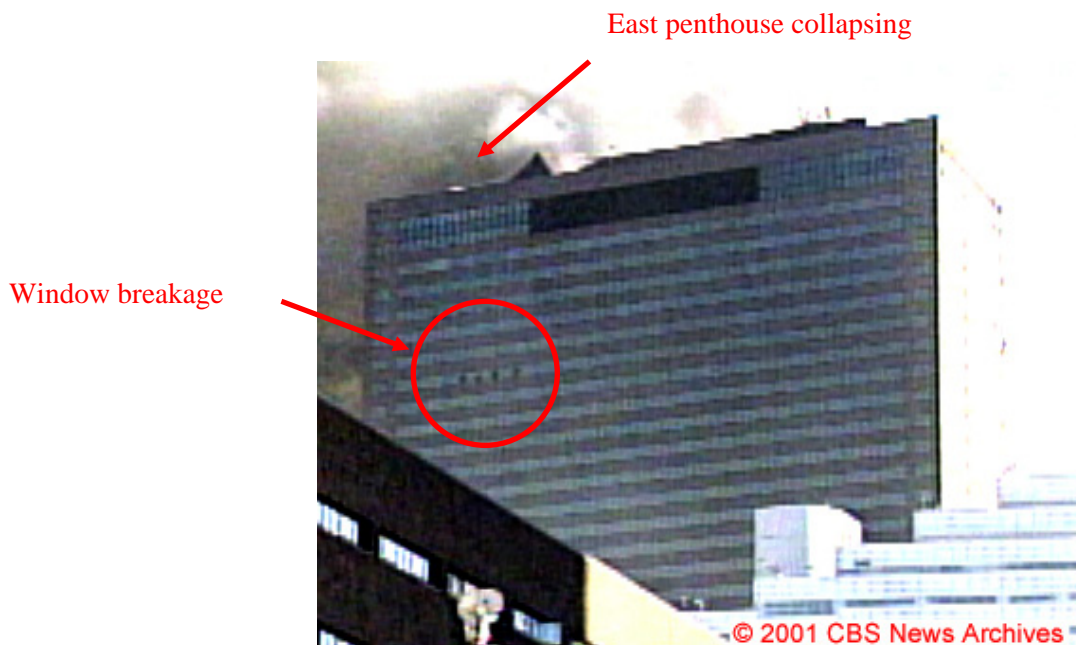
Figure 8–2. East penthouse collapses as roof gives way – windows break between column lines 43 and 45.

As evidenced by the breaking glass in the upper stories (Figure 8–2 and Figure 8–4), collapse on the east side of the building was not limited to the roof and penthouse. Failures were likely occurring on many floors below with sufficient energy to cause the 47 story building to move laterally in its strong (east-west) direction (Figure 8–3). An analysis of one of the videos using frame subtraction to highlight differences between two video frames (Appendix C), revealed that the northwest edge of the building showed horizontal motion of around 15 in. peak-to-peak oscillation as the east penthouse collapsed (Figure 8–8). Measurable, though smaller, vibrations (about ± 2 in.) were detected at least 6 s before the east penthouse began to collapse. This suggested that a major disturbance occurred within the building prior to visible evidence of collapse (movement of the east penthouse) from available video recordings.

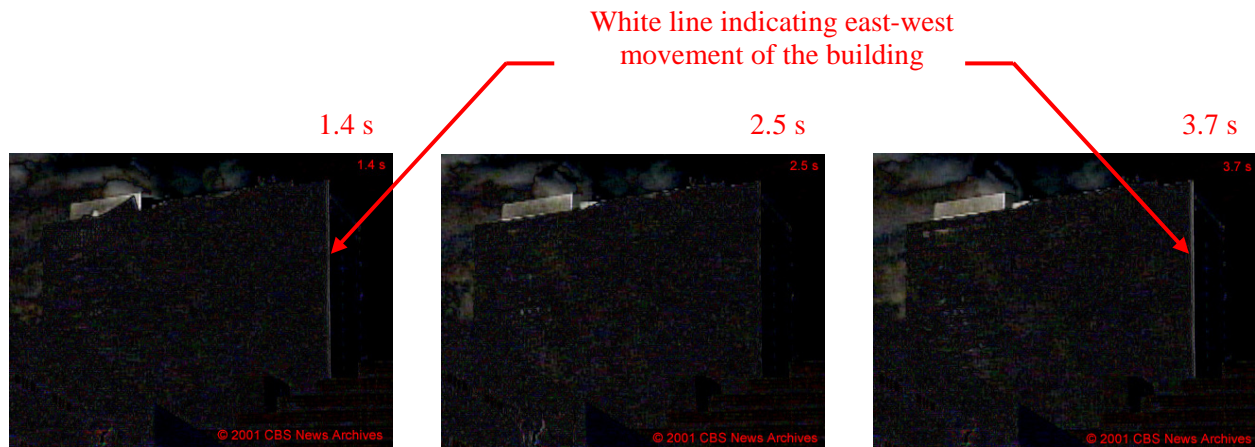
- Horizontal motion of the northwest corner of the building was detected during the collapse of the east penthouse and vertical progression of failure, as evidenced by video frame subtraction, as explained in Section 5.7 (Figure 8–3).

Figure 8–3. Motion of northwest edge of building detected by video frame subtraction.

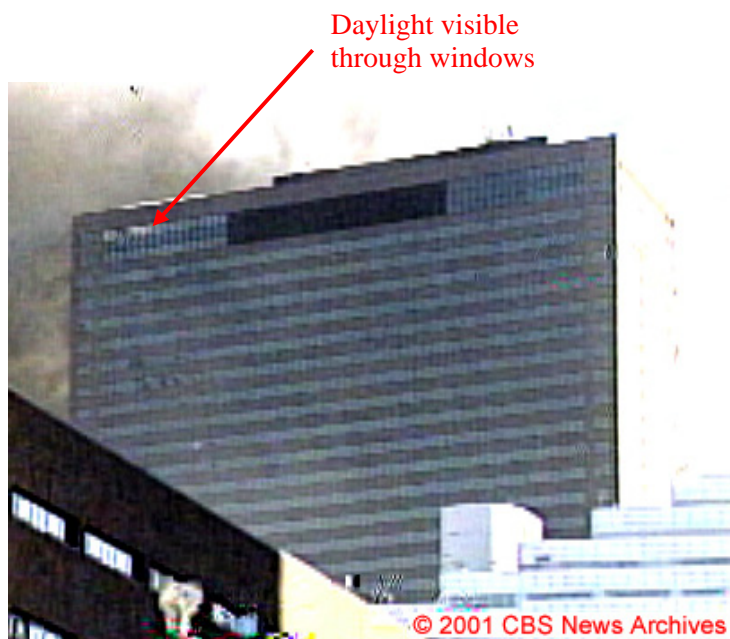
Figure 8–4. Daylight visible where roof collapsed on east side of building.

For the widespread failure of the roof on the east side of the building to occur, as evidenced by daylight visible through the upper story windows (Figure 8–4), it appeared likely that Column 79 failed along with the girders that framed into it (including the one that spanned to Column 44) and the surrounding roof beams. The east side of the east penthouse was observed to first move downward before rotating inward, which would be consistent with loss of support of the failed roof beams. The west side of the east penthouse did not move downward initially (Figure 8–2), but rather rotated about its base, which aligned with the east edge of the core along Columns 76, 77 and 78 (Figure 8–7). Thus, at the time of collapse of the east penthouse, it is likely that at least the east edge of the core was still supporting load.

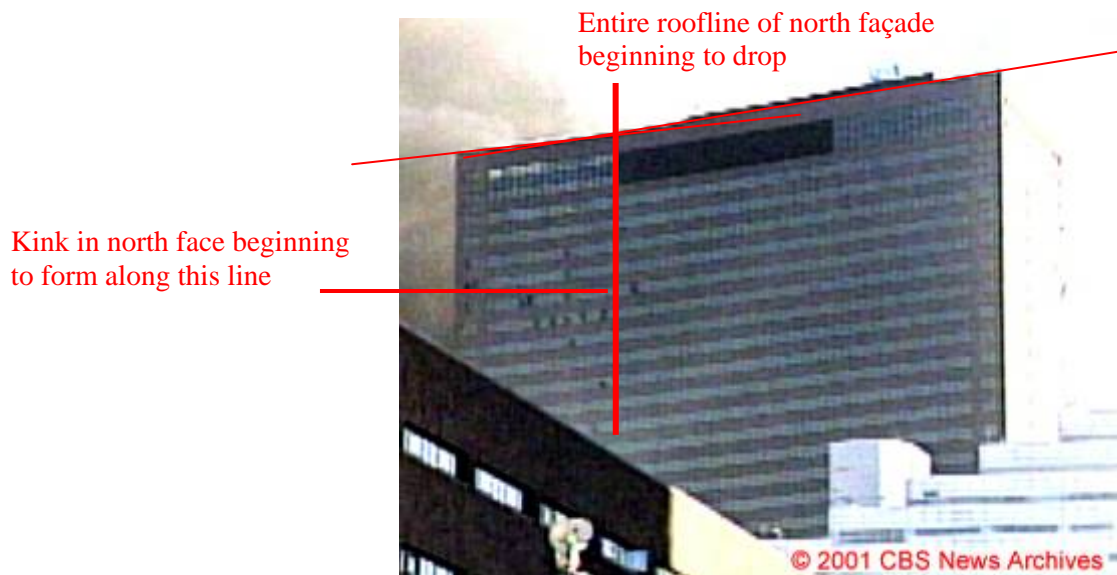
Figure 8–5. Global collapse of WTC 7 begins about seven seconds after the onset of collapse of the east penthouse.

The global collapse of WTC 7 began approximately 7 s after the onset of downward movement of the east penthouse (Figure 8–5). At this time, the entire upper section of the building – all floors visible in the videos – moved downward together, suggesting widespread failure of the support structure (columns and/or transfer trusses) in the lower levels of the building (Figure 8–6).

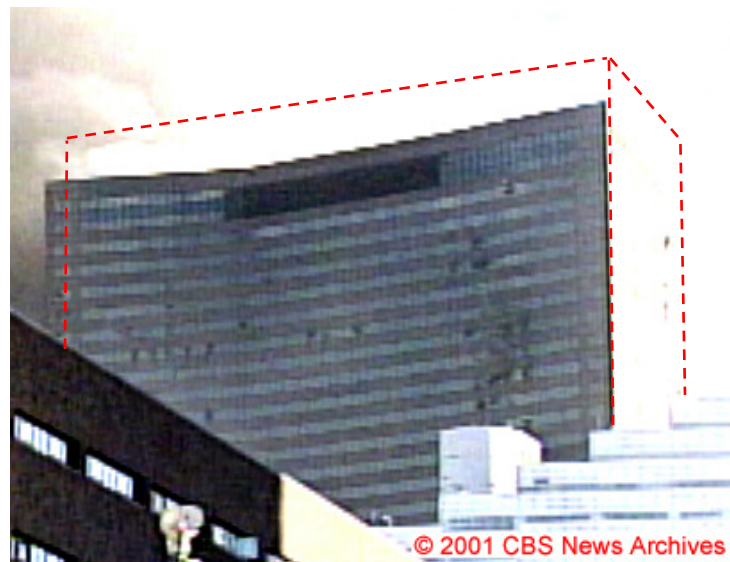
- The entire upper portion of the building, i.e., all floors visible in the videos, began to move downward, and window breakage occurred on the west side of the north face between Columns

53 and 55 as the building collapsed (Figure 8–6). The dashed red lines in Figure 8-6 are the silhouette of the building from Figure 8–1. They are included to provide a qualitative indication of the extent to which the upper portion of WTC 7 had descended.

Figure 8–6. Entire building continues to collapse.

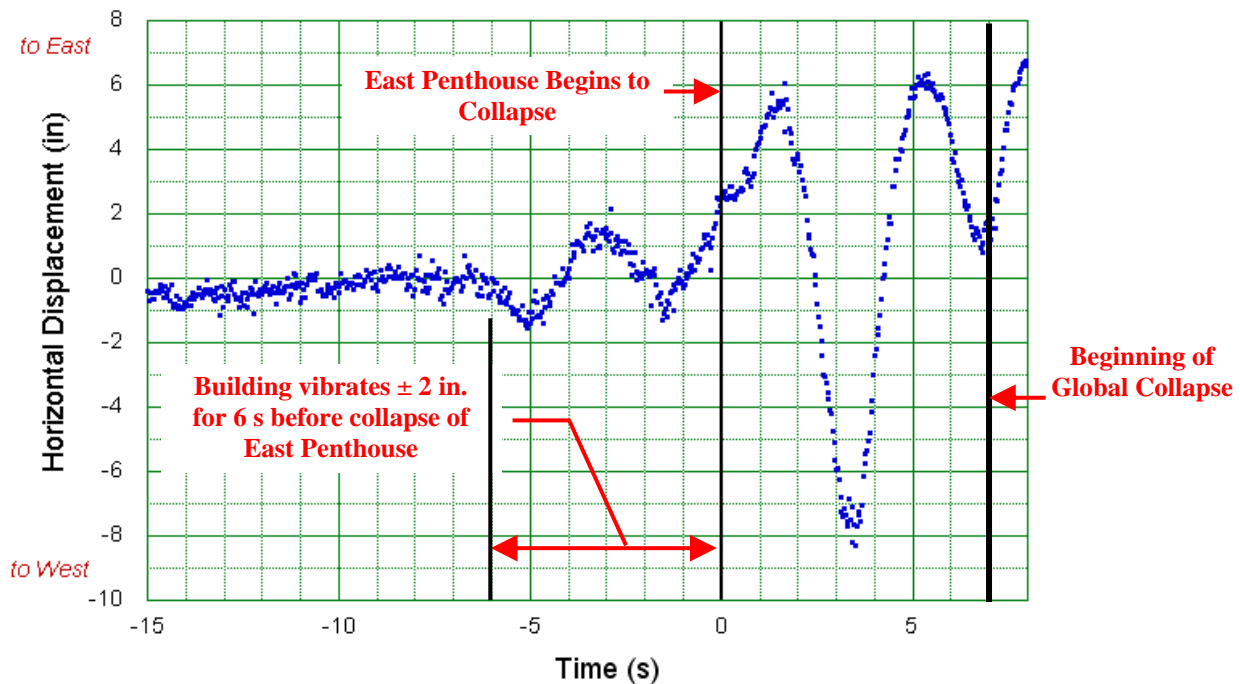
Figure 8–8. Horizontal motion detected on the northwest edge of the building.

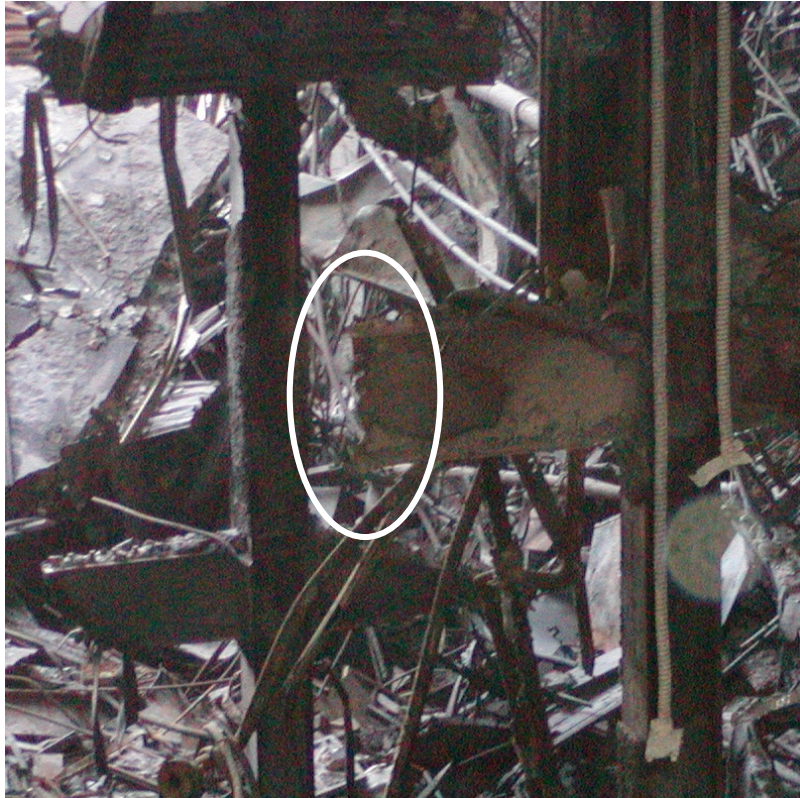
The World Trade Center Building 5 (WTC 5) was a 9 story office building located on the northeast corner of the World Trade Center Plaza. The collapse of WTC 1 caused damage to WTC 5 and started fires in it (McAllister 2002). The uncontrolled fires resulted in complete burnout of most floors and partial collapse of four floors. The building was steel frame construction with field-bolted connections between floor beams and column tree assemblies. Failure of large sections of floor, in areas not damaged by falling debris from WTC 1, resulted from bolt tear-out at these connections as a result of the uncontrolled fires (Figure 8–14). Photographs of two recovered samples of floor beams (Figure 8–15) show how the field bolts tore out from the beam web weakened by the fires (McAllister 2002).

Figure 8–14. Tear-out of beam web due to uncontrolled fires.

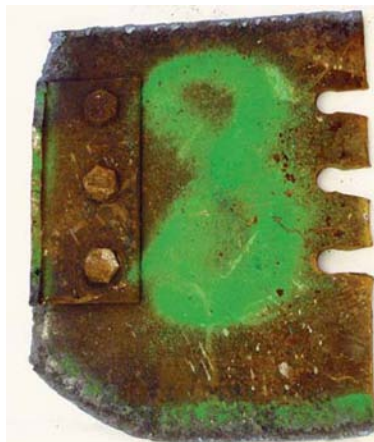
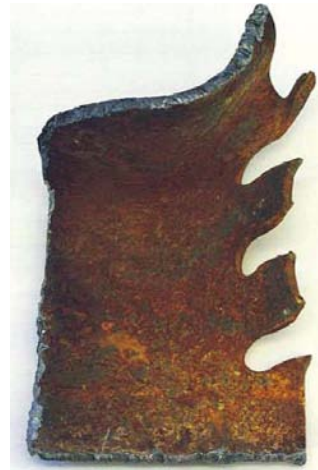
Figure 8–15. Steel samples recovered from WTC 5, showing tear-out of beam web.

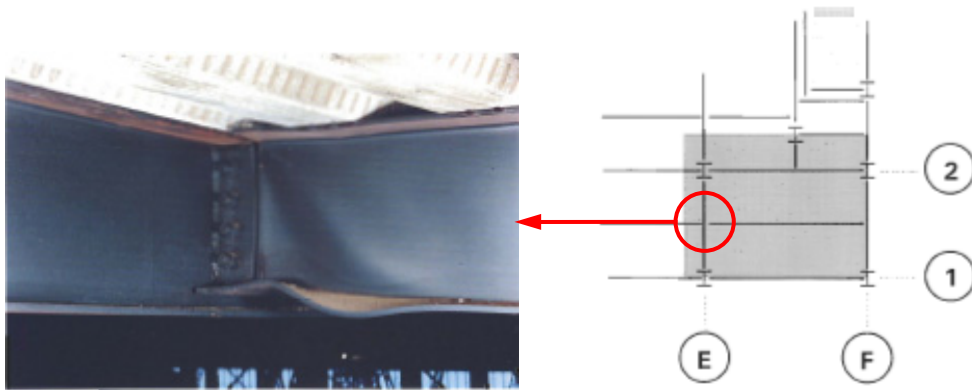
example, Cardington Test No. 3 exposed one bay to a wood crib fire resulting in gas temperatures that reached almost 1000 °C. The floor beam in this test framed into a girder on column line E, and into a spandrel beam on the building exterior on column line F (Figure 8–17). Thermal expansion of the floor beam framing into the girder on column line E was resisted by a floor beam framing from the opposite side (the floor beam spanning between column lines D and E), resulting in forces sufficient to buckle the bottom flange. The top flange of the beam did not buckle, since both the primary and secondary beams were tied to the slab using shear studs.

Figure 8–17. Floor beam buckling at symmetrical framing to girder.

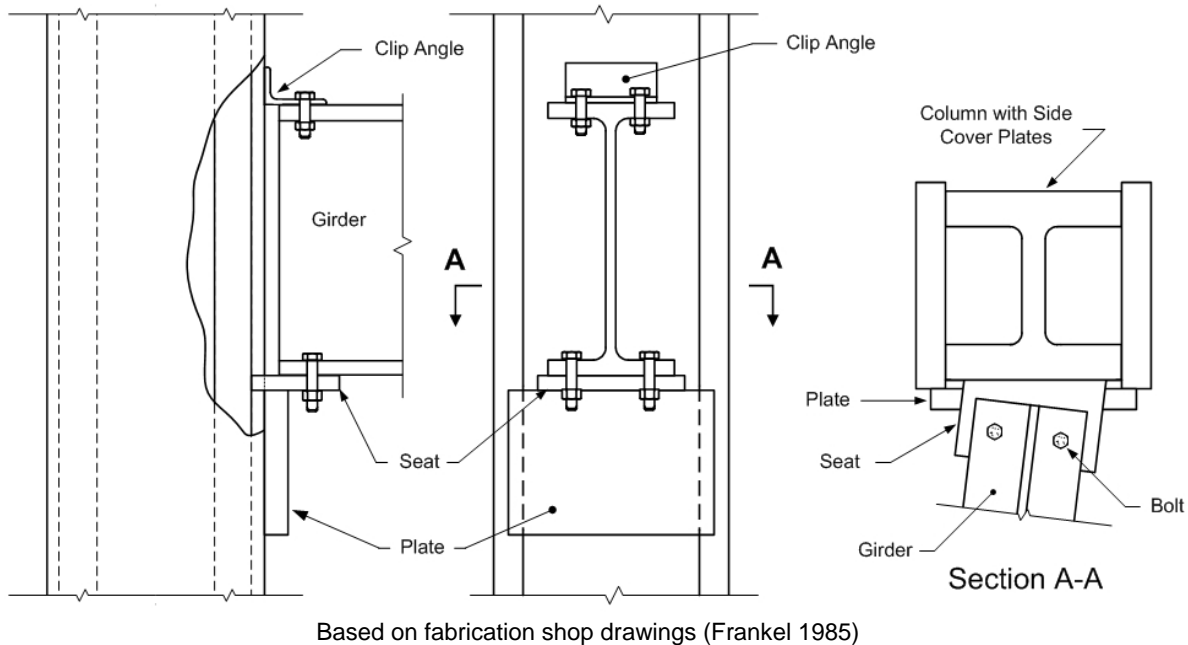
Consider the girder that spanned between Column 79 on the interior of the building and Column 44 on the exterior. Thermal expansion of this girder would have loaded the erection bolts in shear, since (1) there were no shear studs anchoring the girder to the slab (and thereby restraining elongation), and (2) the columns were prevented from lateral movement because they were embedded in the floor slabs which had considerable in-plane stiffness. Additionally, the expansion of floor beams that framed into this girder, because the framing was asymmetrical, tended to add additional shear load to the erection bolts. The combination of these two shear loads could have failed the bolts in shear. If the erection bolts were to fail, then there would be no positive attachment preventing the girder from being pushed off the seat.

Figure 8–21. Seat connection at Column 79.

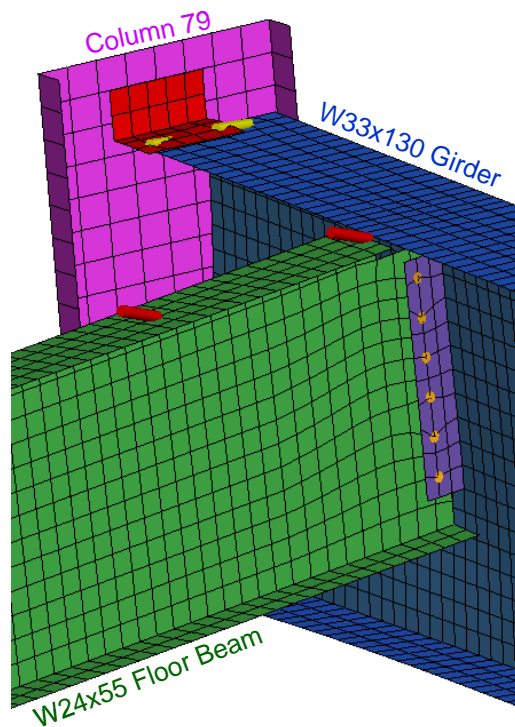
failed, leaving the girder essentially unrestrained against rotation at both ends. After failure of the erection bolts in the seat at Column 44, continued axial expansion of the floor beams pushed the girder laterally, where it came to bear against the inside of the column flange. Axial compression then increased in the floor beams, and at a beam temperature of 436 °C, the northmost beam began to buckle laterally. Buckling of other floor beams followed as shown in Figure 8–27 (a), leading to collapse of the floor system, and rocking of the girder off its seat at Column 79 as shown in Figure 8–27 (b). The collapse process took time to occur in the LS-DYNA analysis, during which the temperatures had ramped up to their maximum values in the simulation.

Figure 8–26. Lateral displacement of girder due to thermal expansion of floor beam.
Note: failed bolts and shear studs

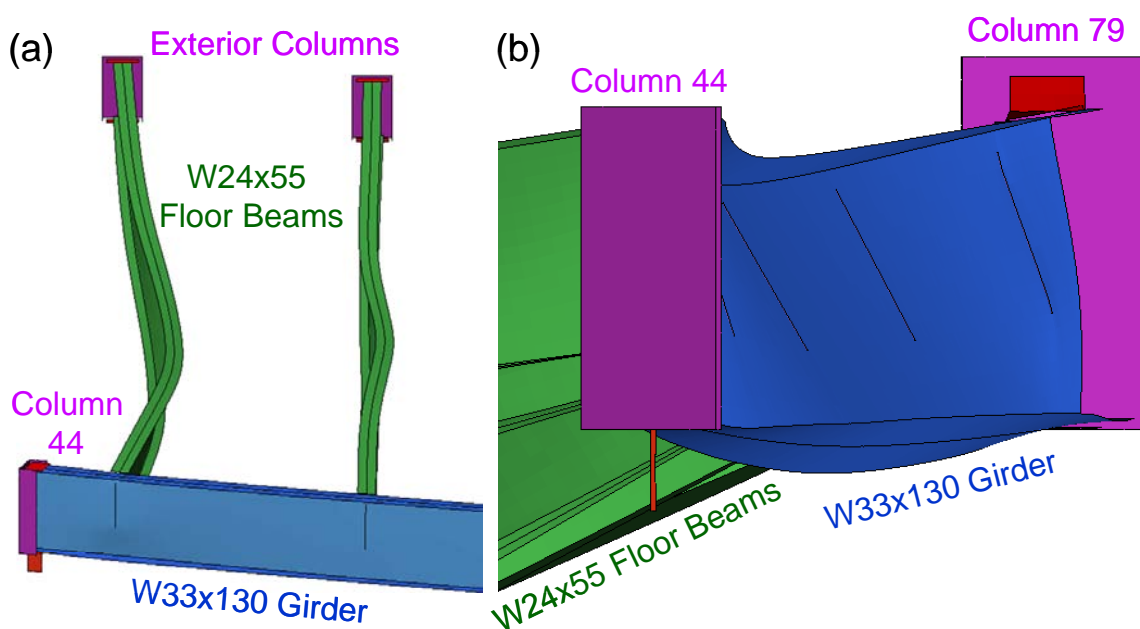
Figure 8–27. Buckled floor beams shown from above (a) and along girder (b).

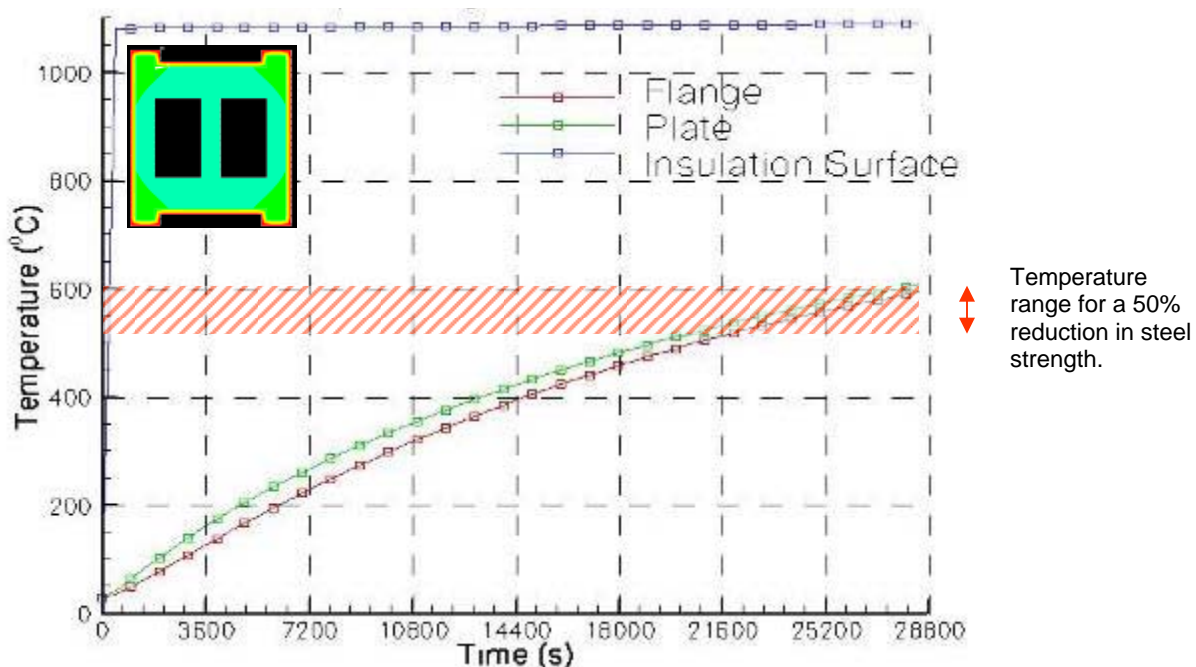
Chapter 8 suggests that the initial effect of a fire weakening the building structure would have occurred on the east side of the building. The interior columns that might have been affected were Columns 79, 80, and/or 81. Figure 9–3 shows the developing thermal conditions for these heavy columns, insulated with 9/16 in. of thermal insulation³, when exposed to a uniform temperature of 1100 °C. It would have required a continuous, fully developed fire at the location of a column for approximately 7 h for a 50 percent reduction in its strength to occur (Section 4.1.2, NIST NCSTAR 1-6).

Figure 9–3. Minimum heating of reinforced heavy columns to initiate global collapse.
The column modeled is a W14x730 with 9/16 in. of thermal insulation.

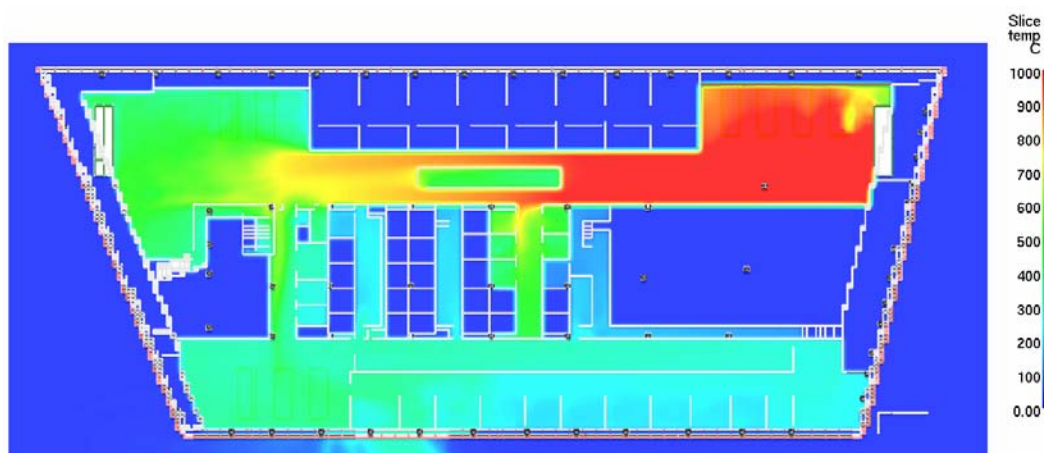
Scenario 1.a, maximum duration, over-ventilated fire: To be sustained for the approximately 7 h between the collapse of WTC 1 and the collapse of WTC 7, the fuel would have had to be pumped at about 1.8 L/s (29 gal/min), which was well within the capacity of the pumps. A large open pool of diesel fuel burns at a surface regression rate of about 4 mm/min (Gottuk and White 2002). A pool fire that burned the fuel at the same rate as it was being pumped would have had a surface area of about 30 m². For the purpose of the simulation, the pool was assumed to be a square, 6 m on a side, sited underneath the valve rig at location (a) in Figure 9-1. The needed air would have been supplied by continuously operating fans (95 m³/s, 200,000 ft³/min) and through breached partitions at elevator lobbies and the large gap on the south face. The steady state heat release rate from the over-ventilated fire would have been 50 MW to 60 MW. As suggested by the FEMA Building Performance Study Report (McAllister 2002), this fire scenario could have heated critical structural elements to high enough temperatures that the structural elements would have become incapable of maintaining the required load.

Figure 9–4. Gas temperatures near the 5th floor ceiling for the hypothetical maximum duration, over-ventilated diesel fuel pool fire after 7 h (Scenario 1.a).

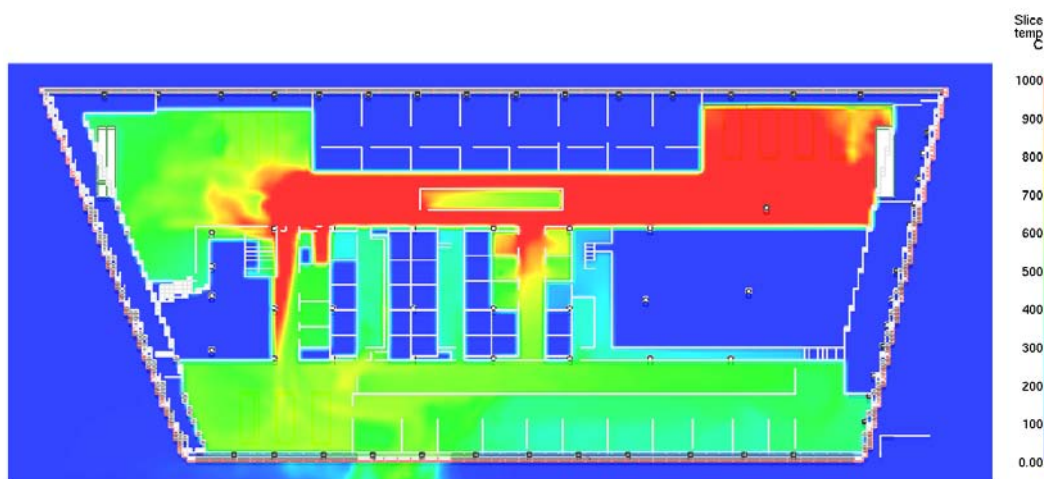
Result: The predicted temperatures of the upper layer of the 5th floor about 3.5 h into the fire are shown in Figure 9–5. The temperatures were somewhat higher across the floor as compared to Scenario 1.a, even though the total energy content was the same (that is, 100 MW to 120 MW heat release rate for half the time). The higher temperatures were due to the reduced amount of time for heat to be lost through the walls. The outcomes for Scenarios 1.a and 1.b were the same: the high temperatures near Column 79 could not be sustained because the environment around all the diesel generators and the electrical distribution system would likely have caused the electrical power to the fuel pumps to fail. Neither Column 79 nor the 7th floor composite floor system would have been thermally weakened.

Figure 9–5. Gas temperatures near the 5th floor ceiling for the hypothetical maximum intensity, over-ventilated diesel fuel pool fire after 3.5 h (Scenario 1.b).

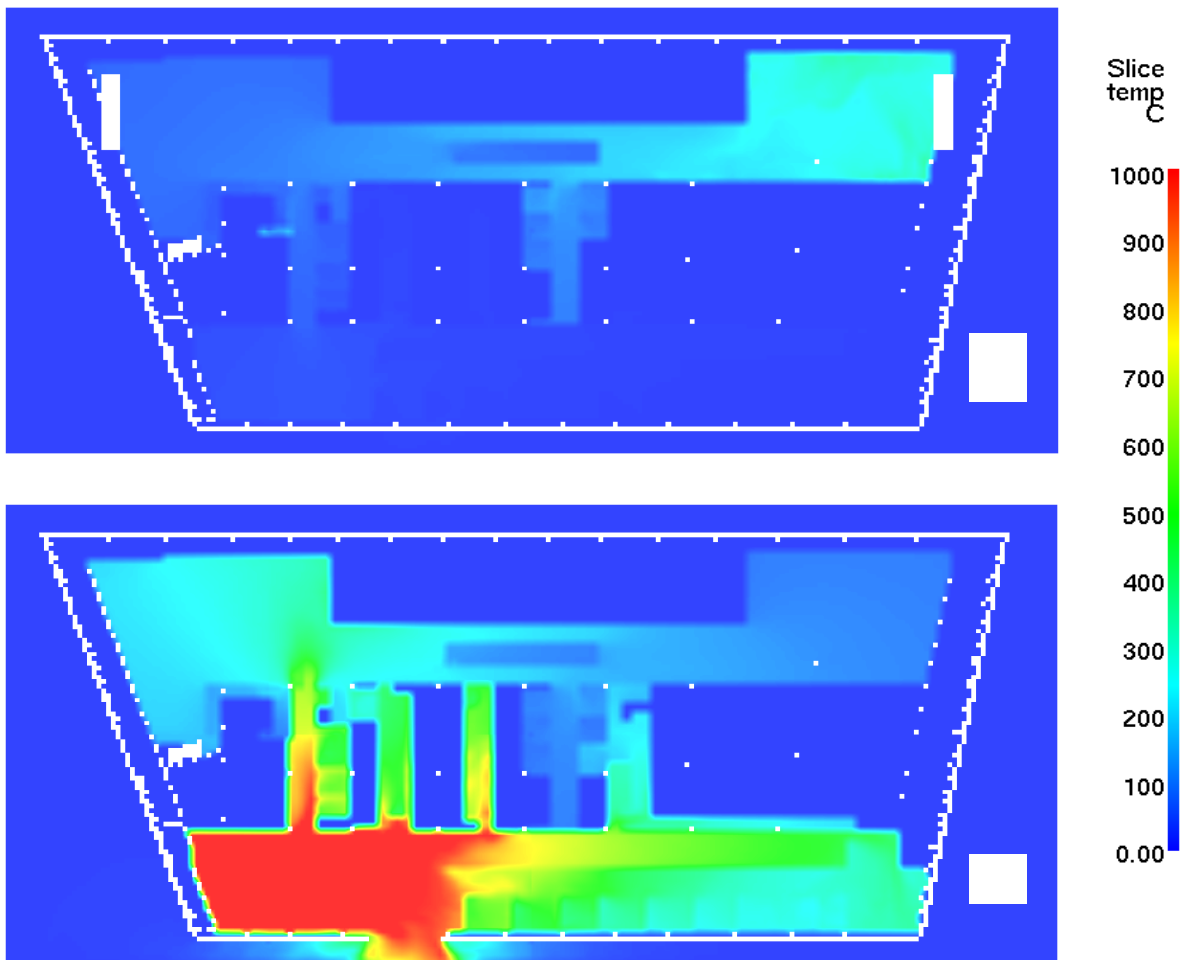
Result: An FDS simulation showed gas temperatures near the ceiling ranging between 300 °C and 400 °C after about 15 min. A map of the temperatures near the ceiling for this time is shown in Figure 9–6a. Figure 9–6b shows the estimated gas temperatures near the ceiling more than two hours later,

Figure 9–6. Gas temperatures near the 5th floor ceiling for a hypothetical under-ventilated diesel fuel pool fire with the louvers closed (Scenario 1.c); (a) after 15 min; (b) after 3 h.

when the oxygen in the vicinity of the liquid fuel had been consumed and the flames were forced to find a fresh supply in the southwest corner of the building. This stage of the fire was highly speculative since the flames were no longer available to provide the heat needed to vaporize the diesel fuel in the pool. At any rate, the sustained temperature in the vicinity of Column 79 did not exceed 400 °C. Thus, the column temperature would not have risen to the point where significant loss of strength could have occurred. The generators in the northeast, northwest, and southwest sections would likely have all ceased to operate at these temperatures. Neither Column 79 nor the 7th floor composite floor system would have been thermally weakened.

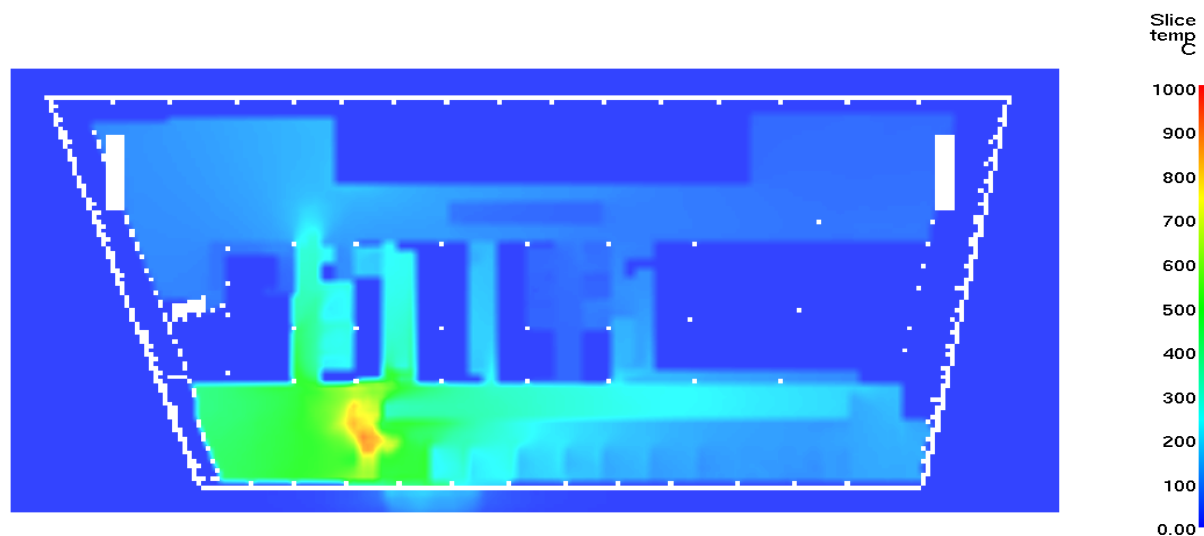
Result: The air flow through the breach in the south wall was sufficient to consume the fuel and support an approximately 60 MW fire. The temperatures near the ceiling of the 5th floor above the southwest corner generator room quickly exceed 1000 °C, which would have caused the generators in this corner to fail soon after the fires would have begun. The generators on the north side would not have been able to operate after their fuel supply line was broken. However, if, somehow, enough fuel was able to keep at least one generator operating, the temperatures near the ceiling of the 5th floor might have reached the close-to-steady state shown in Figure 9–7. Note that the ceiling in the generator room was the bottom of the 7th floor slab. The plume from the fire was predicted to extend well outside the breach on the south wall. There was no photographic evidence of fires originating from this area; however, the actual fire would have been difficult to distinguish from the plumes of other fires and dust on the south side of WTC 7. The nearby columns, especially those whose insulation was damaged by the debris from WTC 1, likely would have reached temperatures high enough to decrease their strength substantially. However, this scenario provided no open path for the hot gases to reach Columns 79. Any weakening of the 7th floor composite floor system would have been on the south side of the building, in the same region as the debris damage from the collapse of WTC 1.

Figure 9–7. Gas temperatures near the 5th floor ceiling for a hypothetical diesel fuel pool fire in the southeast generator room in steady-state (Scenario 2).

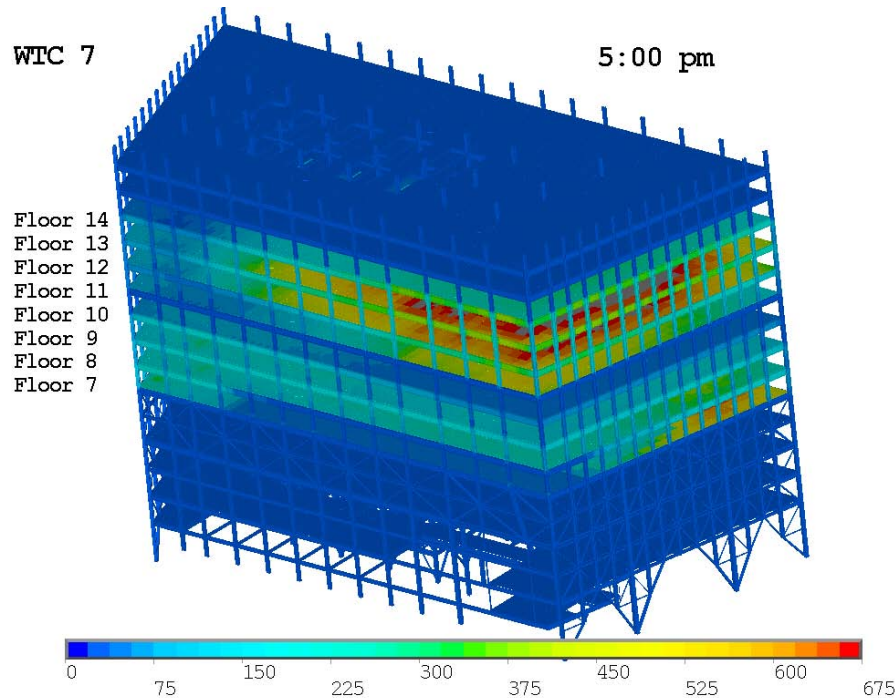
Figure 10–2 shows the thermal data generated with FSI and subsequently transferred to the ANSYS and LS-DYNA structural models for analysis (Chapters 11 and 12). The figure shows the exterior and core columns extending from the ground level to Floor 16. The figure also shows the beams and concrete floor slabs. Only a fraction of the entire model is visible because of the concrete slabs. As noted above, the simulations showed essentially no thermal gradient across the thickness of the steel components. The depicted slab temperatures are in the midpoint of the uppermost thermal element. For the 7th floor slab, this was approximately 12.5 mm (0.5 in.) below the top surface; for the other floors, this was approximately 6 mm (0.25 in.) below the top surface.

Figure 10–2. View from the southeast of the computed thermal loading of the 16 lower floors of WTC 7 at 5:00 p.m. (Case A).

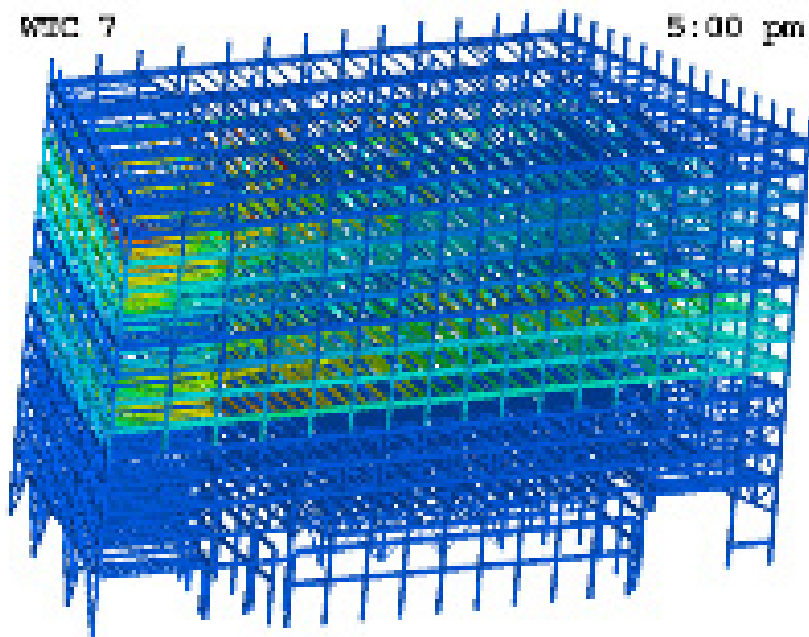
Figure 10–3 shows a view of the same 16 floor simulation from the northeast corner. Here, the concrete slabs have been removed in the image to allow a better view of the internal floor beams and columns.

Figure 10–3. View from the northeast of the computed thermal loading of the 16 lower floors of WTC 7 at 5:00 p.m. (Case A, floor slabs removed).

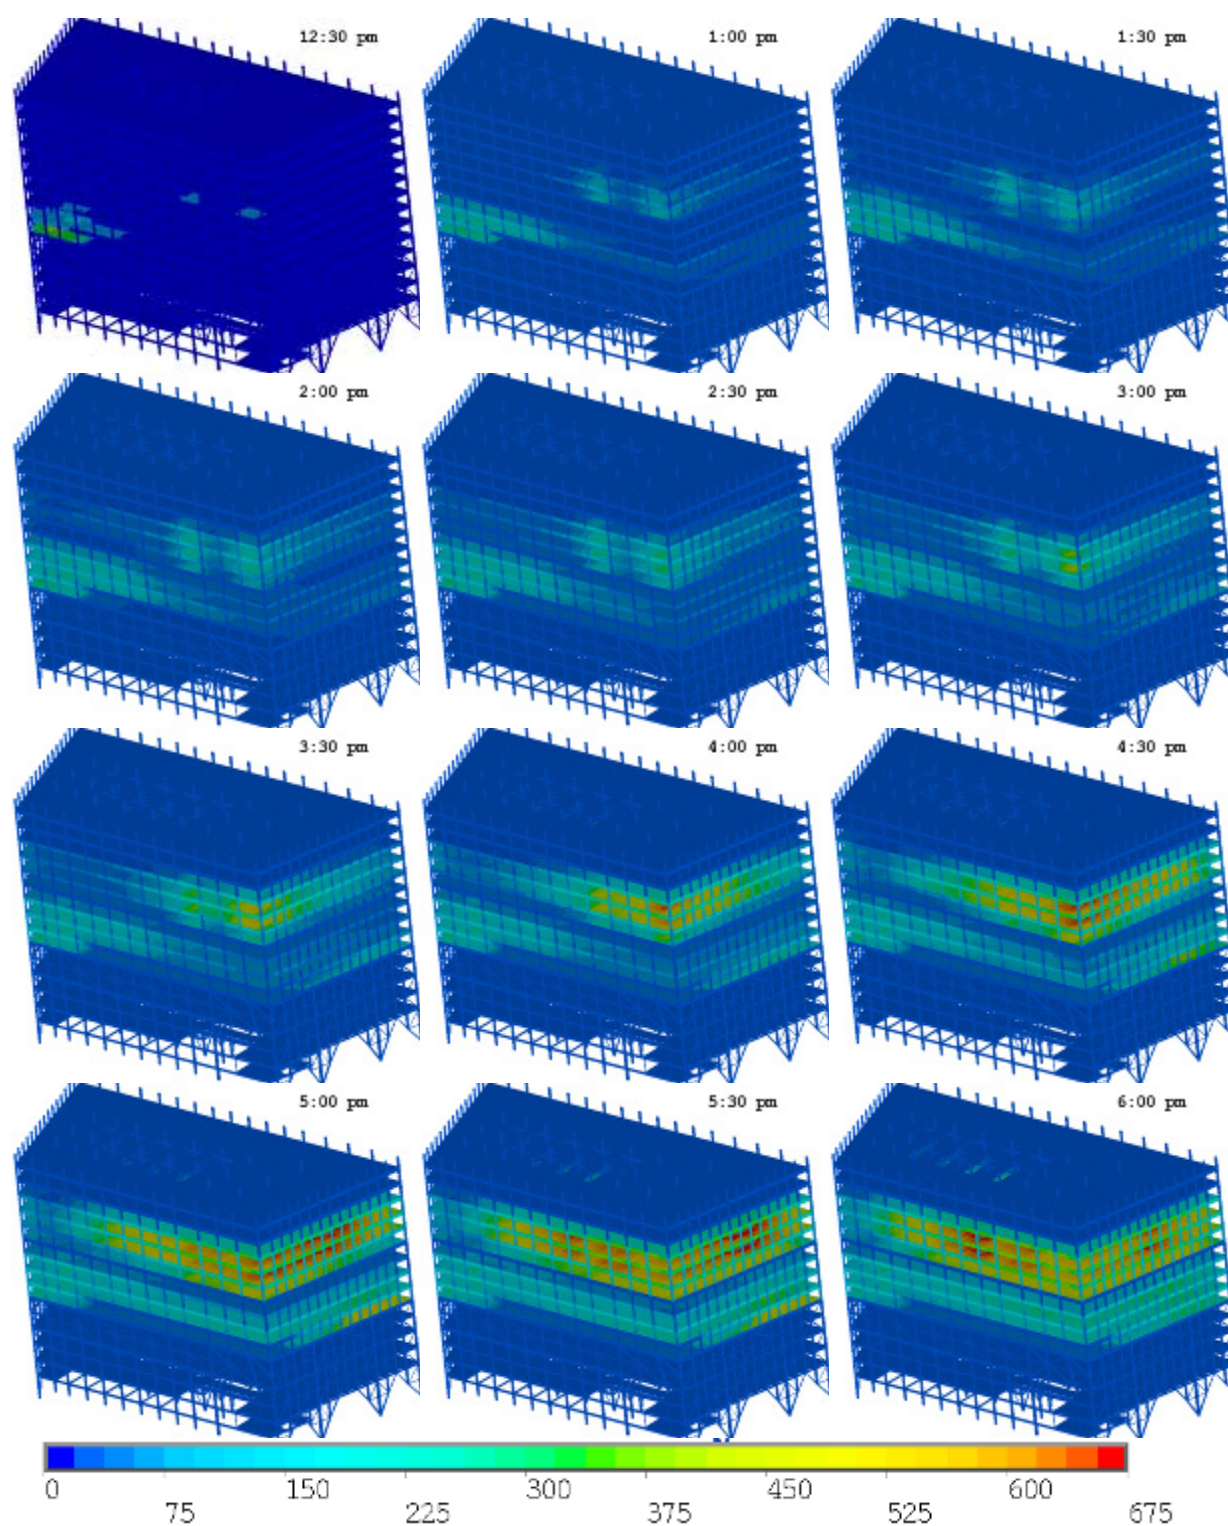
Figure 10–4 shows the thermal loading on the 16 floor model at 12 different instants in time. Each sub-figure shows a view of the WTC 7 model from the southeast corner, similar to that shown in Figure 10–2. Each sub-figure shows the thermal state at the time stamp noted in the top right hand corner. The results are presented at half hour intervals, with the first sub-figure showing the thermal loading at 12:30 p.m.

Late in the day, the most intense heating was in the northeast sector and the center of the south wall, just east of where there was extensive debris damage.

Figure 10–4. View from the southeast of the computed thermal loading of the lower 16 floors of WTC 7 at 12 different instants in time (Case A).

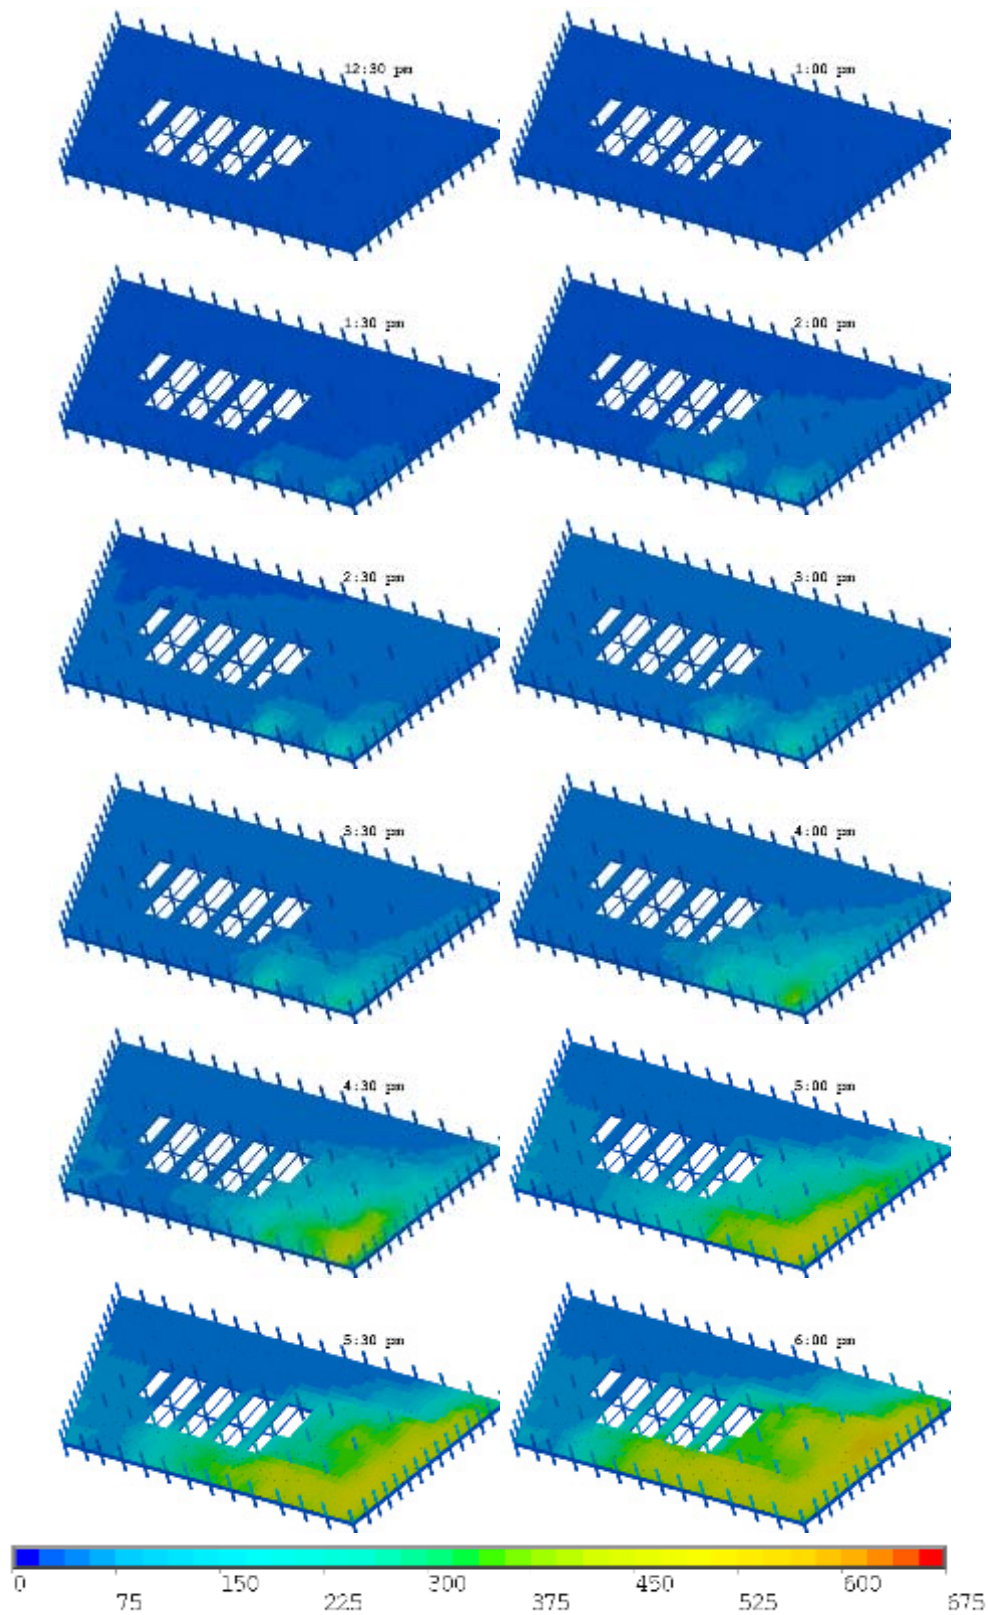
Figure 10–14 and Figure 10–15 show the thermal response of the 11th floor. In Figure 10–15, the cold floor beams reflected the absence of a fire on the 10th floor. The fire on the 11th floor caused only a modest temperature rise in the insulated columns. The temperature on the top of the floor slab approached 600 °C on the east side of the floor.

Figure 10–14. Computed temperature distribution (°C) in the top layer of the concrete slab of Floor 11 at 12 different instants in time (Case A).
