**Federal Building and Fire Safety Investigation of the
World Trade Center Disaster**

**Structural Fire Response and
Probable Collapse Sequence of
World Trade Center Building 7**

VOLUME 1

November 2008

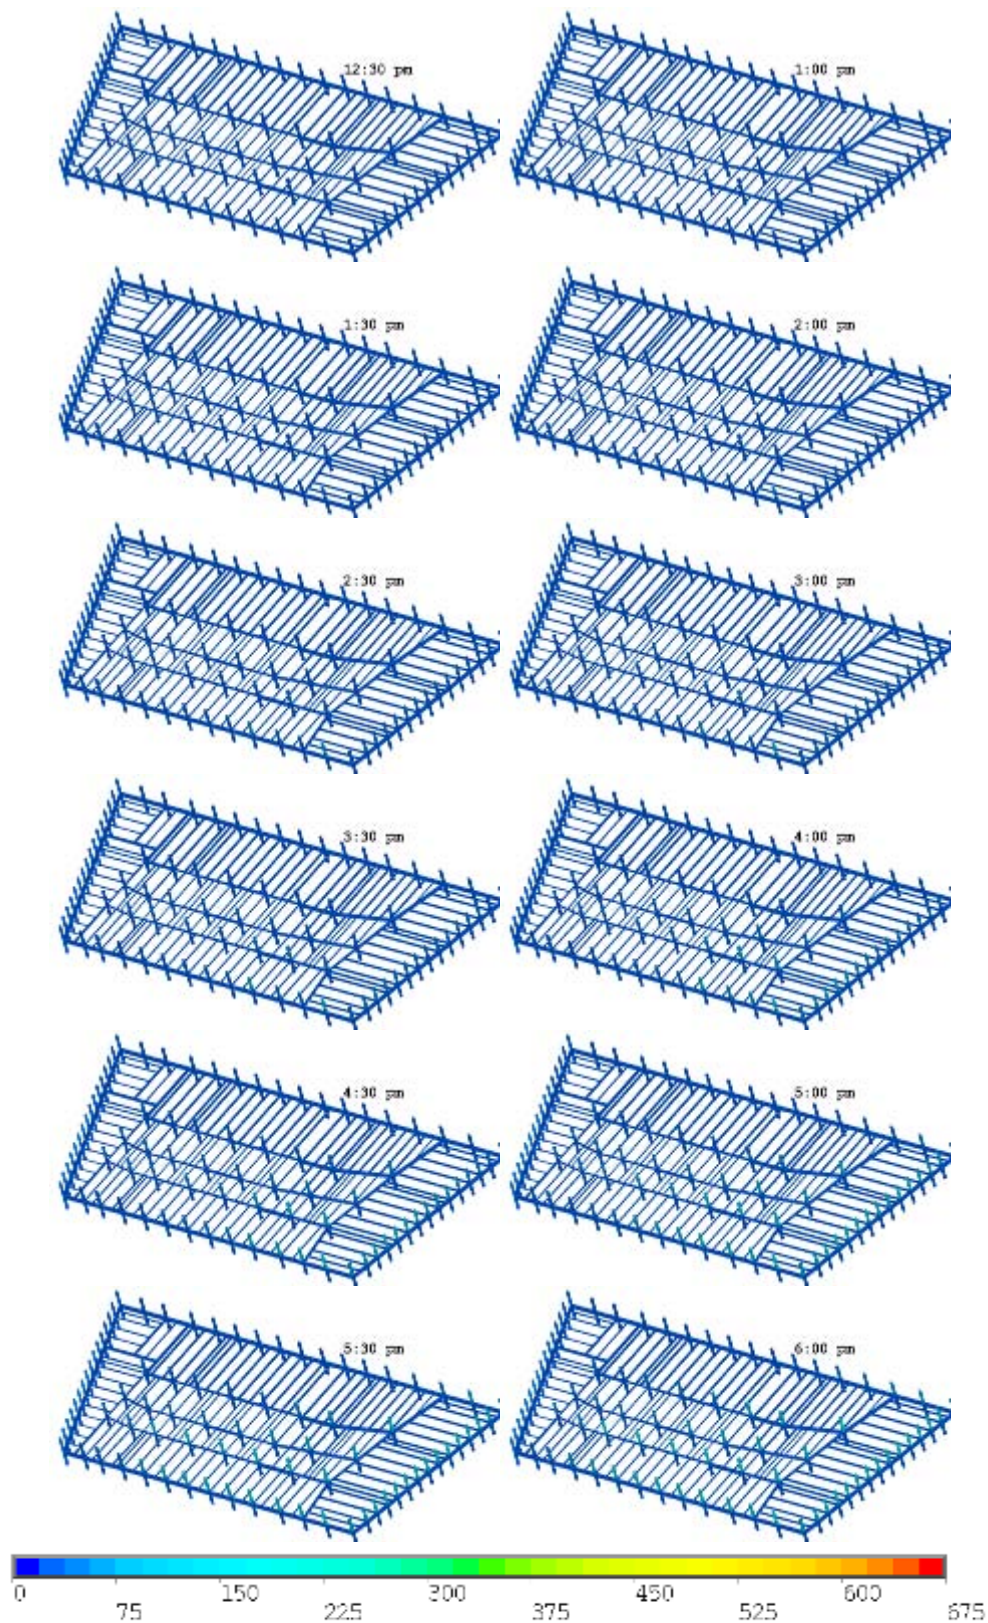
Figure 10–14 and Figure 10–15 show the thermal response of the 11th floor. In Figure 10–15, the cold floor beams reflected the absence of a fire on the 10th floor. The fire on the 11th floor caused only a modest temperature rise in the insulated columns. The temperature on the top of the floor slab approached 600 °C on the east side of the floor.

Figure 10–15. Computed temperature distribution (°C) on the floor beams of Floor 11 at 12 different instants in time (Case A, floor slab removed).

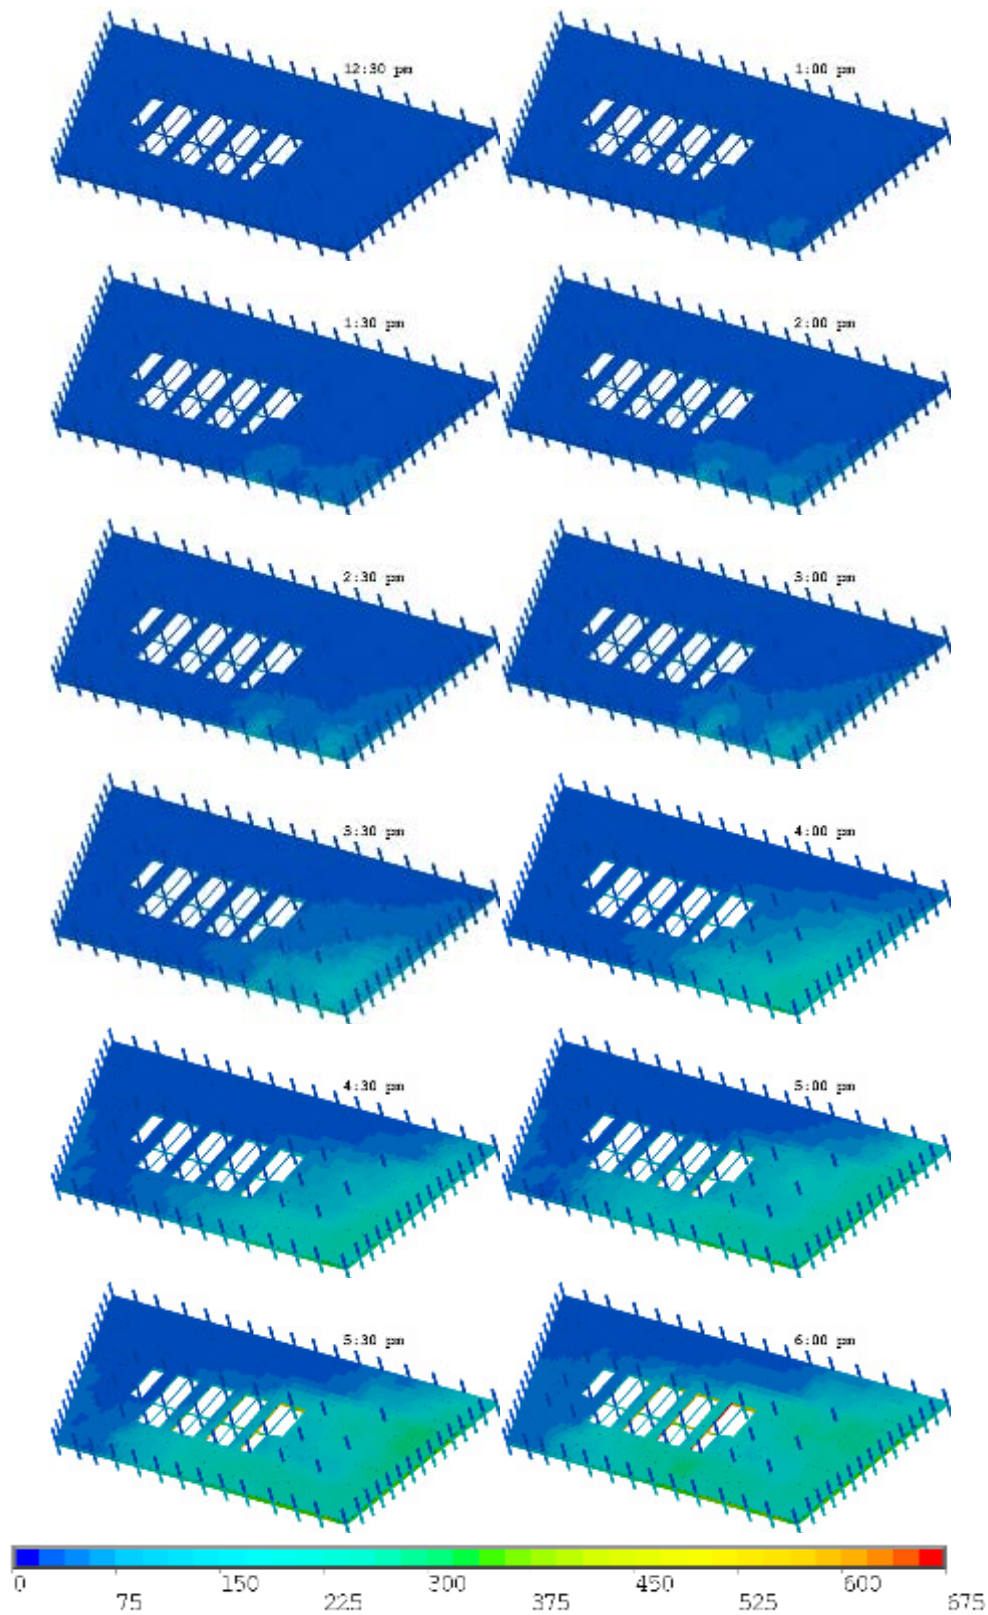
Figure 10–20 provides an example of the degree of conductive heat transfer through the floor slab. With no fire on the 14th floor, but a severe fire on the 13th floor, the temperature on the top of the slab rose only about 100 °C by the end of the simulation. The temperature rise in the floor beams in Figure 10–21 was as expected from a fire on the 13th floor that was equal to the 12th floor fire displaced one-half hour earlier.

Figure 10–20. Computed temperature distribution (°C) in the top layer of the concrete slab of Floor 14 at 12 different instants in time (Case A).

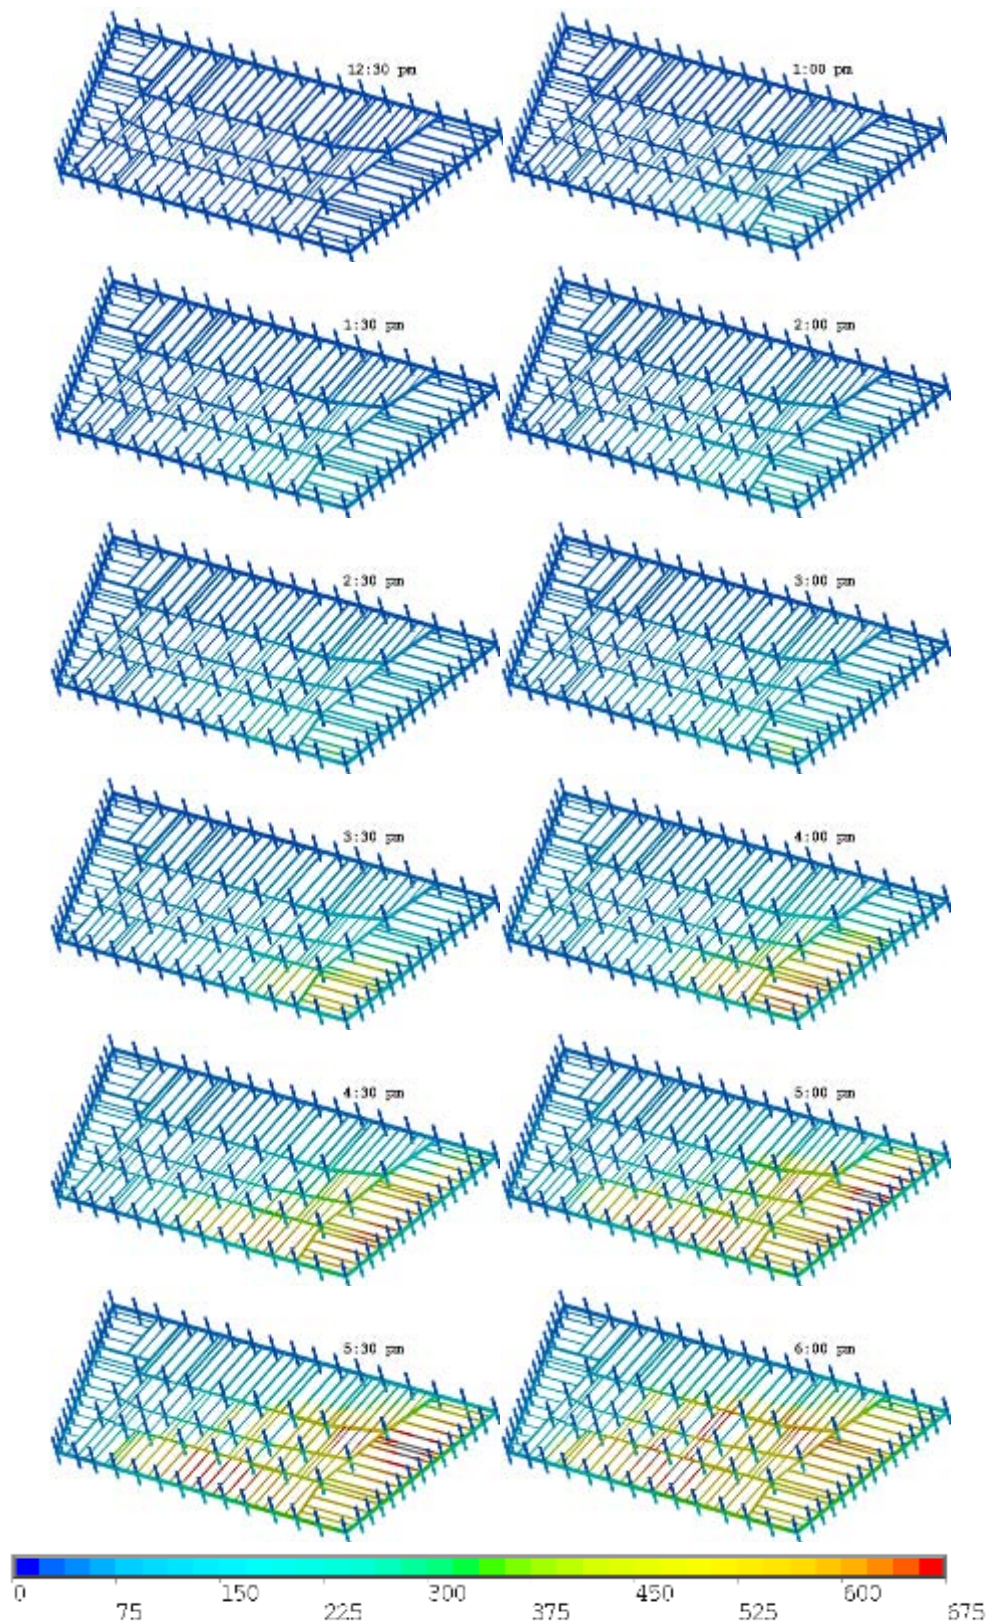
Figure 10–21. Computed temperature distribution (°C) on the floor beams of Floor 14 at 12 different instants in time (Case A, floor slab removed).

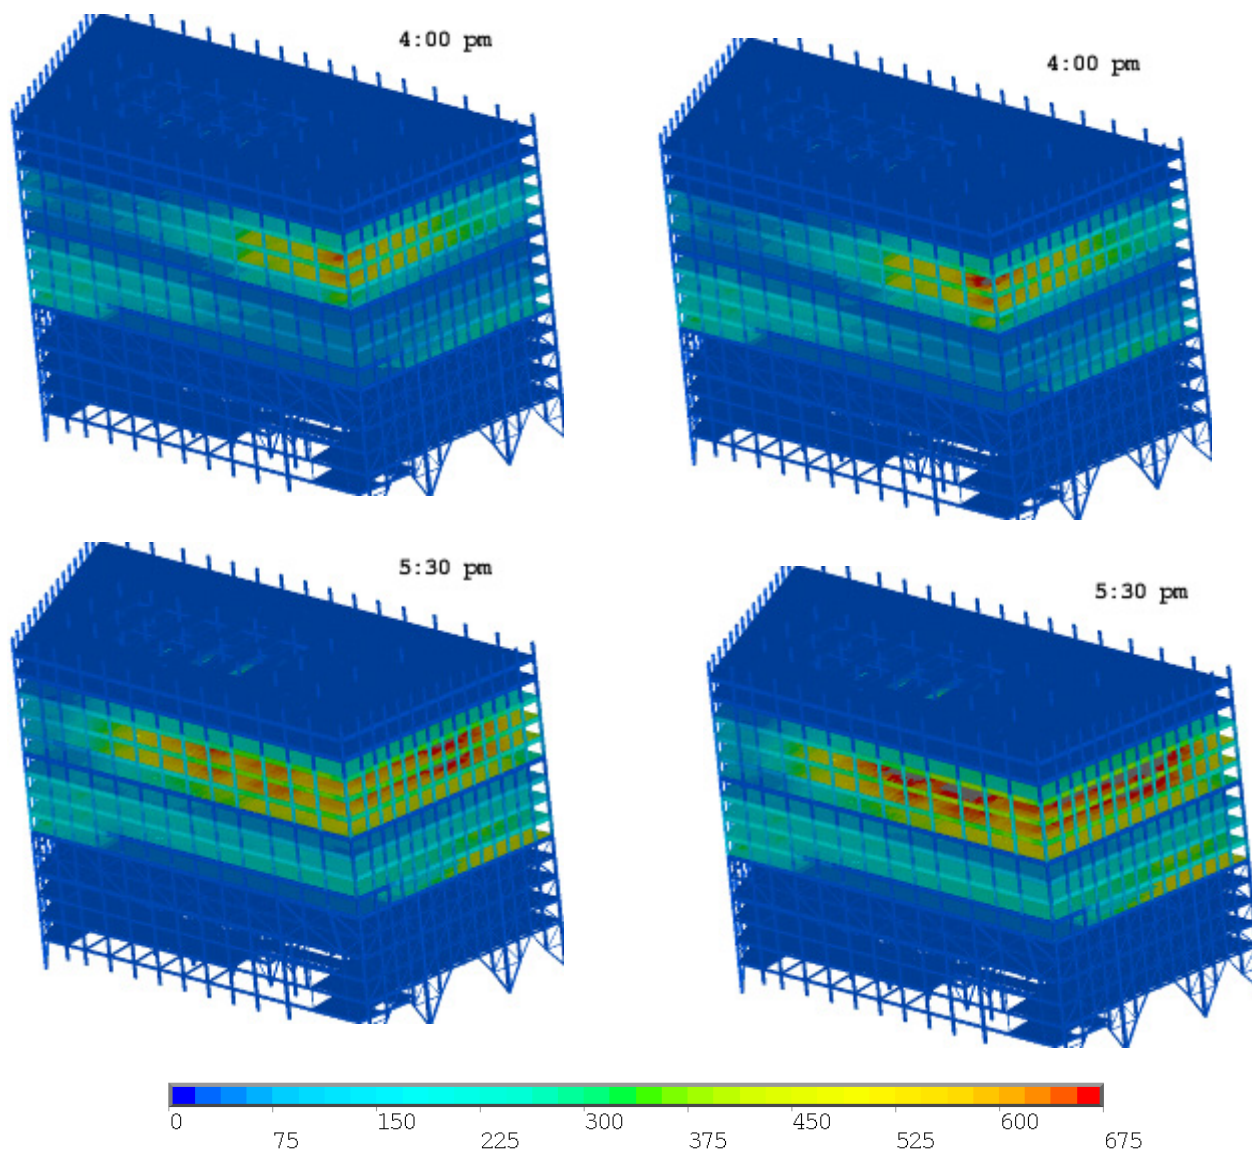
For Case B, the temperature increase at each location on Floors 7 through 14 was assumed to be 10 percent higher than that computed from the FDS simulation of Case A, which was within the expected range of reasonable and realistic fire-generated temperatures. Figure 10–22 and Figure 10–23 compare the temperatures of the building at two times for these two cases. Case A is on the left, and Case B is on the right. As expected, Case B resulted in mildly higher temperatures in the steel and concrete, wider hot zones, and greater overlap of hot zones between adjacent floors.

Figure 10–22. View from the southeast of the 16 lower floors of WTC 7, comparing Case A (left) and Case B (right) temperatures at two different times.

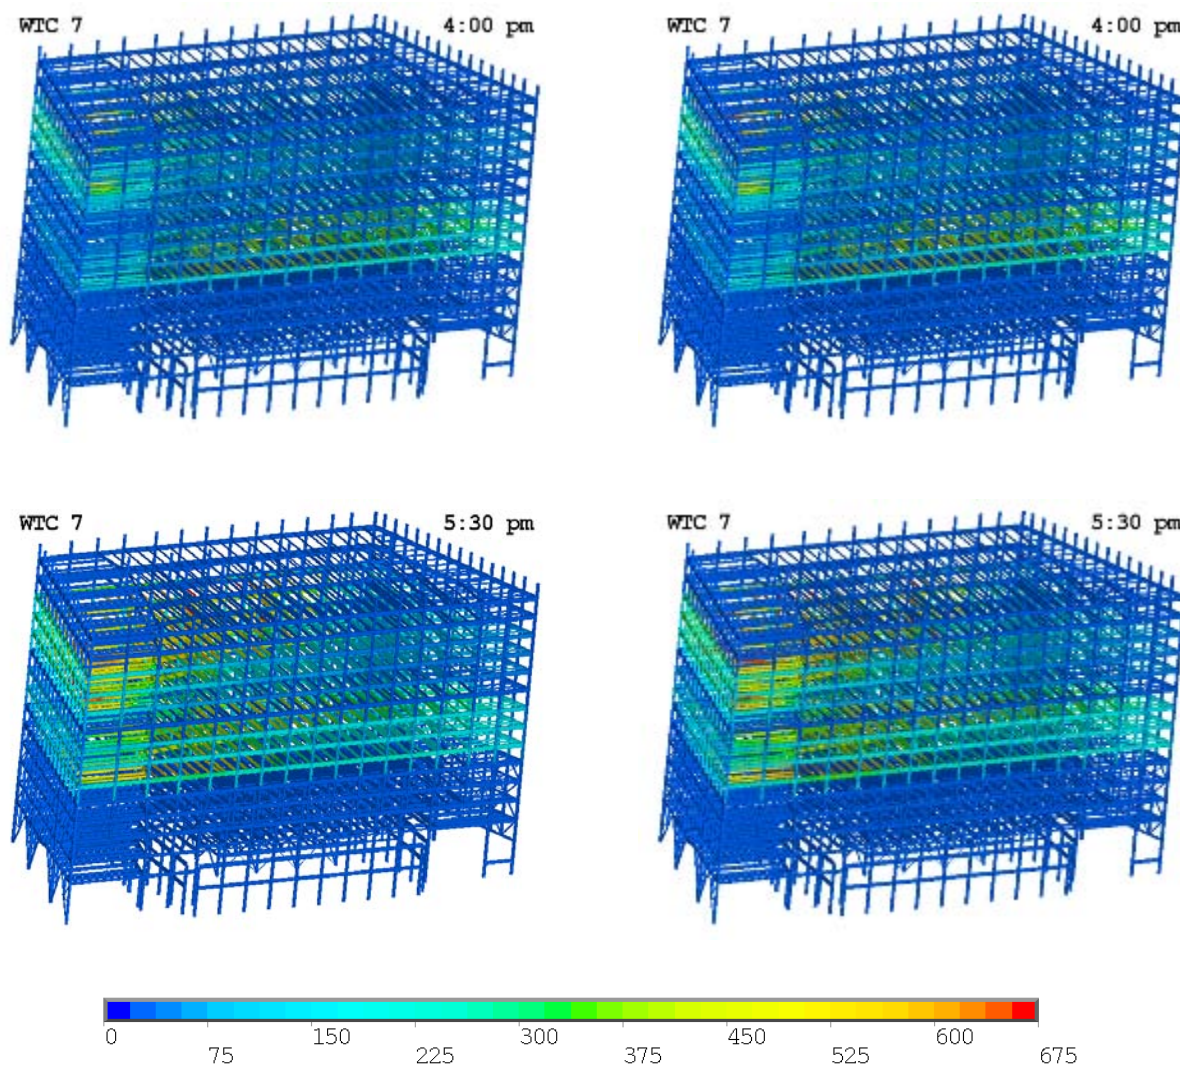
Figure 10–23. View from the northeast of the 16 lower floors of WTC 7, comparing Case A (left) and Case B (right) temperatures at two different times (floor slabs removed).

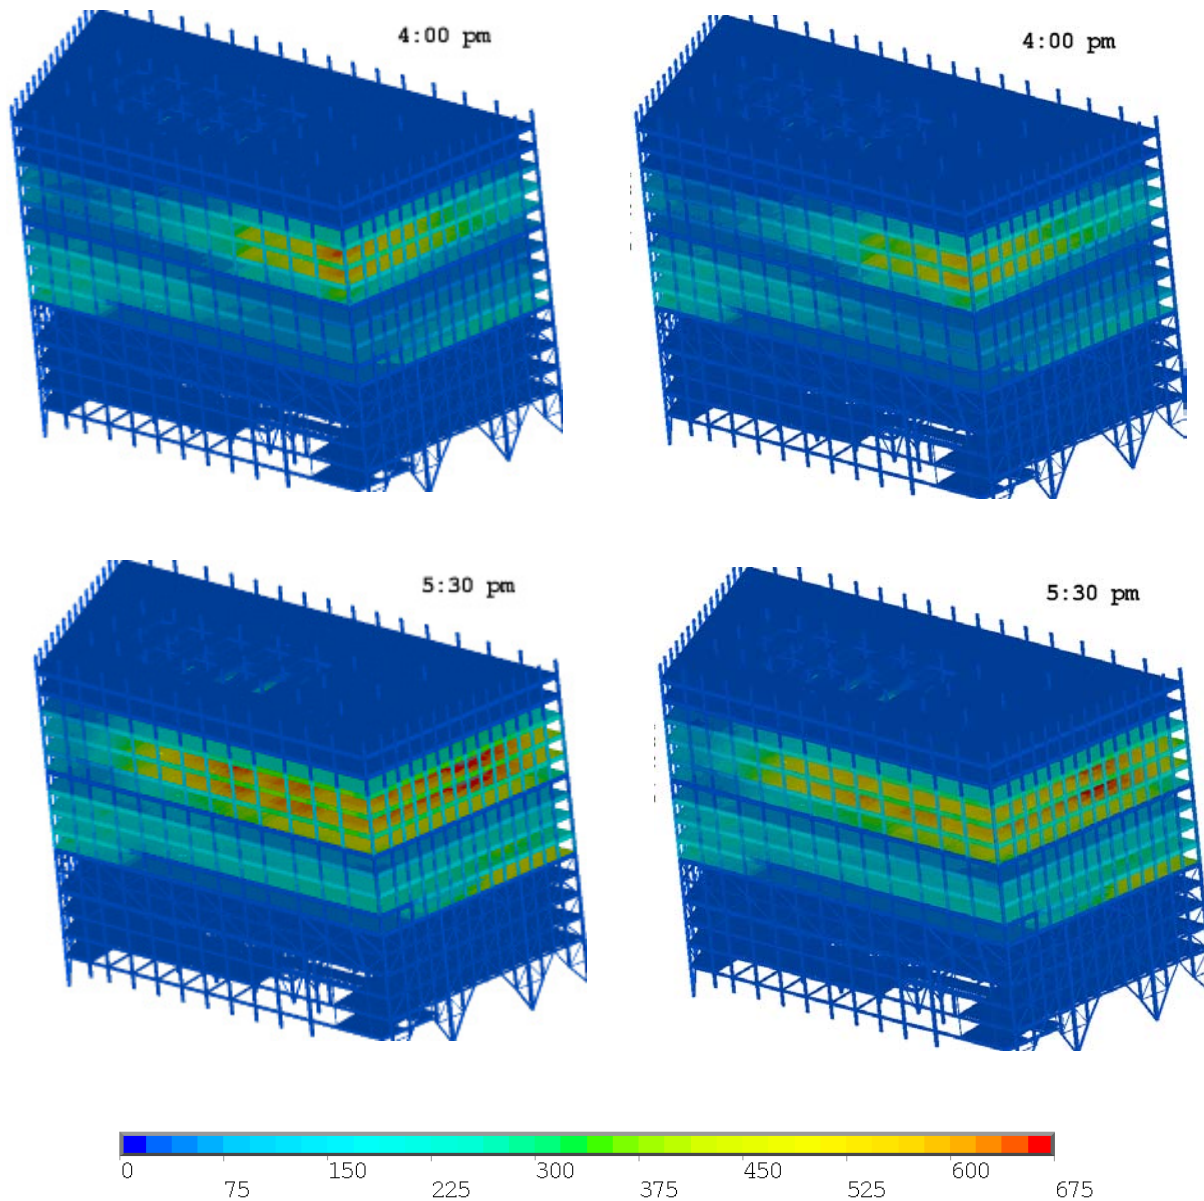
For Case C, the air temperature increase at each location on Floors 7 through 14 was assumed to be 10 percent lower than that computed from the FDS simulation of Case A, which was within the expected range of reasonable and realistic fire-generated temperatures. Figure 10–42 and Figure 10–43 compare the temperatures of the building at two times for these two cases. Case A is on the left, and Case C is on the right. As expected, Case C resulted in mildly lower temperatures in the steel and concrete, narrower hot zones, and lesser overlap of hot zones between adjacent floors.

Figure 10–42. View from the southeast of the 16 lower floors of WTC 7, comparing Case A (left) and Case C (right) temperatures at two different times.

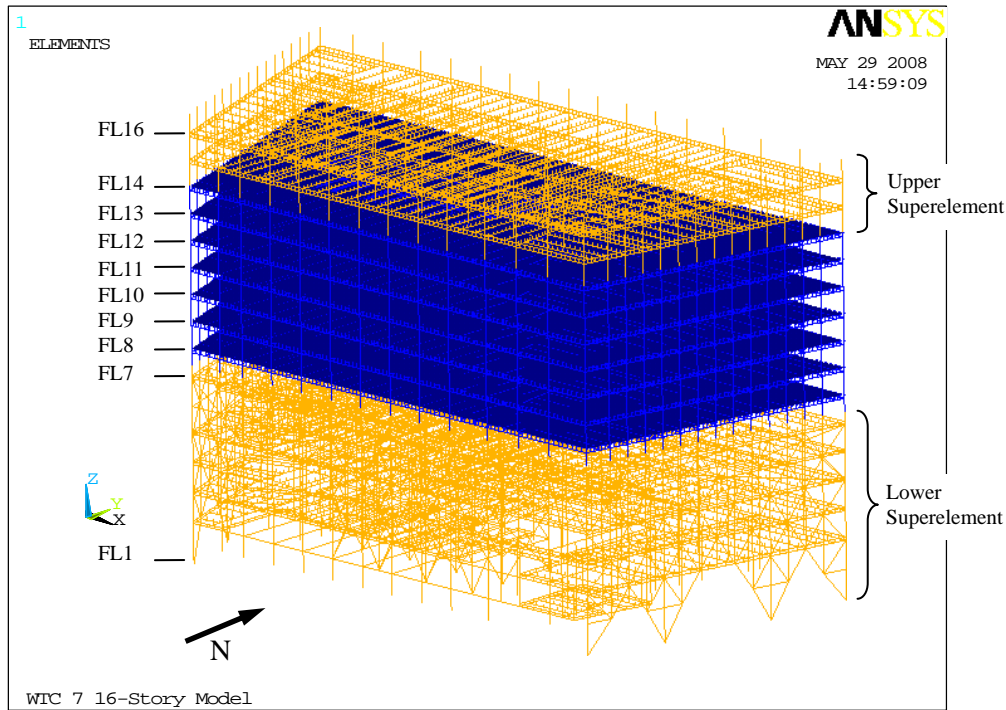
A finite element model, referred to hereafter as the 16 story model, was developed and is illustrated in Figure 11–1. As fires were observed on Floors 7 to 9 and 11 to 13, the floors and columns in these areas were subject to heating and possible thermally induced failures, while floors and columns above Floor 14 and below Floor 7 were not. Floor framing between Floors 8 and 14 and columns between Floors 7 and 14 were explicitly modeled, while Floor 7 and below and Floors 15 and 16 were modeled using superelements. Superelements reduce the degrees of freedom, and hence, computational time, while appropriately representing the stiffness at the top and bottom of the model.

Figure 11–1. 16 story model representing lower 16 floors of the WTC 7 building.

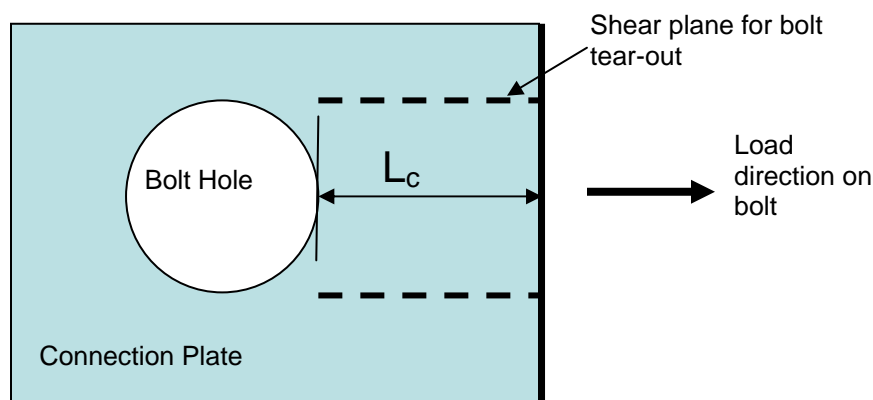
Tear-out failure occurs along two shear planes in the connector plate, as indicated in Figure 11–5. The ultimate tear-out strength, $R_{u-tearout}$, was given by

Figure 11–5. Tear-out mode of failure.

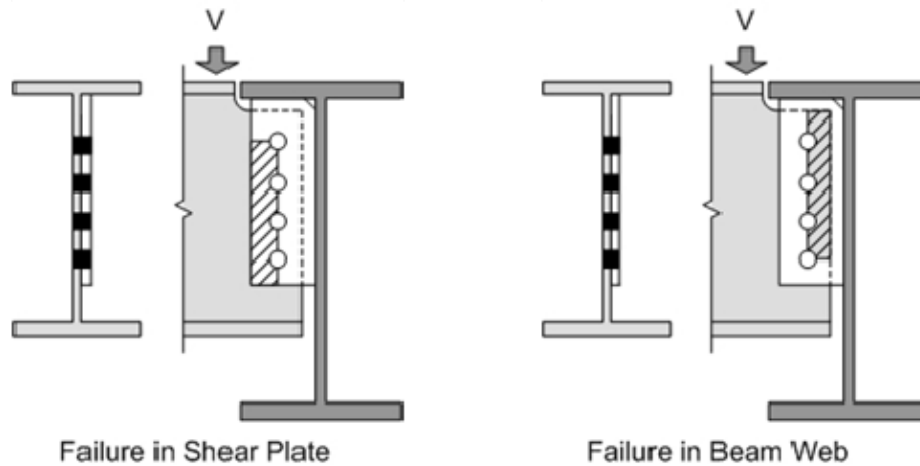
Block shear is a rupture or tearing phenomenon, where the ultimate strength is computed as the sum of the shear strength and tensile rupture strength along a failure path. Block shear under a vertical load is a possible failure mechanism in single shear plate (fin) connections in both the coped beam web and the shear plate, as shown in Figure 11–6. Figure 11–7 shows possible shear failure paths when a double angle connection is subjected to horizontal loading. Cases 1, 2, and 3 have failure in the connection angles and Case 4 corresponds to failure in the beam web. Note that in Figure 11–6 and Figure 11–7 the failed block is cross-hatched.

Figure 11-6. Block shear failure planes for vertical shear forces.

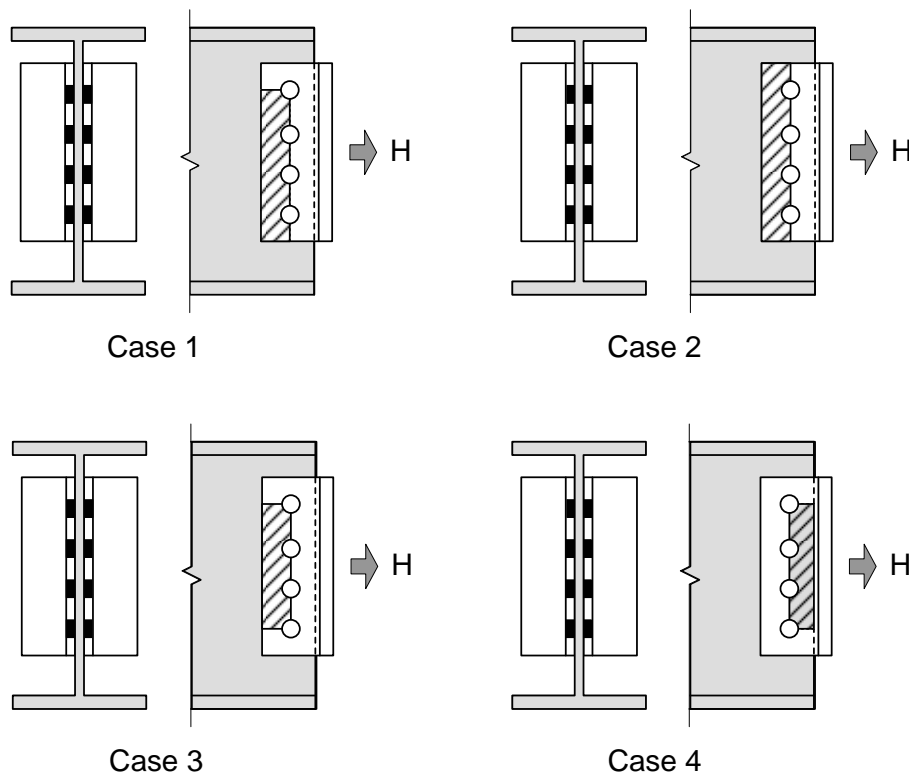
Figure 11-7. Block shear failure planes for horizontal tension force.

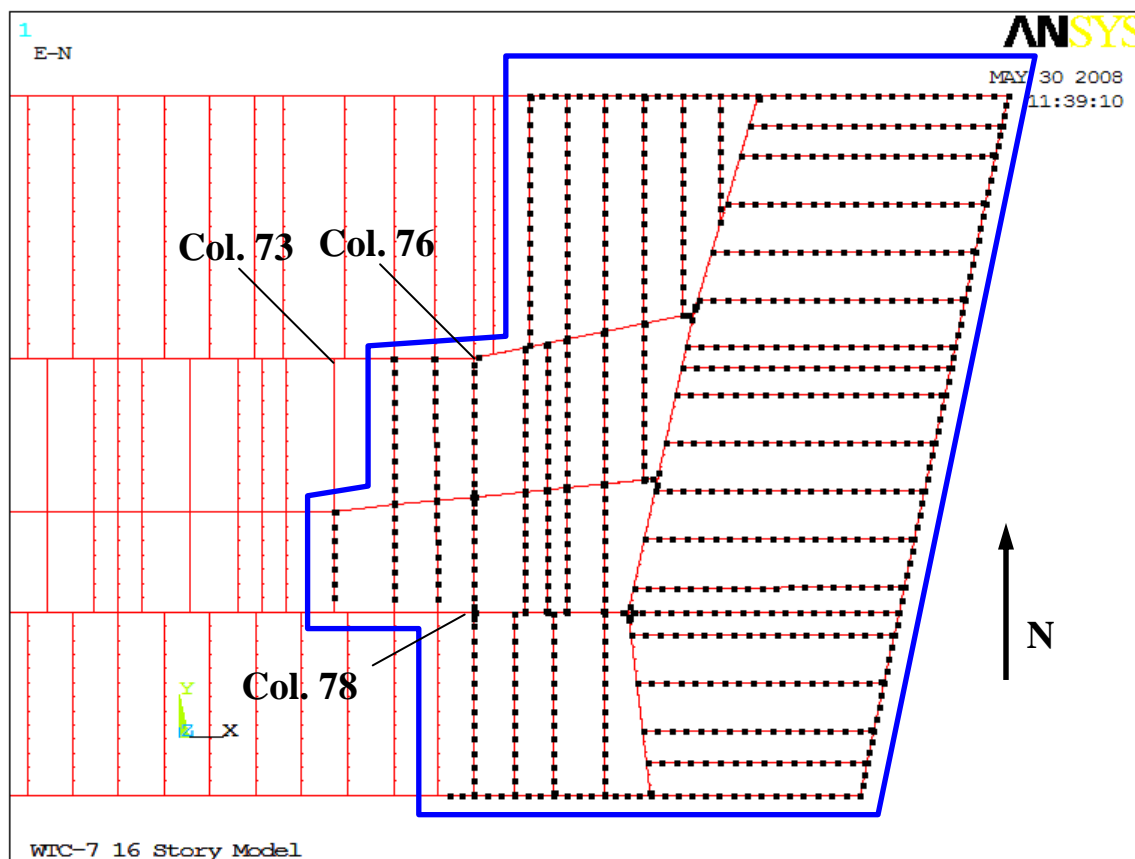
Note: Black colored dots show the location of shear studs and connections modeled with break elements.

Figure 11–9. Area of the floor where connection failures were modeled.

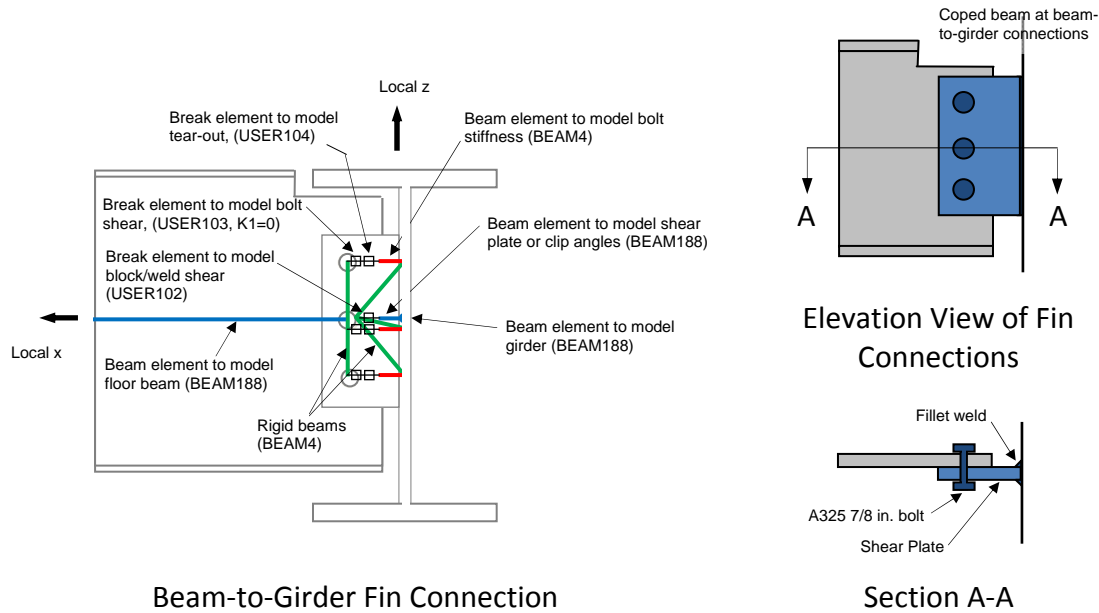
The analytical model used for the fin connection is depicted in Figure 11–10. The girder is located on the right side in each diagram in Figure 11–10. The model shown has three bolts, but a fin connection in WTC 7 had up to 6 bolts. The connection model accounted for: (1) shear failure of individual bolts, (2) tear-out failure at each bolt location, (3) vertical block shear failure of the connection plate, (4) horizontal block shear failure of the web or connection plate, and (5) vertical and horizontal failure of the connection plate-to-column weld.

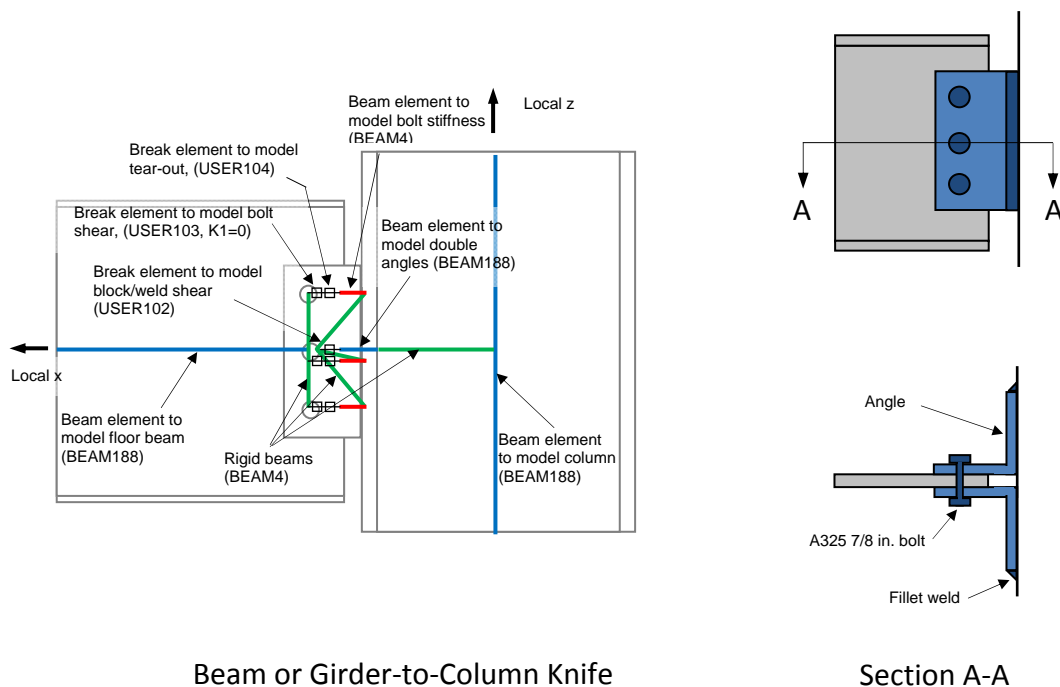
The analytical model used for the knife connection is depicted in Figure 11-11. The model shown has three bolts, but knife connections in WTC 7 had up to 8 bolts. The connection model accounted for: (1) shear failure of individual bolts, (2) tear-out failure at each bolt location, (3) vertical block shear failure of the double angles, (4) horizontal block shear failure of the web or angles, and 5) vertical and horizontal failure of the angle-to-column fillet welds.

Figure 11-11. Analytical model for a knife connection.

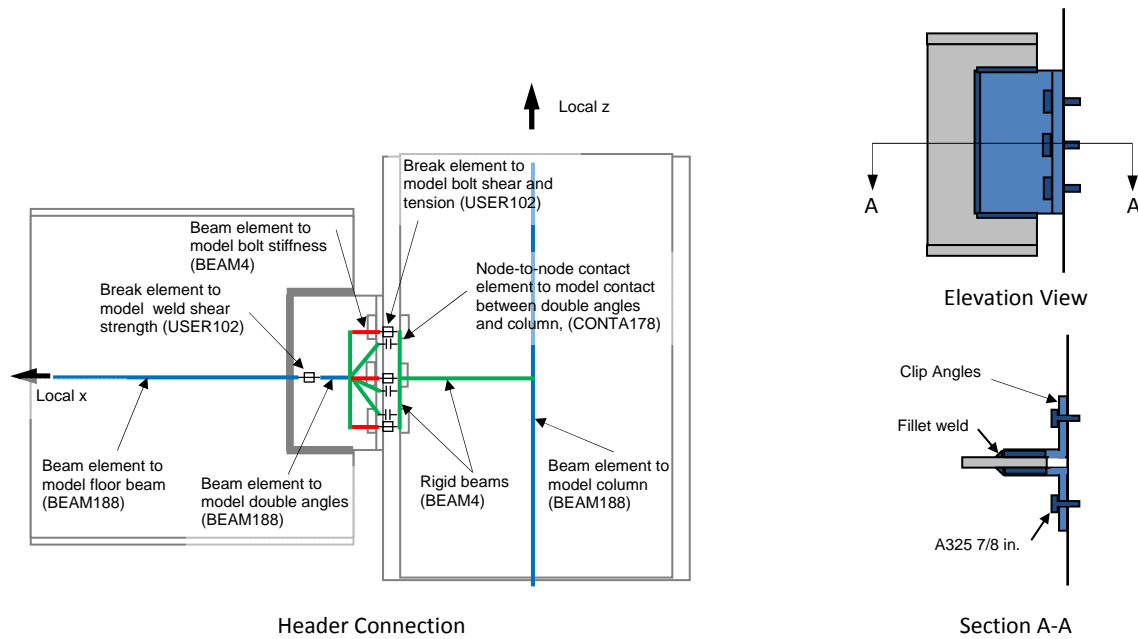
The analytical model for the header connection is depicted in Figure 11-12. The model shown has six bolts (three per row), but a header connection had up to 10 bolts (five per row). The connection model accounted for: (1) shear failure of individual bolts, (2) tension failure of individual bolts, and (3) vertical and horizontal failure of the fillet weld connecting the angles to a girder web or column.

Figure 11-12. Analytical model for header connection.

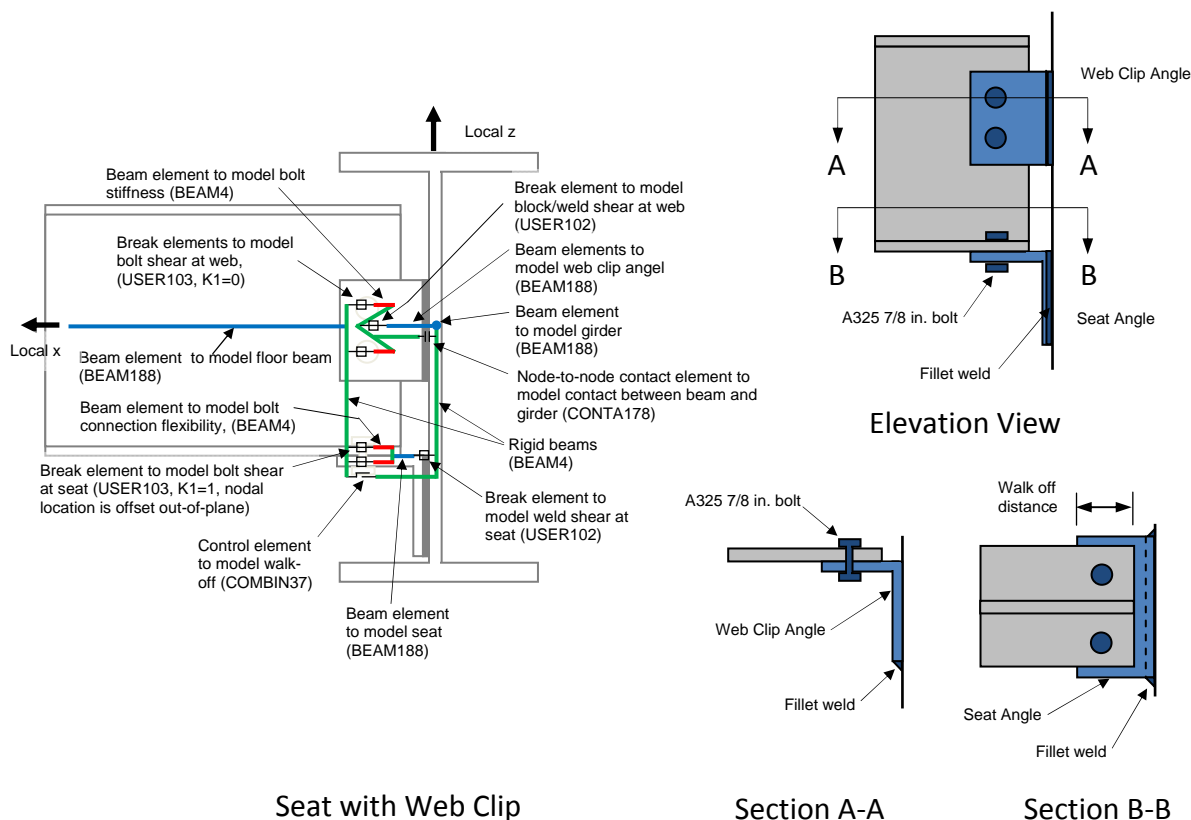
If the web clip failed and the bolts that attached the beam to the seat were sheared, the beam could either walk off the seat laterally or be pulled off the seat. Failure of the web clip and shearing of the bolts did not cause the beam to lose vertical support, but a prerequisite for the beam end walking off the seat. The travel distance for a beam to walk off a seat was 2.5 in. A control element (COMBIN37), a unidirectional linear spring element with the capability of turning on and off during an analysis, was used to model walk-off.

Figure 11–13. Analytical model for SWC connection.

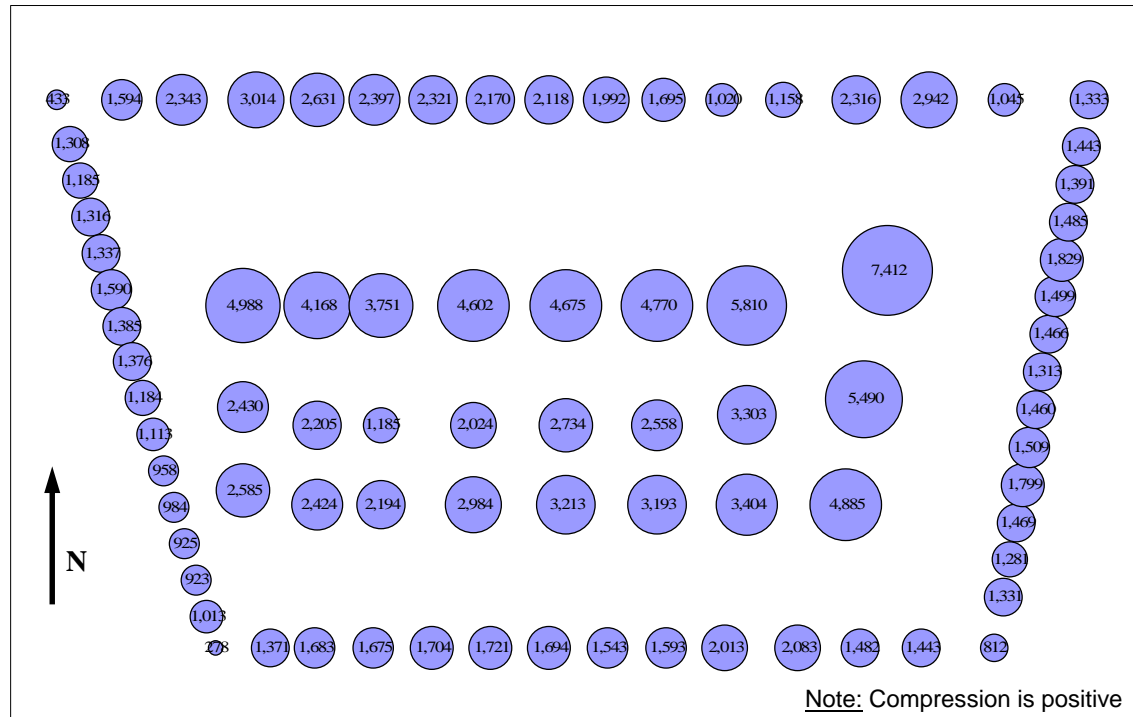
Figure 11–28. Damage state of connections, beams, and girders in Floor 14 at 3.5 h for Case B temperatures.

Summation of Column forces:

North: 32,500 kip	East: 19,300 kip
South: 21,100 kip	West: 16,600 kip
Interior: 87,000 kip	Total: 176,500 kip

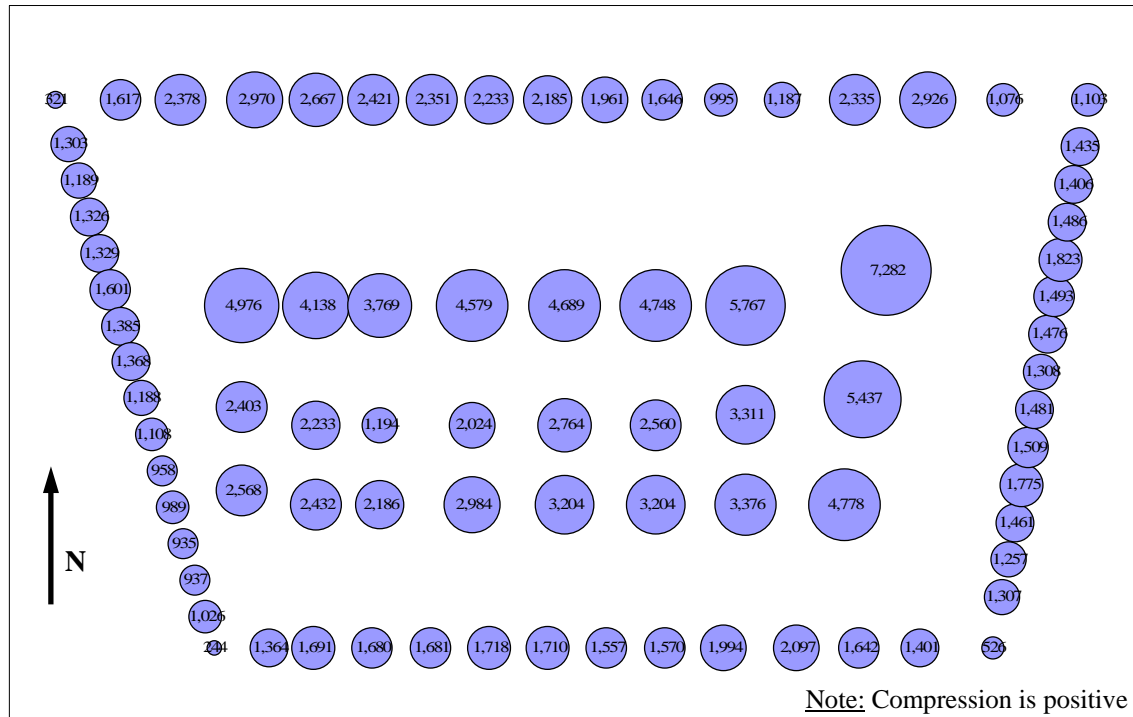
Figure 11-36. Damage state of connections, beams, and girders in Floor 14 at 4.0 h for Case B temperatures.

Summation of Column forces:

North:	32,400 kip	East:	19,200 kip
South:	20,850 kip	West:	16,650 kip
Core:	86,600 kip	Total:	175,700 kip

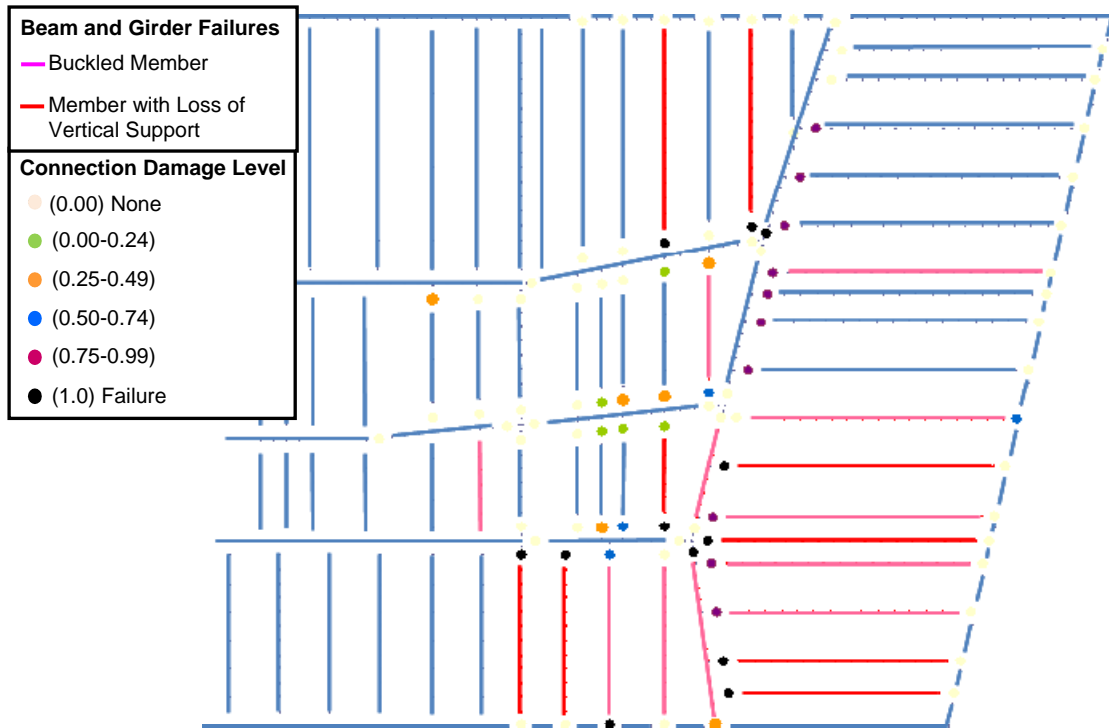
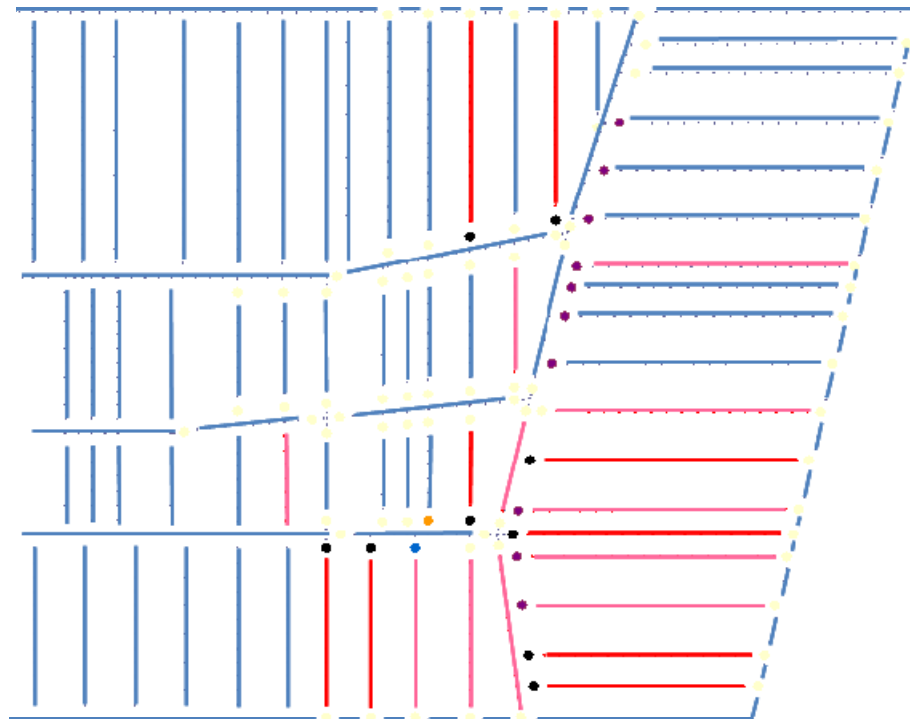
Figure 11–44. Damage state of connections, beams, and girders in Floor 14 at 4.0 h for Case C temperatures.

a) Damage state of connection in the horizontal direction

b) Damage state of connection in the vertical direction

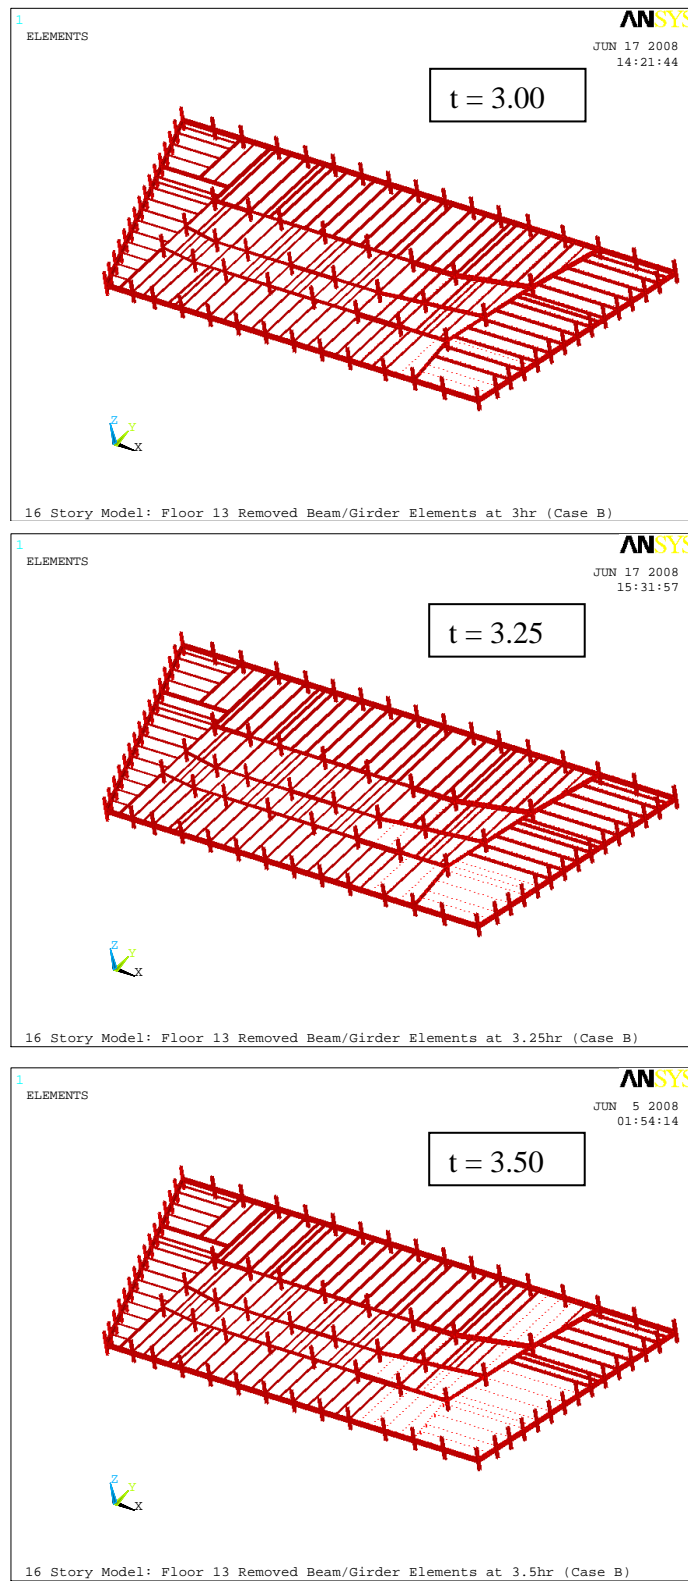
Figure 11–47. Floor 13 Case B temperatures at 3.0 h to 3.5 h.

Beams and girders that buckled or had end connection damage are indicated with dotted lines.

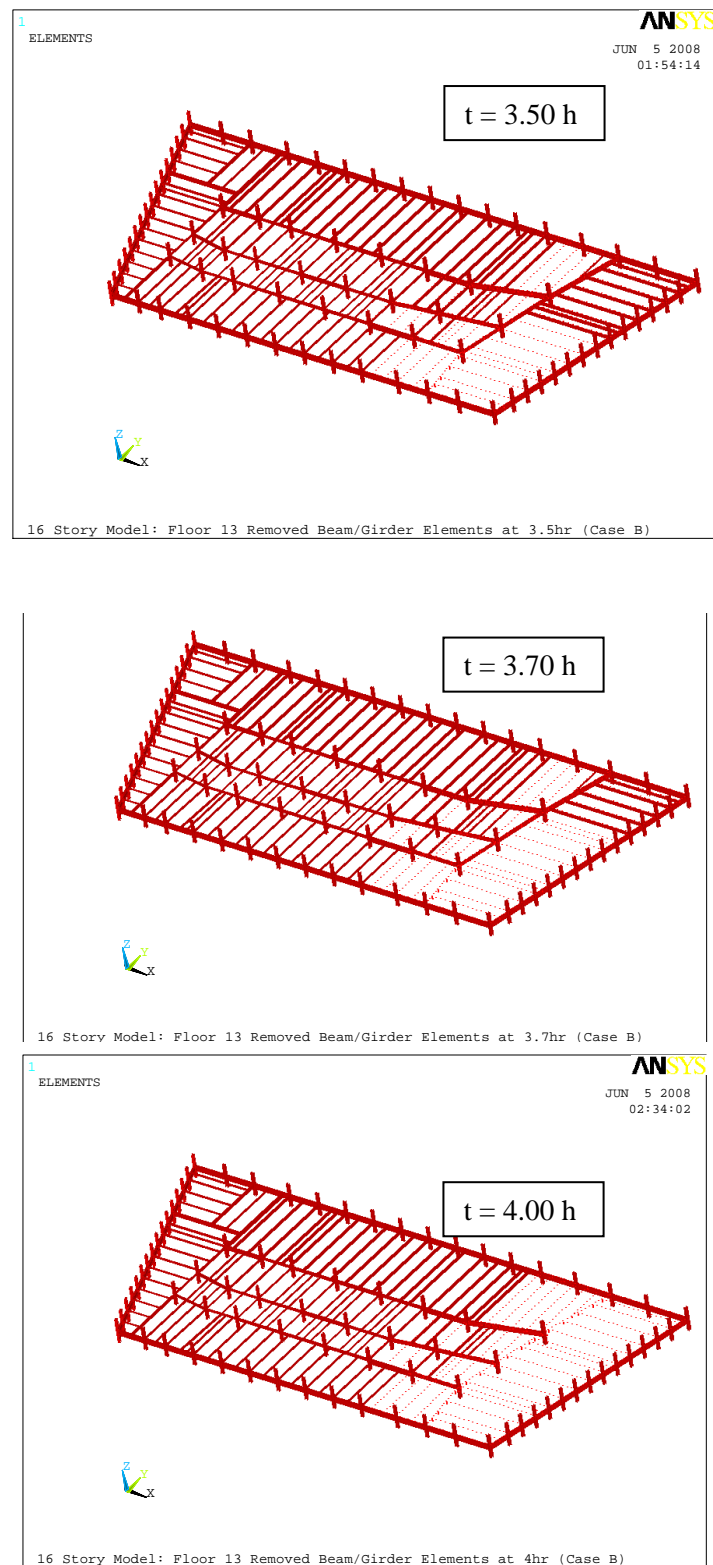
Figure 11–48. Floor 13 Case B temperatures at 3.5h to 4.0 h.

Beams and girders that buckled or had end connection damage are indicated with dotted lines.
