**Federal Building and Fire Safety Investigation of the
World Trade Center Disaster**

**Structural Fire Response and
Probable Collapse Sequence of
World Trade Center Building 7**

VOLUME 1

November 2008

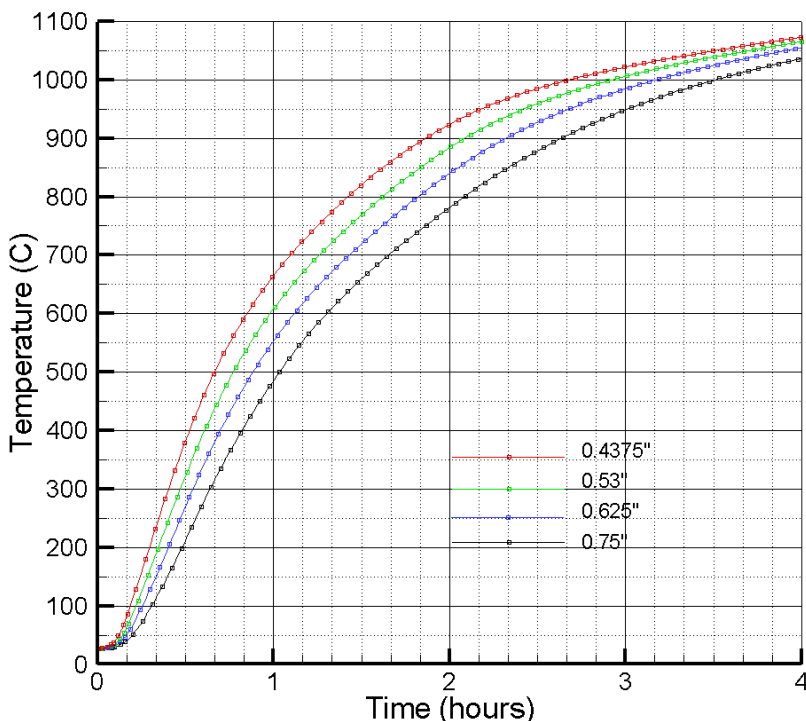
Figure 11–50.
Heating of a typical floor beam (W24 x 55) subject to an ASTM E 119 temperature profile for different SFRM thicknesses.

Thus, an increase in the SFRM thickness on the floor beams would have delayed heating of the floor beams by 10 min to 20 min, but would not* have altered the outcome.

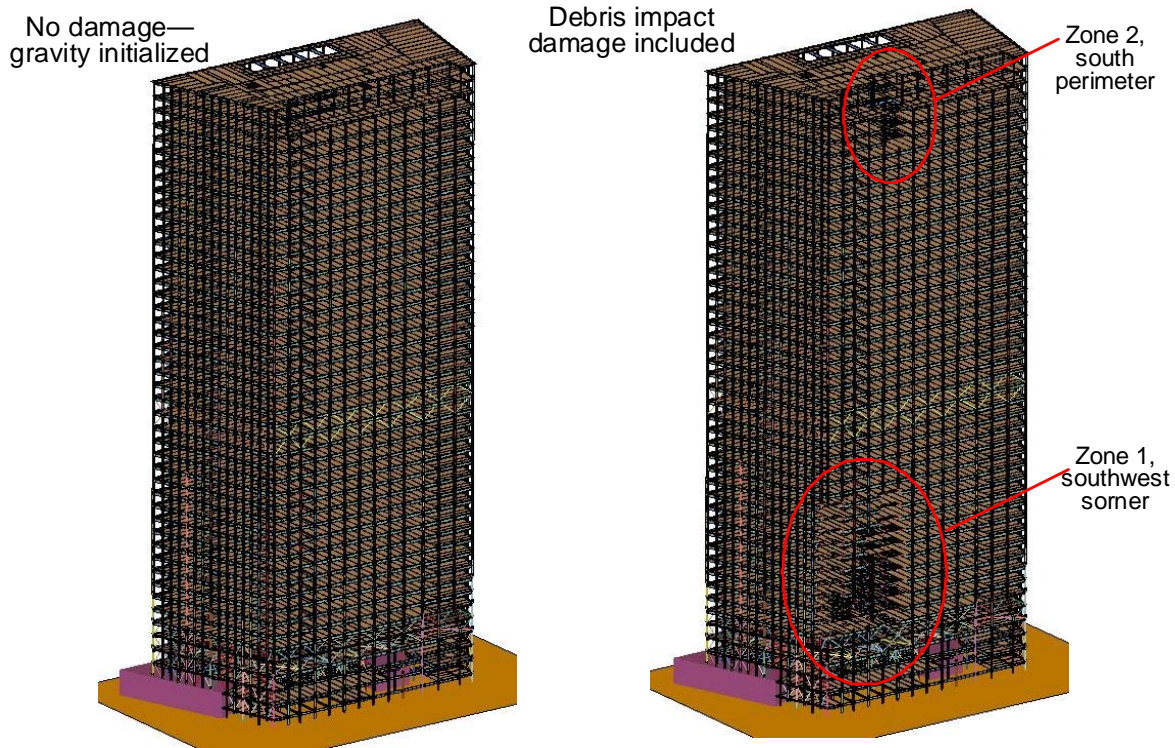
After gravity initialization, debris impact damage due to the collapse of WTC 1 (Section 5.5.3) was applied to the global model instantaneously. The damage was applied to the building through the sudden removal of a number of elements from the model. The damage included two zones, as shown in Figure 12-33. Zone 1 was in the lower southwest quadrant of the building and included damage to the exterior columns and floor framing extending to the south core perimeter. In Zone 1, exterior Columns 14A through 20 were severed above Floor 7. Some floor sections in the debris zone that were not removed cantilevered out from the core. Damage to Zone 2 at the upper floors along the central-southern face was less extensive. Column 20 and some floor structure extending to the core perimeter were removed from the calculation above Floor 43. After the damage was instantaneously applied to the model, the calculation was allowed to progress for 2 s prior to temperature application.

Figure 12-33. Debris impact damage application to the global LS-DYNA model.

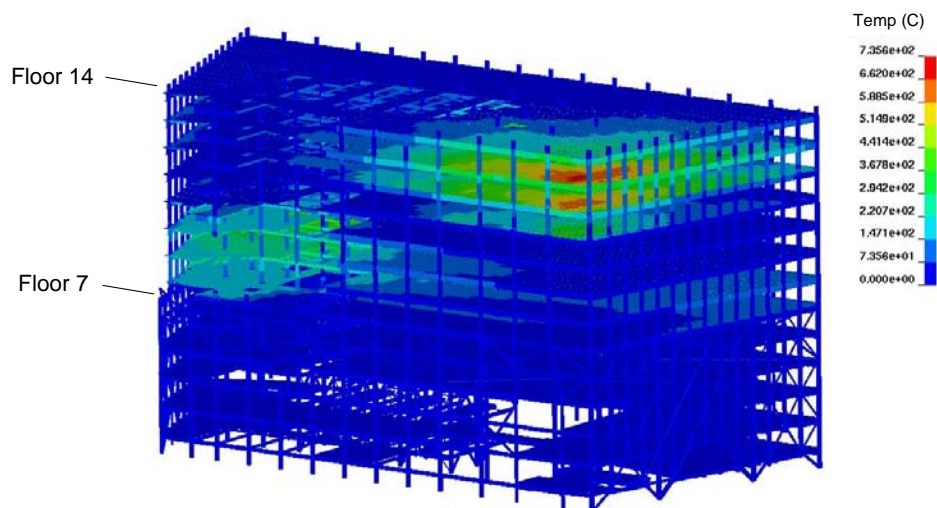
As shown in Figure 12-32, temperatures were applied to the model smoothly over the duration of 2 s. Temperatures applied to the fire-affected zone in the global model were Case B temperatures at 4.0 hours (Section 10.3.3). The affected zone was between Floors 7 and 14. The temperatures were applied to the nodes in the model and followed the prescribed time-dependent load curve. The final temperature distribution applied to Floor 7 to 14 in the global model is shown in Figure 12-34.

Figure 12-34. Temperature profile in Floors 7 through 14.

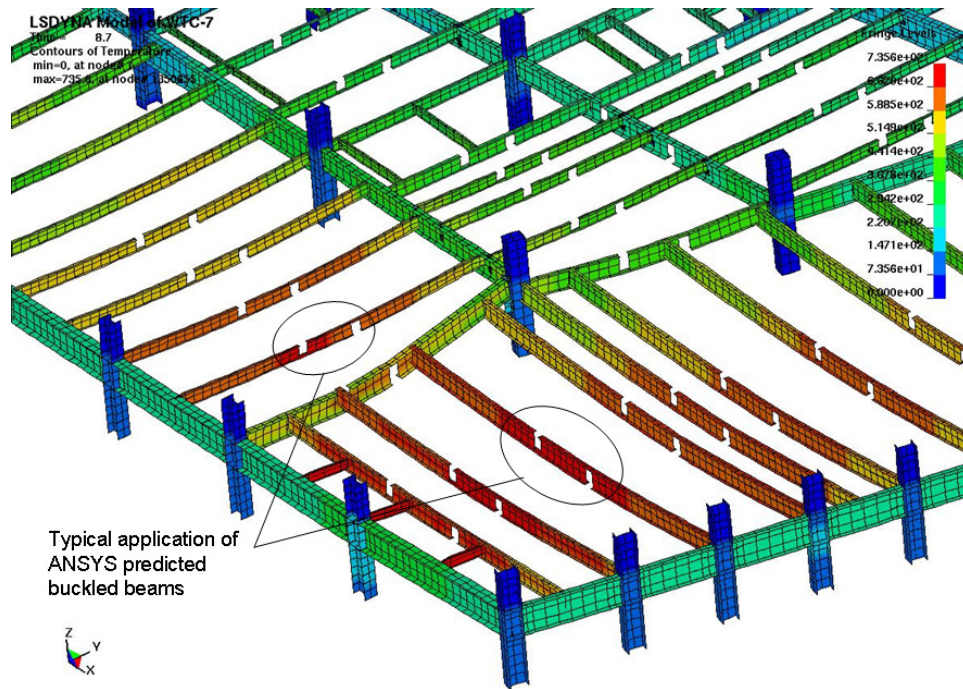
The fire-induced damage included buckled beams and connection damage. Buckled beams were modeled by removing a few flange and web elements, such that the beam would lose its axial and flexural strength, but the weight of the beam would remain in the calculation. An example of how buckled beams were modeled at the southeast corner in Floor 14 of the global model is shown in Figure 12–35. Contours shown are steel temperatures with a range of 0 °C to 736 °C.

Figure 12-35. Approach used to model buckled beams in LS-DYNA model.

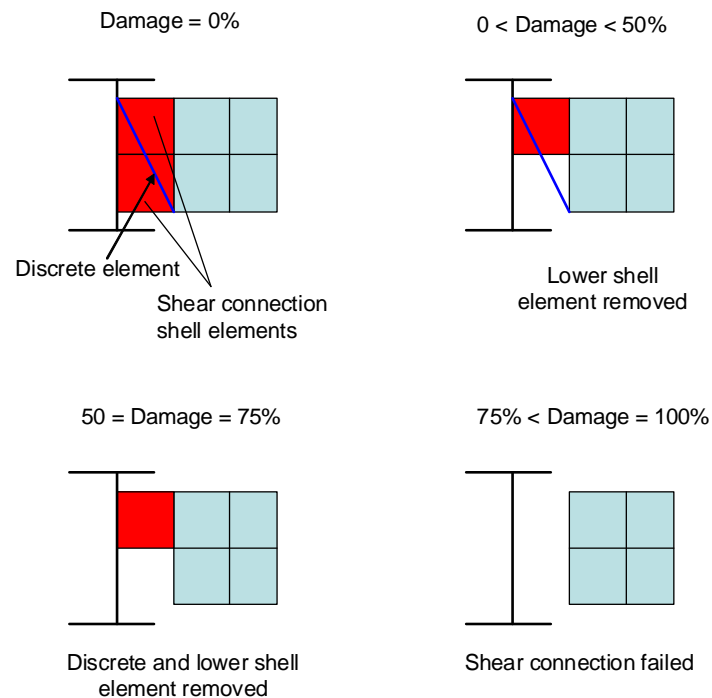
The connection damage data from ANSYS was transferred to the LS-DYNA global model using a damage index (Section 11.5). The damage index described the degree of connection damage according to the following groups: 0 to 0.25, 0.25 to 0.5, 0.5 to 0.75, and 0.75 to 1.0, where 0 was no damage and 1.0 was failure. Horizontal support and vertical support were specified separately. Due to the coarseness of the shell element modeling of the fin, knife, and header connections in the LS-DYNA model, approximations of the damage state were made as shown in Figure 12–36.

Figure 12-36. Shear connection damage application in LS-DYNA model.

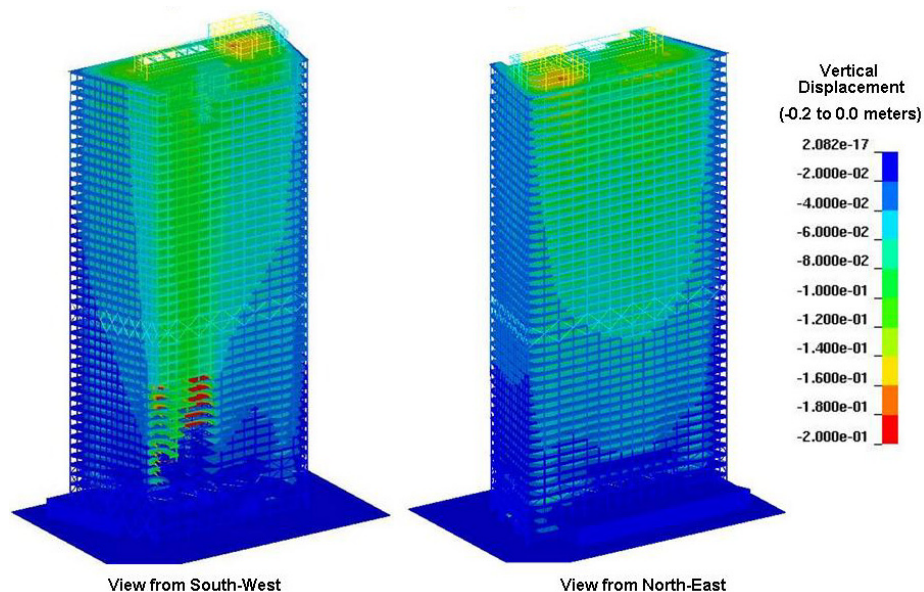
debris impact damage application. The figure shows a downward displacement of up to 8 in. (about 1/900 of the total building height) on the south face toward Zone 1 damage due to column removal. The analysis shows that the building remained stable and that columns and floors above the damaged zone were able to redistribute the loads through Vierendeel truss action.

Figure 12–39. Calculated vertical displacements after impact damage.

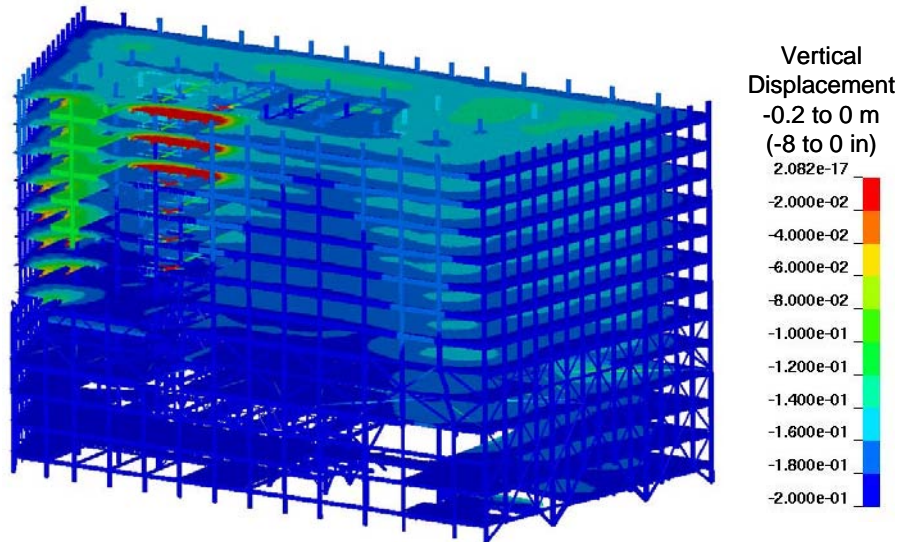
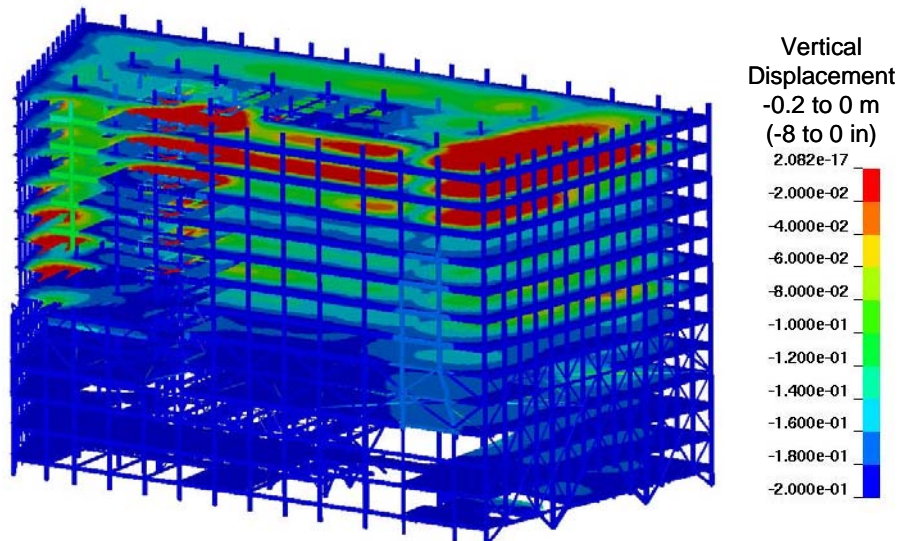
temperature application. This figure illustrates where the heated floors displaced vertically due to damaged floor framing and connections. The analysis also showed that the combination of the impact damage and thermal loading produced significantly higher stress states throughout the lower floors of the building.

Figure 12–41. Detailed comparison of vertical displacements after damage and temperature initializations.

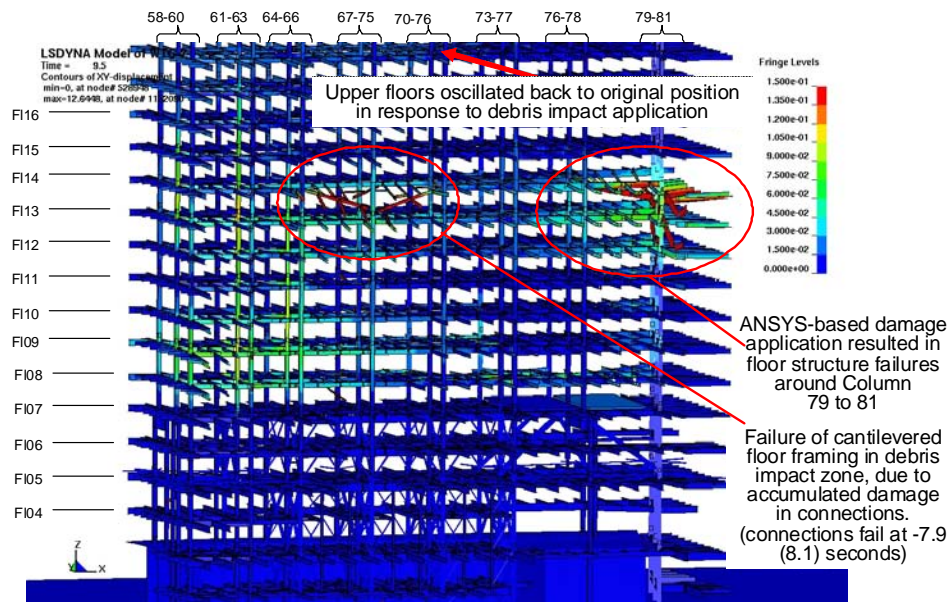
After the fire-induced ANSYS damage was applied, floor sections surrounding Columns 79 to 81 on Floors 13 and 14 collapsed to the floors below, as shown in Figure 12–42. The LS-DYNA analysis calculated the dynamic response of the structure to the floor failures and resulting debris impact loads on the surrounding structure. The thermally weakened floors below Floors 13 and 14 could not withstand the impact from the collapsing floors, resulting in sequential floor collapses. The floor systems progressively failed down to Floor 5, where the debris accumulated, as shown in Figure 12–43.

Figure 12–42. The collapse of Floors 13 and 14 in the northeast region [Time: -6.5 (9.5) s]

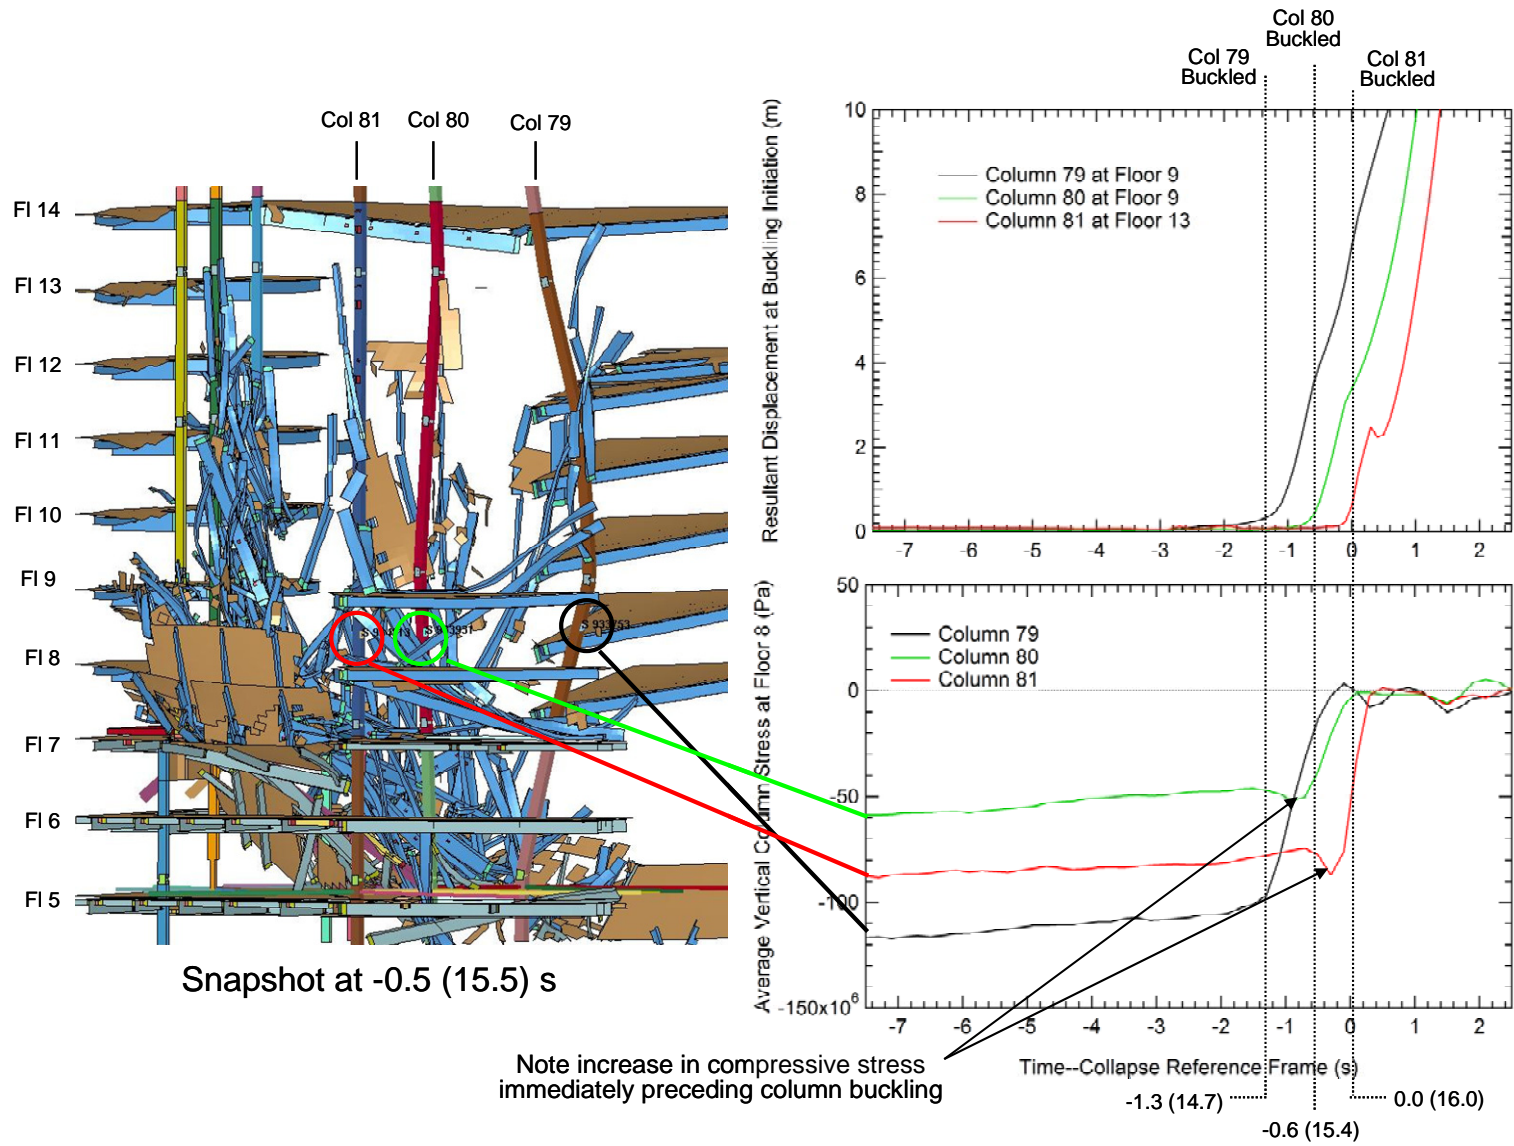
Figure 12–43 shows a cutaway view that illustrates the structural condition surrounding Column 79 as it buckled to the east. Figure 12–43 includes resultant lateral displacements and column axial stress histories for Columns 79 to 81. The plots show that Column 79 buckled 1.3 s before the kink was observed in the east penthouse roof framing (which occurred at 0 s (16.0 s) in the analysis). The rapid increase in lateral displacement indicates column buckling. Likewise, the axial column stresses indicated a rapid loss of stress at the time, signifying column buckling. Column 79 was laterally unsupported in the

Figure 12-43. Column 79 to 81 stress and displacements.

The cascading failures of the floors surrounding Column 79 on Floors 6 to 14 led to increased unsupported length in Column 80. Column 80 became laterally unsupported, as shown in Figure 12–47. Column 80 buckled about 0.8 s after Column 79 buckled, as shown in Figure 12–43.

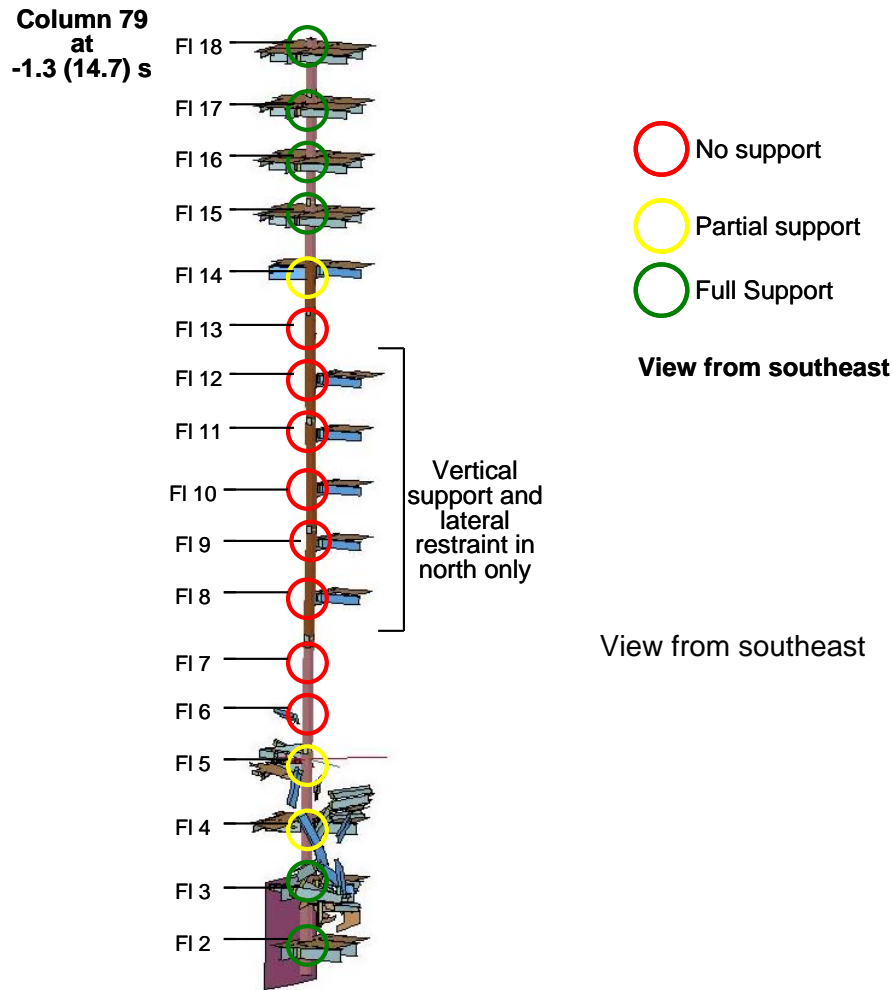
east-west and south directions between Floors 5 and 14. There was still some lateral support in the north direction at Floors 8 to 12 and Floor 14, as the erection bolts in the seated connections had all failed at these girder ends, but the girders had not walked off the bearing seats. Thus, these girder connections possibly prevented lateral displacement in the north direction, but did not resist lateral displacements in the east, west, or south direction. At Floor 14, the girder to the west of Column 79 (between Column 79 and 76) was still attached and provided lateral restraint from the west. Figure 12–44 illustrates the girder-to-column connection status at the time of buckling of Column 79.

Figure 12–44. Column 79 lateral support status at time of buckling initiation.

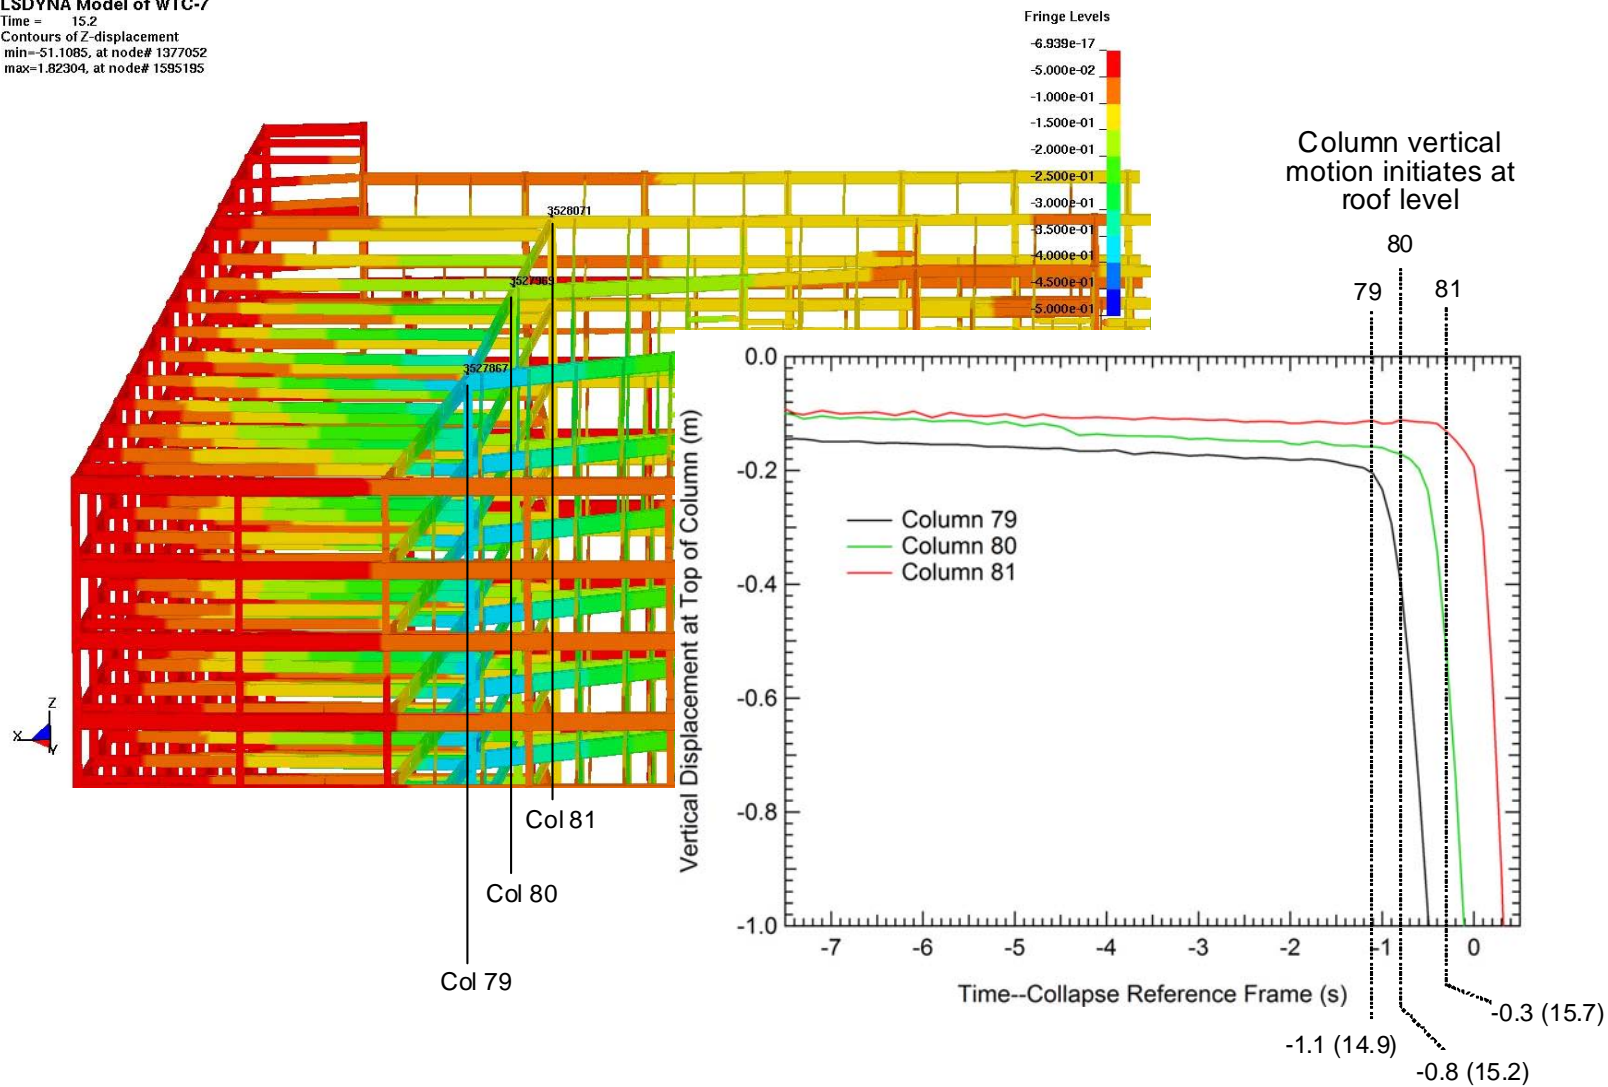
Figure 12-45. Column 79-81 vertical displacement with contours from -0.5 m to 0 m.

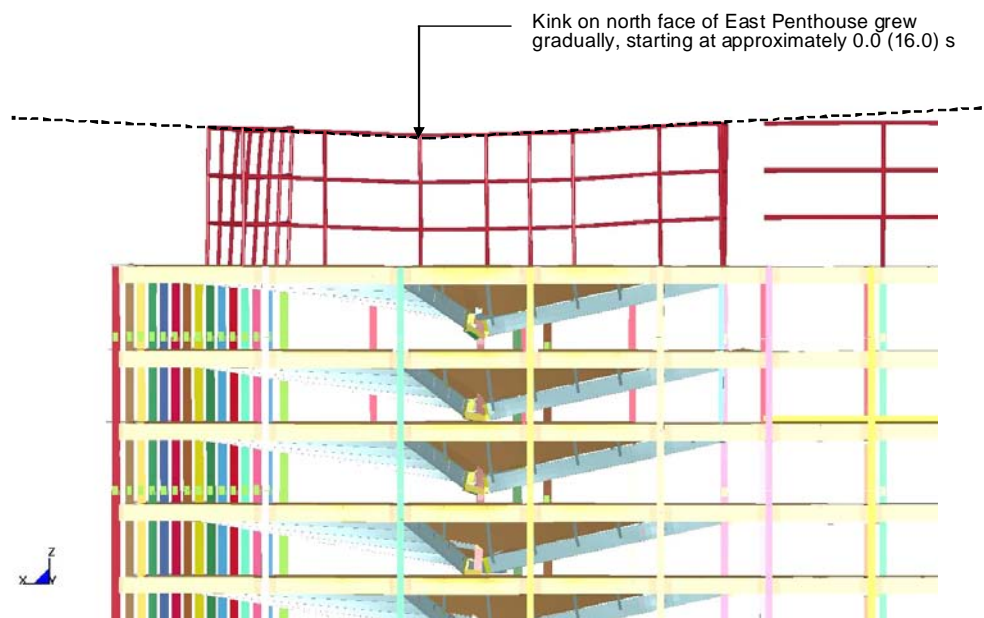
Figure 12-46. Kink on east penthouse as it moves downward [Time 0.2 (16.2) s].
View from north.

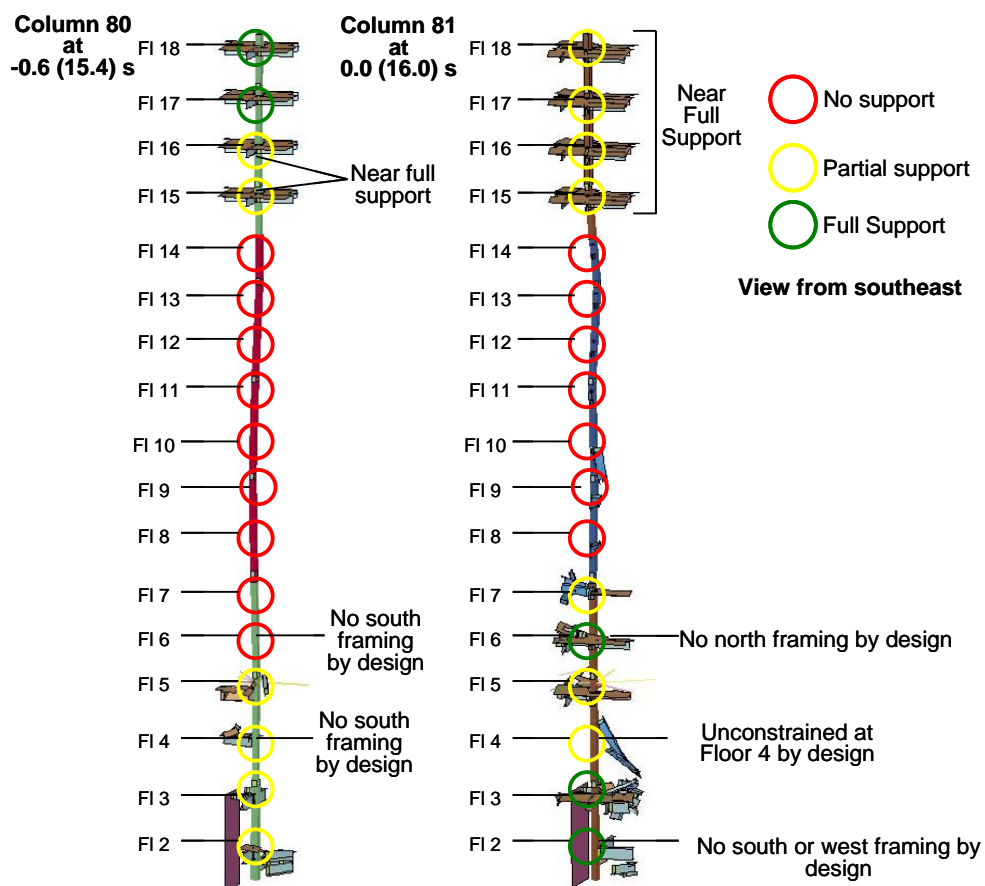
In a similar fashion, Column 81 became laterally unsupported in both directions between Floors 7 to 15, as a result of the progressive floor system failures that occurred as both Columns 79 and 80 buckled (Figure 12–47). Column 81 buckled about 1.3 s after Column 79 buckled, as shown in Figure 12–43. In addition to axial compressive loads that could cause buckling, the columns were subject to lateral loads from falling debris and failure of girder connections occurred. These lateral perturbations aided the onset of column buckling. Note that Columns 80 and 81 buckled after the vertical progression of floor failures around Column 79.

Figure 12-47. Columns 80 and 81 lateral support status at time of buckling initiation.

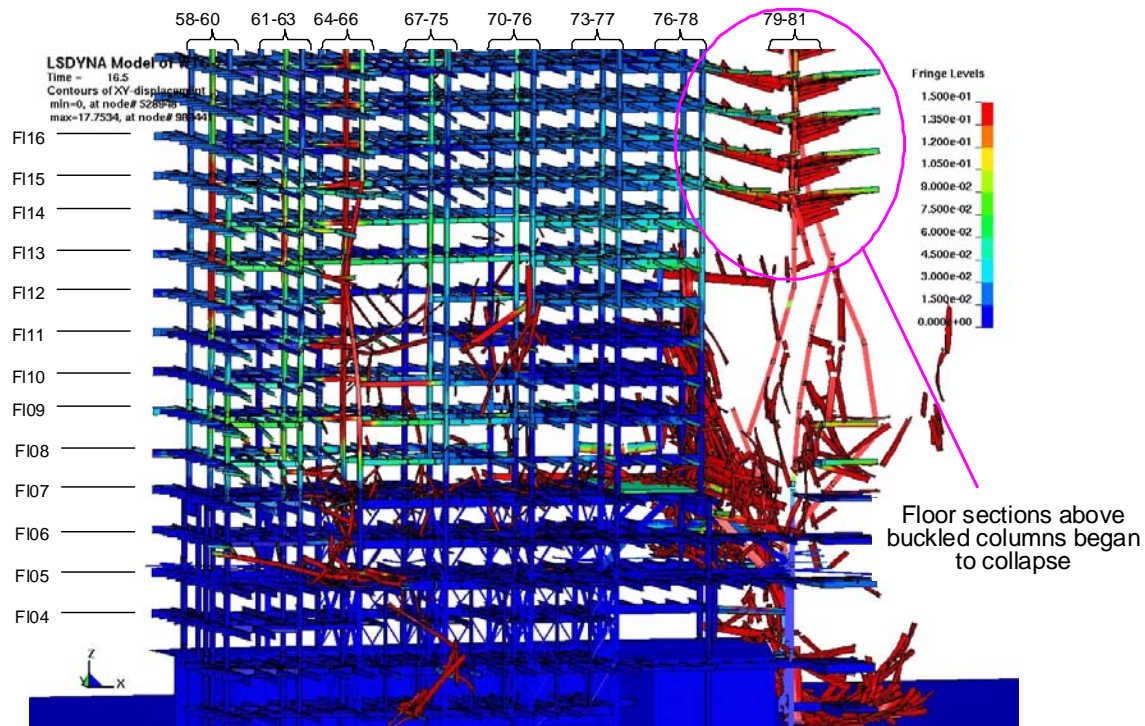
Figure 12–48 shows a view of the interior of WTC 7 from the southwest from the ground up to Floor 18. The figure shows the vertical progression of floor and column failures on the east side of the building, following the buckling of Columns 79, 80, and 81.

Figure 12-48. Vertical progression of failures on the east side of the building [Time: 0.5 (16.5) s].

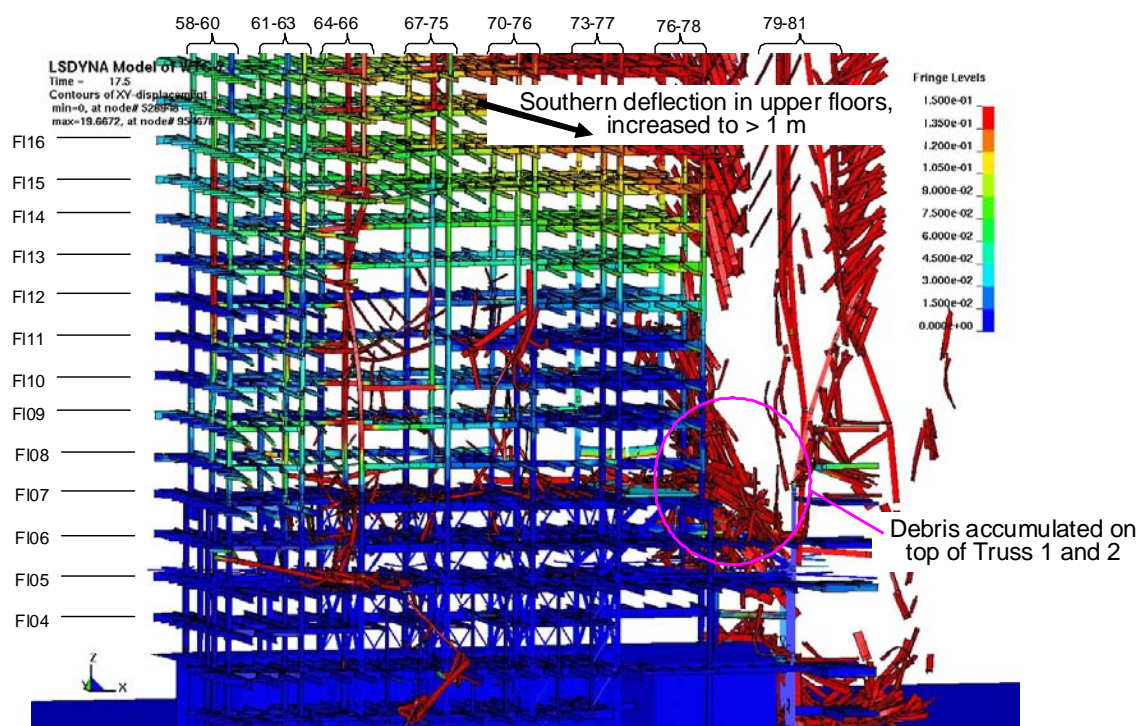
During the vertical failure progression, the falling floors pulled on adjacent columns until the floor connections failed on the east side of Columns 76, 77, and 78, resulting in a loss of lateral support on the east side, as shown in Figure 12-49. Additionally, debris from floor systems and columns fell from the upper floors, and impacted adjacent intact columns and floors, including Truss 1 and Truss 2. The accumulation of debris and debris impacts eventually caused Truss 2 to fail, as shown in Figure 12-50 and Figure 12-51.

Figure 12-49. Debris from the vertical progression falling onto the lower floors, Trusses 1 and 2, and Columns 76, 77, and 78 [Time: 1.5 (17.5) s].

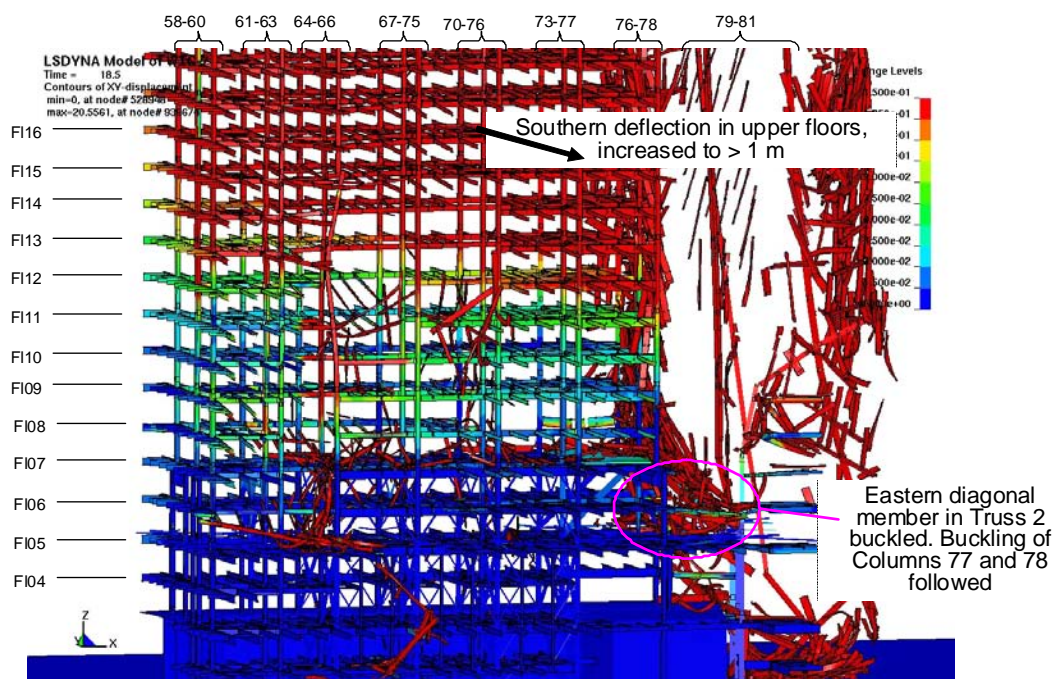
The failure of Truss 2 precipitated the buckling of Columns 77 and 78, as shown in Figure 12–52. The loss of the Truss 2 diagonal resulted in a loss of support for Column 77. When the Truss 2 diagonal member failed, support for the girder MG-23 at Column 77 was also lost, which subsequently led to loss of support for Columns 78.

Figure 12-52. Failure of Columns 77 and 78 due to failure of Truss 2 from debris impact [Time: 2.5 (18.5) s].

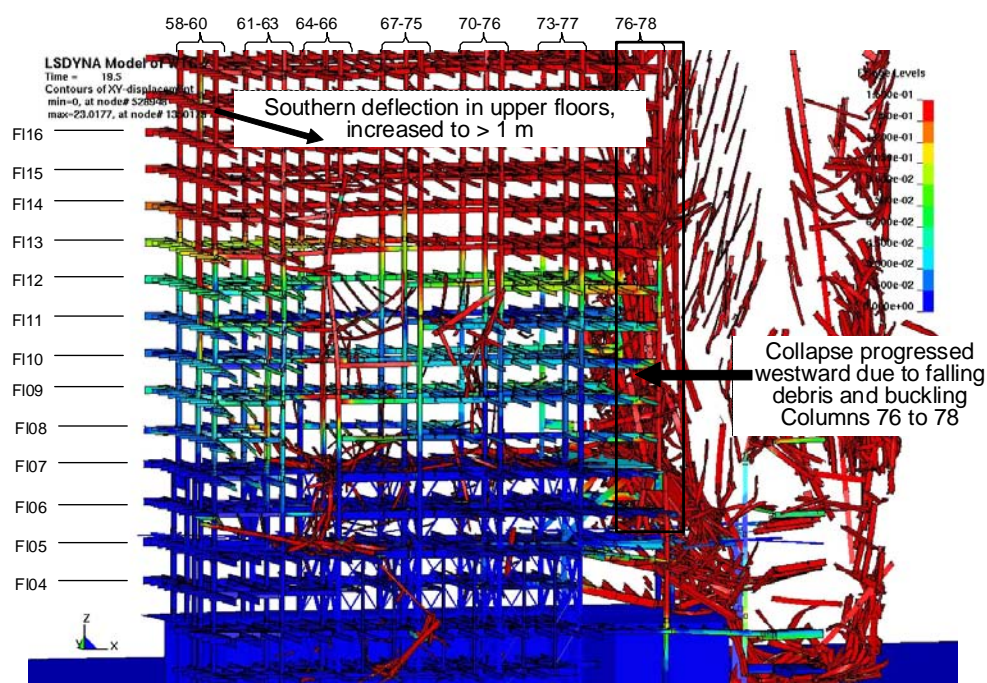
Column 76 failed in the next second, as indicated in Figure 12–53, due to loss of lateral support as the floor connections failed, the impact of falling debris, and load redistribution from adjacent columns.

Figure 12-53. Buckling of Column 76 from the load transfer and debris impact from the buckling of Columns 79 and 77 [Time: 3.5 (19.5) s].

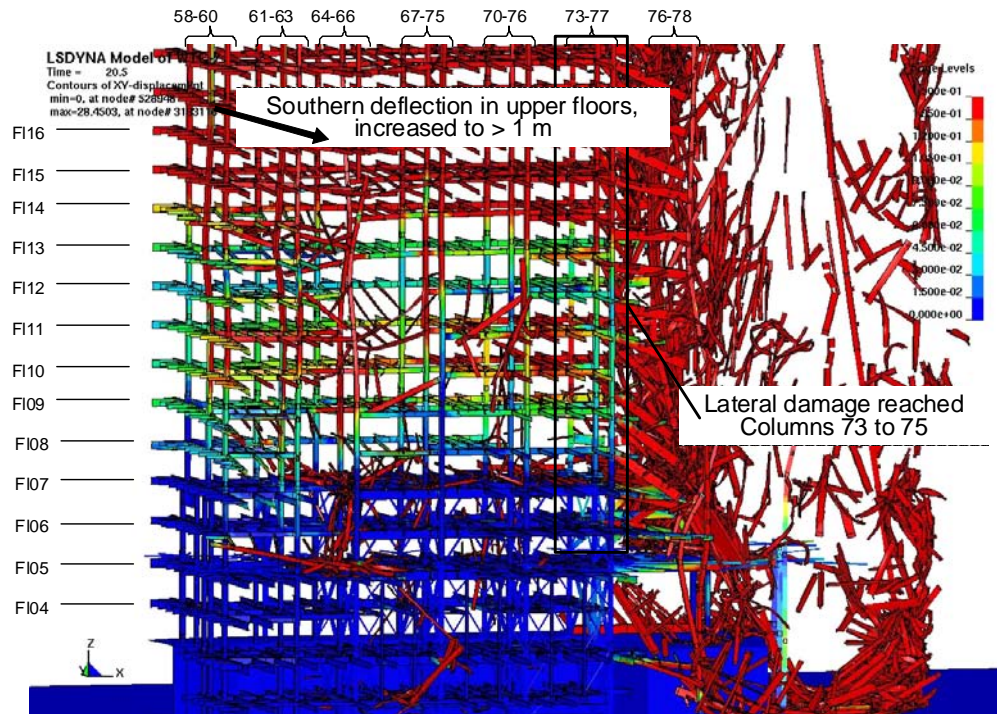
Columns 73 to 75 buckled in the next second, as shown in Figure 12–54, as the process continued where there were sequential failures of each north-south row of interior columns, due to loss of lateral support as floor connections failed, impact of falling debris, and load redistribution from adjacent failing columns.

Figure 12-54. Failure of Columns 73 to 75 from the load redistribution and debris impact [Time: 4.5 (20.5) s].

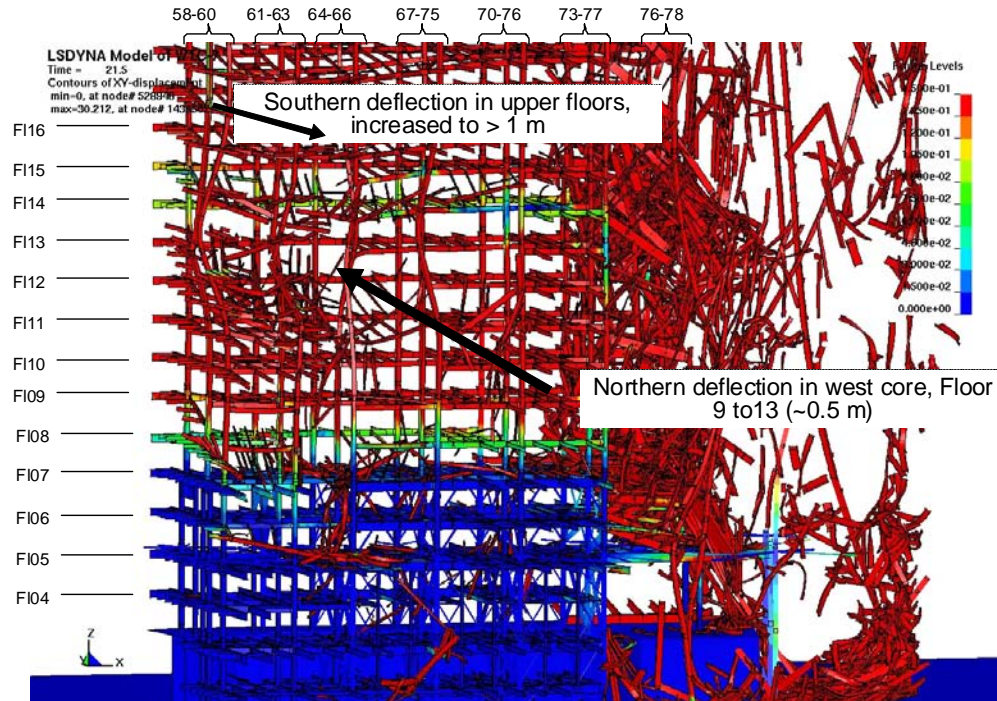
Column buckling and floor failures continued to propagate from east to west across the core in the lower floors, until all the interior columns buckled between Floors 9 and 14. This occurred 6.5 s after the kink was observed in the east penthouse, and 6.7 s after Column 79 buckled, as indicated by Figure 12–55.

Figure 12-55. Buckling of all interior columns [Time: 6.5 (22.5) s].

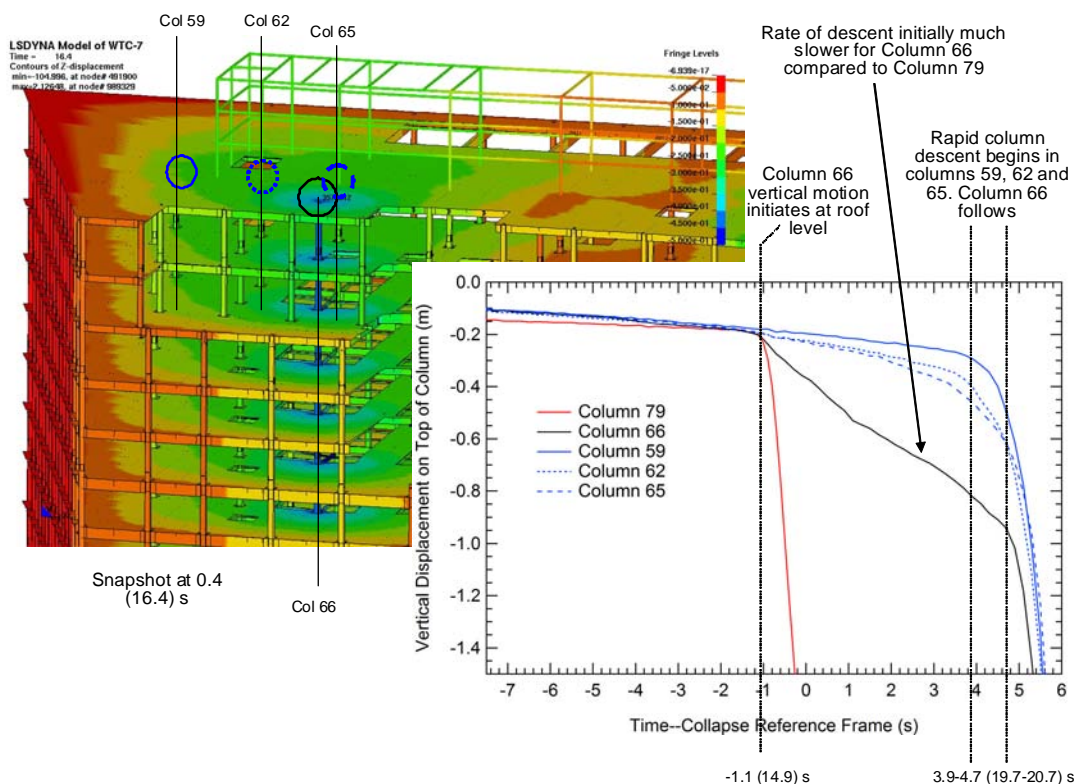
Figure 12–56 shows that west interior Columns 59, 62, 65, and 66, which had damaged floor connections after the debris impact by WTC 1 and by the fires, did not buckle until 4.7 s after the kink was observed in the east penthouse, or 6 s after Column 79 buckled. The west interior columns did not buckle until they were affected by the horizontal progression of failures. They also buckled due to loss of lateral support as floor connections failed, impact of falling debris, and the load redistribution from adjacent failing columns.

Figure 12-56. Western core column vertical displacements (contours: -0.5 to 0 m).

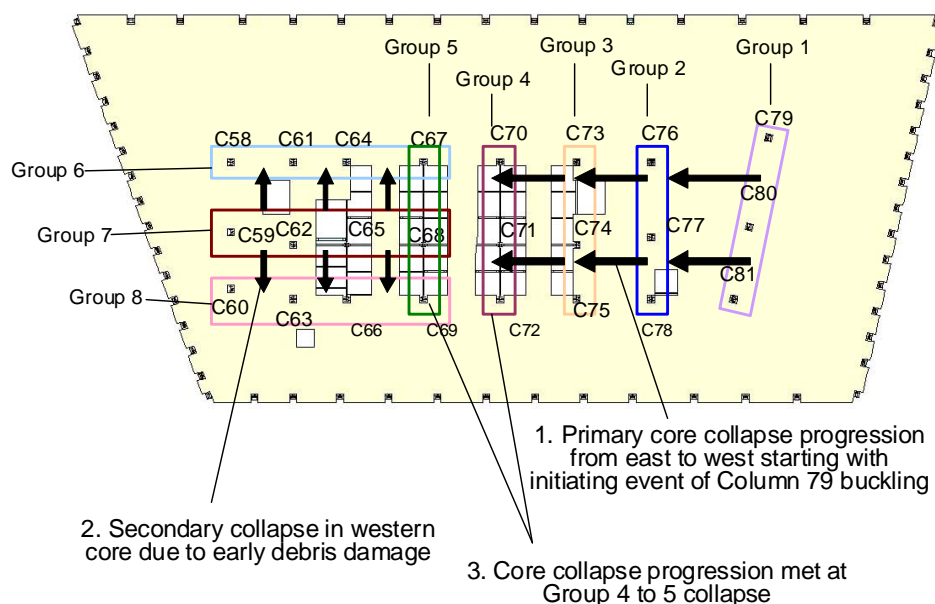
To better understand the progression of interior column failures, the change in column loads with time in the global collapse analysis was examined. Figure 12-57 shows column groups to indicate the general westward progression of interior column failures. Corresponding loads for the column groups 1 to 5 during the horizontal progression of buckling are shown in Figure 12-58. Column group 1 (Columns 79, 80, and 81) failed at -0.5 s before the kink was observed in the east penthouse, and column groups 1 to 5 had failed by 6.3 s. Column loads for column groups 6 to 8 are shown in Figure 12-59. Column group 7 failed at 4.3 s and column groups 6 to 8 had failed by 6.3 s. At this time, all the interior columns had buckled.

Figure 12-57. Horizontal progression of column buckling and interior column groupings.

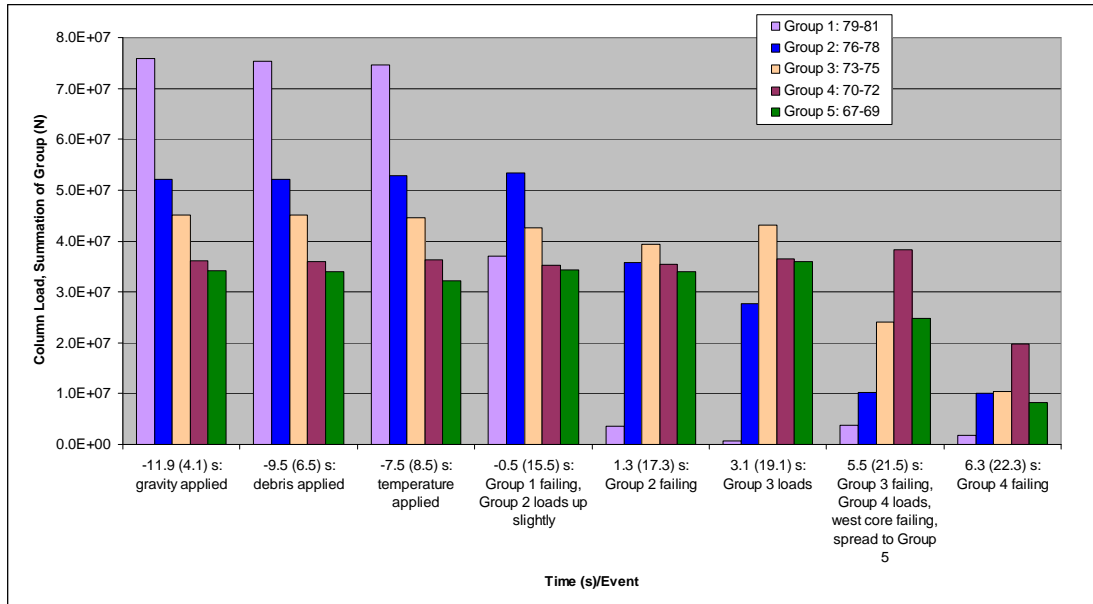
Figure 12-58. Interior column loads illustrating east to west collapse progression.

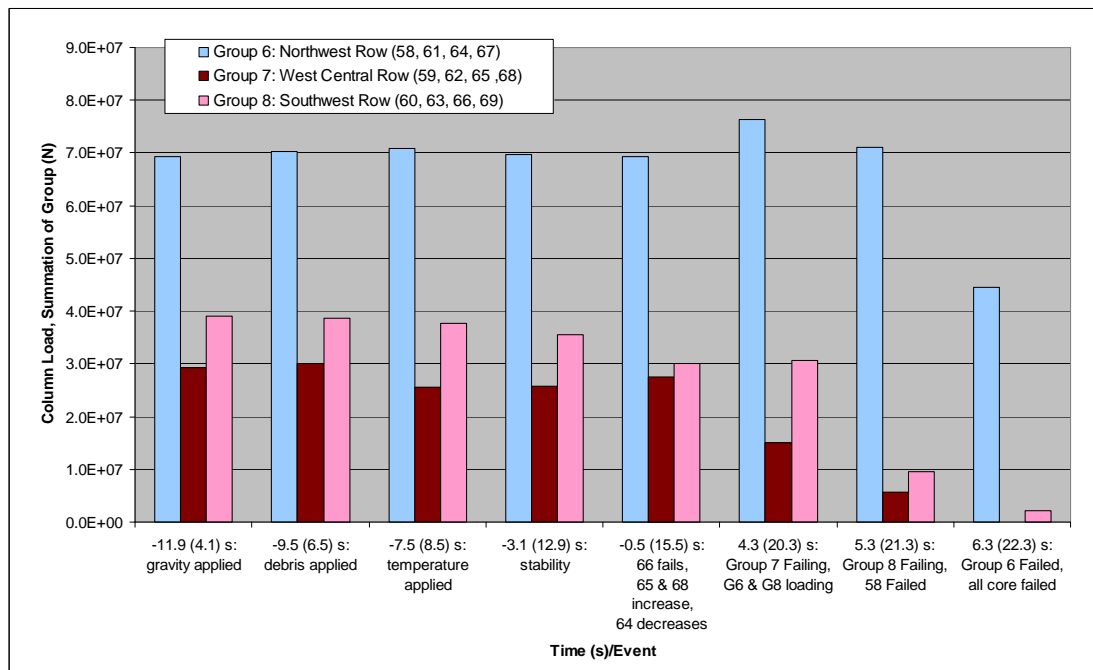
Figure 12-59. West interior column loads illustrating progression of failure.

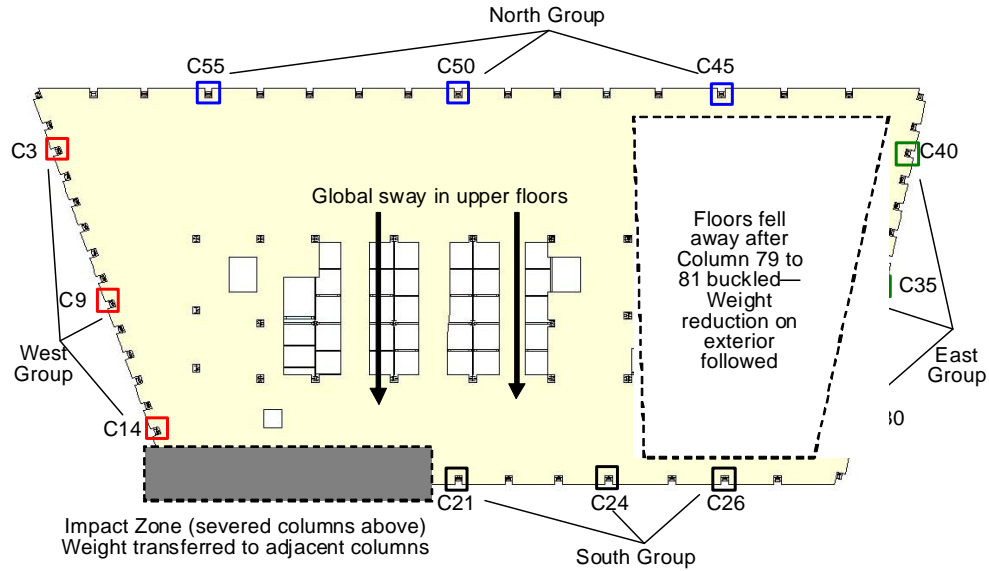
Figure 12–60 shows a schematic view of Floor 8 that highlights the exterior columns that were used to track the column load history for each face. Also noted on the figure is the debris impact zone from the collapse of WTC 1, which shows the southwest columns that were severed. Loads were extracted just above Floor 8 for three columns per face and were averaged to generate the loads shown in Figure 12–61.

Figure 12-60. Exterior columns used in load groupings.
