**Federal Building and Fire Safety Investigation of the
World Trade Center Disaster**

**Structural Fire Response and
Probable Collapse Sequence of
World Trade Center Building 7**

VOLUME 1

November 2008

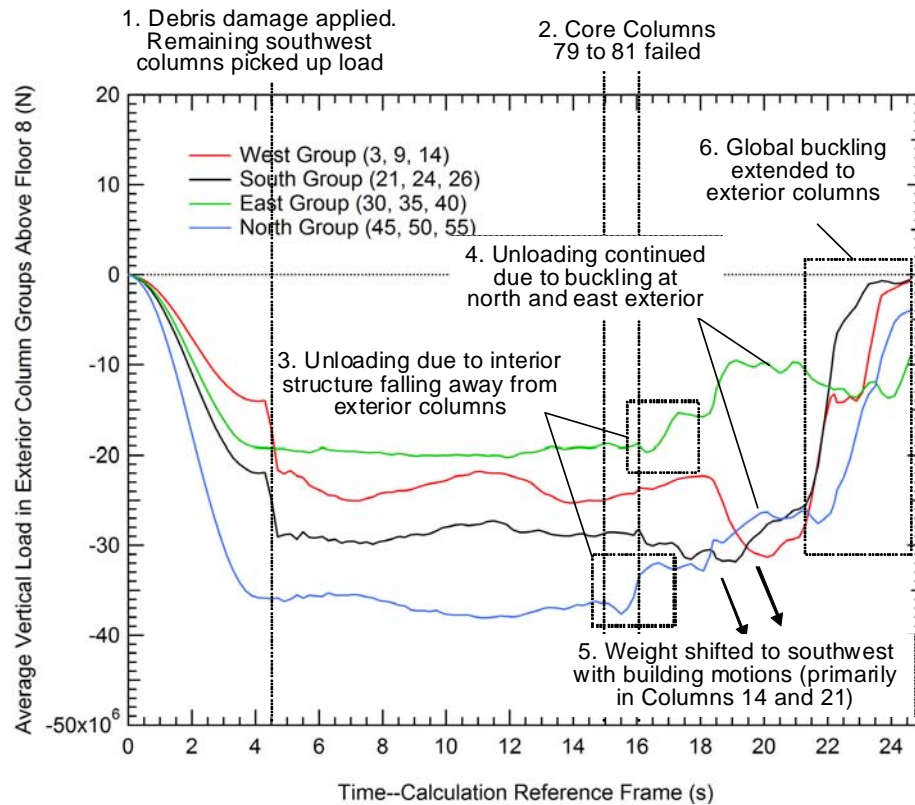
Figure 12–61 shows that selected exterior column forces increased as gravity loads were applied (compressive loads are negative). As indicated at 4.5 s (LS-DYNA calculation time), there was an increase in compressive forces on the west and south faces of the building after debris impact damage was applied. As Columns 79, 80, and 81 buckled and the floor systems failed on the east side of the building (at 15 s to 16 s), column forces reduced in the north and east faces. The west face column forces were dominated by the forces in Column 14, which was adjacent to the severed columns in the southwest corner. At 21.5 s, exterior column buckling began at Column 14, between Floors 10 and 12. The exterior columns adjacent to the (seven) columns severed in the southwest region due to the collapse of WTC 1 were the first to buckle due to the increased forces in these columns following the debris impact damage. The south and west face columns buckled first, followed by the north and east face columns.

Figure 12-61. Average exterior column forces by group.

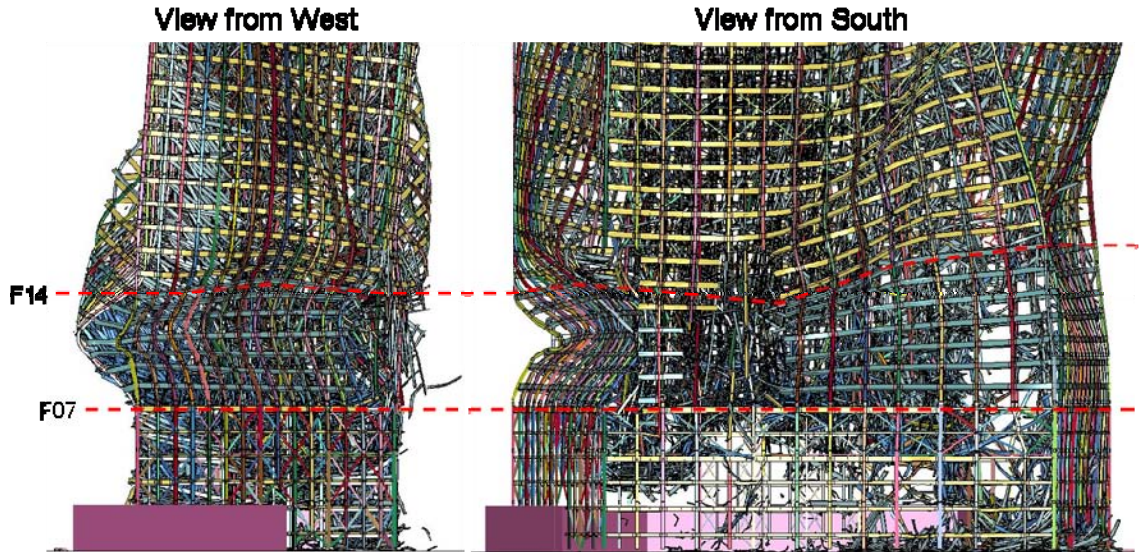
The floor connections to the west face columns had not failed above Floor 9 because no fires were observed on the west side of Floors 10 through 14. The intact floor framing pulled the exterior columns inward as the interior columns fell downward during the horizontal progression of failure stage and the floors pulled on the exterior columns. As the interior columns buckled across the building, the exterior columns were left laterally unsupported normal to the east, south, and north faces. Exterior column buckling spread from column to column, as loads were redistributed, until all the exterior columns had buckled between Floors 7 and 14 within approximately 2 s.

Figure 12–63. Detailed view of exterior column buckling at lower floors (slabs removed from view).

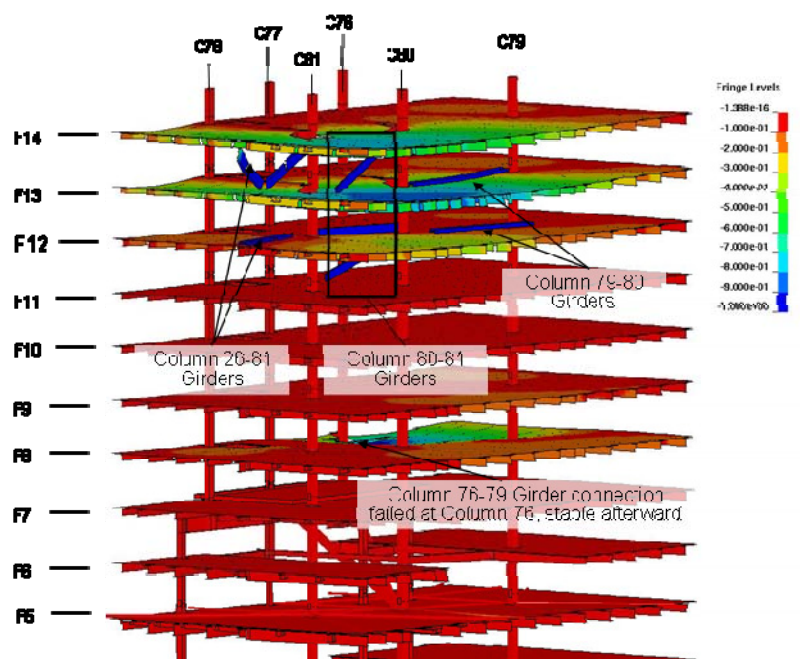
The structural damage at 3.5 h in the ANSYS analysis had floor failures in the southeast corner at Floors 8, 13, and 14 and connection damage at Floor 12. After applying the 3.5 h ANSYS damage at 8.5 s, a few girders connected to Columns 79, 80 and 81 in Floors 12 to 14 fell to floors below, as shown in Figure 12–64. However, the damage was not sufficient to fail other floor structures below Floor 12 or to initiate a vertical collapse. Vertical displacement contours in Figure 12–64 show some significant vertical displacements, but the structure was stable at the end of the analysis. Comparison to Figure 12–43 from the 4.0 h damage case (Section 12.4.4) shows that, for the 3.5 h damage case, the overall damage was significantly less extensive in the floors surrounding Columns 76 to 81.

Figure 12-64. Floor framing damage around Columns 76 to 81 after stability has been reached -3.24 s (12.76 s). Contours of vertical displacement shown -39 to 0 in. (-1 to 0 m).

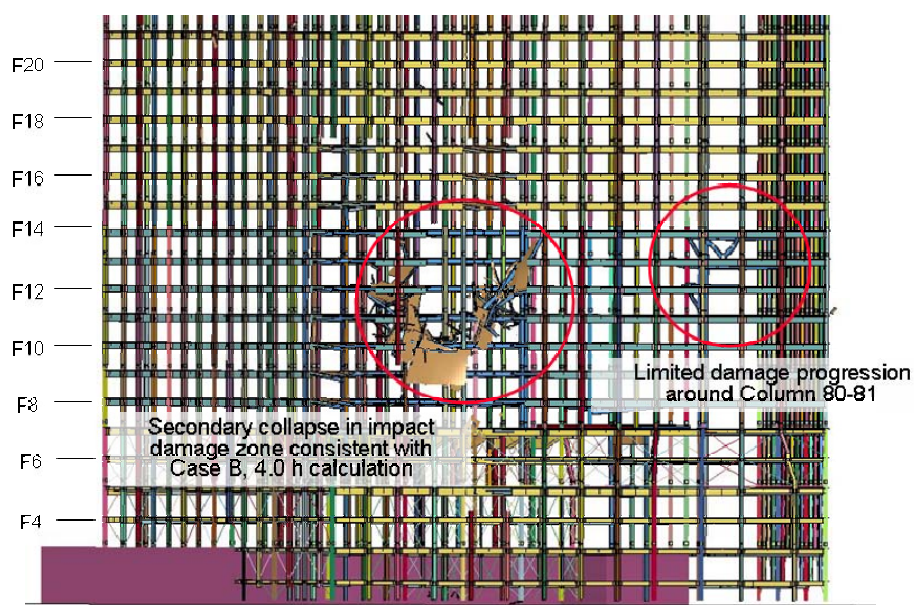
Figure 12–65 illustrates the structural failures across the lower floors after the application of the fire-induced damage at 3.5 h. Similar to the 4.0 h ANSYS analysis with debris damage (Figure 12–42), there was damage to connections at several west core column over 11 stories, which occurred during the application of the WTC 1 debris impact damage. However, the structure remained stable due to the lack of an initiating event (i.e., buckling of an interior column). The response of WTC 7 to the fire-induced damage at 3.5 h was not sufficient to cause an initiating event that would lead to global collapse.

Figure 12-65. Lower floor damage in stable structure at -3.8 s (12.2 s). View from southwest.

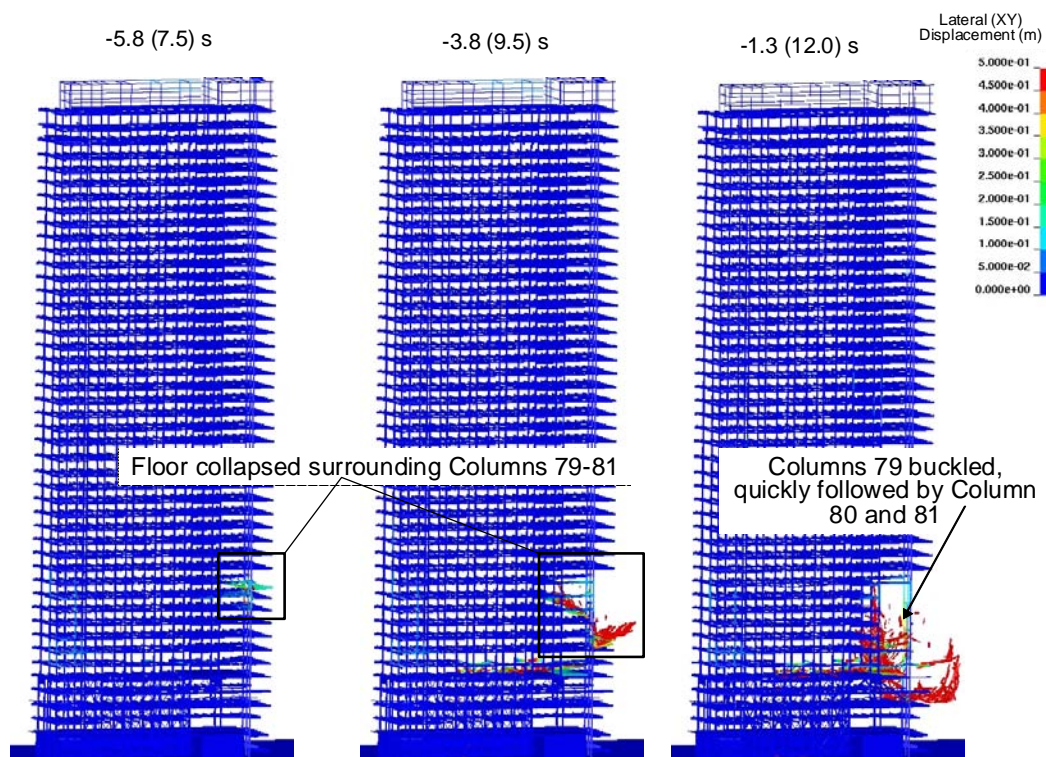
Figure 12–66 shows the structural response from just after application of the fire-induced damage to 1.3 s prior to the kink formation in the east penthouse. The left and center images show the failures that started in Floors 13 and 14, and the cascade of floor failures that occurred subsequently, due to the thermally weakened condition. The right image shows the loss of lateral support around Column 79 and the start of Column 79 buckling. Similar response was shown in Figure 12–42 for the global analysis with impact damage. Note that in this stage of the analysis, relative to the analysis with debris impact damage, there was no early development of western core column buckling that was caused by the application of debris impact damage.

Figure 12-66. Core collapse sequence viewed from the south. Time: -5.8 s to -1.3 s (7.5 s to 12.0 s). Contours of resultant lateral displacement 0 in. to -20 in. (0 m to -0.5 m).

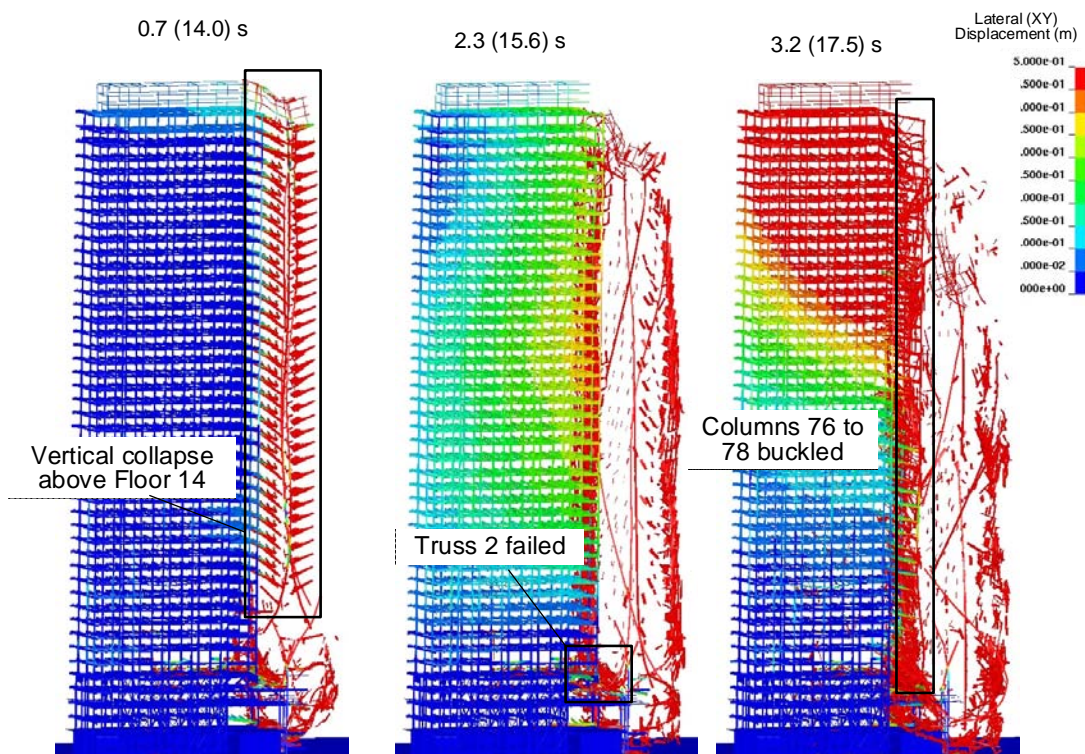
Figure 12–67 shows the structural response from 0.7 s (14.0 s), shortly after the east penthouse kink was observed, to 3.2 s (17.5 s), when Columns 76 to 78 buckled as the horizontal progression of failure began. The left image shows the vertical progression of failure. The center image shows the loss of lateral support to Columns 76 to 78, as well as the failure of Truss 2, due to the effects of debris accumulation and impact during the vertical progression of failure. The right image shows the buckling of Columns 76 to 78. Similar responses were shown in Figure 11–48, Figure 12–49, and Figure 12–53 for the global analysis with impact damage.

Figure 12-67. Core collapse sequence viewed from south. Time: 0.7 s to 3.2 s (14.0 s to 17.5 s). Contours of resultant lateral displacement 0 in. to -20 in. (0 m to -0.5 m).

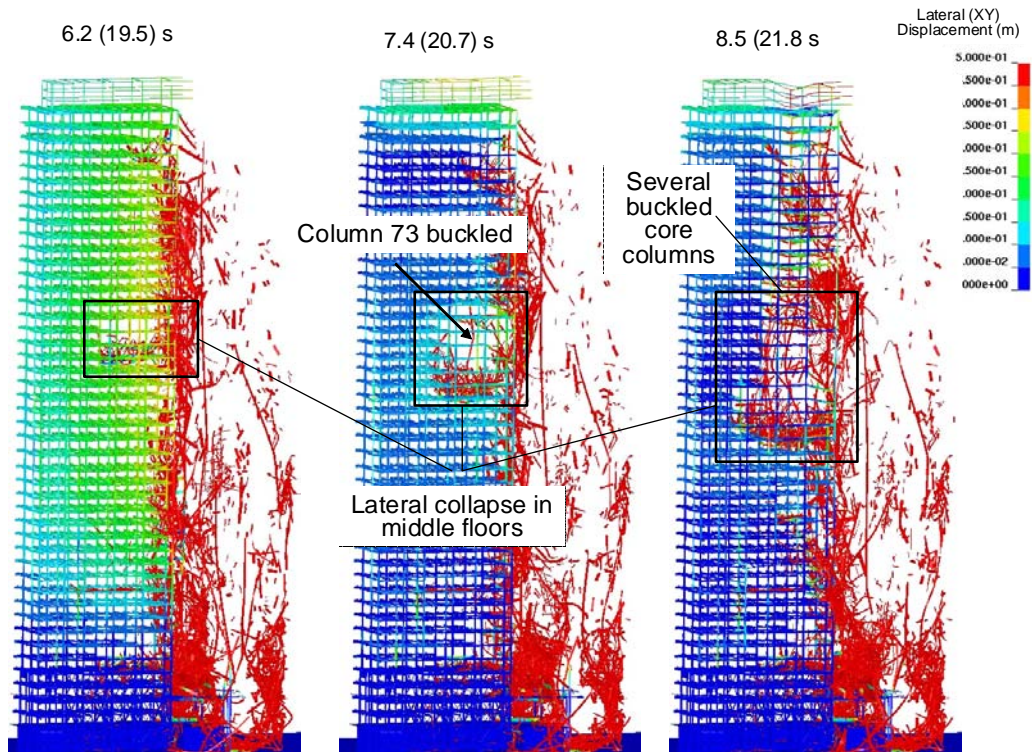
The right image in Figure 12–68 shows that the screening wall fell downward prior to the west penthouse (view is from the southwest), which is consistent with the observed sequence of events. The horizontal progression continued to move westward.

As the horizontal progression moved from east to west, some differences were observed relative to the analysis with impact damage, as shown in Figure 12–68 and Figure 12–69. Some floors failed at mid-height of the building around Columns 73 to 75, leading to the buckling of some interior columns at this location, rather than at lower floors. Between 6.2 s (19.5 s) and 13.5 s (26.8 s), the damage progressed westward and downward across the core as floor structures failed and fell onto the floors below. The horizontal progression in the analysis without debris impact damage moved from east to west over a longer duration. This was due to the lack of western core damage that occurred in the analysis with debris impact damage.

Figure 12-68. Core collapse sequence. Time: 5.5 to 7.8 s (21.5 to 23.8 s). Contours of resultant lateral displacement 0 to -20 in. (0 to -0.5 m).

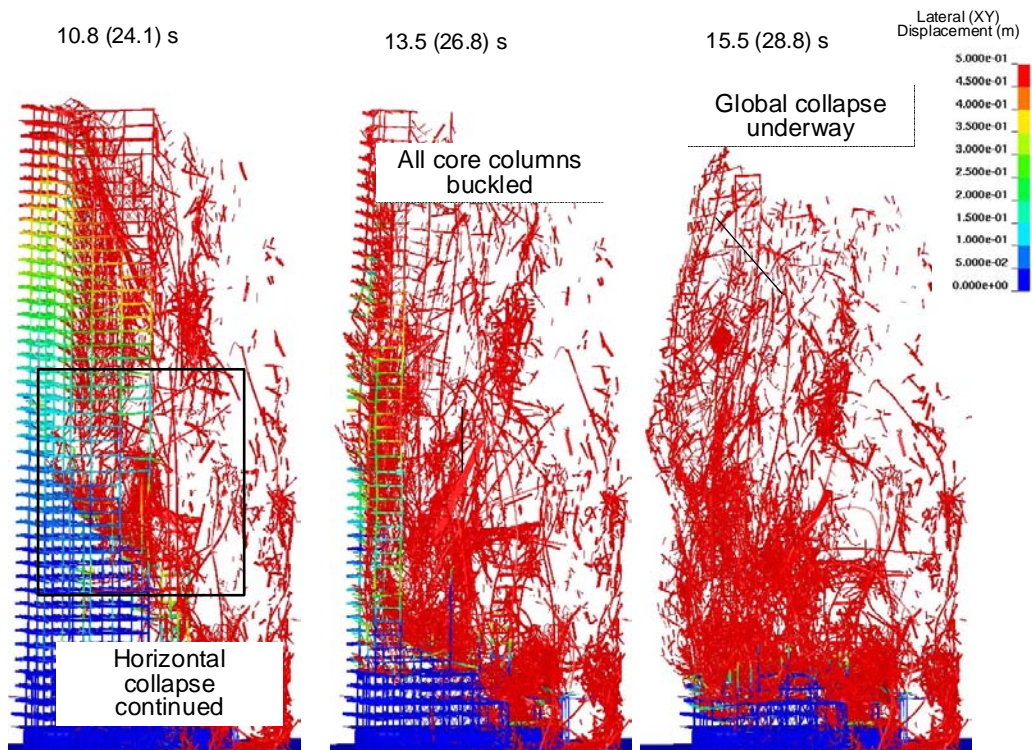
Figure 12-69 Core collapse sequence viewed from the south. Time: 10.8 to 15.5 s (24.1 to 28.8 s). Contours of resultant lateral displacement 0 in. to -20 in. (0 m to -0.5 m).

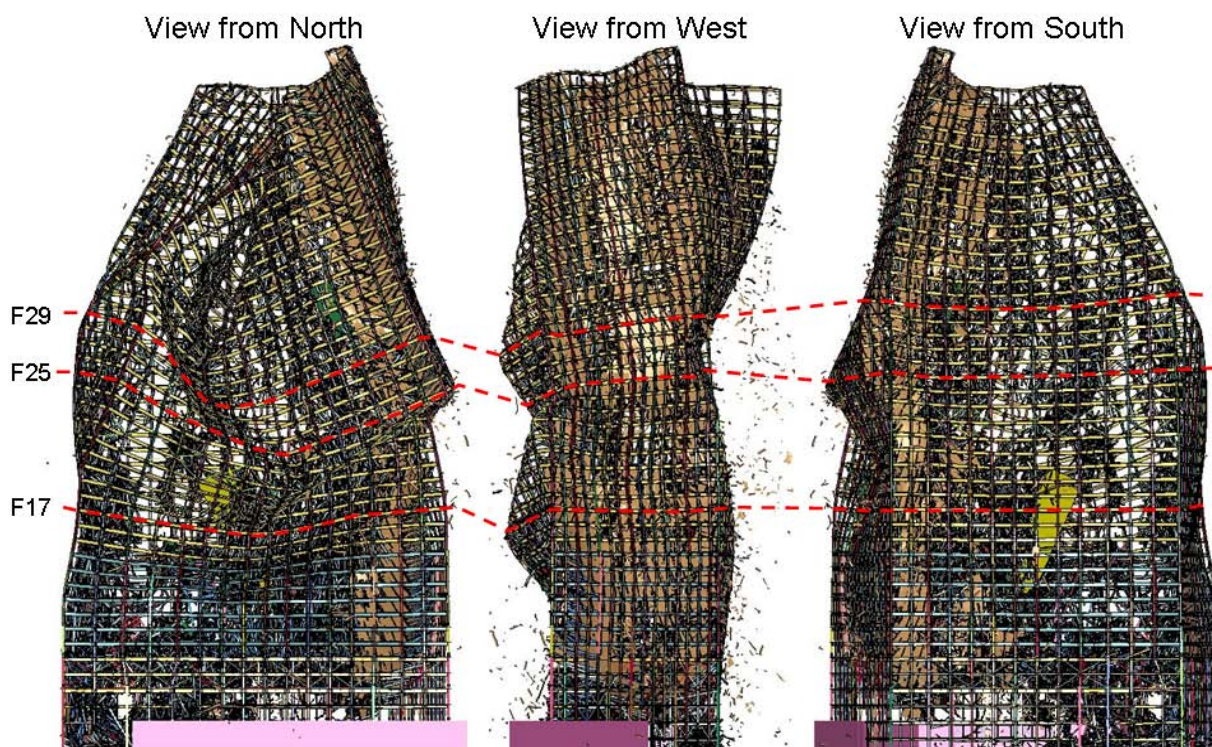
By 13.5 s (26.8 s), all the interior columns had buckled and, at 15.5 s (28.8 s), the global collapse (i.e., buckling of exterior columns) was underway, as shown in Figure 12–70. The exterior columns buckled near mid-height of the building, approximately between Floors 17 and 29.

Figure 12–70. Exterior column buckling after initiation of global collapse with fire-induced damage and without debris impact damage (slabs removed from view).

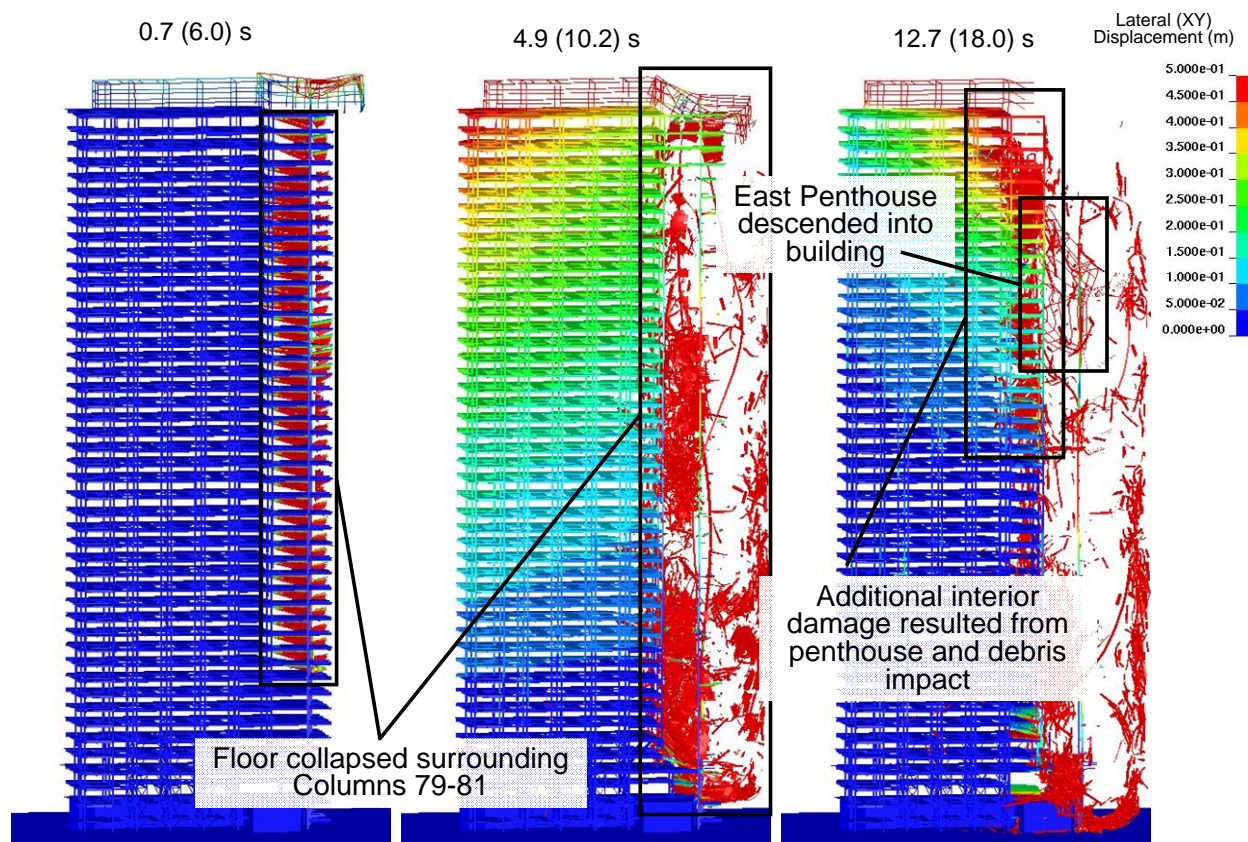
Figure 12–71 shows the structural response of the interior columns between 0.7 s (6.0 s) and 12.7 s (18.0 s). The east penthouse fell into the building at 7.5 s (12.8 s). Most of the east penthouse above Columns 79 and 80 sagged into the building after Columns 79 and 80 buckled, but the east penthouse did not fall into the building until the upper sections of Column 81 failed. The east penthouse was not disconnected from the screening wall structure until 7.5 s (12.8 s). Column 76 was impacted by the east penthouse and other structural debris around Floor 35 at about 10.8 s (16.1 s), causing the column to deflect northward. Column 77 buckled at about 11.0 s (16.3 s) around Floor 36. Column 78 then buckled at about 9.5 s (19.3 s) between Floors 25 and 33.

Figure 12–71. Collapse of the north interior columns from 0.7 s (6.0 s) to 12.7 s (18.0 s). Contours of resultant lateral displacement 0 in. to 16 in. (0 m to 0.4 m).

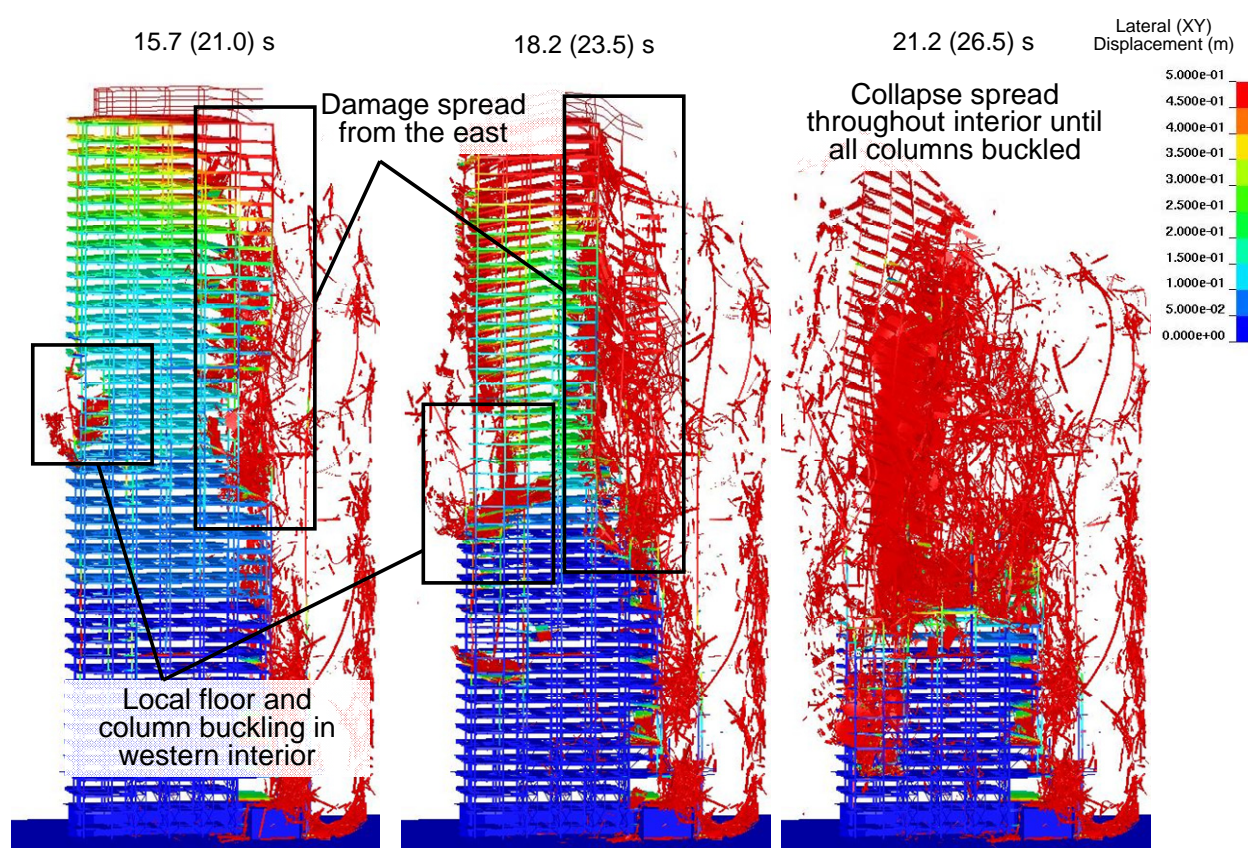
Figure 12–72 shows the structural response of the interior columns between 15.7 s (21.0 s) and 21.2 s (26.5 s). Column damage continued to spread westward with Column 73 buckling at about 15.0 s (20.3 s) between Floors 35 and 37. Column 58 buckled at 14.7 s (20.0 s), following a column splice failure at Floor 31 that occurred 8 s earlier, at about 6.9 s (12.2 s), but did not cause column failure. The column splice initially failed due to relative twisting and shearing motions between floors that were most acute in the northwest corner of the building. The global building motions grew in response to the column and floor structure failures in the eastern interior. The relative motions at the Column 58 splice were magnified compared to other surrounding columns due to the relatively large area supported by Column 58 and the limited shear stud connections in the northwest corner of the building, which together provided relatively less twisting resistance from the composite floor slab. As a result, the Column 58 splice above Floor 31 and some surrounding framing connections sustained damage, which continued to accumulate with subsequent building motions.

Figure 12–72. Collapse of the north interior columns from 15.7 s (21.0 s) to 21.2 s (26.5 s). Contours of resultant lateral displacement 0 in. to 16 in. (0 m to 0.4 m).

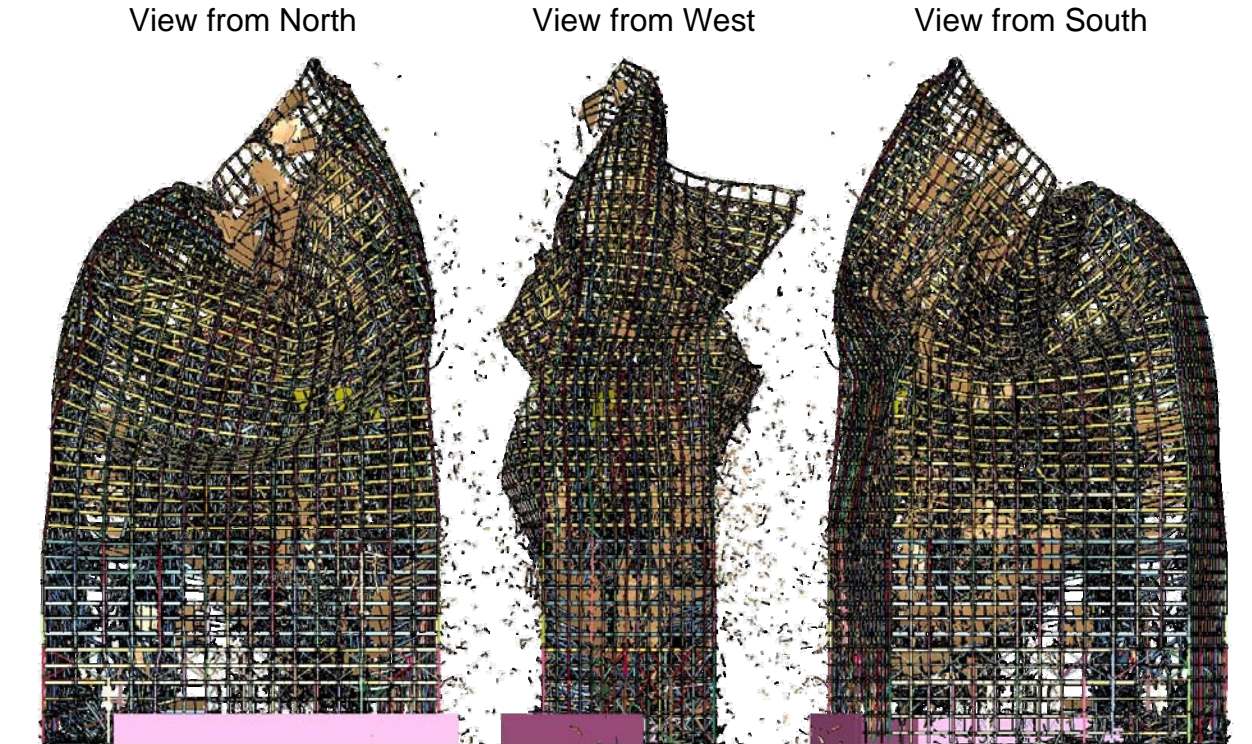
After Column 58 buckled, floor and column collapse propagated horizontally throughout the interior. By 21.2 s (26.5 s), all the interior columns had buckled above Floor 23, and the west penthouse and screening wall had fallen into the building, as indicated in Figure 12–73. Vertical motion at the roofline indicated buckling of the exterior columns, and the start of global collapse.

Figure 12-73. Exterior column buckling after initiation of global collapse for progressive collapse analysis without debris impact and fire-induced damage (slabs removed from view).

This analysis showed that WTC 7 was prone to classic progressive collapse upon the failure of Column 79. WTC 7 was not evaluated for progressive collapse, as it was not (and still is not) standard practice to evaluate commercial office buildings for such an event. Unless a potential hazard is known, a typical progressive collapse analysis includes a critical failure location and identifies areas where the structural design could be strengthened or made more redundant to mitigate against a global or disproportionately large collapse.

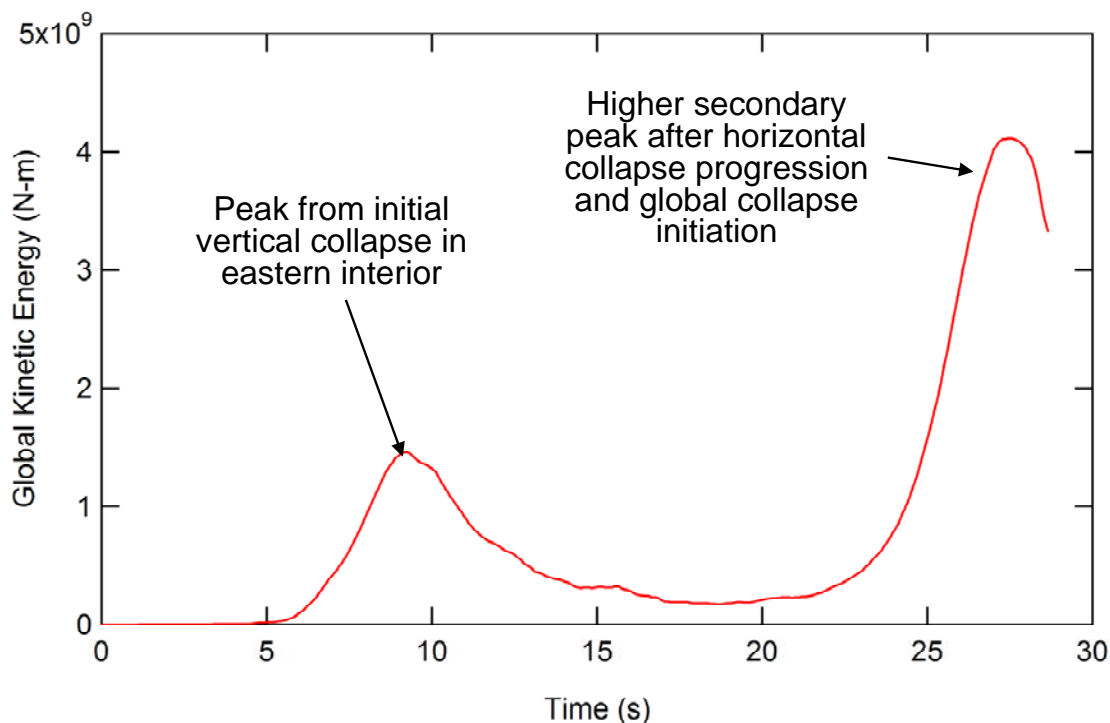
Figure 12-74 is a plot of the kinetic energy in the global model during the analysis, where the kinetic energy is due to falling debris and debris impact. An initial peak kinetic energy occurred around 3.7 s (9.0 s), when Columns 79, 80, and 81 had buckled between 1.3 s (6.6 s) to 5.1 s (10.4 s) and the surrounding floors and columns were falling. After the debris had fallen, the collapse progression slowed, as Columns 76, 77, and 78 did not buckle until 10.8 s (16.1 s) to 14.0 s (19.3 s), respectively. The kinetic energy levels decreased during this period until between 14.7 s (20.0 s) to 16.7 s (22.0 s), after which all the interior columns buckled and led to a sharp increase in kinetic energy.

Figure 12–74. Global kinetic energy during the analysis without fire or debris impact damage.

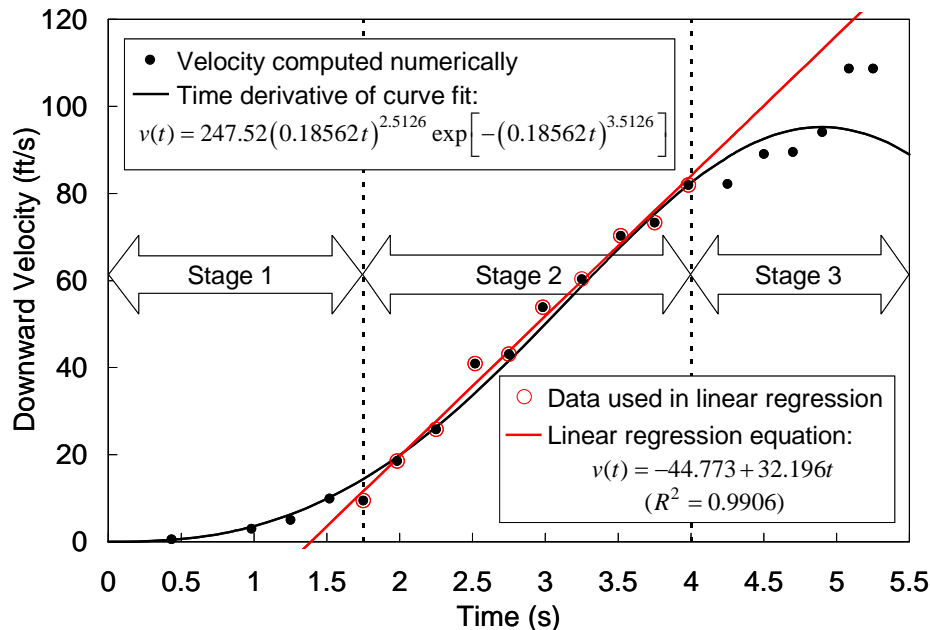
Figure 12-77
Downward
velocity of north
face roofline
as WTC 7 began to
collapse.

For discussion purposes, three stages were defined, as denoted in Figure 12–77:

- In Stage 1, the descent was slow and the acceleration was less than that of gravity. This stage corresponds to the initial buckling of the exterior columns in the lower stories of the north face, as seen in Figure 12–62. By 1.75 s, the north face had descended approximately 7 ft.
- In Stage 2, the north face descended at gravitational acceleration, as exterior column buckling progressed and the columns provided negligible support to the upper portion of the north face. This free fall drop continued for approximately 8 stories (105 ft), the distance traveled between times $t = 1.75$ s and $t = 4.0$ s.
- In Stage 3, the acceleration decreased somewhat as the upper portion of the north face encountered resistance from the collapsed structure and the debris pile below. Between 4.0 s and 5.4 s, the northwest corner fell an additional 130 ft.

As noted above, the collapse time was approximately 40 percent longer than that of free fall for the first 18 stories of descent. The detailed analysis shows that this increase in time is due primarily to Stage 1, in which column buckling was just beginning and gradual increases in displacement and velocity were observed. The three stages of collapse progression described above are consistent with the results of the global collapse analyses discussed earlier in this chapter.

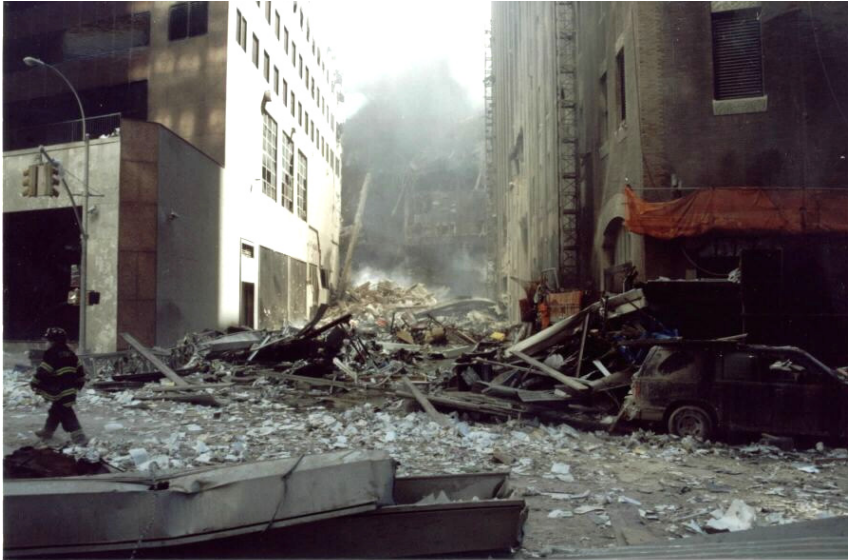
Following the evacuation of the substation shortly before the collapse of WTC 1, the Con Edison portion of WTC 7 was secured by Con Edison, and there was no evidence of anyone reentering the substation building up to the time when WTC 7 collapsed. From the photographs and videos examined, the exterior of the substation suffered no significant direct damage due to the collapse of WTC 1. Figure A-4, a photograph taken sometime in the afternoon, shows the northwest corner of WTC 7, along with a considerable amount of debris on Washington Street. Aside from what appear to be superficial scrapes on the two large street level louvers south of the driveway door, this portion of the building looks intact. (Note that the broken panes above the louvers spanned the 3rd and 4th floors of WTC 7 and were not connected to the Con Edison substation.)

Figure A-4. Northwest corner of the Con Edison substation (building on left), showing light damage from WTC 1 debris. (Photo taken sometime in the afternoon on Sept. 11, 2001.)

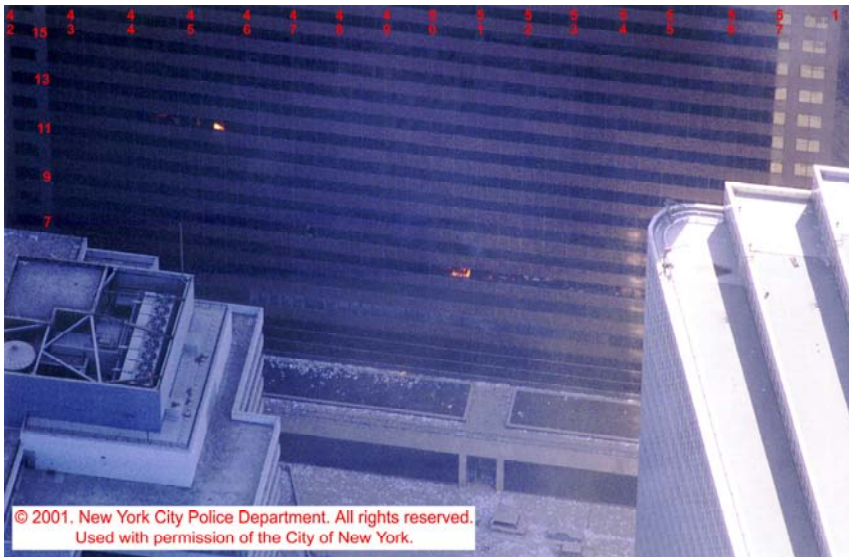
Figure A-5 shows another view of the Con Edison portion of WTC 7, shot from a police helicopter at about 3:00 p.m. Fires can be seen on the 7th and 12th floors of WTC 7. Light debris is visible on the grill work which formed the roof of the north portion of the Con Edison substation; this portion of the Con Edison substation appears to be intact, with no visible evidence of smoke. No photograph, video record, or witness account gathered during the investigation identified smoke or flames originating from the Con Edison portion of WTC 7.

Figure A-5. Aerial view of the middle of the north side of the Con Edison substation, taken at 2:57 p.m. ± 5 min on September 11, 2001.

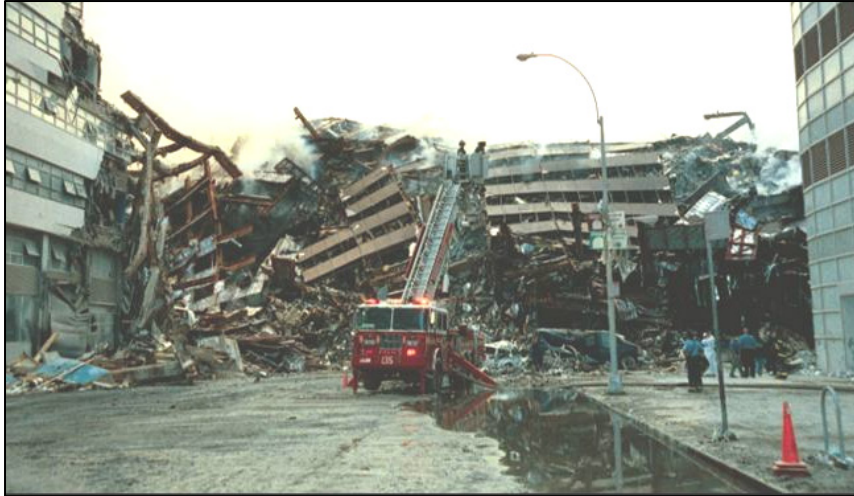
The collapse of WTC 7 buried the Con Edison structure and all the equipment in it. Figure A-6 shows the collapsed building at the beginning of the salvage and clean up operations, viewed looking south from Greenwich Street.

Figure A-6. Debris pile from collapse of WTC 7 onto the Con Edison substation, viewed looking south from Greenwich Street, date undetermined.

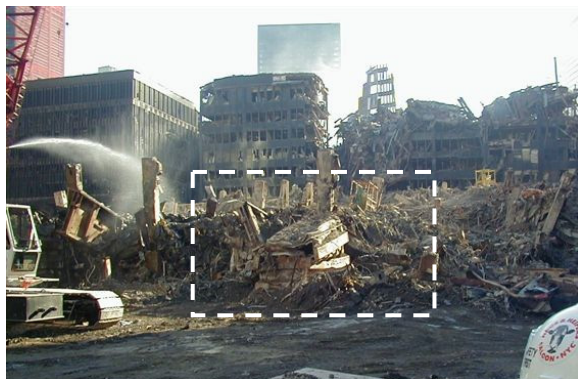
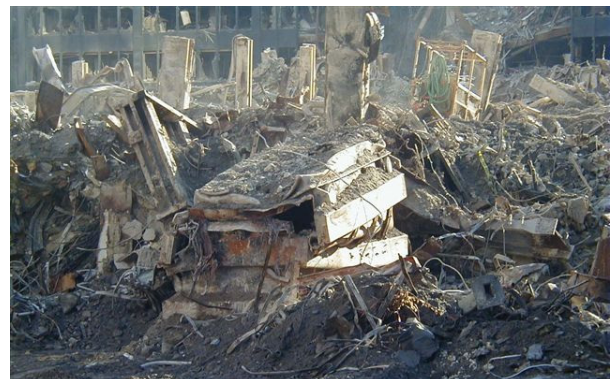
The left photograph in Figure A-7 was taken about five weeks after September 11, 2001. It shows the remnants of the Con Edison substation after the removal of much of the debris. The area outlined in a dotted white line is enlarged in the right photograph in Figure A-7A. From its location in the pile, this appears to be transformer #4, but also may be #8 or #9. The interior of this transformer was described as being severely thermally damaged, possibly by fire³.

Figure A-7. Photographs taken on mid-October, 2001, showing Con Edison transformer #4 (or #8 or #9) uncovered from the debris pile of WTC 7.

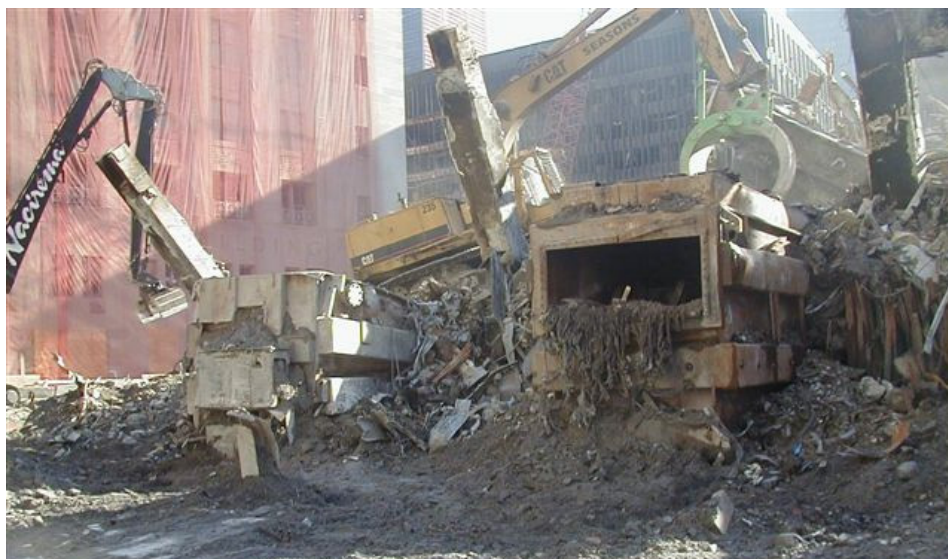
A similar assessment of thermal damage was made for transformer #1, shown on the right in Figure A-8. This is in contrast to transformer #6, which is the unit on the left in Figure A-8. The gray paint on transformer #6 is clearly evident, with little indication of rust or excessive heat.

Figure A-8.
Photograph taken
in mid-October,
2001, showing
Con Edison
transformers #6
and #1 uncovered
from debris pile of
WTC 7.

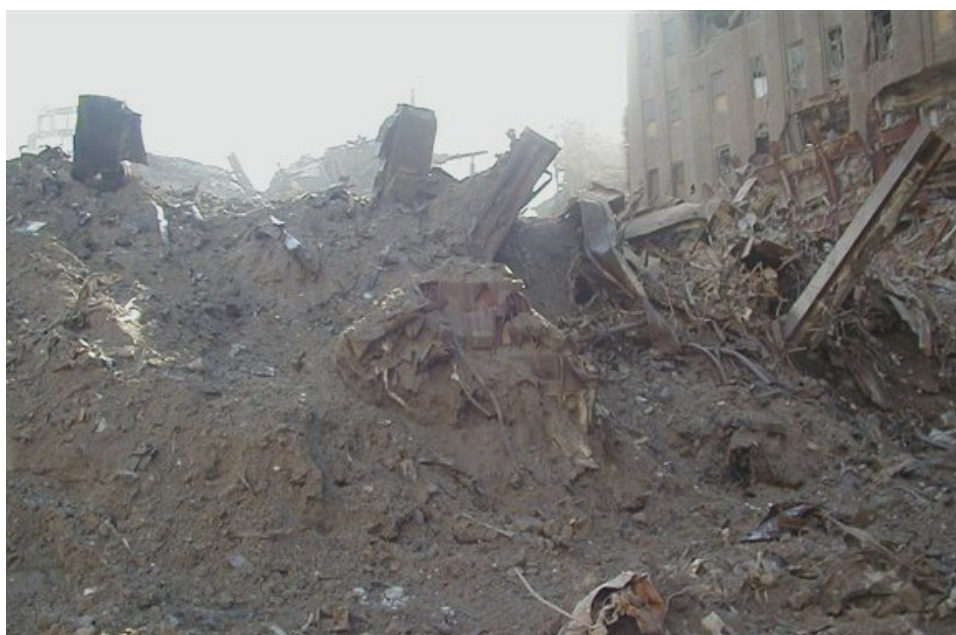
Transformer #7 (or possibly #5) is barely visible within the white box in Figure A-9. This transformer and the other three depicted in Figures A-7 and A-8 were not salvageable and were discarded.

NIST was unable to determine whether the thermal damage to the transformers occurred due to electrical overheating, due to a fire in the substation after the SCADA logs were terminated around 4:33 p.m., or due to burning within the rubble pile subsequent to the collapse of WTC 7.

Figure A-9.
Con Edison
transformer #7
(or #5) uncovered
from debris pile of
WTC 7; photo
taken mid-
October, 2001.

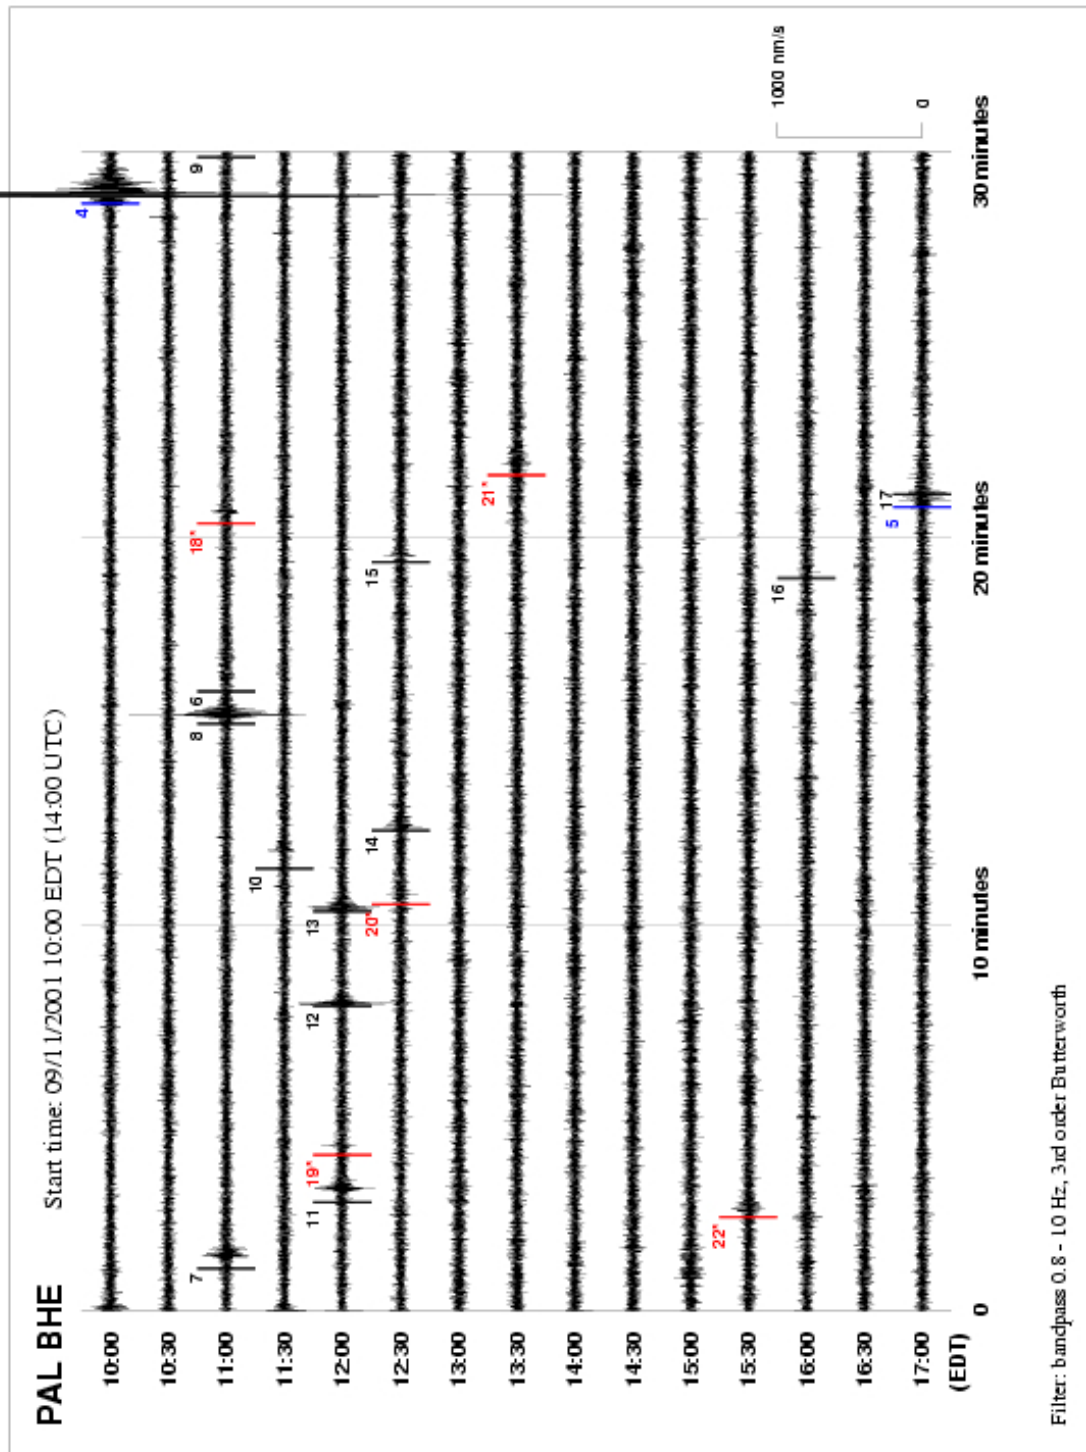
17:20:42	5	40.71	-74.01	0	0.6	WTC 7 collapse initiation
17:20:50	5'	40.71	-74.01	0	0.6	WTC 7 perimeter wall collapse

Figure B-9. Events identified on PAL seismogram.
Refer to Table B-4 for location, strength and description of event type.

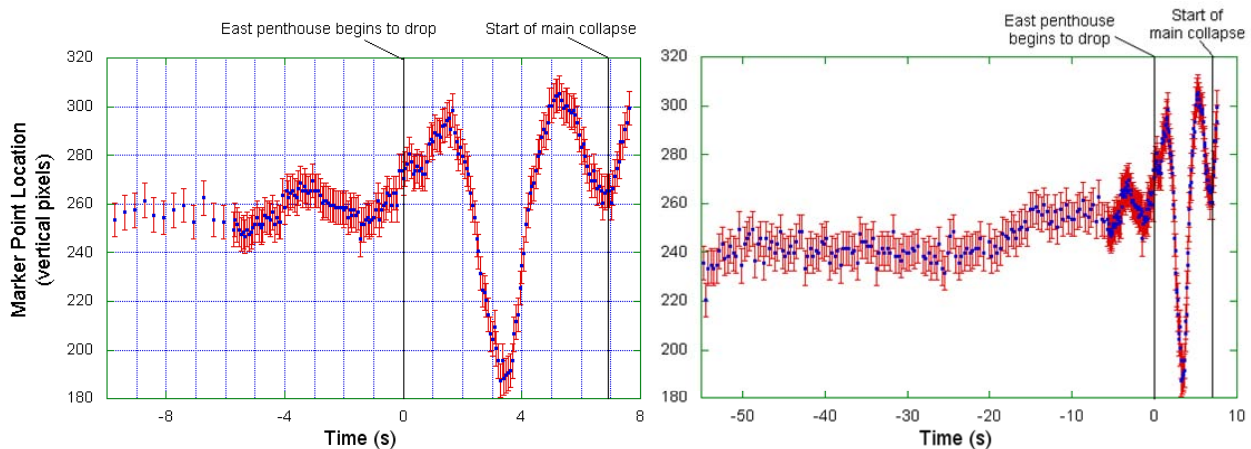
Figure C-6. Marker point data for final 18 s (left) and the final minute (right) prior to the collapse of WTC 7.

Data were collected for every other frame for approximately the final 13.5 s, and for every tenth frame preceding that point. The vertical pixel position of the marker point on the vertical axis was higher for movement downward (indicating northwest corner motion toward the east). The red lines at each data point showed estimated uncertainties of ± 7 pixels. This was a rough estimation, reflecting an inherent risk of error due to the brighter pixels to the right of pixel column 519 and darker pixels to the left of pixel column 517, as well as to the fluctuation of intensity levels along pixel columns 517 and 519. Despite this, the capability of this method to amplify sideways building vibrations was clear. With this near vertical orientation of the northwest edge of WTC 7 relative to the pixel columns, the marker point of equal intensity moved up and down by a total of more than a hundred pixels.

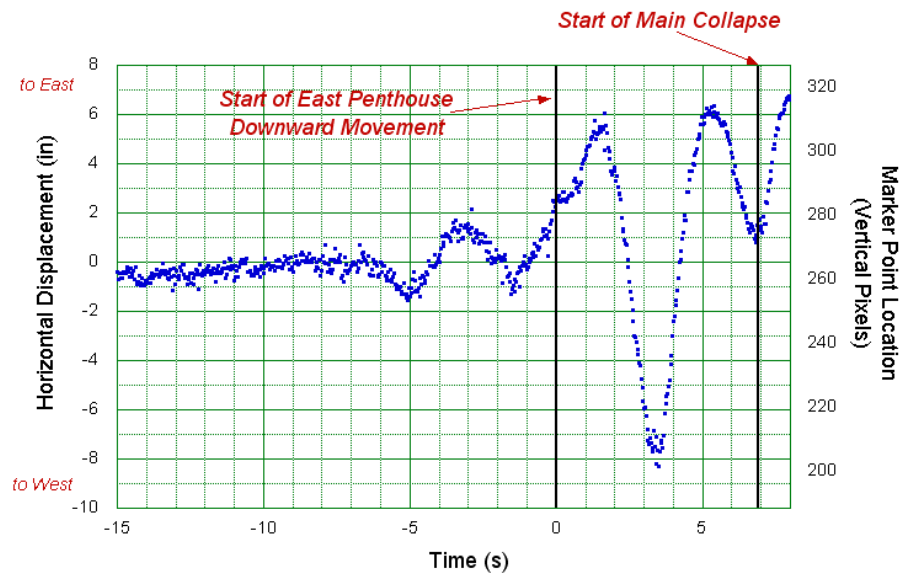
Figure C-8. Horizontal displacement of northwest corner of WTC 7 and marker point location for final 22 s before the start of penthouse downward movement.

Using the conversion factor determined in section C.1.3 allowed labeling of the vertical axis in both marker locations by vertical pixel number and in inches of horizontal displacement. The zero point for displacement was chosen to be vertical pixel number 265, the location of the marker point at the time when final oscillations began. In Figure C-8, some important behavior is apparent. Starting at about 6 s before the penthouse began its downward movement into the building, there was an abrupt change in the slope of the data that marked the beginning of oscillations that continue until collapse. There was also a second abrupt change in the data at about 1.5 s before the penthouse started moving downward.

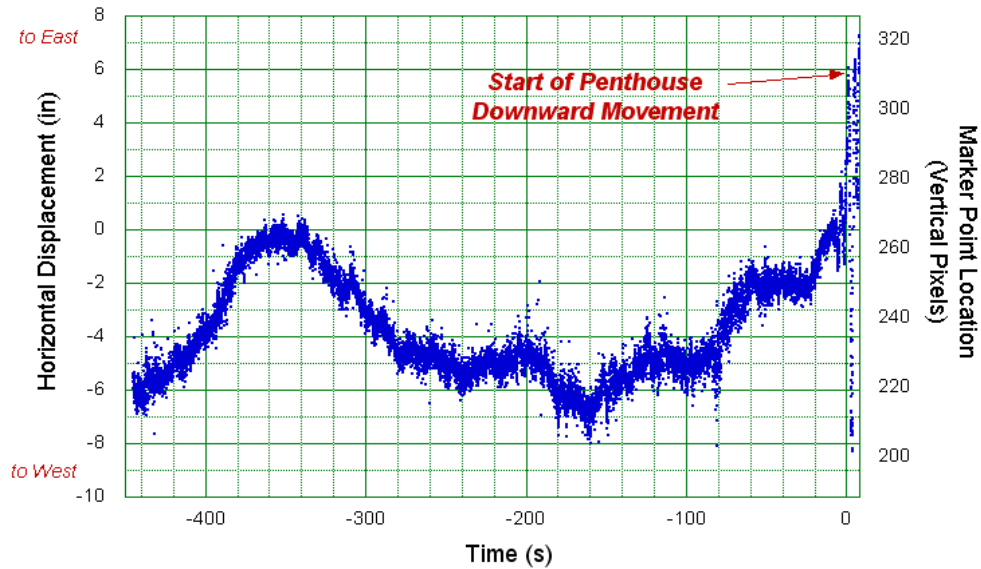
Figure C-9. Horizontal displacement of northwest corner of WTC 7 and marker point location for full 7½ min duration of video before collapse initiation.
