**Federal Building and Fire Safety Investigation of the
World Trade Center Disaster**

**Structural Fire Response and
Probable Collapse Sequence of
World Trade Center Building 7**

VOLUME 1

November 2008

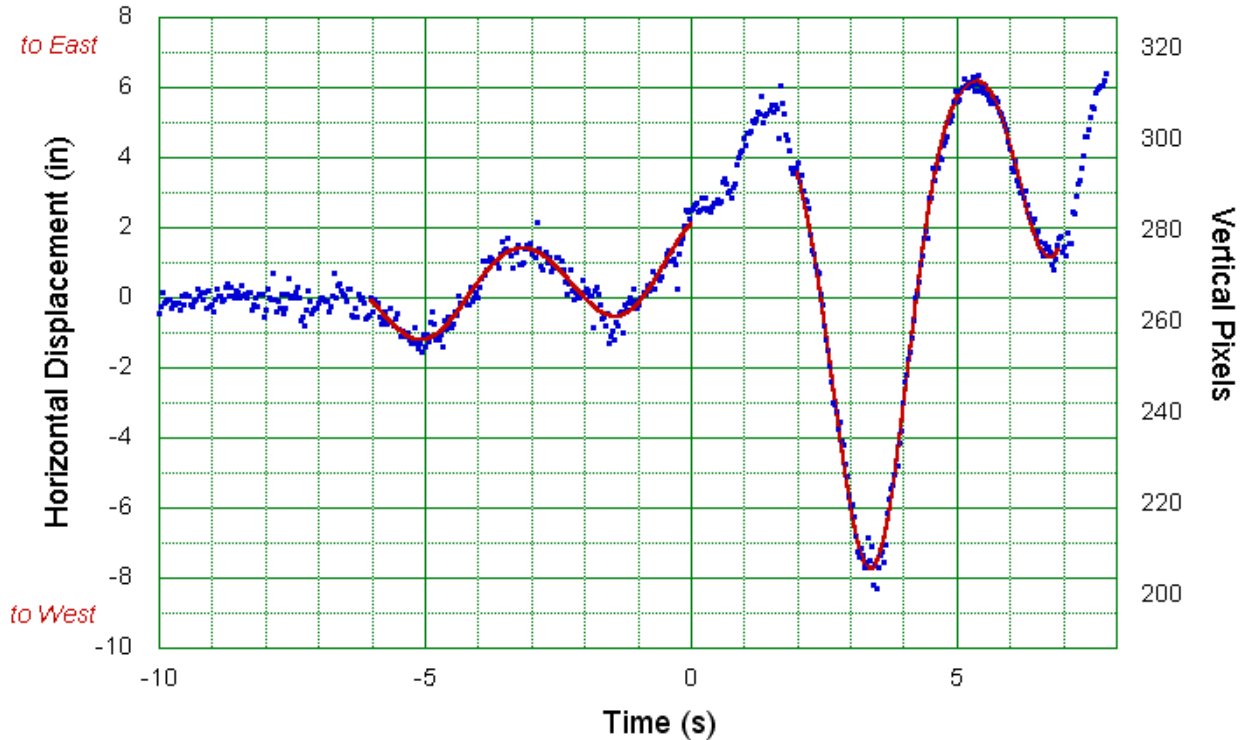
A final comparison of oscillation modes to data is shown in Figure C-14. Before the penthouse began to descend, an undamped mode of period 3.61 s described the building vibrations well. Between the time that the penthouse disappeared and the time that WTC 7 collapsed, a combination of a damped mode of period 3.46 s and an undamped mode of 1.65 s provided a good fit to the data.

Figure C-14. Comparison of data with modes before and after penthouse fall.

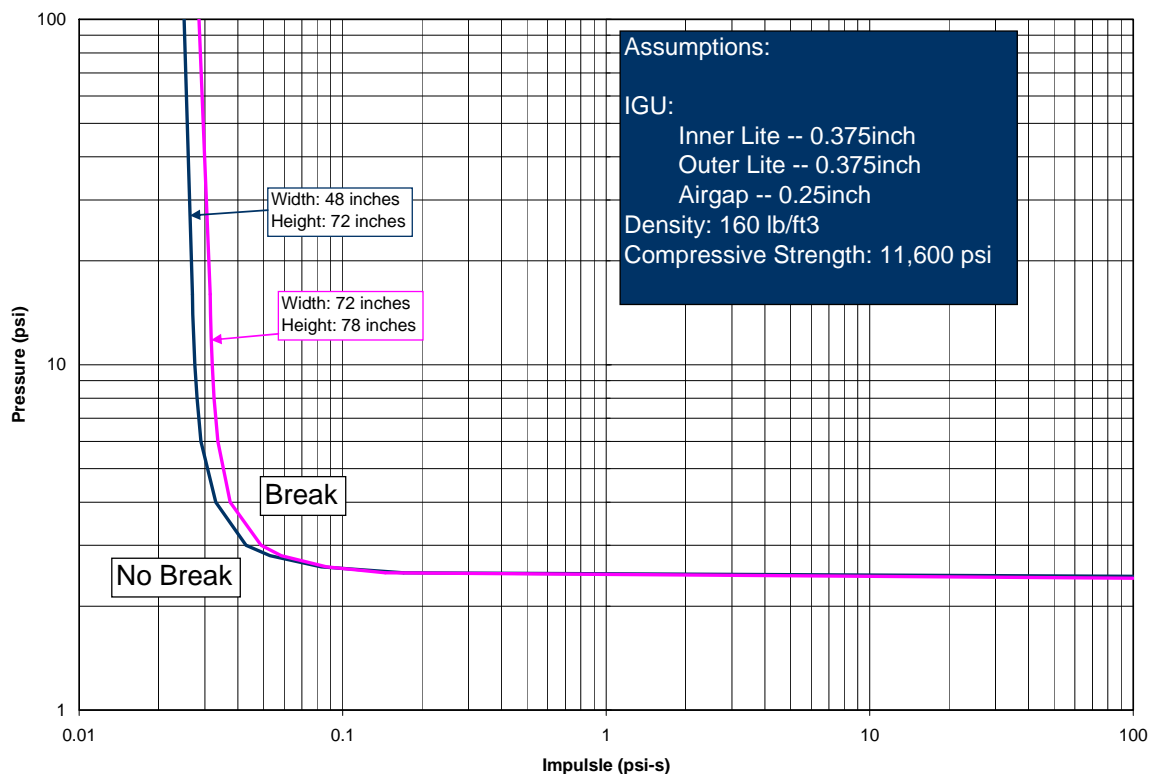
The SFOM window fragility analysis was conducted using available and assumed window details. The resulting P-I curves for two window sizes are shown in Figure D-8. The P-I curves indicate that a minimum overpressure of 2.5 psi was required for window failure in WTC 7. Slightly different minimum impulses were required for failure for the two window sizes considered in the analysis.

Figure D-8. Pressure-impulse requirements for WTC 7 window breakage.

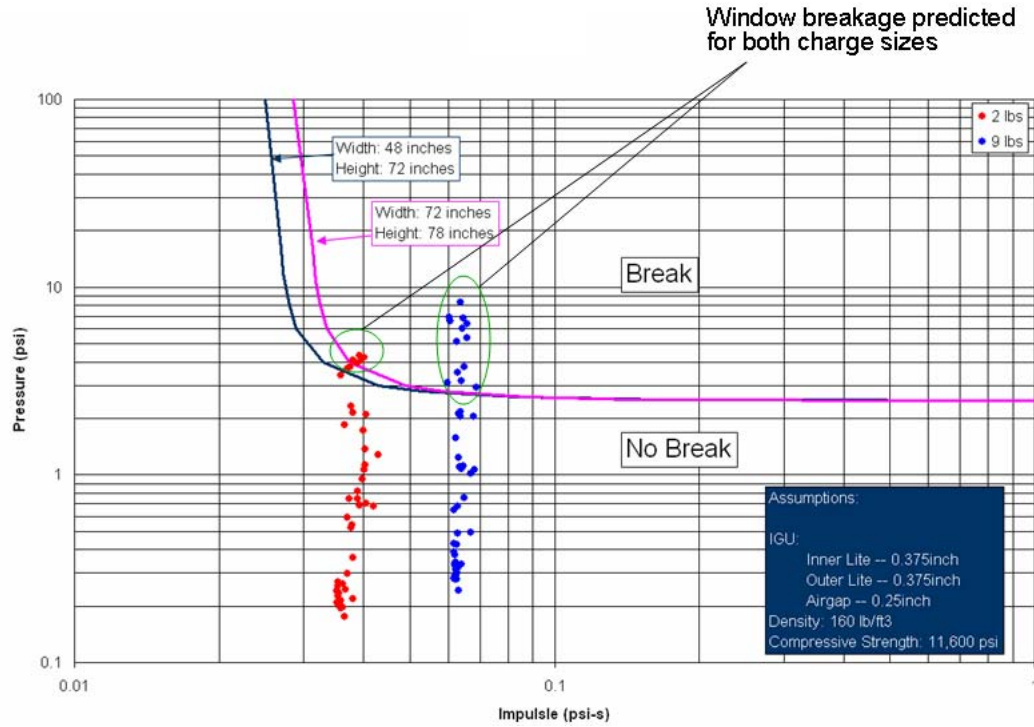
Key results from the Phase II blast analyses are shown in Figure D-9 through Figure D-14. Figure D-9 and Figure D-10 illustrate the predicted pressure-impulse levels at each window location around the building perimeter for Layouts 2 and 3, respectively. Two blast initiating charge sizes are shown: the minimum recommended 9 lb of RDX explosive from Phase I, and a smaller 2 lb charge to examine the sensitivity of the window breakage to charge size. The P-I values at each window location are overlaid on the predicted break/no-break criteria from the window fragility analysis conducted earlier in Phase II. Failure pressure-impulse curves are commonly used in blast analyses to illustrate system failure sensitivity to transient pressure loads.

Figure D-9. Layout 2 pressure-impulse values at window locations compared to predicted failure profiles.

As expected, the more open Layout 2 resulted in more predicted window failure locations for a given charge size, compared to the more extensively built-out Layout 3. Furthermore, the larger 9 lb explosive charge resulted in more window failures than the corresponding 2 lb charge analyses, predominantly on the east face of the building.
