NIST NCSTAR 1-3

**Federal Building and Fire Safety Investigation of the
World Trade Center Disaster**

Mechanical and Metallurgical Analysis of Structural Steel

September 2005

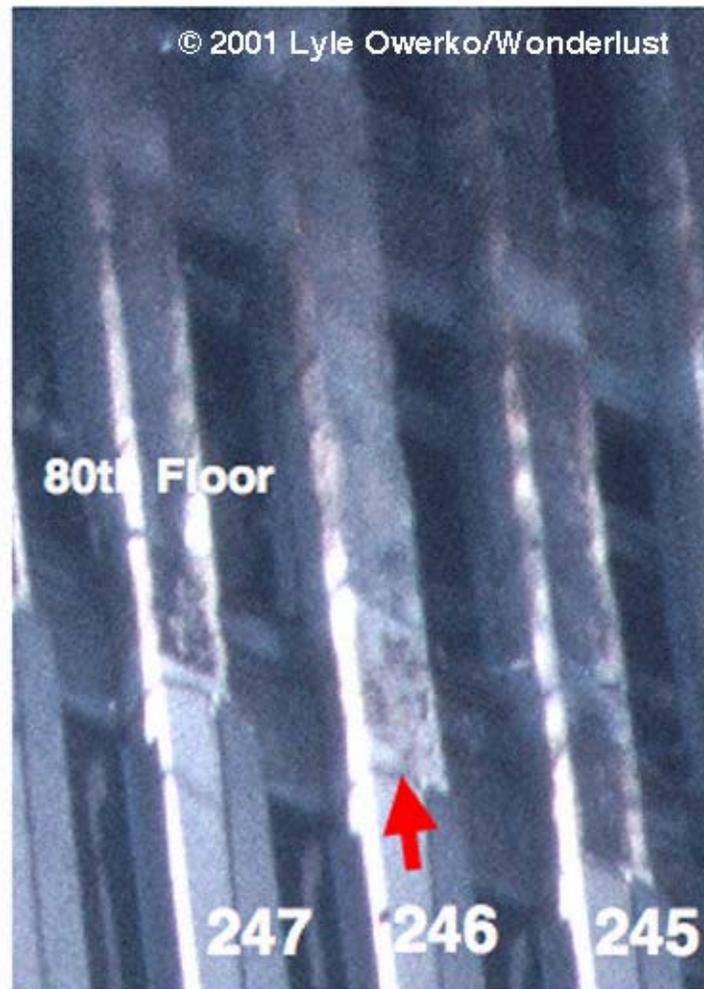
Figure 6–7. Fireproofing that had been applied to the exterior columns. The depression formed by the outer web and the flange tips are completely filled in with fireproofing at the arrow. North face of WTC 2.

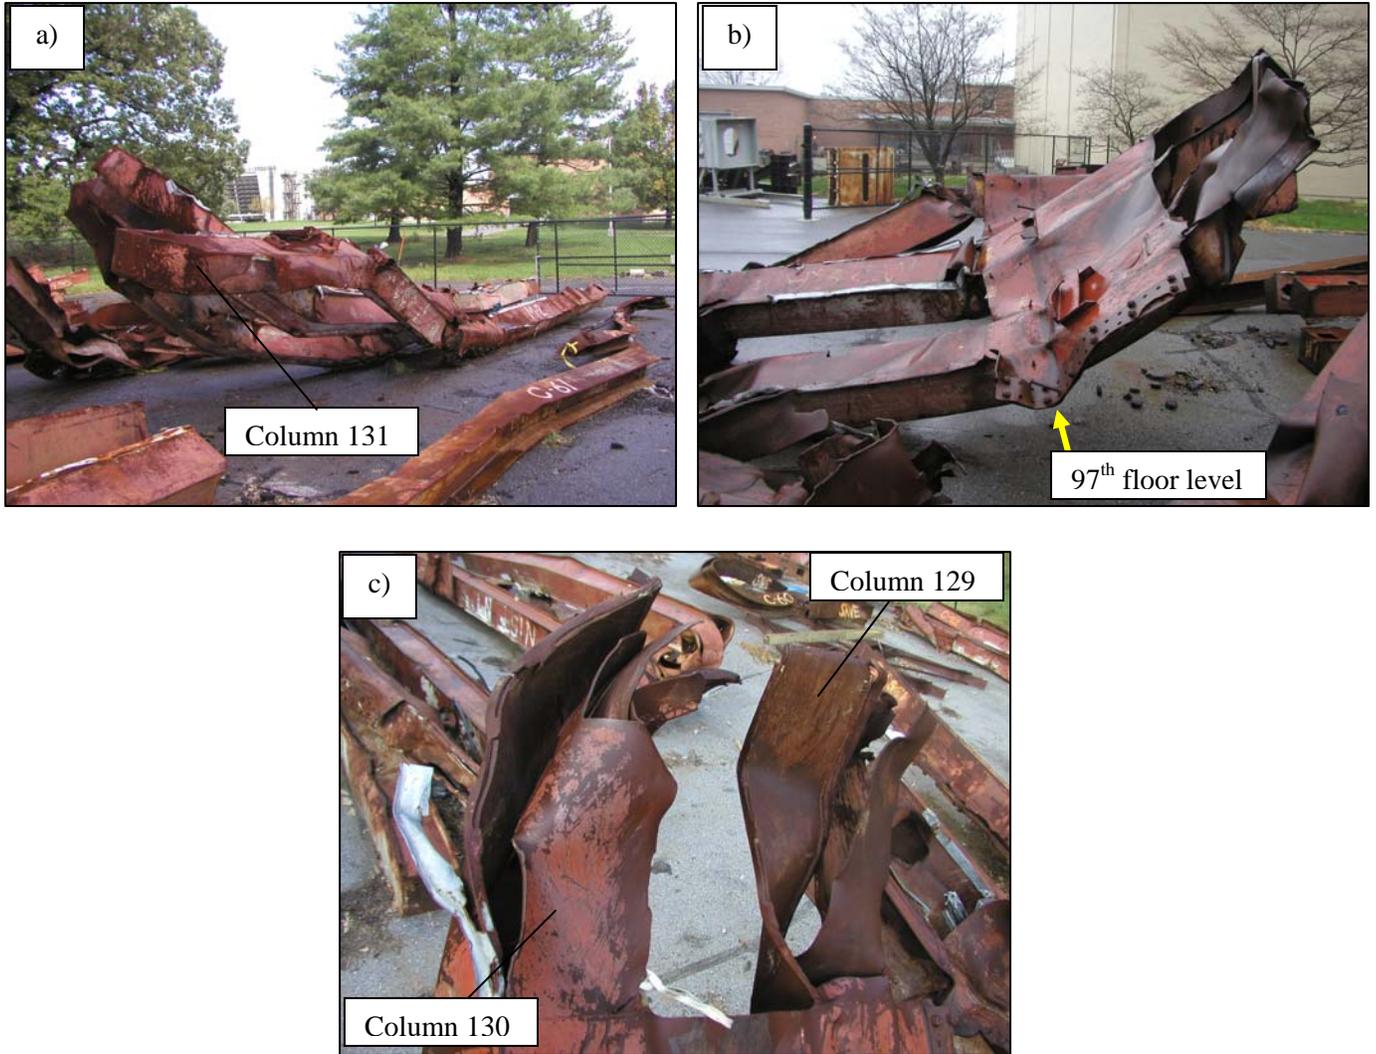
Damage to the lower portion of panel M-2 (WTC 1, column line 130, floors 96 to 99) was clearly associated with impact, which led to the missing endplates for columns 129 and 130. The inner and outer web plates of both columns have thinned in this area due to plastic deformation, Fig. 6-23a. The fracturing of the plates propagated as a 45 degree slant crack, oscillating between positive and negative 45 degrees with respect to the normal of the plate. The necking (thinning) of the outer web plate, plotted in Fig. 6-23b, indicates significant ductility, even at the high-strain rates associated with impact. Large buckles were observed on both flanges for columns 129 and 130 with some splitting occurring in the base material of the flanges (Figs. 6-24a and 6-24b) and spandrels (Fig. 6-24c). However, the welds found near this bending point remained intact (Fig. 6-24d).

Figure 6–22. a) Overall view of panel M-2 (A130: 94-97). Bottom of panel is on the left-hand side of the picture and the outside of the panel is facing down, b) major bend in panel located at the 97th floor level, and c) splayed bottoms of columns 129 and 130.

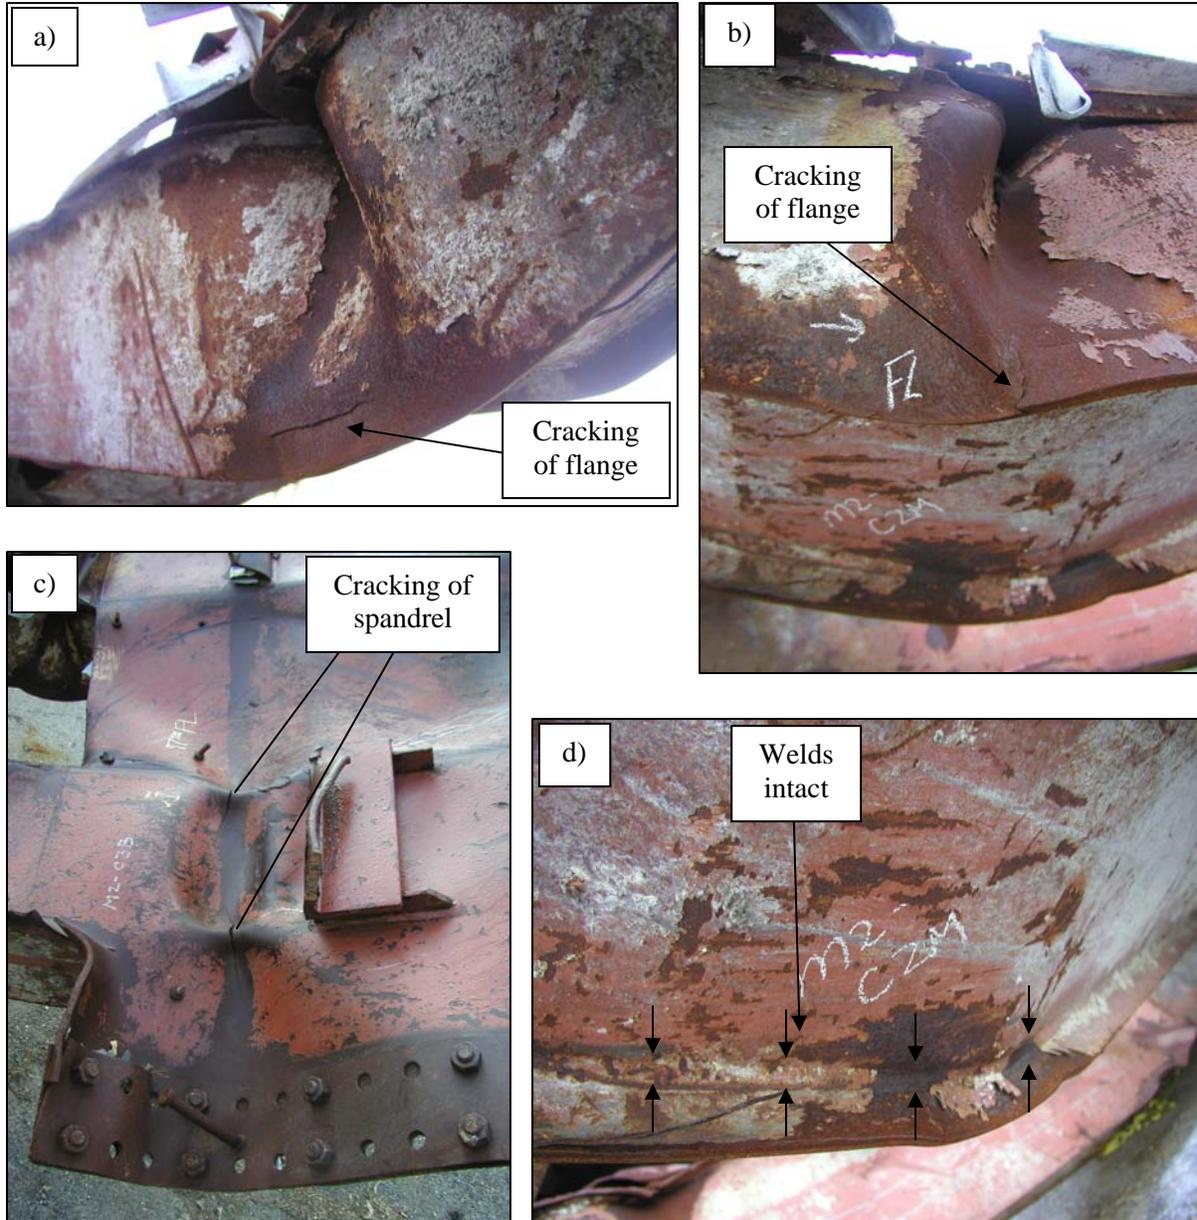
Figure 6–24. Damage images from sample M-2 (A130: 96-99). a) Large buckles observed on the flange plates of column 130, b) cracking of the flange plates on column 130, c) cracking of spandrel at 97th floor level, and d) no cracking of the welds in this area on column 130.

Of particular interest was the fracture behavior of the plates composing the columns that were directly impacted by the airplane. Fractures of the plates in areas away from a welded joint (e.g., fracture occurring perpendicular to the rolling direction of the outer webs of panels M-30 and S-9) exhibited ductile behavior, including necking and thinning away from the fracture, despite the high-strain rates.

Conversely, fractures occurring parallel and directly next to a welded joint exhibit little or no ductile characteristics. Diminished properties of the heat affected zone in the base plate, the geometry of the joint with respect to the direction of impact, stress concentrations due to the geometry, and the orientation of the crack propagation with respect to the rolling direction of the plate are expected to contribute to the lack of ductility.

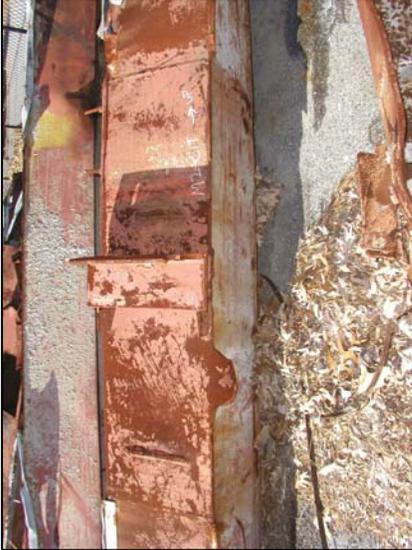
M2-C1T

Column 131, 99th floor

Failure mode: Type 4a, fracture of spandrel

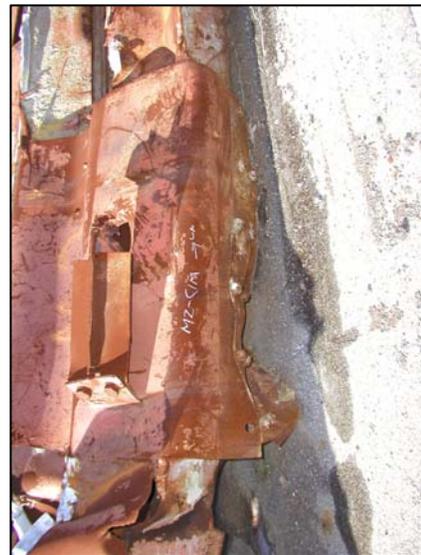
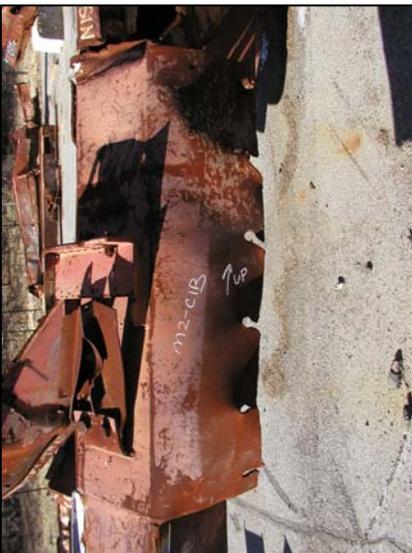
M2-C1B

Failure mode: Type 3, mixed mode of fracture and bolt hole tear out, portion of spandrel from S9-C3B still attached

Column 131, 97th floor

Failure mode: Type 1a, bolt hole tear out

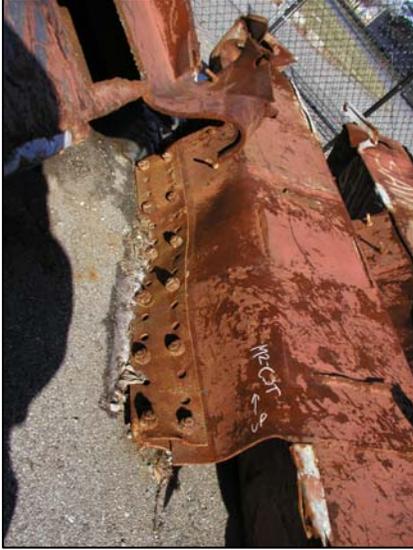
M2-C3T

Column 129, 99th floor

Failure mode: Type 1b, bolt hole tear out

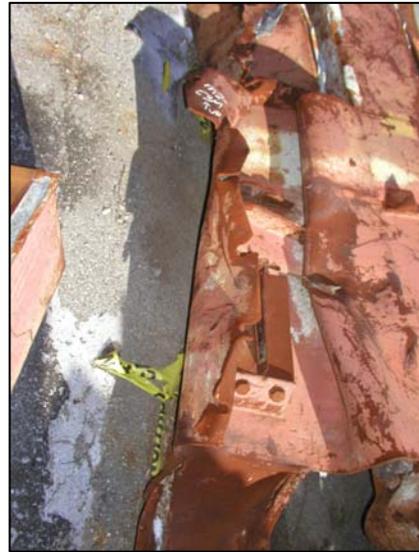
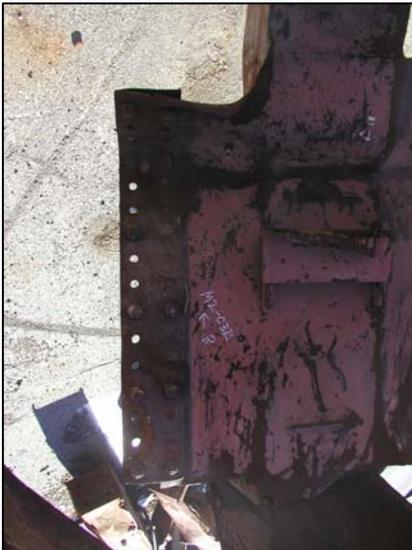
M2-C3B

Failure mode: Type 1a, bolt hole tear out

Column 129, 97th floor

Failure mode: Type 1b, bolt hole tear out

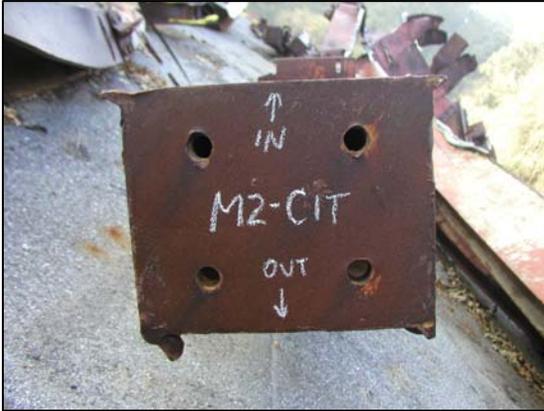
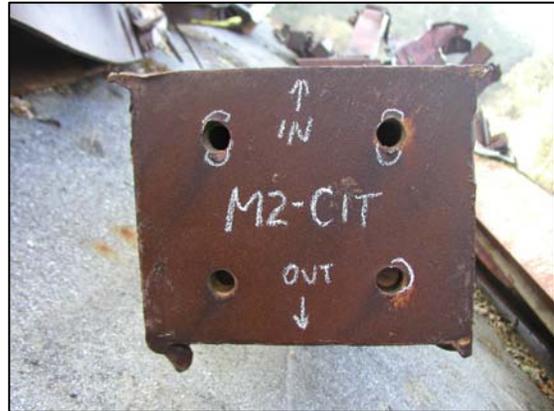
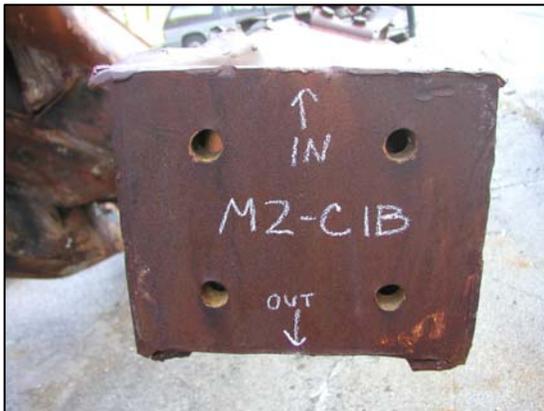
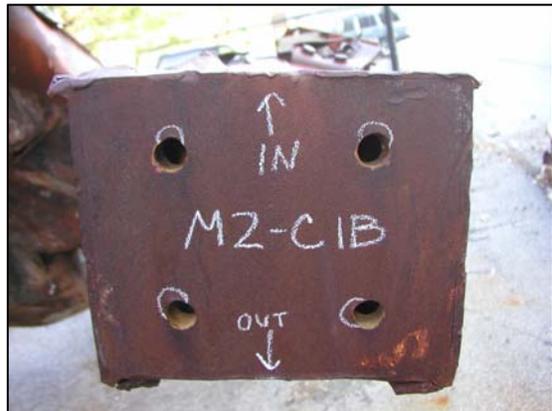
M2-C1T
WTC1
Col 131
F1 99

M2-C1B
WTC1
Col 131
F1 96

Figure 6–26. Photographs of recovered end plate connections from sample M-2 (A127: 97-100). Both ends of column 131 had bolt failure that resulted in deformation of the bolt holes in the end plates.

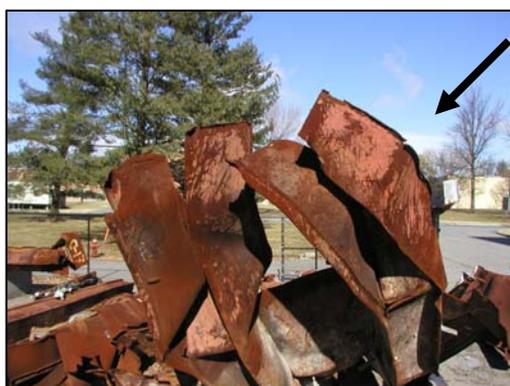
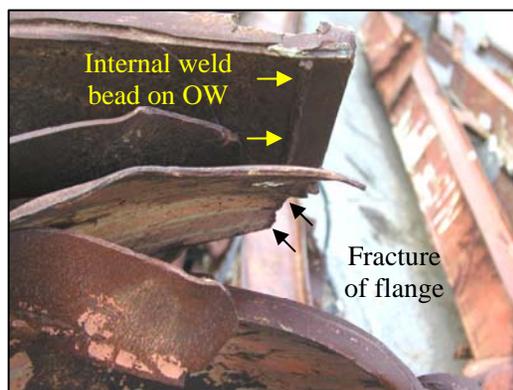
The state of the recovered bottom portion of columns 129 and 130 was nearly identical to the condition after the impact for panel M-2 (A130: 96-99). Both end plates were ripped completely out of the column, Fig. 6–26. Failure was a mixture of fracture in the base plates (portion of the flange/web still attached to the end plate) and clean separation of the end plate from the flange/web (complete flange/web recovered with internal weld bead visible). Bolt hole deformation for column 131 indicated that the connection was broken by bending inward of the lower column of the connection. Finally, while bolt failure was observed at the 99th floor splice of column 129, it can be noted that some separation existed between the flange plates of the column and the endplate.

No change in bolt hole shape

M2-C2T
WTC1
Col 130
F1 99

M2-C2B
WTC1
Col 130
F1 96

Figure 6–26. Photographs of recovered end plate connections from sample M-2 (A127: 97-100). The upper end plate experienced bolt hole failure. The bottom end plate of column 130 was ripped out upon impact of the airplane. Failure was found to be a mixture of fracture in the base plates (portion of the flange/web still attached to the end plate) and clean separation of the end plate from the flange/web (complete flange/web recovered with internal weld bead visible) (continued).

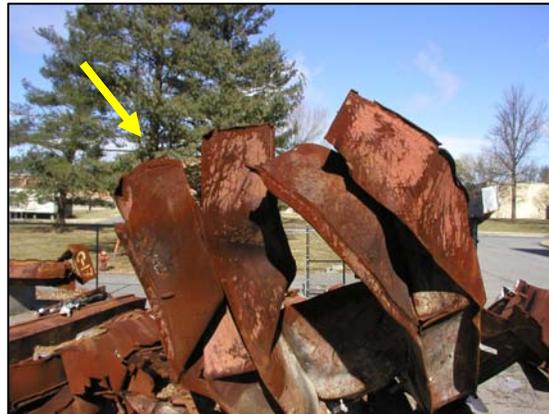
Separation between flange plates and butt plate

M2-C3T
WTC1
Col 129
F1 99

M2-C3B
WTC1
Col 129
F1 96

Figure 6–26. Photographs of recovered end plate connections from sample M-2 (A127: 97-100). The upper end plate experienced bolt hole failure. The bottom end plate of column 129 was also ripped out upon impact of the airplane. Failure was found to be a mixture of fracture in the base plates (portion of the flange/web still attached to the end plate) and clean separation of the end plate from the flange/web (complete flange/web recovered with internal weld bead visible) (continued).

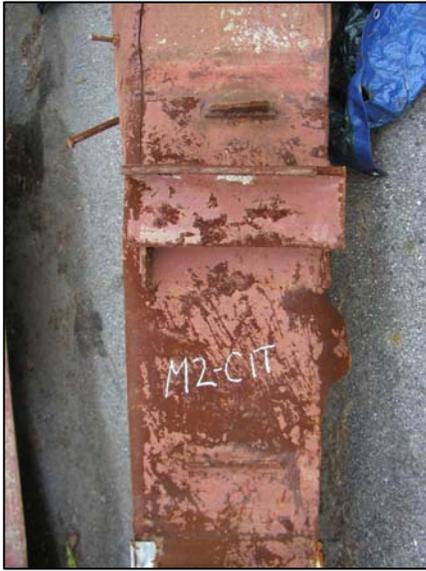
M2-C1T (Co 131, Fl 99)

Type A

1 standoff plate remains, seat and other standoff plate ripped off at welds;

Gusset plate with damper unit intact, bent up.

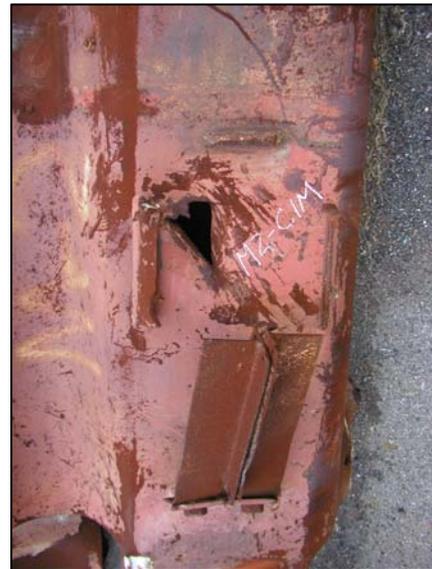
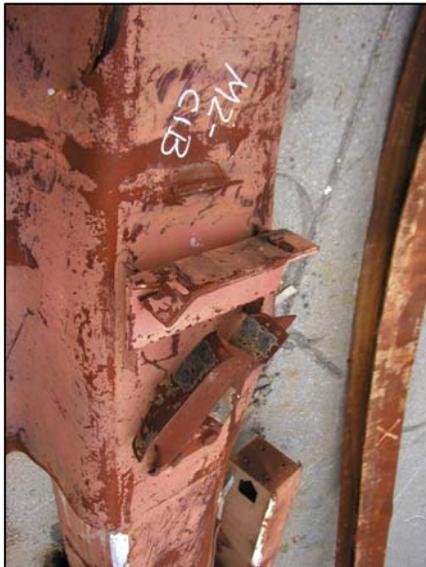
M2-C1B (Co 131, Fl 97)

Type A

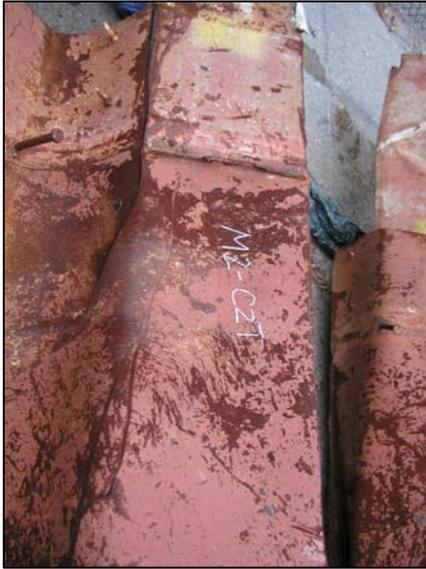
M2-C2T (Co 130, F1 99)

Type C

Seat Detail: 5210

Portion of tab plate remains, bent up.

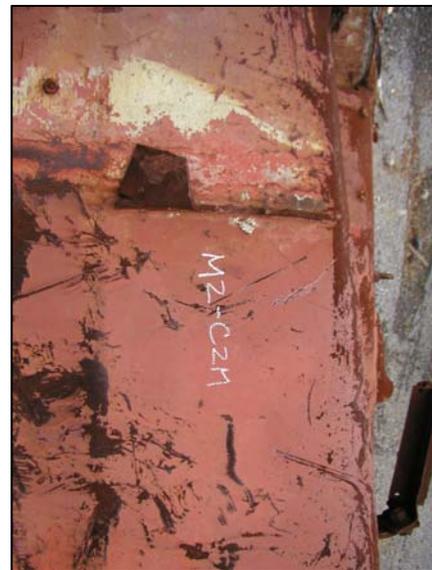
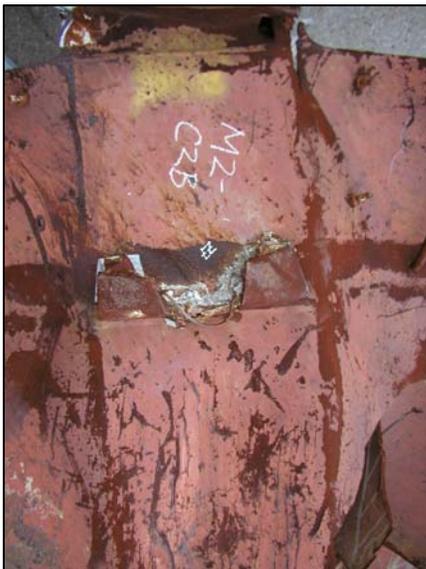
M2-C2B (Co 130, 97)

Type C

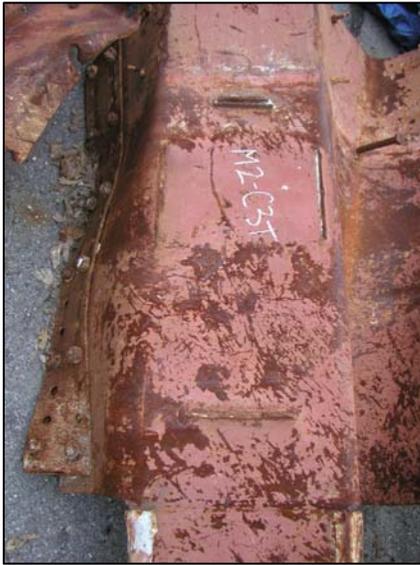
M2-C3T (Co 129, FI 99)
Type A
Seat Detail: 1411
Tab plate ripped off at weld;
Standoff plates ripped off at welds;

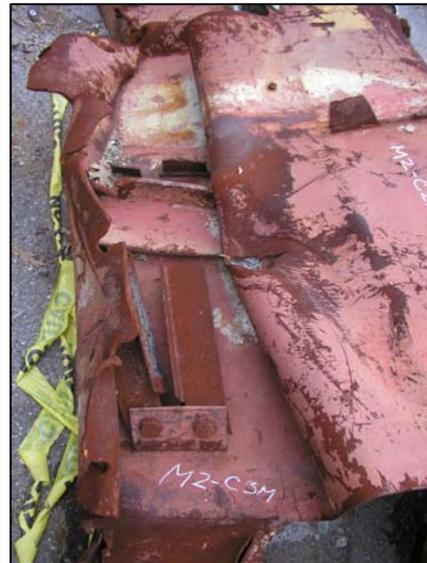
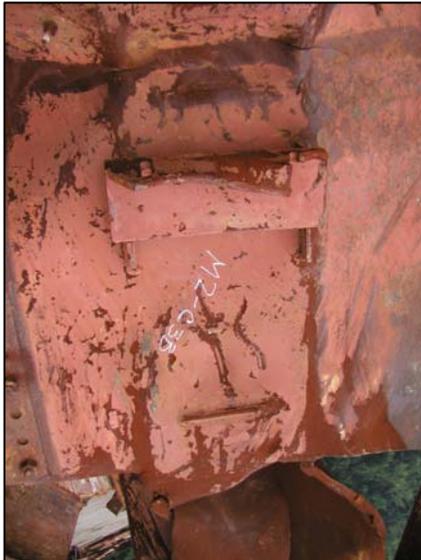
M2-C3M (Co 129, FI 98)

Type A
Seat Detail: 1411
Tab plate remains;
Seat intact, bent down, 1 bolt hole remains intact with bolt, other ripped out;

M2-C3B (Co 129, FI 97)

Type A
Seat Detail: 1411
Tab plate ripped off at weld;
Seat intact, bent down, 1 bolt hole remains intact, other ripped out;

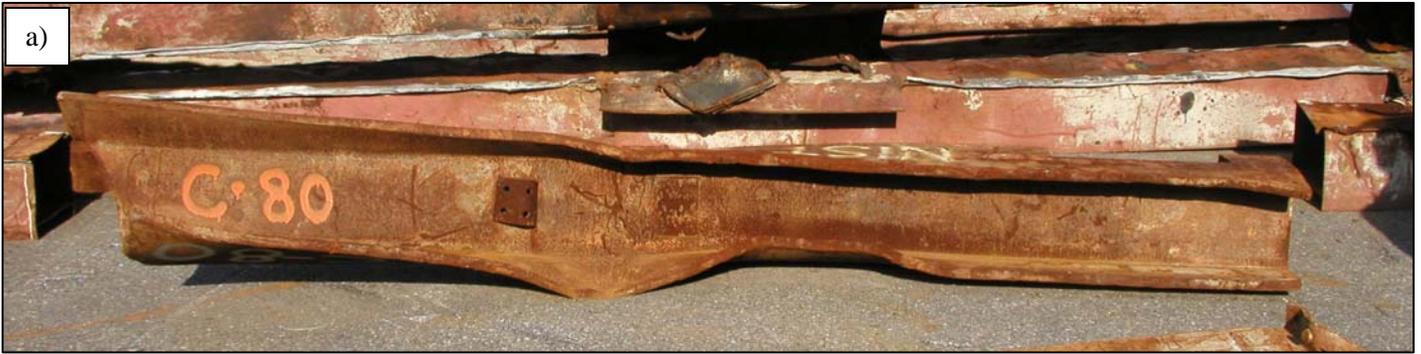
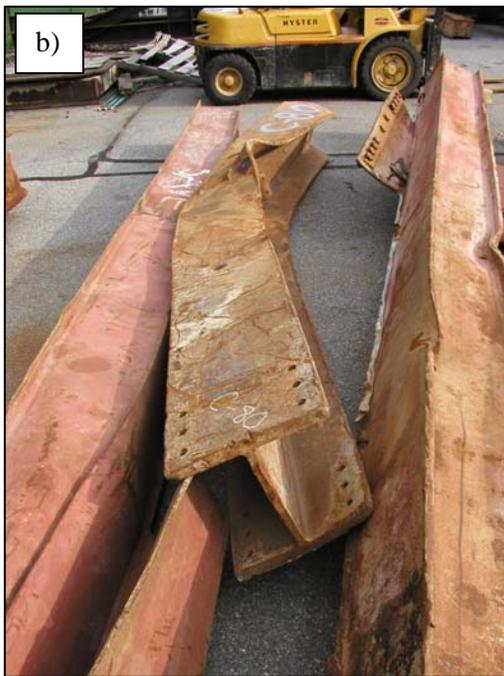
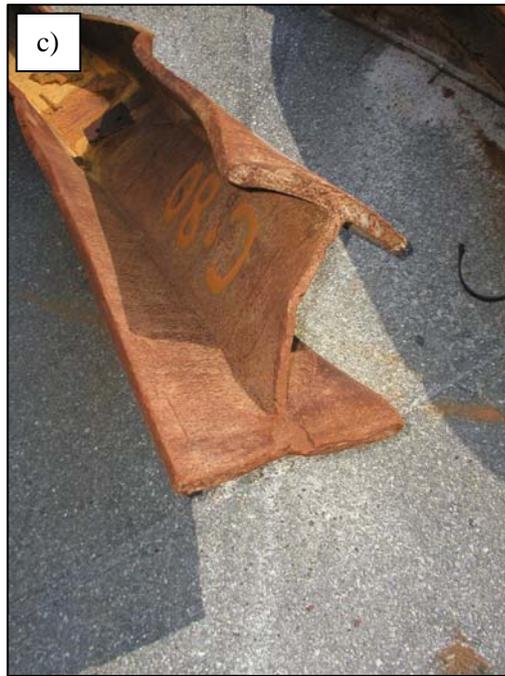
Sample C-80 (Fig. 6–30a), from WTC 1, was a 36 ksi wide-flange located in the middle of the second row of core columns along the north face. Only the lower third of the column was recovered (approximately 13 ft). The location of the column indicated that it did not sustain impact damage. Consistent with the column’s position, modeling results indicated that this column was not in the path of the aircraft debris (NIST NCSTAR 1-2). Different failure modes were observed for each end (Figs. 6–30b and 6–30c). Bolt fracture occurred at the lower portion of the column (92nd floor region), while the upper portion of the wide-flange was torn through its section (near the 93rd floor region). No visible necking (localized reduction in area) was observed in the immediate vicinity of the fracture.

Figure 6–30. Core column C-80 (603A: 92-95). a) Overall view of recovered column, b) view of connection in the 92nd floor region, failure as a result of bolt fracture, and c) torn end of column near the 94th floor region.

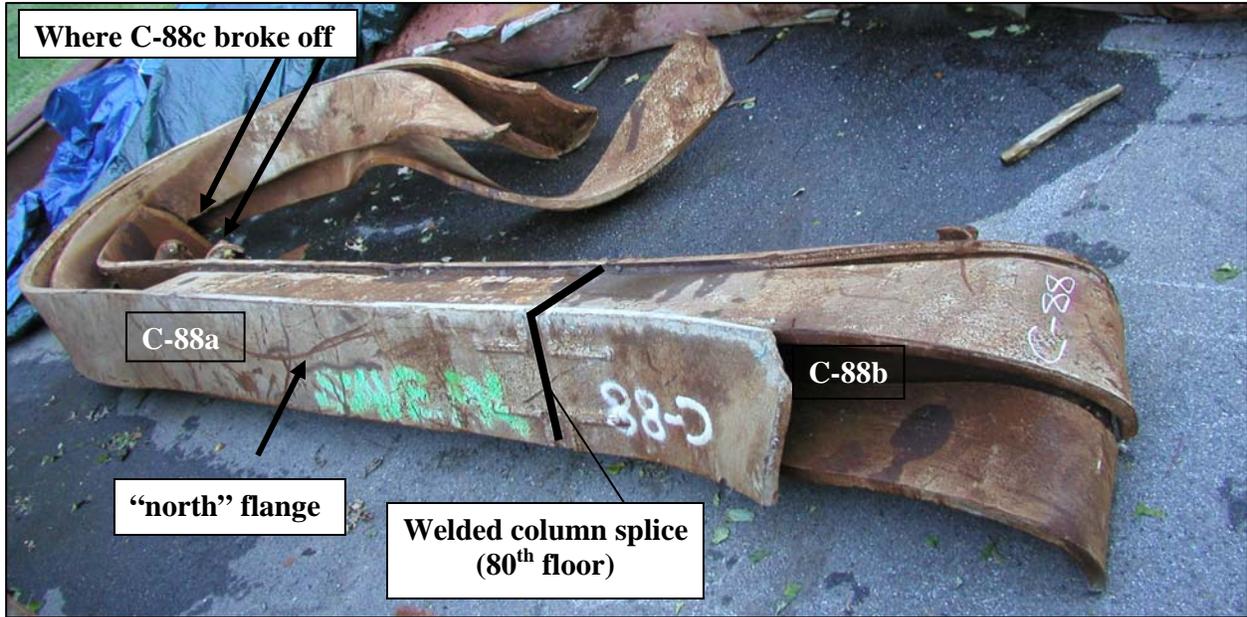
Core columns C-88a and C-88b, from WTC 2, were unique among the recovered core elements in that the columns were still connected at the welded column splice, Fig. 6–31. Both columns were 42 ksi built-up box columns with their shared splice in the 80th floor level. The lower 16 ft of C-88a was recovered (floors 80 through 82), whereas the upper 8 ft of C-88b was still attached (primarily within the 80th floor). The location of the column C-88b suggested that impact damage may have been sustained. Both webs and the “south” flange were severely bent to the east and had flame cut ends, Fig. 6–32. The bends occurred just below the connector for the channel associated with the 80th floor. The “north”

Figure 6–31. Overall view of recovered core columns C-88a (801B: 80-83) and C-88b (801B: 77-80).

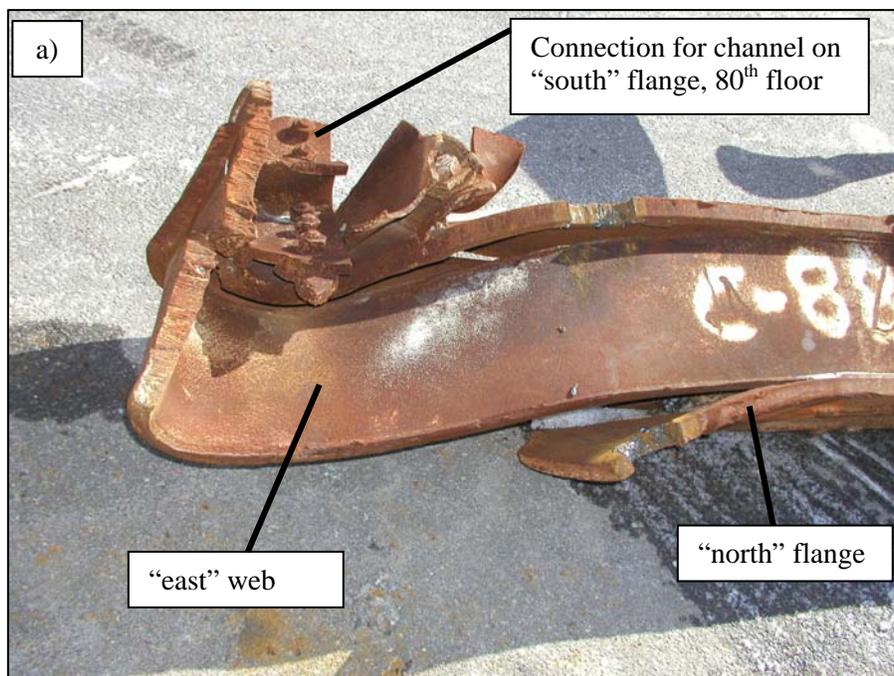
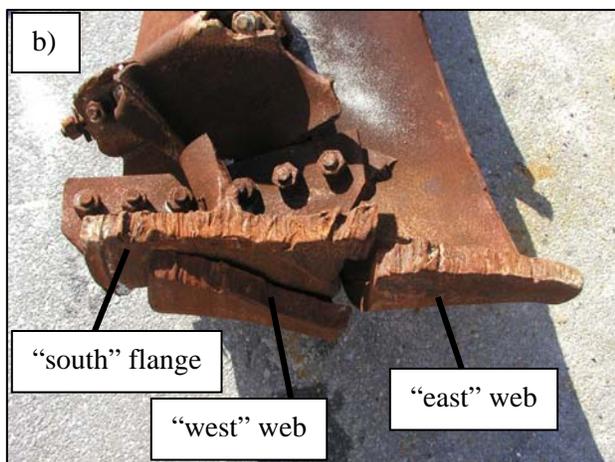
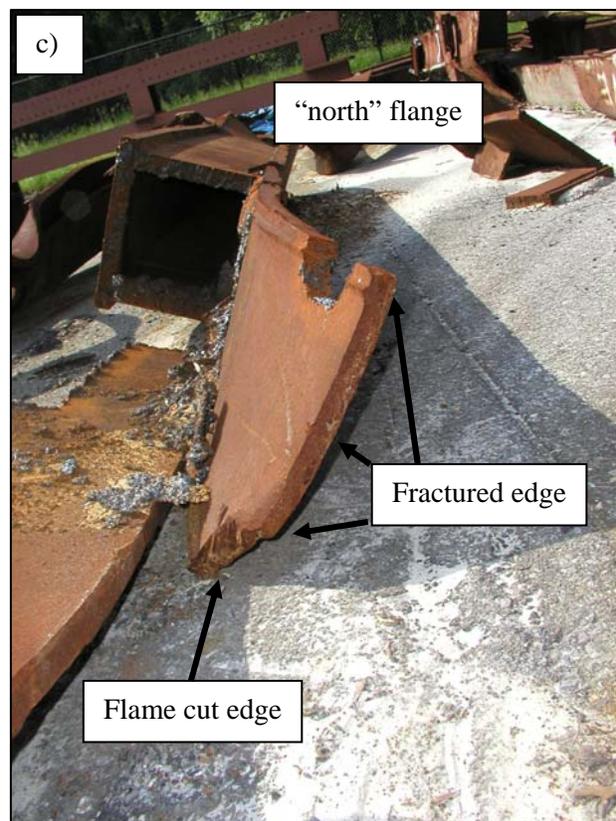
Figure 6–32. Damage associated with core column C-88b (801B: 77-80). a) Overall view of failed end, b) bottoms of "south" flange and both webs bent towards the east just below the 80th floor level, ends were flame cut, and c) "north" flange bent towards the north, majority of plate was fractured with some flame cutting.

flange had a less significant bend toward the north, with approximately 80 percent of the failed end of the plate as a fracture. There was no visible necking of the plate in the area of failure, with the remaining portion of the plate having been flame cut during the recovery effort. This flange was fractured roughly 2 ft below the splice in the 80th floor level. The fracture surfaces were too corroded for analysis. It was believed that the damage of the south flange and the two webs occurred during collapse of the building as the direction of bending was not consistent with the travel of the airplane. However, the damage to the north flange may have been a result of impact damage, as the severity and location of the plate failure was different from the other three plates of the column, and the direction of the bend was consistent with the travel of the airplane. The baseline analysis of the damage model indicated that this core column was not damaged as a result of the impact (NIST NCSTAR 1-2). However, another analysis with parameters set to increase the amount of damage indicated that impact damage was sustained. Core column C-88a did not sustain impact damage as (1) the damage (81st floor level) was above the floors of impact in this region (79th floor level), (2) the columns were bent downward indicating overloading of the column from above, and (3) the bending direction of the plates was opposite to the direction of the travel of the plane. This is also consistent with the modeling results (NIST NCSTAR 1-2).

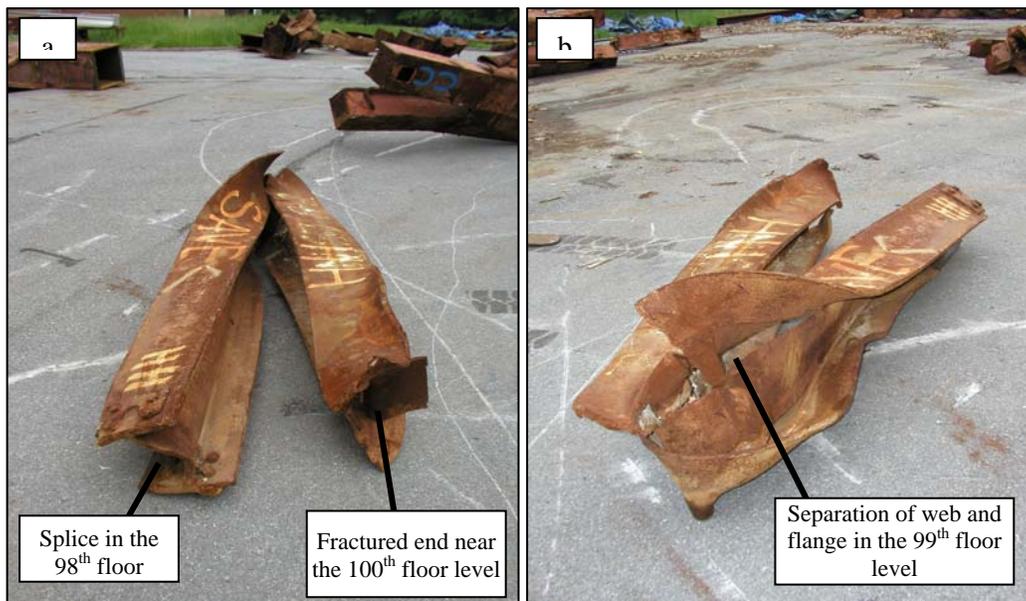
Aside from the three columns discussed above, only one other core column was recovered from within the fire region. Sample HH from WTC 1, Fig. 6–33, was a 42 ksi wide-flange positioned near the middle of the second row of core columns along the north face. The bottom half of the column was recovered (approximately 16 ft). The location of the column was such that damage could not have occurred during the impact. This was corroborated by the modeling results that indicated the core column was not hit during the impact (NIST NCSTAR 1-2). The failure mode of each end was different (Fig. 6–33a). Fracture of the plates used in the bolted connection occurred at the lower portion of the column (98th floor region), while the upper portion was torn through the material (100th floor region). Additionally, the sample was nearly bent in half (99th floor region), with complete fracture of one flange. Figure 6–33b shows that the flanges have become separated from the web in the region of the bend.

Figure 6–33. Core column HH (605A: 98-101). a) Fracture at both ends and b) separation between flange and web in the 99th floor region.

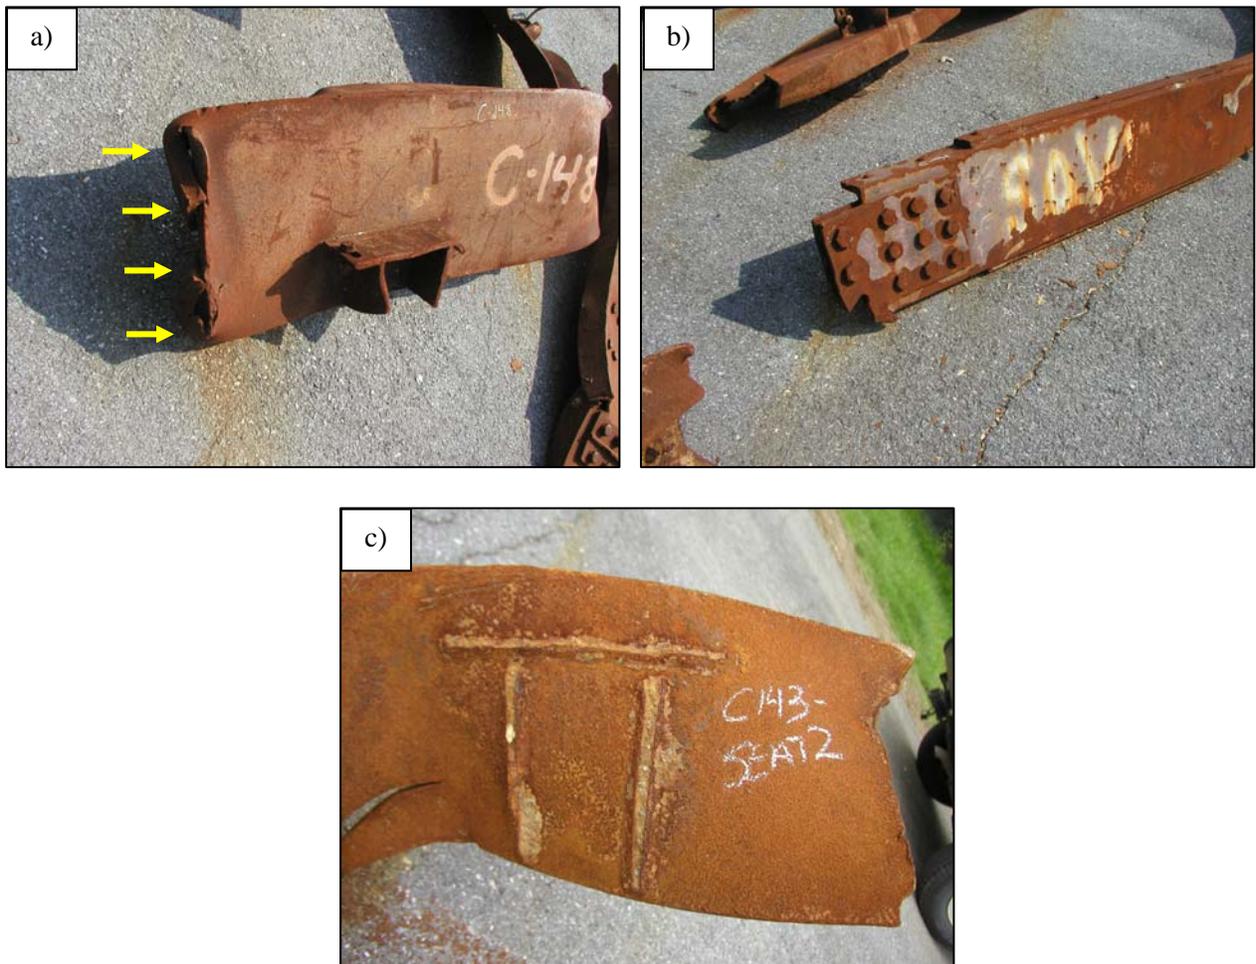
An analysis was conducted to evaluate the failure modes of the recovered channel material and the condition of the core truss seats. Of the 24 channels used to support the floor trusses, half failed at both ends within the channel itself, Fig. 6–34a, while the others failed at one or both of the end connectors, Fig. 6–34b. Twenty-one pieces of channel had seats or remnants of seats attached. Over 90 percent of the seats (31 total) were still intact with the majority of these somewhat deformed. Only two seats had been ripped completely from the channel at the welded joint between the seat and the channel, as shown in Fig. 6–34c. Half of the retained seats were observed to have both bolt holes still intact, while the other half had at least one bolt hole ripped out.

Figure 6–34. Failure modes of core channels. a) Fracture through channel as indicated by arrows, b) failure associated with end connector, and c) seat ripped off at welded connection to channel.

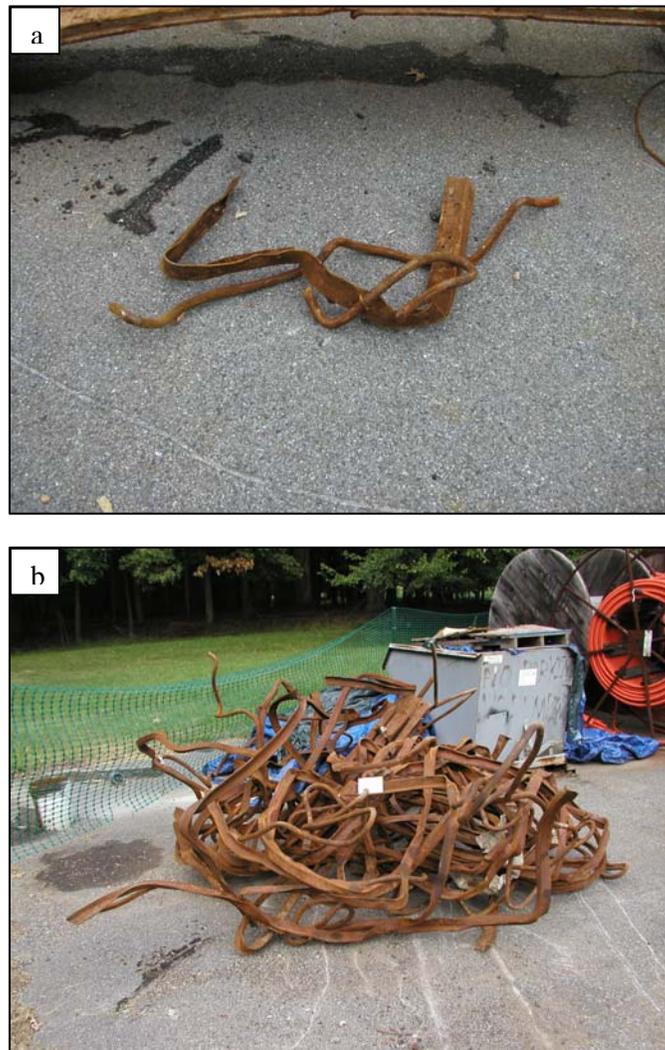
Samples received at NIST were either small sections (less than 3 ft to 4 ft in length) of chord and rod material (Fig. 6–35a) or large, entangled masses in the form seen in Fig. 6–35b. According to Structural Engineers Association of New York (SEAoNY) volunteer members involved in the recovery effort, it was necessary to “ball up” any truss pieces of significant size to facilitate removal from the WTC site and subsequent handling in the recovery yards. This was necessary since the primary and bridging trusses for a given floor were welded together into huge grids. During the collapse, these lightweight floor sections were severely damaged and could not be easily removed. Thus, it is unknown when specific damage features occurred. Further, it is likely that sections of multiple trusses were “balled” together and labeled as a single unit rather than that NIST labeled samples consisting of just one pre-fabricated truss unit.

Figure 6–35. Examples of recovered floor truss material. a) Small sections of rod and chord (sample C-53) and b) “balled-up” sections of rod and chord (C-137f).

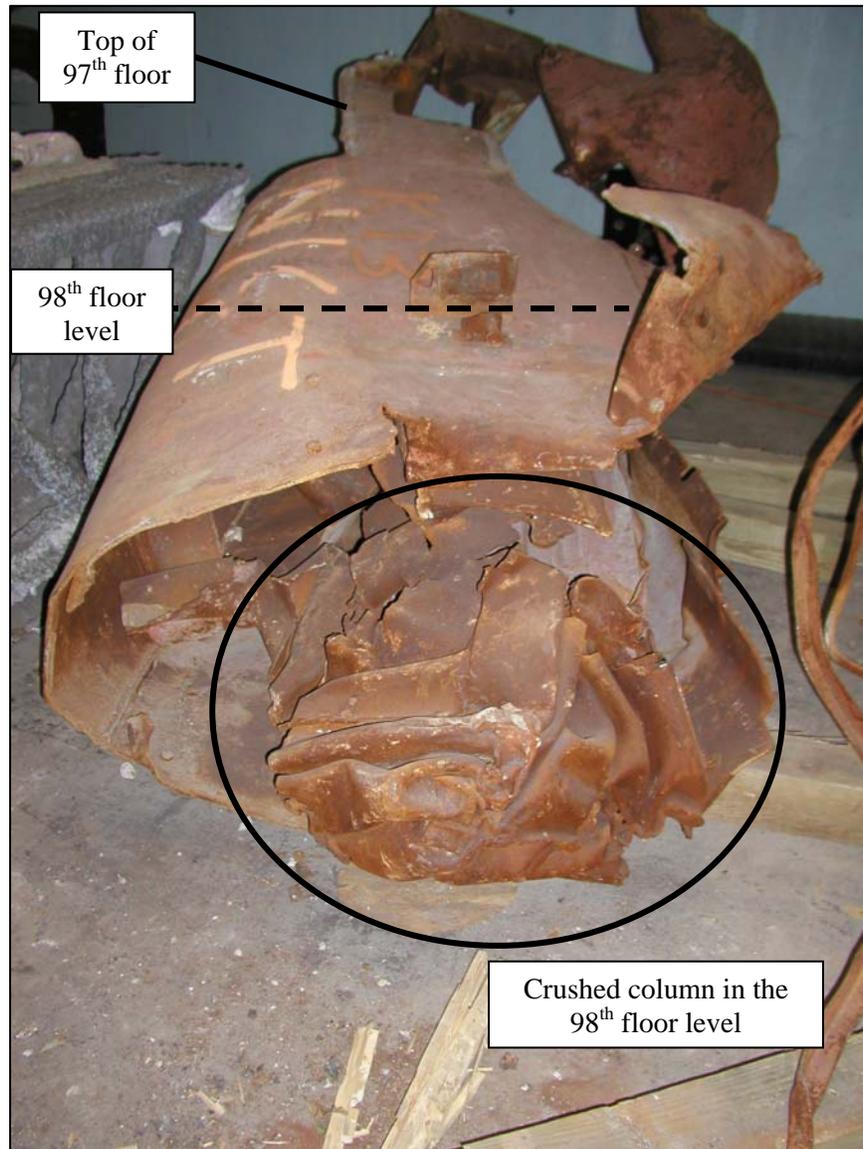
1. Panel K-1, WTC 1, column 210, flange and inner web of 98th floor region. Prior to the collapse of WTC 1, the panel was observed to have experienced varying degrees of fire exposure for a minimum of 31 cumulative minutes in this area. A unique feature of this panel is that the upper portion of the column was crushed while generally maintaining concentric axial alignment with the lower portion of the column, Fig. 6–36. This suggests that deformation occurred at the onset of collapse, while the lower portion of the column was still constrained due to the bolted splice (endplates).

Figure 6–36. Crushed portion of column 210 in the area of the 98th floor (from sample K-1, A209: 97-100). Paint had mud cracking characteristic in this region.

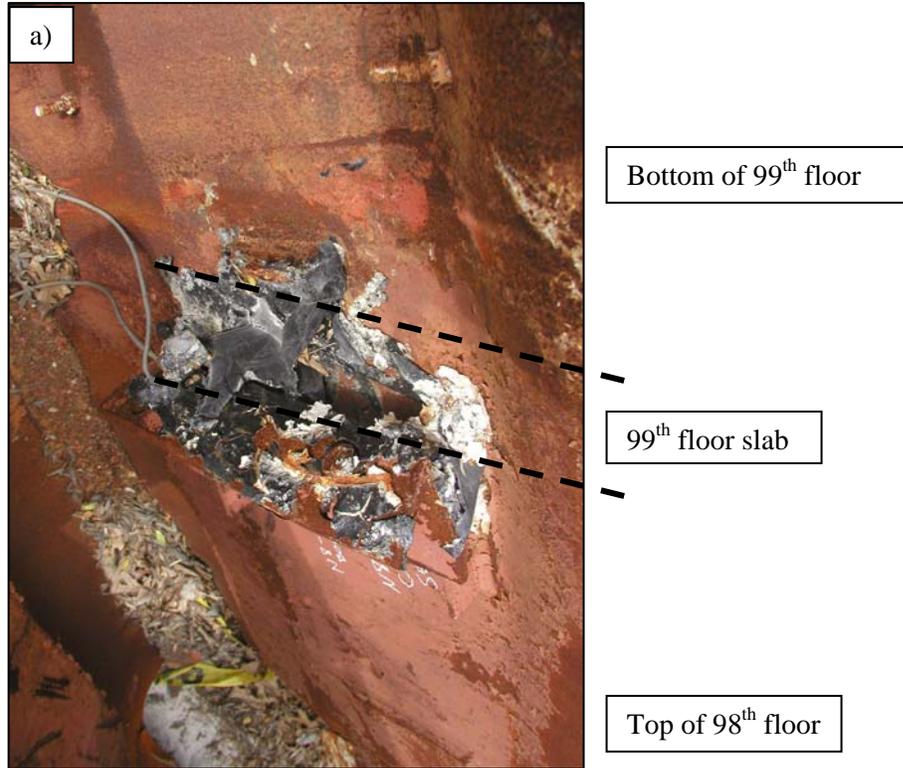
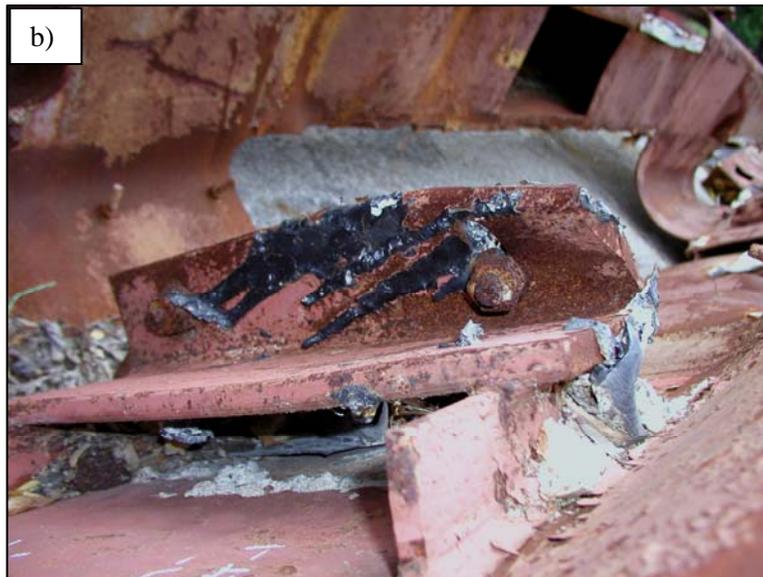
3. Panel N-8, WTC 1, column 143, seat and standoff plates of the 99th floor. This seat (Fig. 6–38) was exposed to fire for a minimum of 18 cumulative minutes before collapse. Mud cracking was not observed on the spandrel plate to which the seat was welded.

Figure 6–38. Truss seat of the 99th floor on column 143 of sample N-8 (A142: 97-100). a) Top view showing the re-solidified black plastic with embedded papers, most likely a binder of some type and b) bottom view showing the drip pattern. It was unknown when the high-temperature excursion may have occurred.

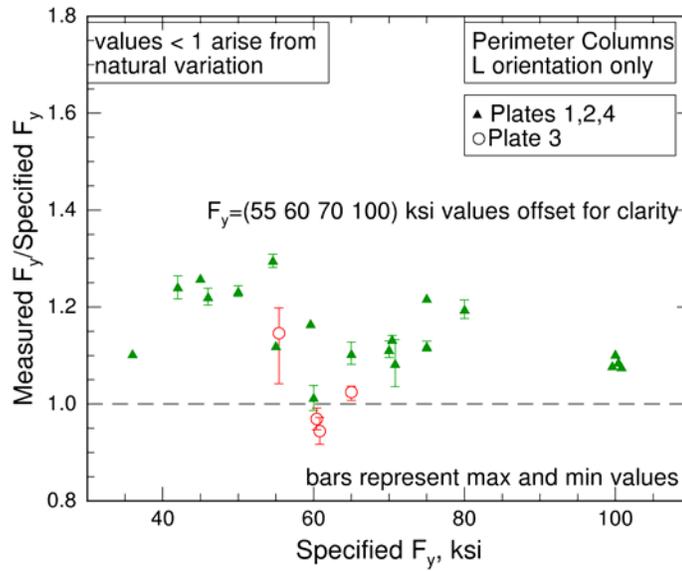
Assessing the measured tensile properties in relation to the requirements of the various specifications was not straightforward in many cases. NIST was able to quantify the mechanical properties and chemical composition of the steel pieces in their recovered state. These “product” tension tests on representative specimens of the 52 different recovered steels established their yield and tensile strengths and elongations to failure. Chemical characterization established whether the composition of the recovered steel lay within the limits set by the various standards.

Figure 7–3. Ratio of measured yield strength or yield point to specified minimum yield point for WTC perimeter column steels.

Four issues complicated the task of positively assessing the likelihood that the properties of the recovered steel were consistent with the requirements of the relevant specifications. The first was that the WTC steels could be supplied to many different, overlapping specifications. No documents exist that identify the ASTM specification for a given column. Only the specified minimum yield strength was known. Secondly, differences between the NIST test procedures and the mill test procedures that originally qualified the steel, including testing rates, specimen sizes, and test locations, could result in values for the NIST-measured yield strengths that were less than the requirements of the relevant specification. Thirdly, the natural variability of steel properties within a heat can cause some locations to have yield strengths that are lower than the minimum required by the relevant standard. Finally, even slight damage to the steel, caused by the collapse of the WTC towers or subsequent recovery efforts, could remove the yield point behavior in the tensile test. Most low- and medium-strength steels are qualified using the stress measured at the yield point, rather than the 0.2 percent offset yield strength. For standards that define the yield strength as the yield point, the absence of yield point behavior in a NIST-conducted test can lead to values of yield strength that are less than the minimum required by the specification.

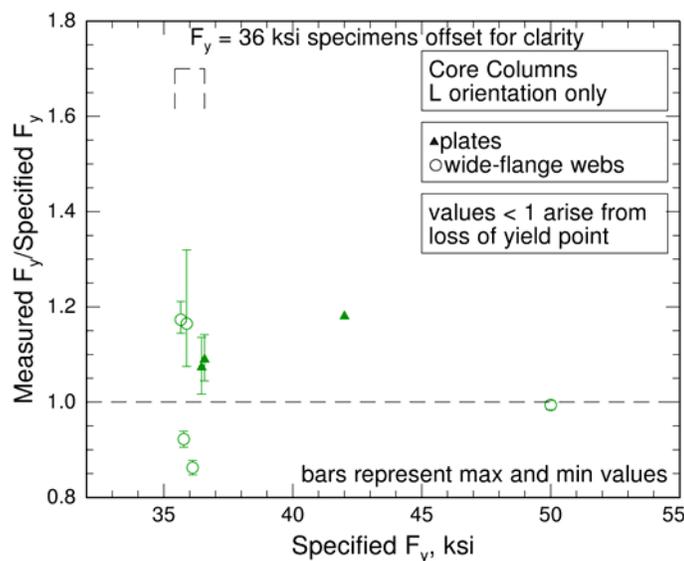
Figure 7–4. Ratio of measured yield strength or yield point to specified minimum yield point for WTC core column steels.
