NIST NCSTAR 1-3

**Federal Building and Fire Safety Investigation of the
World Trade Center Disaster**

Mechanical and Metallurgical Analysis of Structural Steel

September 2005

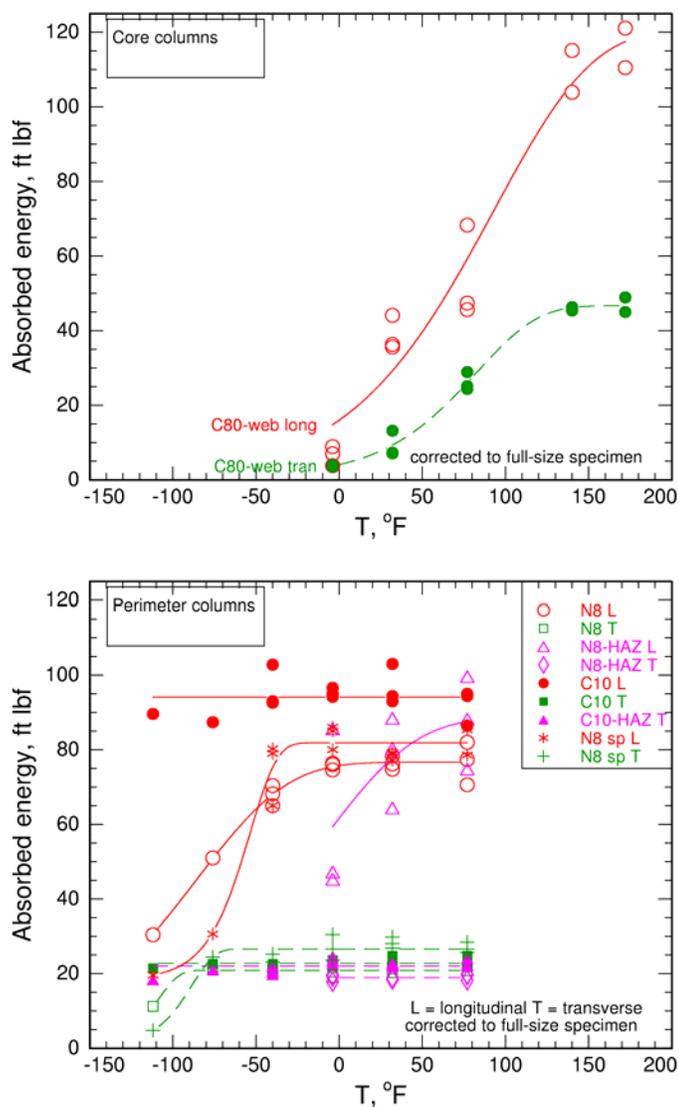
Figure 7–7 summarizes the results of Charpy tests on perimeter and core column steels. All the perimeter column steels have large upper shelf energies and transition temperatures well below 0 °F. The transition temperatures of the web of the wide-flange specimen, Fig. 7–7, and the truss rods and angles, not shown, are near room temperature, but they still possess adequate toughness for use as structural steels. The transition temperatures of the truss seat steels are above room temperature, and the absorbed energy of the steels even at room temperature is low, indicating a propensity for low-energy failure.

Figure 7–7. Summary data for Charpy tests. Lower figure: perimeter column steels; upper figure: core column steels.

Current building construction specifications, as well as those of the WTC construction era, do not generally specify minimum requirements for Charpy absorbed energies. The room temperature absorbed energy values of the WTC steels tested are similar to those of construction steels of the WTC era.

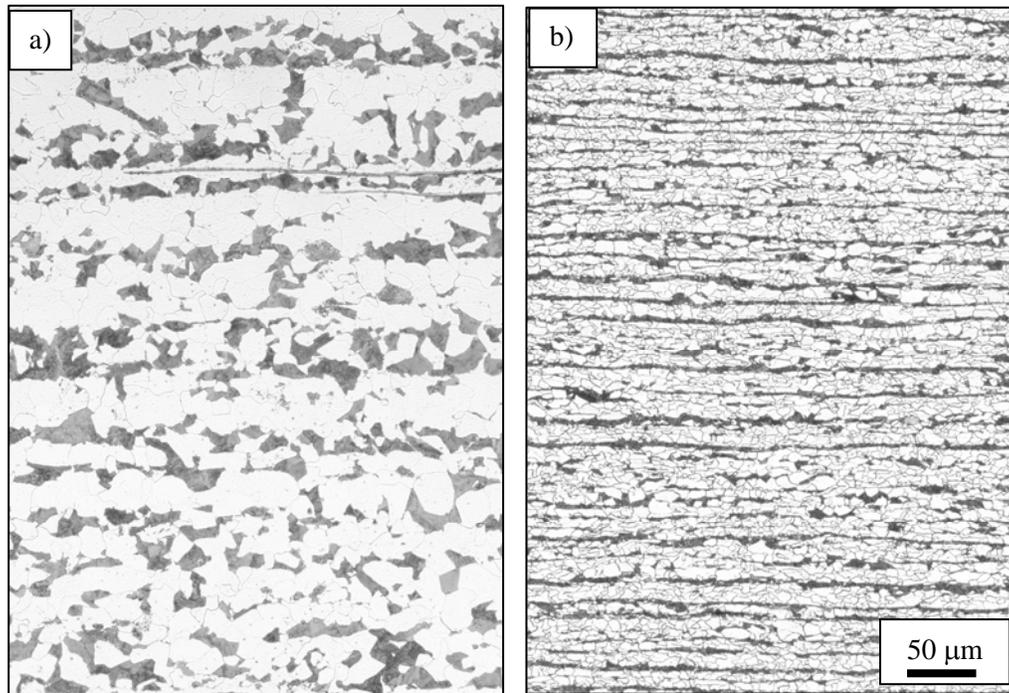
For the exterior panel sections, two different microstructural types were observed. Flange, web, and spandrel plates with specified minimum yield strengths less than 70 ksi were ferrite-pearlite (Fig. 8–1). Additionally, inner webs with F_y of 70 ksi and 75 ksi were ferrite-pearlite. For the Yawata produced plates (flange, outer web, and spandrel), this type of microstructure was expected given the measured plate thickness and specified minimum yield strength (refer to NIST NCSTAR 1-3A). Plates with F_y less than 70 ksi were typically hot rolled unless the following sizes were exceeded for a given F_y : 0.5” for 65 ksi, 1.25” for 60 ksi, and 1.5” for 55 ksi. For these specified plates, as well as those with minimum yield strengths equal to or greater than 70 ksi, “quenched-and-tempered” microstructures were observed (Fig. 8–2).

Figure 8–1. Microstructure of ferritic-pearlitic WTC perimeter column flange plate steels. a) $F_y = 45$ ksi (unidentified perimeter column with “45” flange stamping) and b) $F_y = 60$ ksi (WTC 1, column 126, 97th floor).

For each of the designated minimum yield strengths, the type of structures observed was expected for steels of that era. While the microstructural features may have varied from plate to plate, there was no indication that the practices followed to produce the plates were improper.

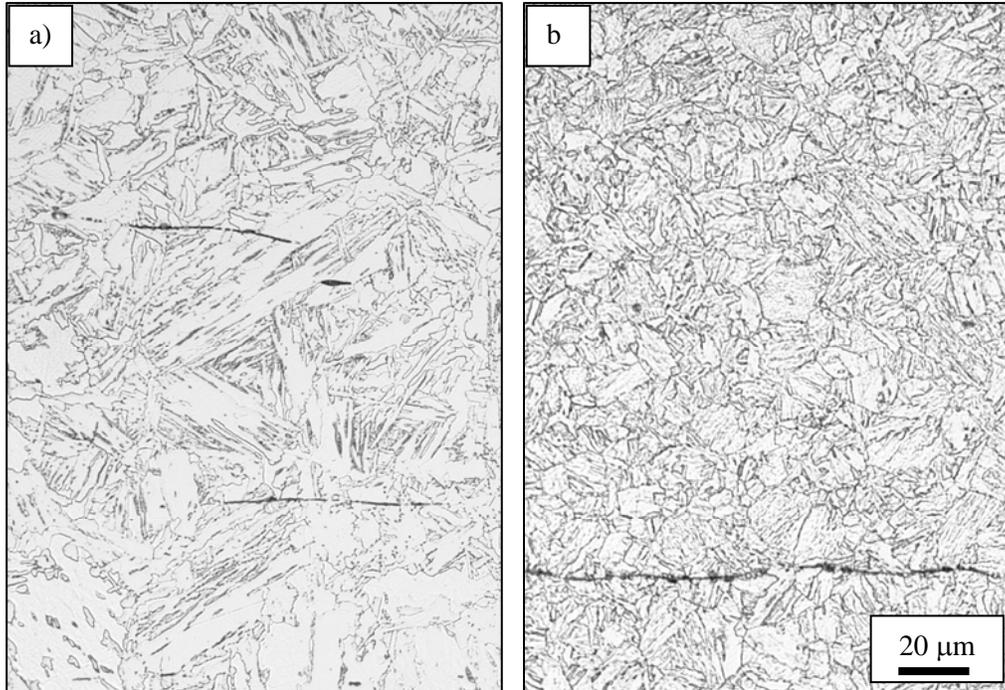
Microstructure varied within each of the two structure types, depending on product type, gauge, and strength level. Ferrite-pearlite steels had variations in ferrite grain size, ferrite grain shape, pearlite lamellar spacing, and banding of microstructural constituents with a change in specified F_y and gauge of the plate. Examples of these microstructures are shown in Fig. 8–1. Similarly, the quenched and tempered steels had variations with F_y . Plates with $F_y = 70$ ksi had a coarse Widmanstätten morphology of ferrite with coarse cementite precipitates while the higher strength plates had what appeared to be a tempered martensitic structure, as shown in Fig. 8–2.

Figure 8–2. Examples of “quenched and tempered” WTC perimeter column flange steel. a) $F_y = 70$ ksi (WTC 1, column 224, 94th floor) and b) $F_y = 80$ ksi (WTC 1, column 207, 89th floor).
