NIST NCSTAR 1-5

**Federal Building and Fire Safety Investigation of the
World Trade Center Disaster**

**Reconstruction of the Fires in the
World Trade Center Towers**

September 2005

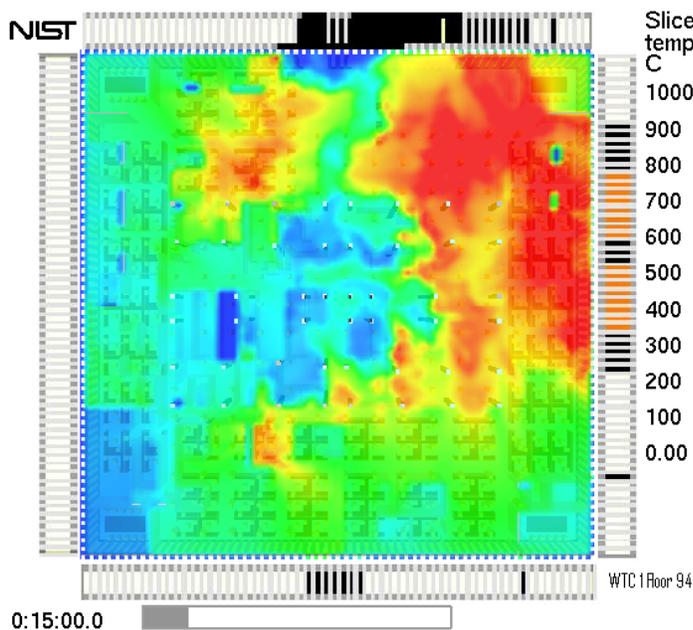
The results of the FDS simulations of the perimeter fires were compared with the fire duration and spread rate as seen in the photographs and videos. A sample of the basis for such a comparison is shown in Figure E–1. This depicts the room gas temperature 0.4 m below the ceiling slab (in the “upper layer” of the compartment). Surrounding this are “stripes,” each representing a window on that floor. Black stripes denote broken windows, orange stripes denote windows where flames have extended outward from the building, and yellow stripes denote fires that were seen inside the building. Fires deeper than a few meters inside the building could not be seen because of the smoke obscuration and the steep viewing angle of nearly all the photographs.

Figure E–1. Upper layer temperature of WTC 1, floor 94, 15 min after impact.

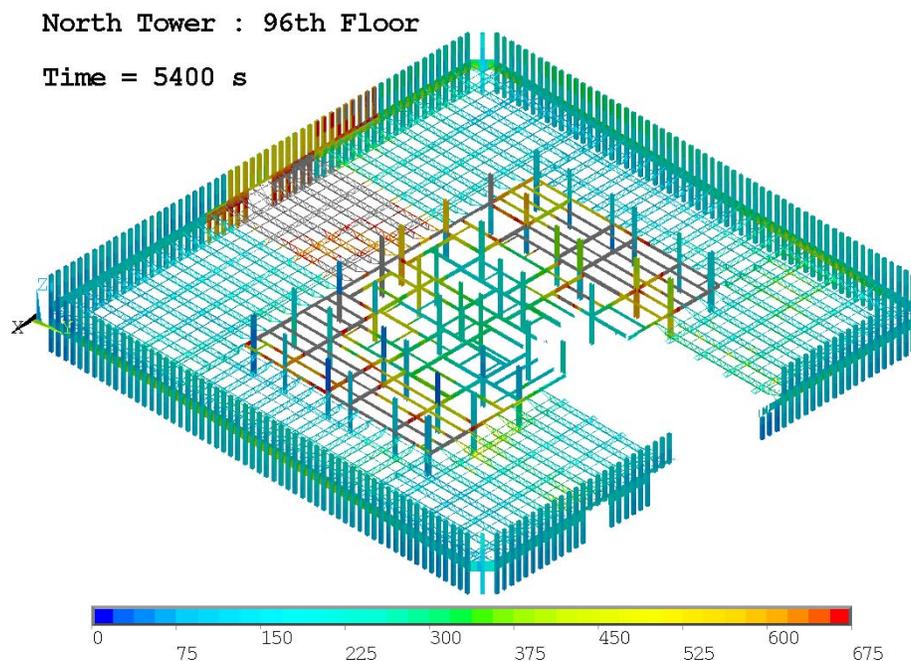
Figure E-4. Thermal response of floor 96 of WTC 1 at 5,400 s after impact, Case B.

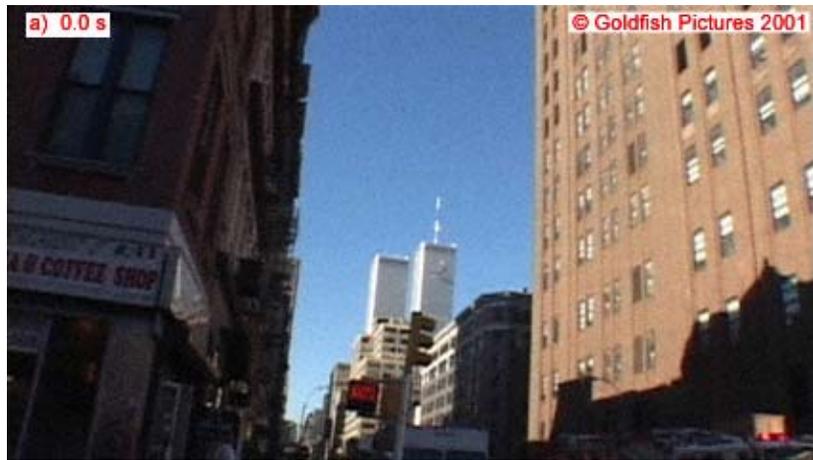
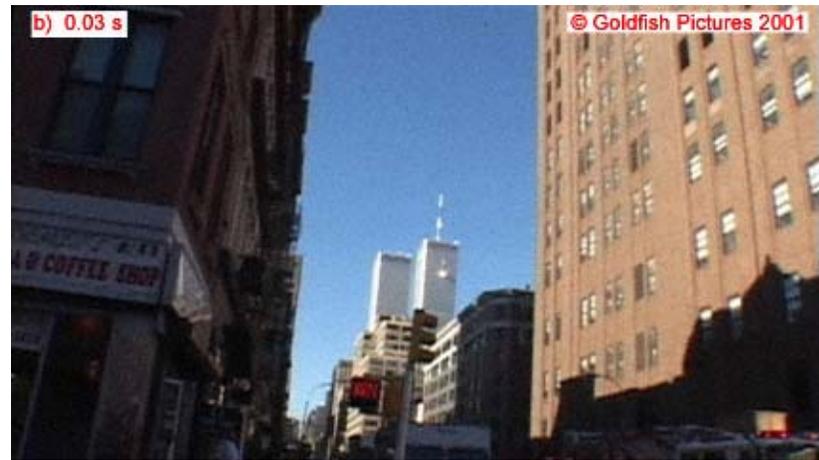
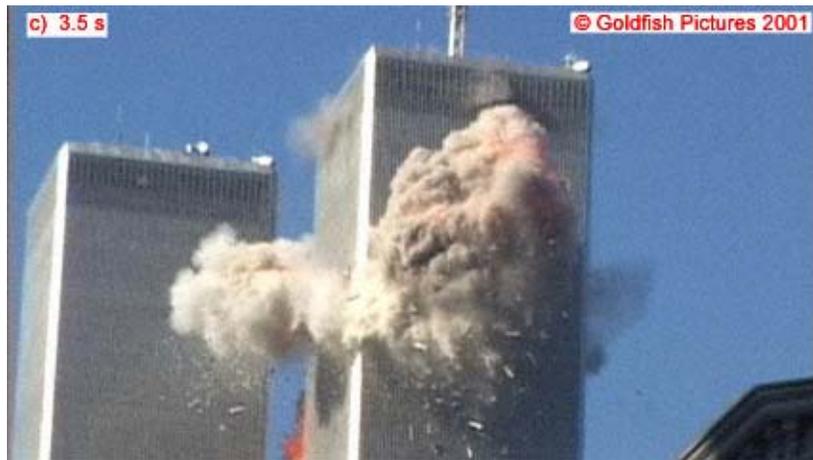
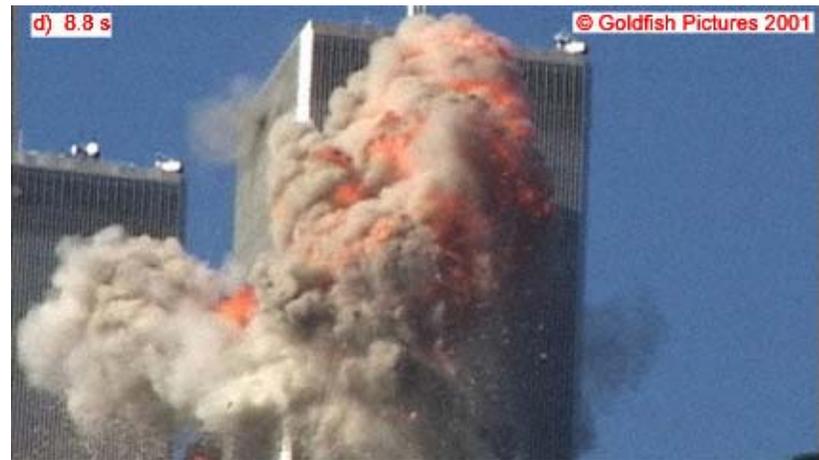
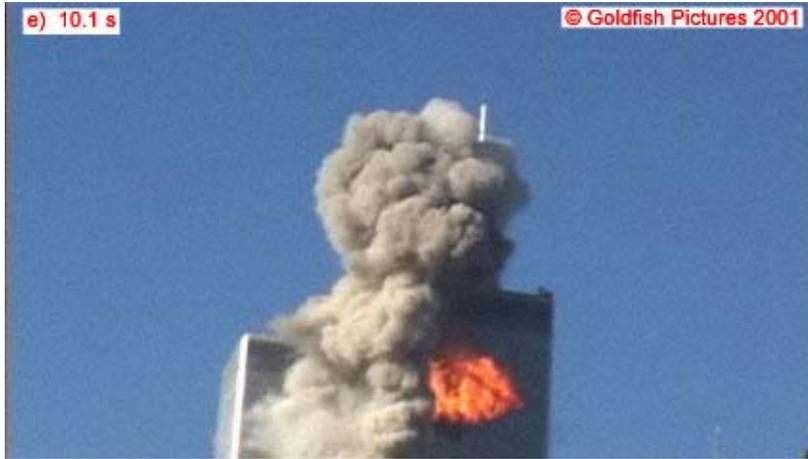
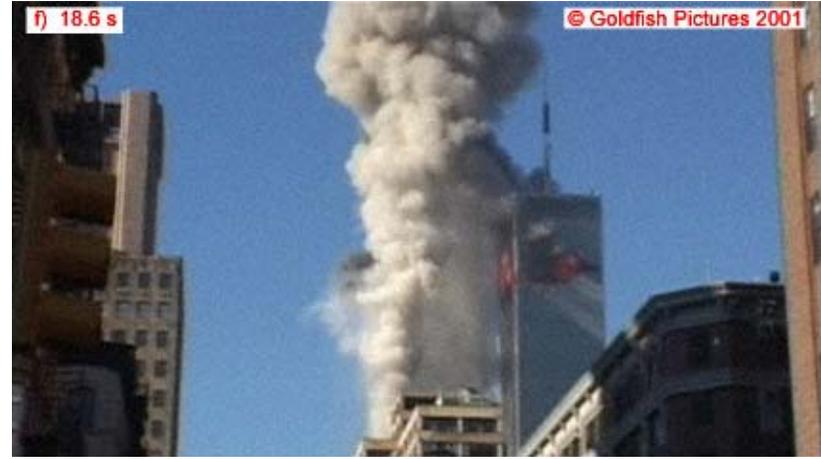
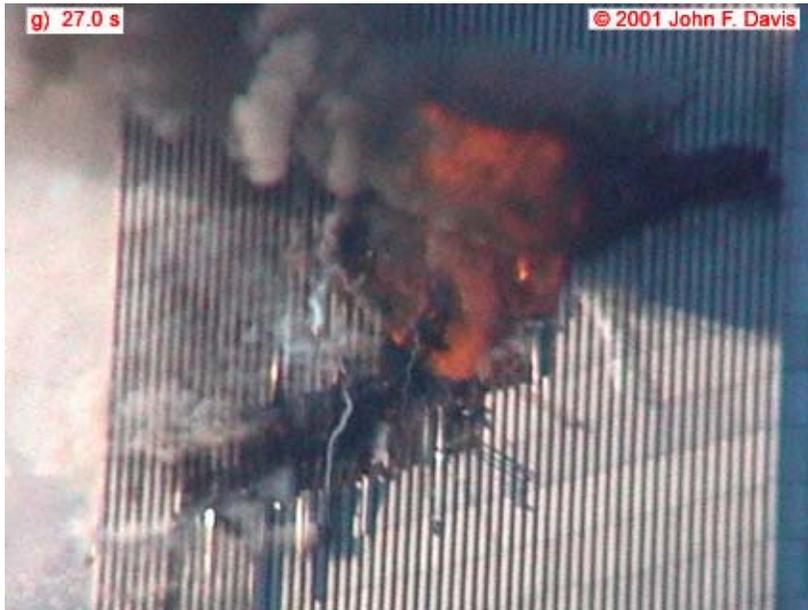
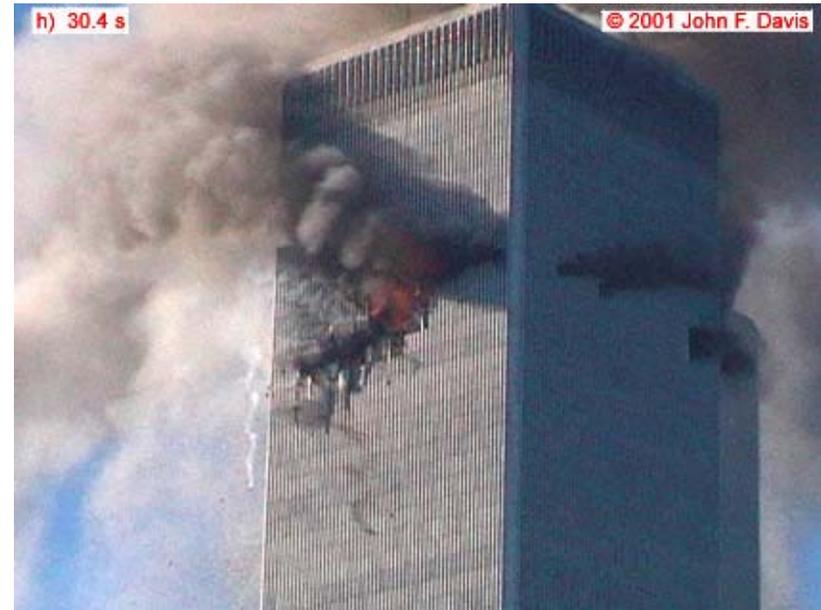
Figure 2-1. Series of frames from videos that show the aircraft striking WTC 1 and the immediate aftermath. The times relative to the plane strike are shown in the upper right-hand corner.

Figure 2-1. Series of frames from videos that show the aircraft striking WTC 1 and the immediate aftermath (cont.).

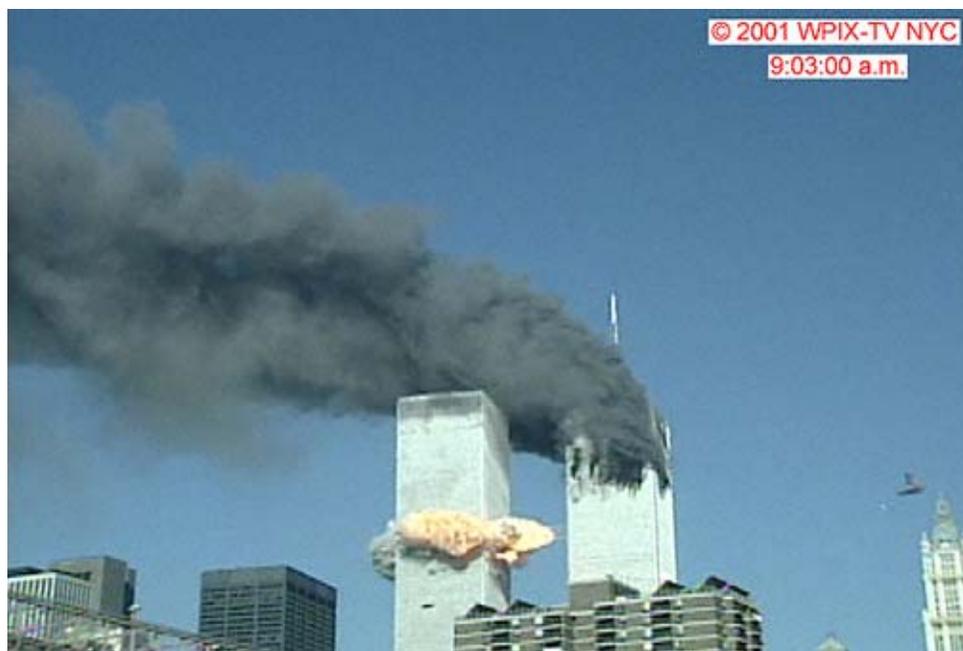
Figure 2–5. The nascent fireballs and dust clouds formed on WTC 2 1.2 s after the aircraft struck WTC 2.

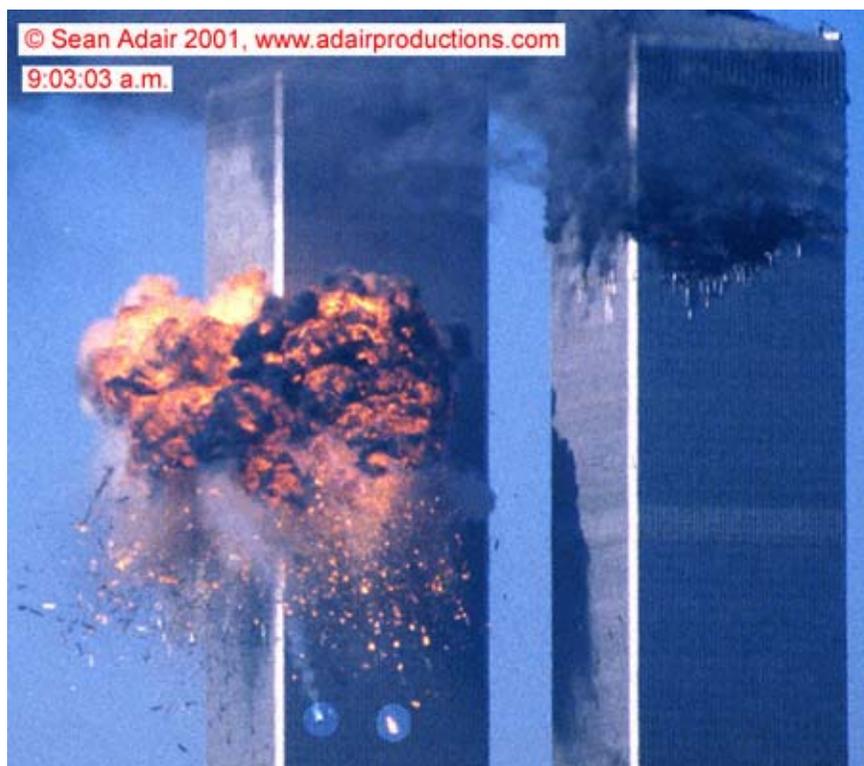
Figure 2–6. Photograph of the towers recorded from the north-northeast 4.3 s after the aircraft struck WTC 2.

The fireballs continued to expand and rise for several more seconds before receding. Videos indicated that the fireball created on the east face lasted 11 s, that on the north face lasted 10 s, and that the small fireball on the south face lasted about 8 s. An analysis similar to that for WTC 1 indicated that less than one sixth of the jet fuel burned immediately within the building. Three previous estimates (McAllister 2002, and two in Baum and Rehm 2005) found that about 10 percent to 25 percent of the total jet fuel burned outside WTC 2. Since most of the fuel that formed the fireballs came from the starboard fuel tank, this suggested that 20 percent to 50 percent of this fuel burned externally with another few percent consumed inside the building. The remainder of the fuel was left behind in the tower following the initial fire. Almost all of the fuel in the aircraft's port fuel tank was also inside, primarily on the 78th and 79th floors. There was no visual evidence that the fuel from the port tank fuel burned in the short term.

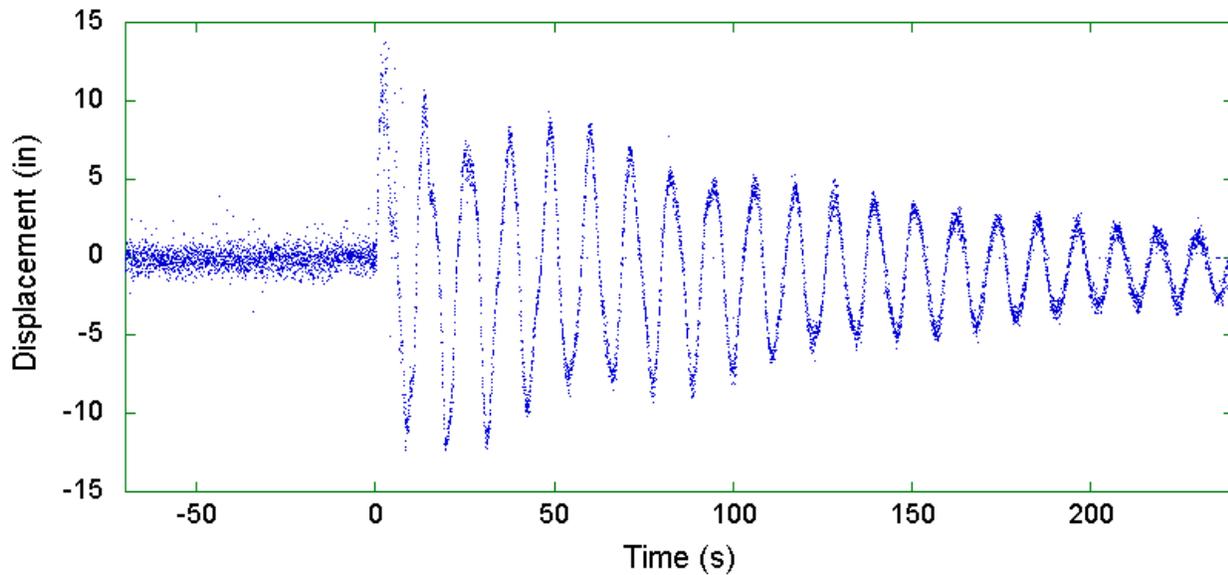
Close examination of the stable video revealed a perceptible movement of WTC 2 after it was struck by the aircraft. The building rocked back and forth, much like a pendulum, for many minutes. The stable nature of a video shot from the east allowed a detailed analysis of the north-south and torsional (twisting) motion of WTC 2 to be performed using image analysis of the Moiré patterns. Figure 2–9 shows the position of a location on the tower on the 70th floor as a function of time. A large increase in the motion of the tower followed the aircraft impact and slowly decreased after that. The peak amplitude of the movement in the north-south direction was determined to be 12 in. ± 1 in. at the 70th floor, which extrapolated to a value of 20 in. ± 3 in. at the roofline. Frequency analysis of the results revealed the fundamental north-south mode to have a period of 11.4 s, a torsional mode with a period of 5.3 s, and two higher frequency modes with periods of 3.9 s and 2.2 s. All periods were determined to an accuracy better than ± 0.1 s. The period of the fundamental mode was consistent with the expected range based on measurements of similar frequencies in WTC 1 (NIST NCSTAR 1-2). Similar measurements using a short video shot from the north yielded an amplitude of 12 in. ± 2 in. for the east-west motion, with a period of 5.3 s.

Figure 2-9. Displacement of the left-most window line on the 70th floor of WTC 2 as a function of time, determined using Moiré analysis.

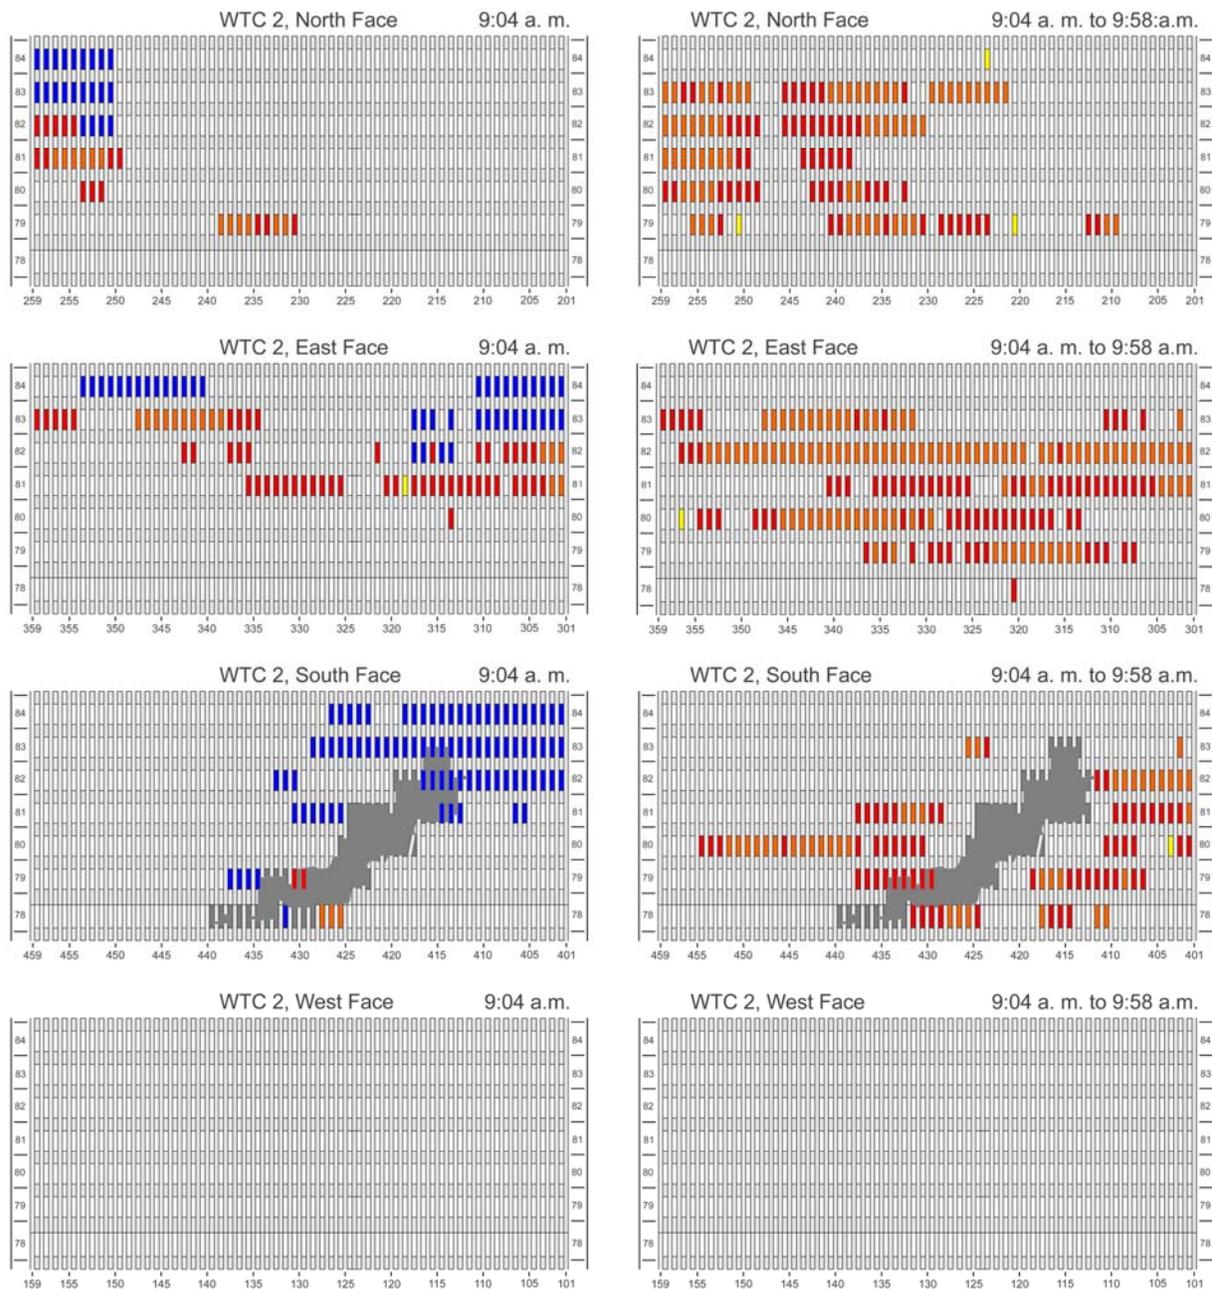
A curious aspect of the fire behavior in WTC 2 was the presence of the cold spot on the north face, which covered three floors over a length equal to one-sixth of the face width. The existence of the cold spot implies that little fuel was available in the immediate vicinity to support burning. A number of possible explanations were considered for the absence of fuel. One is that the area was vacant and that there was limited fuel present prior to the aircraft impact. NIST is unaware of any information that supports such a conclusion. A second possibility is that the fireballs that exited through the area were so intense that they pushed most available fuel in the area to the sides or out through the opened windows. A third possibility is that the floor slabs, particularly on the 81st and 82nd floors, in the immediate area collapsed during the aircraft impact and fireballs, in effect, creating a cavity behind the cold spot. The available visual evidence both supports and argues against all three possibilities. NIST has concluded that insufficient information is available to allow a likely formation mechanism for the cold spot to be postulated.

Figure 2-12. Maps of observed fire distributions on the four faces of WTC 2 shortly after the aircraft impact (near 9:04 a.m.) and corresponding integrated fire observations for the entire period between 9:03 a.m. and 9:59 a.m.

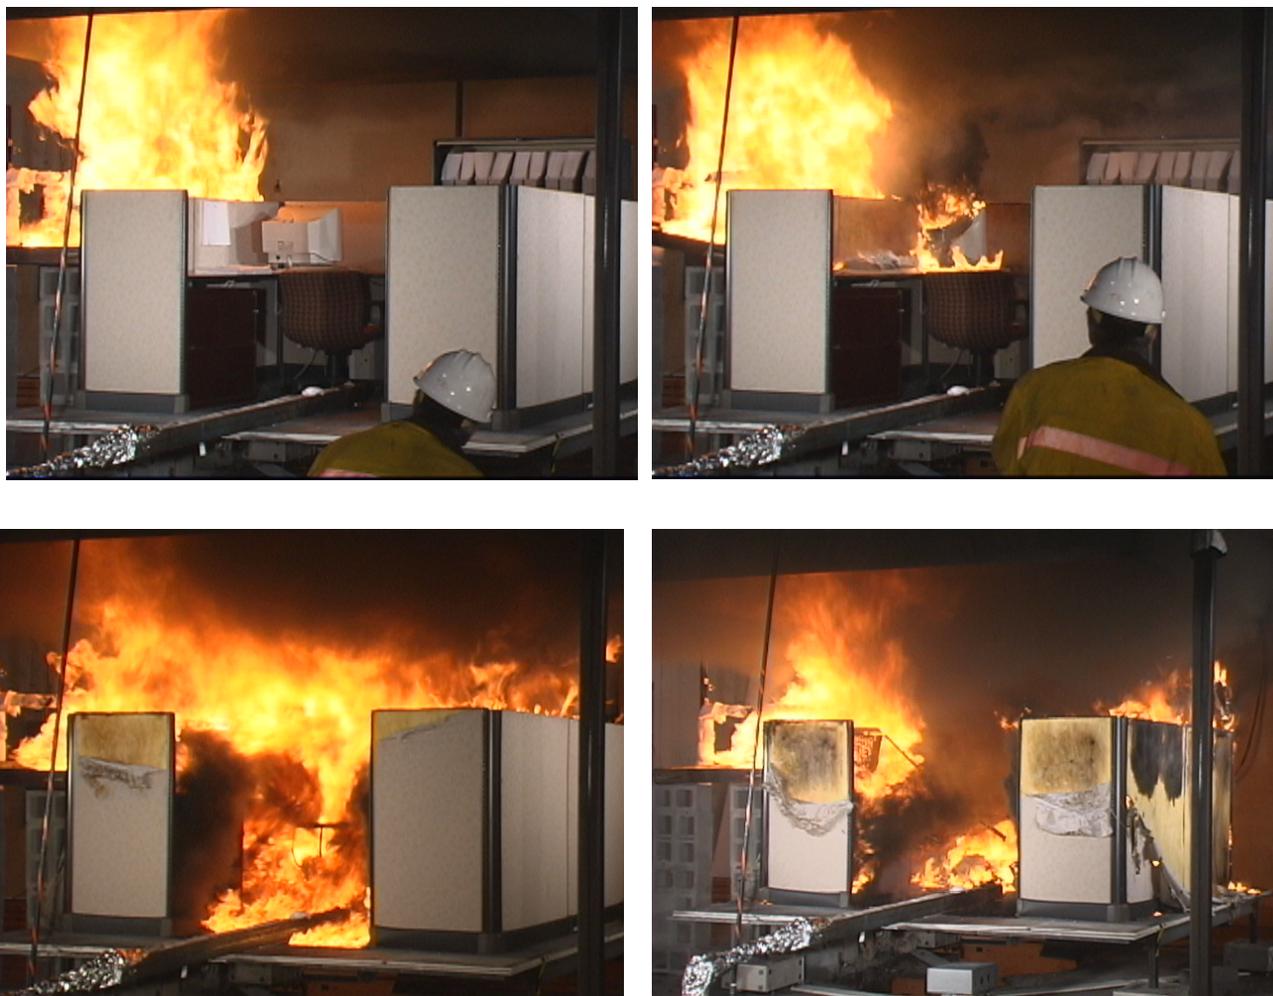
Figure 3–8. Photographs of a burning workstation at beginning of test, 165 s into test, near the peak heat release rate at 533 s, and at 965 s.

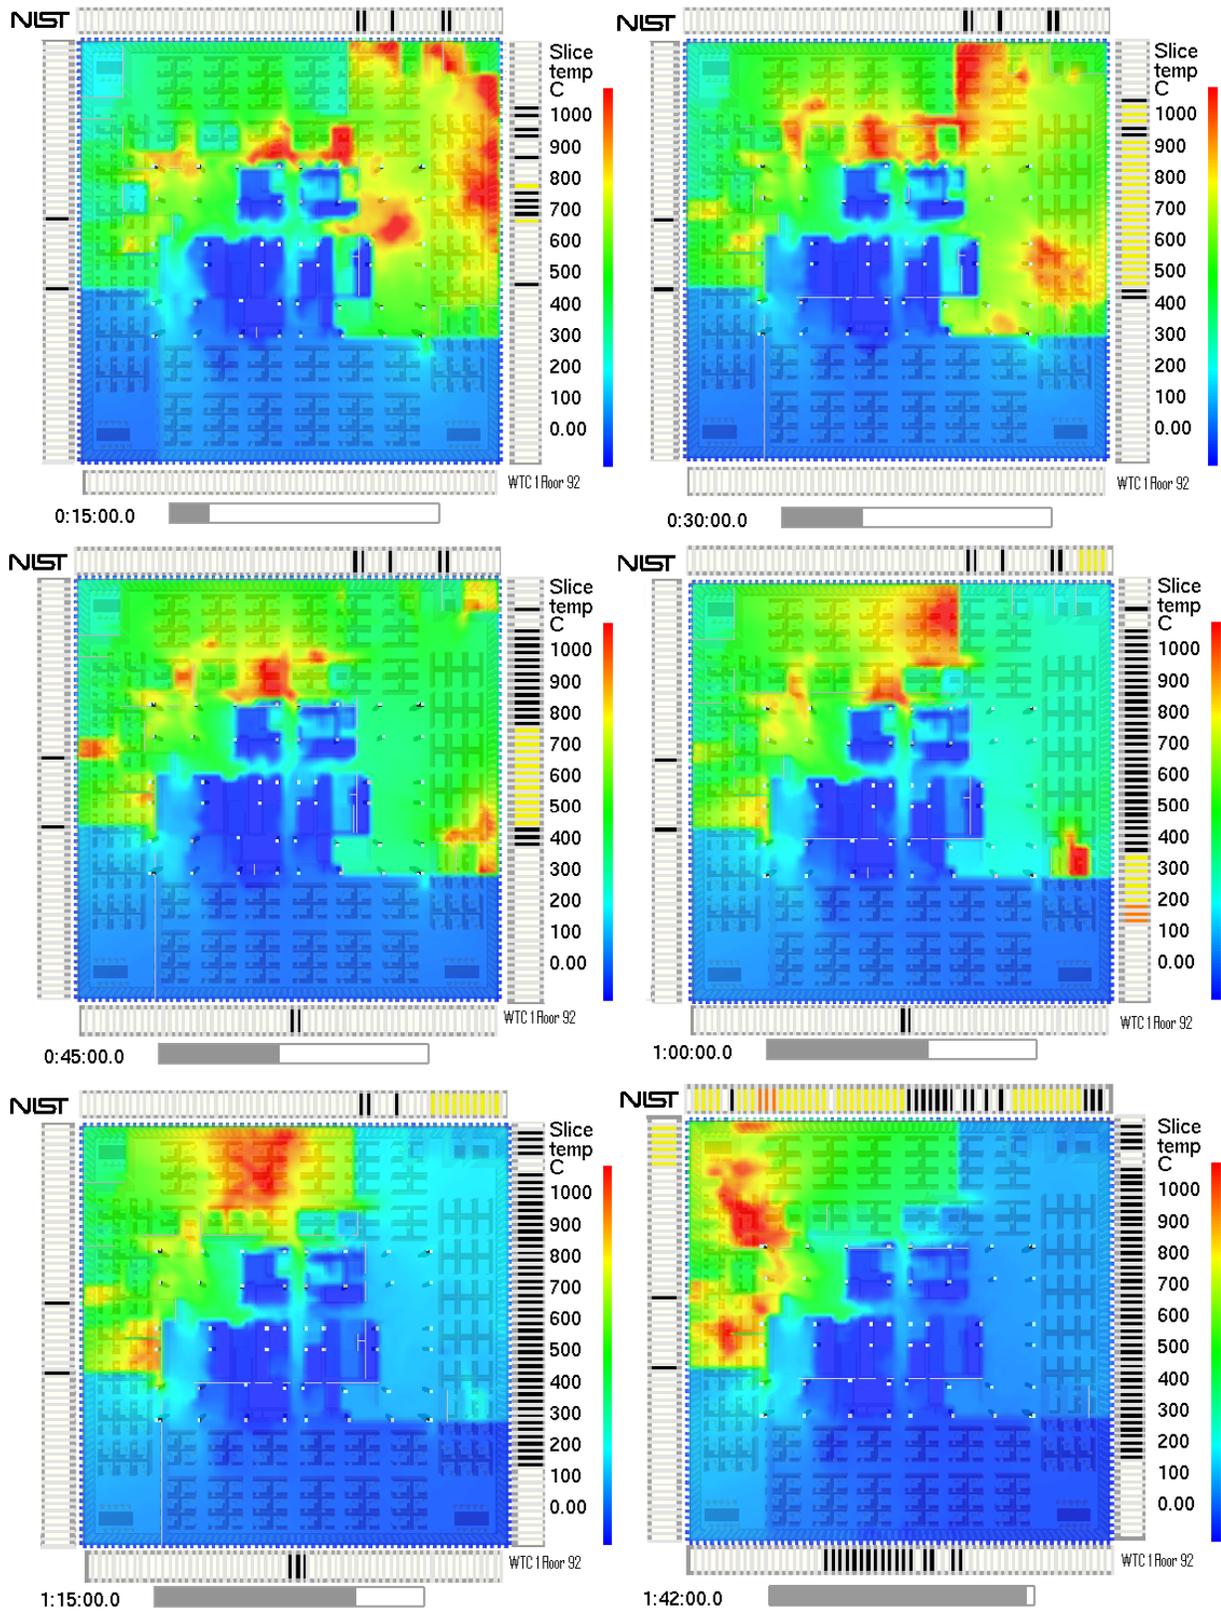
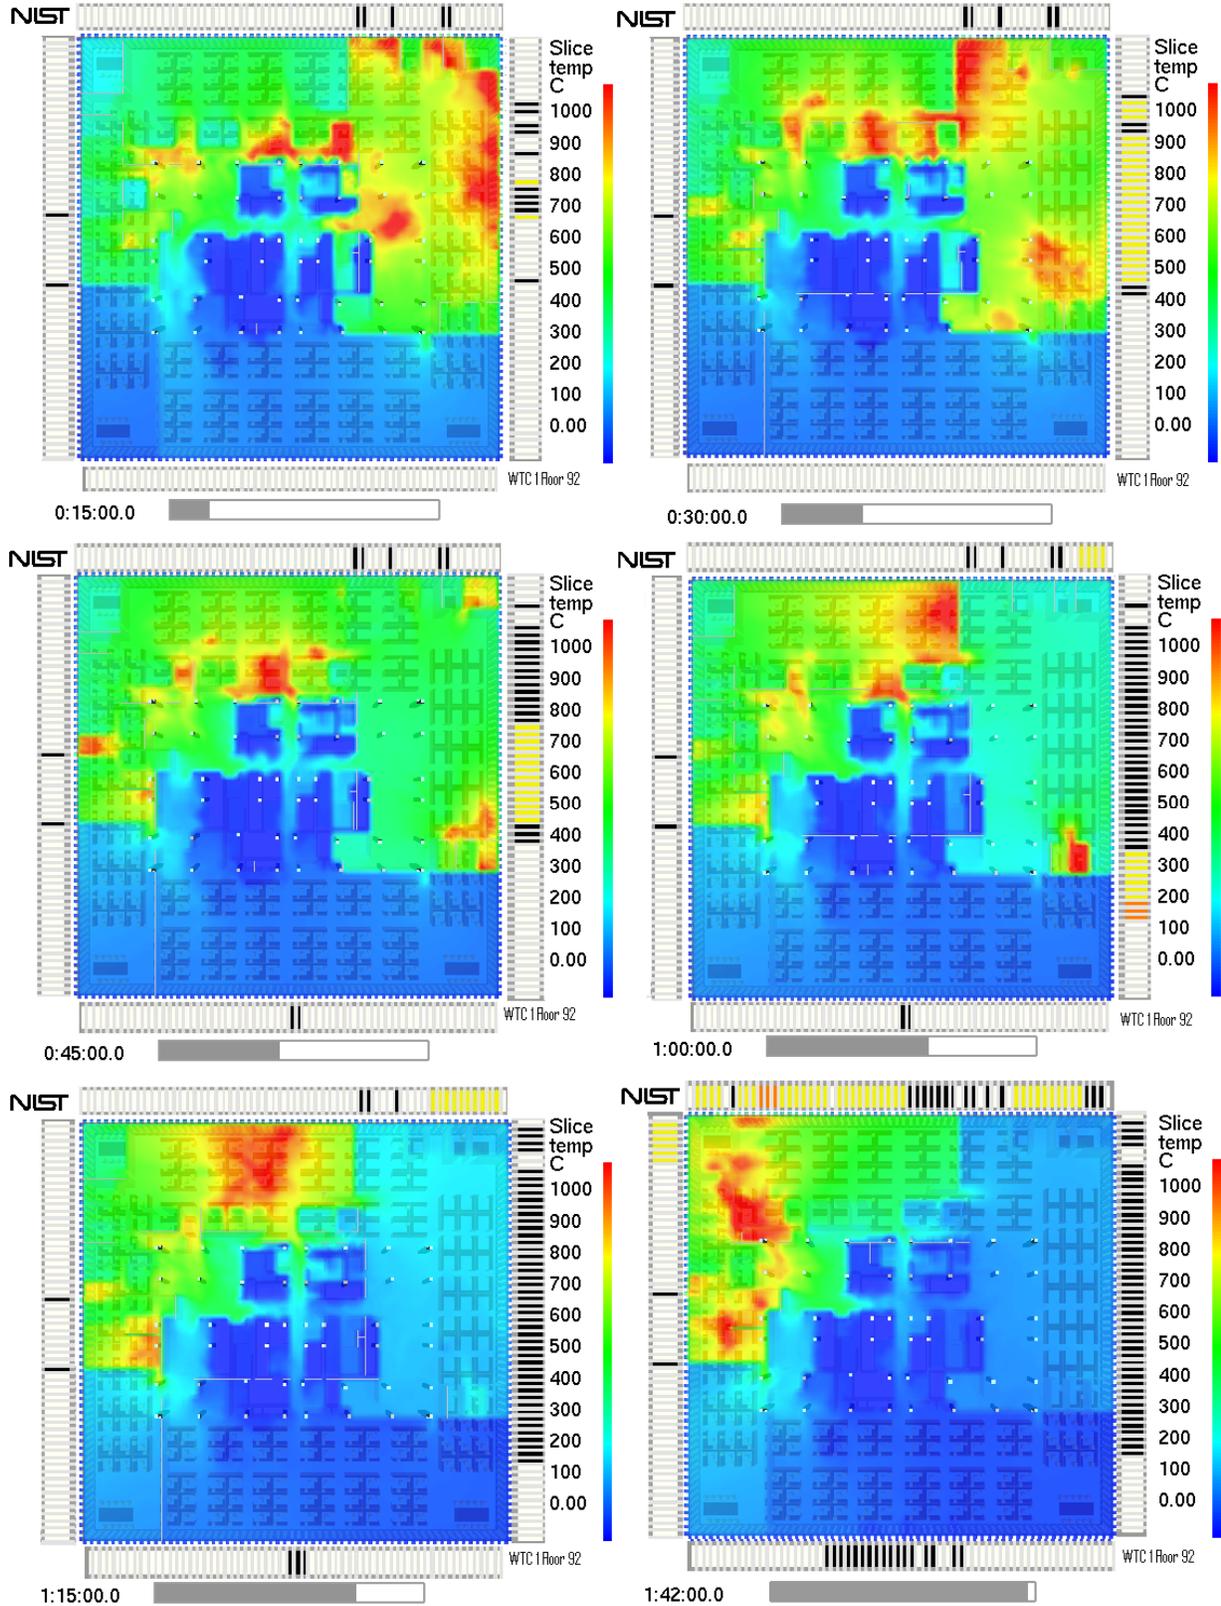
In the simulation, there was no damage on this floor other than window breakage. The ignition of jet fuel in the northeast corner and air from broken windows led to sustained burning of the contents in that corner. The combustibles were consumed about 45 min after the aircraft impact, and the fires moved south along the east face (where they were stopped by a partition) and west along the north side of the interior core. There was a wall that blocked the fires from spreading directly to the north face.

Eventually, the simulated fires arrived at the north face about 15 min sooner than was observed in the photographs and videos. The fires never reached the south section of the floor because of various walls that obstructed their spread.

The general pattern of the simulated fires was consistent with the photographic evidence. However, the burning rates were faster than observed: the simulated fire in the northeast corner burned out faster than actually observed, and the simulated fire on the west grew faster. The actual fire on the east face moved slightly further to the south than in the simulation, suggesting that the wall location was incorrect or that the wall had been penetrated. If the latter, it was not clear what caused the fire to stop where it did.

Figure 6–1. Simulated upper layer temperatures on floor 92 of WTC 1, Case A.

Figure 6–2. Simulated upper layer temperatures on floor 92 of WTC 1, Case B.

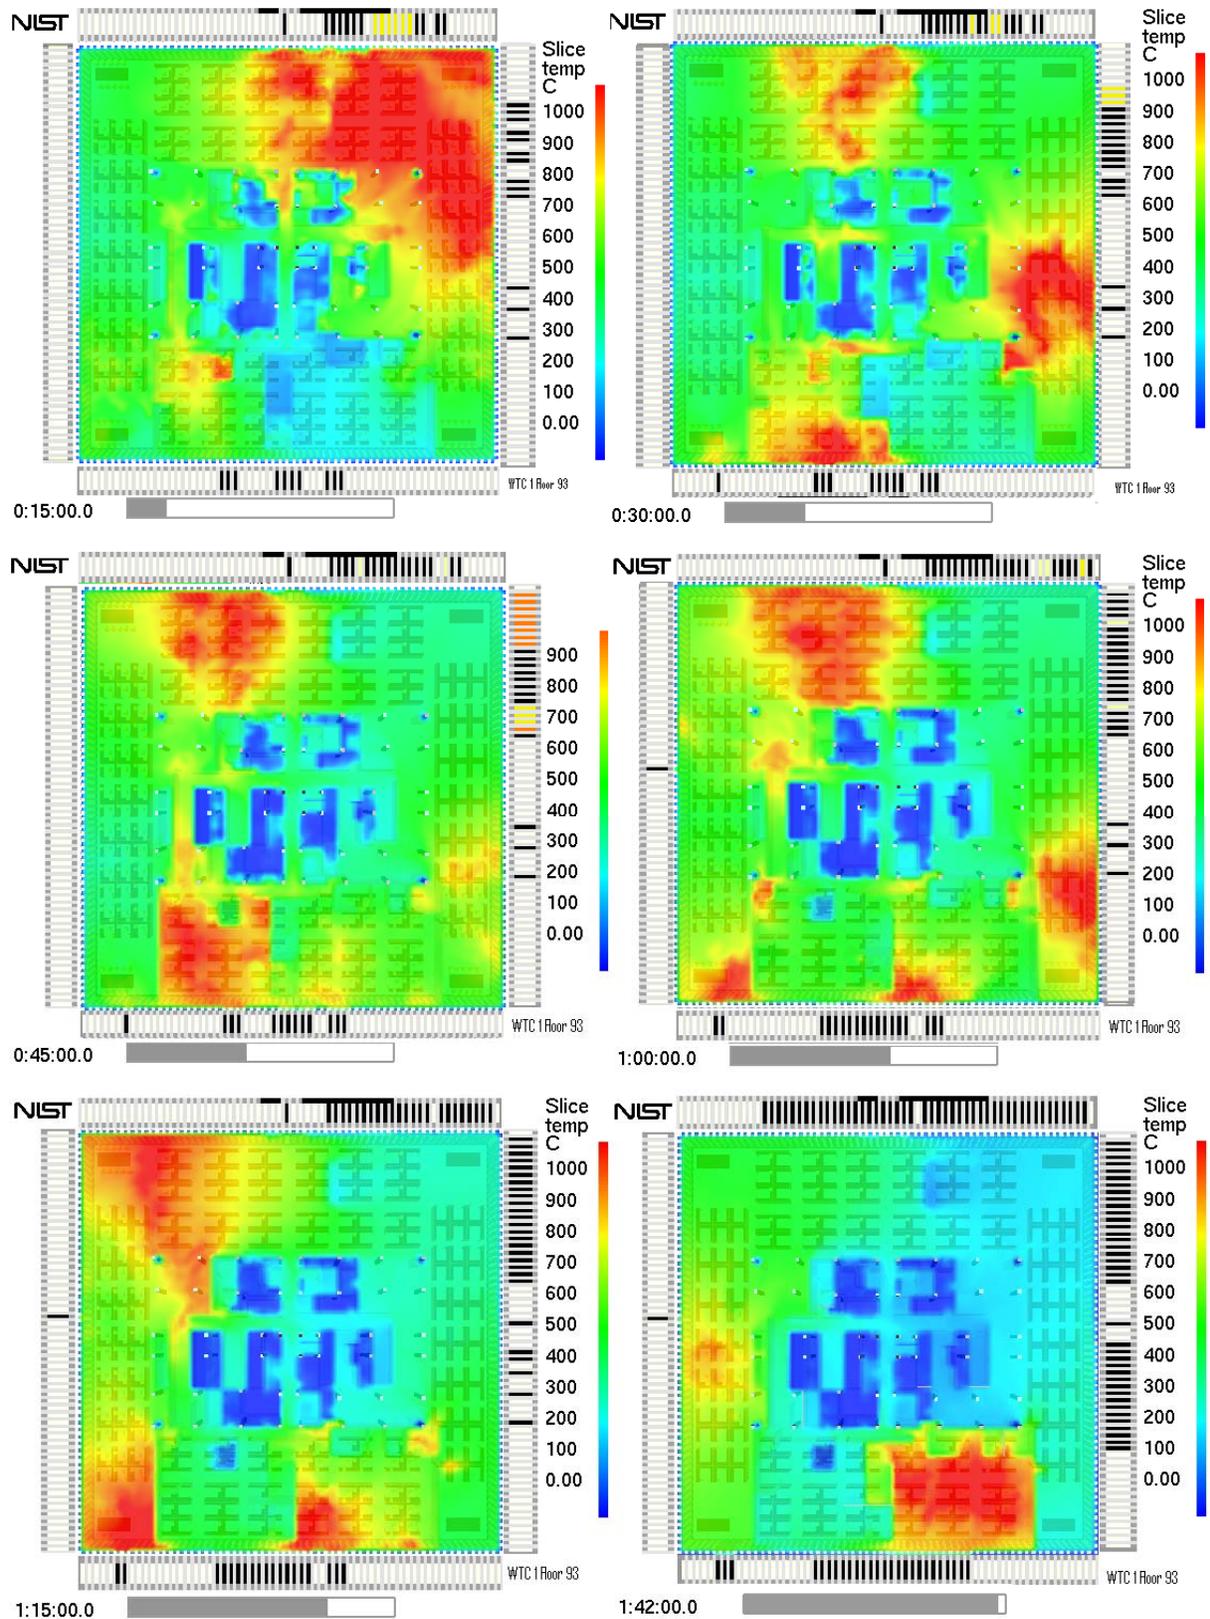
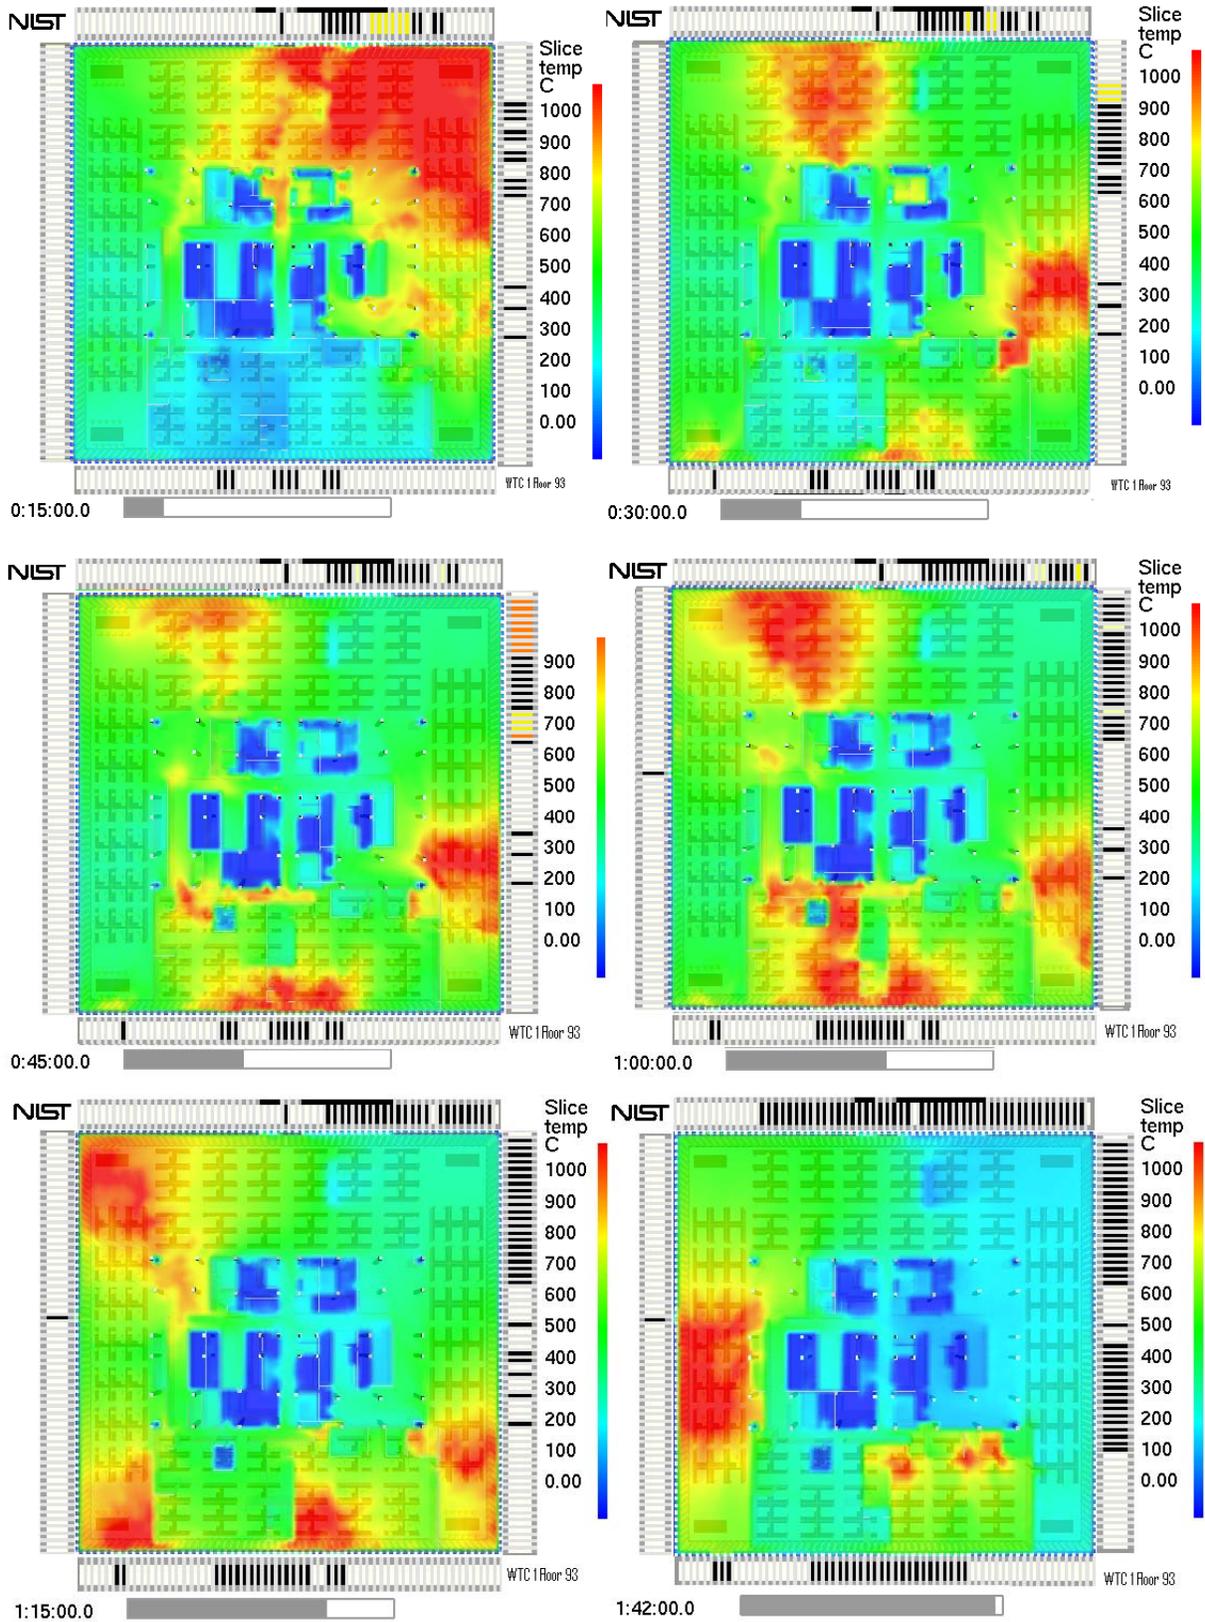
As on the 92nd floor, the simulated fires began in the northeast corner, just under where the left wing of the aircraft dripped jet fuel through the damaged floor slab from the 94th floor. Consuming the combustibles in the northeast in about 30 min, the fires moved west along the north face and south along the east face.

burning rate. The breaking of about 20 windows on the west side of the north face in the last 10 min indicated that there were interior fires or an overall build-up in the temperature of the gases. The observed window breakage along the south face in the last 10 min indicated the presence of a fire, but unlike the simulation, the fires had to have been away from the perimeter since they were not observed through the windows.

Figure 6–3. Simulated upper layer temperatures on floor 93 of WTC 1, Case A.

Figure 6-4. Simulated upper layer temperatures on floor 93 of WTC 1, Case B.
