NIST NCSTAR 1-5

**Federal Building and Fire Safety Investigation of the
World Trade Center Disaster**

**Reconstruction of the Fires in the
World Trade Center Towers**

September 2005

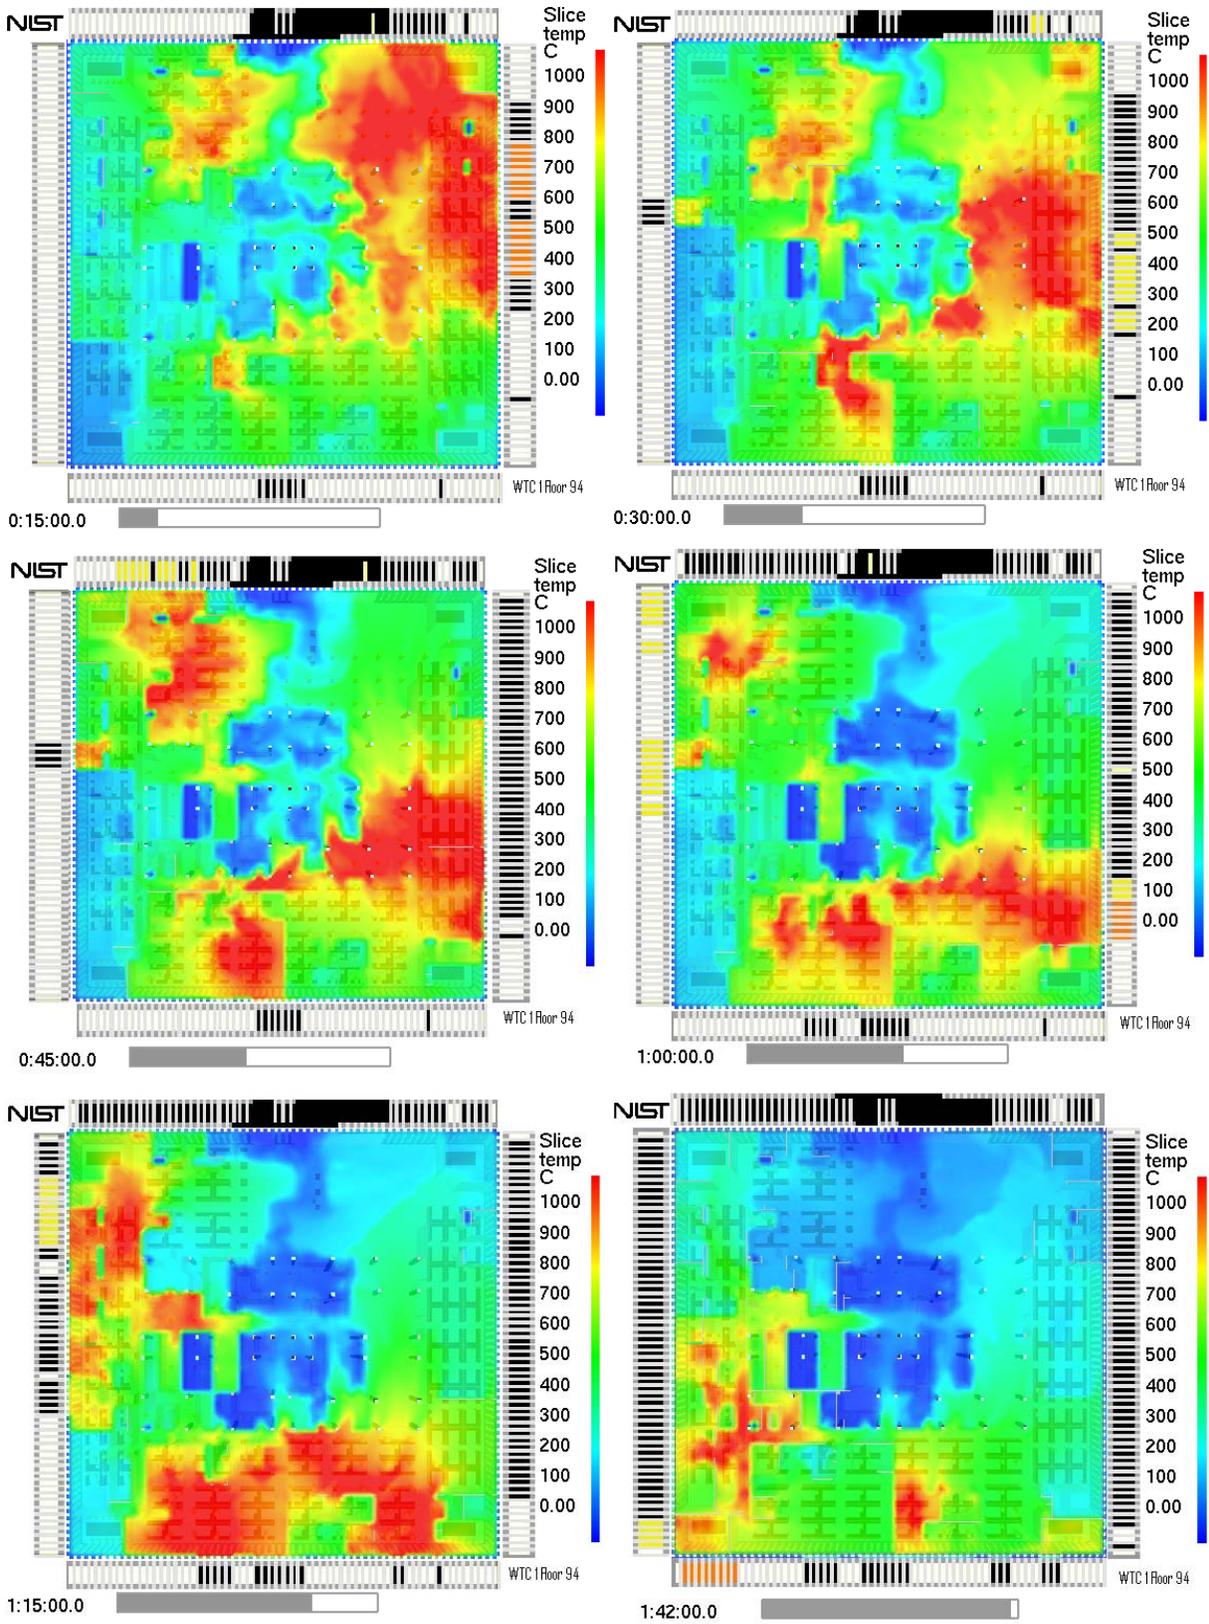
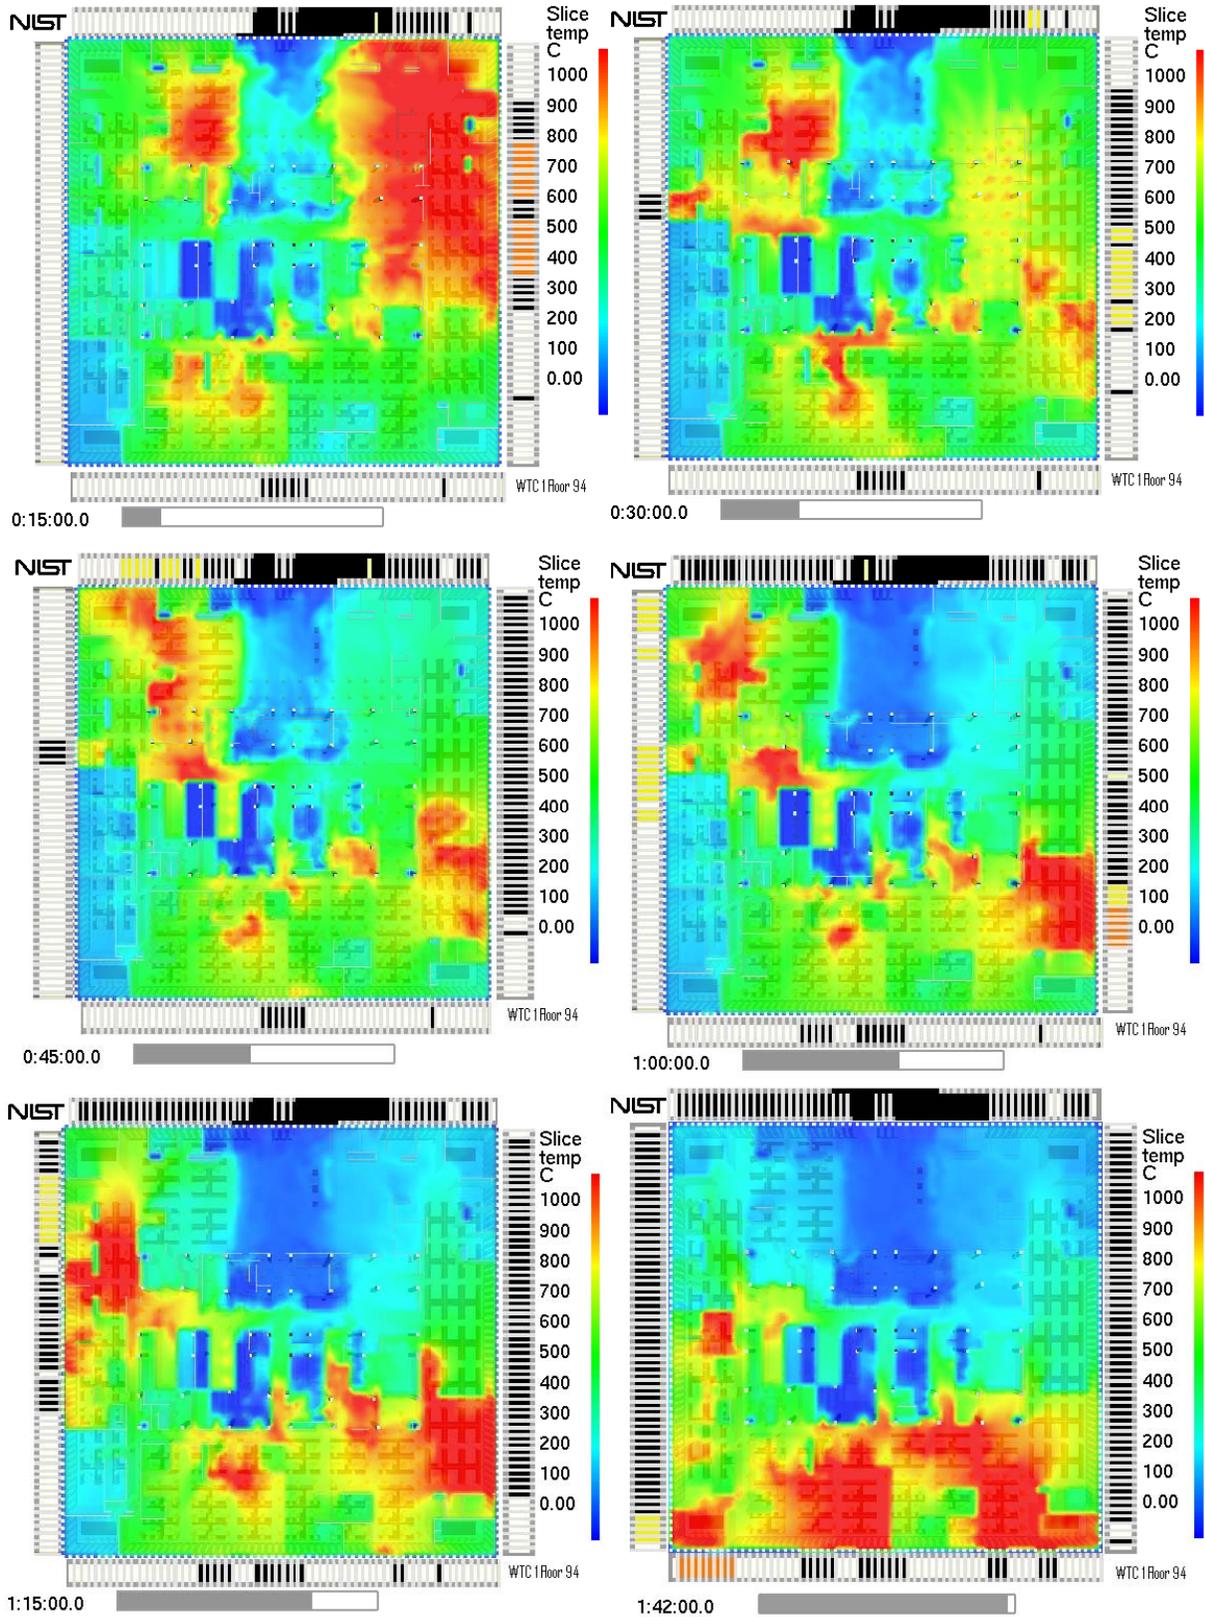
Floor 94 was directly impacted by the left wing of the aircraft, and a substantial amount of jet fuel was spread throughout the east side of the floor. Initially, severe fires were observed on the east face, and then steadily spread around the floor, with the heaviest activity in the end being in the southwest quadrant.

The simulation captured the movement of the fires reasonably well. The simulated fires burned vigorously in the northeast quadrant for the first 30 min. Then for the next hour, the fires moved at roughly the same rate as the real fires clockwise toward the southeast and counterclockwise toward the southeast. In some areas, the simulation shows the burning to be too close to the windows. The late fire on the south face was not seen in the photographs and videos.

Figure 6–5. Simulated upper layer temperatures on floor 94 of WTC 1, Case A.

Figure 6–6. Simulated upper layer temperatures on floor 94 of WTC 1, Case B.

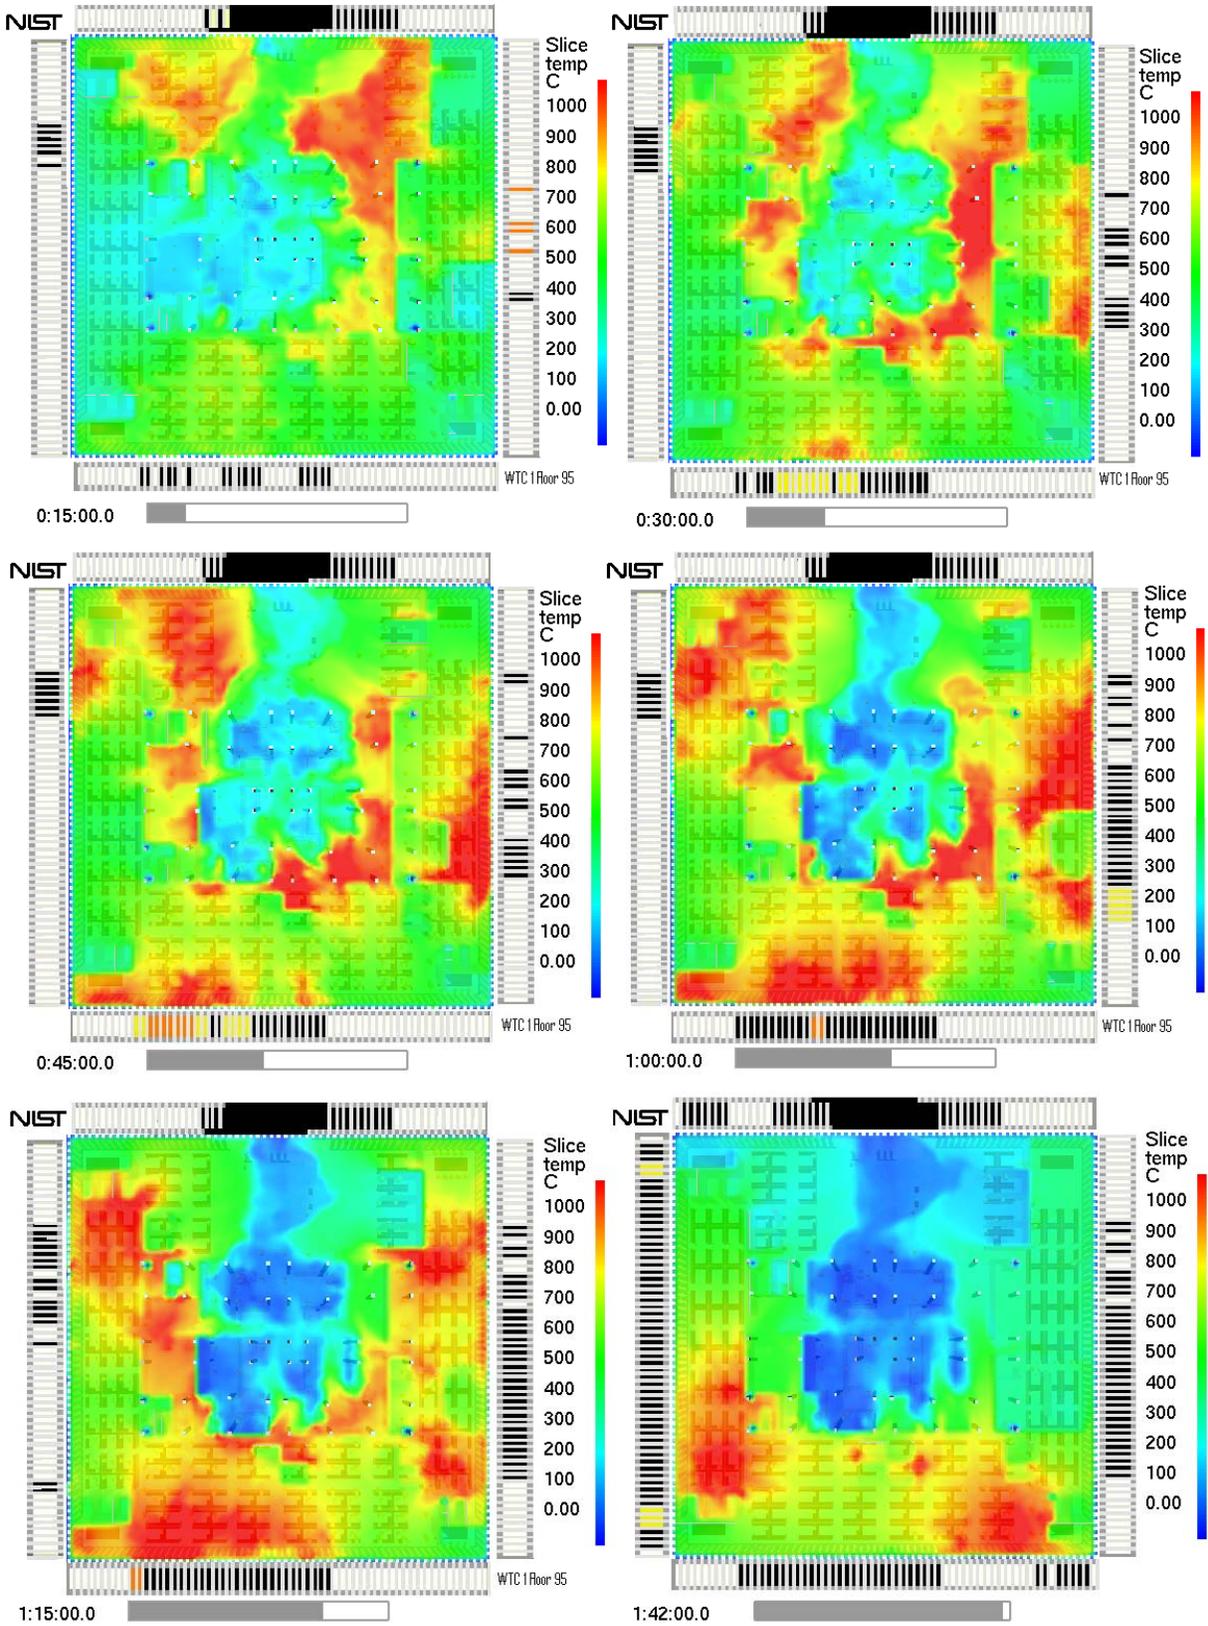
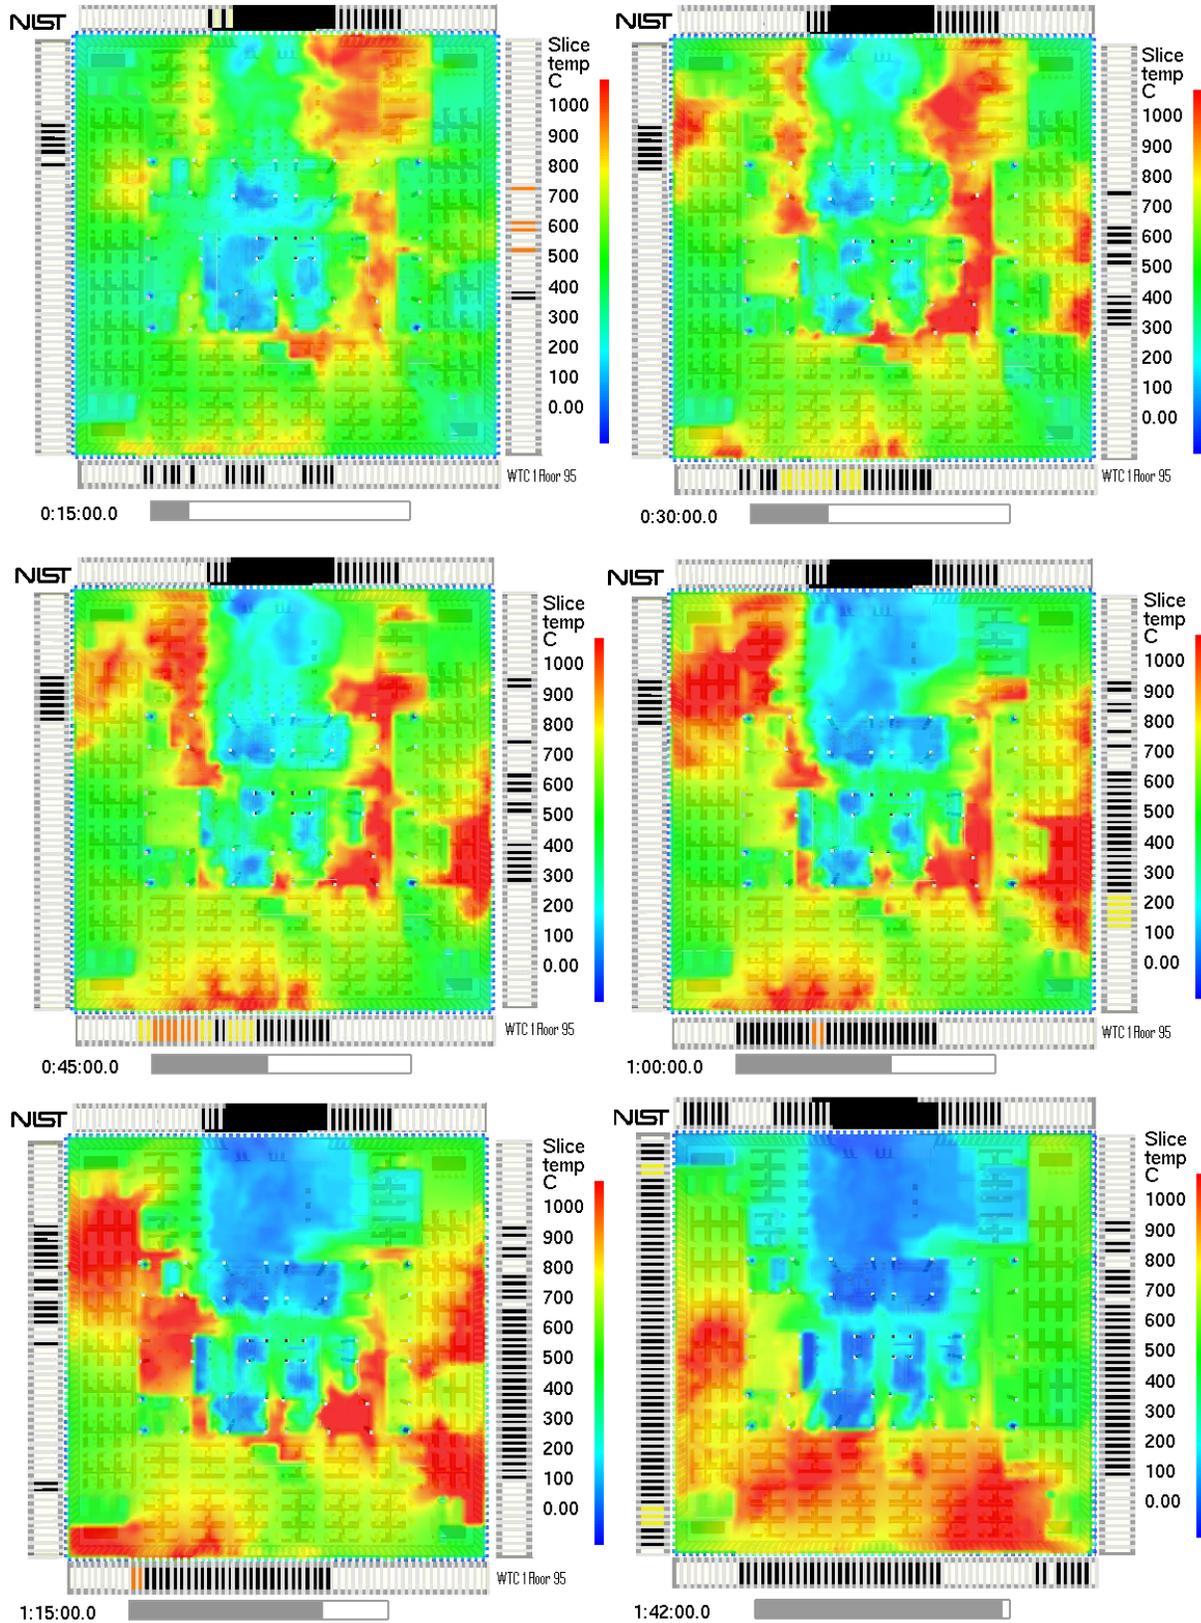
The simulated fires started around the center of the north face where the fuselage of the aircraft hit. The fires then followed the pattern of window breakage. There was substantial fire activity predicted in the building core due to the extensive wall damage (NIST NCSTAR 1-2). The simulations suggested that air rising through the core mixed with the oxygen-starved fuel gases that were accumulating on this floor because of the relatively light exterior damage away from the impact zone. However, there was no evidence to confirm or deny the existence of vigorous fire activity within the core.

Taking into account the tendency to simulate burning too close to the windows, the overall pattern of the fires is reasonably consistent with the observations. The fire on the north side of the building was growing just before additional windows break there. The same is true for the fire on the middle of the east side. The early fire simulated on the south side is consistent, but burns too long or too close to the broken windows.

Figure 6–7. Simulated upper layer temperatures on floor 95 of WTC 1, Case A.

Figure 6–8. Simulated upper layer temperatures on floor 95 of WTC 1, Case B.

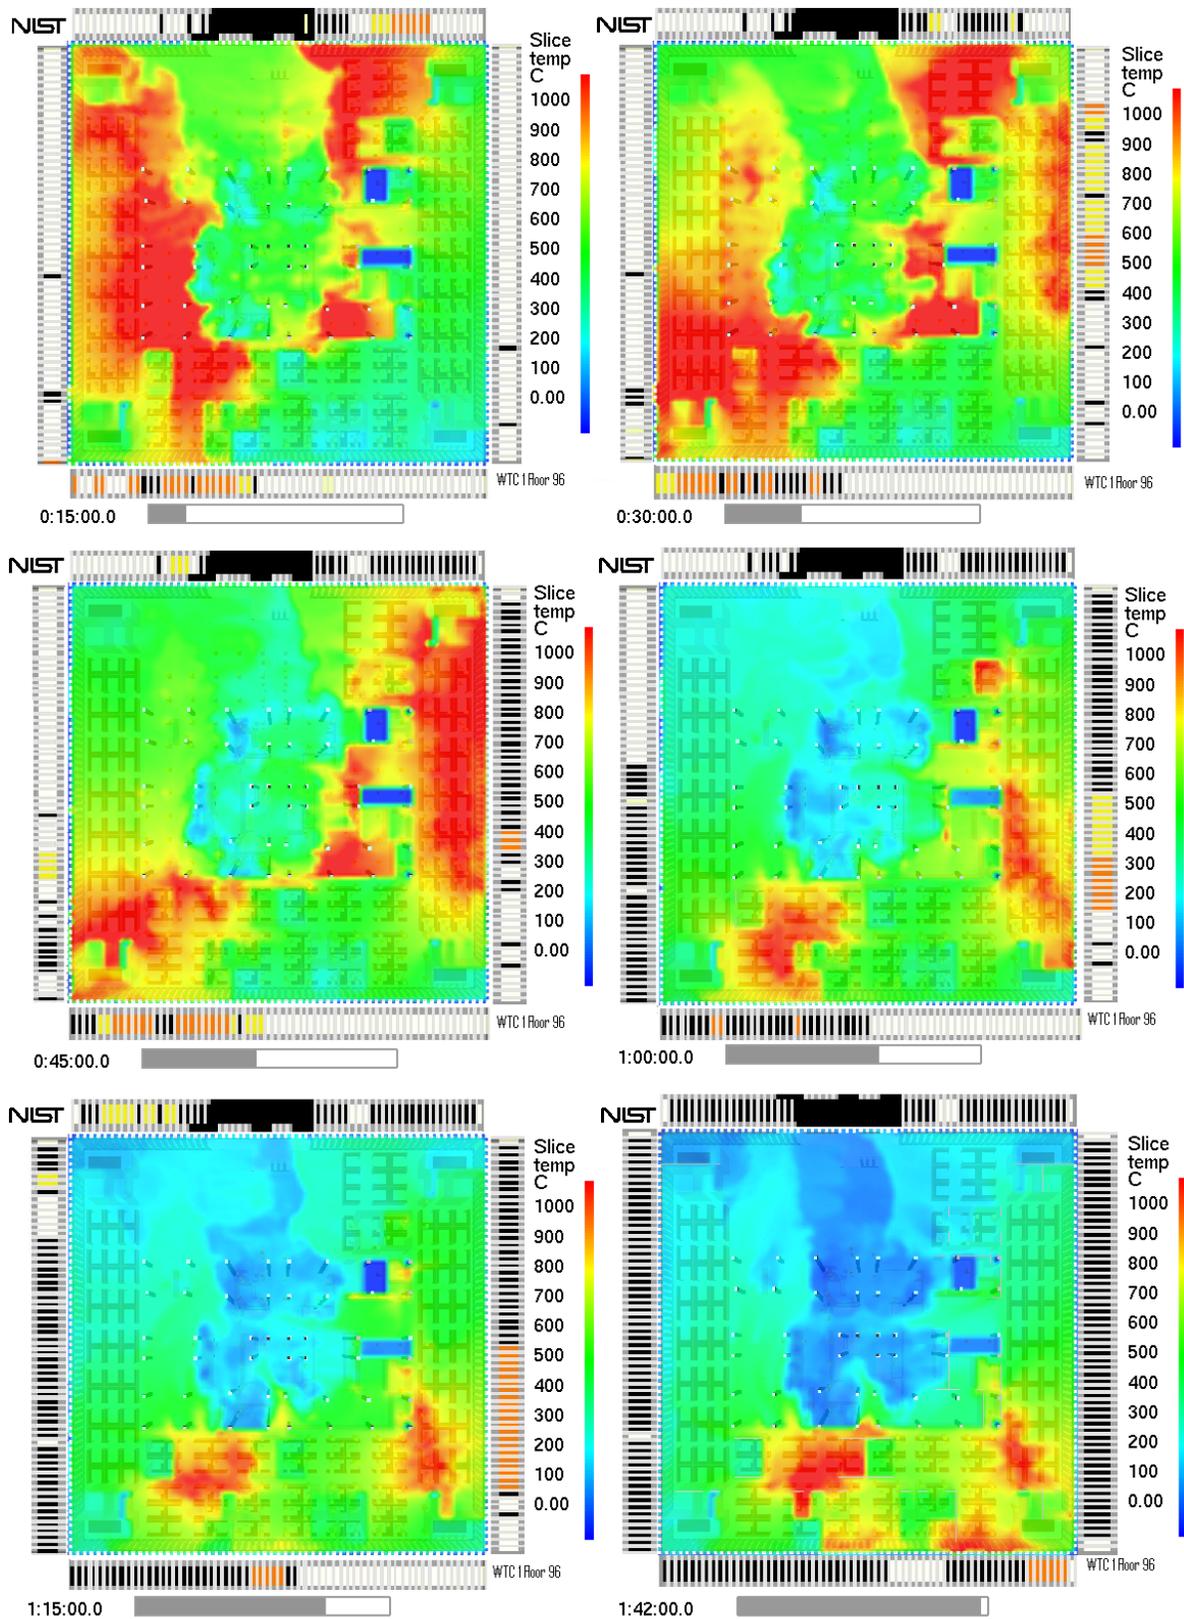
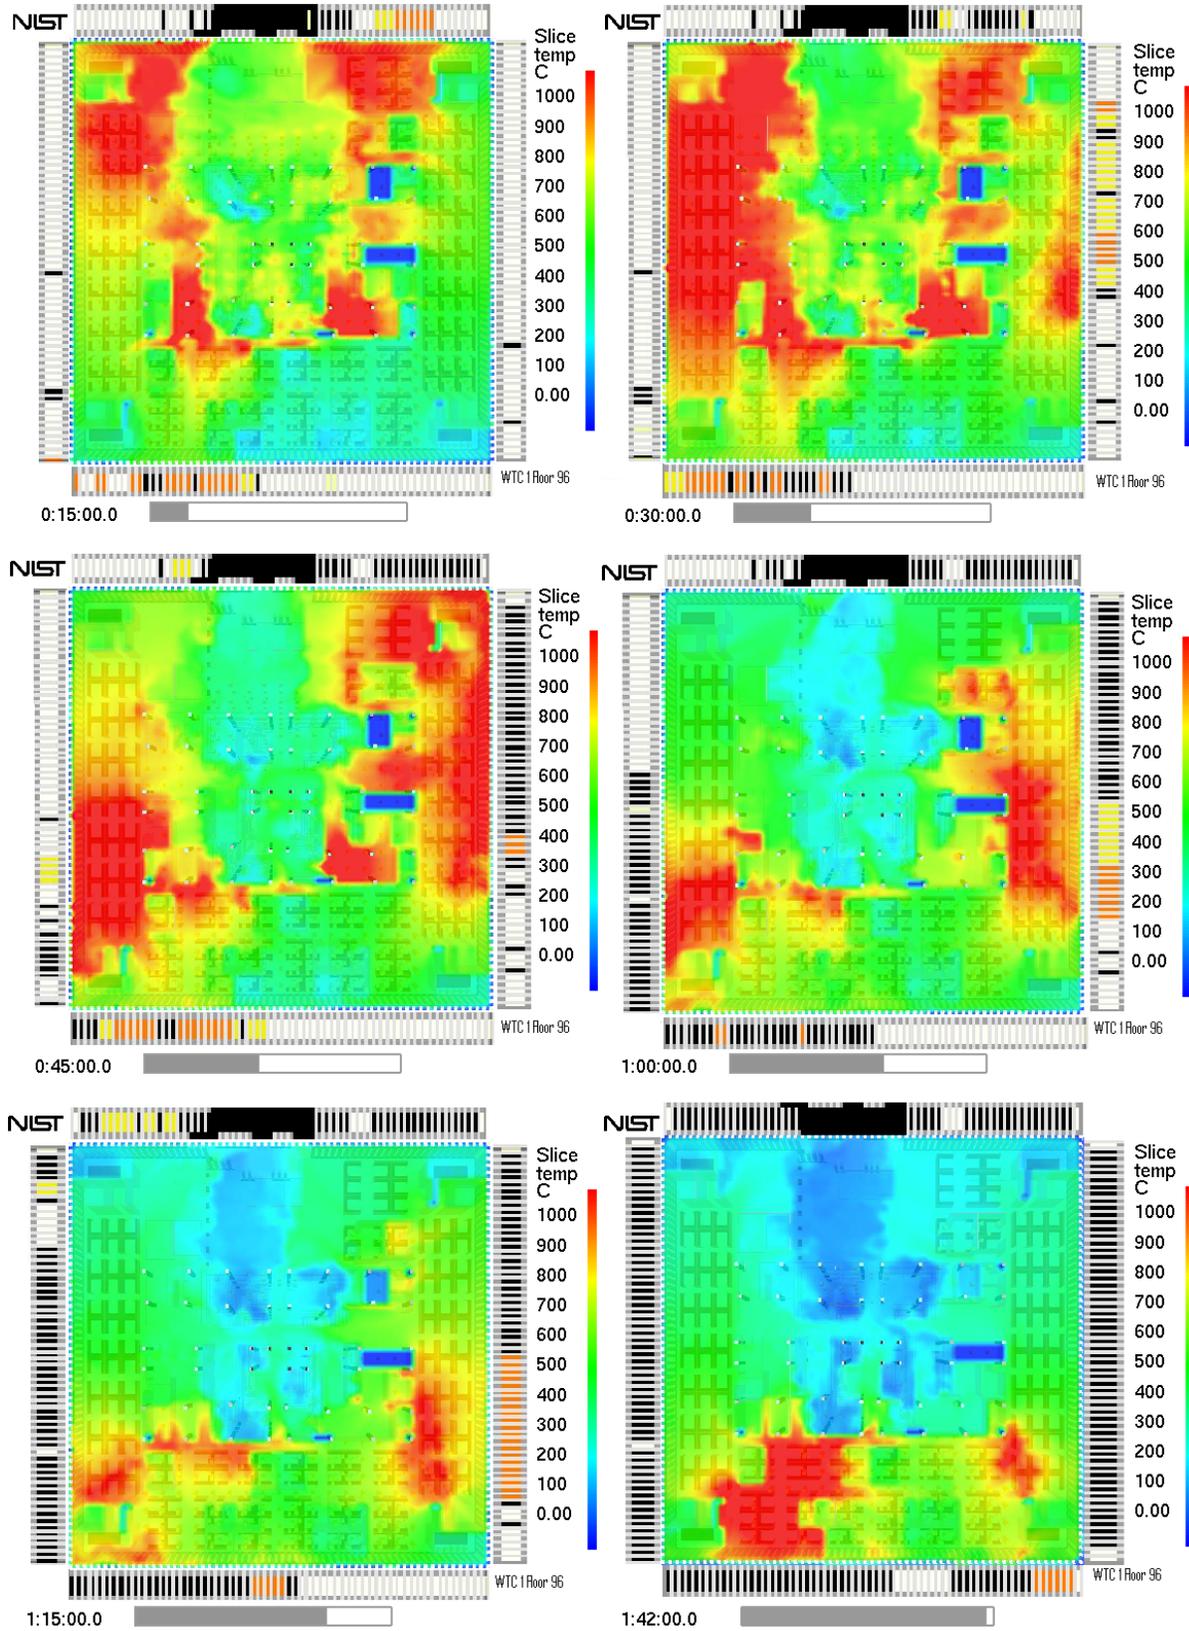
Floor 96 was directly impacted by the aircraft fuselage and inner wings. There was extensive damage to the core and internal walls. One simulated fire started to the east of the impact hole, spread southward along the east side of the building, and turned the corner to the south face. This behavior mimics closely the behavior of the actual fire. By contrast, the simulation overestimated the extent of the fire on the west face. The visual observations suggested that this fire originated in the south, not the impact area. The simulation is a fair rendition of the observations on the south side of the tower beginning about 15 min to 30 min after the aircraft impact. The model captured the delayed movement of the fires along the south face due to the presence of office walls.

Figure 6–9. Simulated upper layer temperatures on floor 96 of WTC 1, Case A.

Figure 6–10. Simulated upper layer temperatures on floor 96 of WTC 1, Case B.

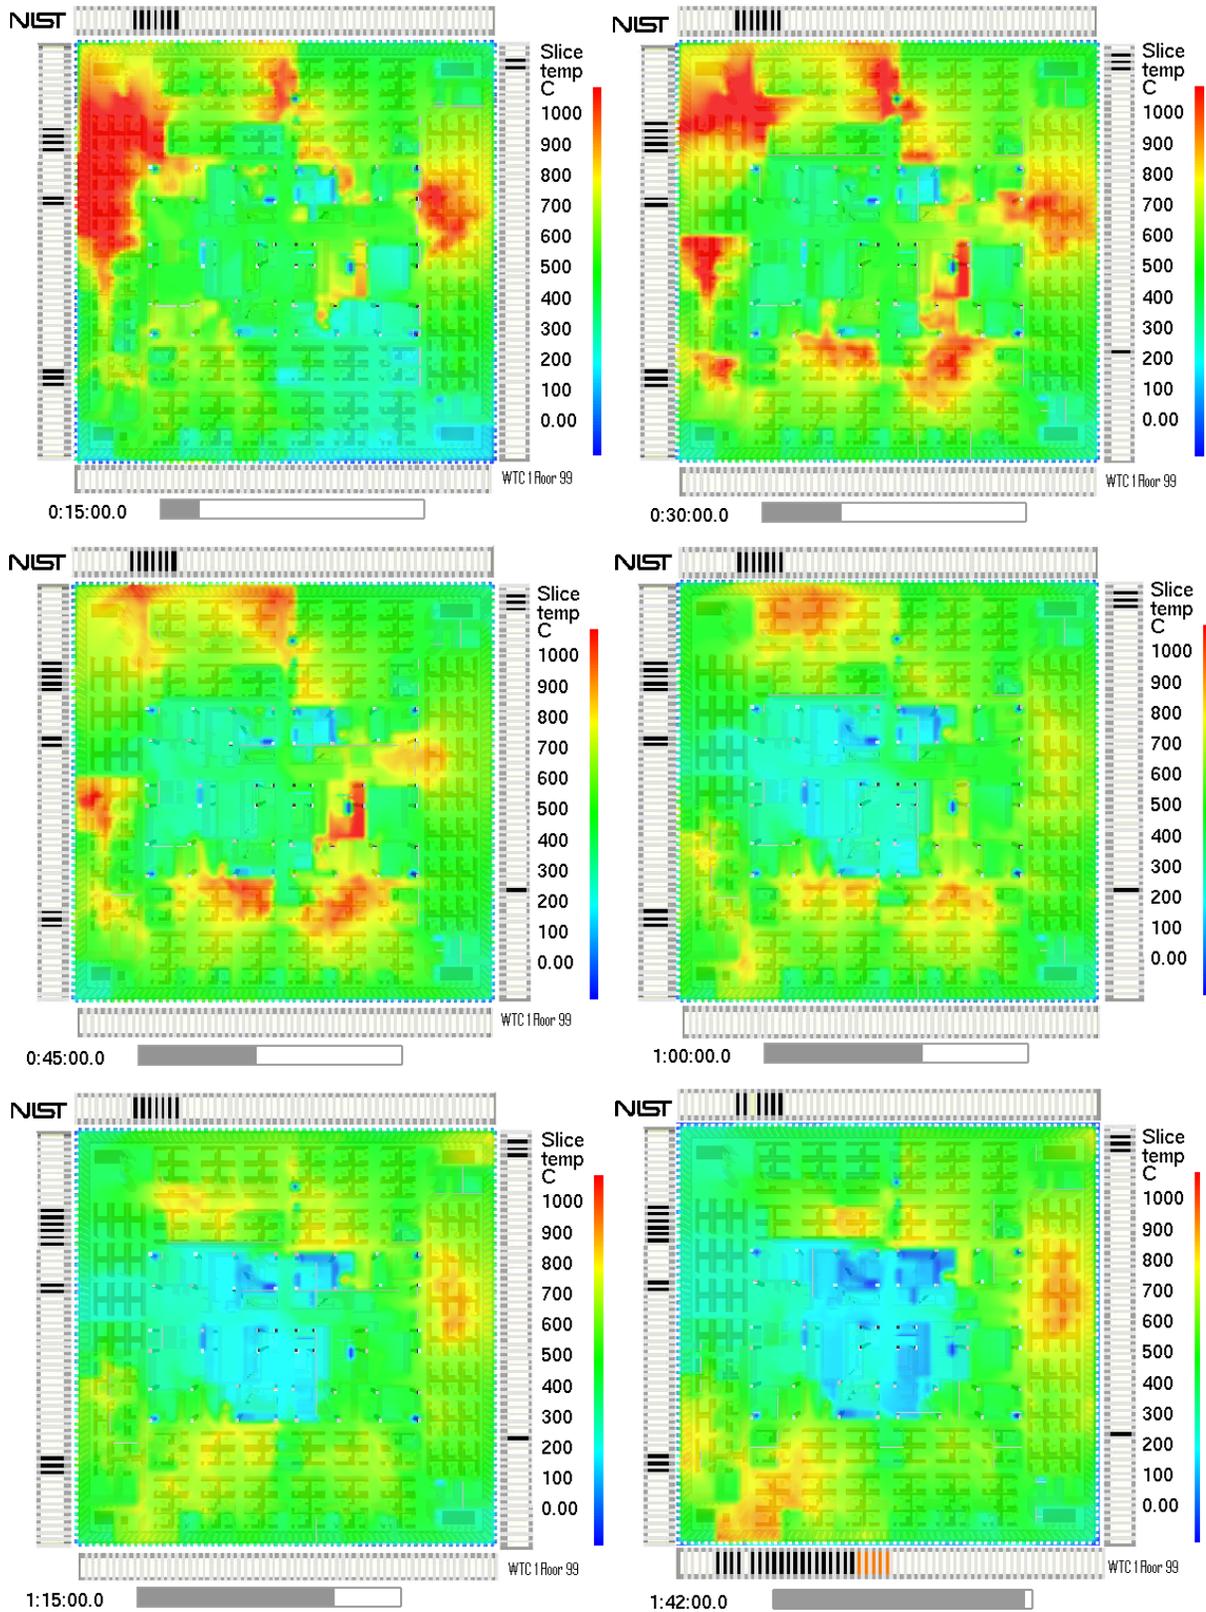
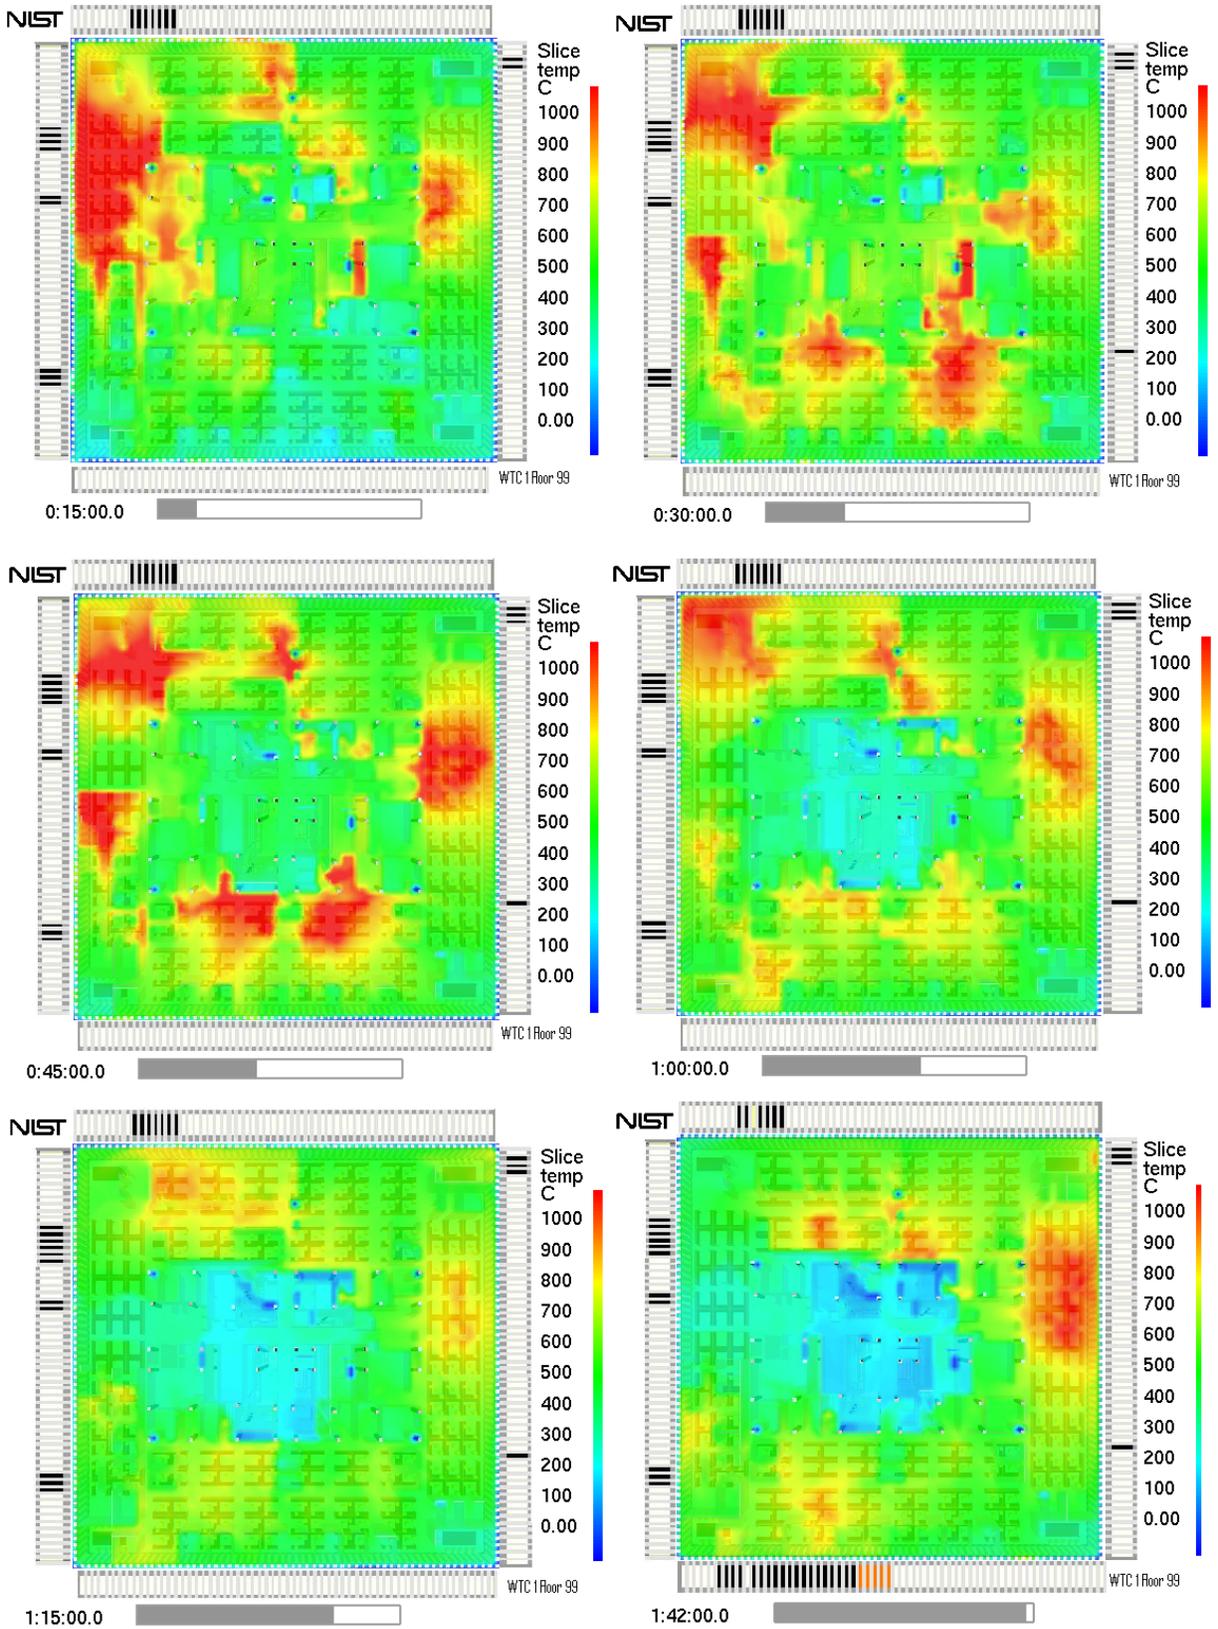
The 99th floor was impacted by the very tip of the right wing, and the window damage was minimal. The simulated fire activity was light and did not show any discernable trends, nor did it provide any clues to the late fire activity observed on the south face.

Figure 6–15. Simulated upper layer temperatures on floor 99 of WTC 1, Case A.

Figure 6-16. Simulated upper layer temperatures on floor 99 of WTC 1, Case B.

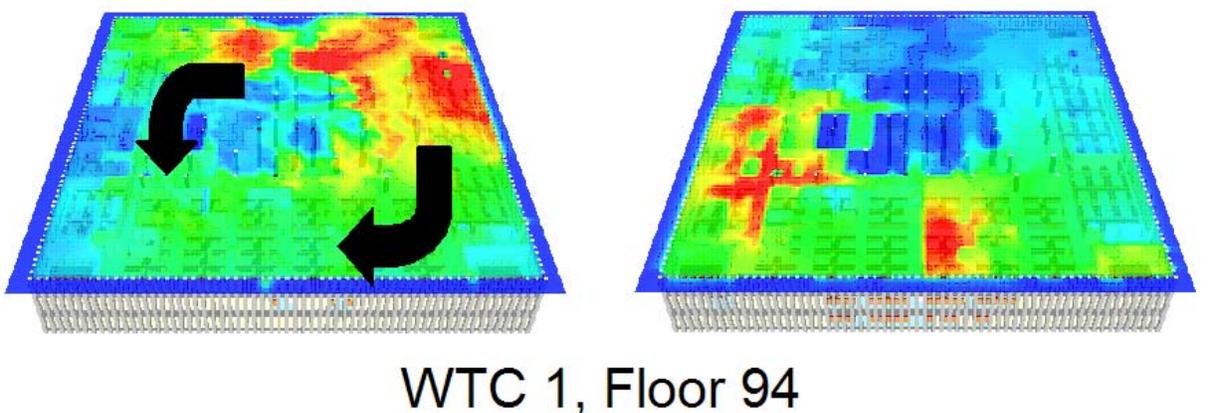
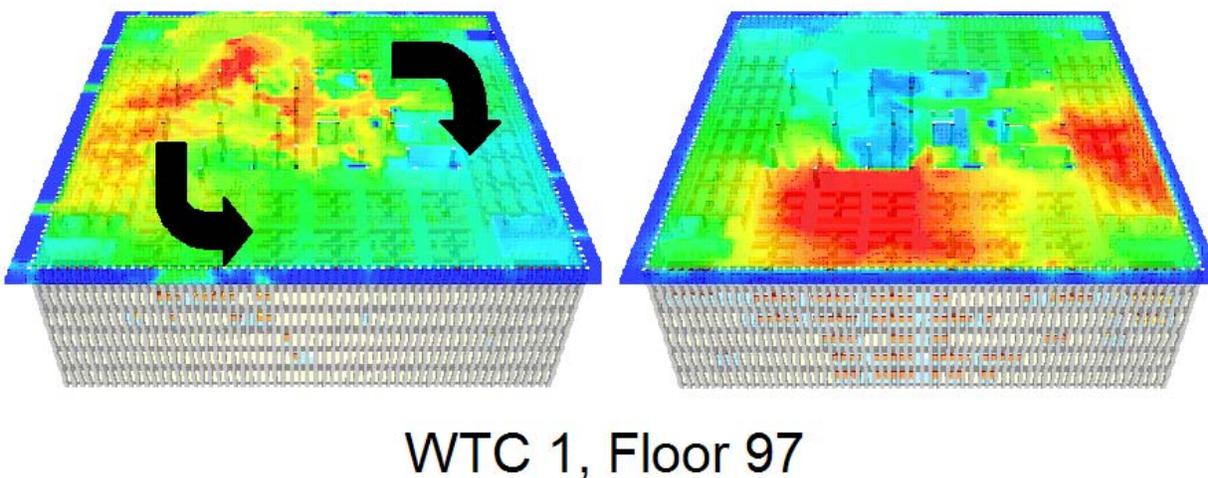
In WTC 1, much of the fire activity was initially in the vicinity of the impact area in the north part of the building, then it spread around the east and west faces, and was last observed to be concentrated in the south part of the building at the time of collapse, as depicted in Figure 6–29.

Figure 6–29. Direction of simulated fire movement on floors 94 and 97 of WTC 1.

The fact that the simulated fires encircled the building in roughly the same amount of time as the actual fires supported the estimate of the overall combustible load of 20 kg/m² (4 lb/ft²). Simulations performed with higher loads required a proportionately longer amount of time to bring the fires around to the southeast because of the fact that the burn time was roughly proportional to the fuel mass in the oxygen-limited interior of the fire floors.

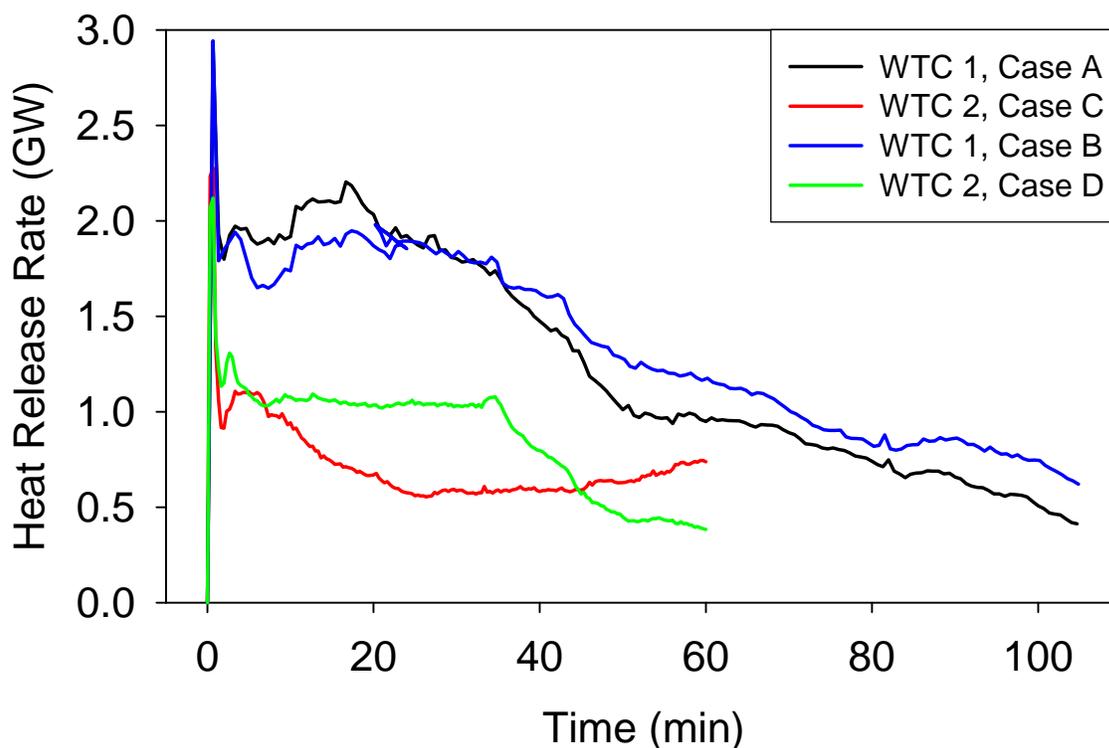
Figure 6–30. Predicted heat release rates for fires in WTC 1 and WTC 2.

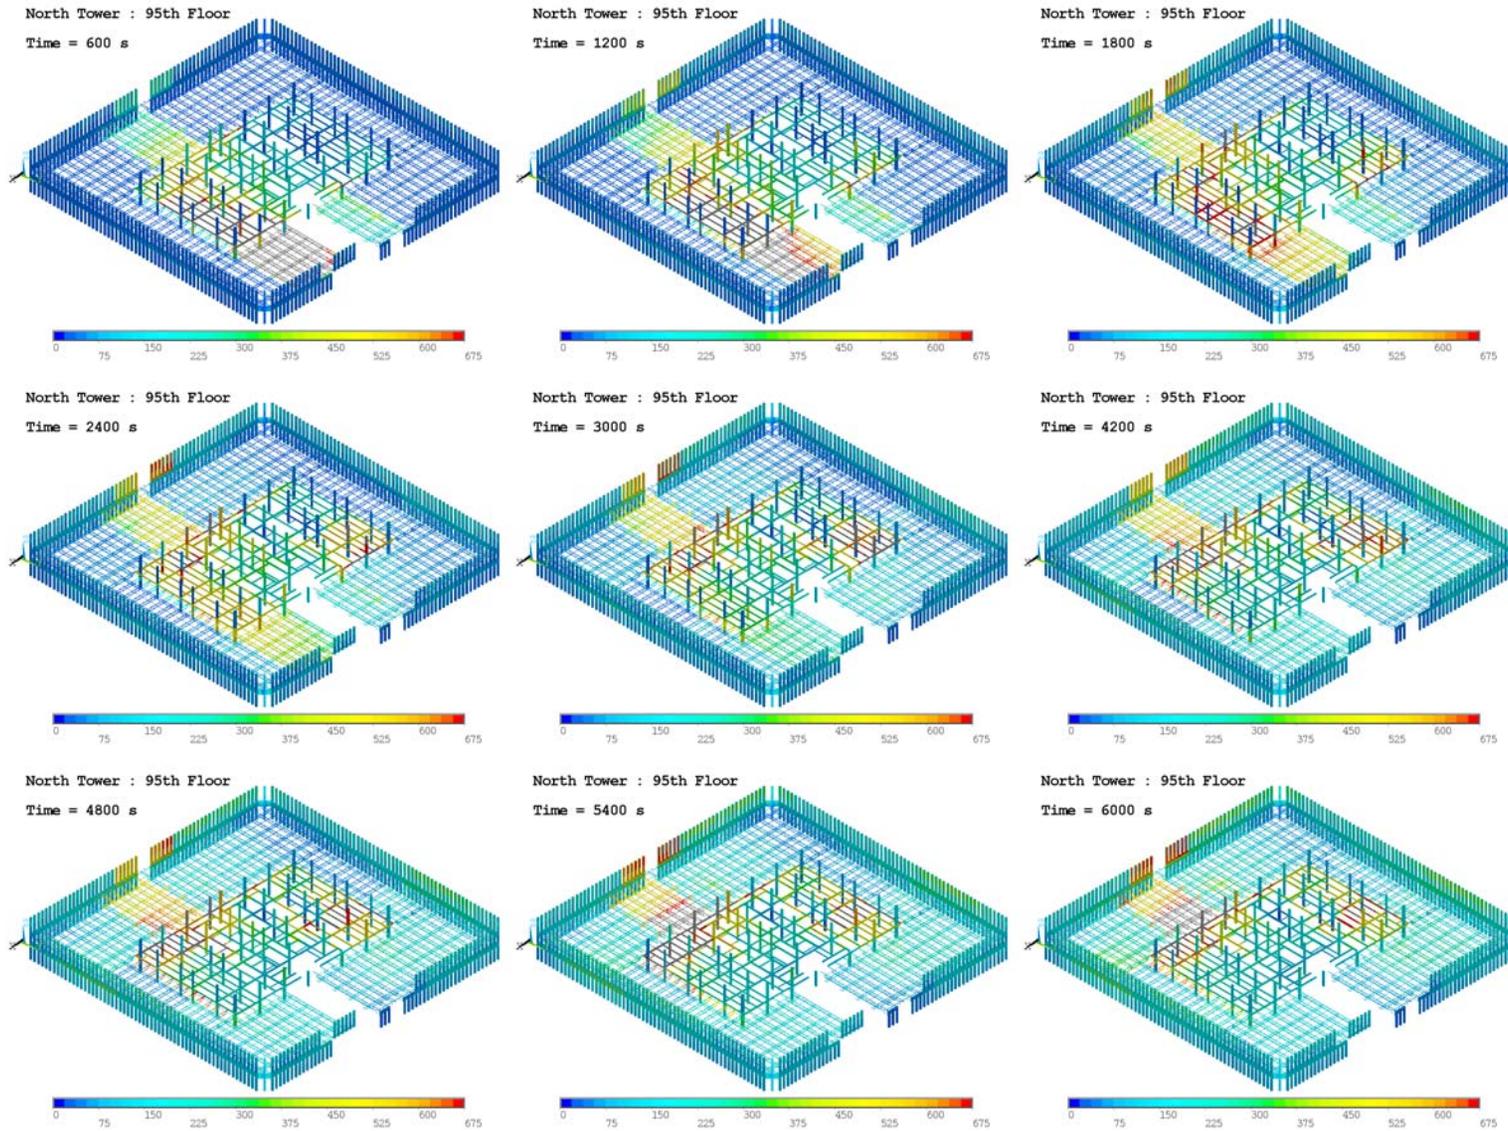
Figure 6-36. Thermal response of floor 95 of WTC 1, Case B.

There was extensive insulation damage to the trusses that supported the slab on the 95th floor, and those in the northeast heated rapidly. They cooled gradually as the fire moved southward.

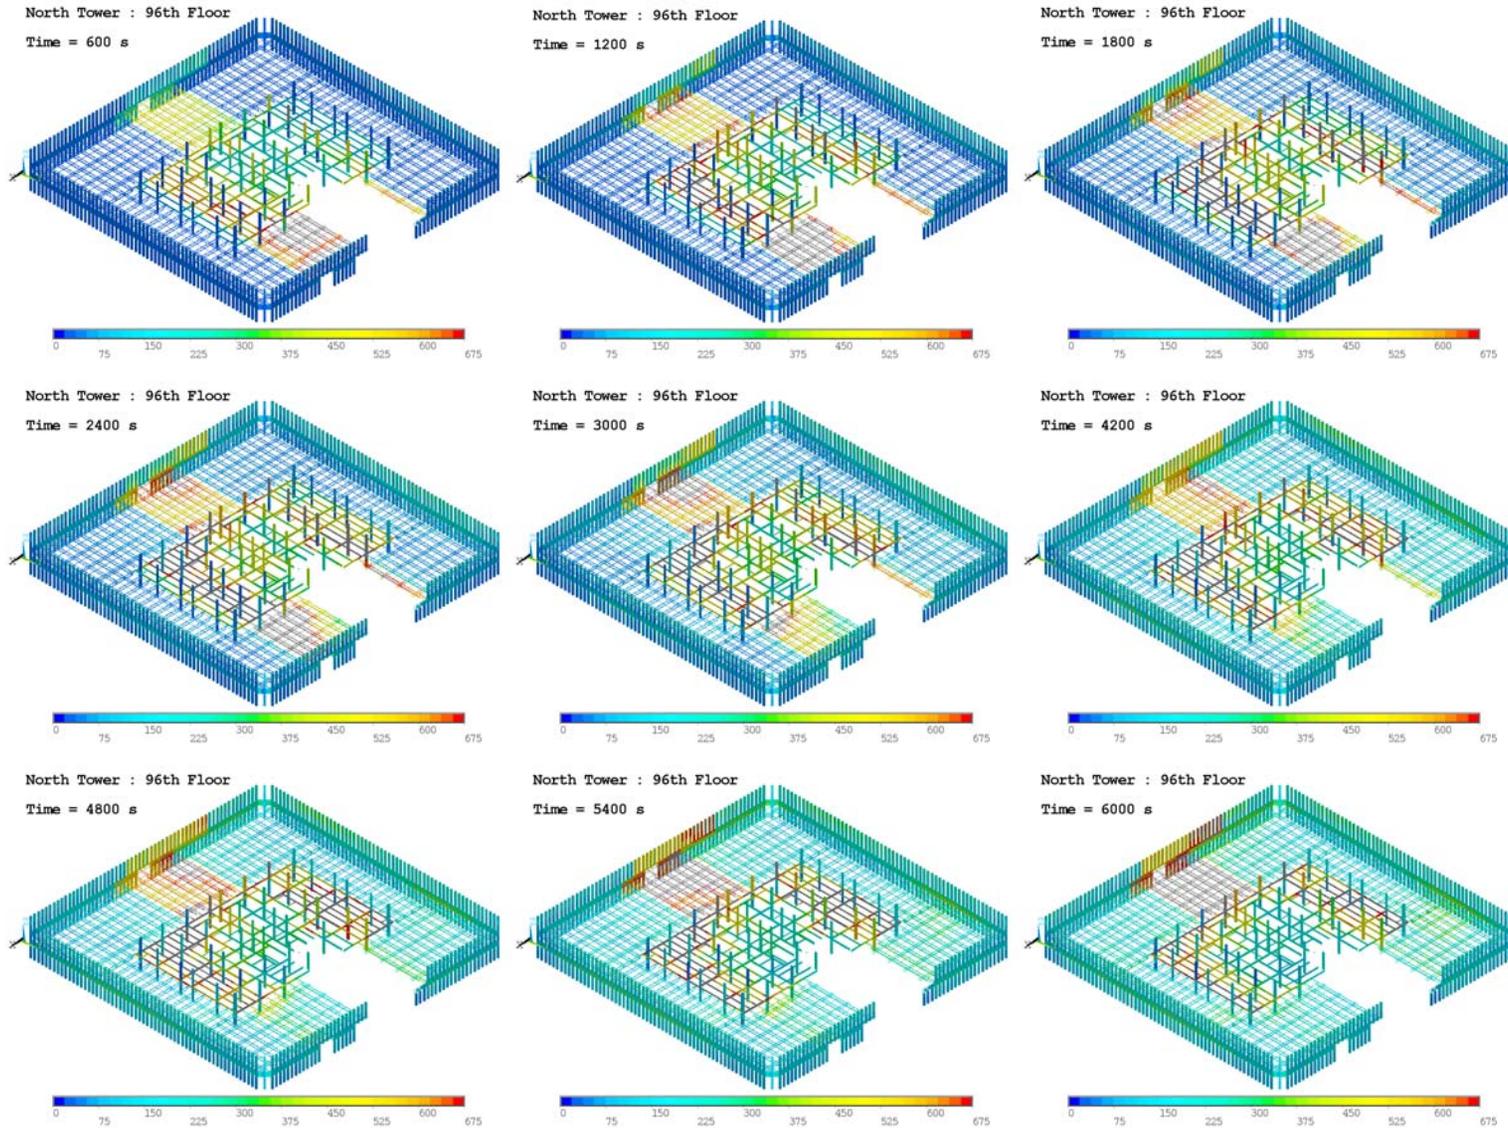
Figure 6-38. Thermal response of floor 96 of WTC 1, Case B.

The insulation-damaged trusses on the north face heated rapidly in the first 30 min after impact. They then cooled as the fire moved to the south. The fully insulated trusses at the west face only reached peak temperatures of approximately 150 °C.
