NIST NCSTAR 1-5

**Federal Building and Fire Safety Investigation of the
World Trade Center Disaster**

**Reconstruction of the Fires in the
World Trade Center Towers**

September 2005

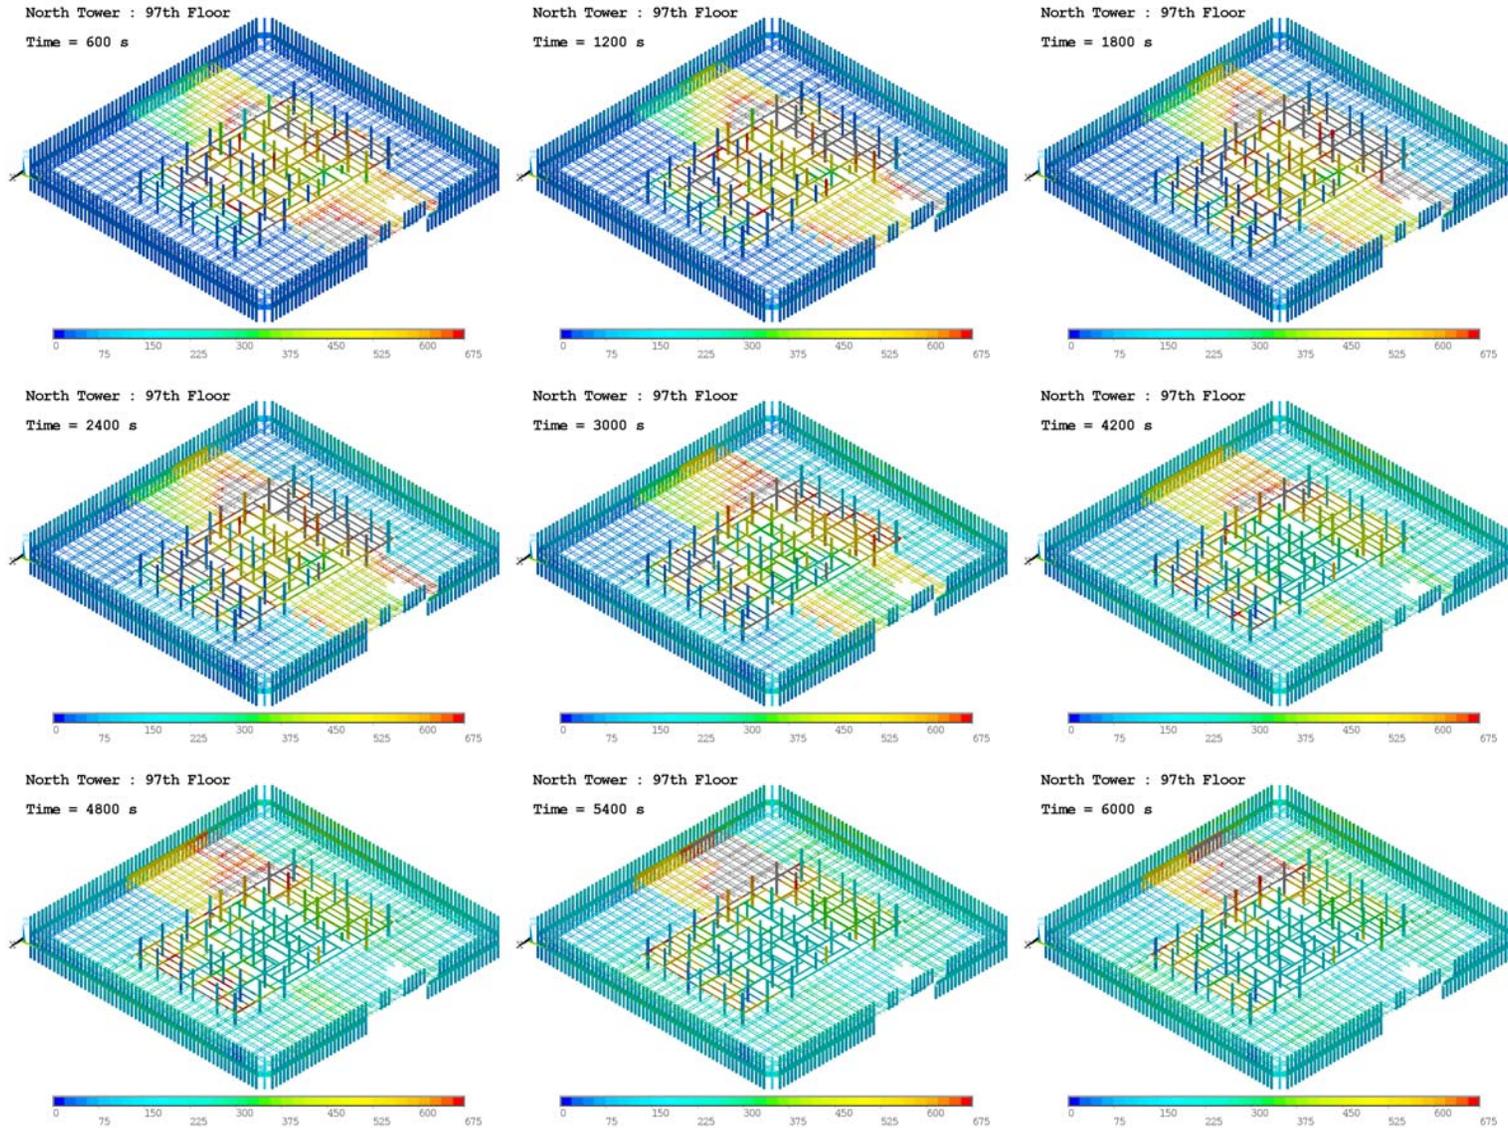
Figure 6-40. Thermal response of floor 97 of WTC 1, Case B.

The west side of the core on floor 97 suffered extensive insulation damage, and this resulted in heating up of the core columns. Core columns on the east side of the core have their insulation intact and as a result stay relatively cool.

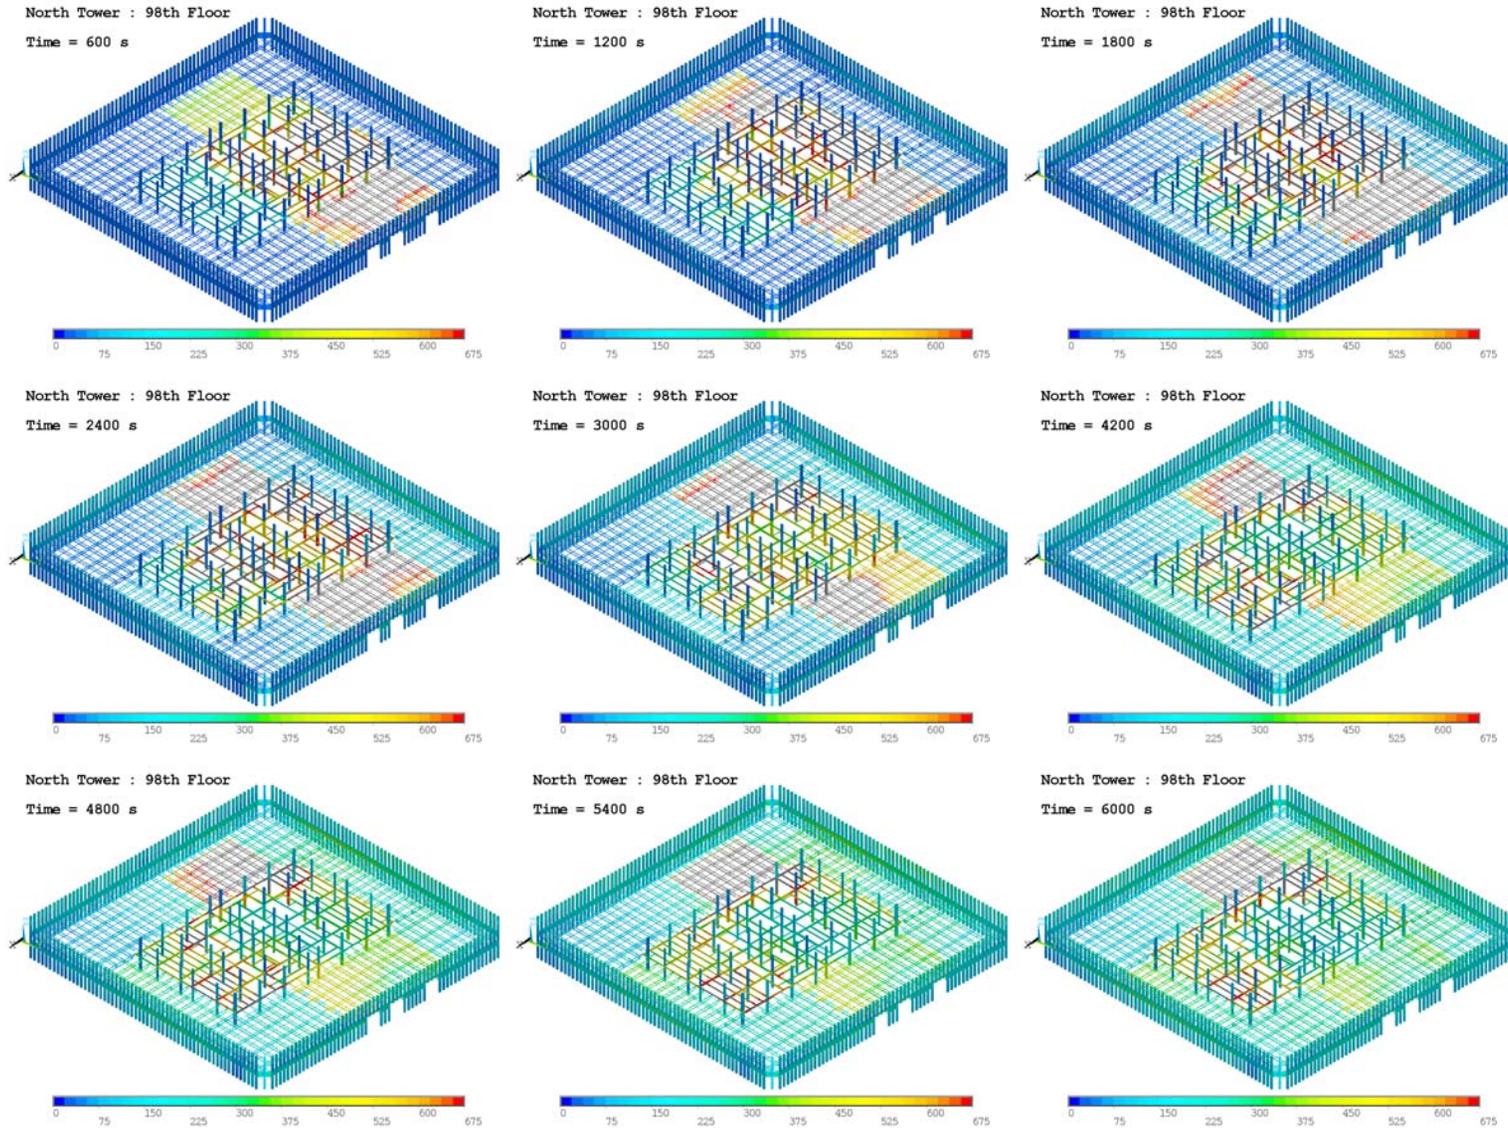
Figure 6-42. Thermal response of floor 98 of WTC 1, Case B.

For the core columns, we observe higher temperatures on the west side, because of insulation damage and fire activity in this region. Some core columns indicated very high temperature below the concrete slab and relatively low temperatures above the slab. This was due to differences in insulation status and fire activity in the immediate vicinity of these columns on floors 97 and 98.

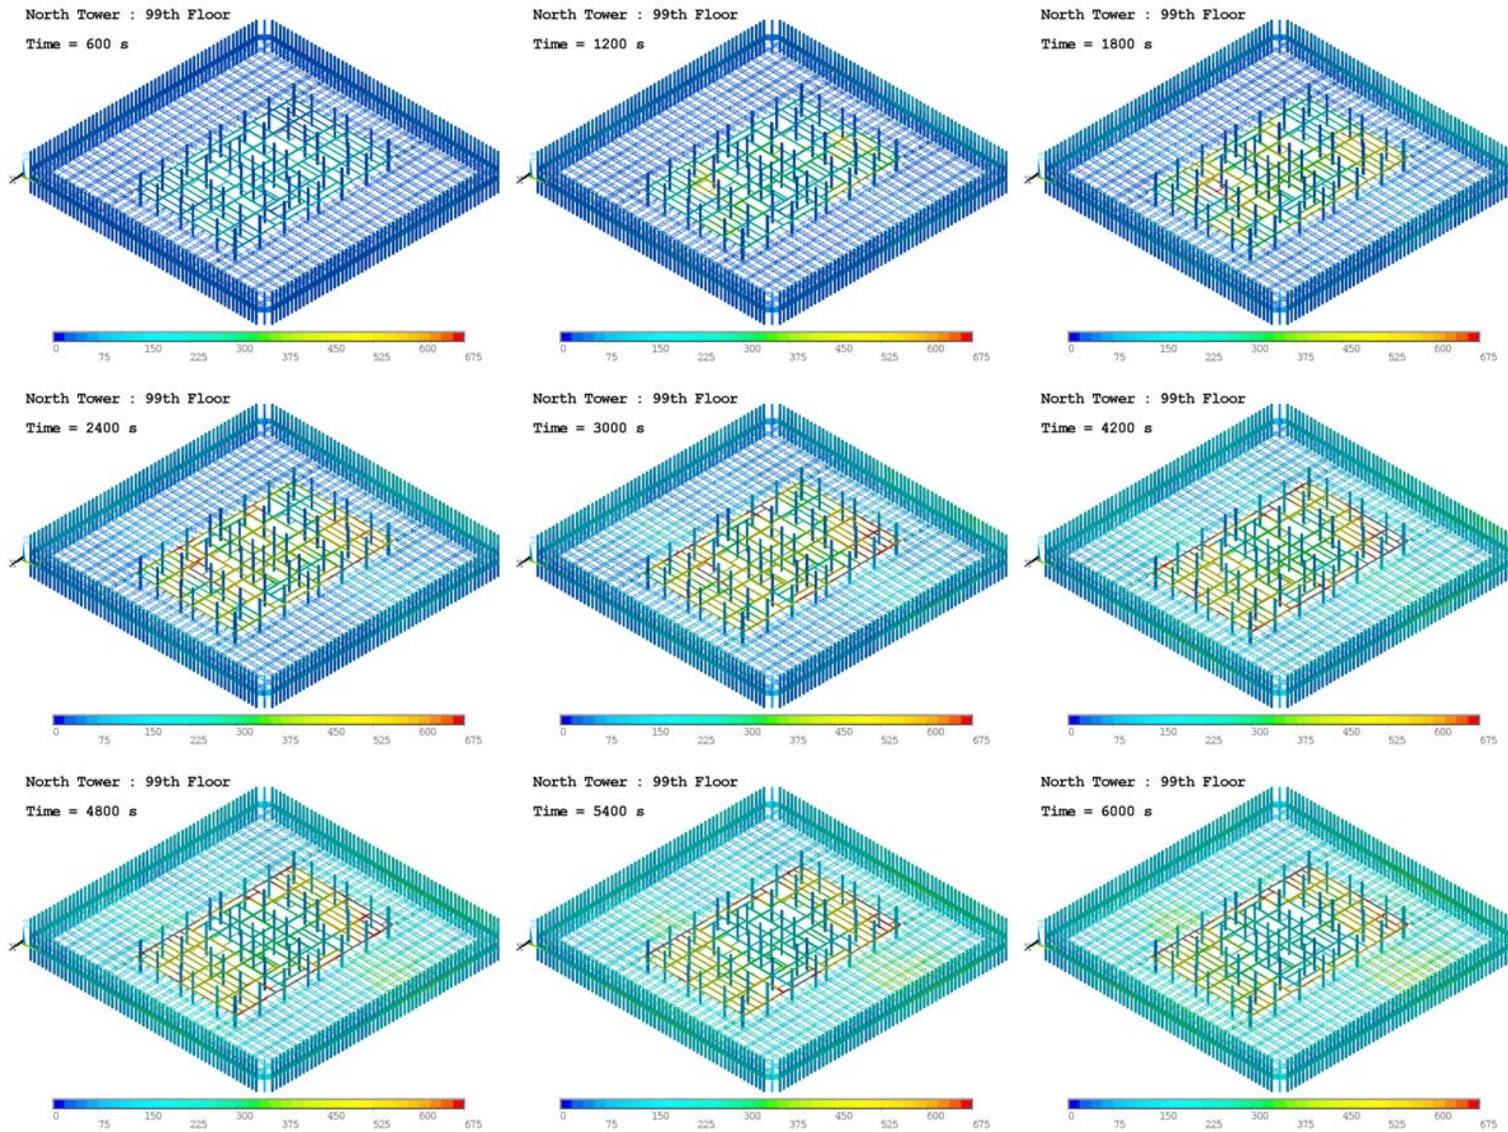
Figure 6-44. Thermal response of floor 99 of WTC 1, Case B.

There was no structural or insulation damage to the trusses, core beams, perimeter columns, or core columns. As a result, the structural temperature rises were modest.
