4. TITLE AND SUBTITLE  
SPILL PREVENTION CONTROL AND COUNTERMEASURES PLAN, FINAL REPORT

IT CORPORATION  
ENGLEWOOD, CO

84333R02

ROCKY MOUNTAIN ARSENAL (CO.)  
COMMERCE CITY, CO

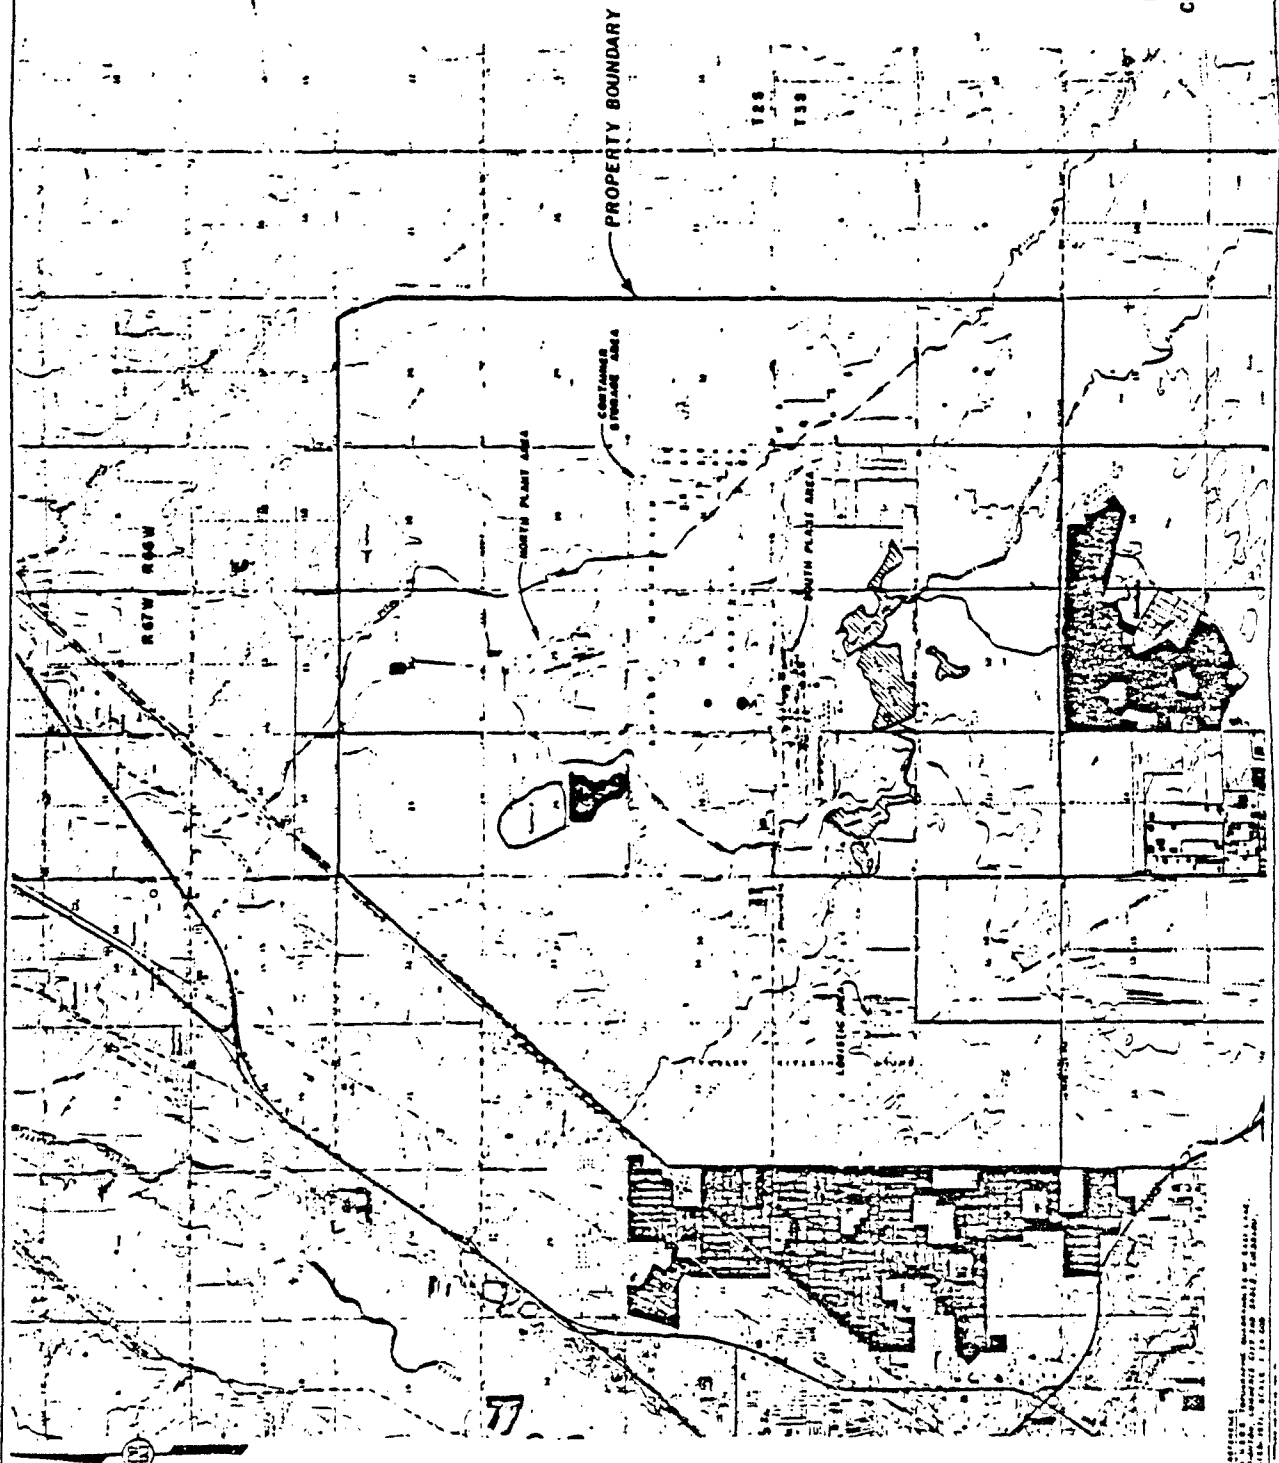
FIGURE 1

VICINITY MAP

RMA is located in Adams County, Colorado about ten miles northeast of the central business district of the City of Denver. RMA includes 17,238 acres and is bordered on the south by Denver's Stapleton International Airport, various business and warehouse districts including some city office buildings, and the residential subdivision of Montbello. The residential areas of Commerce City, Dupont, and Irondale adjoin the western boundary of RMA. Agricultural land with scattered residences is adjacent to RMA on the northwestern, northern, and eastern boundaries. One residential trailer park subdivision also adjoins the eastern boundary. A location map of RMA and the surrounding area as well as the topography is provided in Figure 1.

The local surface water drainage system in the area consists of several lakes, irrigation ditches, streams, canals, diversion ditches, storm drains, the sanitary sewer system and the South Platte River. Located in the southern section of RMA are three small lakes (Ladora, Lower and Upper Derby) with an approximate total surface area of 325 acres fed by the Highland Lateral Ditch. The principal drainages on RMA are the Sand Creek Lateral and First Creek, both of which average 10 feet wide and 2 to 6 feet deep (from the tops of the banks) with a slope of 0.002 percent. First Creek, an intermittent stream, runs from the southeast corner of RMA north-northwest toward a "bog" located at the middle of RMA's northern boundary. It then flows northwest toward the South Platte River. The Sand Creek Lateral runs from Lower Derby Lake to the north, draining into First Creek approximately 1,000 feet south of RMA's northern boundary. The lakes are drained by Sand Creek Lateral and also by Irondale Gulch which runs to the west and then the north. Irondale Gulch ends in a low point along the northwest RMA boundary. See Figure 1 for drainage systems at RMA.

A detailed description of each tank included in the SPCC Plan including the tank features discussed in Section 3.1 is presented in this section. The tanks are grouped by the areas in which they are located. These areas are the Logistic Area, North Plant Area, Container Storage Area and South Plant Area. Figure 1 presents an overall RMA location map. Figures 2, 3, 4 and 5 indicate the specific tanks included in the SPCC Plan in the four areas listed above, respectively.

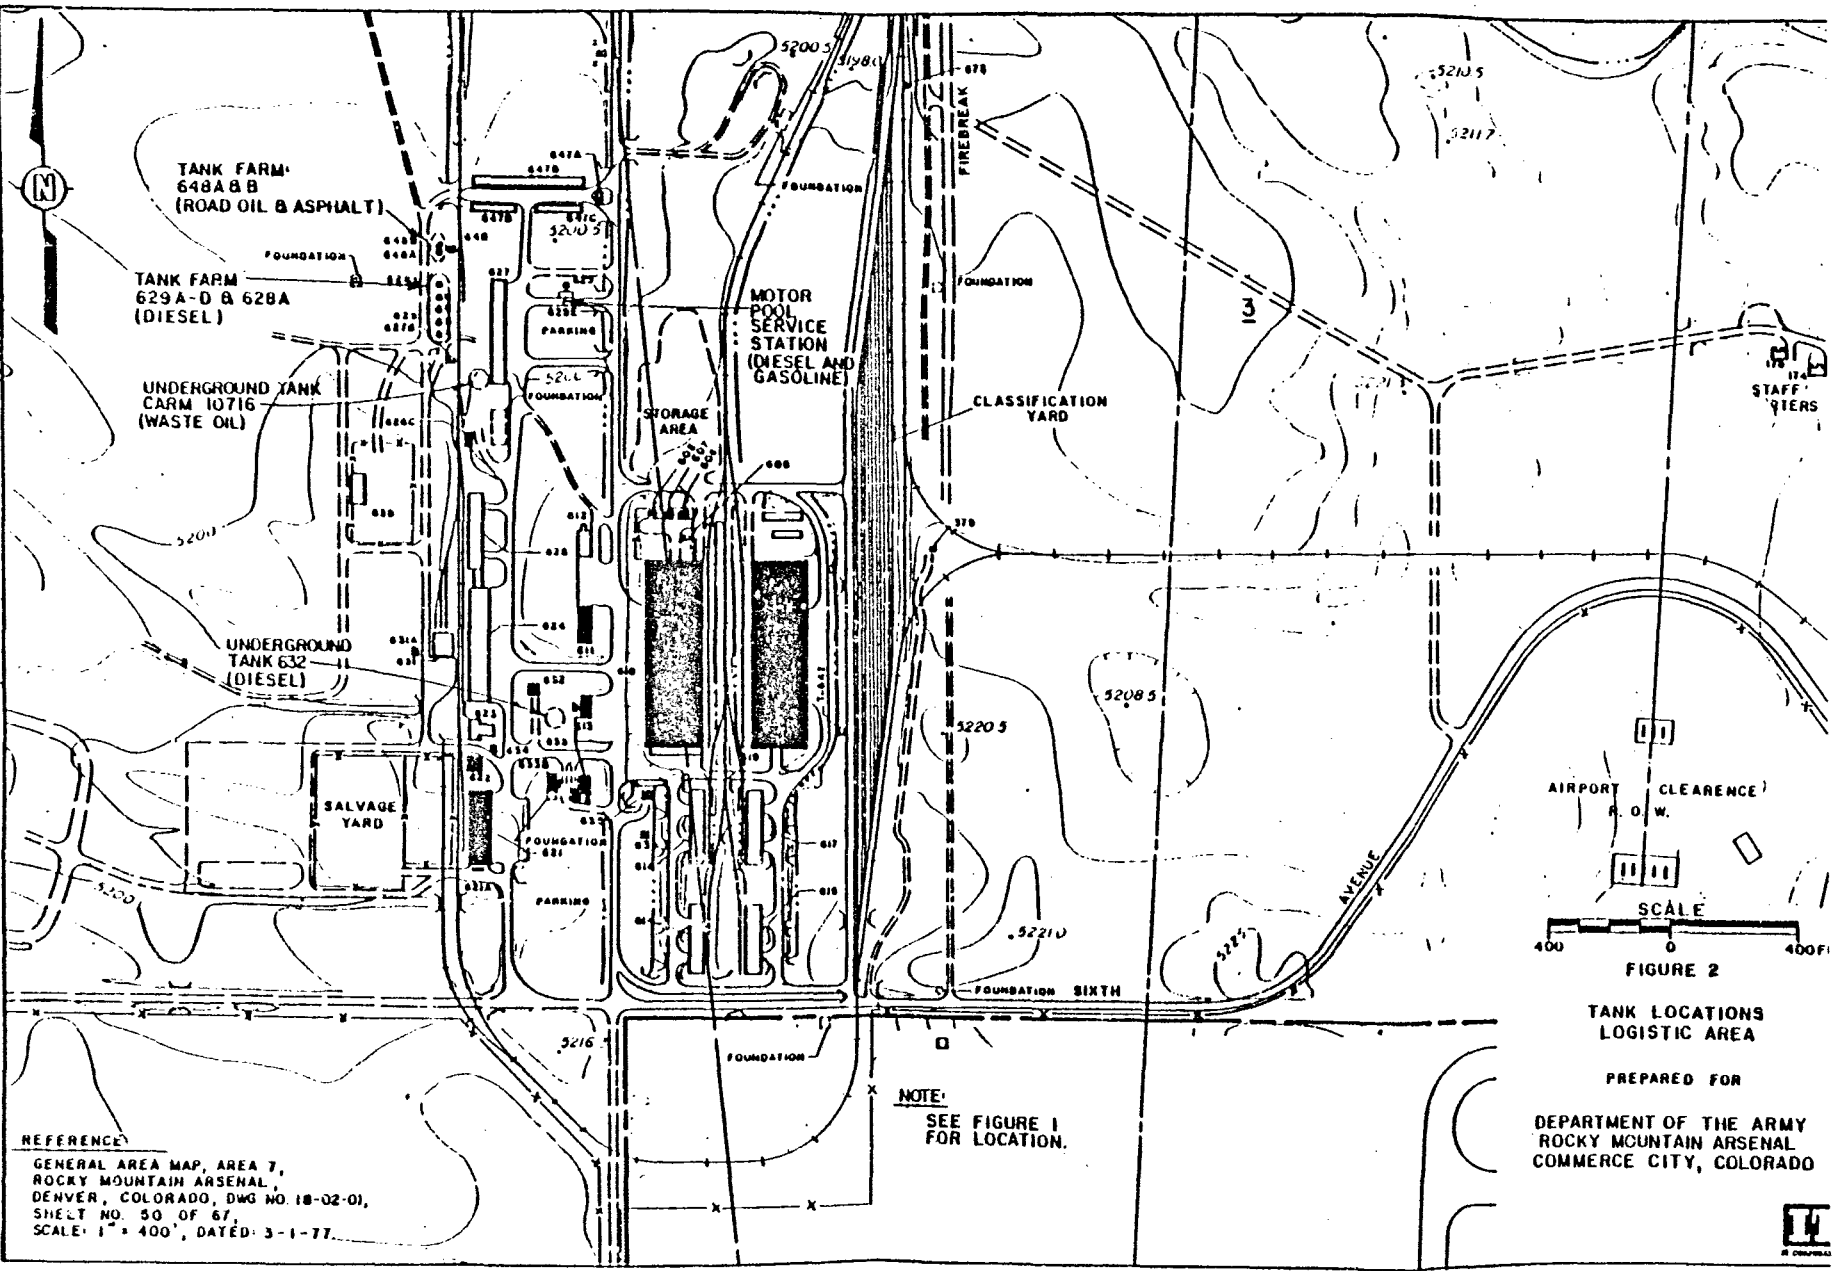
**REFERENCE**  
 GENERAL AREA MAP, AREA 7,  
 ROCKY MOUNTAIN ARSENAL,  
 DENVER, COLORADO, DWG NO. 18-02-01,  
 SHEET NO. 50 OF 67,  
 SCALE: 1" = 400', DATED: 3-1-77.

**NOTE:**  
 SEE FIGURE 1  
 FOR LOCATION.

The Logistic Area is located in the southwest portion of RMA (see Figures 1 and 2). The tanks discussed in the following sections are located within this area.

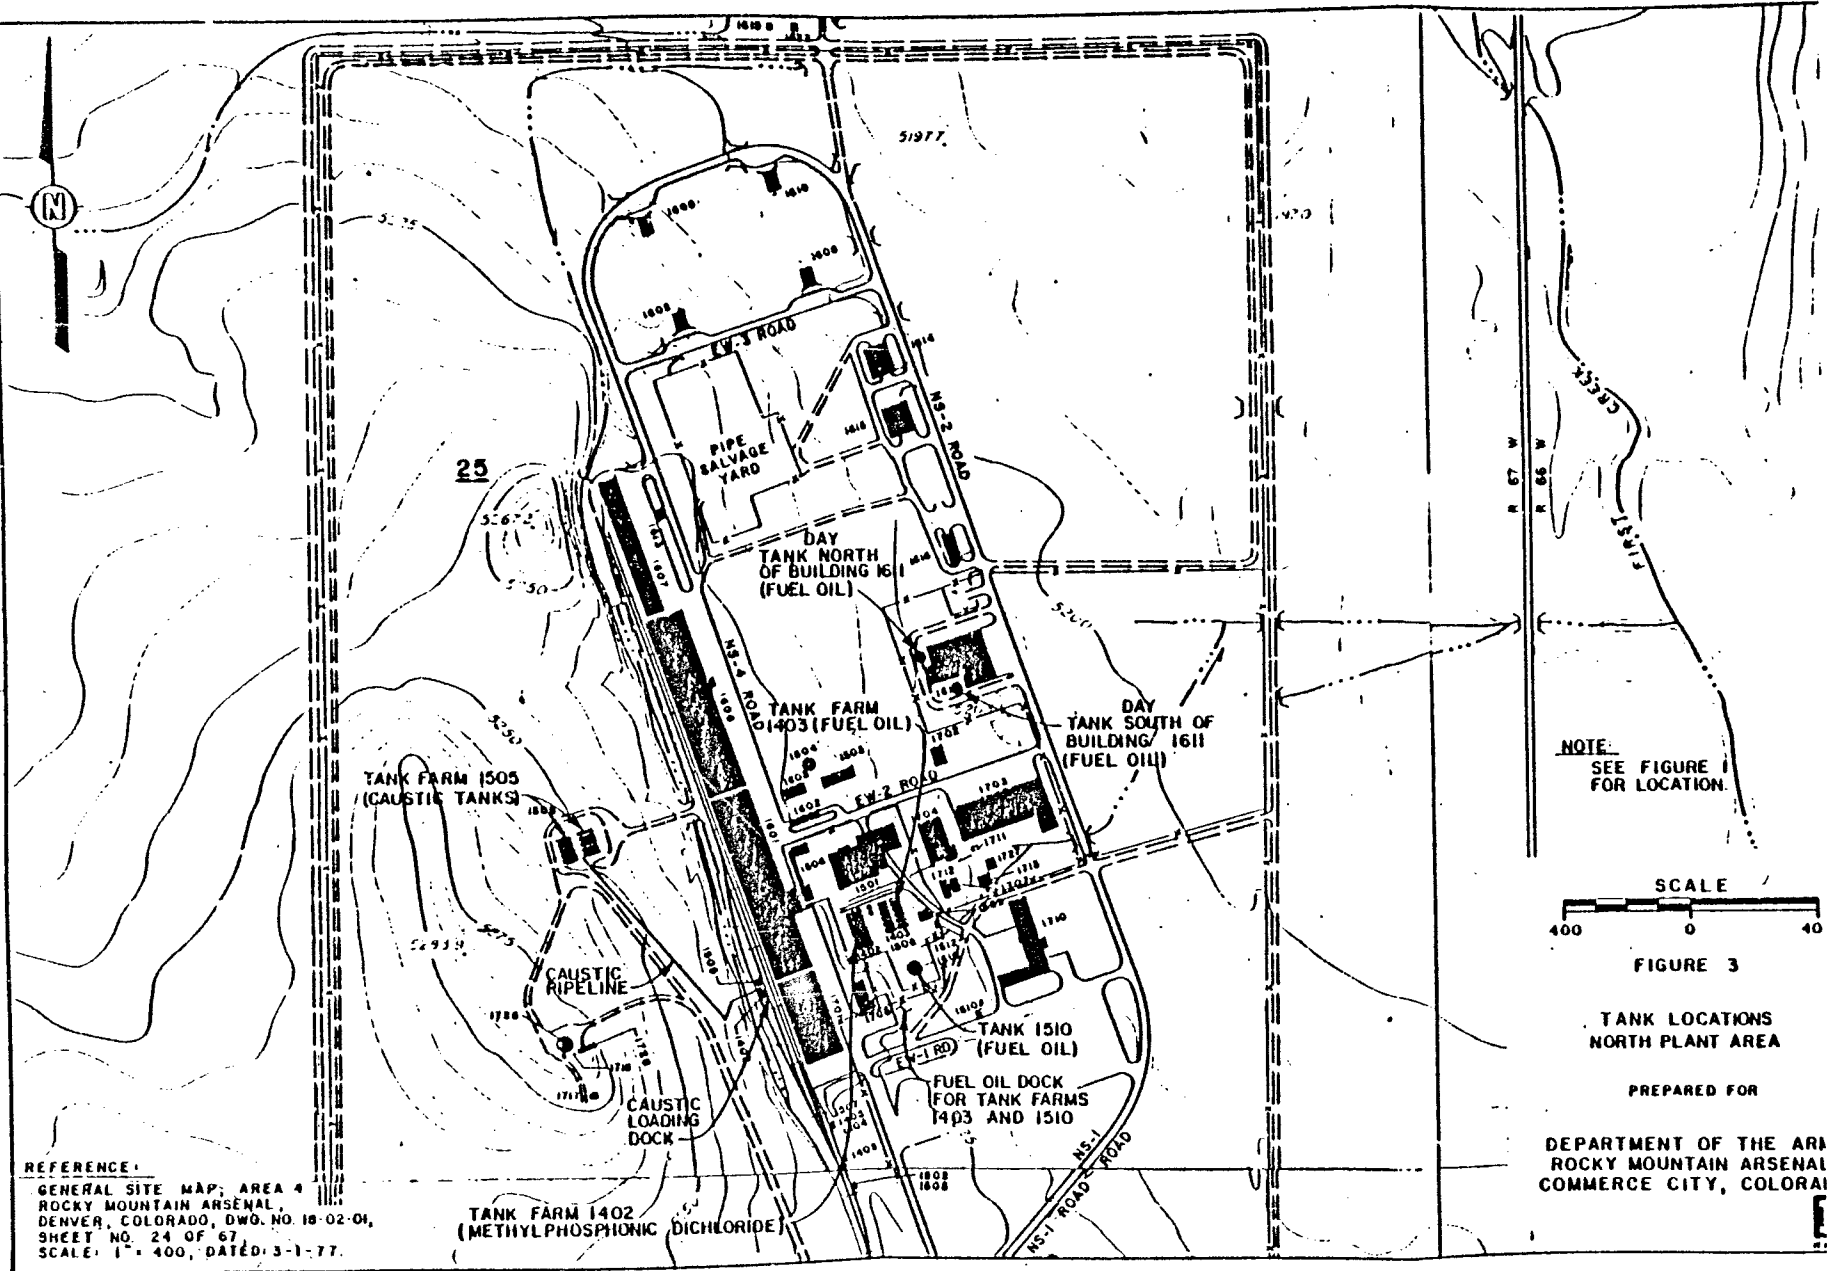
REFERENCE:  
GENERAL SITE MAP, AREA 4  
ROCKY MOUNTAIN ARSENAL,  
DENVER, COLORADO, DWO. NO. 18-02-01,  
SHEET NO. 24 OF 67  
SCALE: 1" = 400', DATED: 3-1-77.

NOTE:  
SEE FIGURE 1  
FOR LOCATION.

The North Plant Area is located in the north central portion of RMA (see Figures 1 and 3). The tanks discussed in the following sections are located in this area.
