NEWS BRIEFING

Secretary of Defense William J. Perry
General John Shalikashvili, USA, Chairman of the Joint Chiefs of Staff
Major General James Andrus, USAF, 3rd Air Force Commander
Ms. Kathleen M. deLaski, ATSD (PA)
Wednesday, July 13, 1994 - 2:15 p.m.

We are here today to present you with the findings of the Department into the circumstances surrounding the tragic incident in Northern Iraq in which two of our fighters accidentally shot down two of our helicopters.

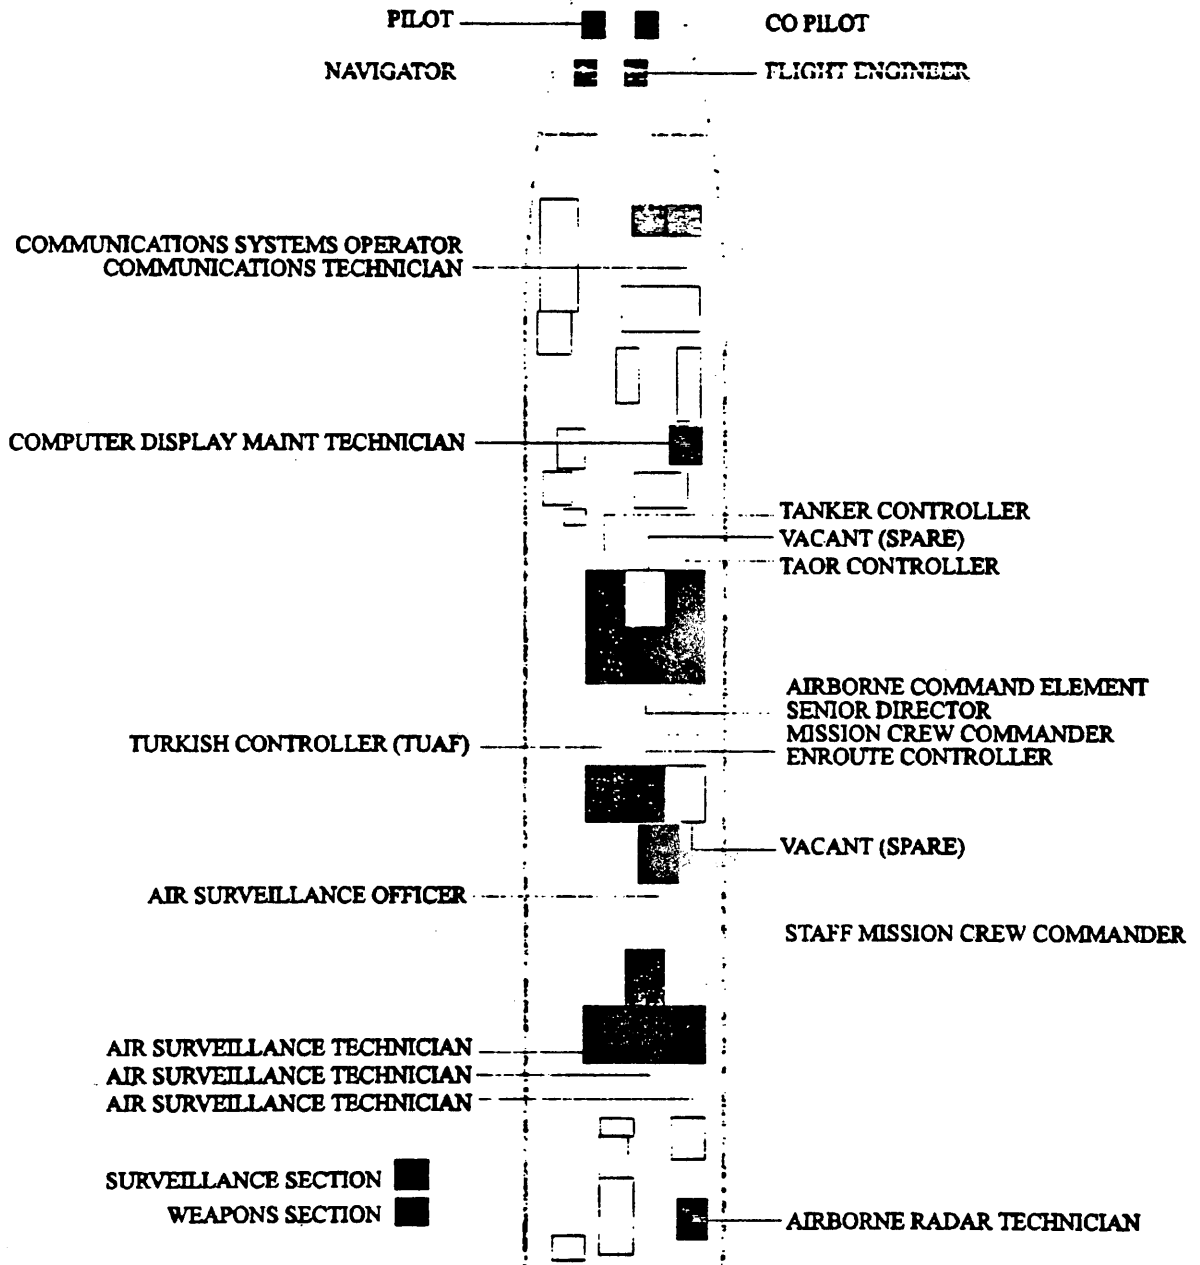
Figure 2 (AWACS Layout)

E-3B AWACS

The airborne command element (ACE) is also on board. He is the CFACC's representative and works directly with the mission crew commander and SD. CTF PROVIDE COMFORT OPLAN 91-7 provides that, "An airborne command element (ACE) will be aboard [AWACS] to serve as the representative of the CFACC for time critical decisions."⁶¹ CFAC operating instructions for the ACE provide that the ACE will act as the "eyes and ears" of the CFAC DO in the execution of the combat operations. They provide that the ACE has primary responsibility for the mission outside of a 50 NM circle of Incirlik, but emphasize that reference should be made to the CFAC DO. They imply that actions required for emergency or unsafe conditions can be taken by the ACE, who would then contact the CFAC DO as soon as possible.⁶² The CFACC, in his testimony, stated that the ACE had no decision-making authority.⁶³
