### Cleanup of Johnston Atoll missile launch facility

AFRRI TR88-1

THE DAMASCUS MISSILE MISHAP

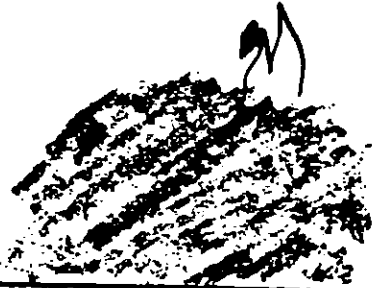
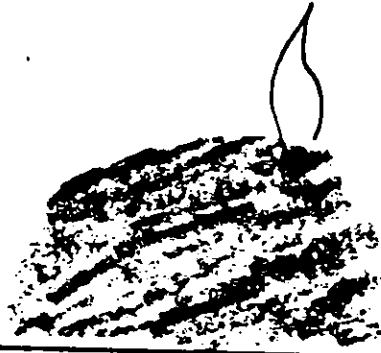
T+0 SEC  
DIFFUSION FIRE

2000' EAST OF SILO  
(OBSTRUCTION BY 30' TREE)

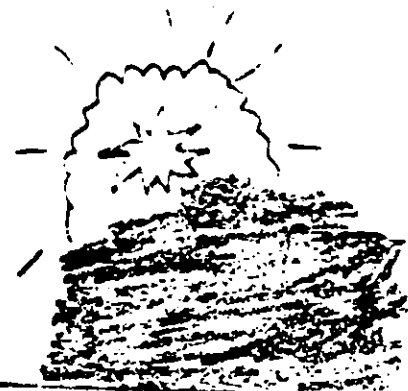
T+4.5 SEC  
SECOND LARGE EXPLOSION

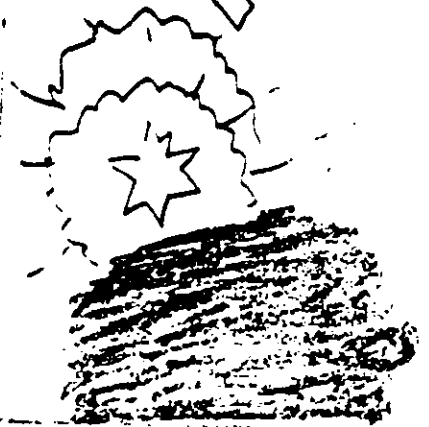
T+4.6 SEC FIREBALL

SILO COVER DOOR → T+4.6 SEC

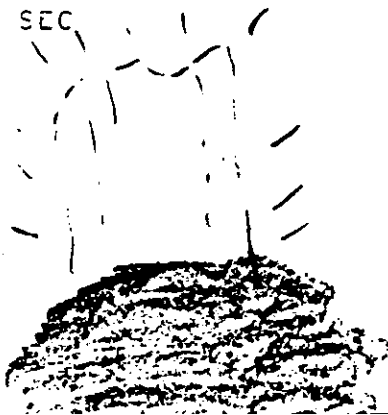
T+5.0 SEC

FLAME AND  
THIRD  
EXPLOSION  
T+5.0 SEC
