NIST NCSTAR 1-2

**Federal Building and Fire Safety Investigation of the
World Trade Center Disaster**

Baseline Structural Performance and Aircraft Impact Damage Analysis of the World Trade Center Towers

September 2005

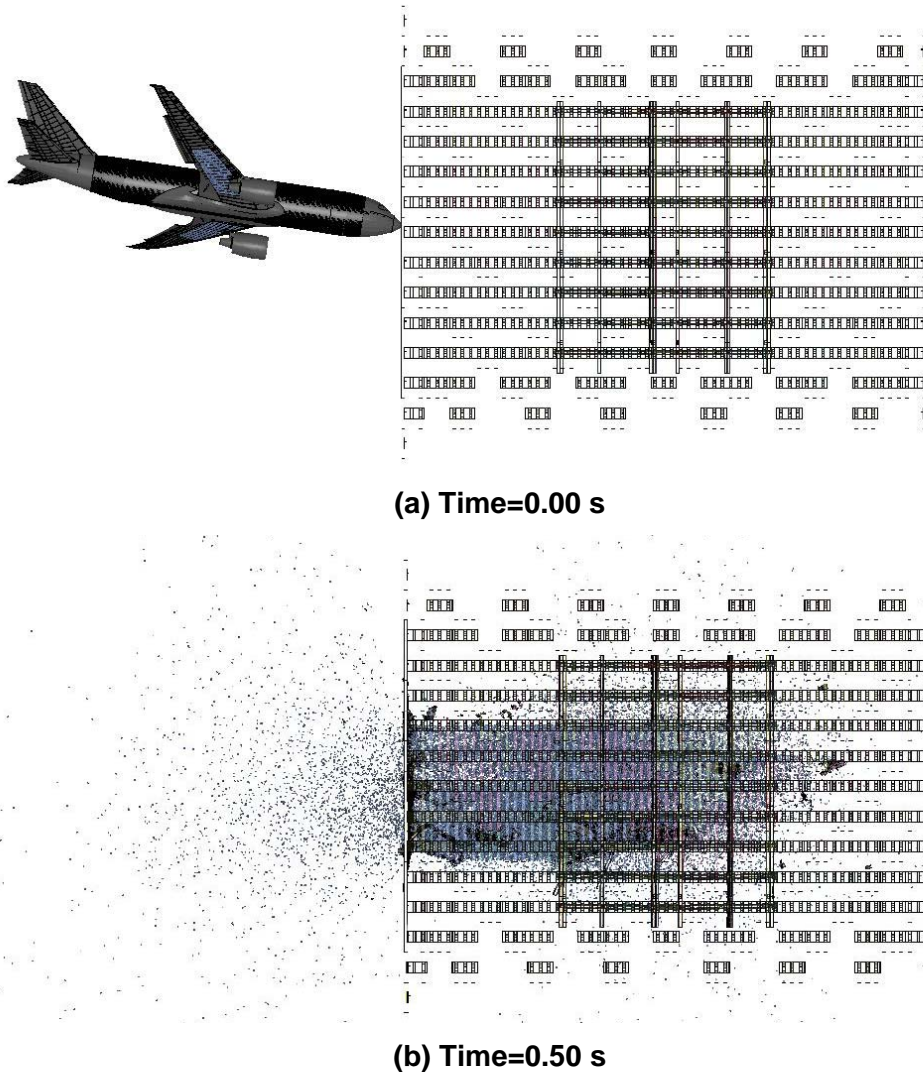
structures in half. The downward trajectory of the aircraft structures caused the airframe to collapse against the floor, and the subsequent debris motion was redirected inward along a more horizontal trajectory parallel to the floor. The downward trajectory of the aircraft structures transferred sufficient vertical load such that the truss floor structures on the 95th and 96th floors collapsed in the impact zone.

Figure E-26. WTC 1 base case global impact analysis – side view.

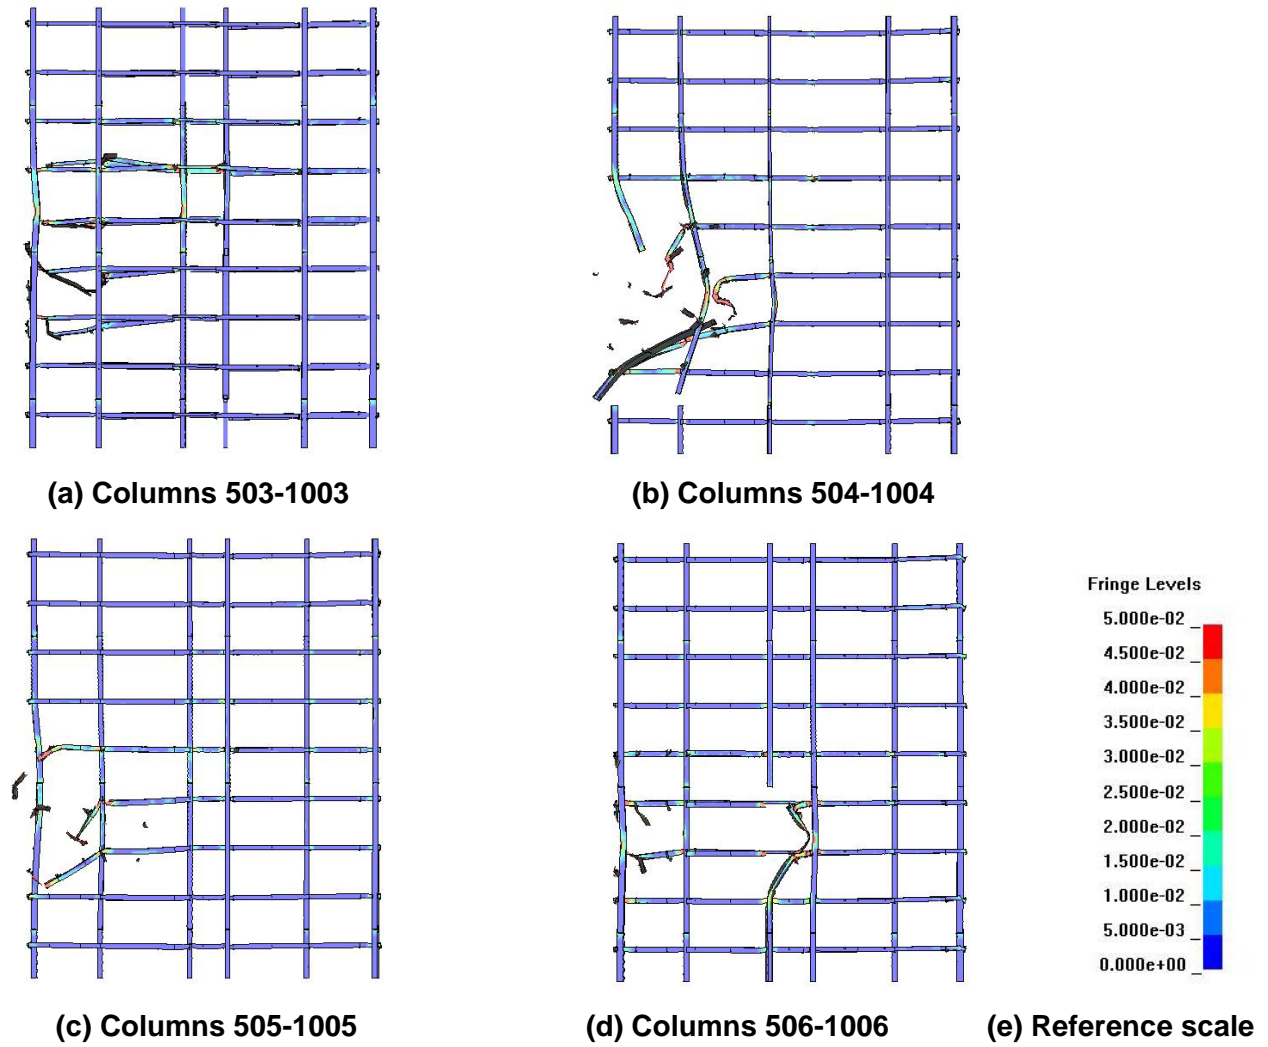
Figure E-29. Base case impact damage to the WTC 1 core columns.

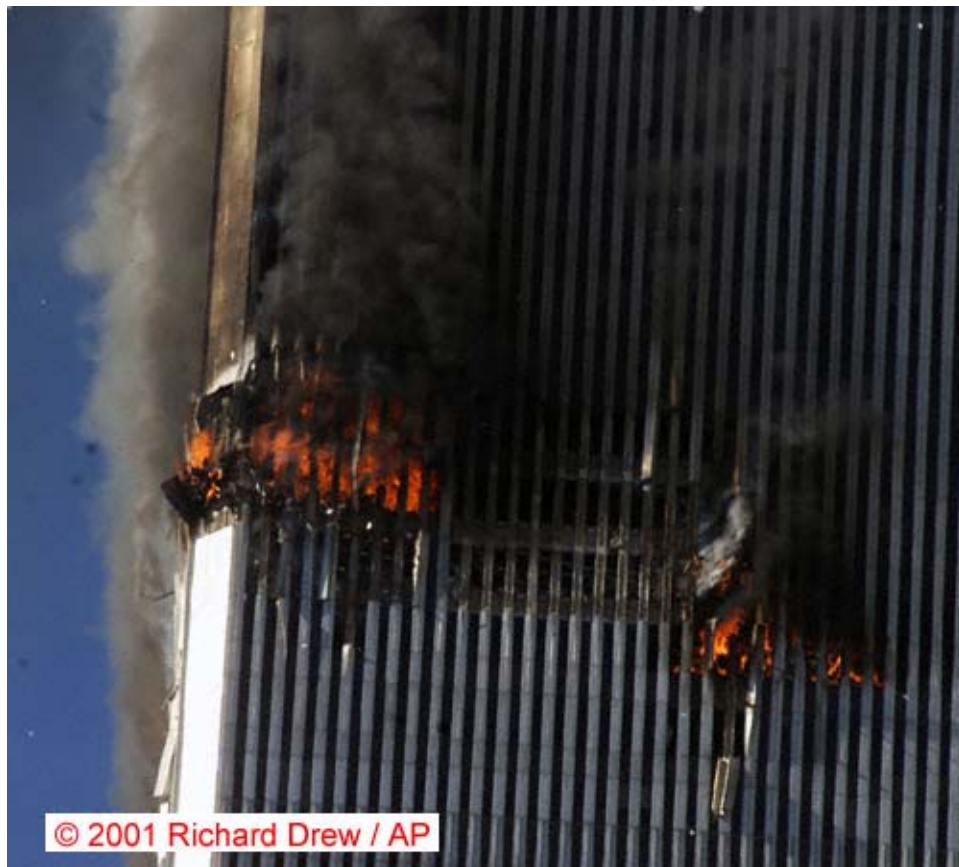
Figure 7–74. Impact damage to the northeast corner of the exterior wall of WTC 2.
