USAF Nuclear Safety

AFRP 122-1 JAN/FEB/MAR 1970, NO. 1

VOLUME 65 (PART 2) SPECIAL EDITION

PROJECT CRESTED ICE

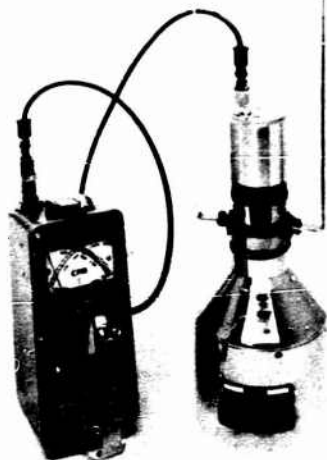
FIDLER

The most significant aspect of radiological monitoring at Thule was the use of a gamma detector, the FIDLER, for area survey. Undoubtedly, the addition of this instrument to our kit represents a sizable contribution to the tools of the trade; however, there will always be a requirement for alpha survey meters such as the PAC-1S for equipment and personnel monitoring.

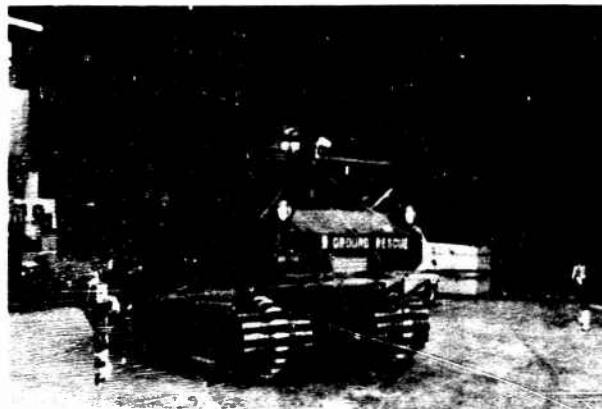
SPA-3 probes on the weasel.

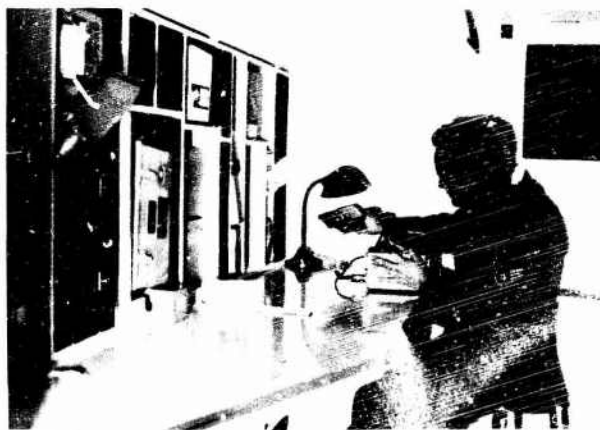
Inside the air-transportable radiac package.

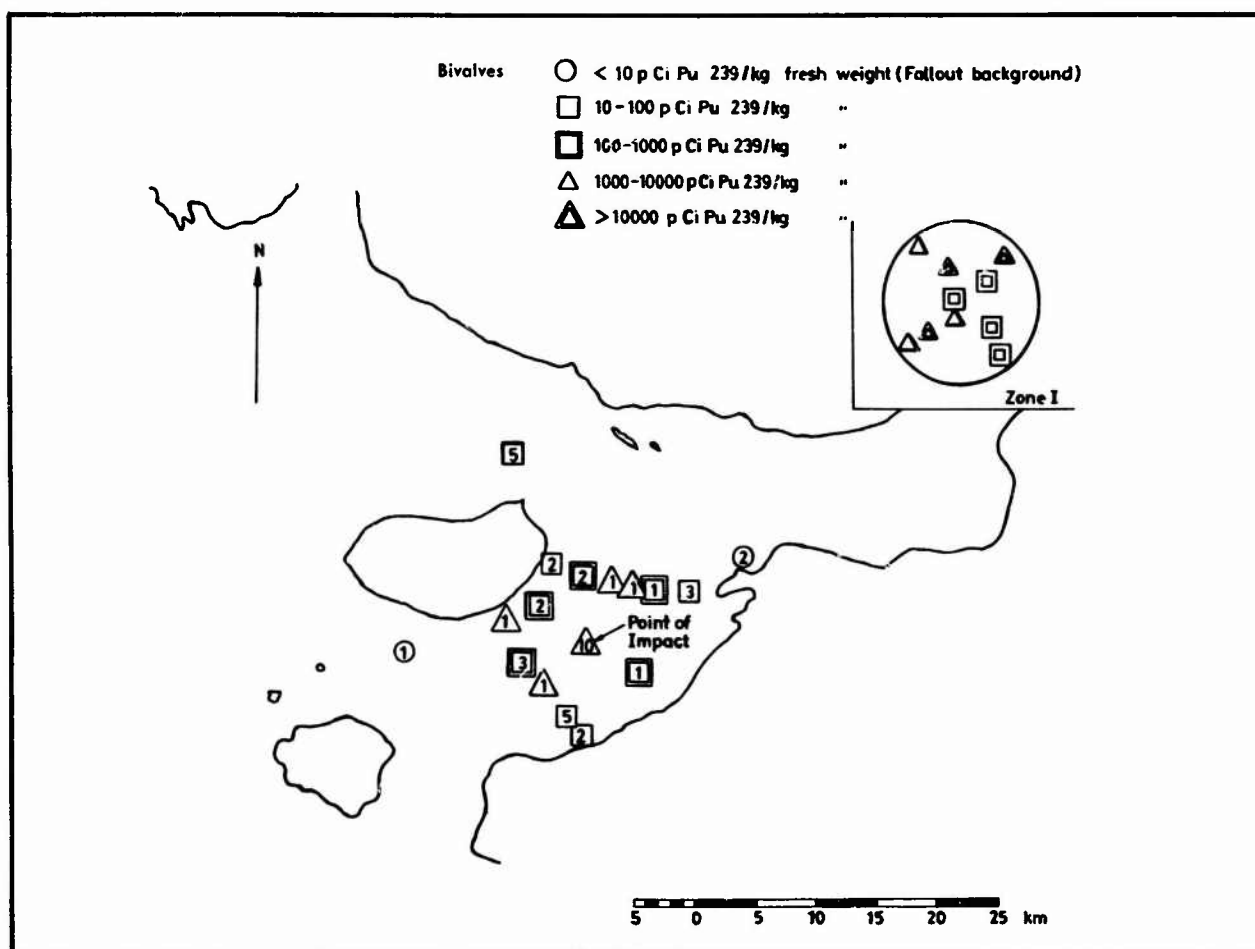
Figure 8 Pu 239 levels in bivalves. The numbers refer to the number of samples analyzed from each location.

• **Crustacea.** Eight samples of *Crustacea* caught during trawling on the outskirts of Zone I were analyzed. Some samples were divided into flesh and shell. The median level of the total animal samples was 1,900 pCi Pu 239/kg fresh weight. The median levels of the flesh and the shell samples were 95 and 330 pCi Pu 239/kg respectively. The maximum level for *Crustacea* samples was 12,000 pCi Pu 239/kg total animal. Shells normally contained more Pu 239 than did flesh. As these *Crustacea* are bottom animals, it is believed that most of their plutonium content was particles incorporated from the bottom sediments. Samples of *Crustacea* from southwest Greenland contained 3 pCi Pu 239/kg, and samples

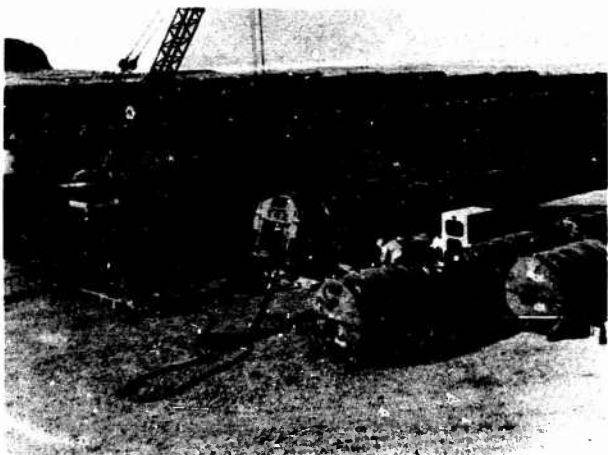
TANK FARM. Pump-transfer crews prepared to pump melted snow water from the large 25,000-gallon tank to small containers to facilitate shipping the residue to the U.S.

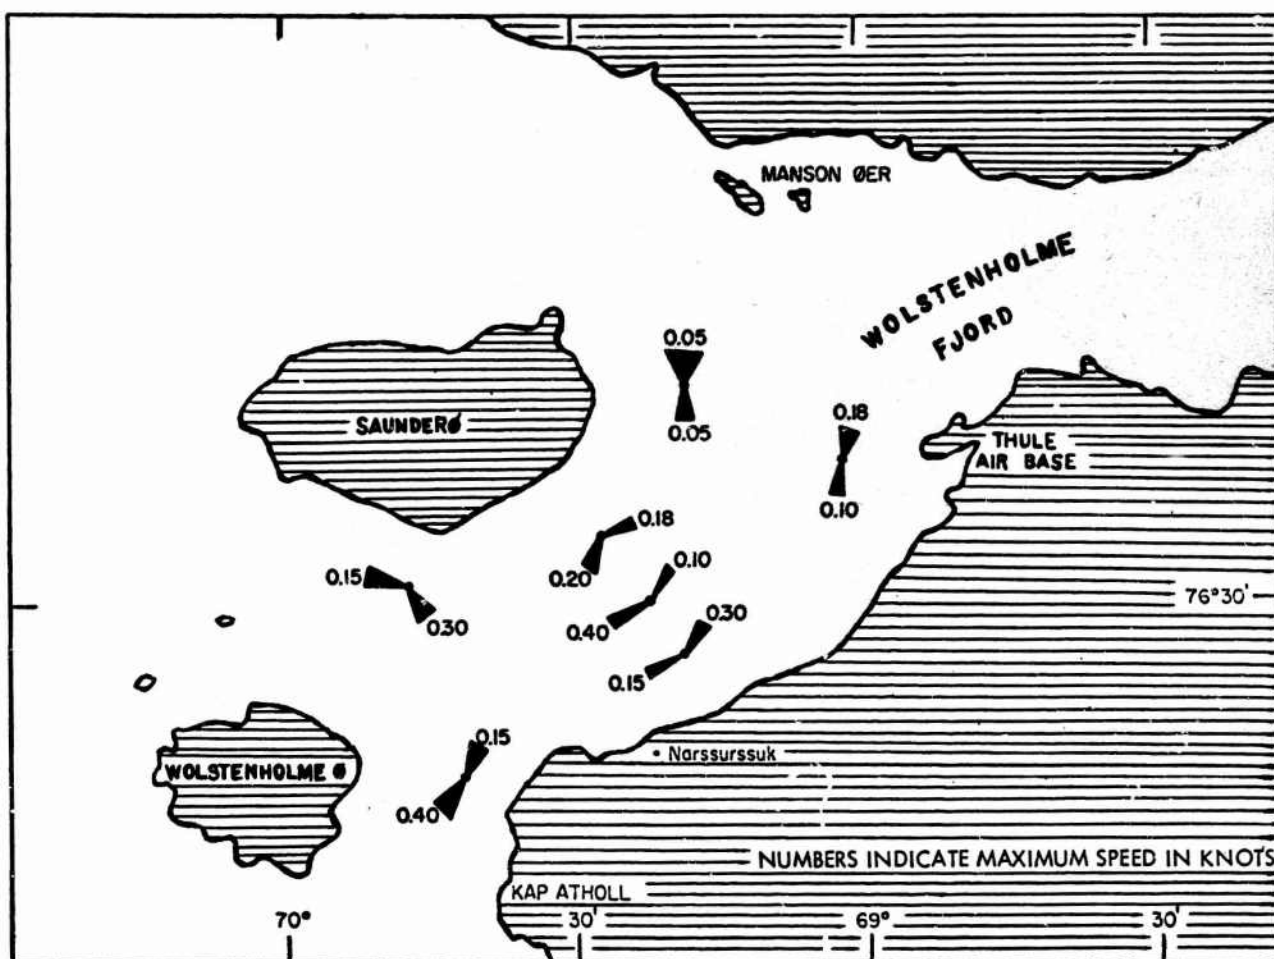
Figure 2. Summary of current data.
