**JEFFERSON MEMORIAL
NATIONAL MALL & MEMORIAL PARKS
WASHINGTON, DC**

CONTRACT # 1443C2000040800
REPAIR AND CONTROL SETTLEMENT AT JEFFERSON
MEMORIAL SEAWALL, NORTH PLAZA, AND TRANSITION
AREAS
PMIS NO. 128232

SUPPLEMENTAL DOCUMENTS

NATIONAL PARK SERVICE
DENVER SERVICE CENTER
April 2, 2009

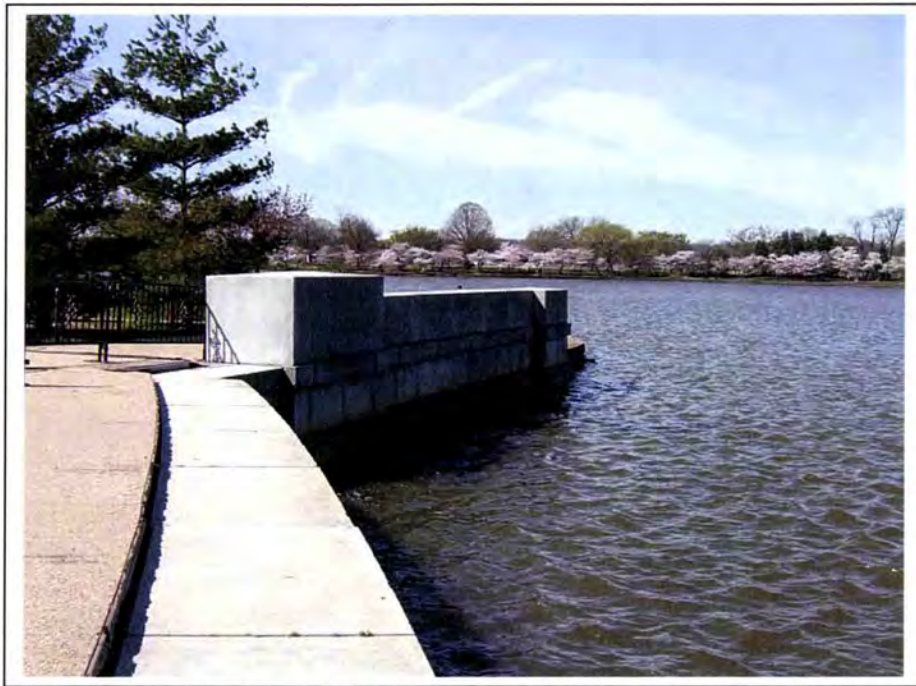
The wall is comprised of 10 wall segments separated by joints. At the joints between wall segments, the capstones of the Ashlar Seawall are displaced with respect to each other, indicating relative movement and/or rotation between the seawall segments. Figures 2 and 3 are photos of the Ashlar Seawall and North Plaza interface.

Figure 2. View Standing on the Ashlar Seawall Looking West (3-29-07)

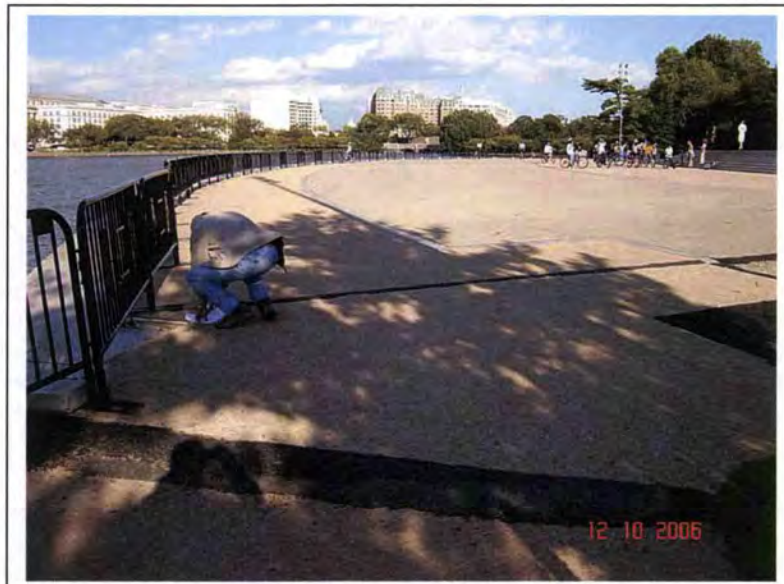
The walkway joins the North Plaza through a roughly triangular-shaped segment of exposed aggregate concrete. The foundation for this triangular wedge is unknown. The HNTB report from 2008 indicates the existence of a significant void underneath this area. It is possible that this triangular wedge is supported on piles or that it is partially bearing on the walkway grade beam and on the North Plaza foundation. The triangular wedge is experiencing settlement, but at a lesser rate than the slab-on-grade Circular Roadway. Figure 7 shows the triangular wedge bounded by asphalt patches.

Figure 7. Standing on West Approach Walk and Looking at Triangular Wedge (10-12-06)

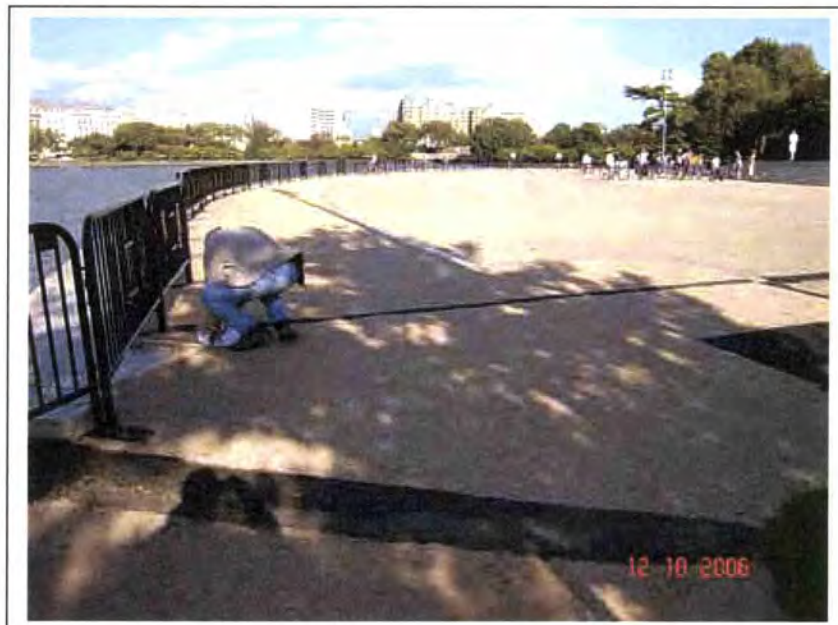
The walkway joins the North Plaza through a roughly triangular-shaped segment of exposed aggregate concrete. The foundation for this triangular wedge is unknown. The HNTB report from 2008 indicates the existence of a significant void underneath this area. It is possible that this triangular wedge is supported on piles or that it is partially bearing on the walkway grade beam and on the North Plaza foundation. The triangular wedge is experiencing settlement, but at a lesser rate than the slab-on-grade Circular Roadway. Figure 6 shows the triangular wedge bounded by asphalt patches.

Figure 6. Standing on West Approach Walk and Looking at Triangular Wedge (10-12-06)

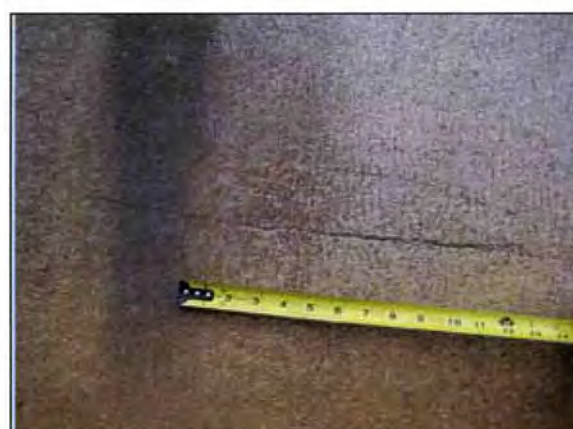
BLOCK 19A

Minor cracks consisting of a maximum width of ½ inch and a varying length of 6 to 18 inches were observed on Blocks 19A, 20A, 33A, and 91A. Spalling was observed on Blocks 13A, 14A, 29A, 55A, 85A, 27B, 29B, and 81B. A significant crack with spalling exists at Block 33B, where the spalling width is 2 inches and the height is 13 inches. This block will require special measures for handling during removal and replacement. Photos of the deposits, cracks, and spalls are included in Appendix A. Sketches, notes, and Schmidt hammer values are included in Appendix B.

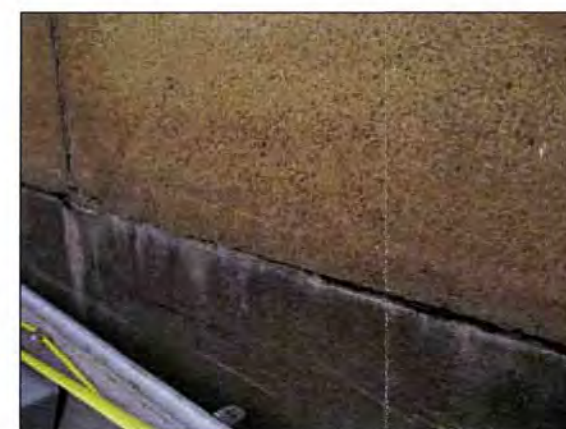
BLOCK 24B

The Ashlar Seawall capstones and Ashlar facing stones appeared to be in generally good condition. The facing stones in the top row were on average 65 in. long and 40 in. high, and 70 in. long and 40 in. high in the bottom row. Light colored deposits (stains) were observed along the entire seawall that seem to be caused by leaching of the seawall concrete through the joint between the capstones and the upper facing blocks. These deposits are more significant at Section 8. As discussed in previous design documents, this section has rotated toward the Tidal Basin. It is not clear whether the staining and rotation are related or not. Deposits and/or discoloration were also observed on Blocks 4A, 5A, 6A, 7A, 38A, 39A, 50A, 52A, 24B, 55B, and 69B.

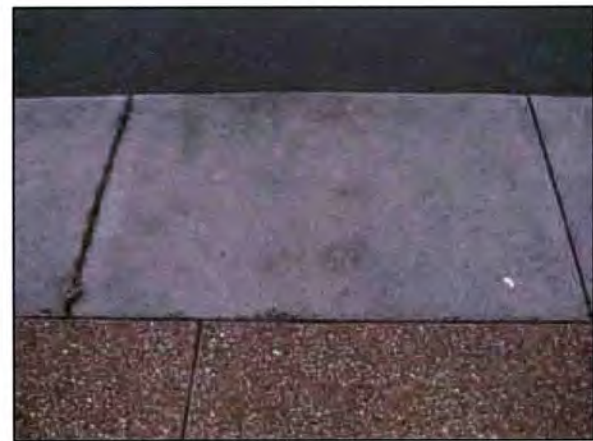
CAPSTONE 47

Comments	Sketch
Capstone 45		
Capstone 46		
Capstone 47	Damage at corner of block (See photo and sketch)	
Capstone 48

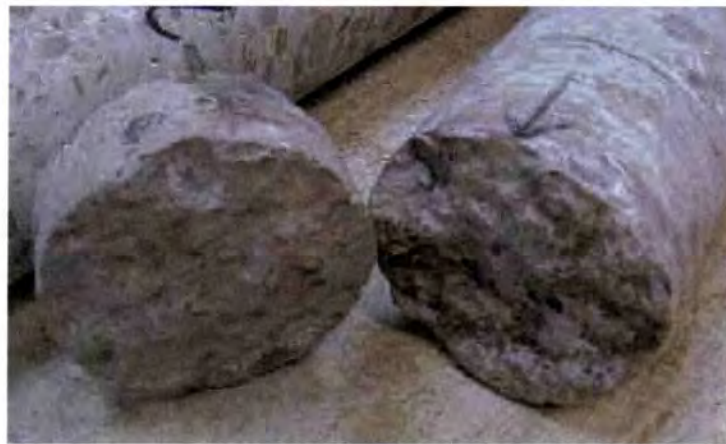
Photo 3: Core 1, Segments 9 and 10 - Cross section of break.

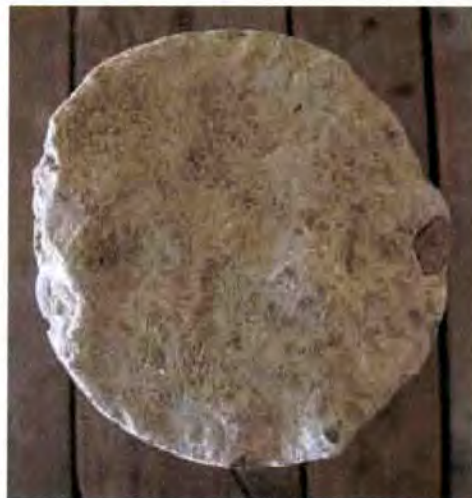
Photo 15: Core 3, Segment 7 - Evidence of wearing across joint.

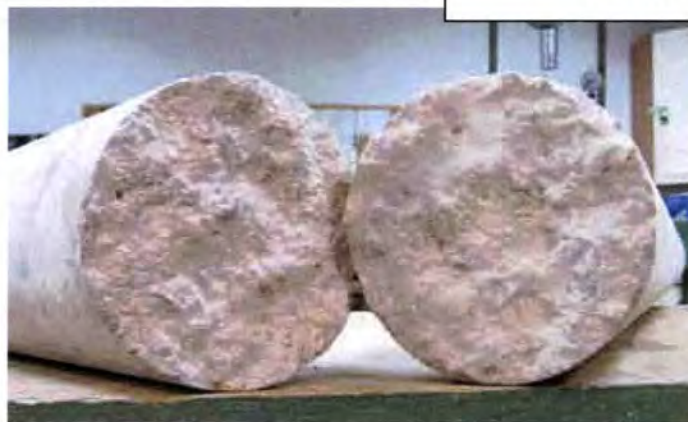
Photo 23: Core 4, Segments 7 and 8 - Cross section of break shows evidence of wearing.

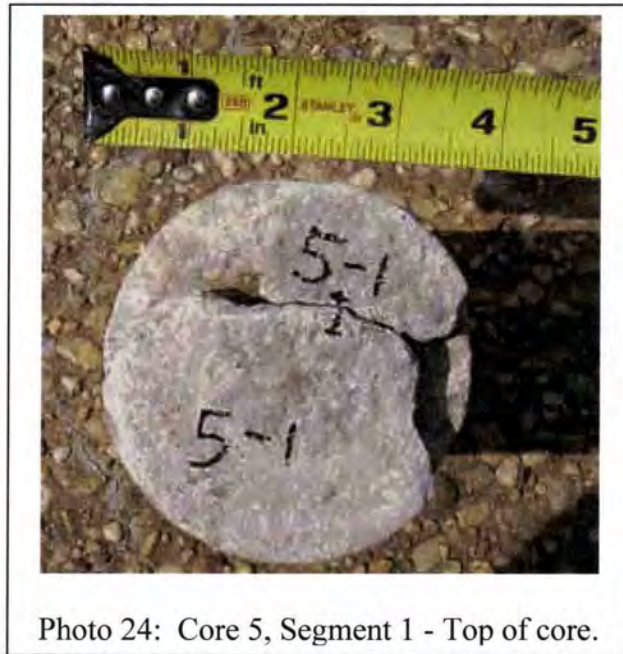
Photo 24: Core 5, Segment 1 - Top of core.

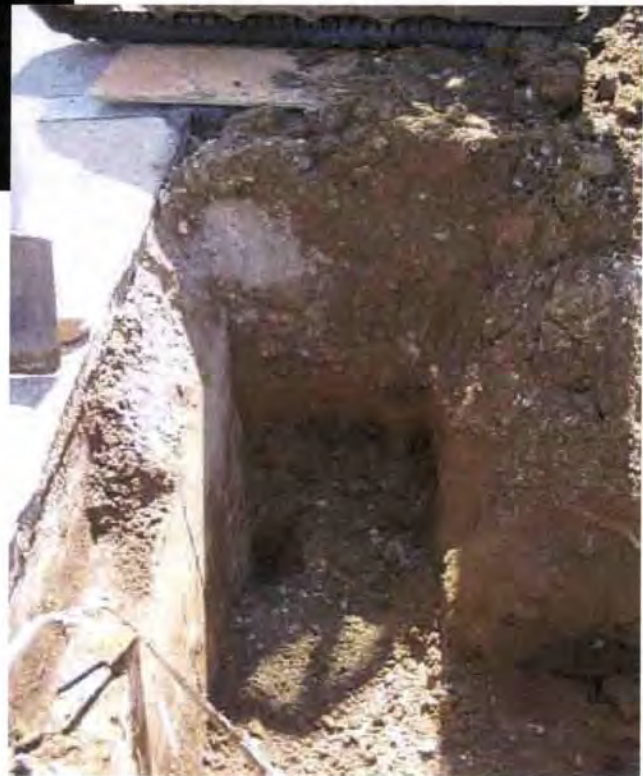
A two to three inch void and loose soils were observed below the grade beam adjacent to the north plaza (See Photos 3 and 5). Ground-Works personnel were able to easily push the handle of a shovel about 14 inches into the loose, moist soil below the grade beam. The concrete plaza slab above the grade beam was about 13-inches thick. The grade beam stuck out 5.5 inches beyond the slab joint as shown in Photos 6 and 7. No bond breaker was observed between the slab and the beam.

PHOTO 5 – Void below
eastern grade beam

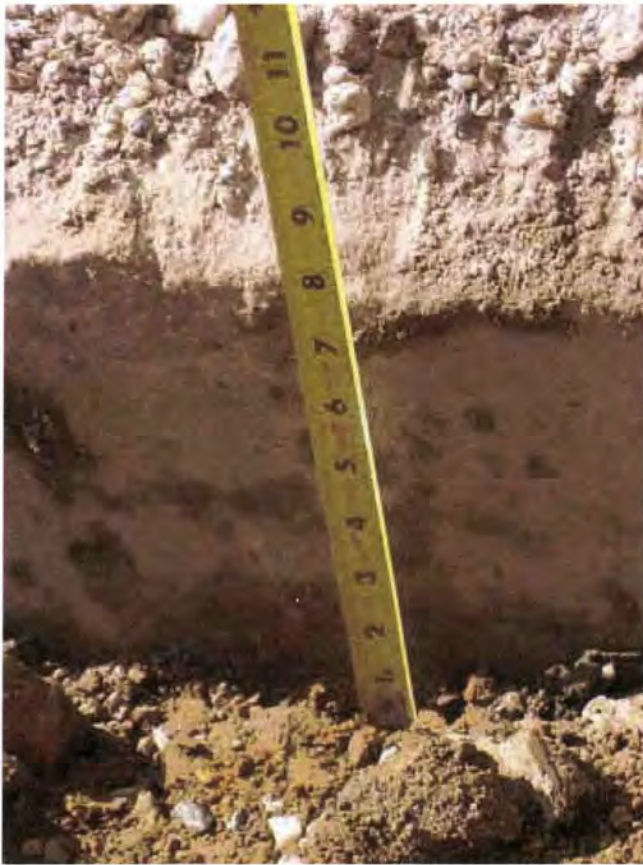
Test Pit #2 was excavated to a depth of about four feet exposing an approximate 3'-2" grade beam as shown in Photo 16. The six-inch concrete slab was removed. The slab contained reinforcing bar running from the northern slab towards the south, but terminating before the granite pavers and running from the eastern slab towards the west, also terminating before the granite pavers (See Photo 17). Soils encountered were brown silty sand with cobbles and green-gray clay with cobbles and brick fragments. The concrete slab above the grade beam was about eight-inches thick, and the beam stuck out about six inches beyond the slab joint as shown in Photos 18 and 19. No bond breaker between the slab and the beam was observed.

PHOTO 18 – Concrete slab
above grade beam

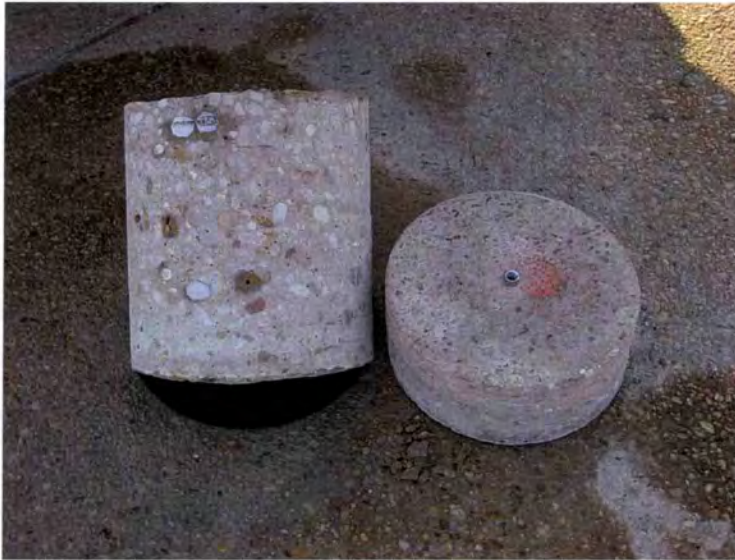
Schnabel personnel cored the concrete slab of the North Plaza in order to advance Boring JMI-05; the core was about 18-inches thick. During observation of the core hole, a void of about one inch was observed beneath the bottom of the North Plaza slab. The void is documented in Boring JMI-05, located in Appendix A.

PHOTO 1: JMI-05 18-inch core
