Sweeney, Christopher J (ISI), 07:39 AM 2/3/2003, Thoughts and Prayers

Howard M. Adelman, 01:13 PM 2/3/2003, Response to questions about Columbia

Date: Wed, 12 Feb 2003 13:48:15 -0500
To: r.h.daugherty@larc.nasa.gov
From: "Katherine A. Barnstorff" <k.a.barnstorff@larc.nasa.gov>
Subject: Associated Press article

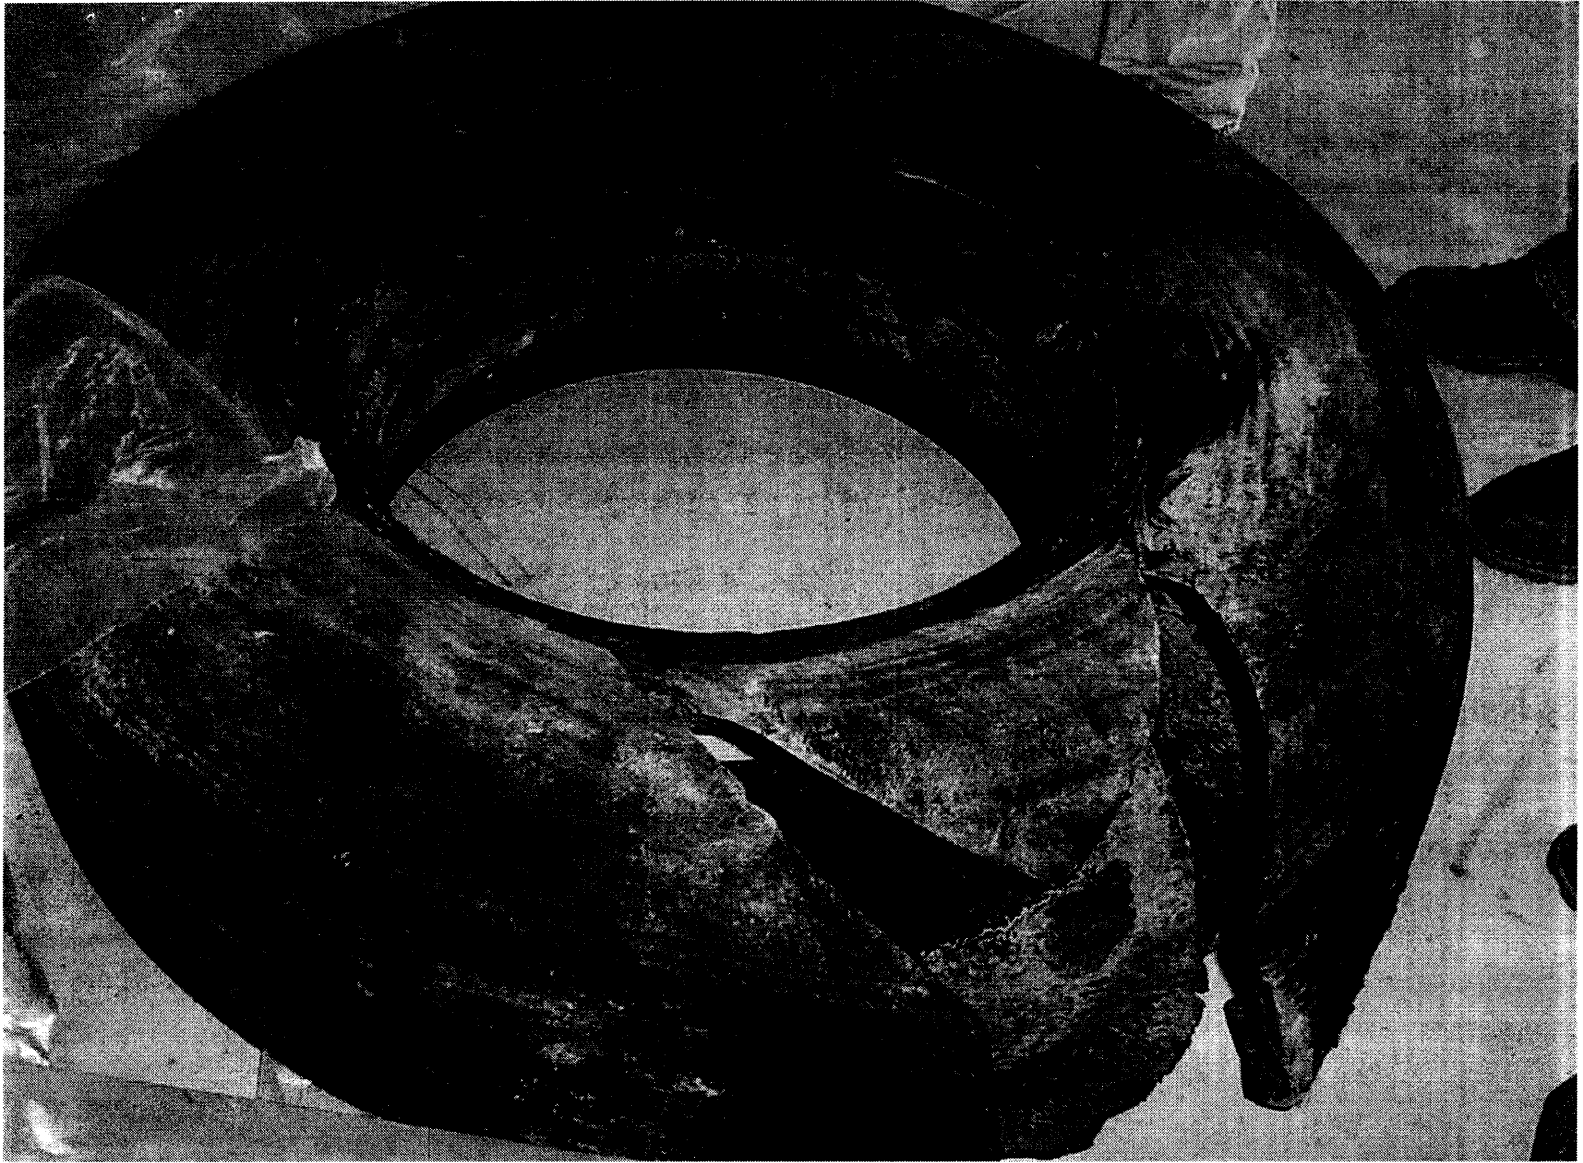
DSCN0028.JPG

CAMPBELL, CARLISLE C., JR (JSC-ES2) (NASA), 10:12 AM 2/14/2003, FW: Tire Photo

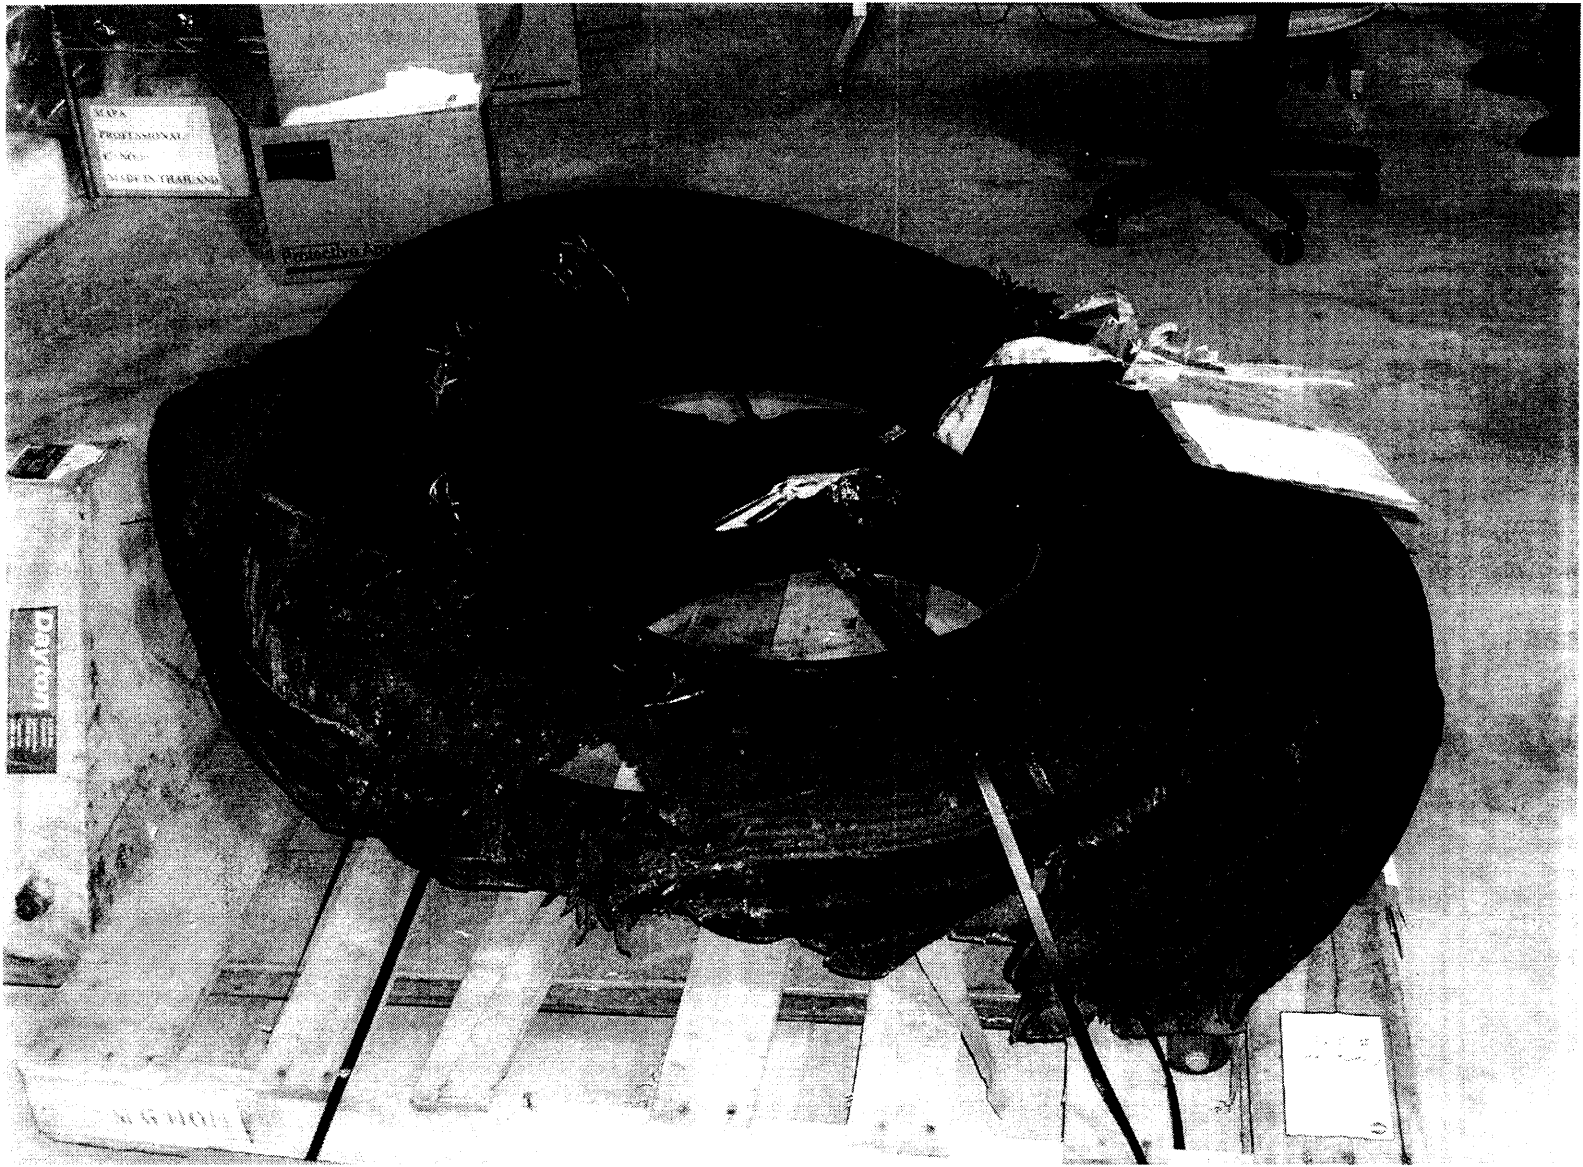
tirebalance.jpg

CAMPBELL, CARLISLE C., JR (JSC-ES2) (NASA), 11:53 AM 2/14/2003, FW: Tire at KSC

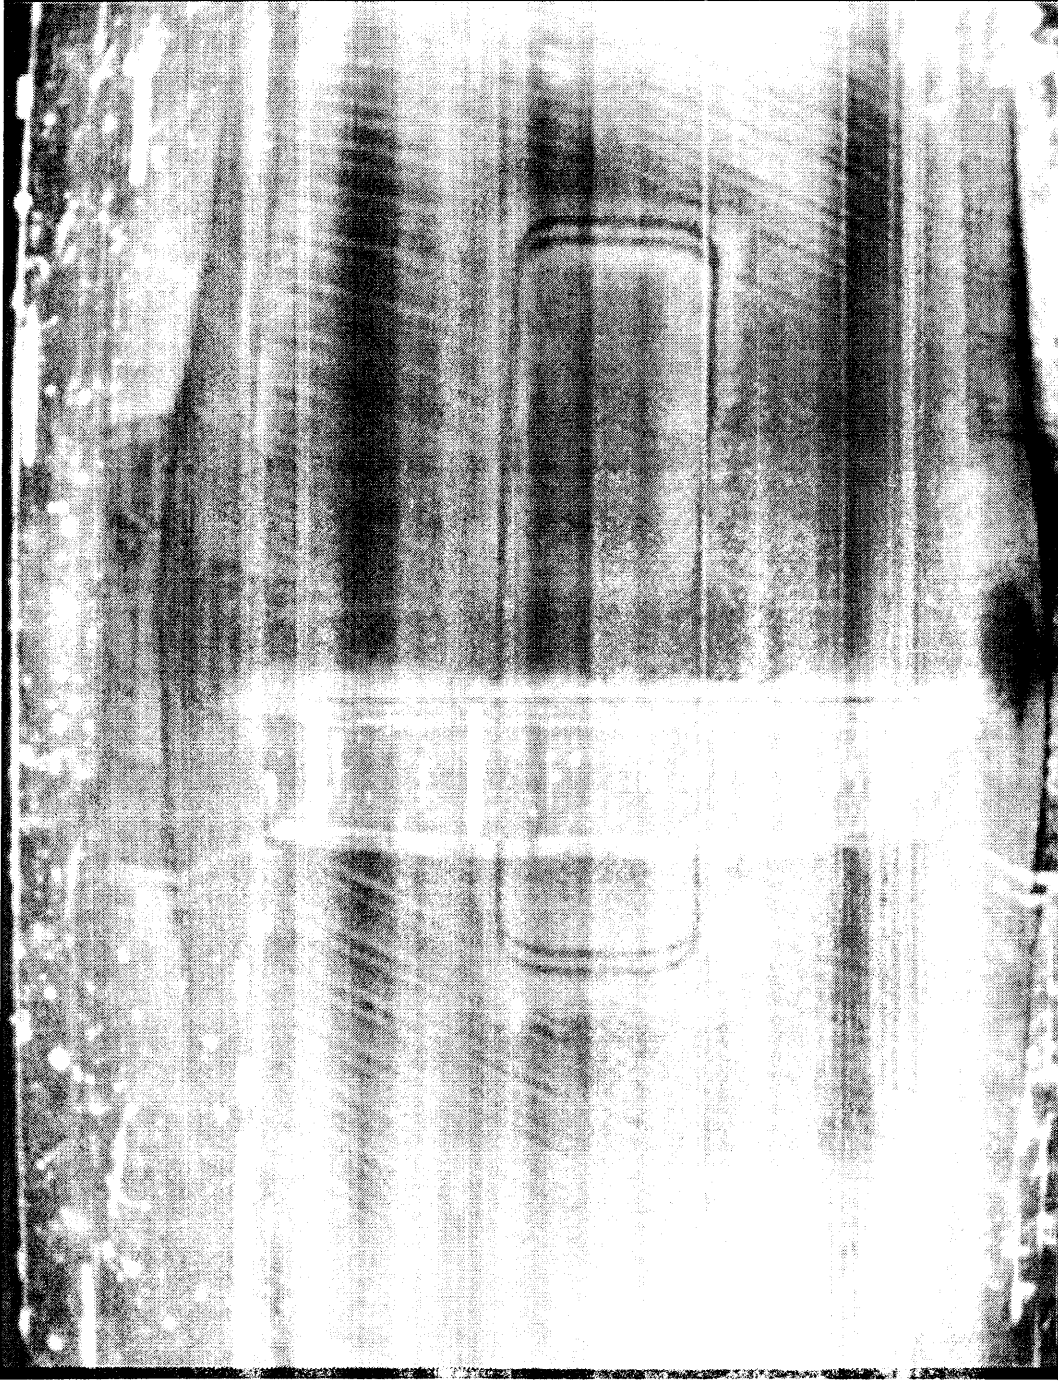
Tire Serial No. 0171U02004 LGTF Tire Code No. 503-N

Balance Pad: 3.5 ounce pad located approximately 180+ degrees from the serial number.
